**Aboriginal Heritage Due Diligence Assessment
Prepared by
Extent Heritage**

18 January 2022

Dural Health Hub, 679-685 Old Northern Road Dural – Aboriginal Due Diligence

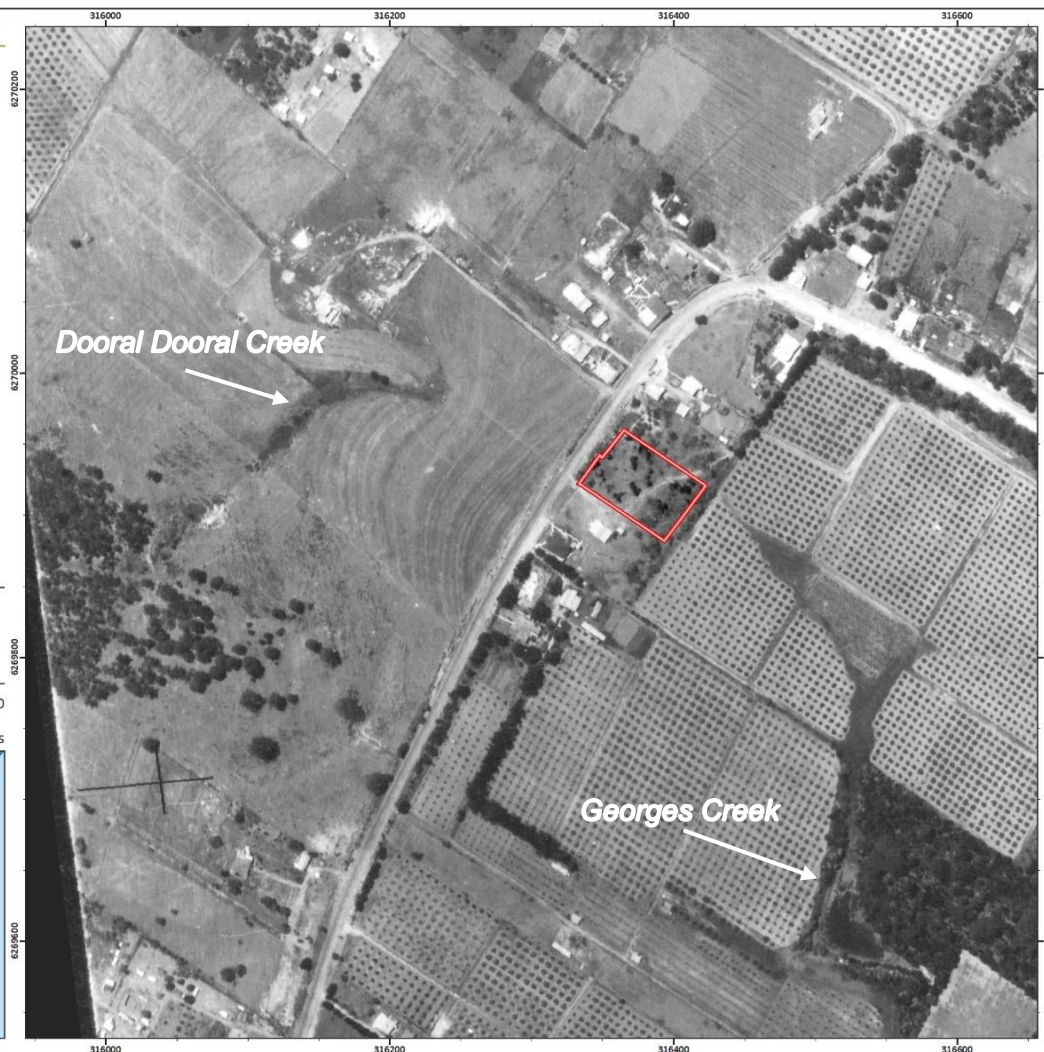
Figure 6. 1947 aerial photograph showing the study area as cleared with some shrubs and/or small trees on it and no structures. The conclusion of the Dooral Dooral Creek offshoot is visible to the west and Georges Creek to the south-east.

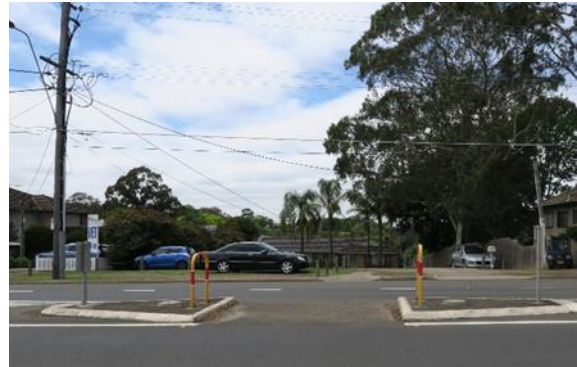
Figure 11. View to the east of 683-685 Old Northern Road. The slope is such that you can only see the roof of the structure from the road.

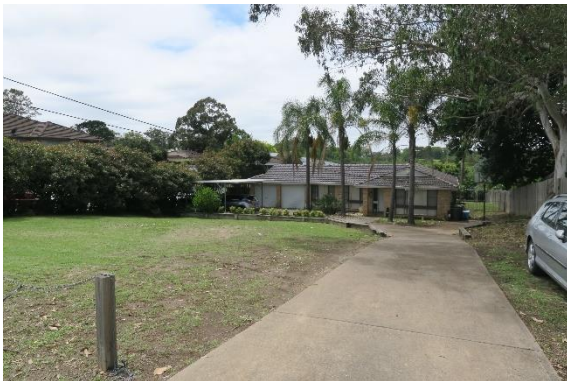
Figure 20. View to the east of 683-685 Old Northern Road showing the front of the property.

683-685 Old Northern Road consisted of a single storey brick structure with a concrete driveway providing access to a carport at the front of the property (Figure 20). The rear yard was grassed with several small trees at the perimeter (Figure 21). Two concrete tanks were observed on the south-eastern side of the house (Figure 22). Two areas of exposed soil were visible at 683-685 Old Northern Road. One on the northern side of the property indicated a mixed clay fill, likely associated with the construction of the house. Another exposure was visible in the front portion of the property and revealed a mixed sandy loam material with some gravel inclusions. This exposure appears to have been the result of downslope erosion.

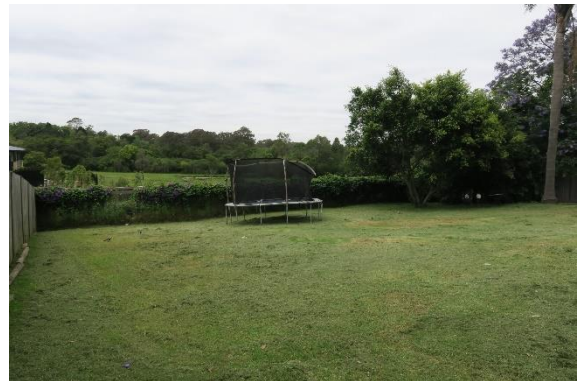
Figure 21. Rear sloping yard of 683-685 Old Northern Road, looking east.

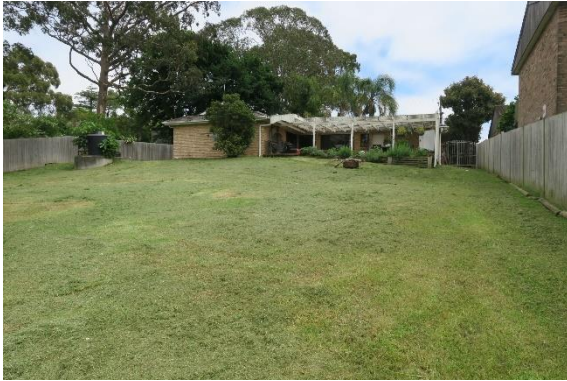
Figure 22. View to the west of the 683-685 Old Northern Road showing the eastward slope, the house and two concrete tanks on the southern side of the house.

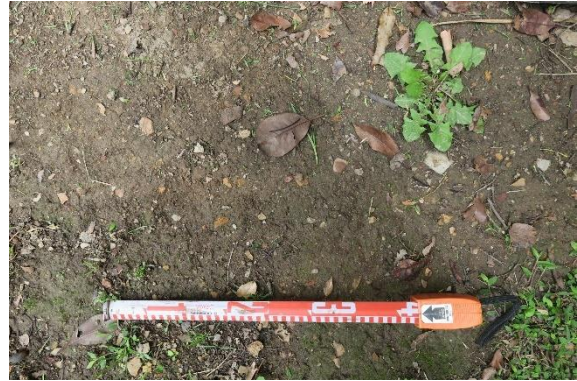
Figure 23. Exposed soil on the northern side of 683-685 Old Northern Road. Soil is mixed clay with gravel and brick fragment inclusions.

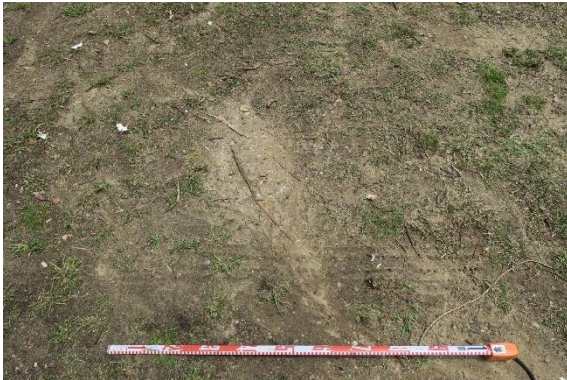
Figure 24. Exposed soil on the western side of 683-685 Old Northern Road, on the slope between the house and Old Northern Road. Soil is a mixed loamy sand with some gravel inclusions.
