Preliminary contamination investigation

Proposed Lot 3, 51 Winter Lane, Summer Hill Creek NSW

Summary report

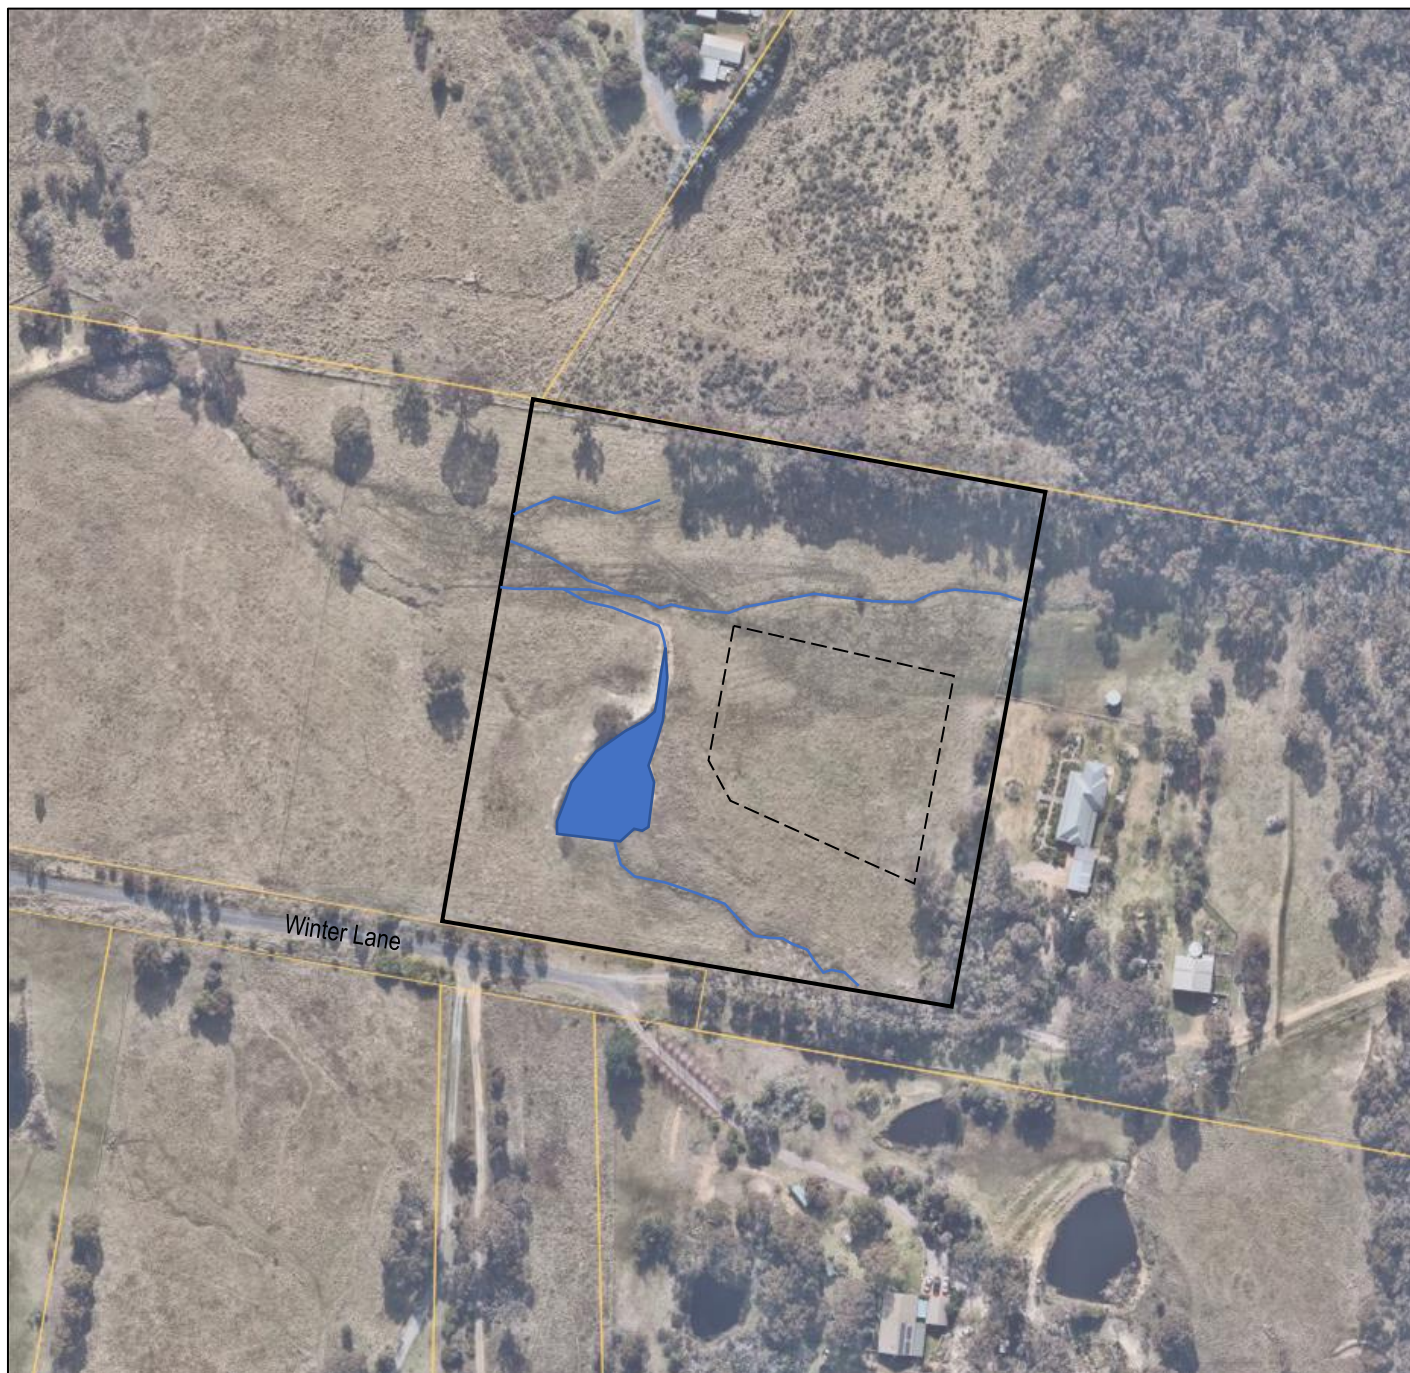
| Figure 2. Site layout | |

No buildings or structures are present in the investigation area. A dam is located in the western section of the proposed Lot 3. Drainage lines were observed in the northern and southern sections of the proposed lot. The proposed building envelope is located in the eastern section of the site.

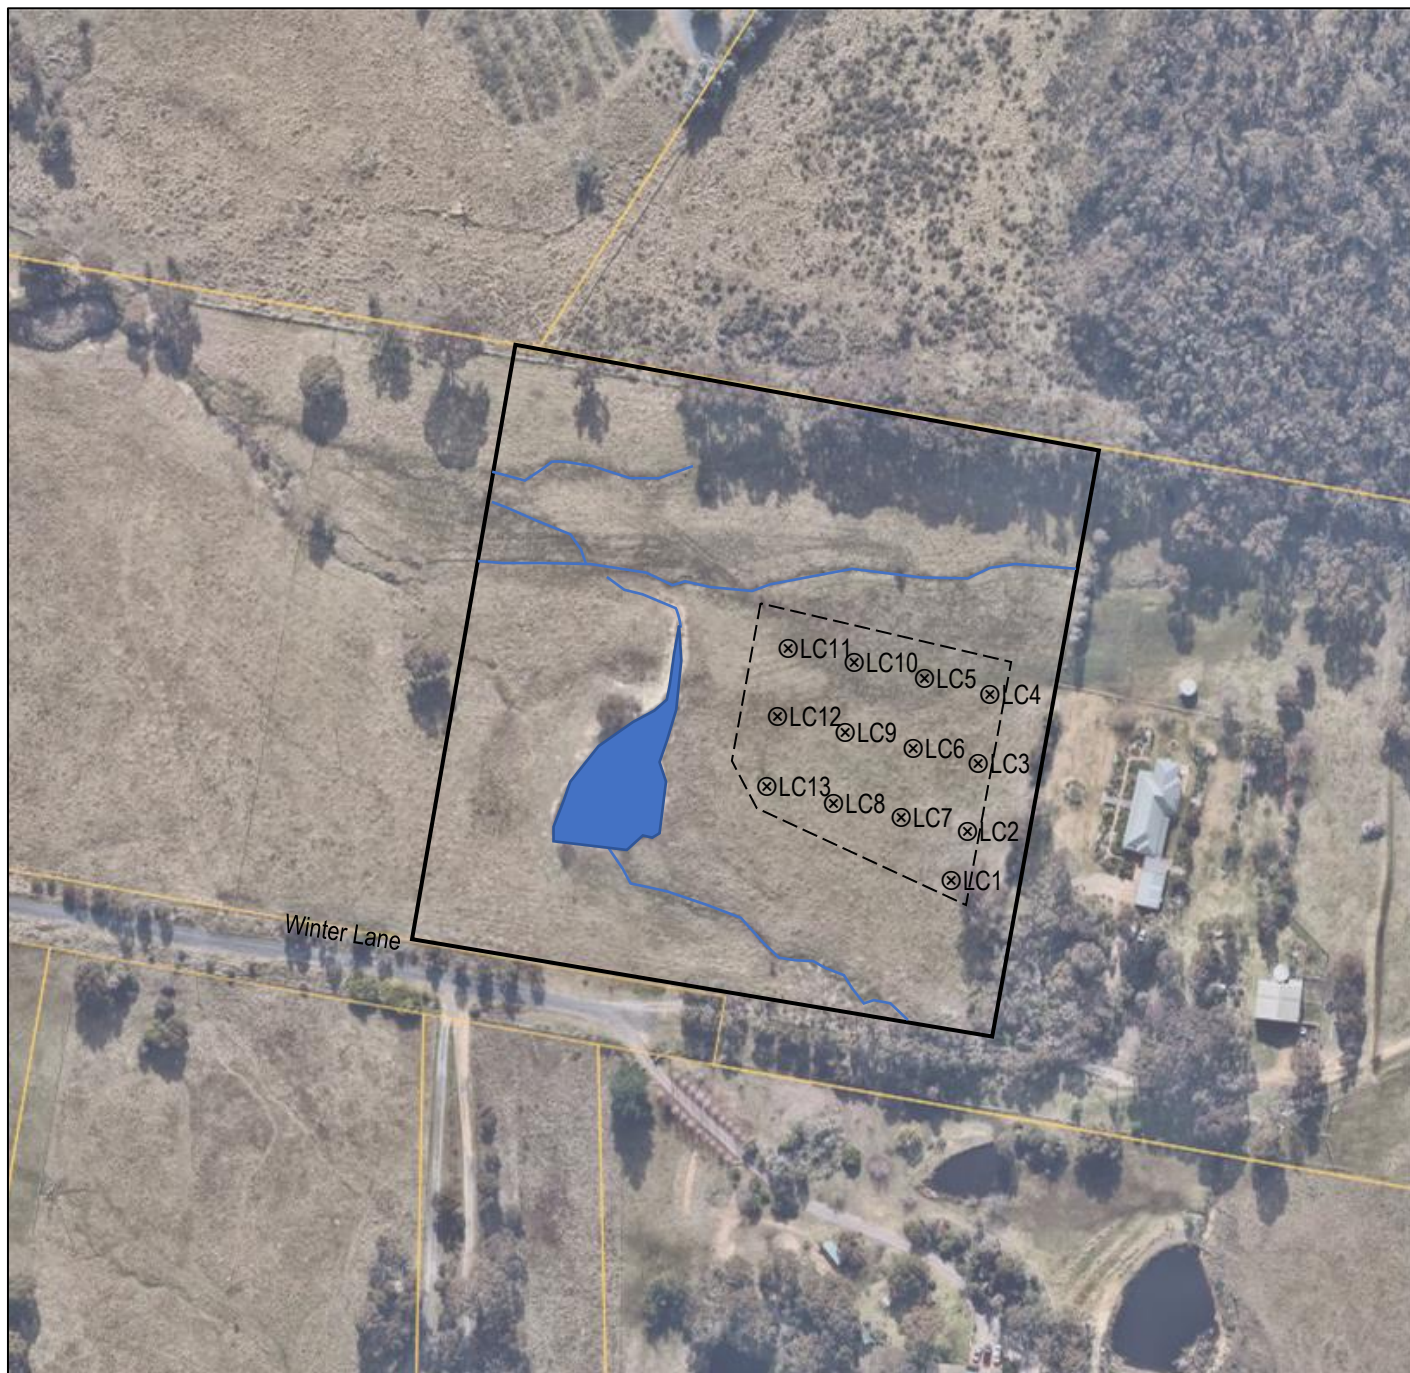
| Figure 3. Sampling locations | |

The sampling density across the site can detect a potential hot spot across the site with a radius of 12m at a 95% level of confidence. The number of sampling locations was in accordance with the recommended density in the EPA sampling guidelines (EPA 2022).

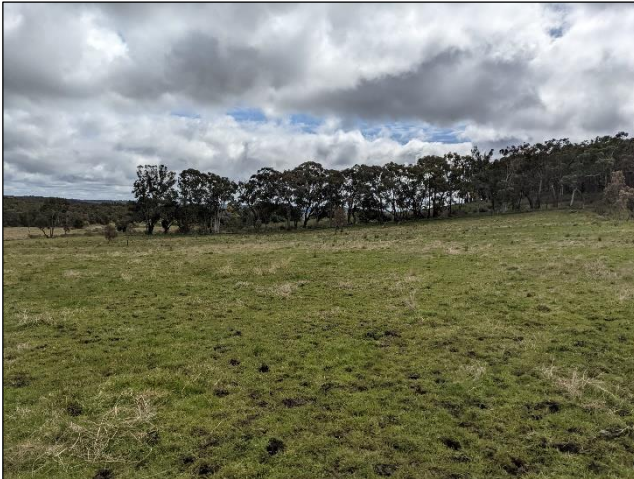
Figure 4. Photographs of the site

No signs of visible contamination such as discolouration or staining was identified on the surface of the site. No signs of settlement or subsidence was identified on the site.

Looking north over the site.

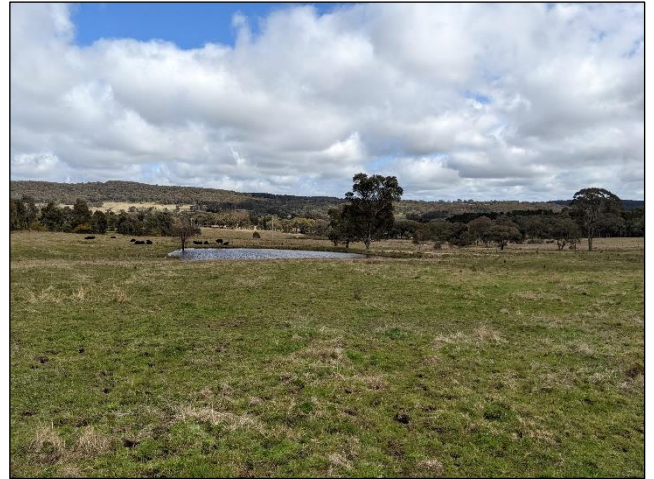
Looking west over the site.
