# **Updated Moore Point Precinct Review Study - Part 1: Contamination, Acid Sulfate Soils & Remedial Strategy**

Newbridge & Bridges Roads, Liverpool, NSW

**Report No:** E22882.E09\_Rev3

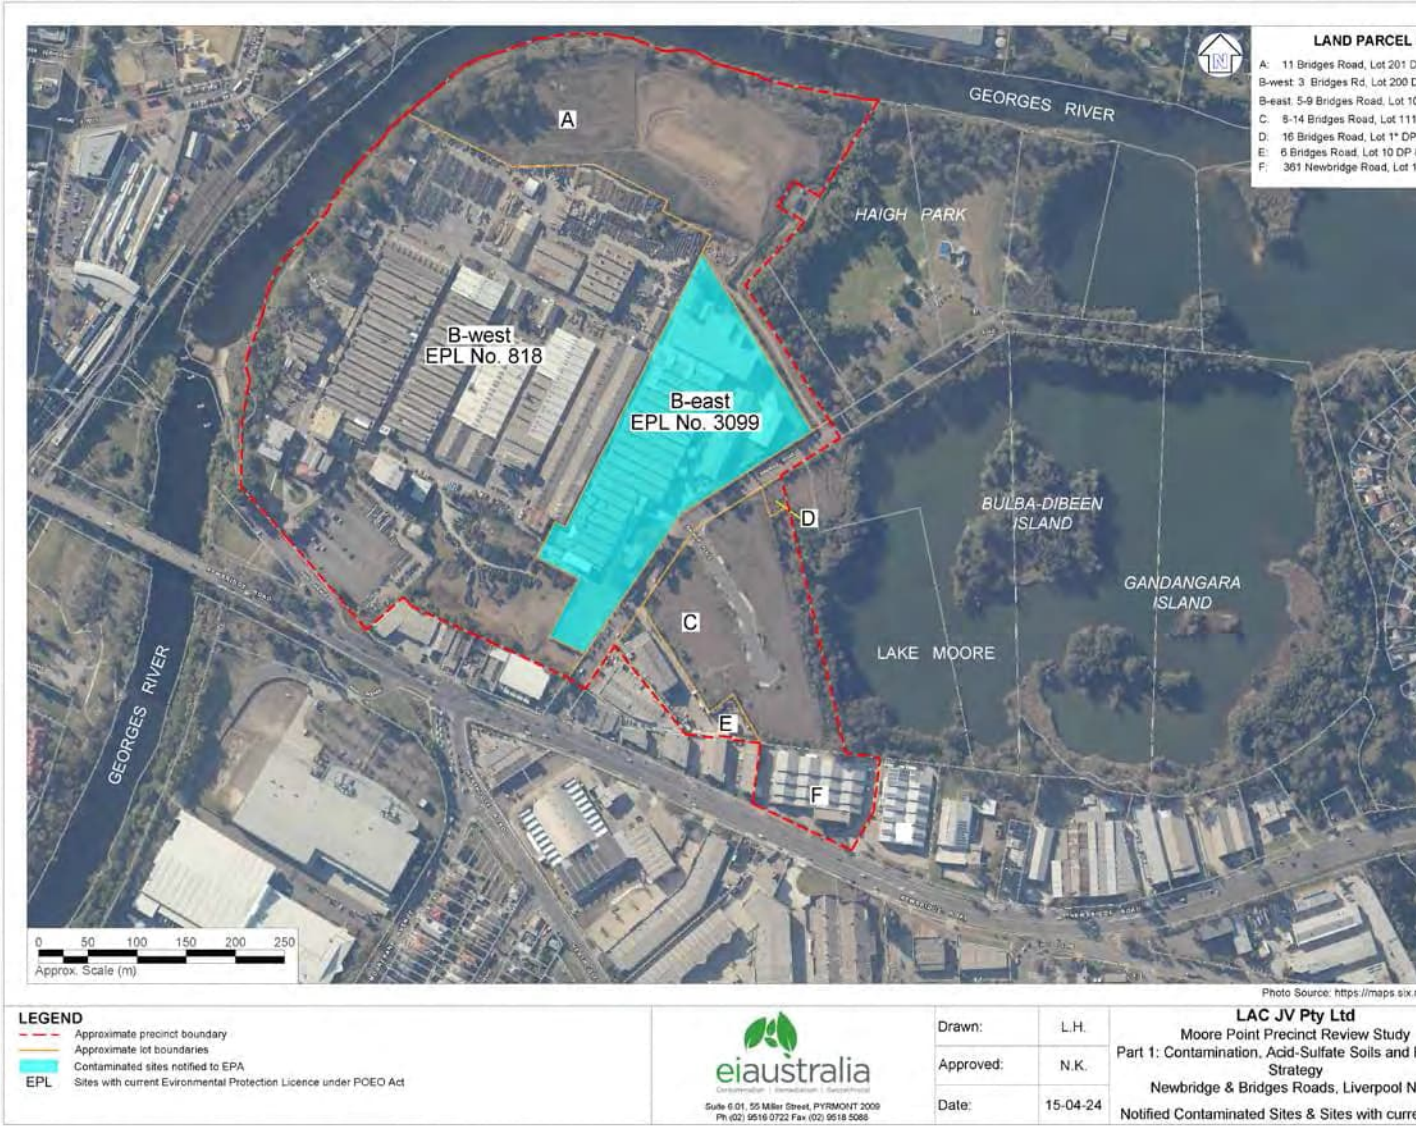
Figure 4-2 Notified Contaminated Sites and Sites with Current EPLs

This search confirmed two properties within the suburb of Moorebank NSW were on the notified sites list (**Table 4-2**). These parcels are highlighted on **Figure 4-2**. It was also noted that the list of notified sites did not include any property located within 500m of the precinct.
