# Arboricultural Impact Assessment for Planning Proposal Stage

Eastwood Rugby Club-  
146 Vimiera Rd Marsfield.

Date: 5 May 2022.

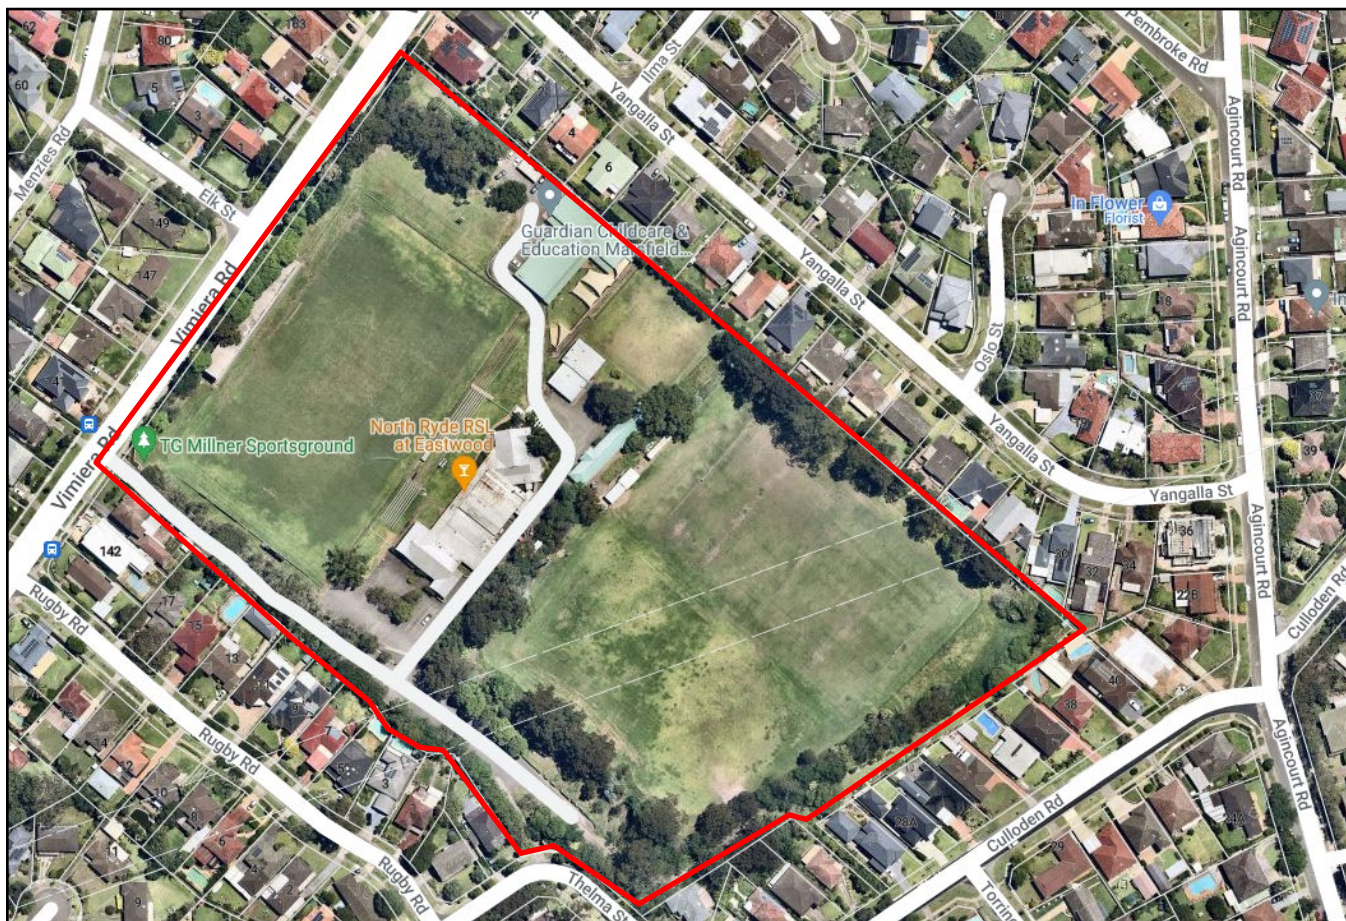
Figure 1- Approximate boundary of the subject site. Image taken from near map image.

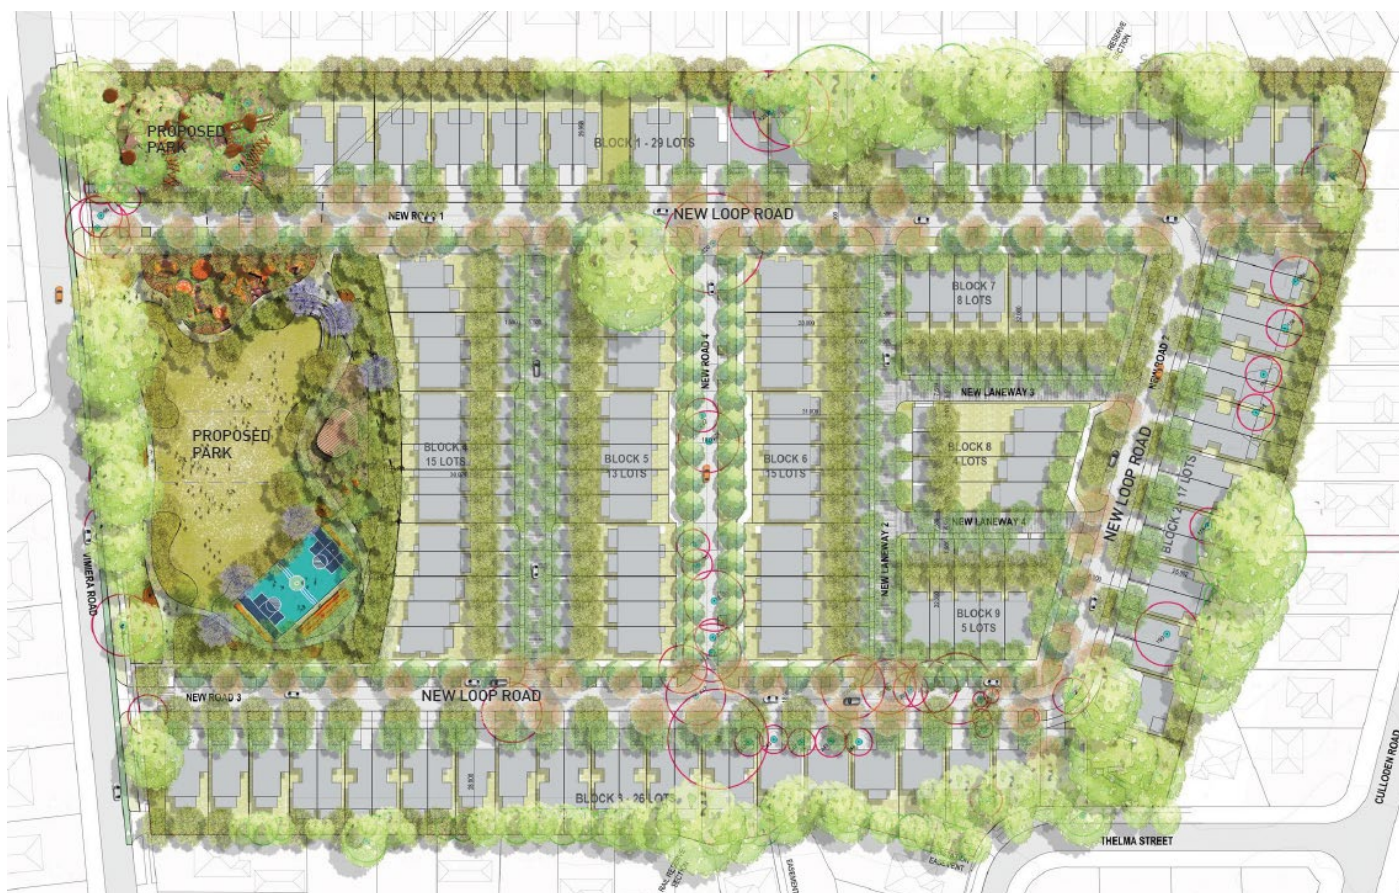
Figure 2- Site plan showing the proposed layout. Please refer to the Landscape Architectural and public domain design report for further detail and clarity.

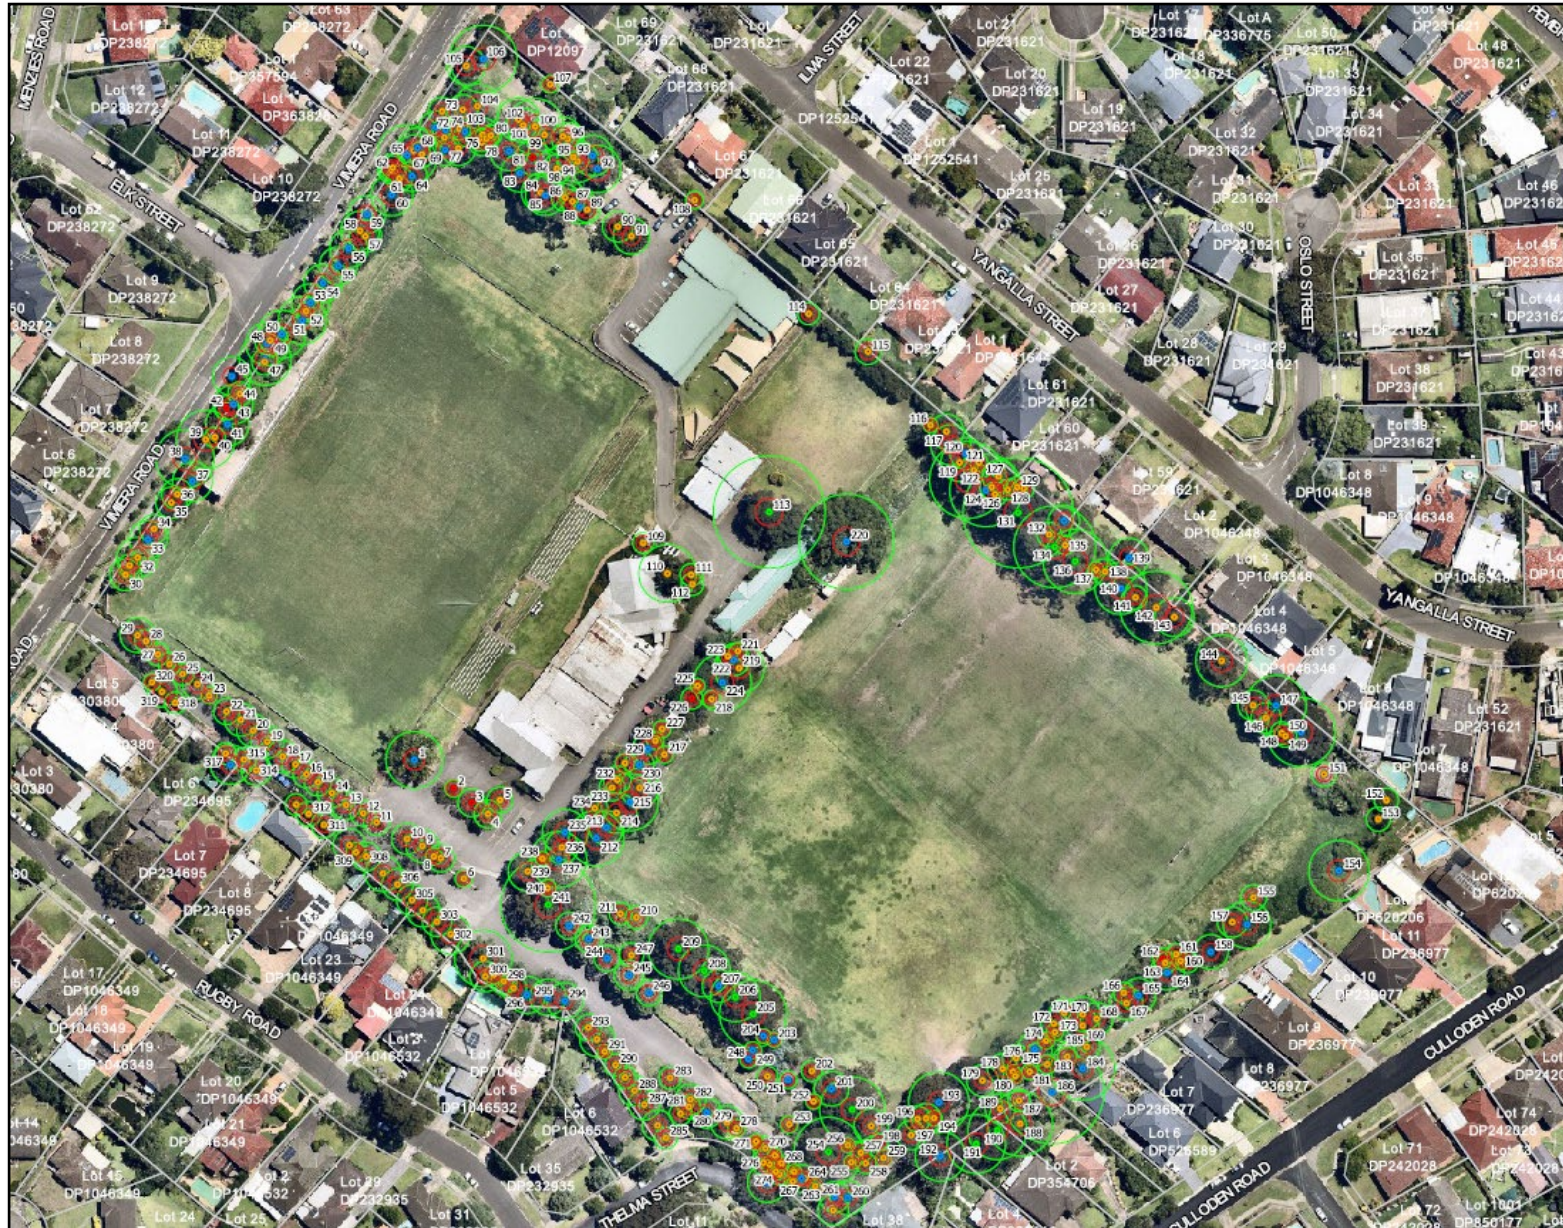
Figure 3- Tree locations with TPZ (Green) and SRZ (Red). Please refer to individual PDF document for superior clarity.

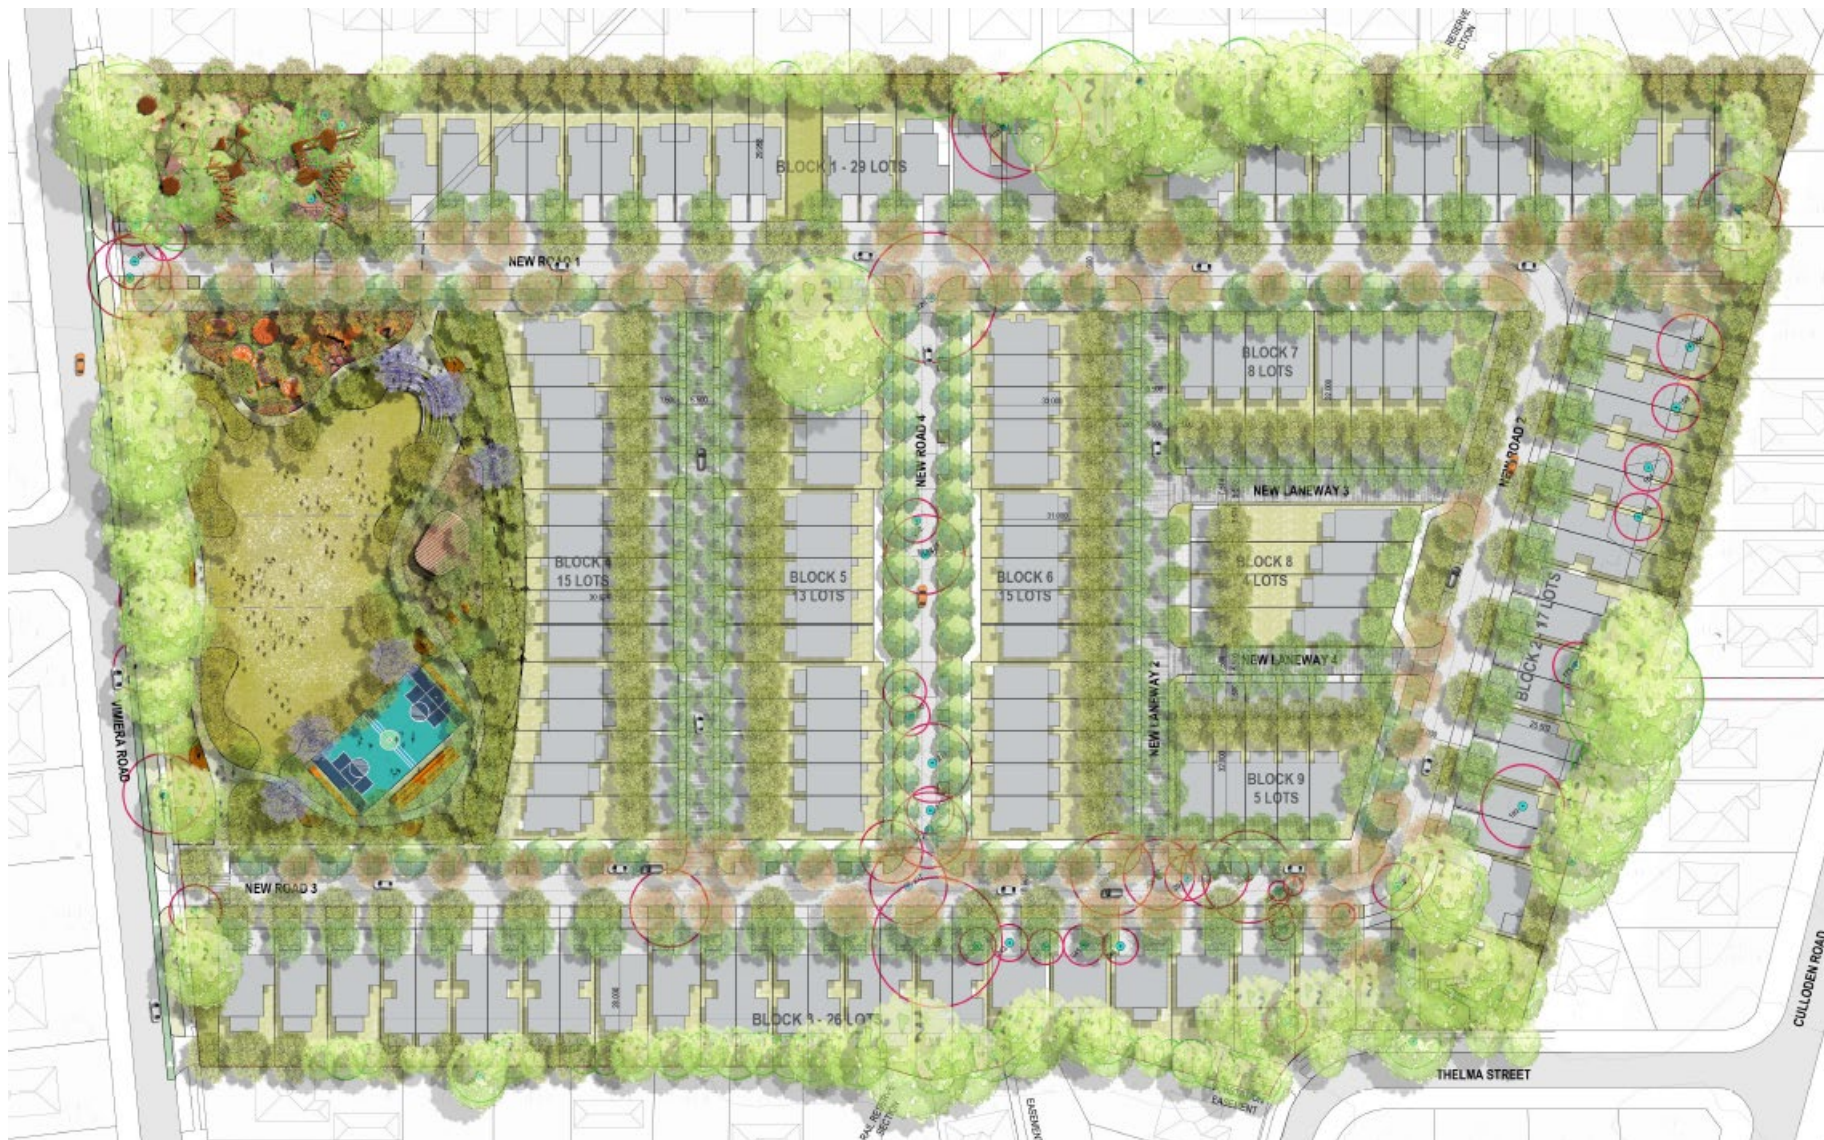
Figure 5- Image showing the illustrative landscape masterplan.

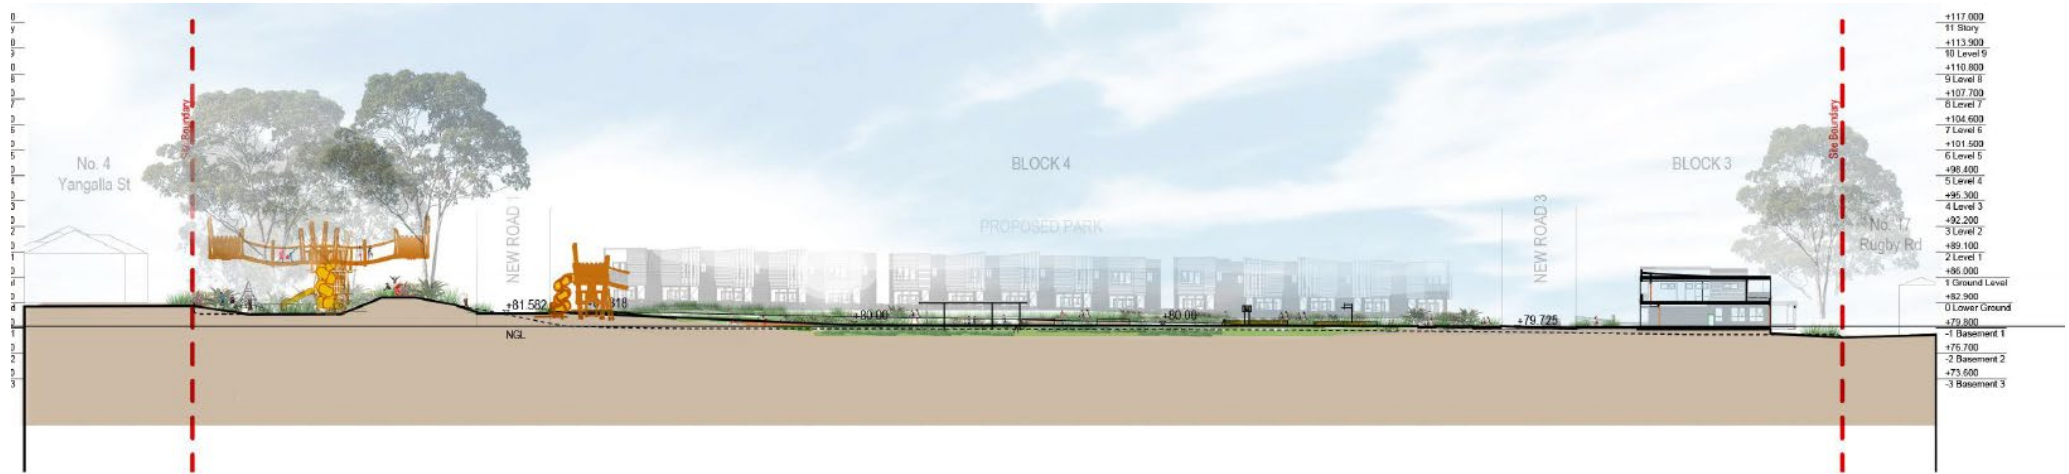
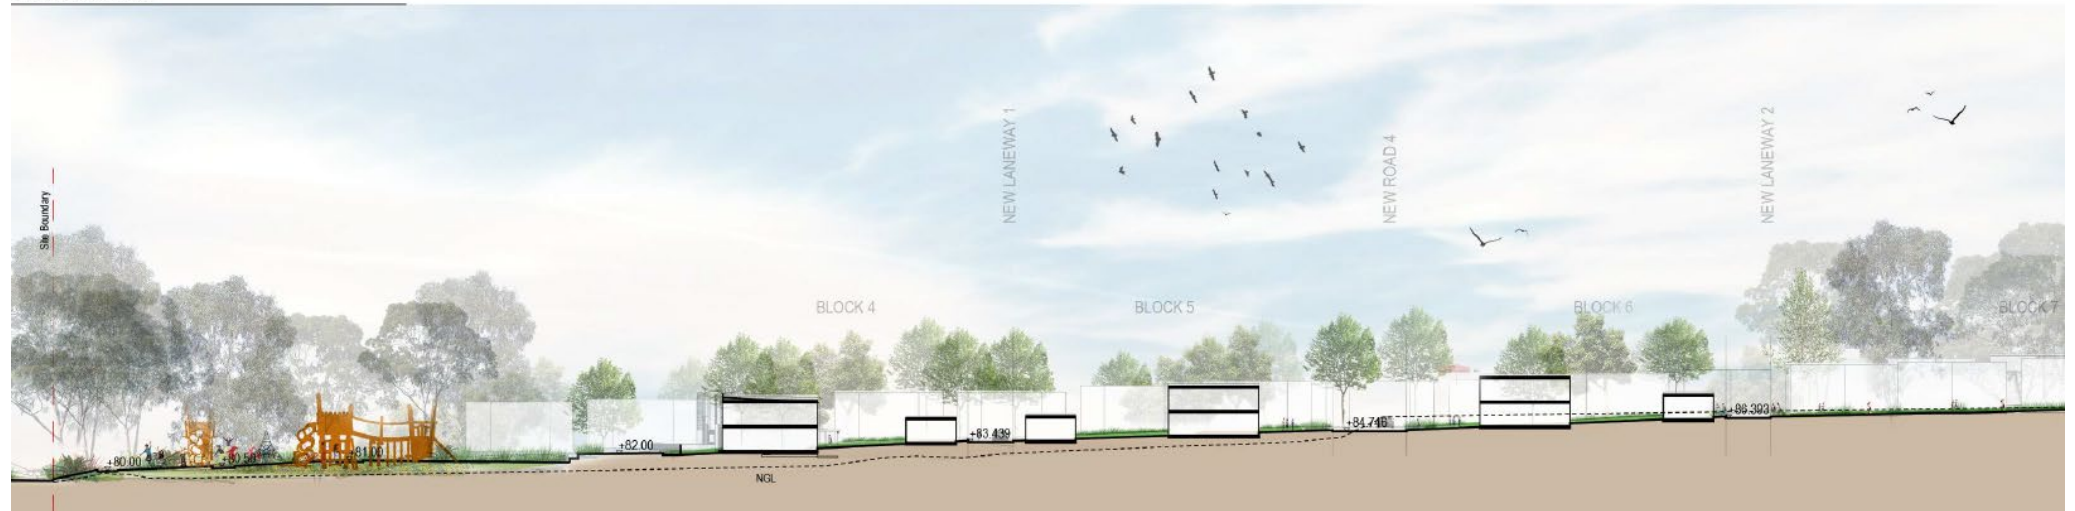
SECTION AA

Figure 6- Section drawings showing existing and proposed levels. Please refer to individual Appendix A Landscape Drawing set for superior clarity.

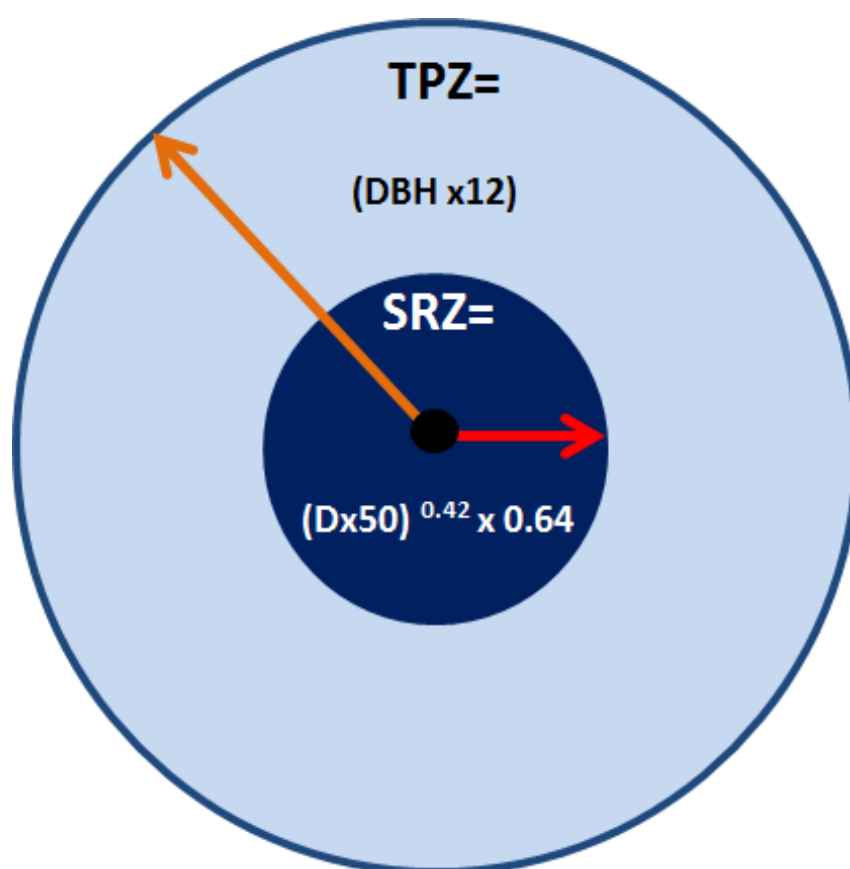
In accordance with Australian Standard *AS4970-2009 Protection of trees on development sites*<sup>13</sup>, Tree Protection Zone (TPZ) radius is calculated using the following procedure. Diameter of the trunk is measured at approximately 1.4m above ground level; this measurement is referred to as DBH (Diameter at Breast Height).  $R_{TPZ} = DBH \times 12$ . For multi-stemmed trees the formula used is  $R_{TPZ} = \sqrt{[(DBH1)^2 + (DBH2)^2 + (DBH3)^2]}$ . The TPZ is measured radially from the centre of the stem and must be protected on all sides.

The Structural Root Zone (SRZ) radius is calculated by measuring the diameter of the stem close to ground level, just above the basal flare. This measurement is taken as  $D$  and then used in the following formula:  $R_{SRZ} = (D \times 50)^{0.42} \times 0.64$  and becomes the Structural Root Zone, measured radially from the centre of the stem.

Figure 8- A representation of TPZ & SRZ calculations.
