# **Preliminary Site Investigation**

**515 Crookwell Road, Kingsdale, NSW**

*Planning Proposal – Large Lot Residential Development*

**Report No:** 20027CC-001

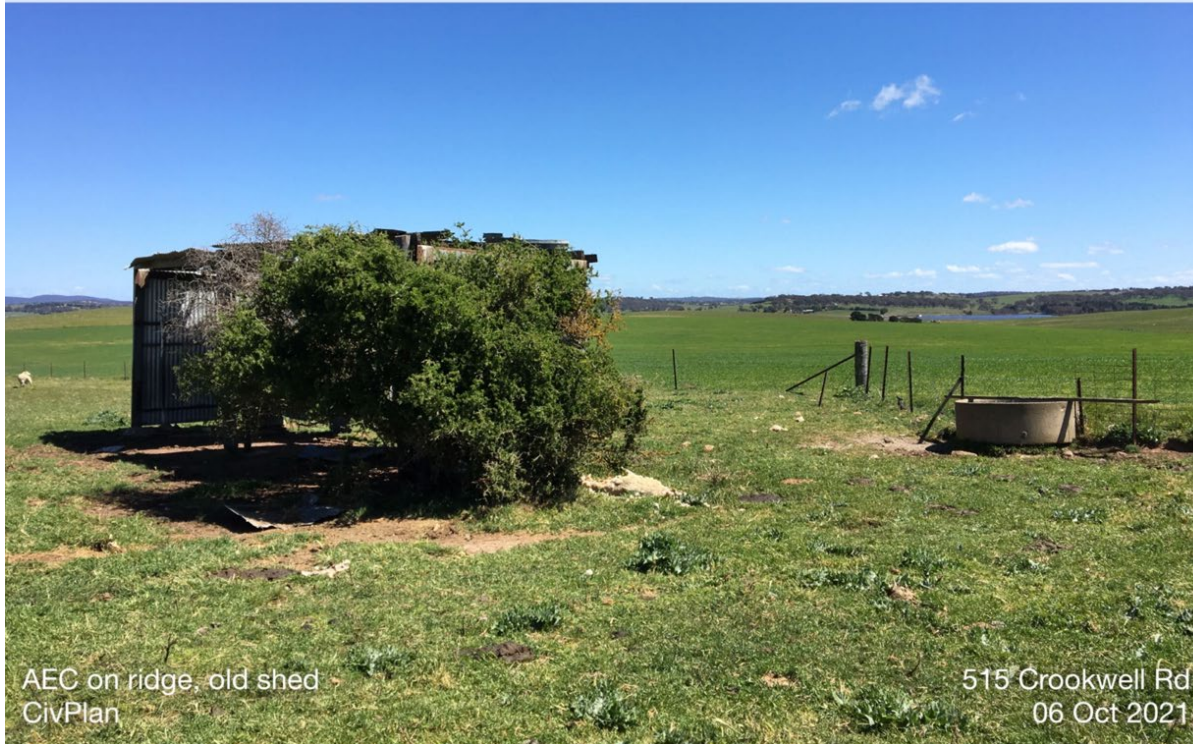
AEC on ridge, old shed  
CivPlan

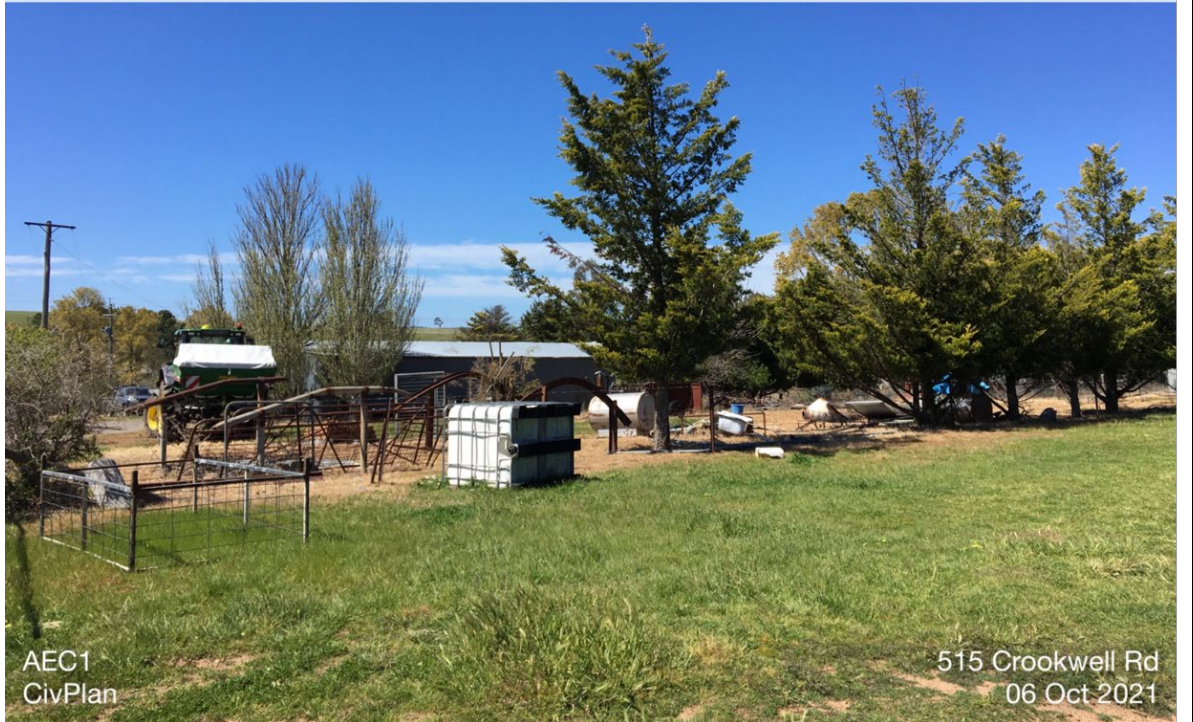
AEC1  
CivPlan

- AEC 1
  - Shed, silo and storage area (HM, TRH, BTEXN, PAH, OCP/OPP, PCB & asbestos)
  - Shed, silo and storage area footprint validation (post demolition) (HM, TRH, BTEXN, PAH, OCP/OPP, PCB & asbestos).

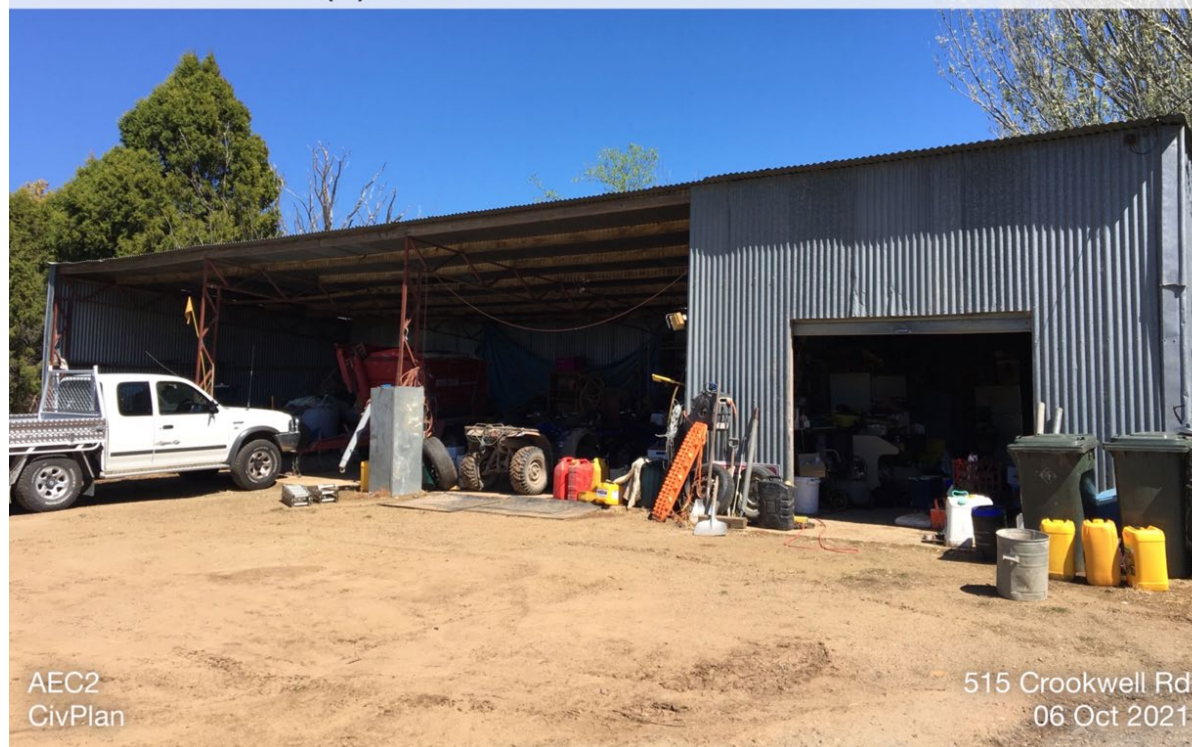
AEC2  
CivPlan

- AEC 2
  - Shed, silo and storage area (HM, TRH, BTEXN, PAH, OCP/OPP, PCB & asbestos)
  - Driveway fill material (HM, TRH, BTEXN, PAH, OCP/OPP, PCB & asbestos)

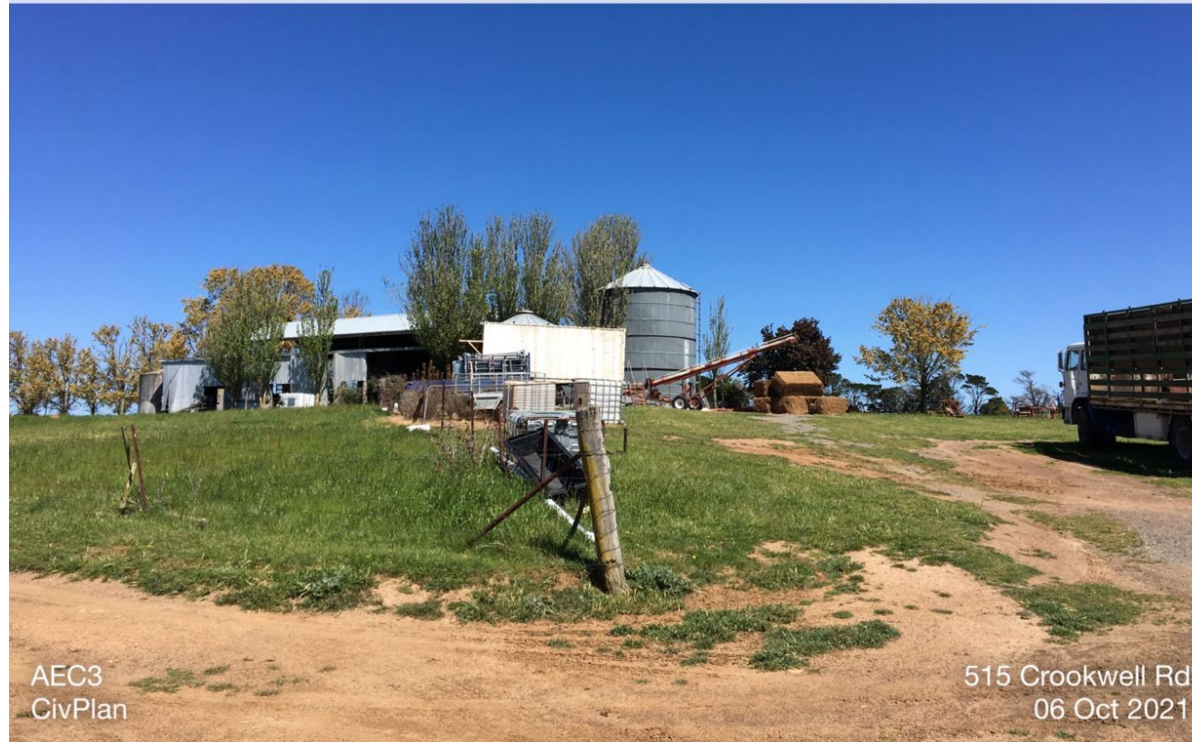
AEC3  
CivPlan

- AEC 3
  - Shed, silo and storage area (HM, TRH, BTEXN, PAH, OCP/OPP, PCB & asbestos)
  - Shed, silo and storage area footprint validation (post demolition) (HM, TRH, BTEXN, PAH, OCP/OPP, PCB & asbestos).

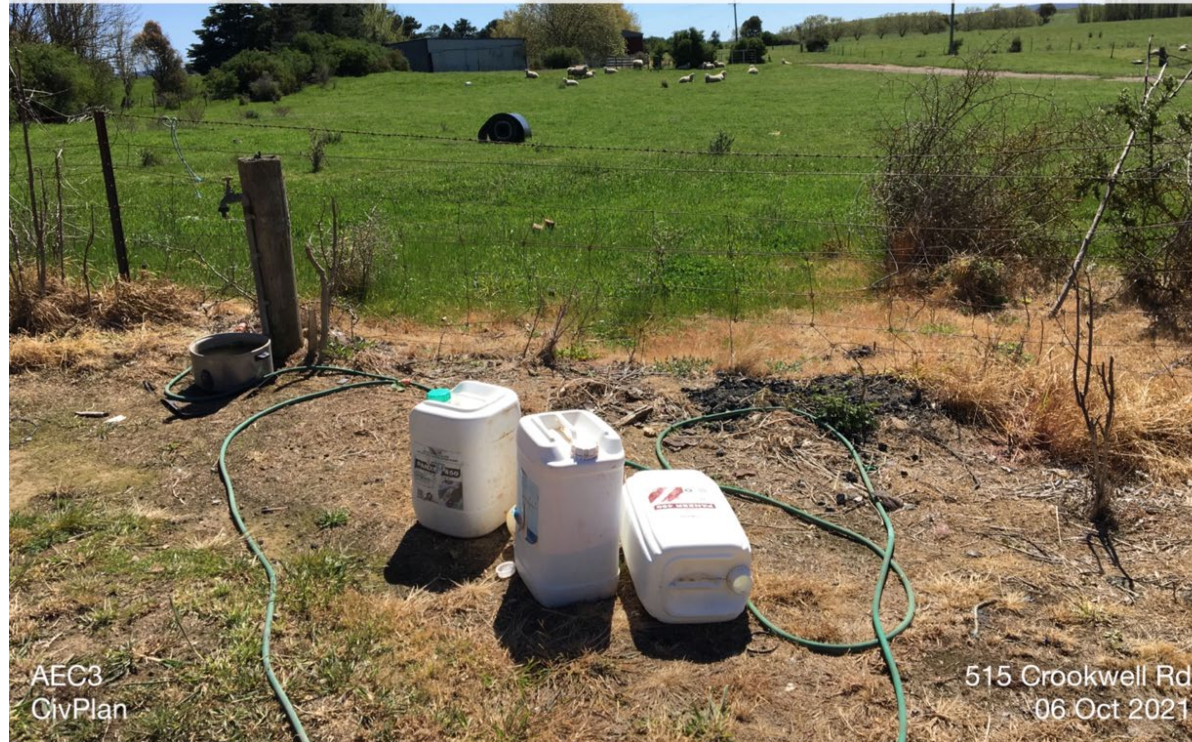
AEC3  
CivPlan

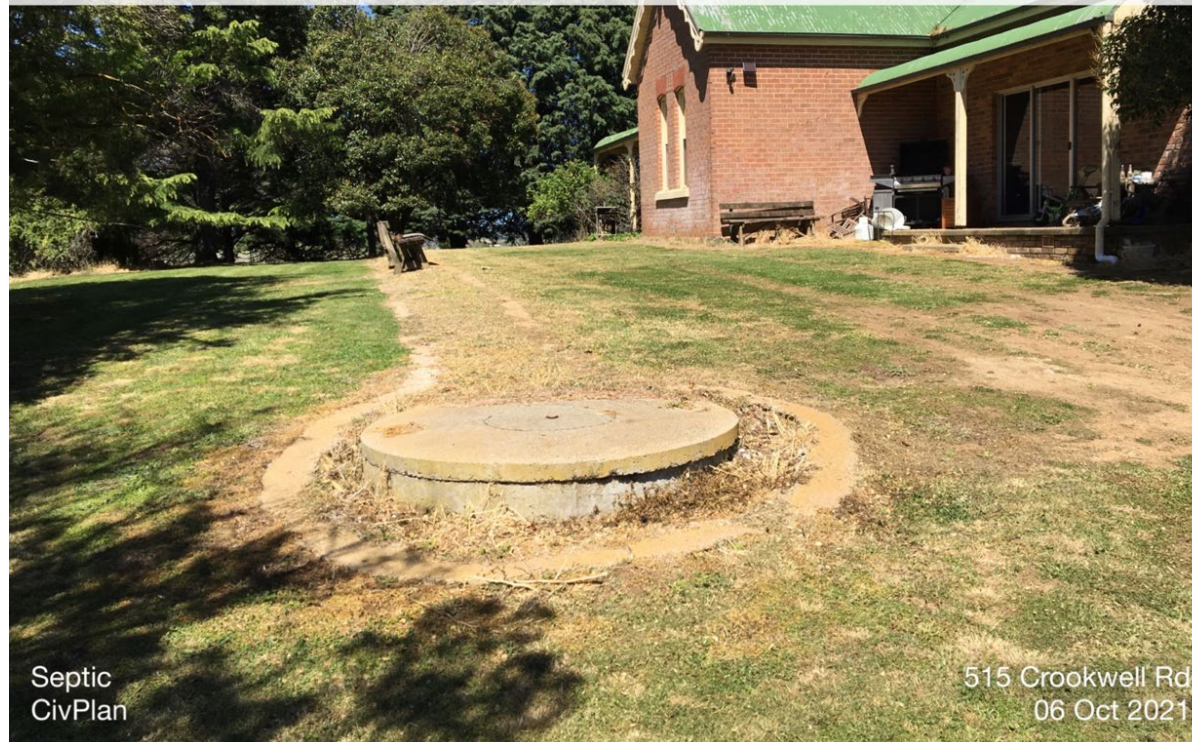
Septic  
CivPlan

- Dwelling and septic (HM, TRH, BTEXN, PAH, OCP/OPP, PCB, asbestos, microbial)
  - Dwelling, shed, silo and storage area footprint validation (post demolition) (HM, TRH, BTEXN, PAH, OCP/OPP, PCB & asbestos).

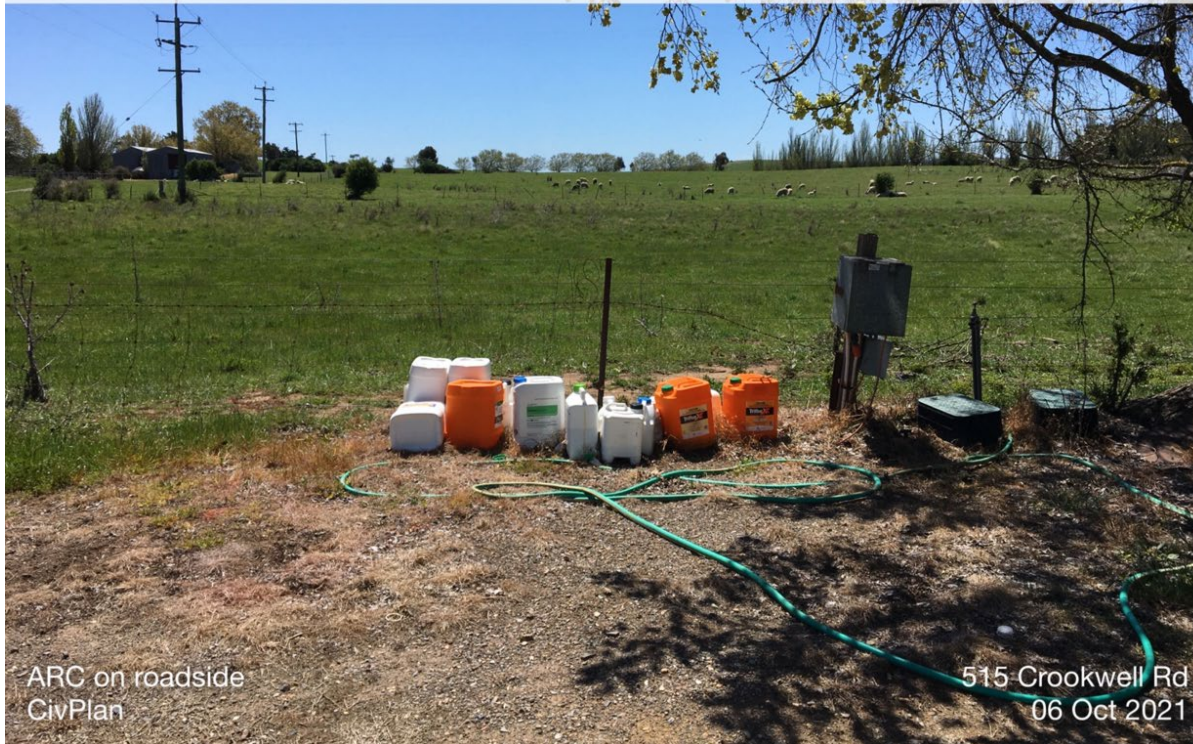
ARC on roadside  
CivPlan

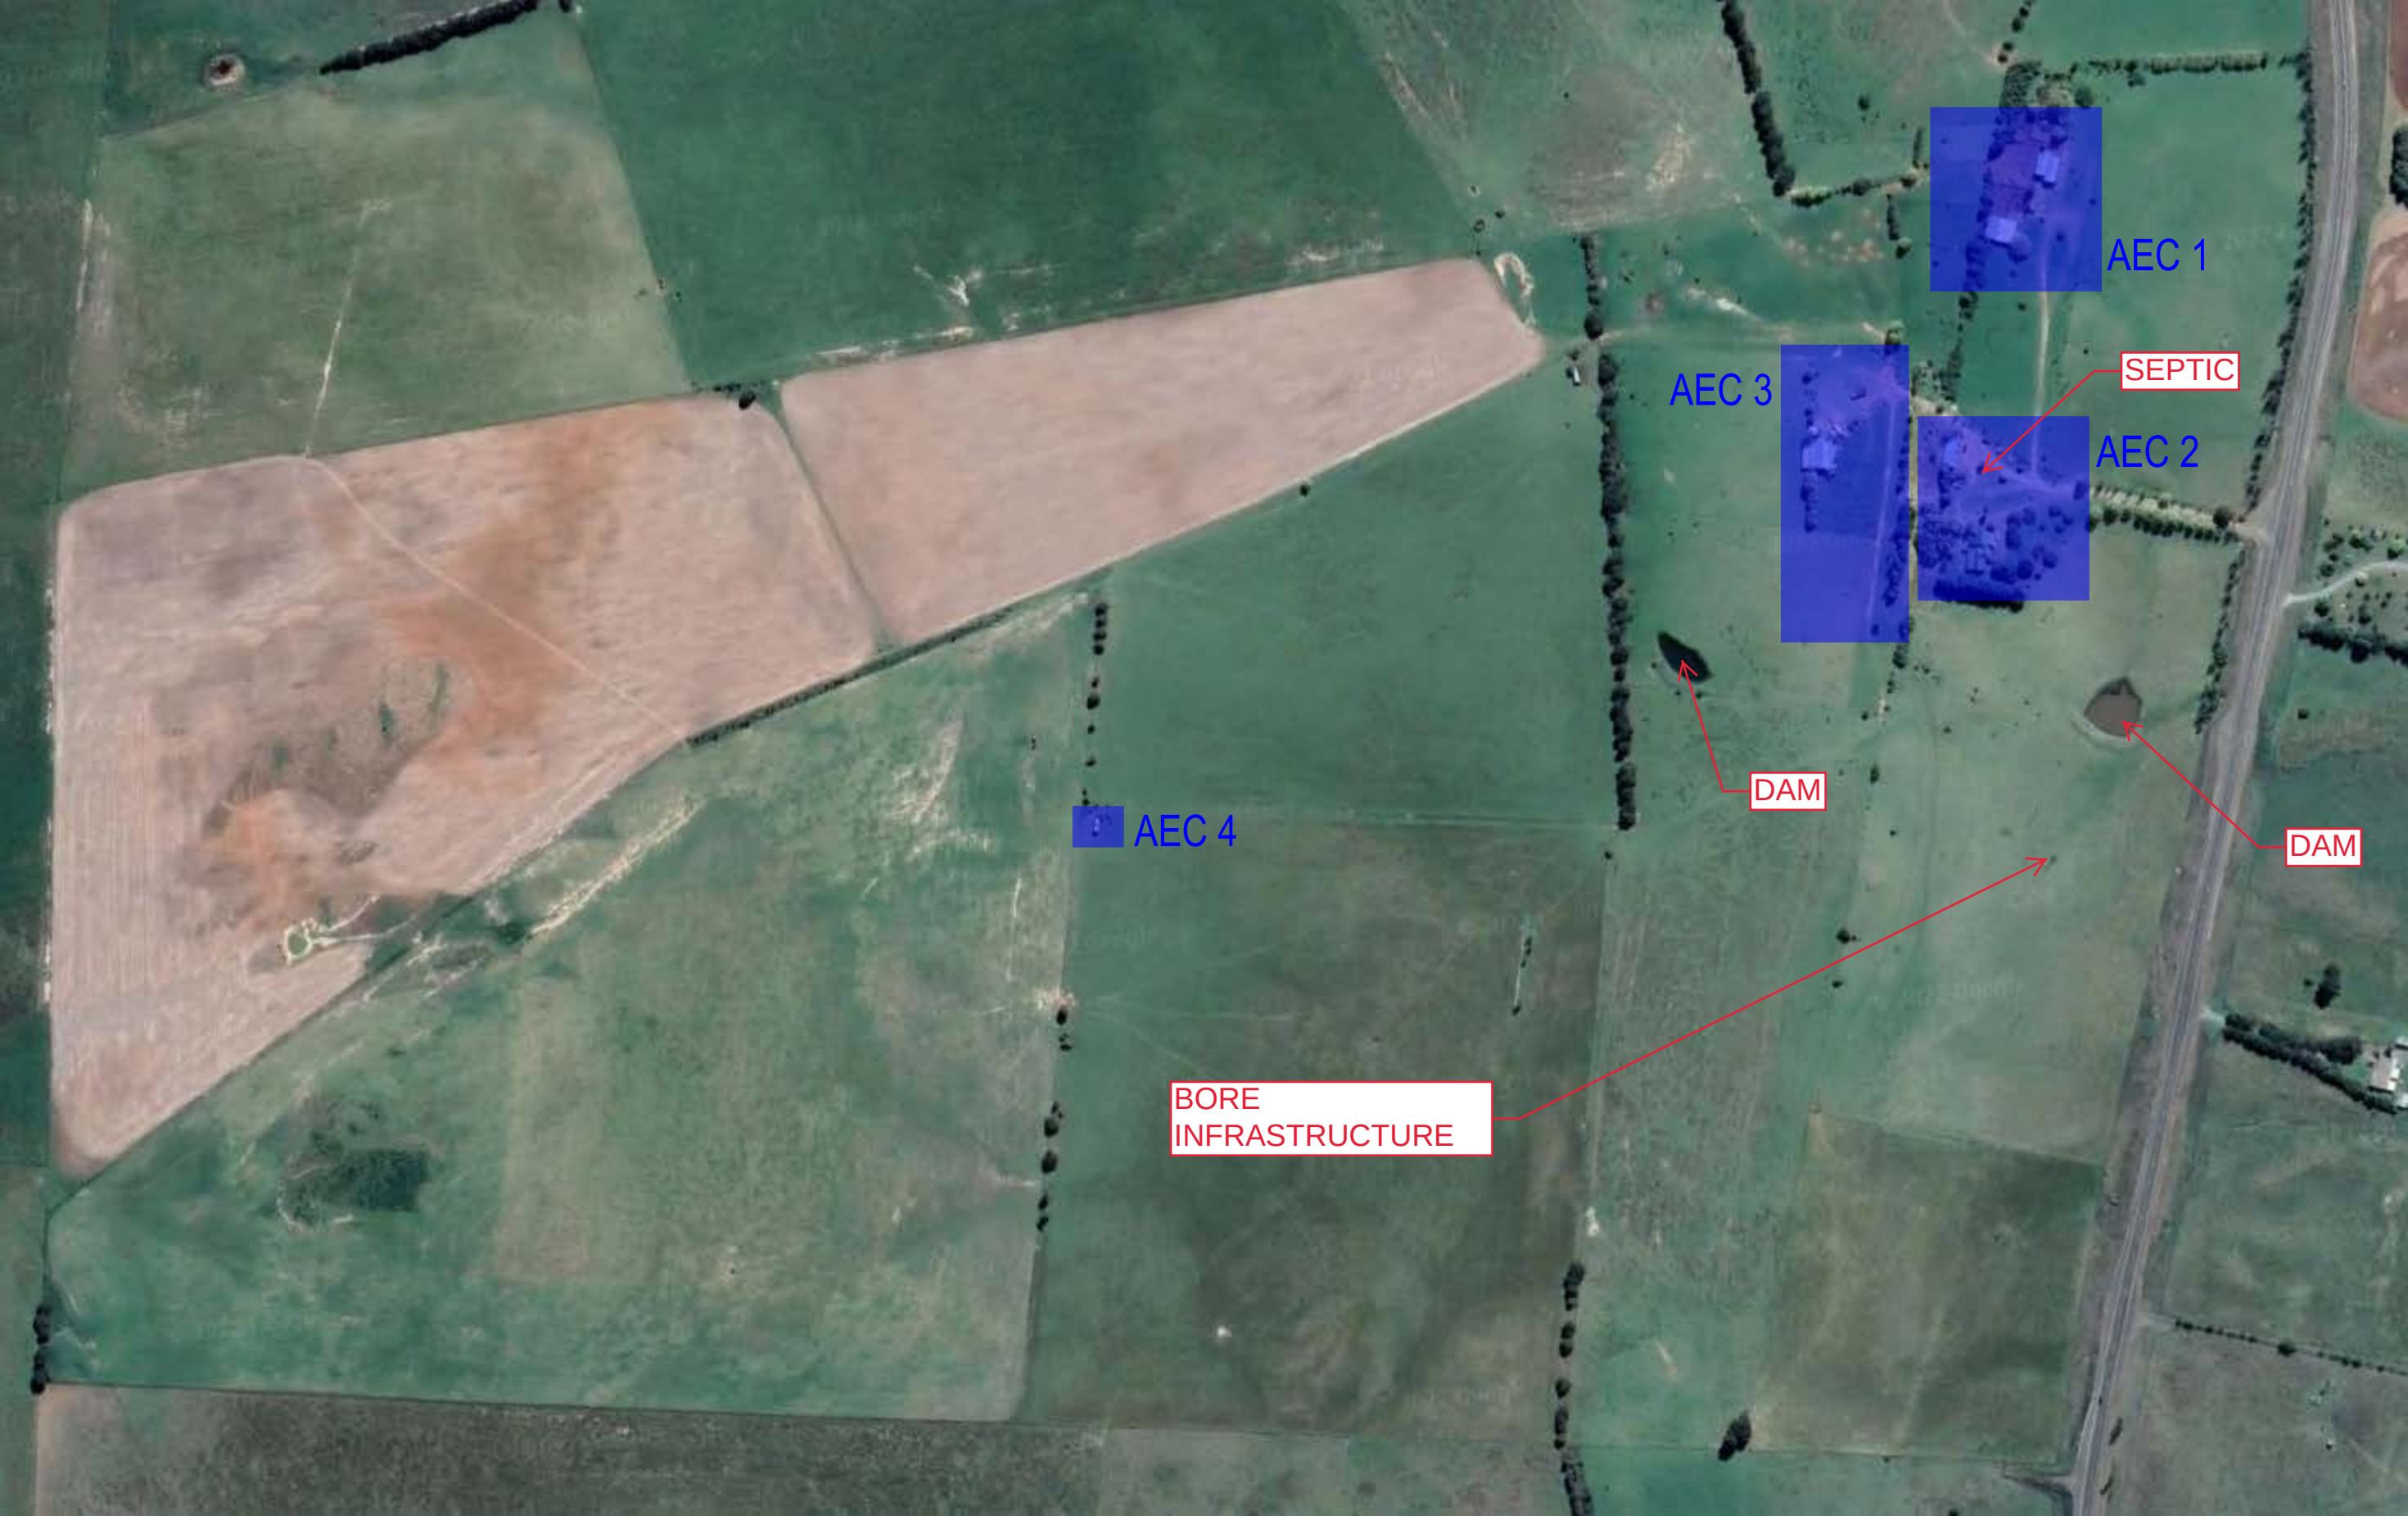
## **Appendix E – Areas of Environmental Concern (AEC) Plan**

AEC 1

AEC 3

Samples are to be tested for the above-mentioned analytes. A map showing the AEC's can be seen in Appendix E.
