## Preliminary Site Investigation and Assessment Report

| <b>Site Address</b> | <b>25 South Parade, Auburn, NSW</b> |
| <b>Project Reference No.</b> | JDRYU152_PSI_V3_25 South Parade,<br>Auburn, NSW_13072023. |

## DR UPSILON ENVIRONMENTS PTY LTD

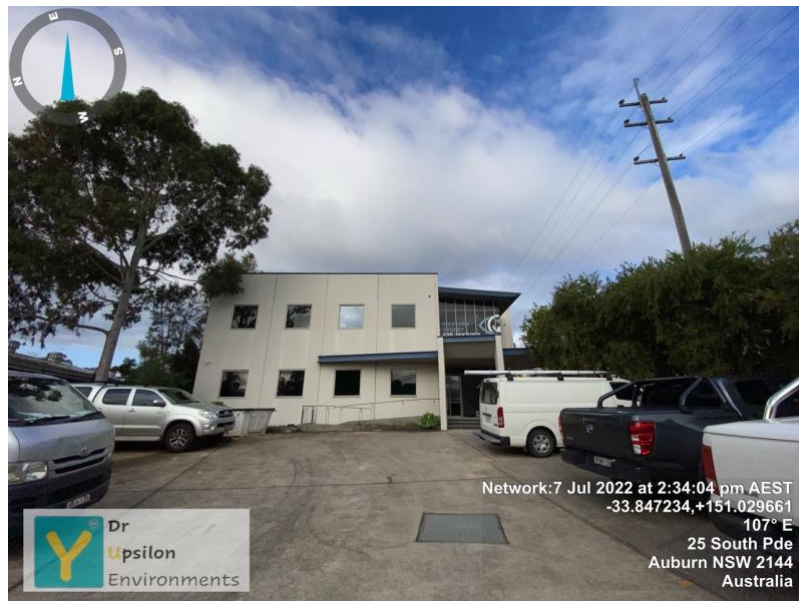
Figure 1 The site at 25 South Parade, Auburn, NSW (facing east) on 7 July 2022.

- The Site is occupied by a two-storey structure with metal sheeting roof and appeared to be recently built and in good condition.
- A hardstand carpark is located at the western section of the site.

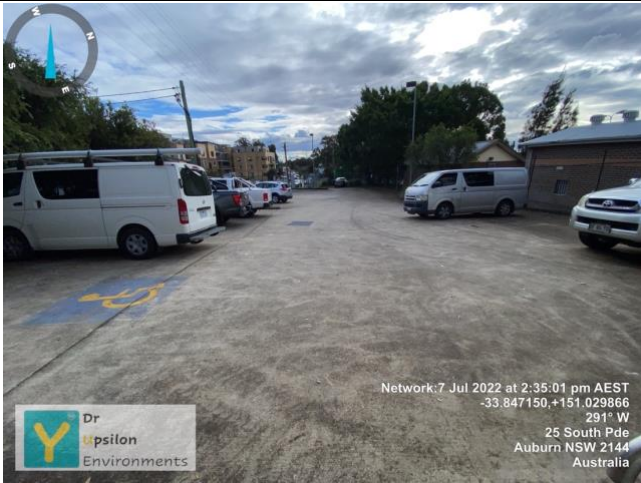
| Item 1 | |

| Item 1 | |
|---|---|
| Location | Hardstand carpark, facing west |
| Result | Encapsulated, concrete throughout |

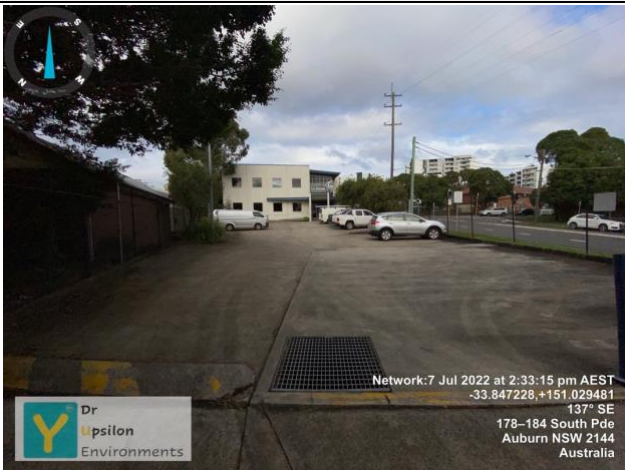
| Item 2 | |

| Item 2 | |
|---|---|
| Location | Hardstand carpark, facing east |
| Result | Encapsulated, concrete throughout |

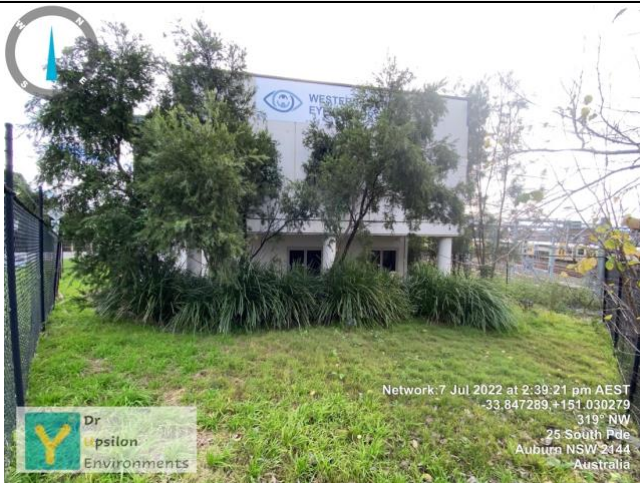
| Item 3 | |

| Item 3 | |
|---|---|
| Location | Eastern corner |
| Result | Grass area. Vegetation stress was not observed. |

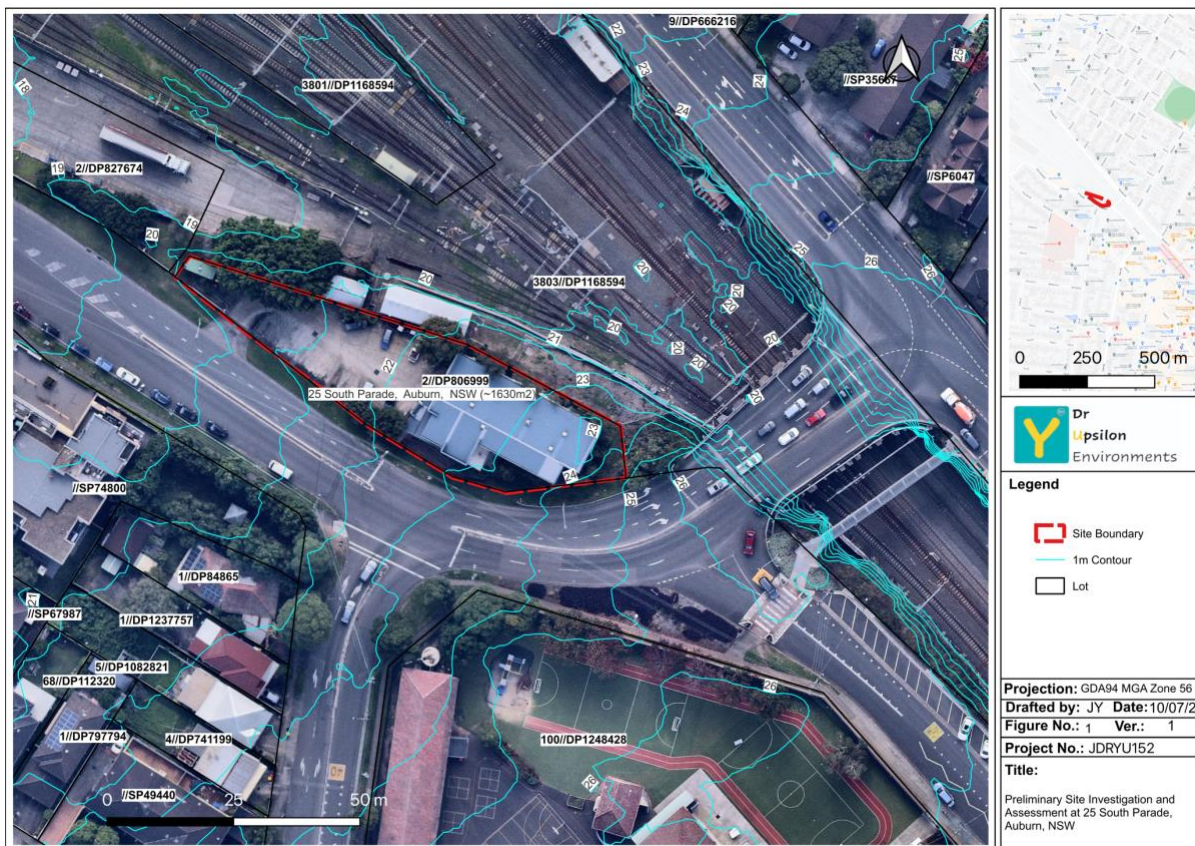
Figure 3 Site layout at 25 South Parade, Auburn, NSW
