29 September 2017
Our ref: MD/C12404

**PROPOSED HILLDOWNS SUBDIVISION
KALKITE ROAD, KALKITE, NSW
PRELIMINARY 'DESK TOP' GEOTECHNICAL ASSESSMENT**

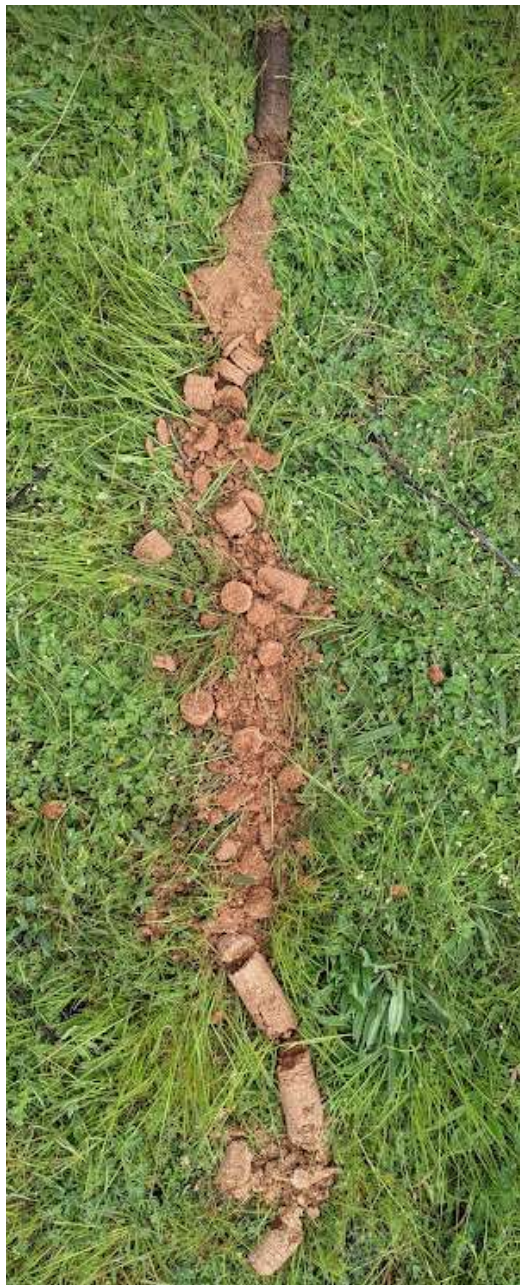
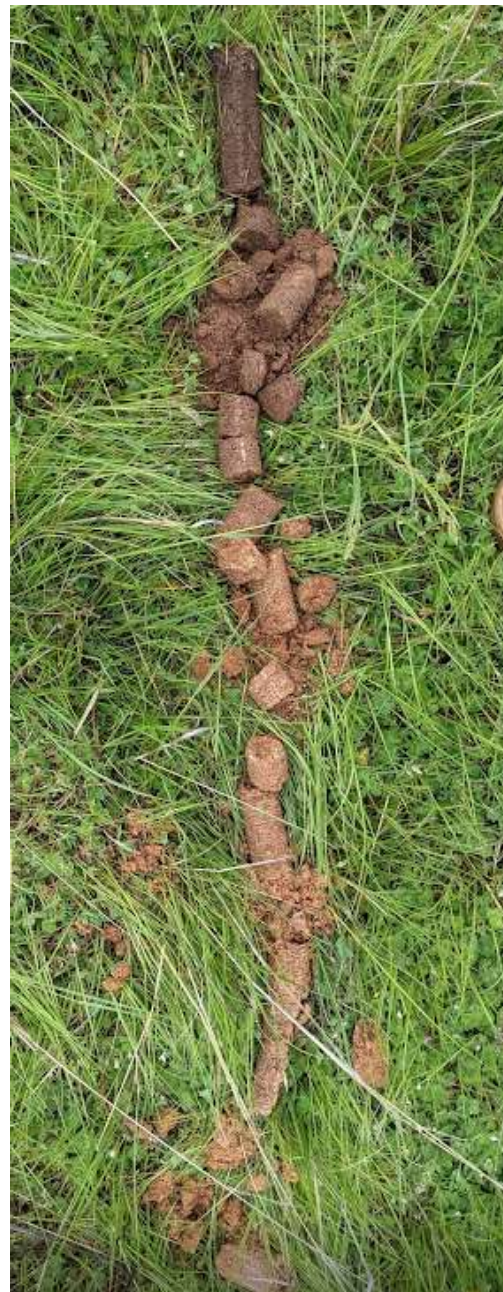
HILLDOWNS SUBDIVISION
KALKITE ROAD KALKITE
SITE PHOTOGRAPHS

The ground surface is covered in pasture grasses, and small rounded granite outcrops are present on the surface over most of the site, however, are more prevalent on the higher slopes. There are essentially no trees on the site, however, there is a farm house located off Hilldowns Road.

The 1:250,000 Bega-Mallacoota geology map indicates the site to be underlain by Silurian age Bullenbalong bedrock, which includes granodiorite and biotite-rich granodiorite. The granodiorite crops out as very numerous, small rounded boulders easily distinguishable from the larger outcrops in the Silurian age bedrock and within the road cutting.

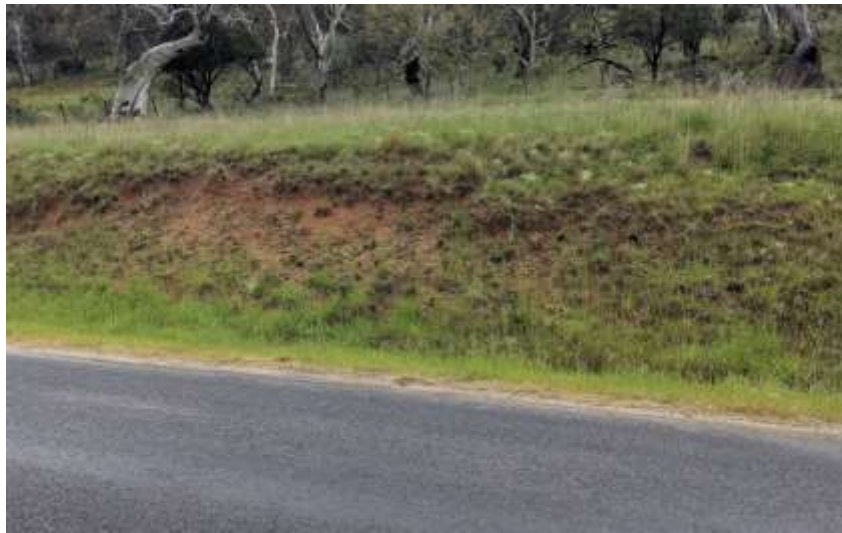
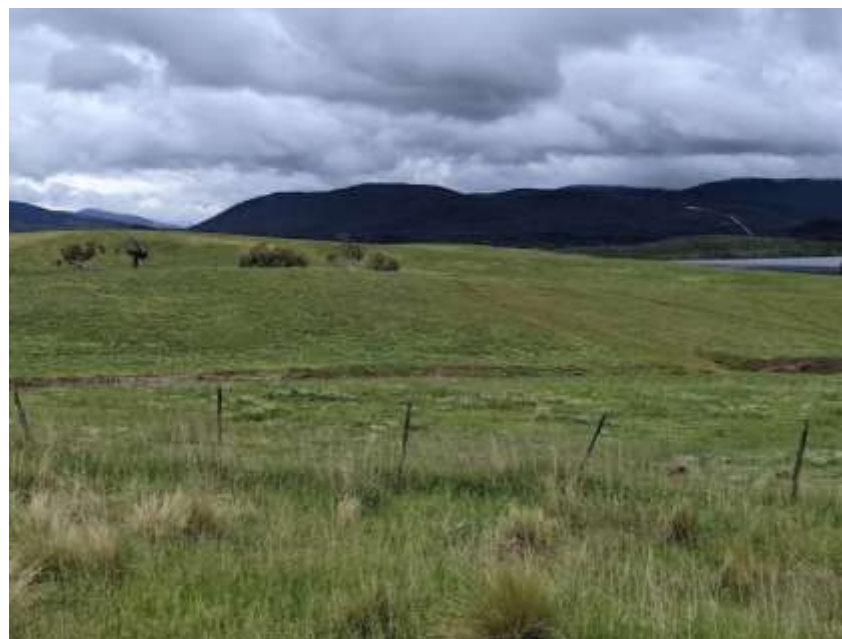
FIGURE 4

HILLDOWNS SUBDIVISION
KALKITE ROAD KALKITE
SITE PHOTOGRAPHS

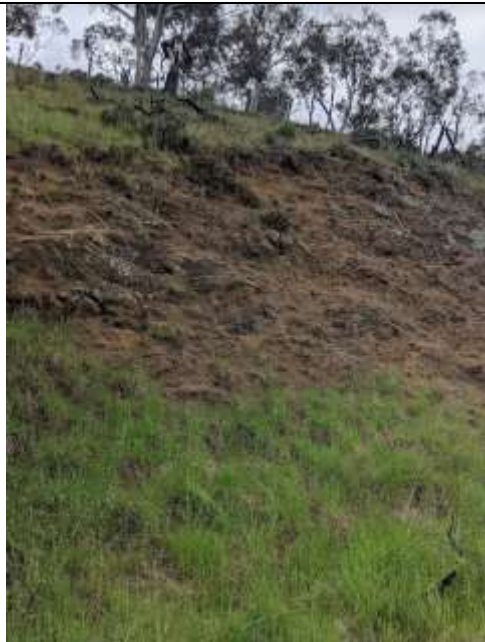
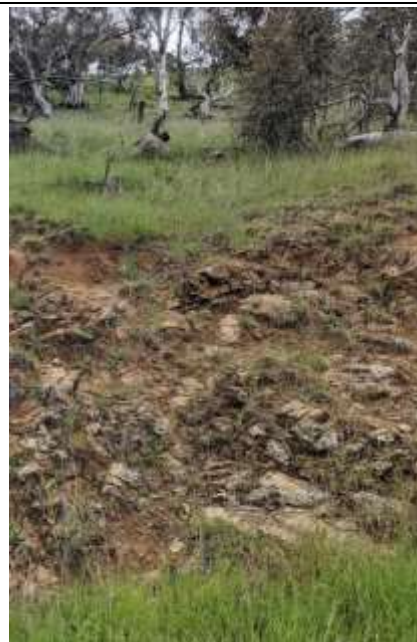
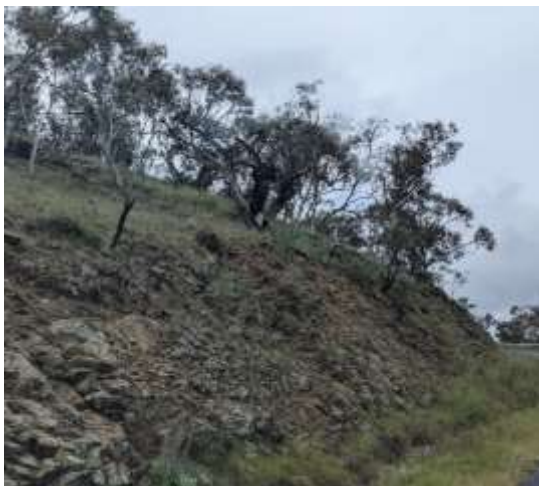
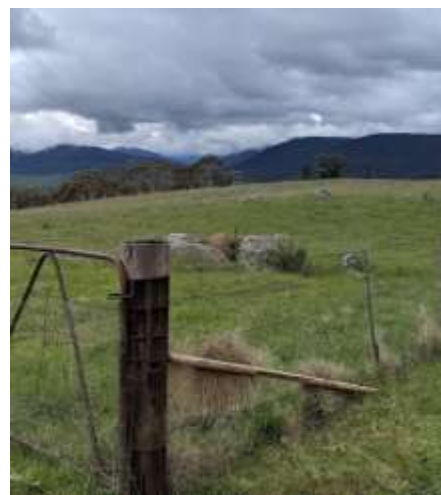
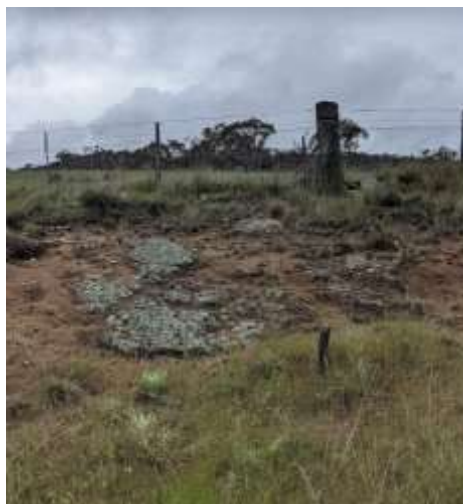
FIGURE 4

ACT Geotechnical Engineers have conducted many investigations and been involved in various projects in and around Jindabyne. Our assessment was based on these past involvements, as well as reference to past and present topographical maps and local soil and geology maps. In addition, three push tube boreholes, designated 1A to 3A, were drilled at the site during the site walk over on 5 November 2021. The borehole logs are attached at the end of the report, and the location of the boreholes are shown on Figure 3. The Photo's in Figure 5 are of the push tube sample from the boreholes.

Depth	Geological Profile
0m to ~0.1m/0.2m	TOPSOIL: Silty Sand; fine to coarse sand, low plasticity silt, black, grass roots, dry to moist, loose.
~0.1m/0.2m - ~0.5m/0.8m	RESIDUAL SOILS: Clayey Sand; low to medium plasticity clay, fine to coarse sand, brown, dry to moist, medium dense to dense.
below ~0.5m/0.8m	GRANODIORITE BEDROCK: coarse grained, extremely weathered (EW) and extremely weak rock.
