**SOUTH JERRABOMBERA ESTATE
STAGE 1F ROAD – ECOLOGICAL ASSESSMENT**

F Dominic Fanning

08 November 2021

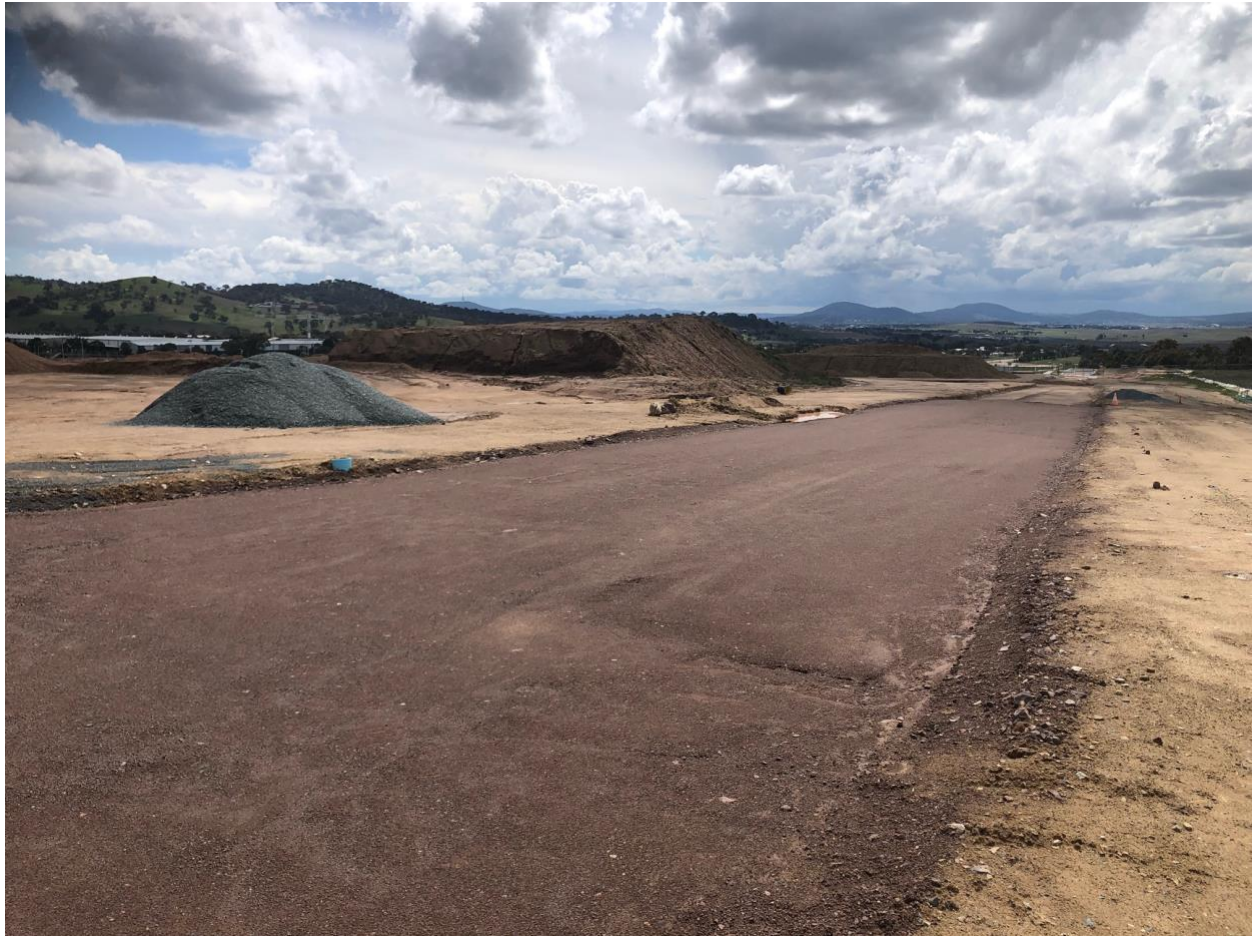
That area of land (the 'triangle' – see Figure 2) has since been cleared; with large mounds of fill currently occupying the 'triangle' (see photograph below). No native vegetation remains within the 'triangle'.

View to the northeast along the approved straightened road running along the southeastern side of Stage 1F. The Stage 1F development area is located in the left midground (to the left of the dark brown road alignment) with the sewerage/water easement and access track to the right. The large mounds of fill (in the middle of the photograph) are located on what was the 'triangle' of land in Stage 1F prior to the approved modification.

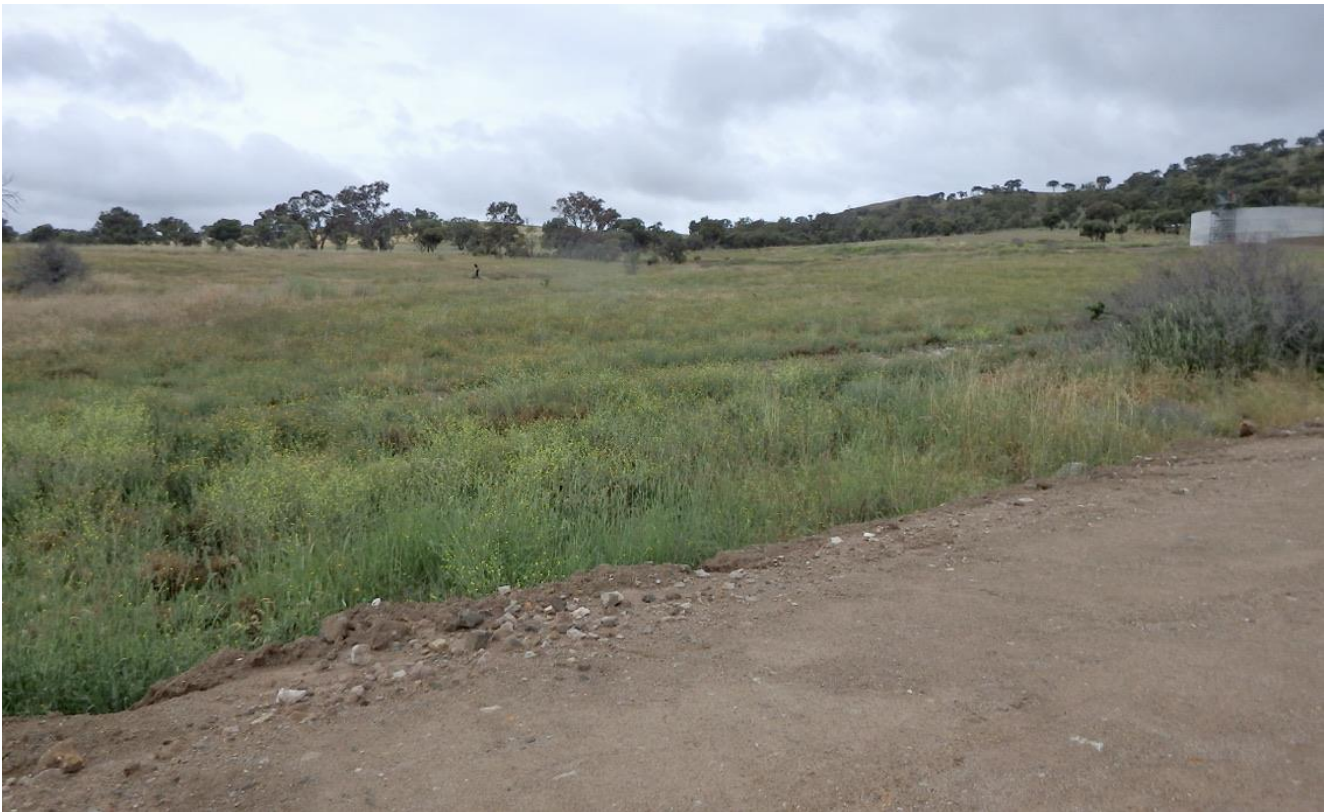
Photo 1 View to the southeast from the approved maintenance easement – over part of the substantial E2 lands to be conserved on the subject land. The approved maintenance easement is located along the eastern boundary of the Stage 1 project lands.

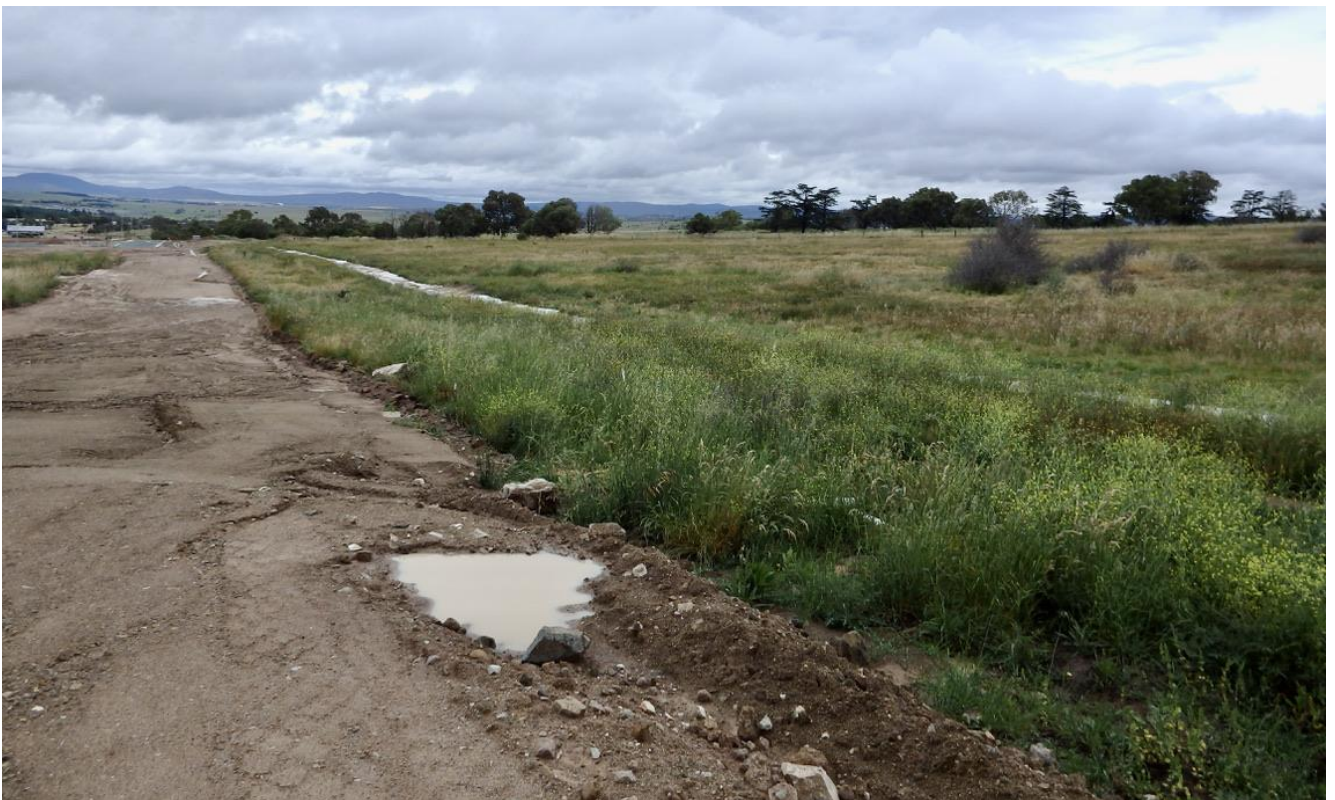
Photo 2 View to the northeast from the approved maintenance easement – over part of the substantial E2 lands to be conserved on the subject land. The E2 lands contain predominantly groundcover native vegetation – with smaller patches of weeds and introduced species.

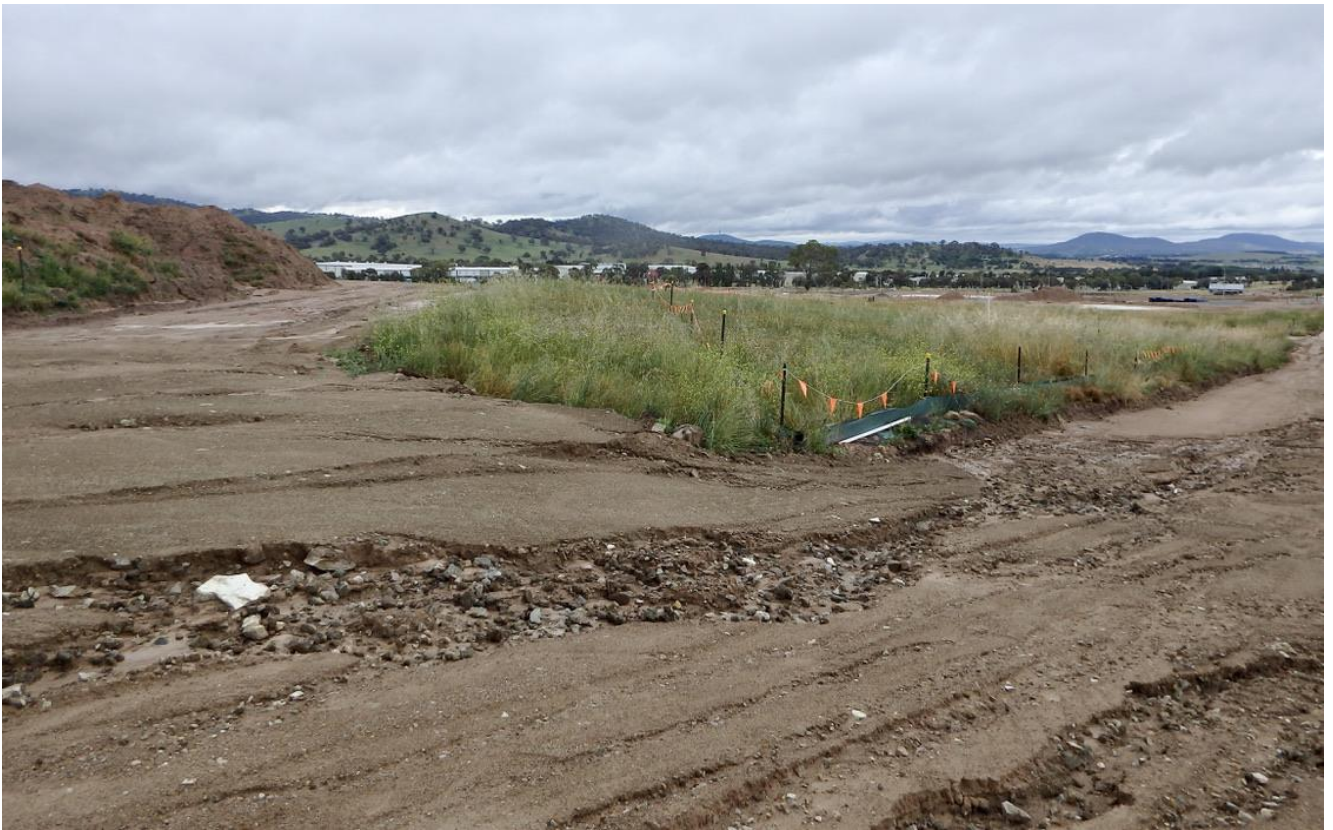
It was my observation in late 2020 that the majority of the vegetation within the 'triangle' was as described by ELA – predominantly of introduced and weed species; with patches (particularly at the northern extremity of the 'triangle') dominated by common and abundant native species. Dominant introduced species included African Love Grass, Patterson's Curse, Cat's Ears and Phalaris.

Photo 3 The small 'triangle' of disturbed land proposed to be rezoned for development purposes. This patch is degraded (consisting predominantly of introduced species) and would provide no ecological valid outcome – as it would be isolated by the road to the left (the west) and the drainage easement (to the right). It provides no biodiversity conservation benefit.

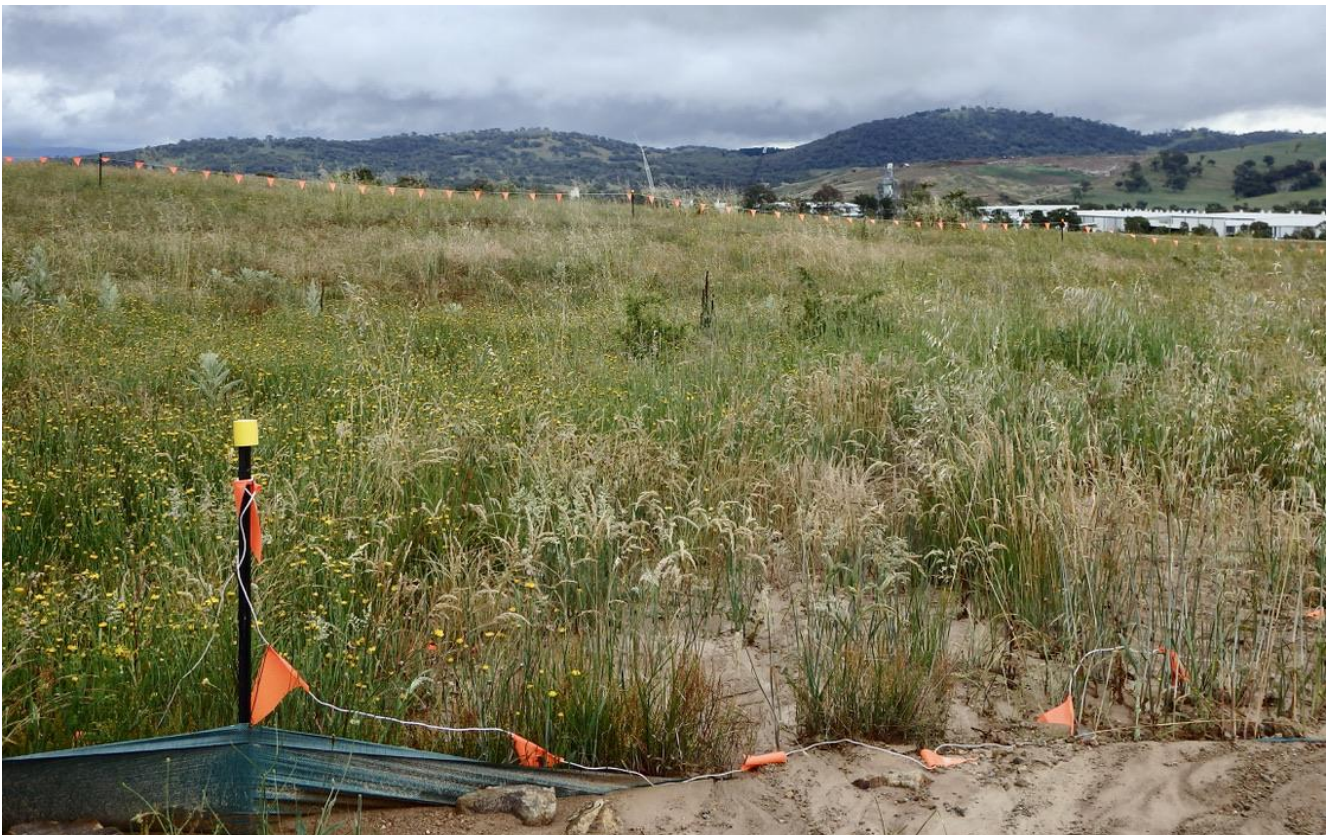
Photo 4 The small 'triangle' of land at Jerrabomberra South – dominated by introduced species. This patch of land is of no biodiversity conservation value.
