Heritage Assessment 'Dalori' - 3  
New Street, Windsor - NBRS &  
Partners Pty Ltd

# HERITAGE ASSESSMENT

'Dalori', 3 New Street, Windsor

FINAL REPORT

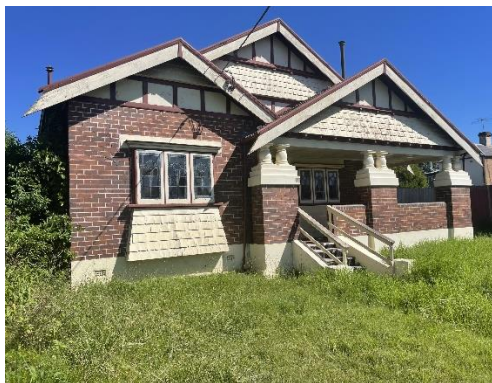
Figure 22: Principal facade of Dalori, fronting New Street. (Source: NBRS 2022)

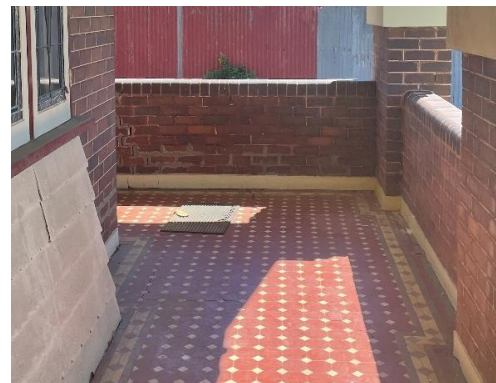
Figure 23: Tessellated tiles on the verandah (Source: NBRS 2022)

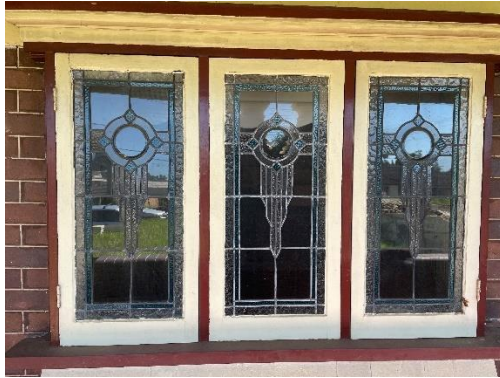
Windows on this façade are timber casement window assemblies comprising three sashes, each with decorative leadlight glazing. The central sash is fixed. (Figure 24). The front door is flanked by a timber-framed sidelight. A metal security door has been recently added. On the righthand side of the entrance door is a plaque reading 'Dalori' (Figure 25).

Figure 24: Typical window detailing on the principal elevation.  
(Source: NBRS 2022)

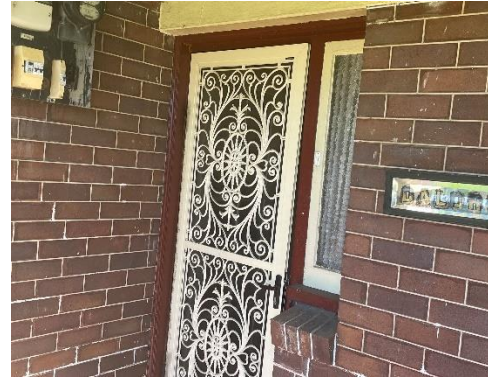
Figure 25: Decorative security door at the front entrance.  
(Source: NBRS 2022)

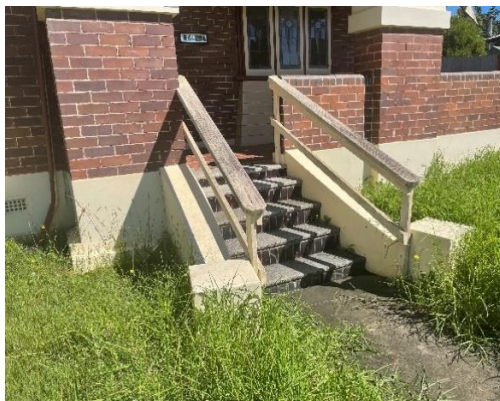
Figure 26: Front steps leading to the entrance, the timber railings are a later addition. (Source: NBRS 2022)

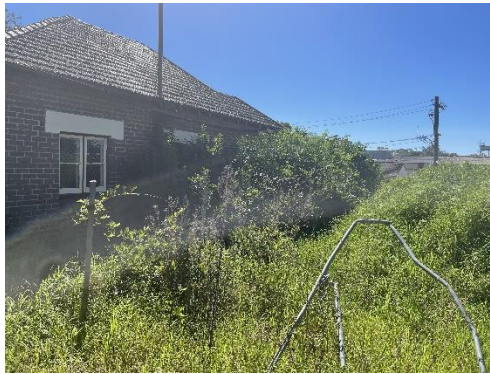
The side elevations have plainer treatment than the principal facade. On the south-eastern side, there are three timber framed casement windows (Figure 27). Above each opening is a solid rendered lintel and an angled brick sill below. The north-western side elevation includes part of the return verandah that extends to the midpoint of this façade (Figure 29). A section of timber-battened panelling runs between the main roof form and verandah opening. Adjacent to the verandah is a window with painted shingle skirting matching the principal elevation windows. A flat timber awning is fixed above this window. Toward the southern end of this elevation, there is a second window opening containing a single timber framed sash window and a narrow chimney pipe located on the roof (Figure 30). The rear extension is slightly setback from the main building and has a single timber framed entrance door fitted with a metal security door.

Figure 27: The front section of the south eastern elevation. (Source: NBR S 2022)

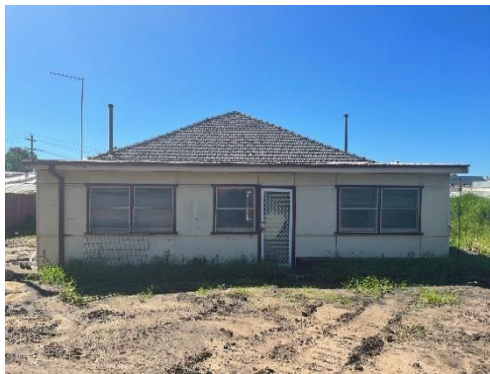
The southwestern elevation shows the rear wall of the sunroom (Figure 31). The extension is constructed of sheet panelling held in place by an externally expressed painted timber frame. On each side of the façade there is a horizontally proportioned double-width opening fitted with timber framed sash windows. At the centre is a single door opening and single sash window.

Figure 31: The south western elevation showing the rear of the building. (Source: NBR S 2022)

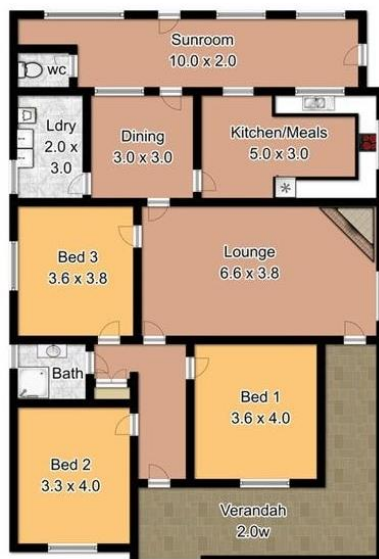
Figure 33: Floor plan of 3 New Street, Windsor. (Source: <https://www.realestate.com.au/>)

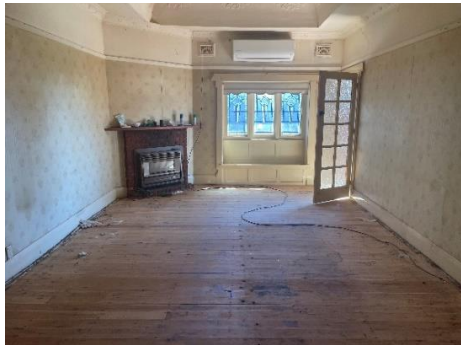
Figure 37: The living room features a fire mantle and decorative bay window. Access to the front verandah is provided by the door shown. (Source: NBR S 2022)

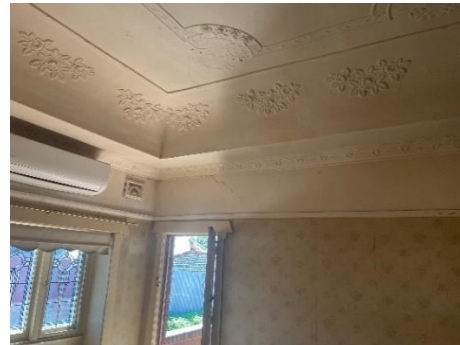
Figure 38: Ornate ceiling recess and cornice in the living room. (Source: NBR S 2022)

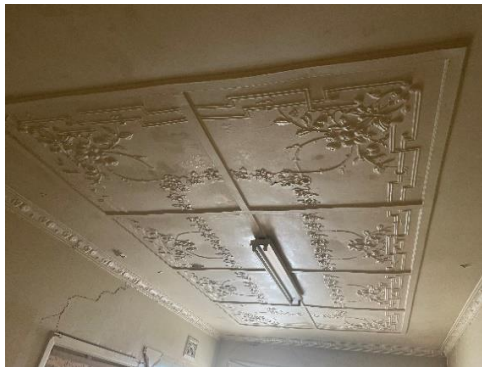
Figure 43: Decorative ceiling detailing in the kitchen. (Source: NBRS 2022)

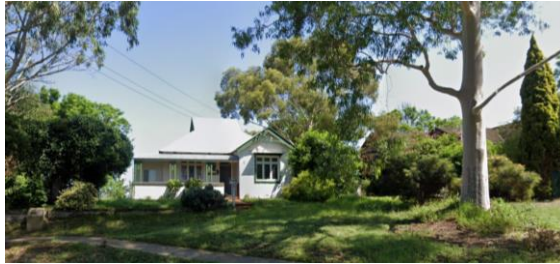
Figure 45: 41 George Street, Windsor. (Source: GoogleMaps 2021)

A single storey rendered brick house with hip and gable corrugated metal roof. The decorative timber barge boards, painted timber frame windows and front verandah indicate that the house was built in the late Federation period (1910s). It appears to have good integrity.

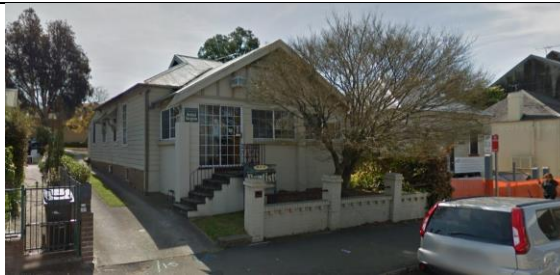
Figure 46: 275 George Street, Windsor. (Source: GoogleMaps 2021)

A brick and timber weatherboard house with hip and gable corrugated metal roof. The building appears to have been periodically modified so that its stylistic legibility has been diminished. The principal façade is potentially a later interwar addition to a Federation residence. The multi-pane glazing on this façade appears to be recent.

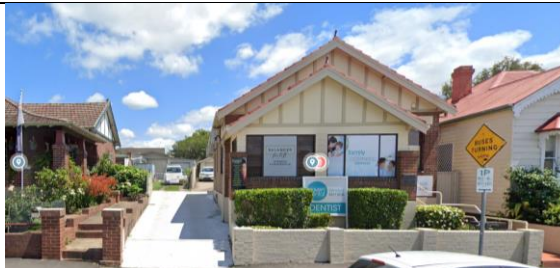
Figure 47: 287 George Street, Windsor. (Source: GoogleMaps 2021)

A single storey face brick house with terracotta tiled gable roof in the California Bungalow style. Two low pitched gable ends are enlivened with rendered brick and timber strapping finish. It appears that the front windows may have been modified and the porch filled in. The low brick fence has been painted.

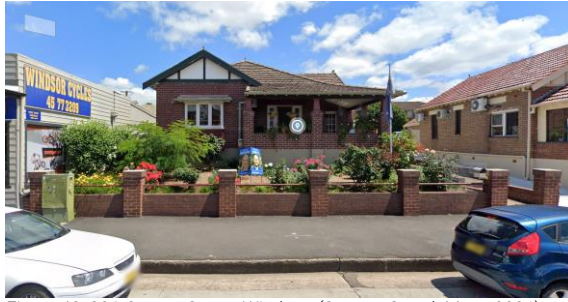
Figure 48: 291 George Street, Windsor. (Source: GoogleMaps 2021)

A single storey face brick house with tiled hip and gable roof. The building combines elements of the Federation era Arts and Crafts style—evident in the sprawling hipped roof form, terracotta finials, timber framed narrow windows—and the California Bungalow Style, as observed in the gable end with rendered surface, timber strapping, the low brick fence, and squat pillared columns. As such it represents a transition between the two styles.

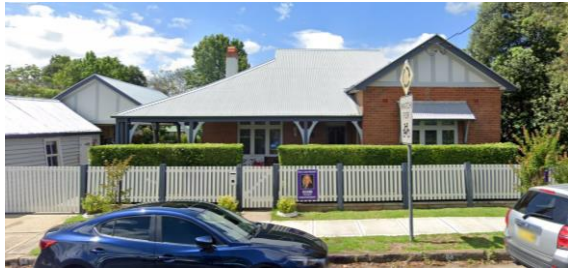
Figure 49: 88 The Terrace, Windsor (Source: GoogleMaps 2021)

A single storey face brick house with hip and gable corrugated metal roof, narrow chimney, timber fretwork, narrow timber framed leadlight windows and open return verandah. The building replaced a two storey Victorian residence that was demolished c1917.

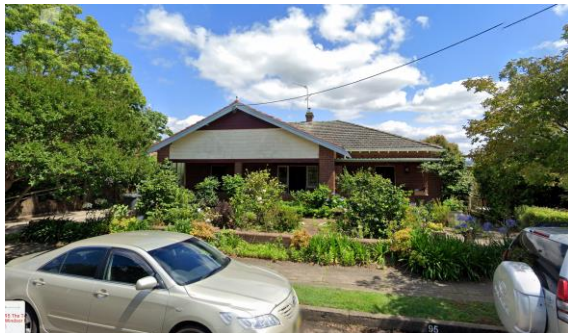
Figure 50: 95 The Terrace, Windsor. (Source: Google Maps 2021)

A single storey face brick house with hip and gable roof and low horizontal massing. The prominent roof form with low pitched gable, exposed rafter ends, wide and deep street frontage are consistent with the California Bungalow style, suggesting that the building was likely constructed in the 1920s.

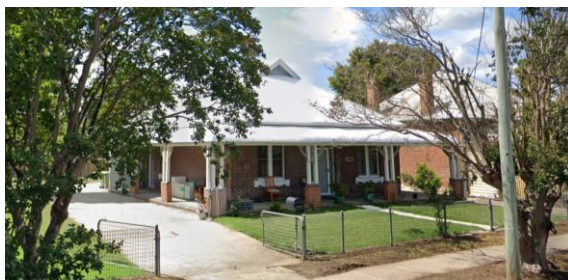
Figure 51: 98 The Terrace, Windsor. (Source: Google Maps 2021)

Fairview is a single storey face brick building with hipped corrugated metal roof built in 1921. Its overall built form is more consistent with early homestead houses, having a symmetrical façade, open wraparound verandah, and corrugated metal hipped roof.

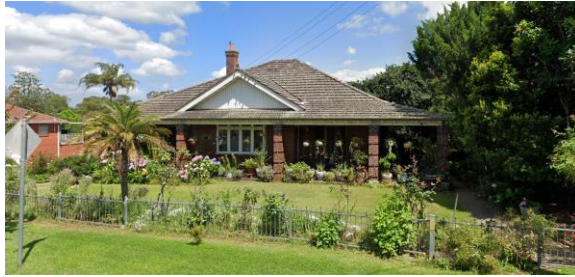
Figure 52: 105A The Terrace, Windsor. (Source: GoogleMaps 2021)

The house at 105A The Terrace is built of brick with a hip and gable tile clad roof. The building is designed in the Arts and Crafts style with some elements of the Bungalow style, evident in its low pitched gable roof and solid massing.

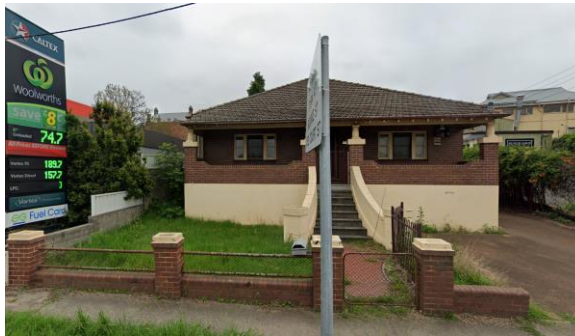
Figure 53: 7 Macquarie Street, Windsor (Source: GoogleMaps 2021)

7 Macquarie Street is a single storey liver brick and render house with hipped tiled roof, symmetrical façade and deep, wide porch accessed by central stairs. The house has retained its setting and low brick fence.

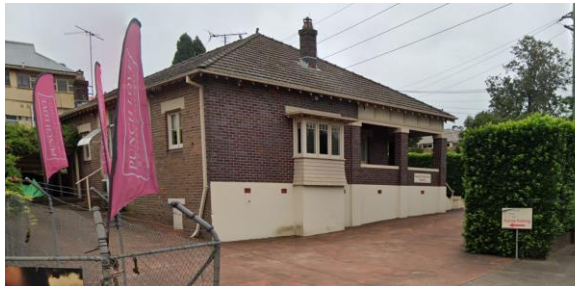
Figure 54: 21 Bridge Street, Windsor (Source: GoogleMaps 2021)

Single storey liver brick and render house with hipped tiled roof punctuated by narrow chimneys and terracotta finials. The design strongly reflects the influence of the Arts and Crafts.
