# STATEMENT OF HERITAGE IMPACT

**Proposed Development at  
Pymble Golf Club  
4, 12 and 14 Cowan Road**

Job No. 10153  
December 2023

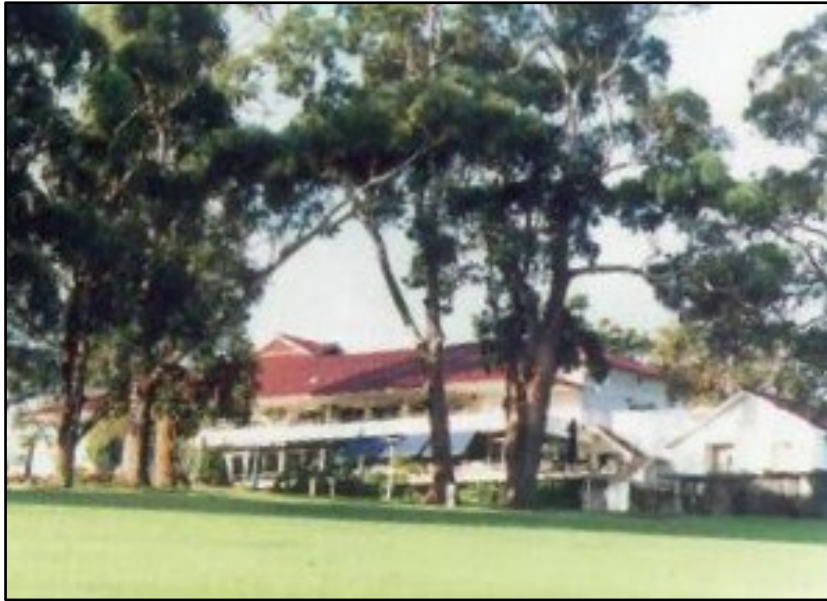
**Figure 26.** 1992 Image of the rear of the building showing the new roof (Source: Ross, Pymble: A biography of Pymble Golf Club).

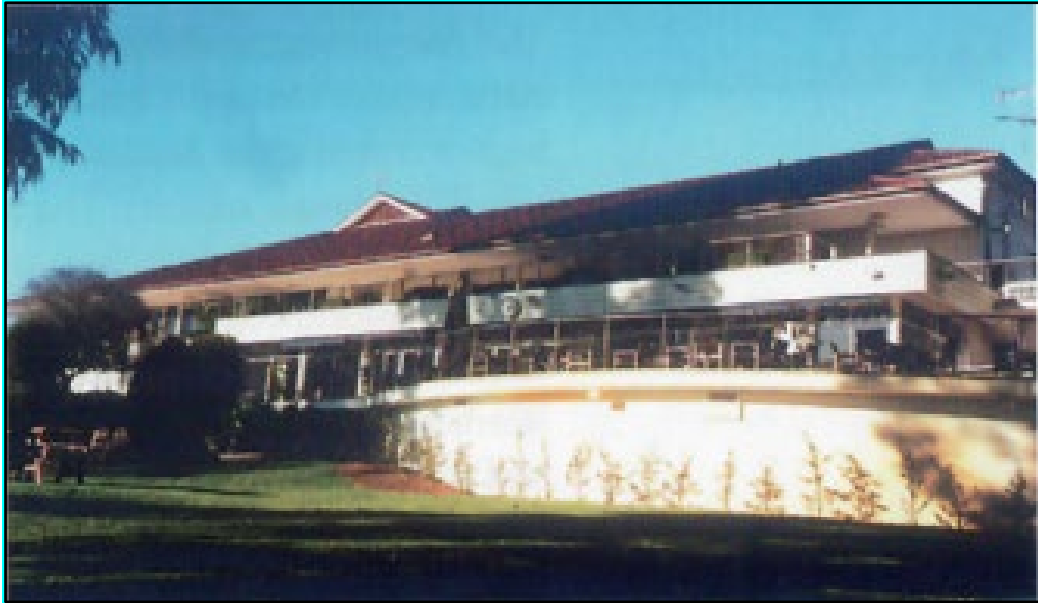
**Figure 30.** Late 1990s deck extension. (Source: Ross, Pymble: A biography of Pymble Golf Club)

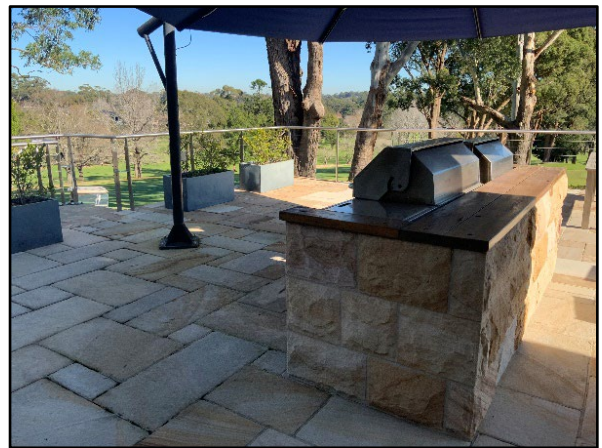
**Figure 53.** External view to the ground floor terrace, showing tiled flooring.

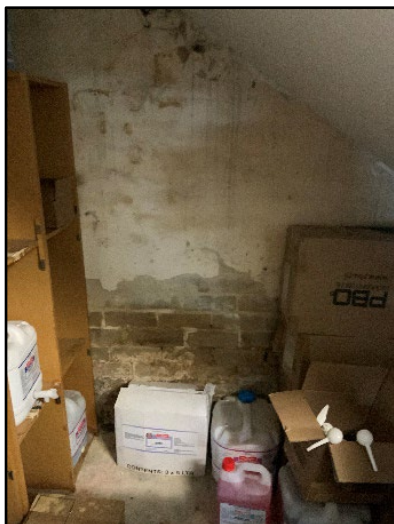
**Figure 63.** Internal view to storage space, basement. Note poor condition of masonry wall.

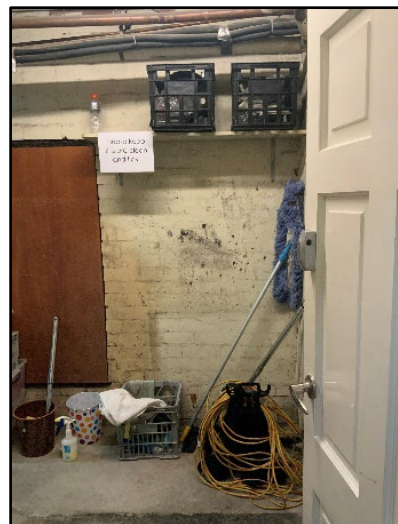
**Figure 64.** Internal view to storage space, basement. Note painted brick masonry walls.

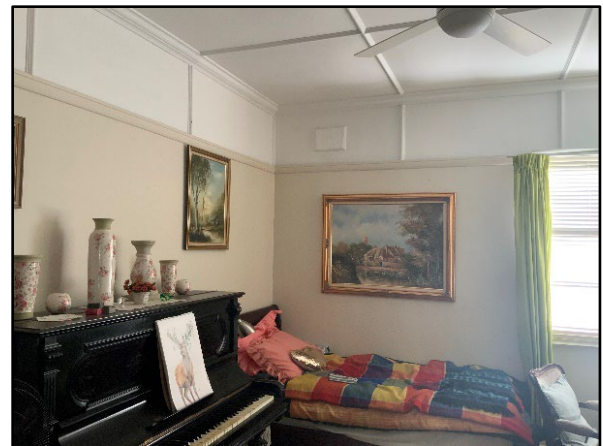
**Figure 116.** Internal view to typical bedroom. Note timber batten ceiling.

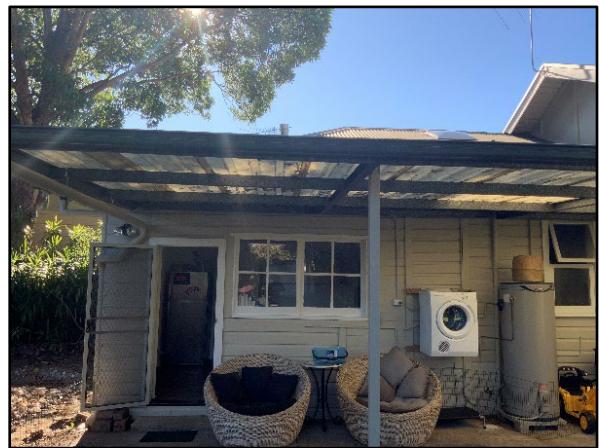
**Figure 131.** External view to side (southern) elevation of dwelling showing non-original extension.

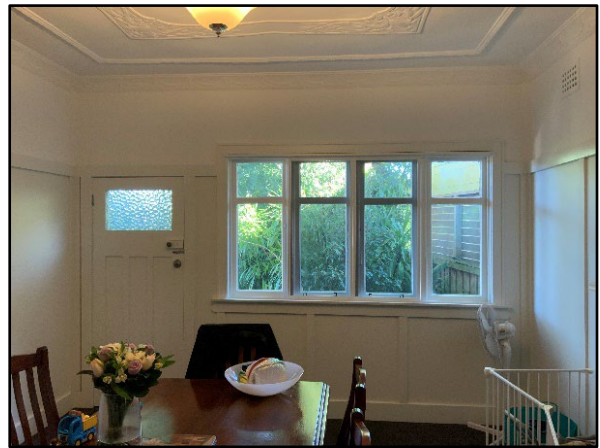
**Figure 135.** Internal view to dining room. Note timber windows, picture rails and timber panelling.

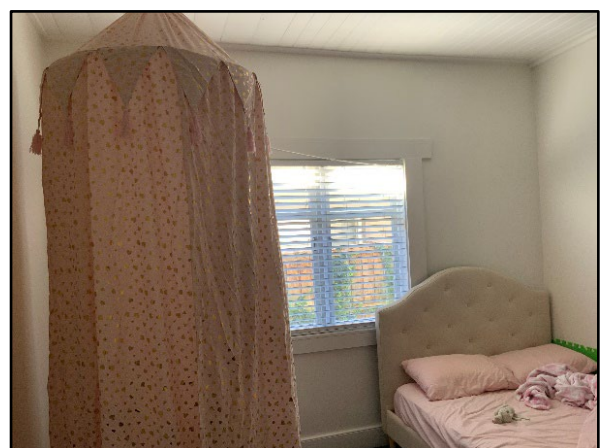
**Figure 143.** Internal view to bedroom detail, note timber architraves to window.

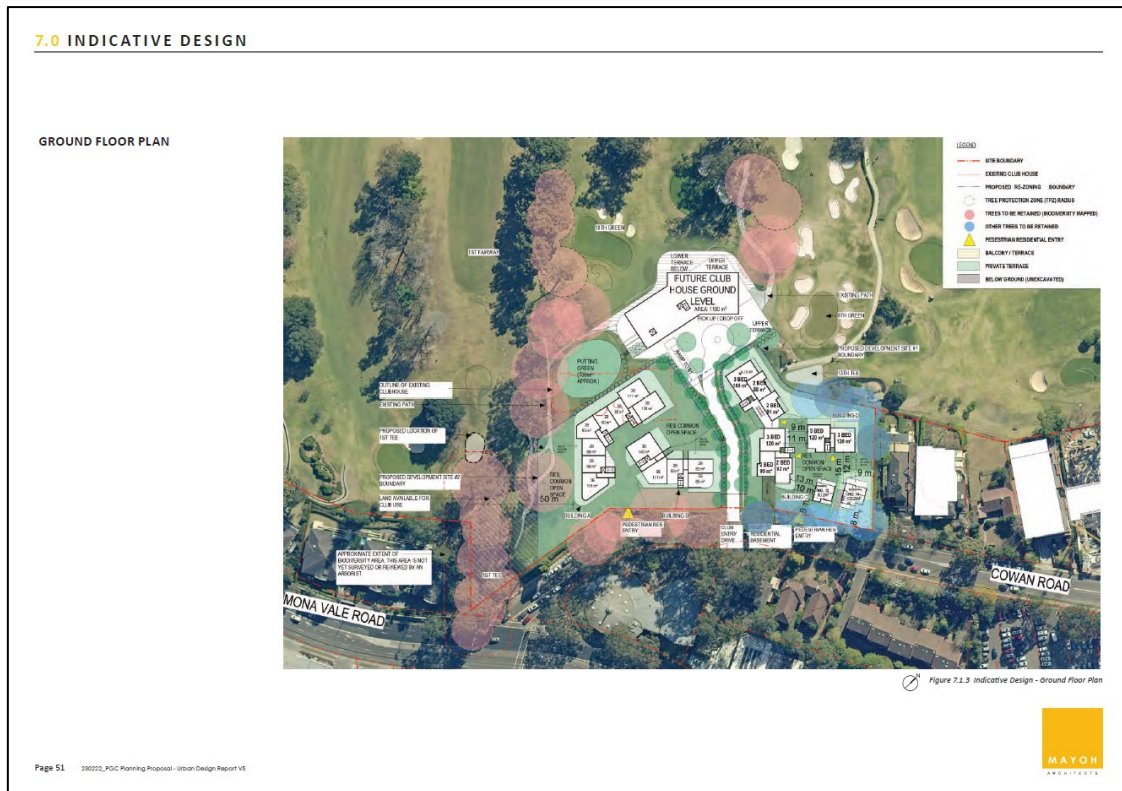
Figure 155. Ground floor plan.

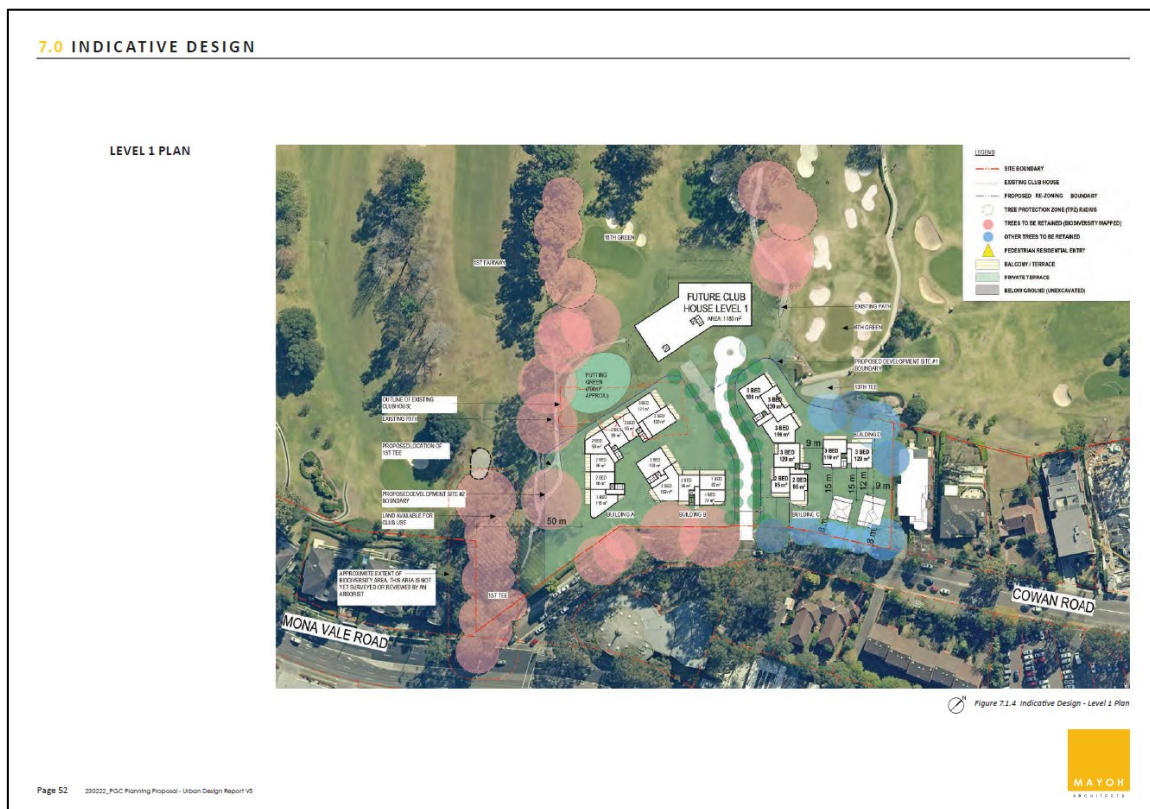
Figure 156. Level 1 plan.

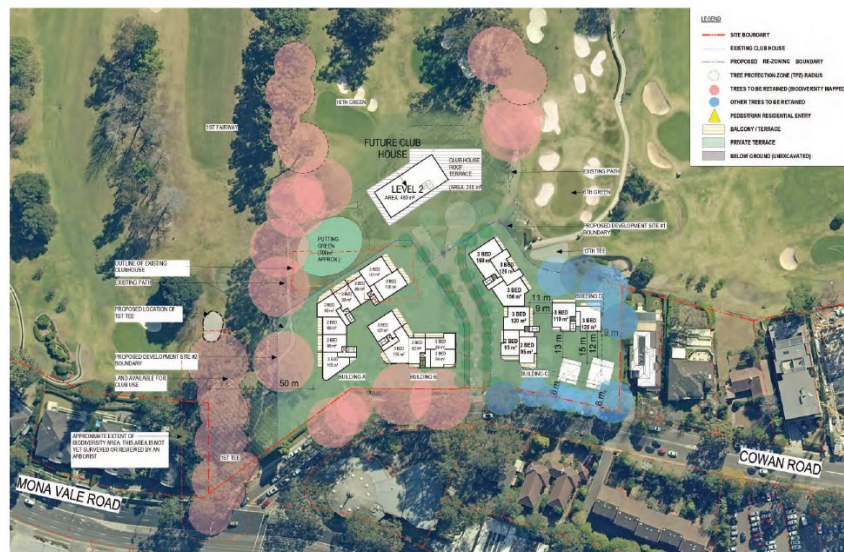
Figure 7.1.5 Indicative Design - Level 2 Plan

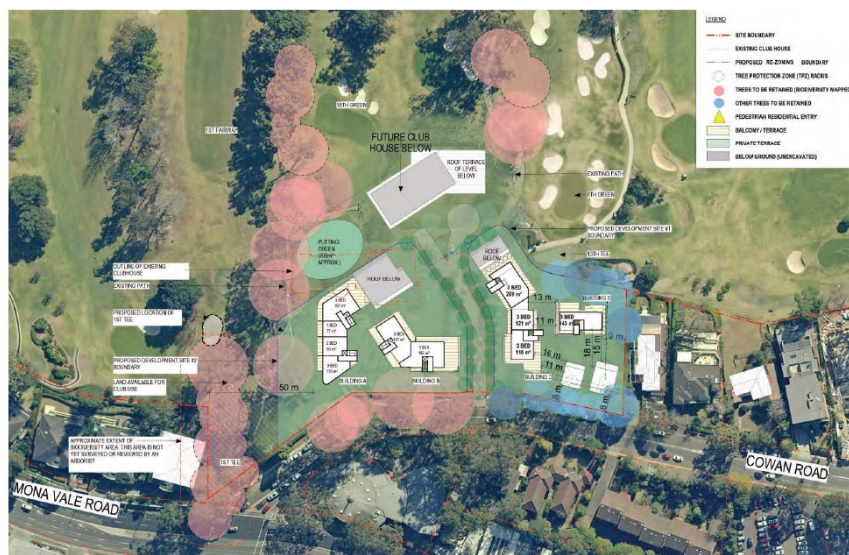
Figure 7.1.6 Indicative Design - Level 3 Plan

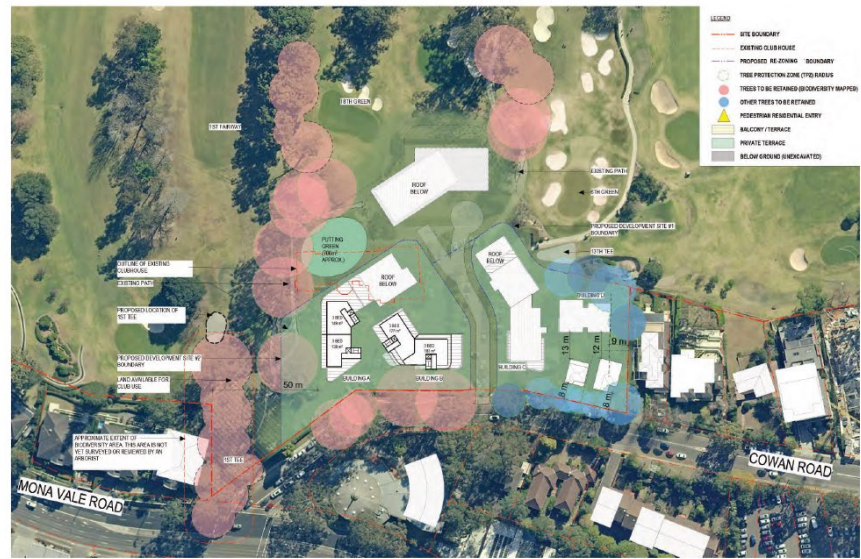
Figure 7.1.7 Indicative Design - Level 4 Plan

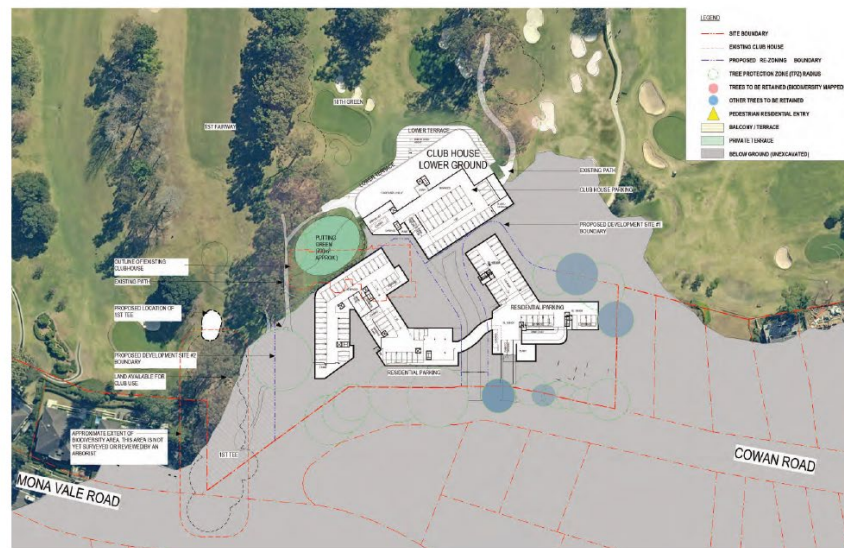
Figure 7.1.8 Indicative Design - Lower Ground/ Basement 1 Plan

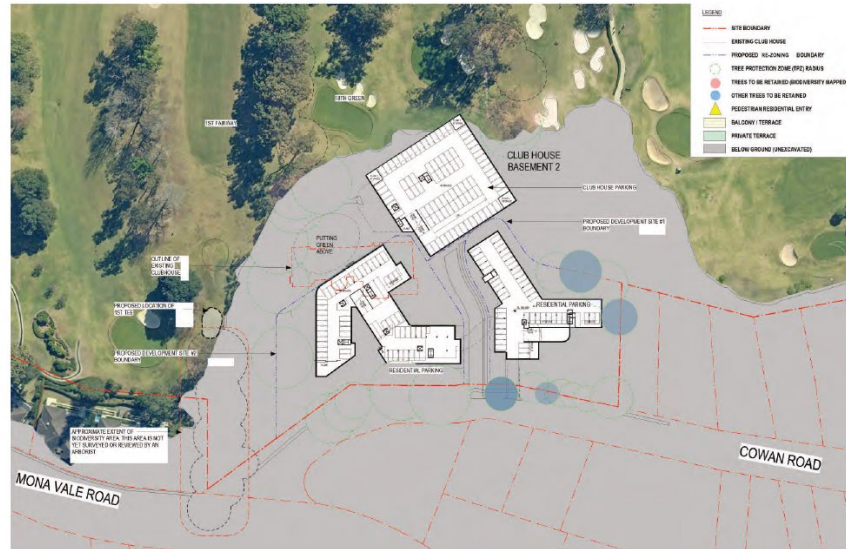
Figure 7.1.9 Indicative Design - Basement 2 Plan

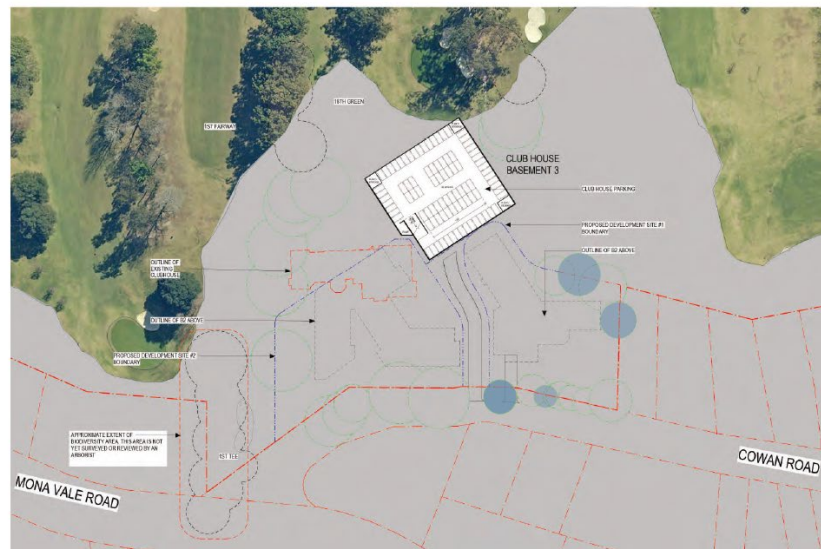
Figure 7.1.10 Indicative Design - Basement 3 Plan

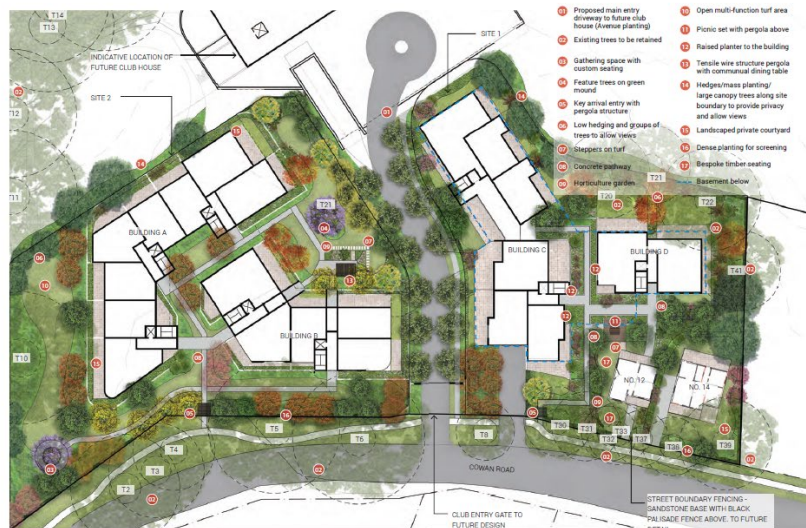
Figure 7.3.1 Indicative Landscape Plan by Place Design Group

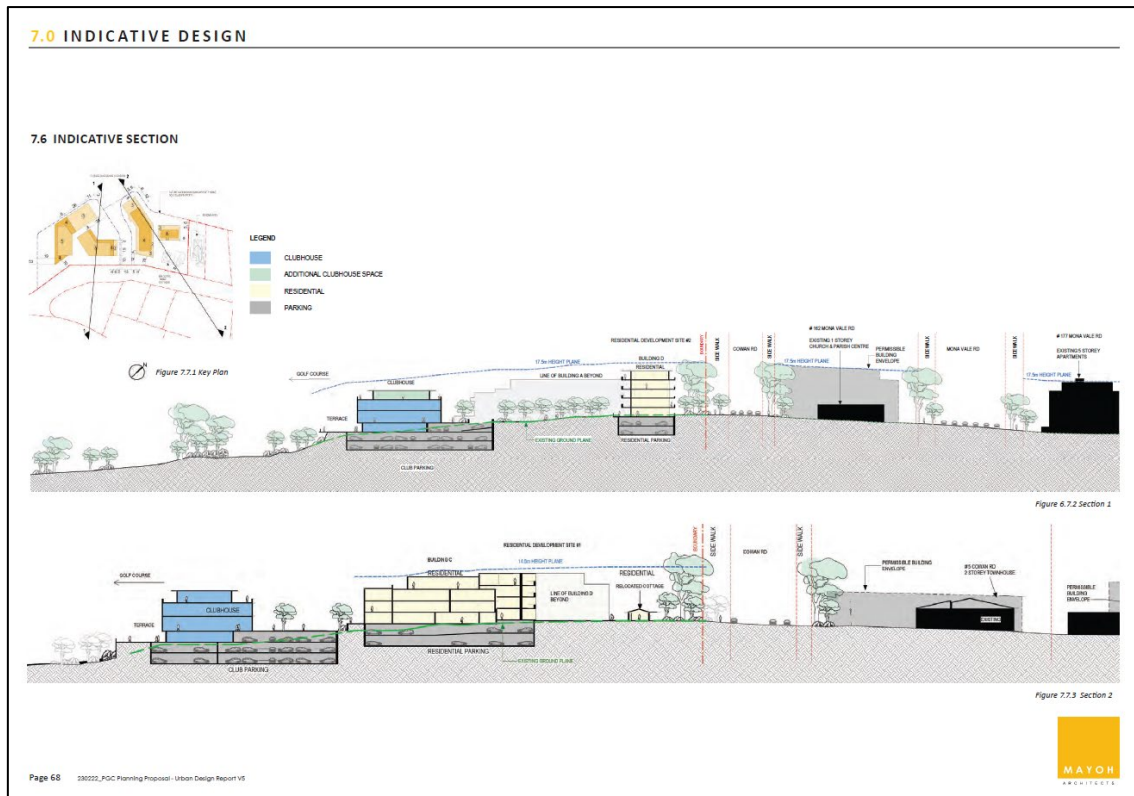
Figure 171. Indicative Section.
