Headfort House
Heritage Assessment Review
95 Stanhope Road, Killara

Claudine Loffi, Ku-ring-gai Council
September 2022

The purpose of this report is to review the existing heritage significance assessment report of Headfort House by GML Heritage that was prepared for Stockland dated May 2017.

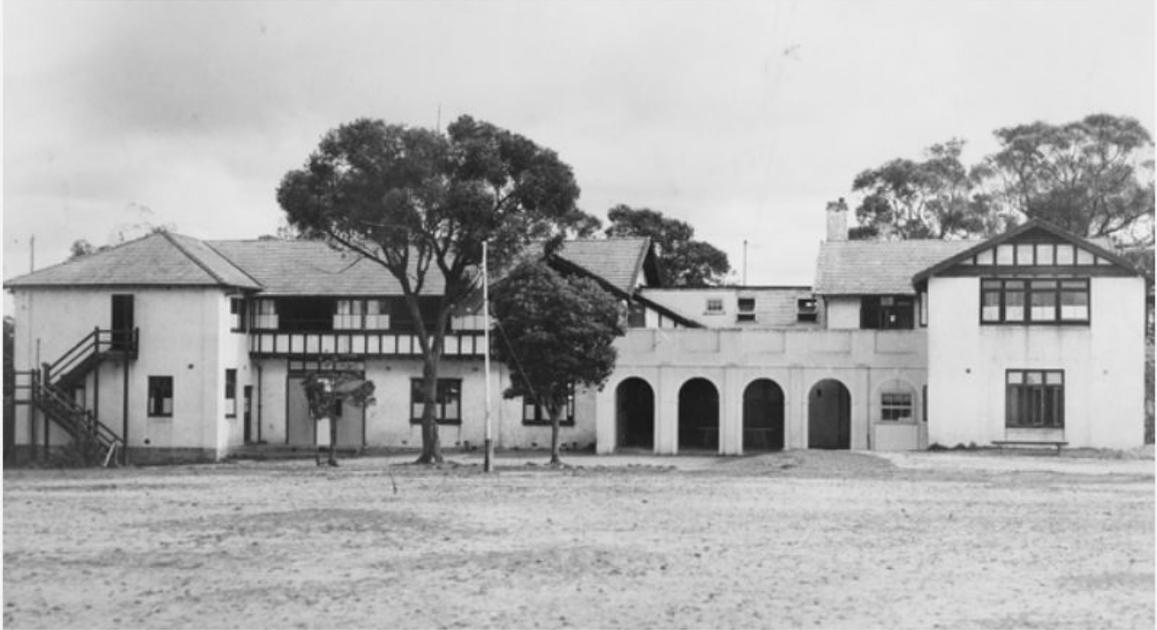
Above: **c1943** view of the former school buildings in use by the Australian Women's Army Service (extant building on right). The GML Heritage report indicates the addition was constructed in 1928 (Source: Australian War Memorial, viewed 5 September 2022, <https://www.awm.gov.au/collection/C45772>).

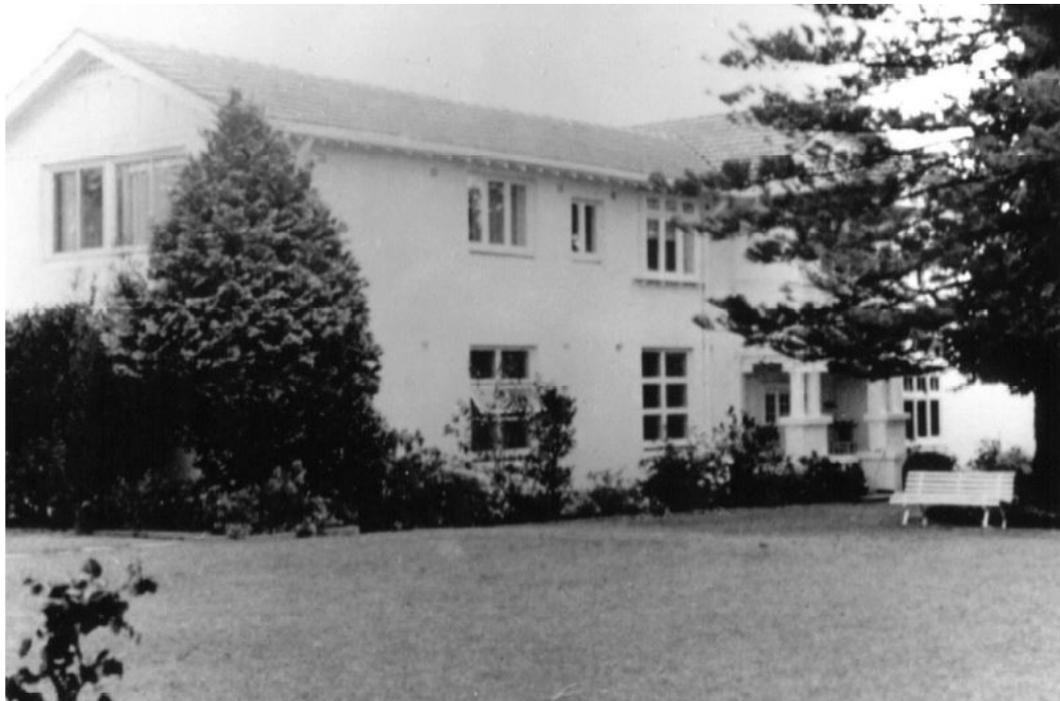
Above: **c1950s** Headfort House street before windows were altered for the 1980s chapel, and front garden, as published in Cook, KM 1991, *The Railway Came to Ku-ring-gai* (Source: Ku-ring-gai Historical Society photographic collection, extracted from 2017 GML Heritage report)

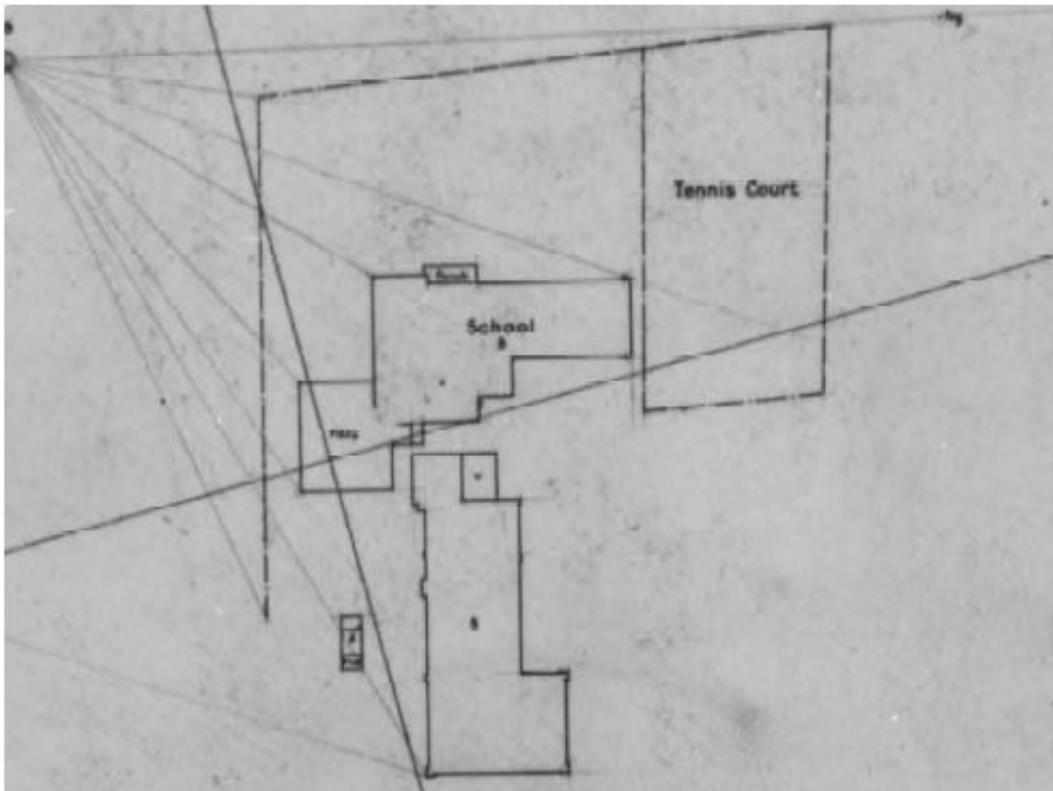
Above: **1927** Sydney Water survey of the Milton Grammar School that did not survey surrounding sport grounds and facilities (Source: Sydney Water Archives, extracted from 2017 GML Heritage report)

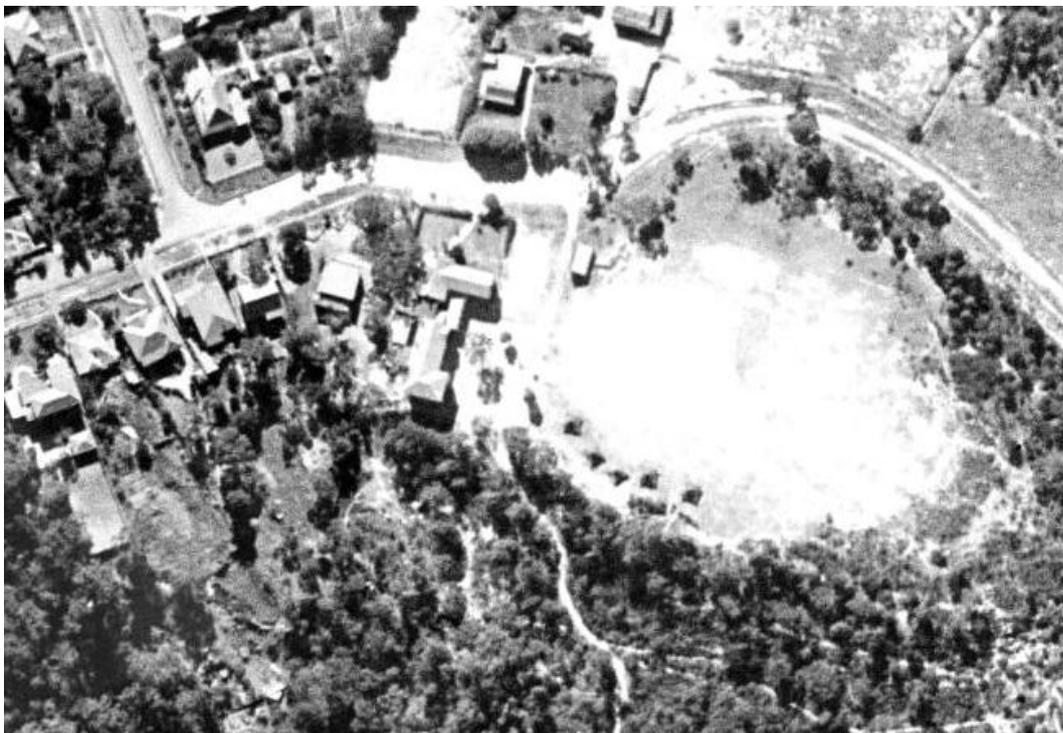
Above: **1943** aerial showing the since demolished building to the west and war training tents on the oval (source: NSW Government, Six maps historical imagery).

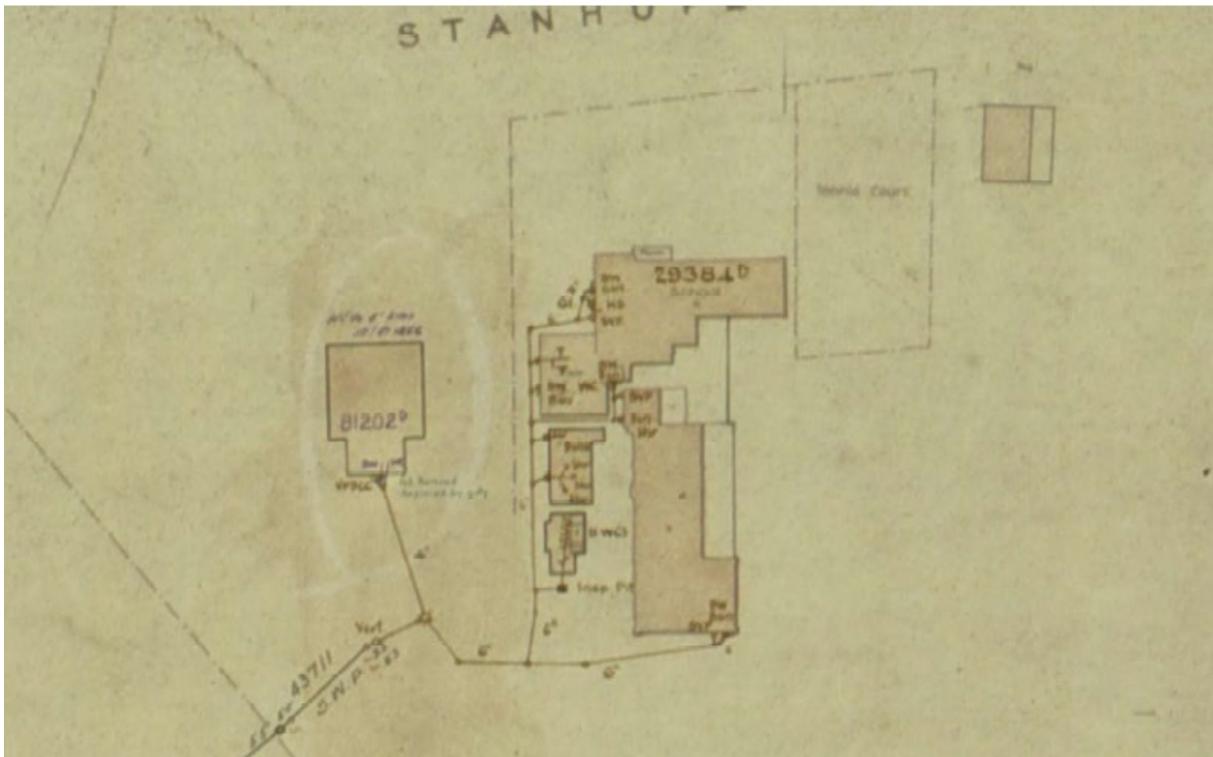
Above: **1927-c1953** Blackwattle Plan showing new buildings to the west and a building to the east of the tennis court on the edge of the oval as in the 1943 aerial (Source: Sydney Water Archives, extracted from 2017 GML Heritage report)

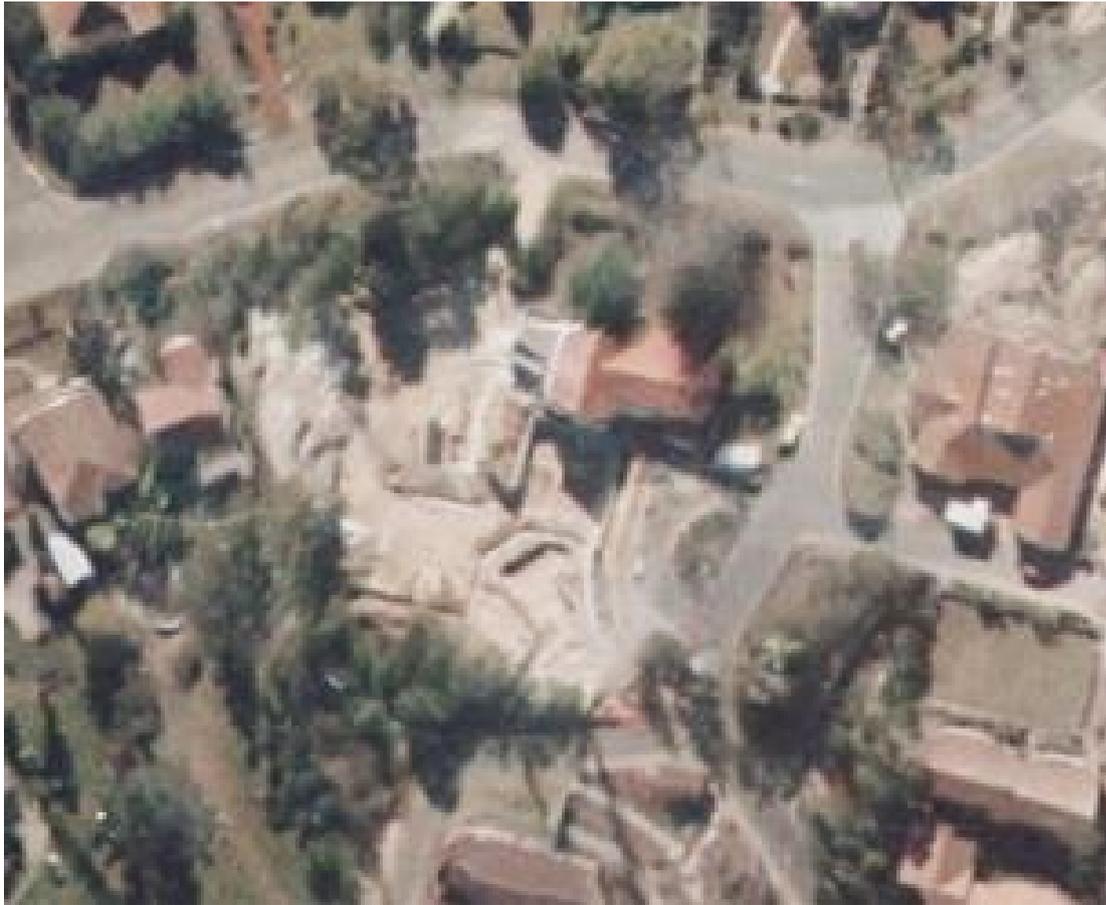
Above: **1986** aerial showing the demolition and groundwork for the new building and carpark (source: NSW Government, Six maps historical imagery).

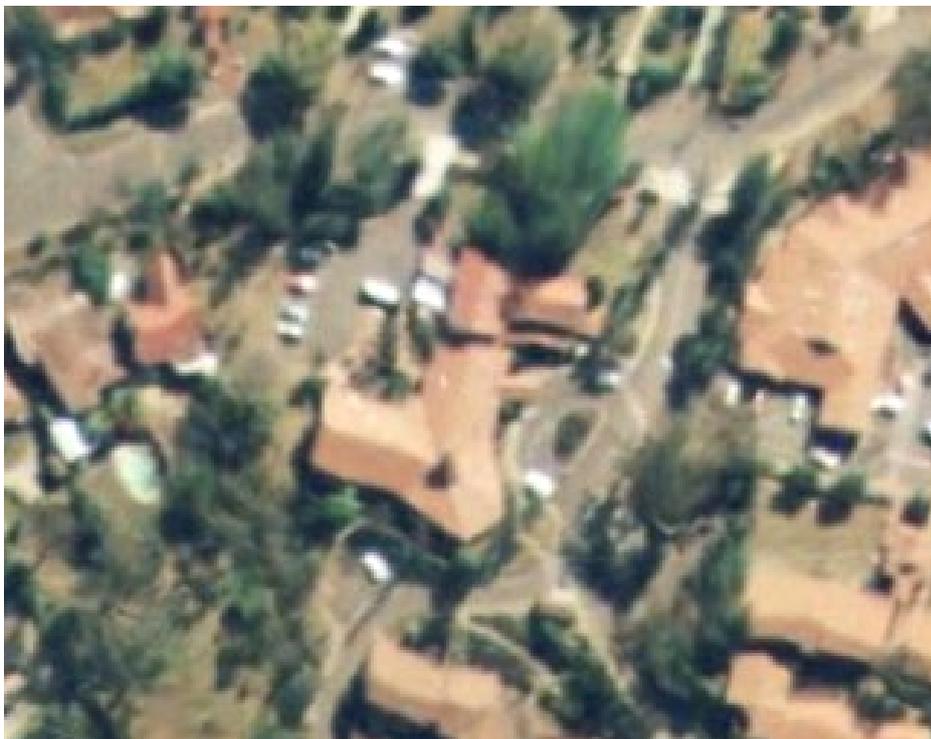
Above: **1991** aerial showing the newly constructed building, additions and carpark (source: NSW Government, Six maps historical imagery).

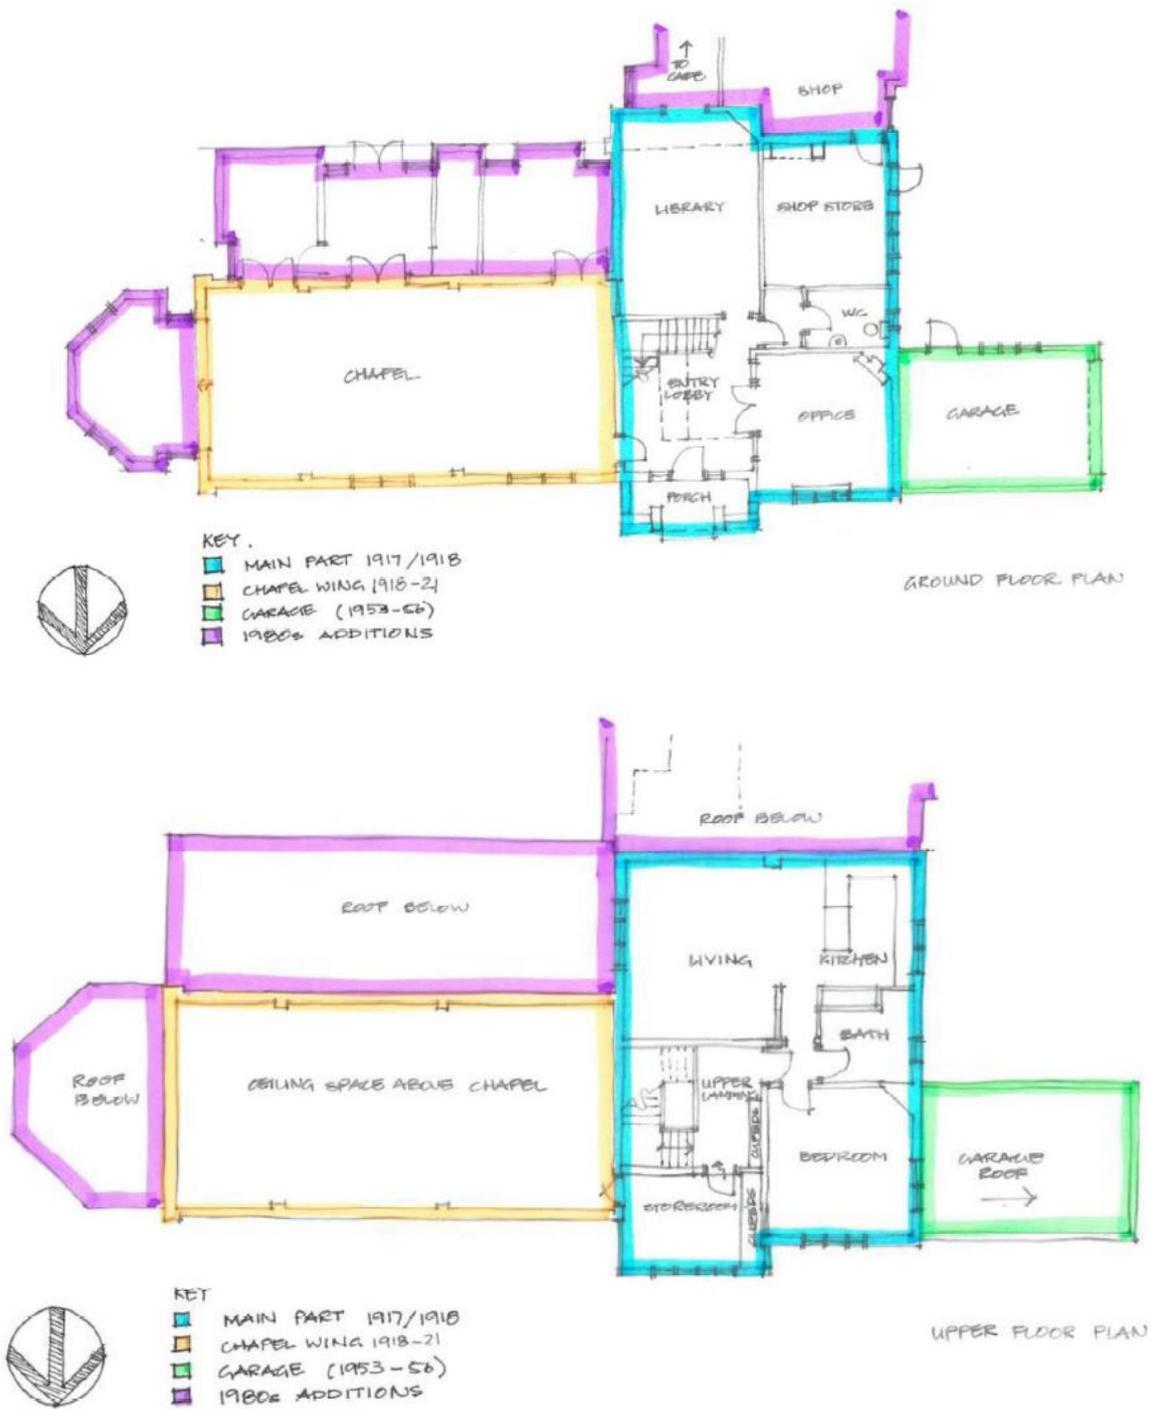
Above: **1917-1980s** building phases of development. Note the garage date is from 1926 based on documentary evidence, not 1950s indicated in this sketch (Source: GML Heritage, 2017)

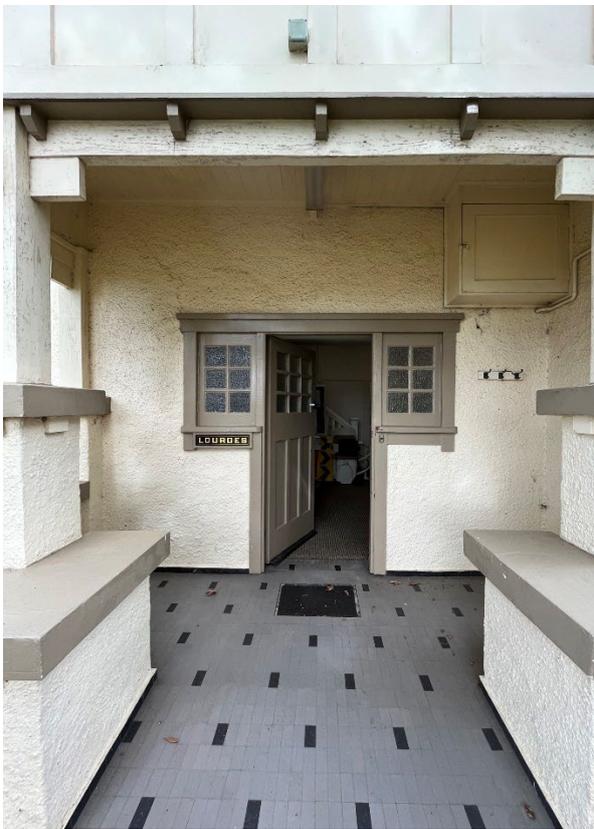
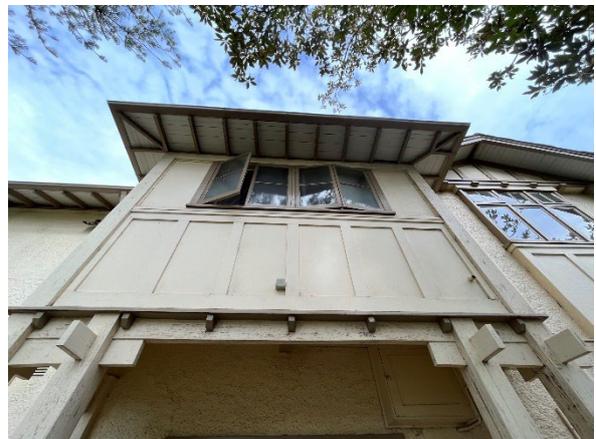
- Building condition appears good-to-fair. Some maintenance is required for the external timberwork and to repair a minor roof leak in the north-west corner.

- Headfort House is generally intact, externally and internally, including the 1920s western garage and 1980s chapel additions. The first floor front verandah has been enclosed, ground verandah tiles replaced and internal timberwork painted.

Street elevation and entrance

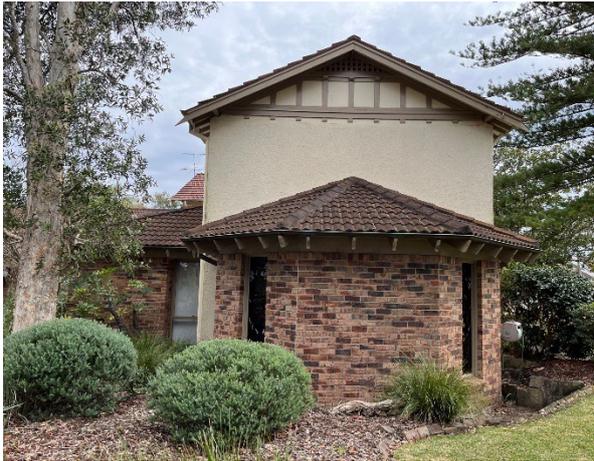
East elevation

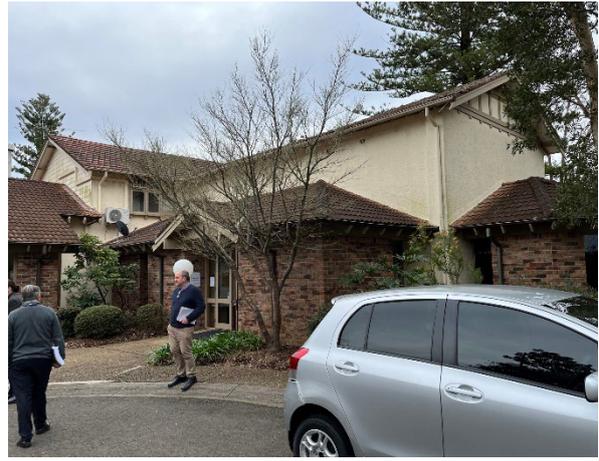
South and east elevations

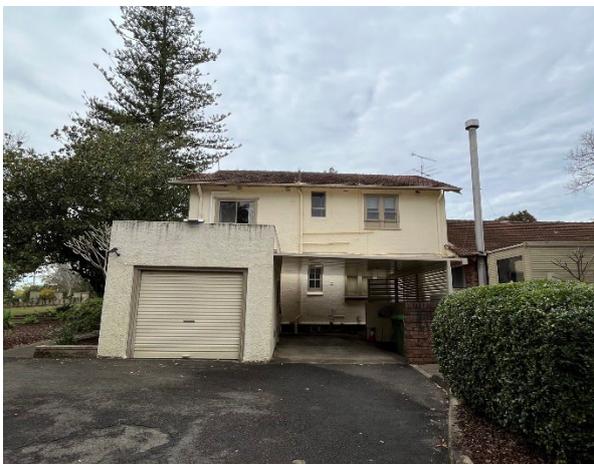
West elevation

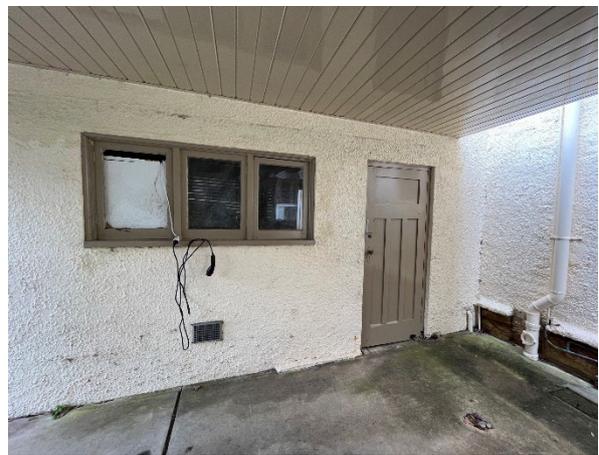
West garage fenestration, c.1920s

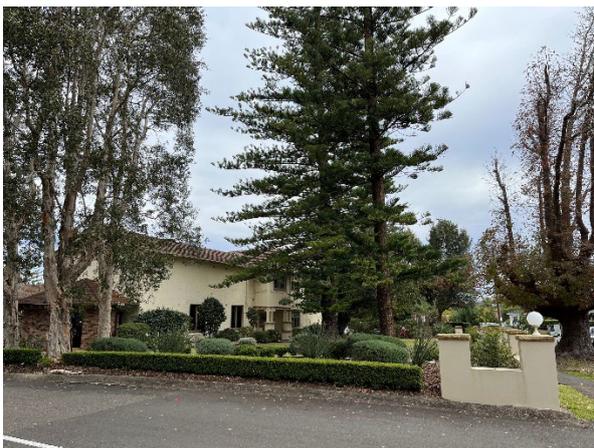
- Grounds retain the landscaped setting and mature trees, with a new front fence and alterations to the garden path and bed layout from the original.
- Entrance drive and turning circle to the east and south-east retain the original alignment with contemporary fabric, a truncated shape to the once circular turning circle and early avenue of Phoenix Palms on the east alignment.

Front garden and fence from entrance drive, north-east

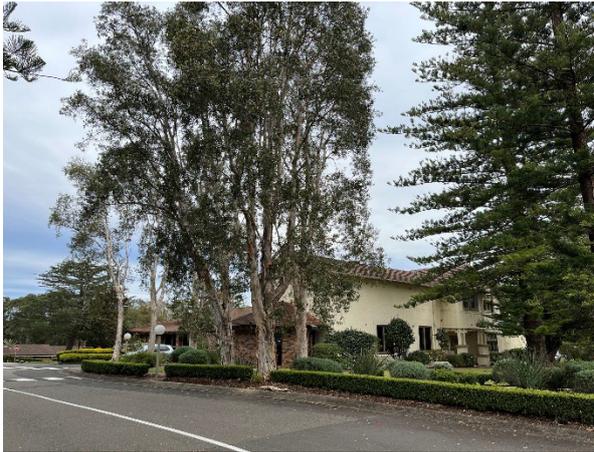
Entrance drive

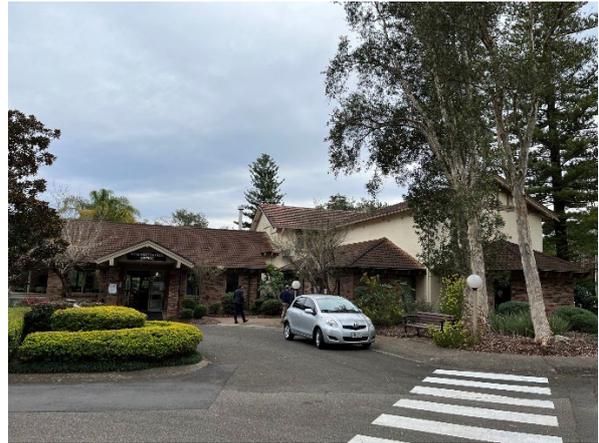
Turning circle and 1980s addition to south-east

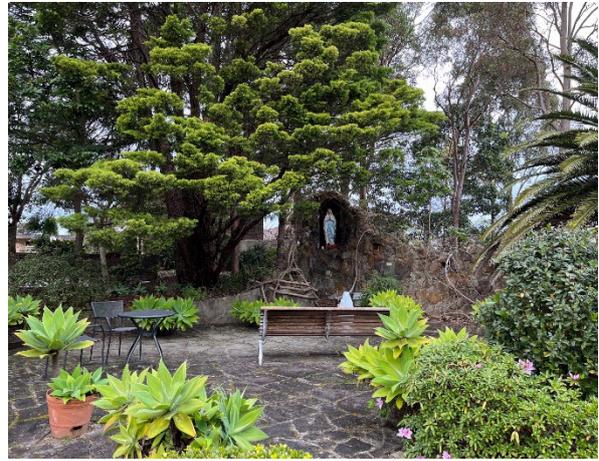
- Grotto to the south east of Headfort House appears intact.

Grotto to the south-east

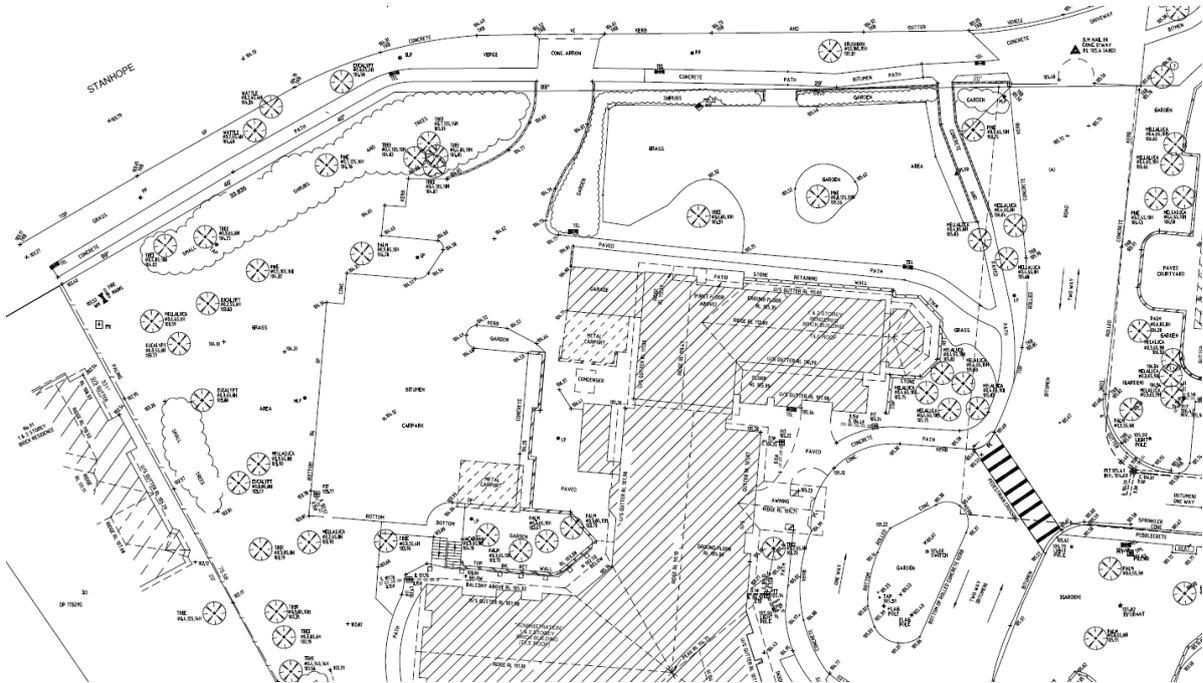
Existing site survey extract (source: Norton Survey Partners, 2022)

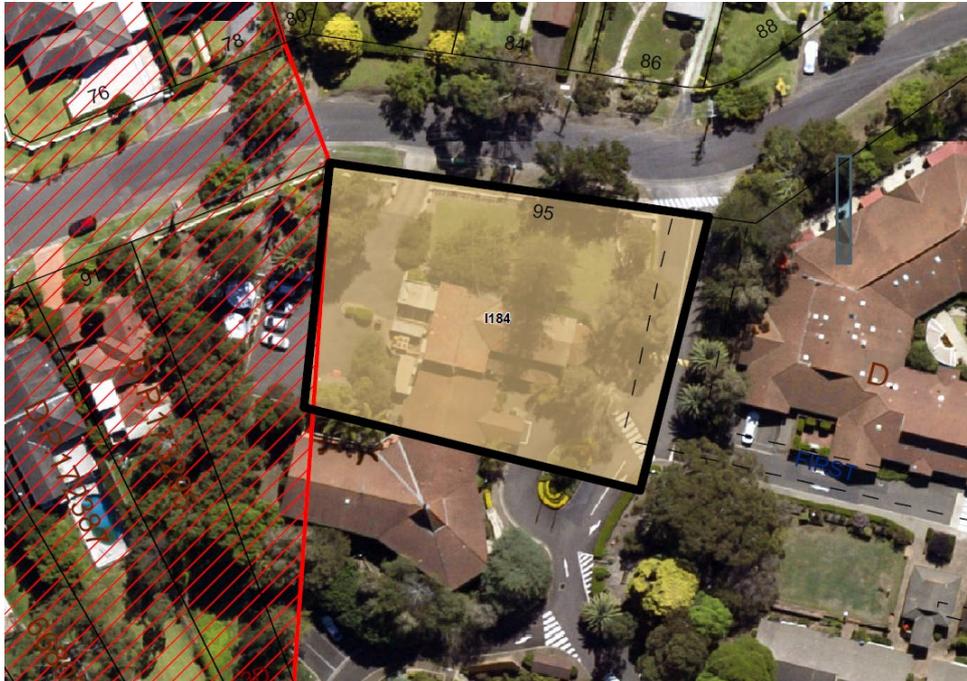
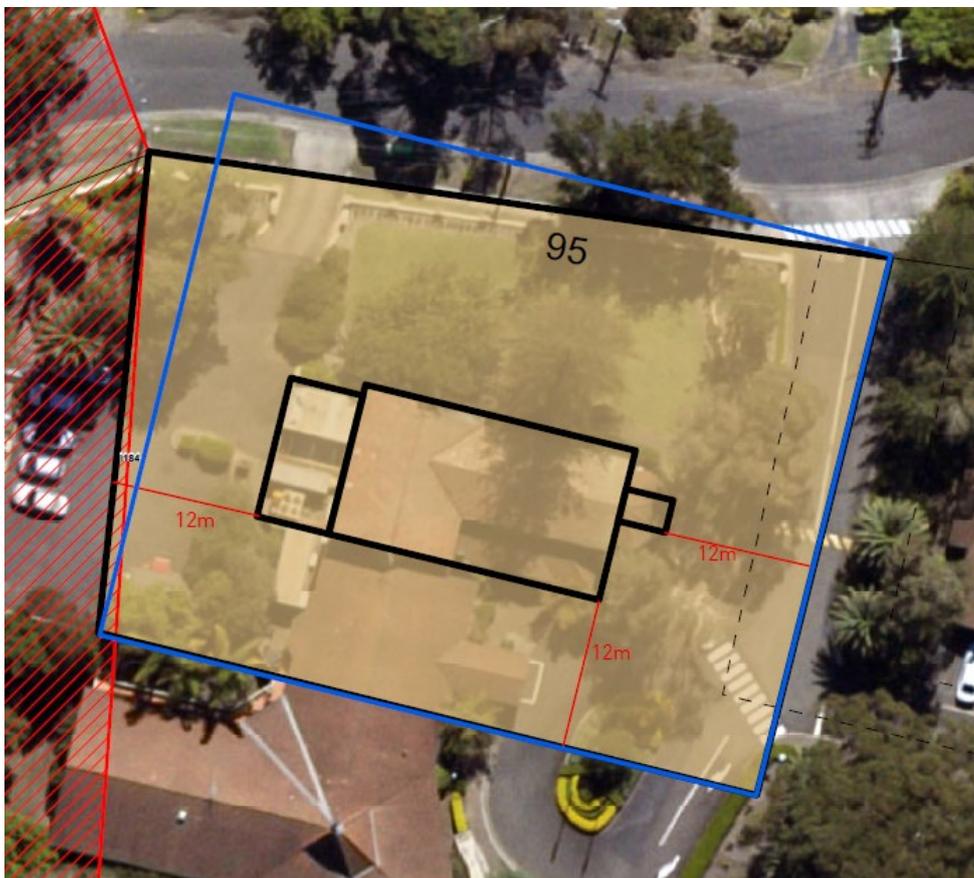
The following sketches illustrate this recommended curtilage in a heavy black line. Dimensions are measured based on the more precise site survey rather than the aerial photo included below for clearer features at this scale. Second sketch indicates the measurements in red, building outline in black and alignment in blue.

- In the absence of significant historic property boundaries to the east, south and west of Headfort House, it is recommended that the internal boundaries follow Ku-ring-gai's established policy for 12-metre setbacks for new development of heritage items in the Development Control Plan section 19E.3.

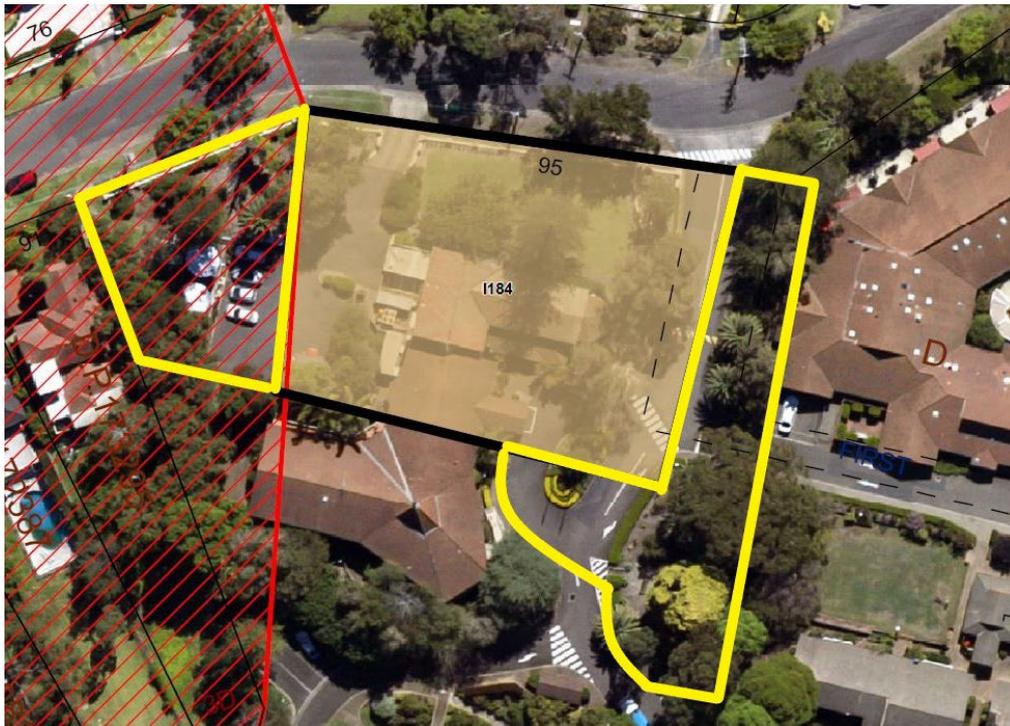
The location of these features beyond the above recommended curtilage is shown within the yellow line of the sketch below.

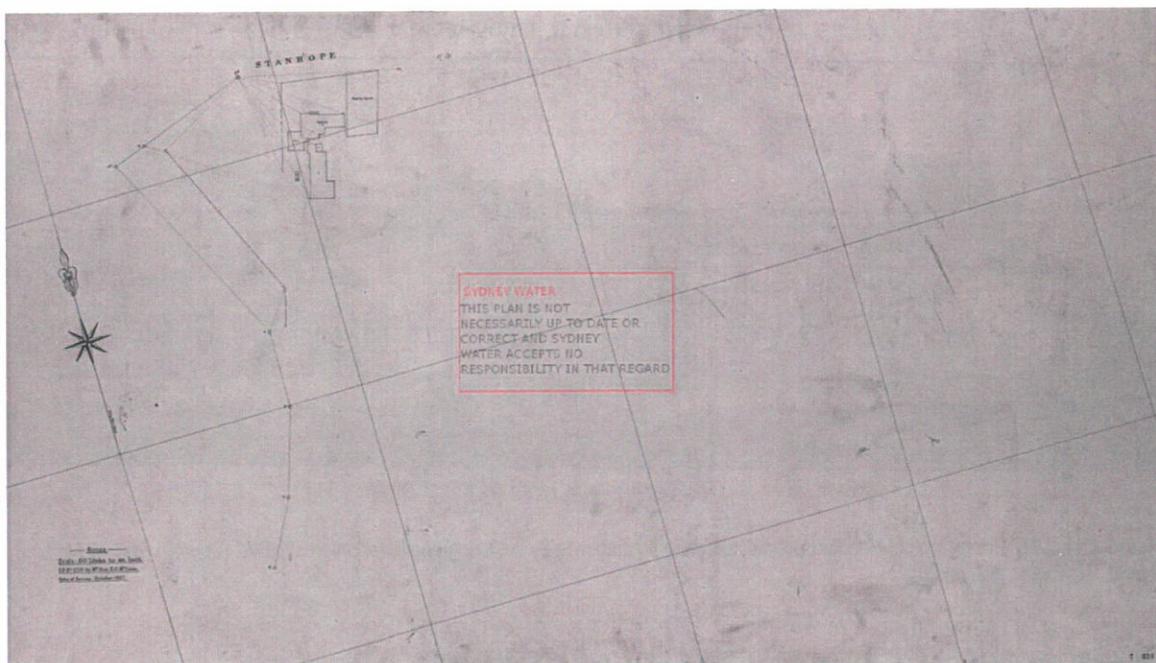
Figure 2.13 1927 Sydney Water survey of the Milton Grammar School. (Source: Sydney Water Archives)

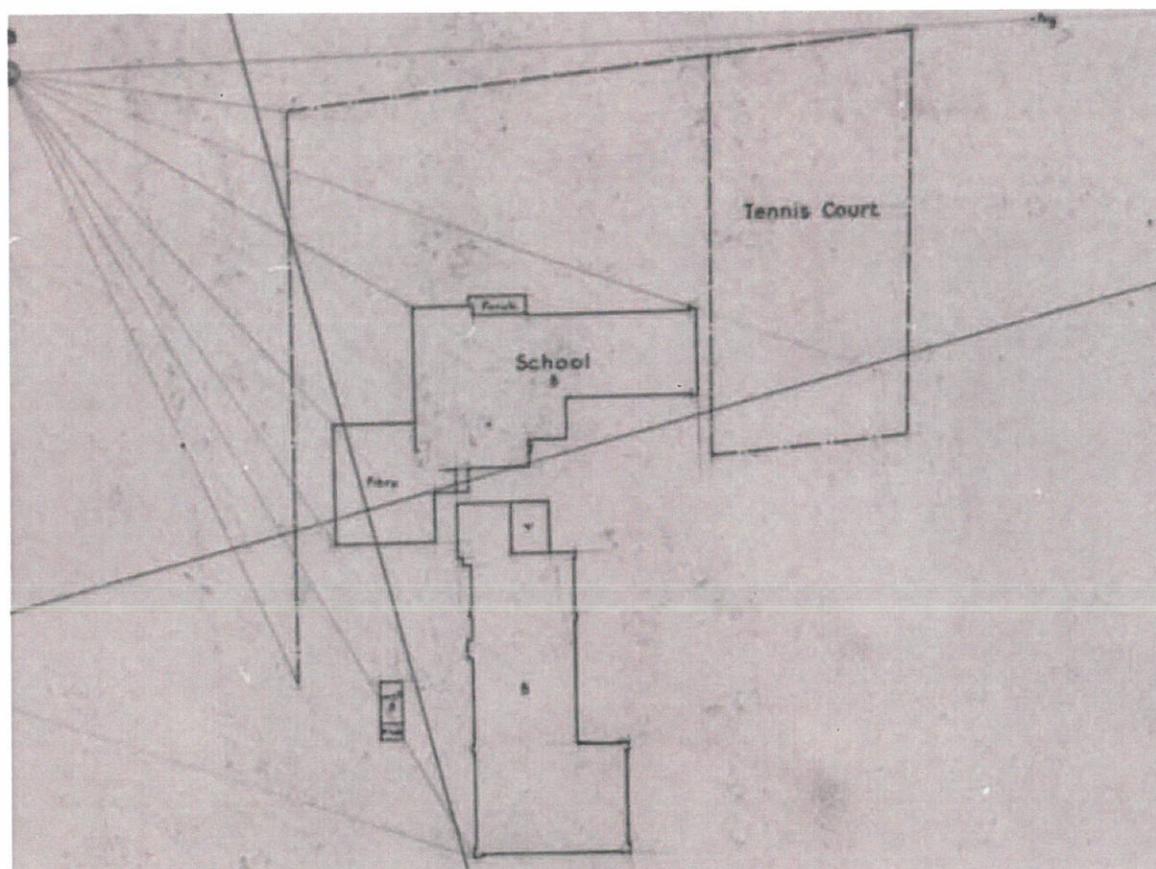
Figure 2.14 Detail of the 1927 Sydney Water survey of the Milton Grammar School. (Source: Sydney Water Archives)

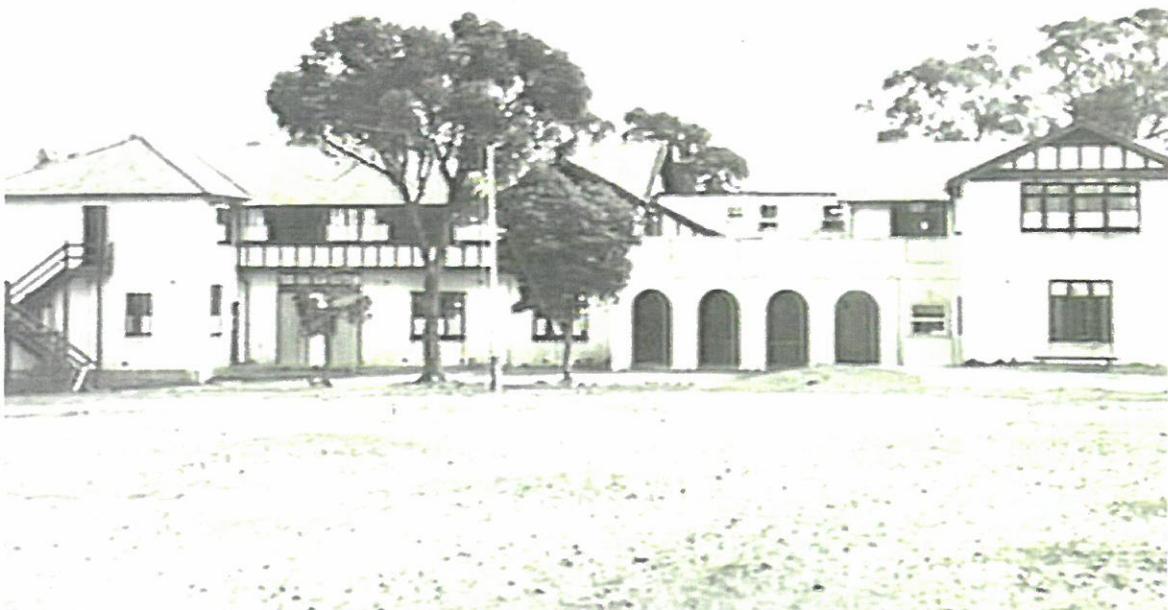
Figure 2.19 1942 view of the former school buildings, here being used by the Australian Women's Army Service. The east elevation of Headfort House is on the left. The arched structure was constructed in 1928. (Source: Australian War Memorial, viewed 22 February 2017 <<http://www.awm.gov.au/collection/P01343001>>)

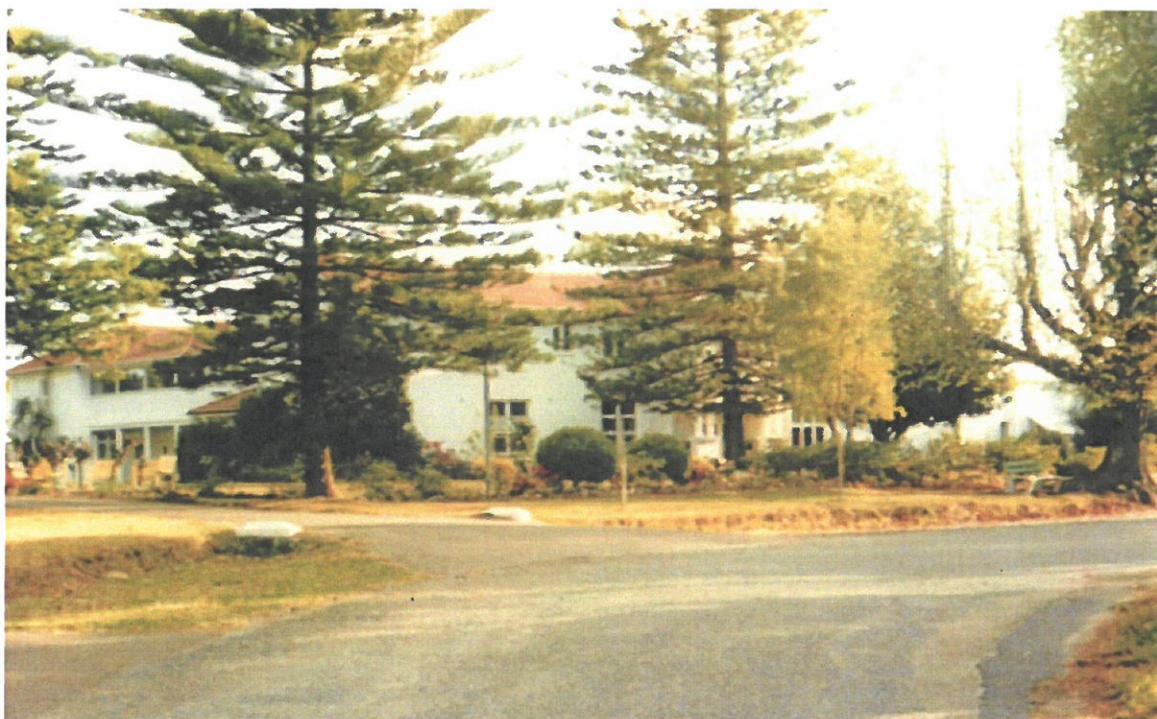
Figure 2.23 Headfort House c1950s, published in Cook, KM 1991, *The Railway Came to Ku-ring-gai*, Genlin Investments, Pymble. Note that the original windows in the chapel wing have been replaced. (Source: Ku-ring-gai Historical Society photographic collection)

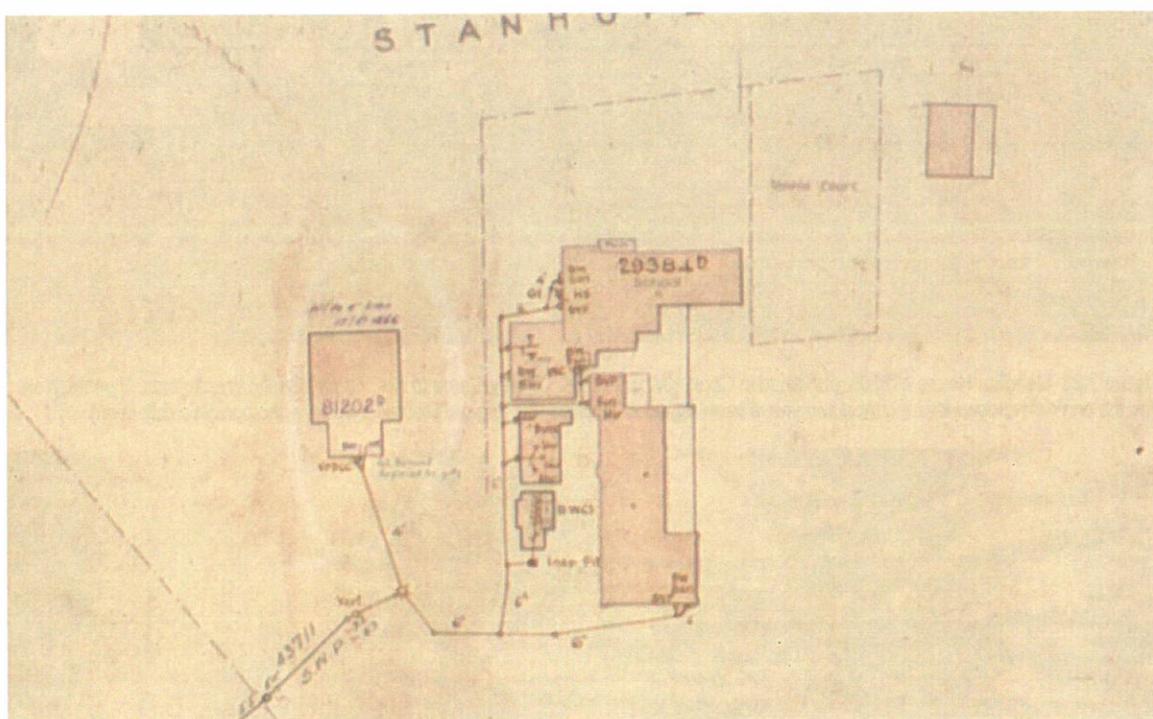
Figure 2.26 The Blackwattle Plan of the subject site, dating between 1927–c1953. (Source: Sydney Water Archives)

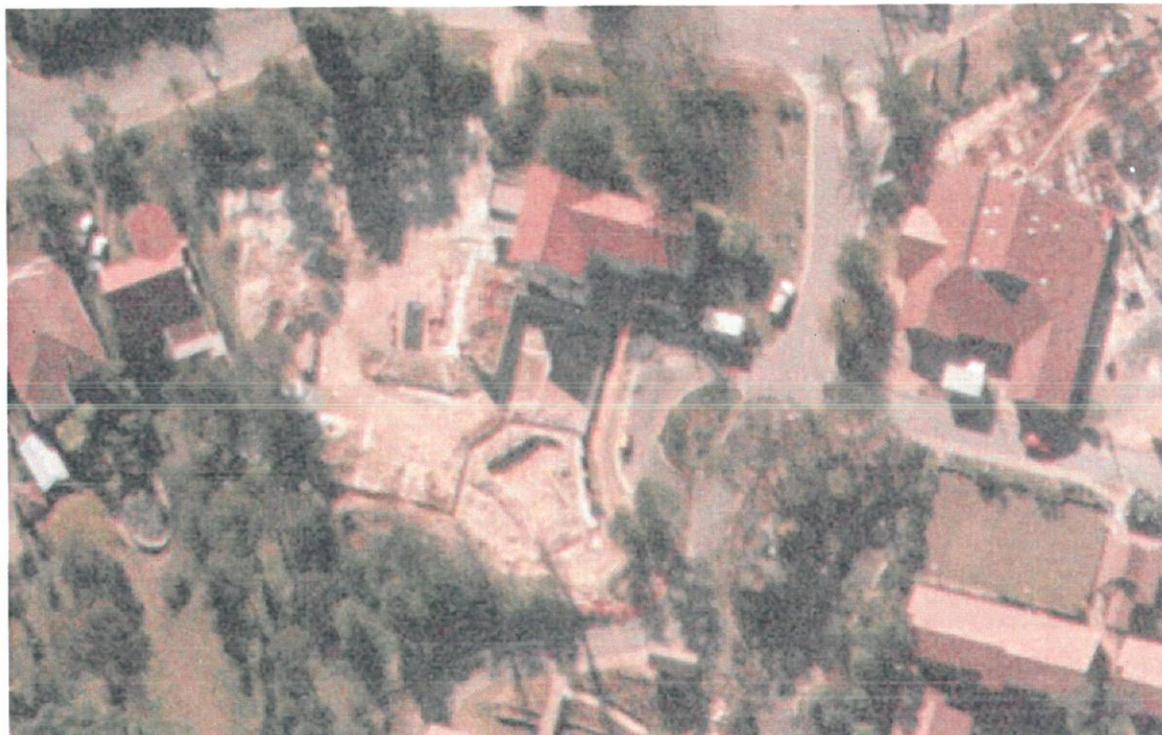
Figure 2.30 Detail of subject site on 1986 aerial showing one of the former school buildings already demolished and the footings of the new administration building. (Source: LPI NSW)

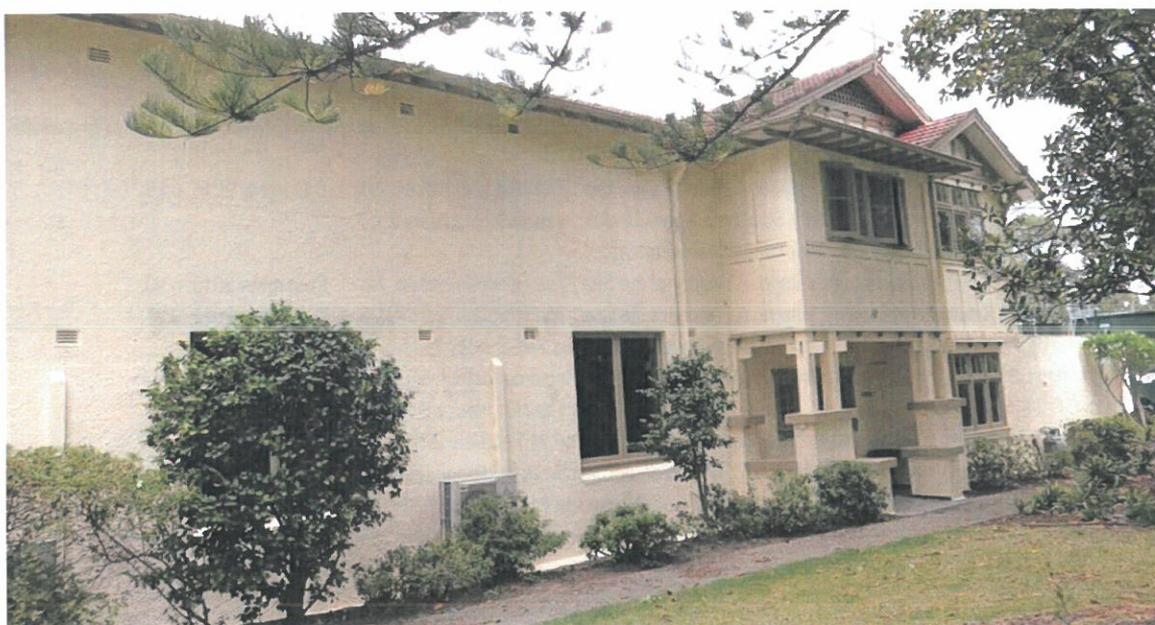
Figure 3.1 The north (front) elevation of Headfort House at 95 Stanhope Road, Killara (facing Stanhope Road), in its garden setting. (Source: GML 2017)

The front of Headfort House addresses Stanhope Road (although the main entrance to the Chapel is on the southern side of the building) (Figure 3.1). The front of the building is parallel to the roadway, and a rectangular front yard—with perimeters defined by garden beds containing hedge plants—separates the building from Stanhope Road (Figure 3.2). The front yard consists primarily of open lawns. Three mature trees are located within the front lawn area—two large Norfolk Island pine trees and a Moreton Bay fig tree, the latter surrounded by a roughly circular garden. Other planting consists of small shrubs and ground covers, generally exotic species. The extent and form of the front garden—areas of flat lawns surrounded by hedges with some planting interspersed—largely matches the 1943 aerial photograph. However, the front garden currently extends further to the east than it did in 1943, when its eastern boundary roughly aligned with the eastern wall of Headfort House. Photographs dating from the late 1920s and 1930s show the front garden's northern and western perimeters further defined by timber post and rail fences with wire mesh infill; these fences no longer exist. On its eastern side was a fenced open area, possibly a tennis court.

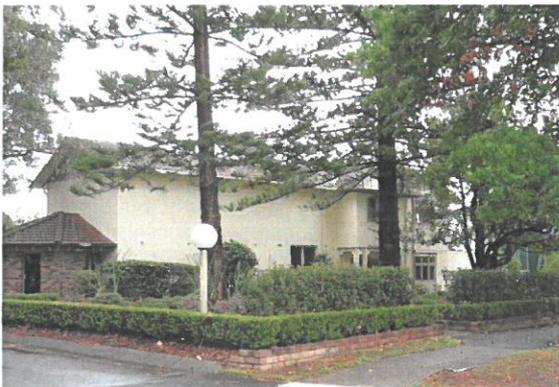
Figure 3.2 View of Headfort House from the northeast. The hedges around its front garden and large trees within the garden can be seen. (Source: GML 2017)

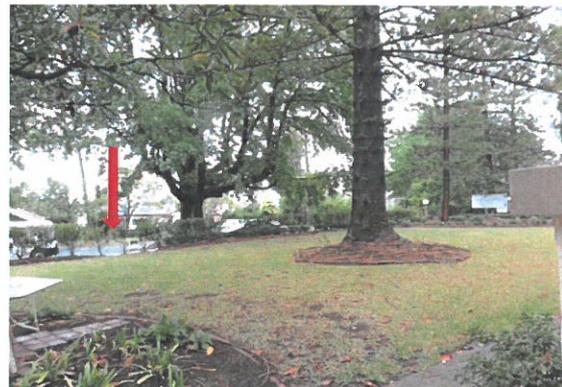
Figure 3.3 View across the front garden looking towards Stanhope Road. The gap in the garden edging at the property boundary (marked with an arrow) is likely the location of the original gateway to the property. (Source: GML 2017)

Historic photographs also show a meandering paved path through the garden leading from Stanhope Road to the front door of the building, with a branch of the path curving around to the western side of the building. Whereas this path no longer exists, a break in the (1980s?) brick garden edging on the Stanhope Road boundary is evidence of where the path was once started (the hedge plants are continuous across the gap) (Figure 3.3). The double-leaf timber joinery gates that marked the start of the path and the public entrance to the garden, as shown in a photograph from the 1930s, no longer exist. Although the three trees within the front yard are mature, only one of the pine trees appears to possibly exist in an aerial photograph dating from 1943. None of these trees appear in the 1927 photograph of the front of the building.

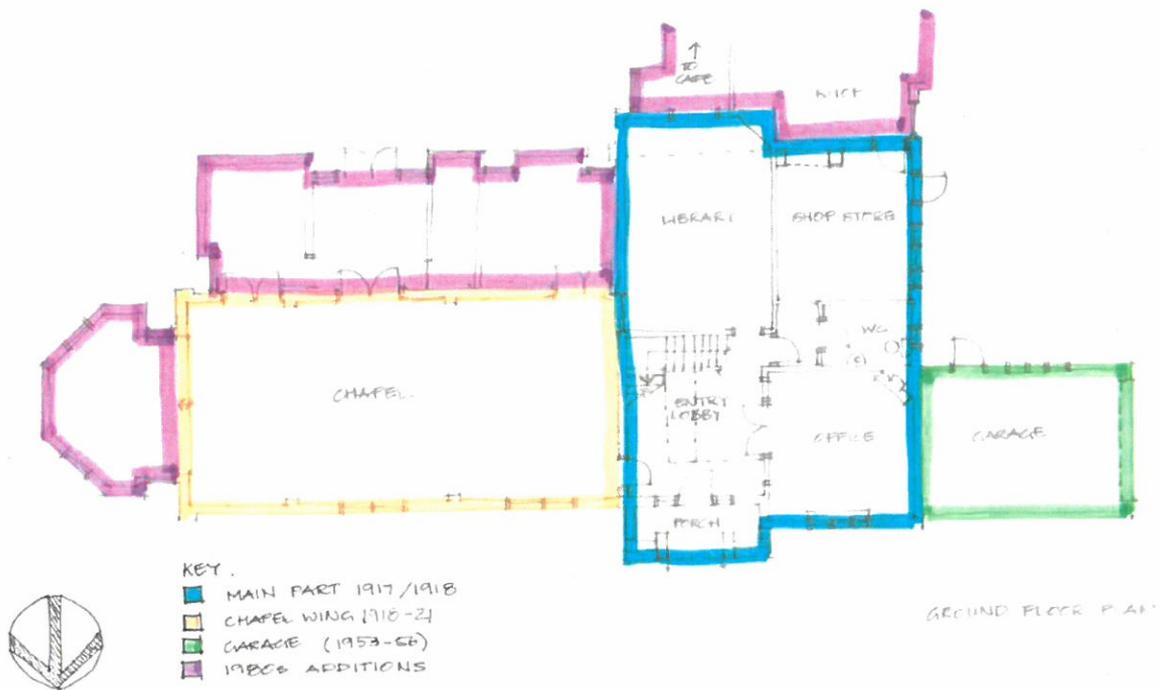
Figure 3.6 Sketch of the existing ground floor plan of Headfort House, coloured to show the construction periods of various components. (Source: GML)
