Headfort House
Heritage Assessment Review
95 Stanhope Road, Killara

Claudine Loffi, Ku-ring-gai Council
September 2022

The purpose of this report is to review the existing heritage significance assessment report of Headfort House by GML Heritage that was prepared for Stockland dated May 2017.

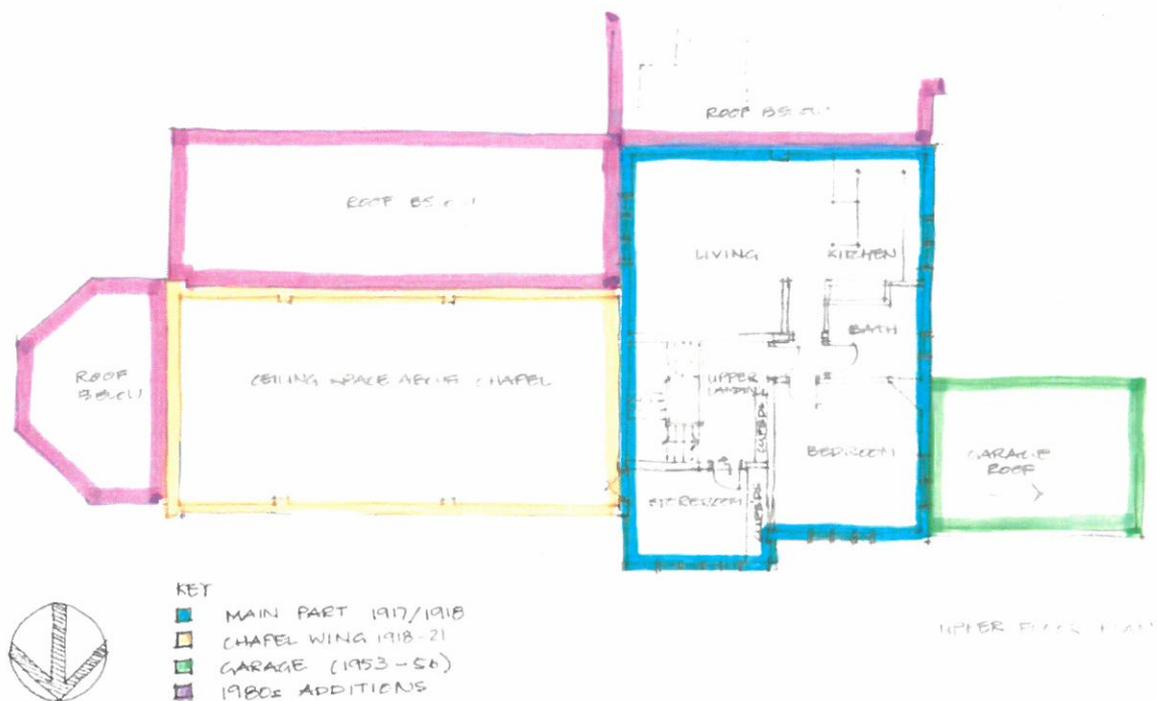
Figure 3.7 Sketch of the existing upper floor plan of Headfort House, coloured to show the construction periods of various components. (Source: GML)

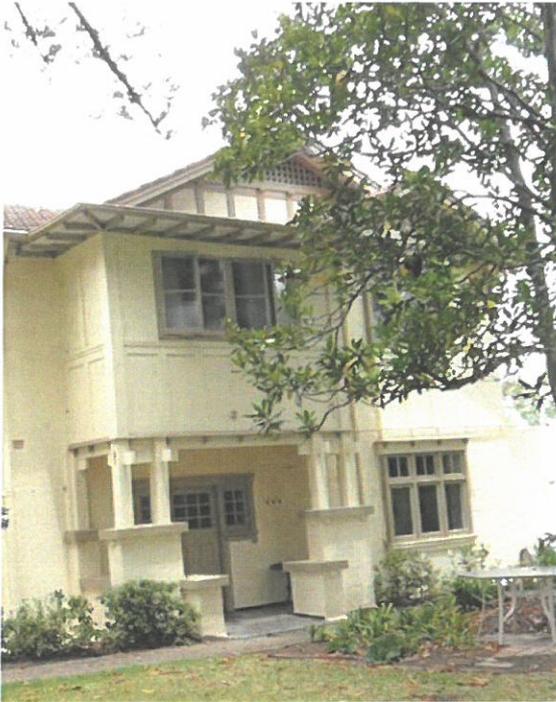
Figure 3.8 The north (front) elevation of the main part of Headfort House at 95 Stanhope Road, Killara (facing Stanhope Road), in its garden setting. (Source: GML 2017)

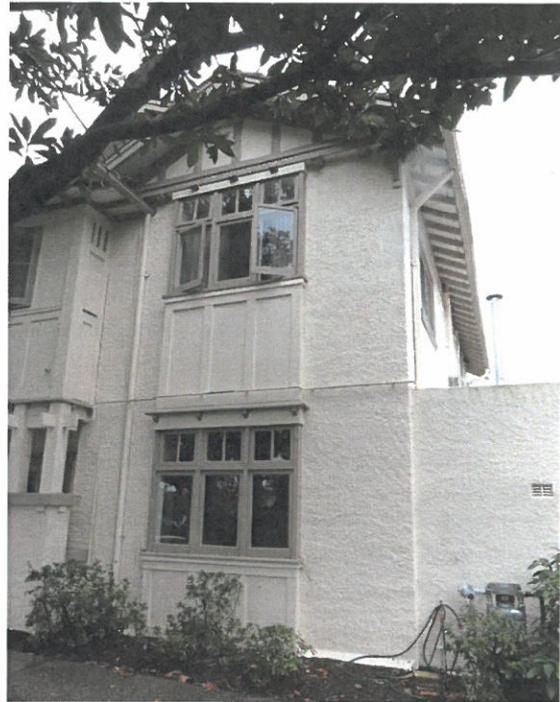
Figure 3.9 The framed wall panels below the windows on the north (front) elevation of Headfort House. (Source: GML 2017)

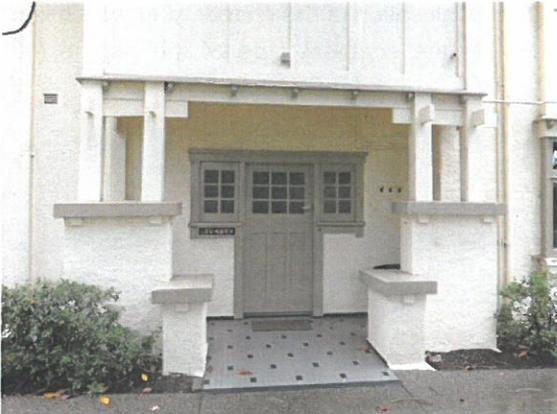
Figure 3.10 The entry porch and front door. (Source: GML 2017)

The front door is a high-waisted timber joinery door, with obscure glazing to its upper portion, divided into nine equal panes (Figure 3.10). Side-lights exist on both sides of the door, each with six equal panes. The door and sidelights appear to be original. The door and sidelights feature obscure patterned glass, a single type used throughout. The door has a contemporary stainless steel lever and lock.

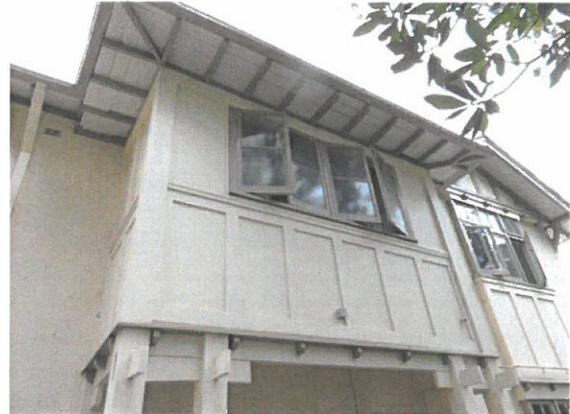
Figure 3.11 The verandah above the entry porch. The windows are a later addition. (Source: GML 2017)

Directly over the entry porch is a projecting framed structure that was originally built as a semi-recessed verandah, but which has now been enclosed (Figure 3.11). Walls are framed and clad with fibrous cement sheet to about one metre in height and feature expressed vertical timber battens, these being the original balustrades around the verandah. Above the balustrade level the original opening on the northern wall has been infilled with timber framed windows with casement sashes. There is a flat roof over the former verandah, with wide projecting eaves that are timber boarded with expressed timber rafters. The verandah structure remains substantially as originally built, except for the insertion of the timber framed window.

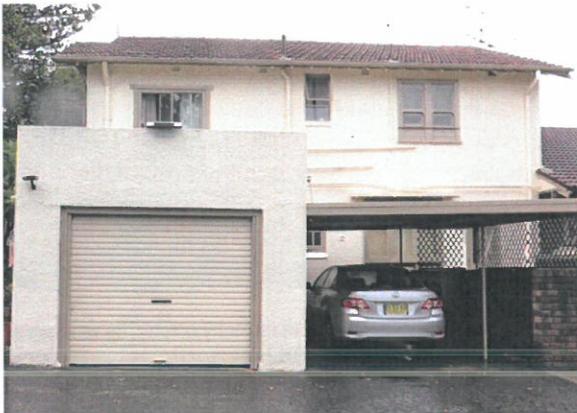
Figure 3.12 The west elevation of Headfort House. (Source: GML 2017)

The west elevation was designed as a secondary elevation, and is not as detailed as the north elevation (Figure 3.12). Masonry walls are stucco and paint finished. Eaves are timber boarded and raking with expressed timber rafters, matching those on the other elevations. The sandstone foundations are also visible on the western elevation.

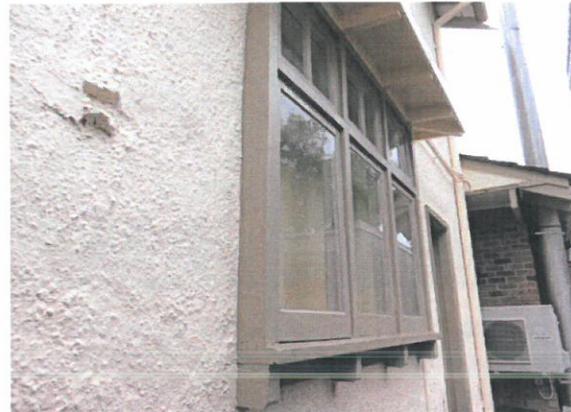
Figure 3.13 Detail of the large timber framed window, west elevation. (Source: GML 2017)

There are two ground floor windows, of which the small casement window is most likely original. It is timber framed, and consists of a single casement sash divided into four equal panes. The head of the opening is slightly arched. The larger window is a timber framed window, with three lower casement sashes and three upper awning sashes. Directly above the window is a narrow farmed flat awning, which provides a degree of weather protection to the window. The awning has a timber boarded soffit and expressed timber rafters. The window is most likely original, or has been relocated from elsewhere on the site (Figure 3.13). To the south of this window is a single leaf door. The door frame is timber and the door leaf is a featureless flush door. The threshold is terrazzo, and is badly damaged. This door is unlikely to be original.

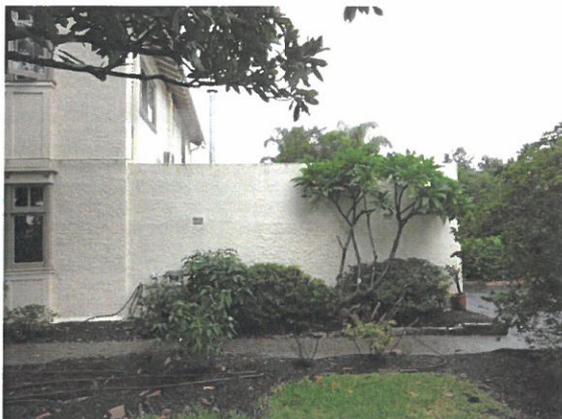
Figure 3.14 The north elevation of the garage. (Source: GML 2017)

The garage is a single-storey masonry structure attached to the western elevation of Headfort House, close to its northern corner. Aerial Photographs and plans indicate that the garage is a later addition to the building, built between 1953 and 1956. The garage's external walls are stucco and paint finished, and extend up to form a parapet on three sides (Figure 3.14). The metal deck roof has a low pitch, and falls to a box gutter adjacent to the western wall. There is a metal roller door (contemporary) on its western elevation, and a single leaf door and window on its southern elevation. The door is a high-waisted timber joinery door with three lower panels, matching the door to the main bedroom; it has most likely been salvaged from elsewhere on the site and reused here (Figure 3.15). The small timber window has three equal casement sashes. It is also possibly salvaged from elsewhere on site: a similar window can be seen in early photographs on the north elevation of the chapel wing (which is no longer in place). There is steel framed carport lean-to on the southern side of the garage (late twentieth century).

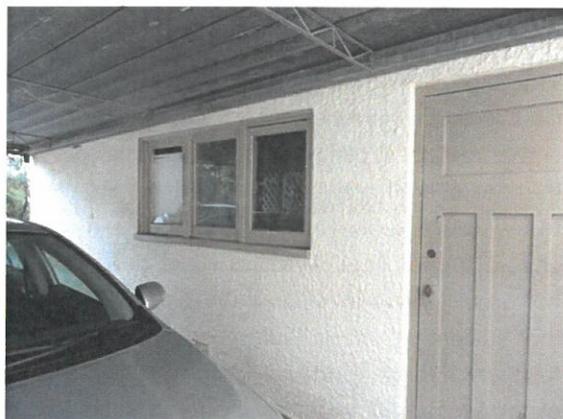
Figure 3.15 The south elevation of the garage, with door and window that are likely to have been salvaged from elsewhere on the site. (Source: GML 2017)

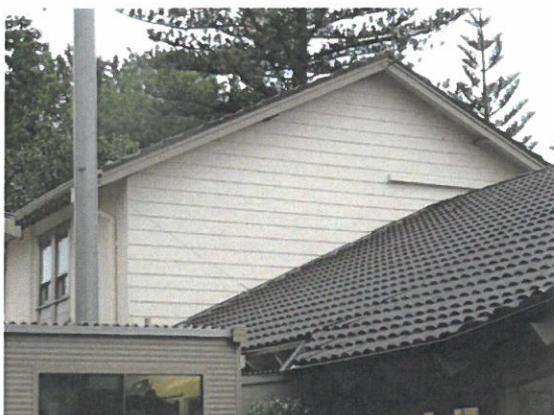
Figure 3.16 The boarded gable is the only part of the south elevation of the main part of the building that is visible. The brown tiled roof in the foreground is part of the 1980s building. (Source: GML 2017)

Due to the adjacent 1980s building on the southern side, only the upper wall of the south elevation is visible. This part of the wall is clad in fibrous cement planks. Eaves are sheet lined. There alterations are recent, and relate to the construction of the 1980s building. No original detailing is visible (Figures 3.16, 3.17).

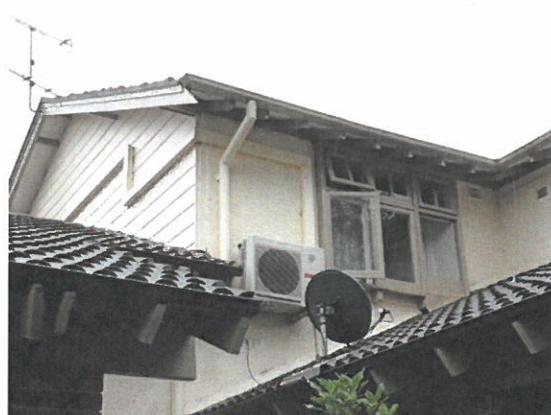
Figure 3.17 The original timber window that exists in the upper part of the east elevation of the main part of the building. The boarded gable of the south elevation can be seen on the left. (Source: GML 2017)

Only a small portion of the east elevation is visible, that being the upper floor external wall above the 1980s single storey additions to the Chapel wing. This wall is stucco and paint finished. The one window in this wall—timber framed, with three lower casement sashes and three upper awning sashes—matches those windows on the north and west elevations, and is most likely original (Figure 3.17).

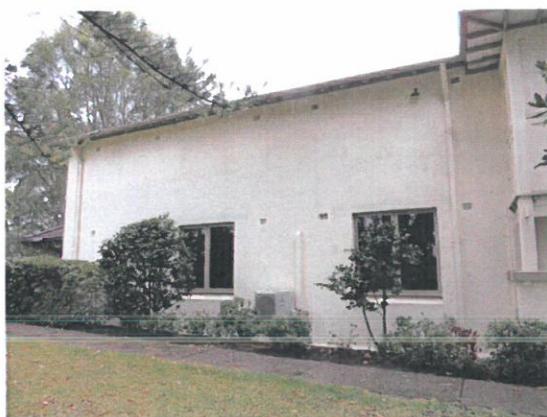
Figure 3.18 The north (front) elevation of the chapel wing. 'Shadows' of former window openings can be seen in the stucco finish. (Source: GML 2017)

The chapel wing has masonry external walls with painted stucco finish, built on sandstone footings (visible on the north elevation). The pitched roof is tiled, and eaves are timber boarded with expressed timber rafters. A comparison of the building's current condition with early external photographs indicate that the overall size and form of the wing remains unchanged, although there have been changes to the wing's fenestration. Discontinuities in the stucco finish on the north and east walls indicate that several upper floor windows have been removed and the openings infilled—three windows on the north wall and one window on the east wall. On the north elevation, the two timber framed windows that currently exist on the ground floor have contemporary detailing, and are not original, although the location of these windows approximates the location of original window openings. There are three rows of terracotta wall vents on the north elevation which match those visible in early photographs (Figure 3.18).

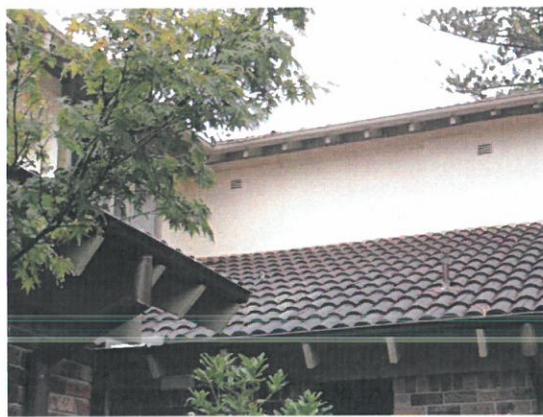
Figure 3.19 The upper part of the wall of the chapel wing can be seen above the 1980s tiled roofs. (Source: GML 2017)

Most of the southern elevation is concealed by 1980s additions (Figure 3.19). However, 'shadows' in the stucco finish indicate upper floor openings that have been infilled. A row of high level wall vents remains, which match those on the northern elevations.

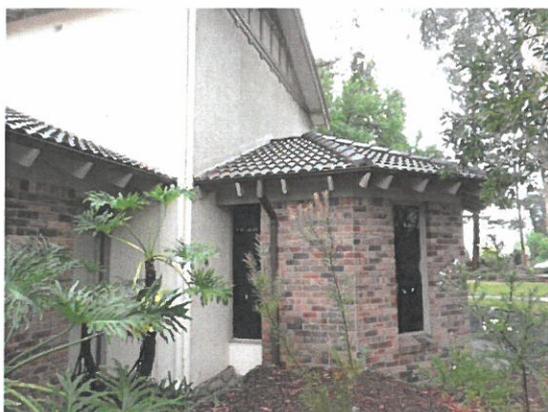
Figure 3.20: The 1980s addition on the eastern side of the chapel wing. (Source: GML 2017)

Single storey 'lean-to' additions were constructed in the 1980s on the southern and eastern sides of the Chapel (Figure 3.20). These additions have face brickwork external walls and hipped dark brown glazed tiled roofs with raking eaves with exposed timber rafters, matching the larger 1980s building located on the south side (and connected to) Headfort House.

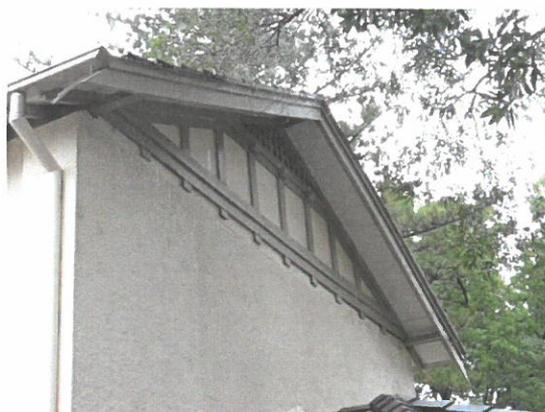
The eastern gable is finished in fibrous cement sheet with exposed timber battens and decorative timber trims. Battens are arranged in a lattice pattern at close to the ridge. This corresponds with the gable detailing that can be seen in early photographs. It also matches the detailing of the main gable on the north elevation (Figure 3.21).

Figure 3.21 The eastern gable of the chapel wing. The shadow in the stucco below shows the location of the window that was originally located in this wall. (Source: GML 2017)

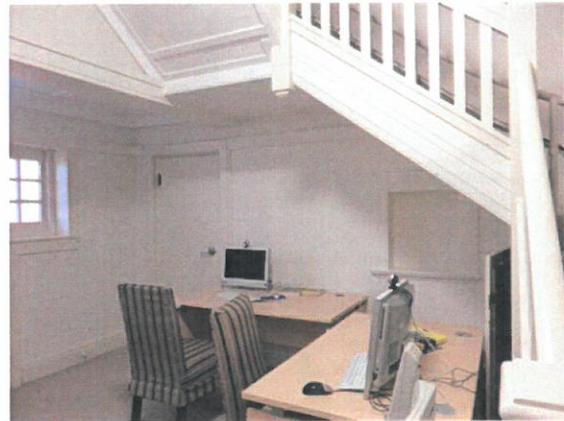
The single leaf door leading to the chapel (timber frame, flush door) is not original (Figure 3.23). The doorway to the office has elaborate built-in joinery at its sides, but the glazed door leafs themselves are not original, and there are signs that indicate that the opening has been adapted to accommodate these door leafs (Figure 3.25). The stair is timber framed with timber newel posts and handrails most likely original. The grooved stair rails appear to be more recent however, and perhaps relate to the installation of the chair lift that runs on the inside face of the balustrade. It is unclear if other parts of the balustrades are also recent replacements for original components.

Figure 3.23 The east wall of the entry lobby, with door to the chapel. (Source: GML 2017)

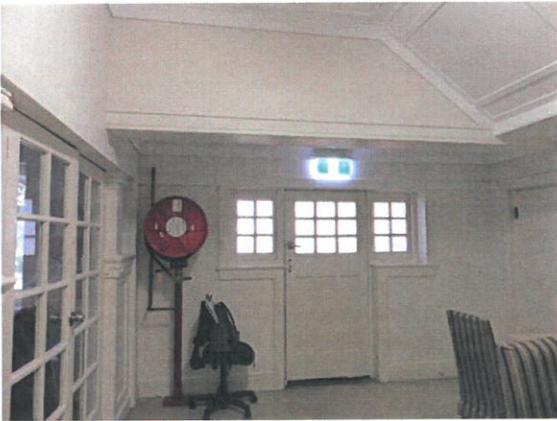
Figure 3.24 The north wall of the entry lobby, with front door and sidelights. (Source: GML 2017)

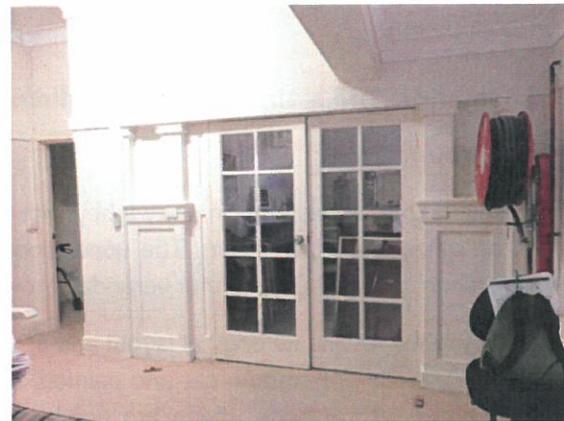
Figure 3.25 The door to the office, as seen from the entry lobby. (Source: GML 2017)

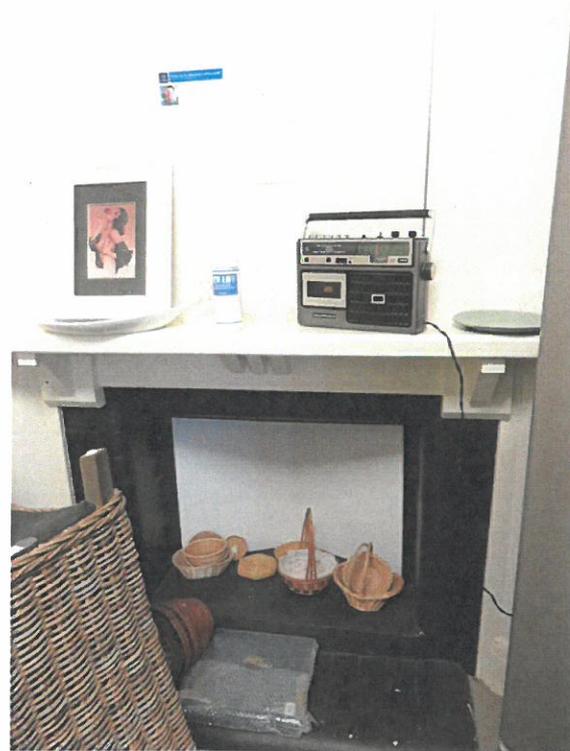
Figure 3.27 The fireplace in the office. (Source: GML 2017)

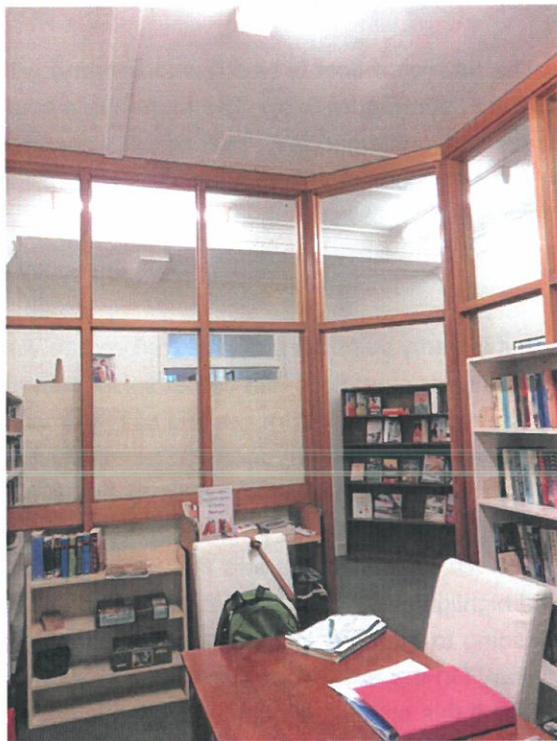
The library is legible as a single large room, even though it is partly subdivided by a glazed screen wall which is a contemporary addition (Figures 3.29–3.31). It has a framed floor with carpet finish, smooth set walls and a smooth set ceiling with battened detail. The room's plaster cornices and ceilings match those in the entry hall and are most likely original. There is a lower section of ceiling adjacent which is not original (with small coved cornices), and its form and finishes are likely to relate to the 1980s building connection. Parts of the room have a timber skirting which matches that in the entry lobby. At the southern end of the room there is a wide opening which allows access into the 1980s building adjacent (Figure 3.31). This has a timber door frame and highlights with obscure glazing, but no doors. On the northern wall is an opening with timber frame leading to the entry lobby, but again there is no door leaf. Both of these doorways are likely to be original. On the eastern wall there is a blocked-in doorway that previously led to the chapel, and it is unclear if this opening is original (Figure 3.29). On the eastern wall at high level are two air grilles that match those in the office, and are original. In the southwestern corner the splayed wall is suggestive of a chimney breast. Bookshelves placed hard against this wall indicate that even if a fireplace remains behind the shelves, no protruding mantelpiece or hearth remains.

Figure 3.30 The contemporary glazed screen wall that divides the room. (Source: GML 2017)

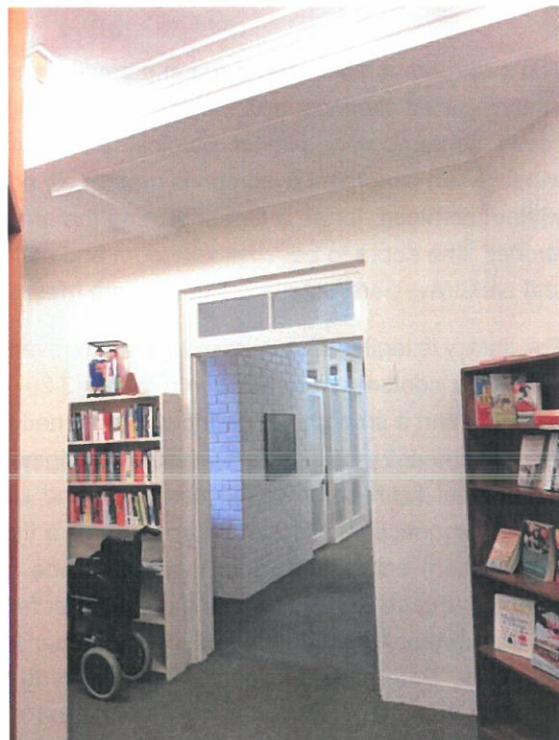
Figure 3.31 The doorway in the southern wall that leads to the 1980s building. (Source: GML 2017)

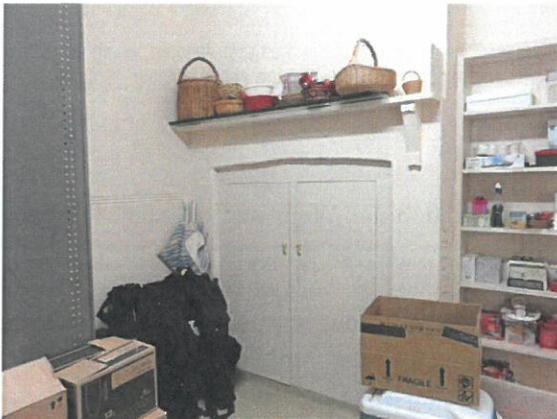
The shop store is accessible from the shop, which is located in the 1980s building. The shop store was likely to have originally been a kitchen; there is a large former cooking hearth in the southeastern corner (Figure 3.32). The former hearth now contains a built-in cupboard, but the original timber mantelpiece remains above. Floors are vinyl sheeted (1980s?) with coved vinyl skirtings. The floor is framed, except for a large concrete section close to the cooking hearth, the extent of which is defined by cracking in the vinyl floor sheeting. Walls are smooth set, with a dado line formed in the plaster that extends around the room. Ceilings are smooth set and without any cornice. The two doors into the room are flush doors. The door that led to the shop is a new opening. The doorway to outside is possibly an early or original opening, but the door leaf is new (Figure 3.33).

Figure 3.32 The former cooking hearth in the southeastern corner of the shop store. (Source: GML 2017)

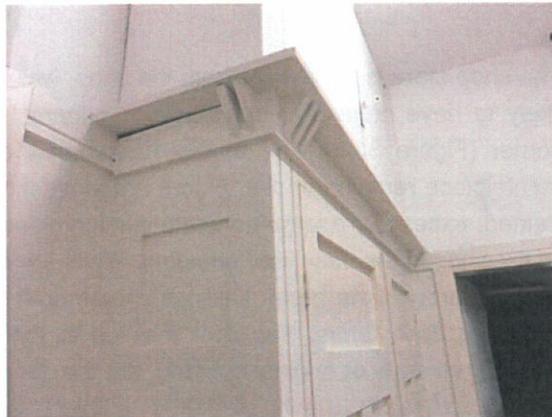
A grooved timber rail runs at door head height around the walls. Skirtings are original on the eastern wall (stair rails) and northern walls, but a different profile skirting has been used on the other walls. On the western wall is a timber joinery cupboard, the upper portion of which is clearly contemporary. The lower portion (up to door head height) is detailed to match other original timberwork in the house, and is most likely original, although it has been relocated from elsewhere; the timber rail on the wall runs along the wall behind the cupboard (Figure 3.35). The timber balustrade at the landing has been replaced, although the newel posts are original.

Figure 3.35 The joinery unit in the upper landing, which appears to have been relocated from elsewhere in the building. (Source: GML 2017)

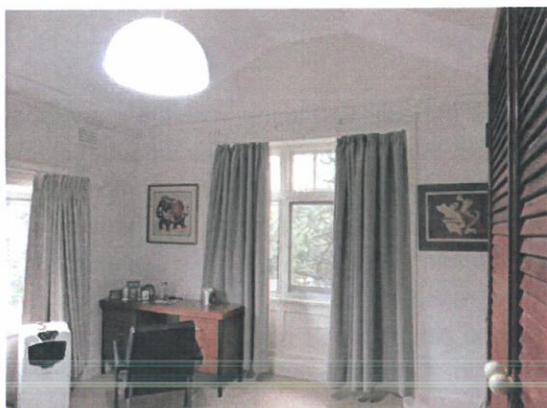
The bedroom has a framed floor with carpet finish (Figures 3.36, 3.37). Walls and ceilings are smooth set, with the ceiling partly raking. Cornices are contemporary coved plaster cornices. Timber skirtings match those in the entry hall, and a grooved timber rail runs around all walls at door head height. The aluminium-framed window in the western wall is of recent construction, but the door appears to be original—the door leaf is a high-waisted timber joinery door, and the door frame is timber (Figure 3.37). Door hardware is however contemporary. Below the window on the northern wall the framed wall has expressed timber battens, matching the external detail (Figure 3.36). The small hall adjacent to the bedroom matches the bedroom in finishes, skirtings and rails. However, unlike the bedroom it has no cornices.

Figure 3.36 The wall of the bedroom. (Source: GML 2017)

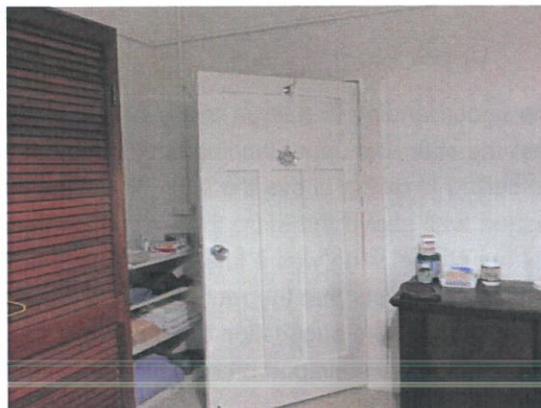
Figure 3.37 The original door into the bedroom. (Source: GML 2017)

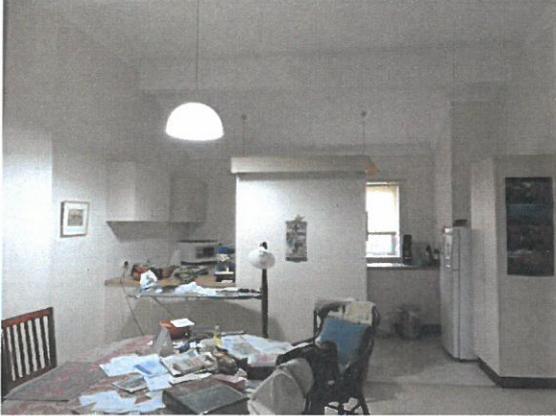
The living room and kitchen are located within a single large room at the southern end of the building (Figures 3.38–3.39). Floors are framed with carpet or sheet vinyl finish. Walls and ceilings are smooth set. The ceilings are partly raking, and have contemporary plaster coved cornices. Skirtings are contemporary, as are all fixtures and fittings. The timber window in the eastern wall is original and matches other windows in the building.

Figure 3.38 The living room, looking west towards the kitchen. (Source: GML 2017)

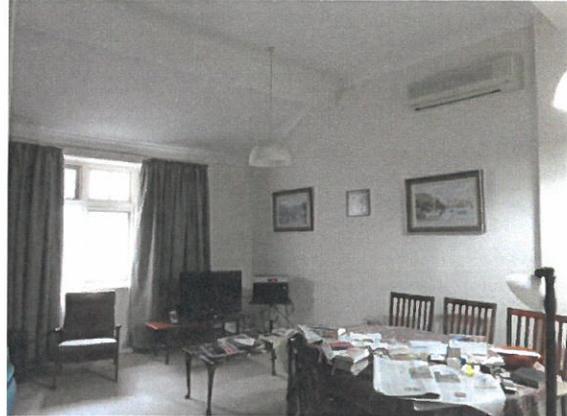
Figure 3.39 The southeastern corner of the living room. (Source: GML 2017)

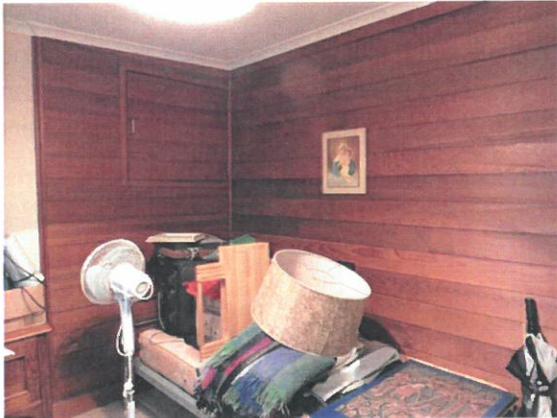
The storeroom/former verandah is accessed from the upper landing (Figures 3.40–3.42). There is a step down into the storeroom at the doorway, the raised form visible beneath the carpet suggesting a stone or concrete door threshold beneath the carpet. The floor of the storeroom is carpet finished over a framed floor. The ceiling is smooth set and rakes slightly down to the north. Cornices are contemporary coved plaster cornices. The southern wall and half of the eastern wall (the masonry walls) are lined with horizontal Western Red Cedar boards, most likely installed to cover the original stucco finish on these walls (Figure 3.40). The remainder of the eastern wall, as well as the northern wall, is framed and lined with smooth set sheet lining (Figure 3.41). The western wall is concealed by built-in cupboards (late twentieth century), but at the rear of the cupboards the original stucco wall is visible. The door leaf is a contemporary flush door but the timber door frame is possibly original.

Figure 3.40 The cedar boarding on the south and east walls of the storeroom. The small door in the panelled wall gives access to the chapel's ceiling space. (Source: GML 2017)

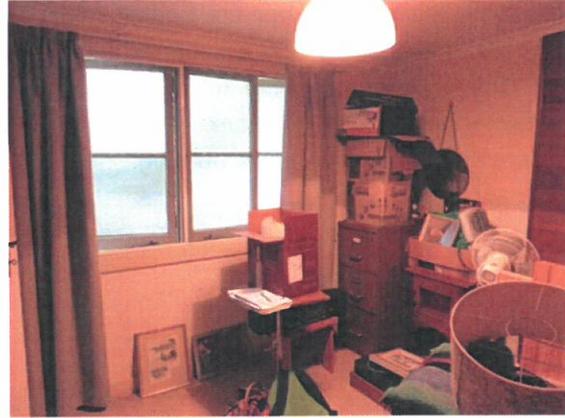
Figure 3.41 The north wall of the storeroom. (Source: GML 2017)

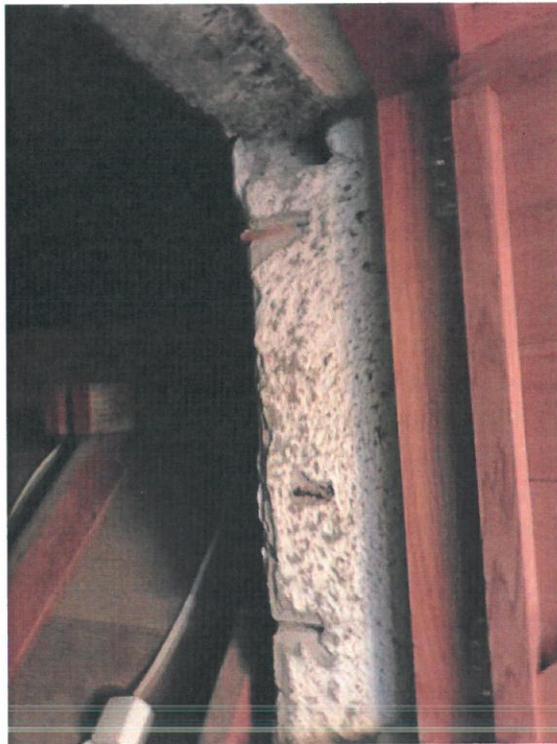
There is a small door on the eastern wall that provides access to the ceiling space above the chapel. Within this opening the original white painted stucco finish of the external walls of the main part of the building is visible. The stucco continues around the eastern wall (the chapel's west wall), which again supports the idea that the chapel wing was built as a later addition to the main part of the building (Figure 3.42).

Figure 3.42 When opened the access door allows for views of the building's original external stucco finish and the space above the ceiling of the chapel. (Source: GML 2017)

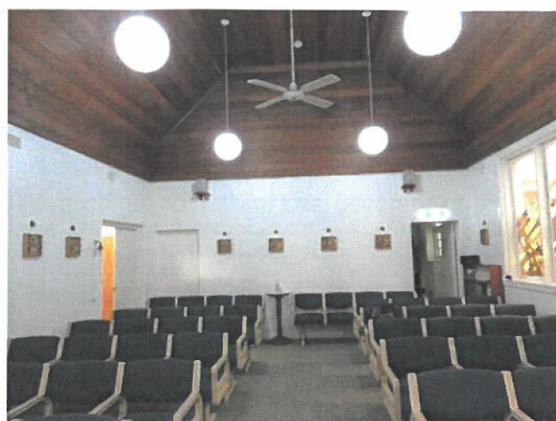
The chapel is a double-height space occupying the whole of the chapel wing (originally the chapel wing had two storeys within the same volume of space) (Figures 3.43–3.46). The floor is framed with carpet finish. Walls are generally smooth set, although western red cedar boarding has been used as a lining on the eastern wall, and upper sections of the northern, southern and western walls. These walls also feature high level air grilles at regular intervals. ‘Shadows’ in the wall plaster suggest a horizontal dado once ran around the room at about 1200mm above floor level. The ceiling is partly raking, and is lined with cedar boards to match those used on the walls. Narrow piers are located on the northern and southern walls, their uppermost portion also lined in cedar boards. These piers have slightly rounded corners for most of their height, but transition to sharp square corners at high level (Figure 3.45). Doors and windows into the room are contemporary, as are all fixtures and fittings.

Figure 3.44 The chapel, looking west. (Source: GML 2017)

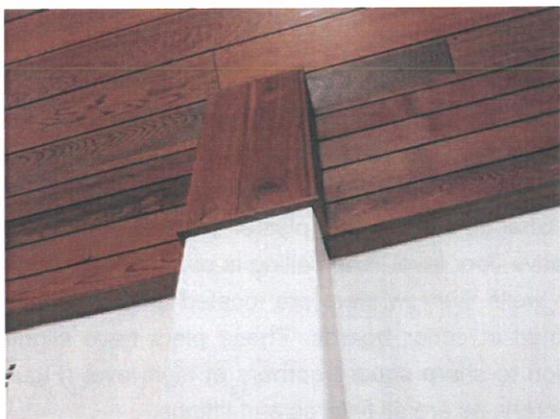
Figure 3.45 A typical wall pier in the chapel. (Source: GML 2017)

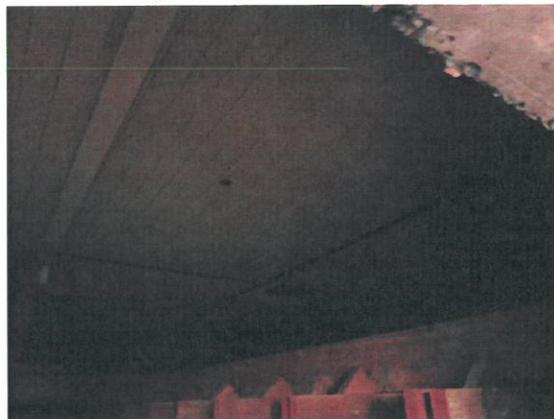
It is possible to view the ceiling space above the chapel, through a small access door in the storeroom on the upper floor (Figure 3.46). The view of the ceiling space reveals the original tongue and groove boarded ceiling intact above the cedar ceiling, which runs across the entire length of the space. Dark lines on the ceiling are possible indications of locations of former walls, indicating that there was at one time a central corridor with rooms on both sides. The ceiling space also shows that walls of the upper floor within the wing were smooth set, with a horizontal dado formed in the plaster. Wall vents can be seen, which are of a slightly different detail to those in the main part of the building, being installed flush with the wall rather than slightly proud of the finished wall surface.

Figure 3.46 The original boarded ceiling remains above the newer cedar ceiling in the chapel. The dark lines possibly indicate the former location of walls. (Source: GML 2017)

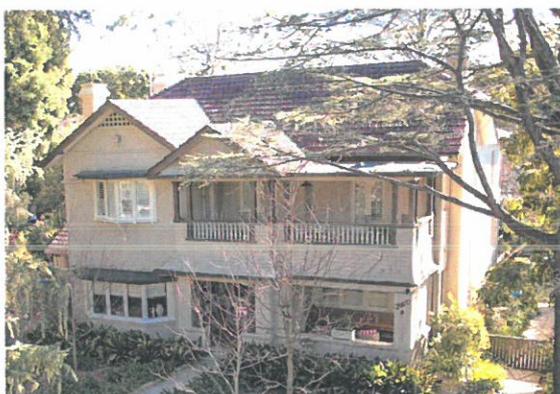
Figure 4.1 2 Stanhope Road, Killara. (Source: <<http://www.realestate.com.au>>)

The house at 2 Stanhope Road, Killara (a heritage item listed on the Ku-ring-gai LEP 2015), is an Arts and Crafts style two-storey masonry building. Like the Chapel, the building has steeply pitched tiled roofs, double gables with lattice detail, and features timber columns on a masonry base around the upper verandah. The verandah has a flat roof similar to that of the verandah of Headfort House. However, its detailing is more refined than that of Headfort House, and includes bay windows and a timber shingle skirted balustrade.

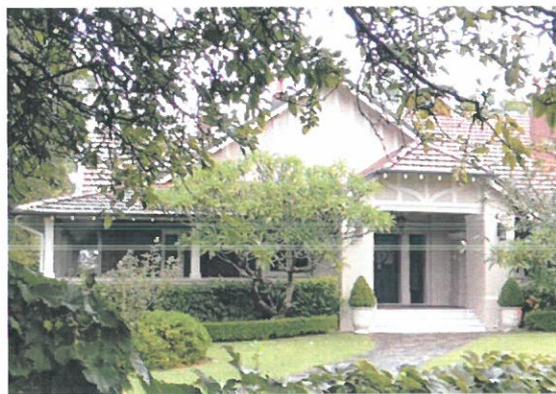
Figure 4.2 49 Springdale Road, Killara. (Source: GML 2017)

The house at 49 Springdale Road, Killara (not listed as a heritage item), has steeply pitched tiled roofs, timber battened detailing to its gables, and a defined covered entry porch slightly proud of the main building—all Arts and Crafts style characteristics that are in common with Headfort House.

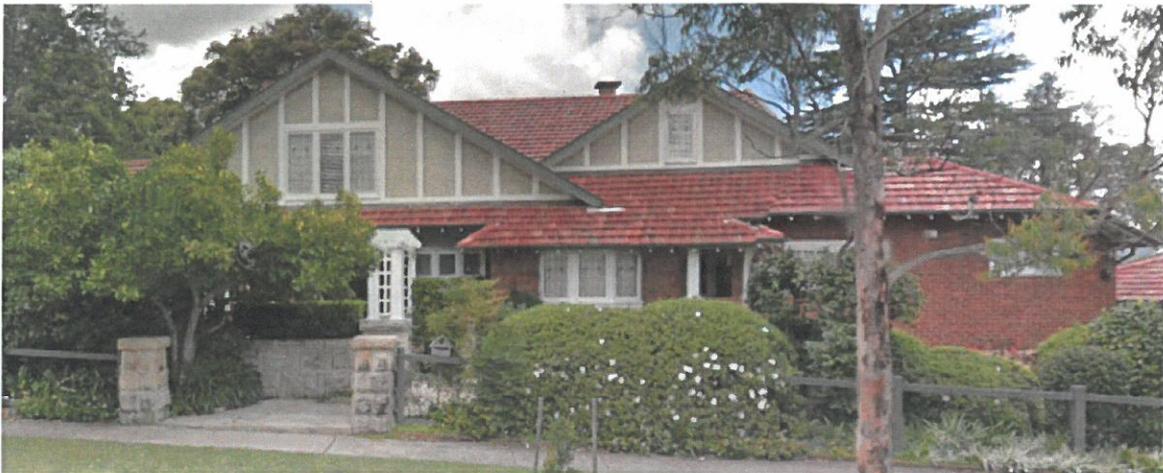
Figure 4.3 77 Arnold Street, Killara. (Source: Google Maps)

The house at 77 Arnold Street, Killara (not listed as a heritage item) has pitched tiled roofs with boarded gables, and expressed timber rafters on its eaves. Large and small roof gables have been used to affect the composition of the street elevation of the house.

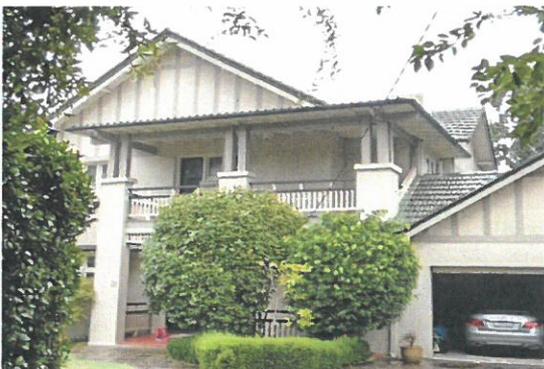
Figure 4.4 26 Springdale Road, Killara. (Source: GML 2017)

There are several houses in Springdale Road that display characteristics of the Arts and Crafts style. Steeply pitched roofs and boarded gables are common features to these houses. The house at 26 Springdale Road also has a flat verandah roof with double timber columns, similar in detail to the entry porch of Headfort House. The single storey house at 24 Springdale Road (listed as a heritage item of local significance) also has a boarded front gable. The front features timber half columns on a heavy masonry base, similar to the detail used on Headfort House.
