UST Environmental Assessment - 13 Endeavour Road, Caringbah NSW

1. Introduction

2. UST Inspection

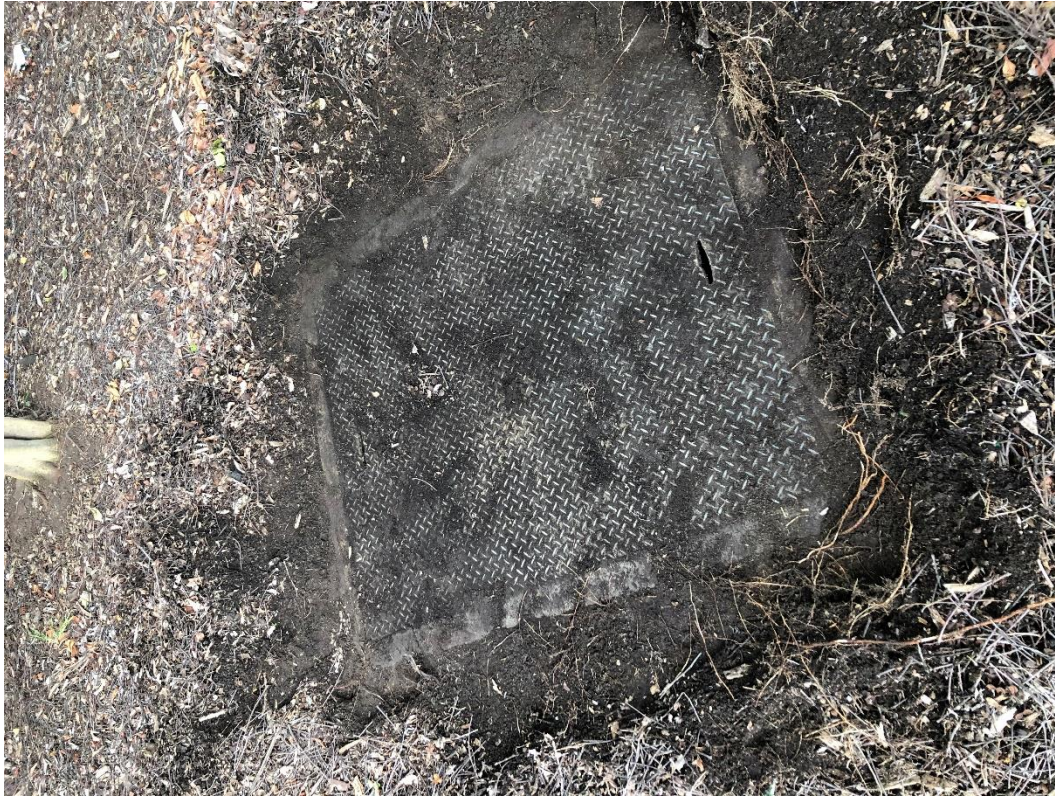
A detailed inspection of the UST area was conducted by a trained and experienced JBS&G Environmental Consultant on 7 January 2021. Photographs of the UST area are provided in **Attachment 3**. The UST was identified to remain *in-situ* with evidence of white foam filling within the internal tank void, consistent with observations made during previous investigations and reported method of decommissioning (**Section 3**).

Photograph 1: UST plate uncovered following removal of overlying fill.

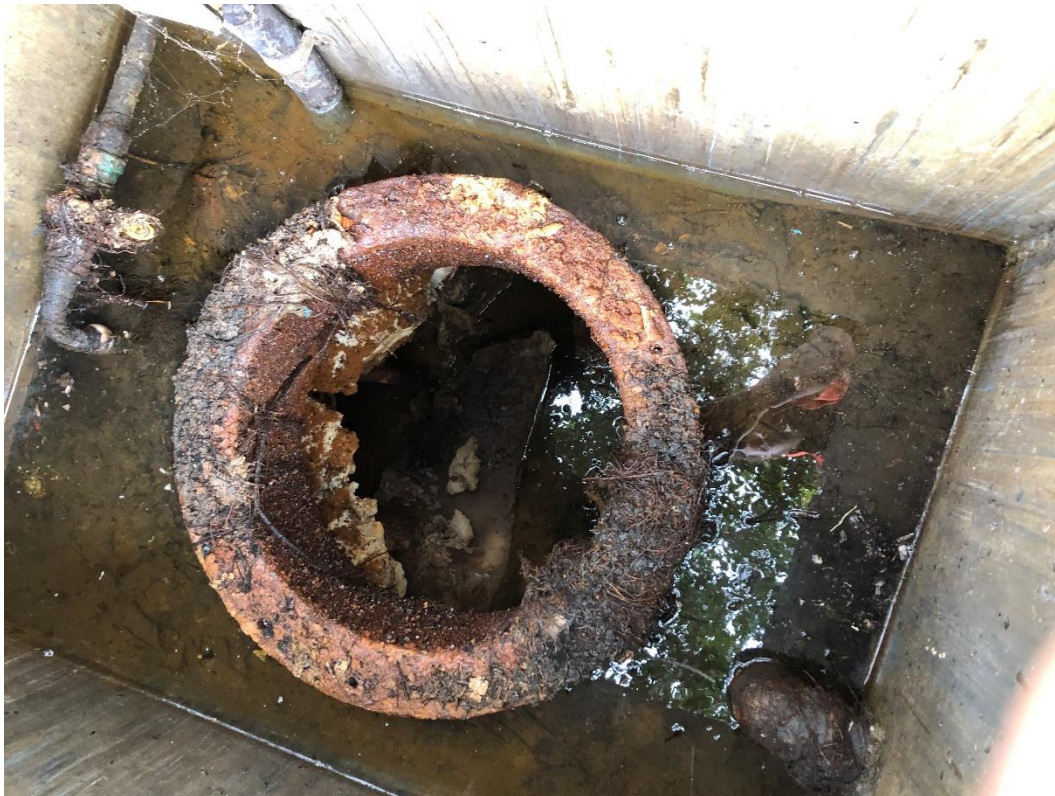
Dangerous Goods Search documentation provided by Workcover NSW on 16 February 2012 did not identify the presence of any petroleum infrastructure on site. Notwithstanding, NA (2012) indicated that a visual inspection of the tank found white foam protruding from the fill point, consistent with the reported methodology for decommissioning (referenced by a decommissioning certificate not cited by JBS&G). This is consistent with observations made by JBS&G in January 2021 (**Section 2**).

Photograph 2: Internal void of the UST with evidence of foam filling.

- Based on the assessment outlined herein, existing UPPS infrastructure at the site is not considered to pose an immediate contamination risk at the site, nor require immediate removal (as part of the planning proposal stage). JBS&G consider that the removal of UPSS and the management of any isolated contamination (should it be identified) can be addressed during a future Development Application (DA) phase.
