Aliro Trusco 1 Pty Ltd
care of
Aliro Management Pty Ltd

Remedial Action Plan
13 Endeavour Road, Caringbah, NSW

11 November 2021

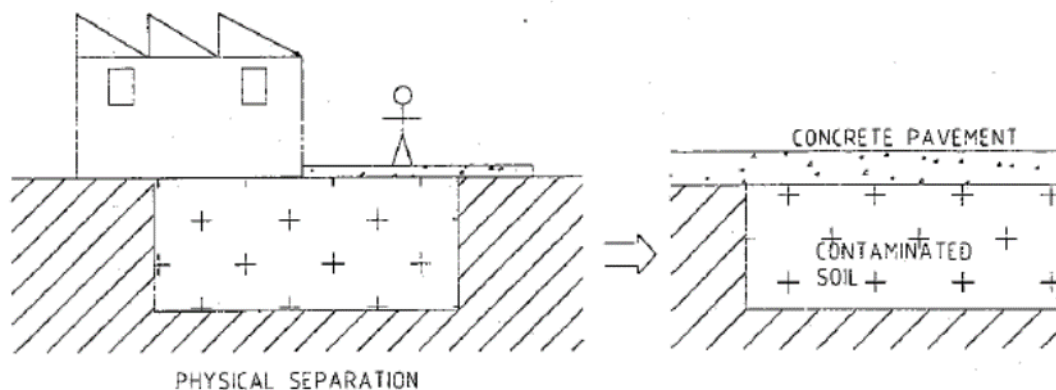
A conceptual sketch, sourced from ANZECC 1999³², is shown following:

ANZECC (1999) notes no soil cover is acceptable where cover is provided by hardstand floor slab or pavement. Asbestos impacted fill is proposed to be managed via containment under existing hardstand capping arrangements (physical separation), which minimise disturbance of asbestos in soil impacts and eliminates the inhalation exposure pathway for airborne asbestos fibres. It is noted the current asbestos impact at the site has been identified at two isolated locations in the eastern car park area (below asphalt pavement) at a depth of approximately 0.3 m below current site levels to a depth of approximately 2.4 m bgs. As part of Stage 1 development activities the impacted material is proposed to be retained *in-situ*. Remediation of the site will include documenting physical separation arrangements in place under the current site configuration to ensure they meet the minimum requirements for containment, specifically, the presence of impenetrable hardstand pavement in a condition sufficient to preclude direct access to subsurface soil.

For retained bonded ACM impacted fill material, validation of the capping arrangement will require to satisfy the requirements of **Section 5.3.3**. That is, validation of the presence of impenetrable hardstand pavement in a condition sufficient to preclude direct access to subsurface soil in areas of asbestos impacted fill.

At least 0.5 m depth capping layer in vegetated areas is required for containment of asbestos impacted soils (ANZECC 1999). However, consideration of proper controls such as an Asbestos Management Plan or Site Management Plan (SMP), including a Ground Disturbance Procedure which minimises the risk of containment failure, may reduce the required thickness if necessary, in certain conditions. Deeper capping layers may be required in tree pit zones (if additional plantation of trees within the area is proposed) to accommodate for the increased root depths of trees, and to minimise potential containment failure during future landscaping works in these areas.

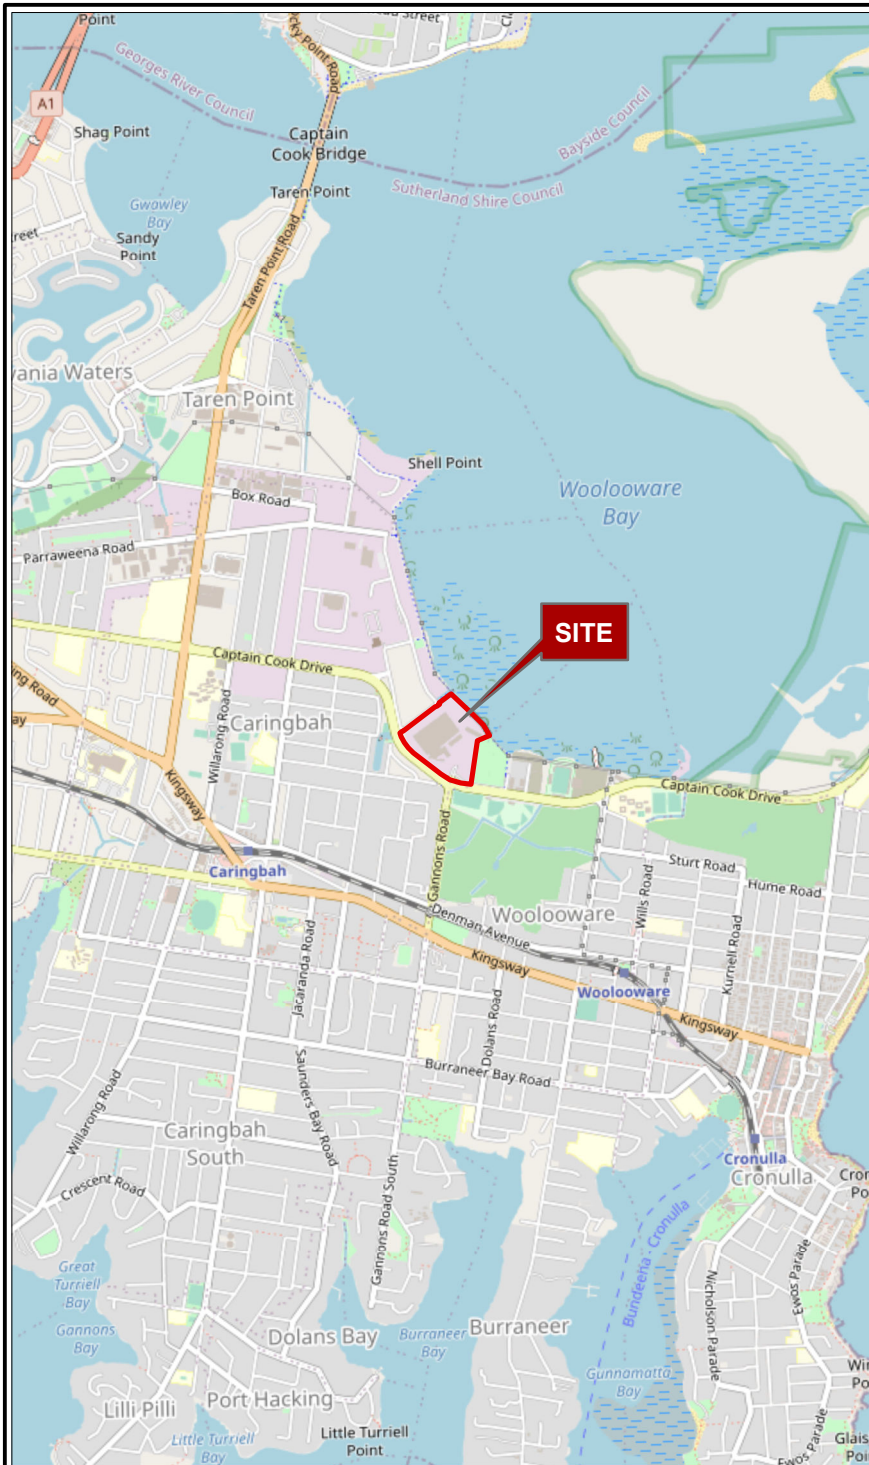
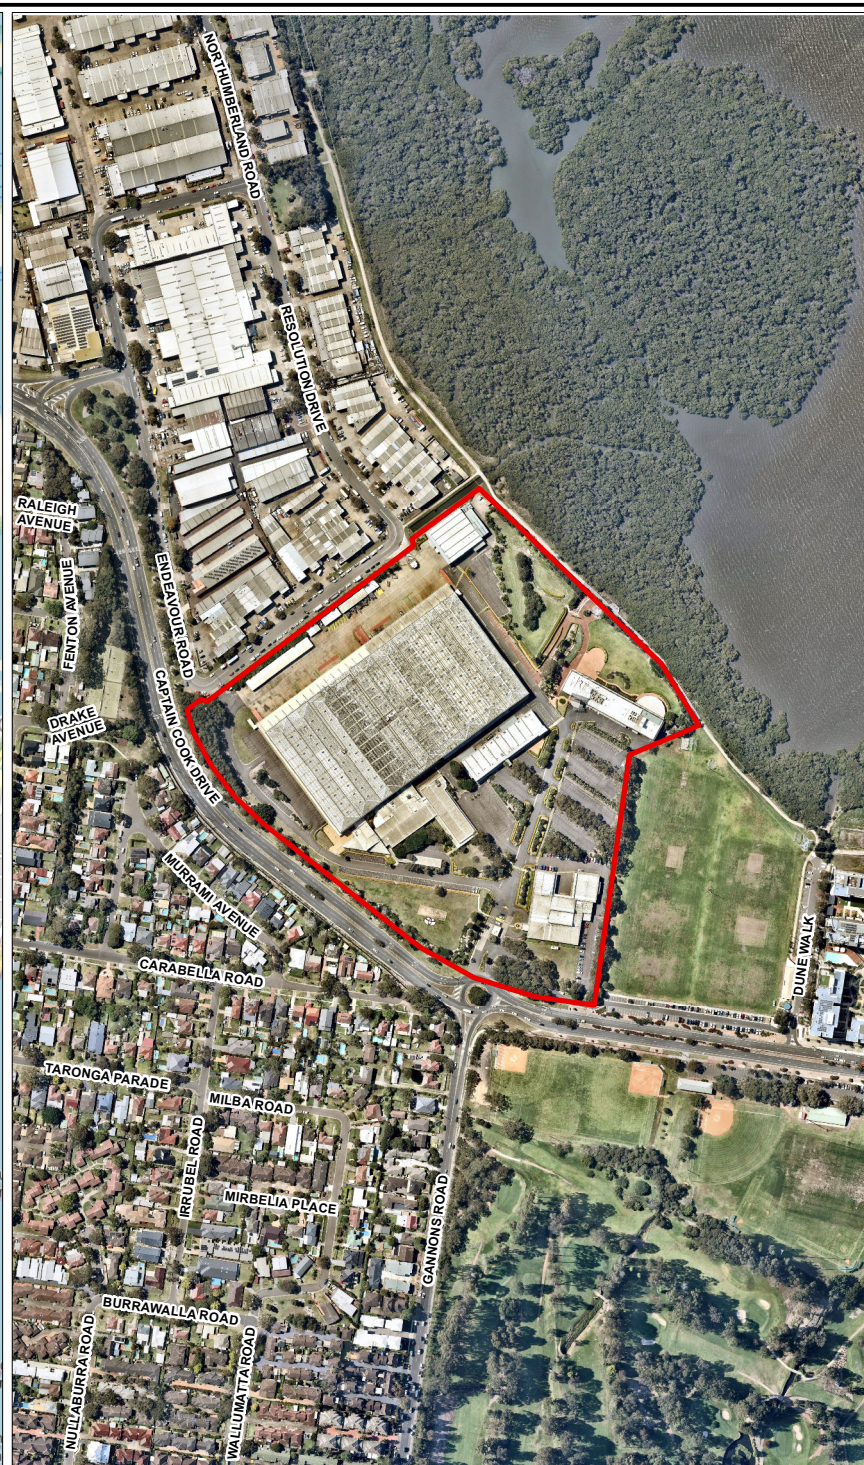
Legend Approximate Site Boundary	
Job No: 58037	
Client: Aliro	
Version: R03 Rev A	Date 26/08/2020
Drawn By: JA	Checked By: CK
Scale 1:40,000 	
Coord. Sys. GDA 1994 MGA Zone 56	
13 Endeavour Road, Caringbah NSW	
SITE LOCATION	
FIGURE 1

The location of the site is shown in **Figure 1**. The current layout is shown in **Figure 2** and the proposed site development layout is shown on **Figure 3**. Site details are summarised in **Table 2.1** and discussed in detail in the following section.

JBS&G Australia Pty Ltd (JBS&G) has been engaged by Aliro Trusco 1 Pty Ltd (Aliro 1, the client) care of Aliro Management Pty Ltd (Aliro Management) to prepare a remedial action plan (RAP) for a property located at 13 Endeavour Road, Caringbah, NSW (the site). The site is legally identified as Lot 2 in Deposited Plan (DP) 714965 and occupies an area of 12.5 hectares (ha). The site location and site layout are shown in **Figures 1 and 2**, respectively.

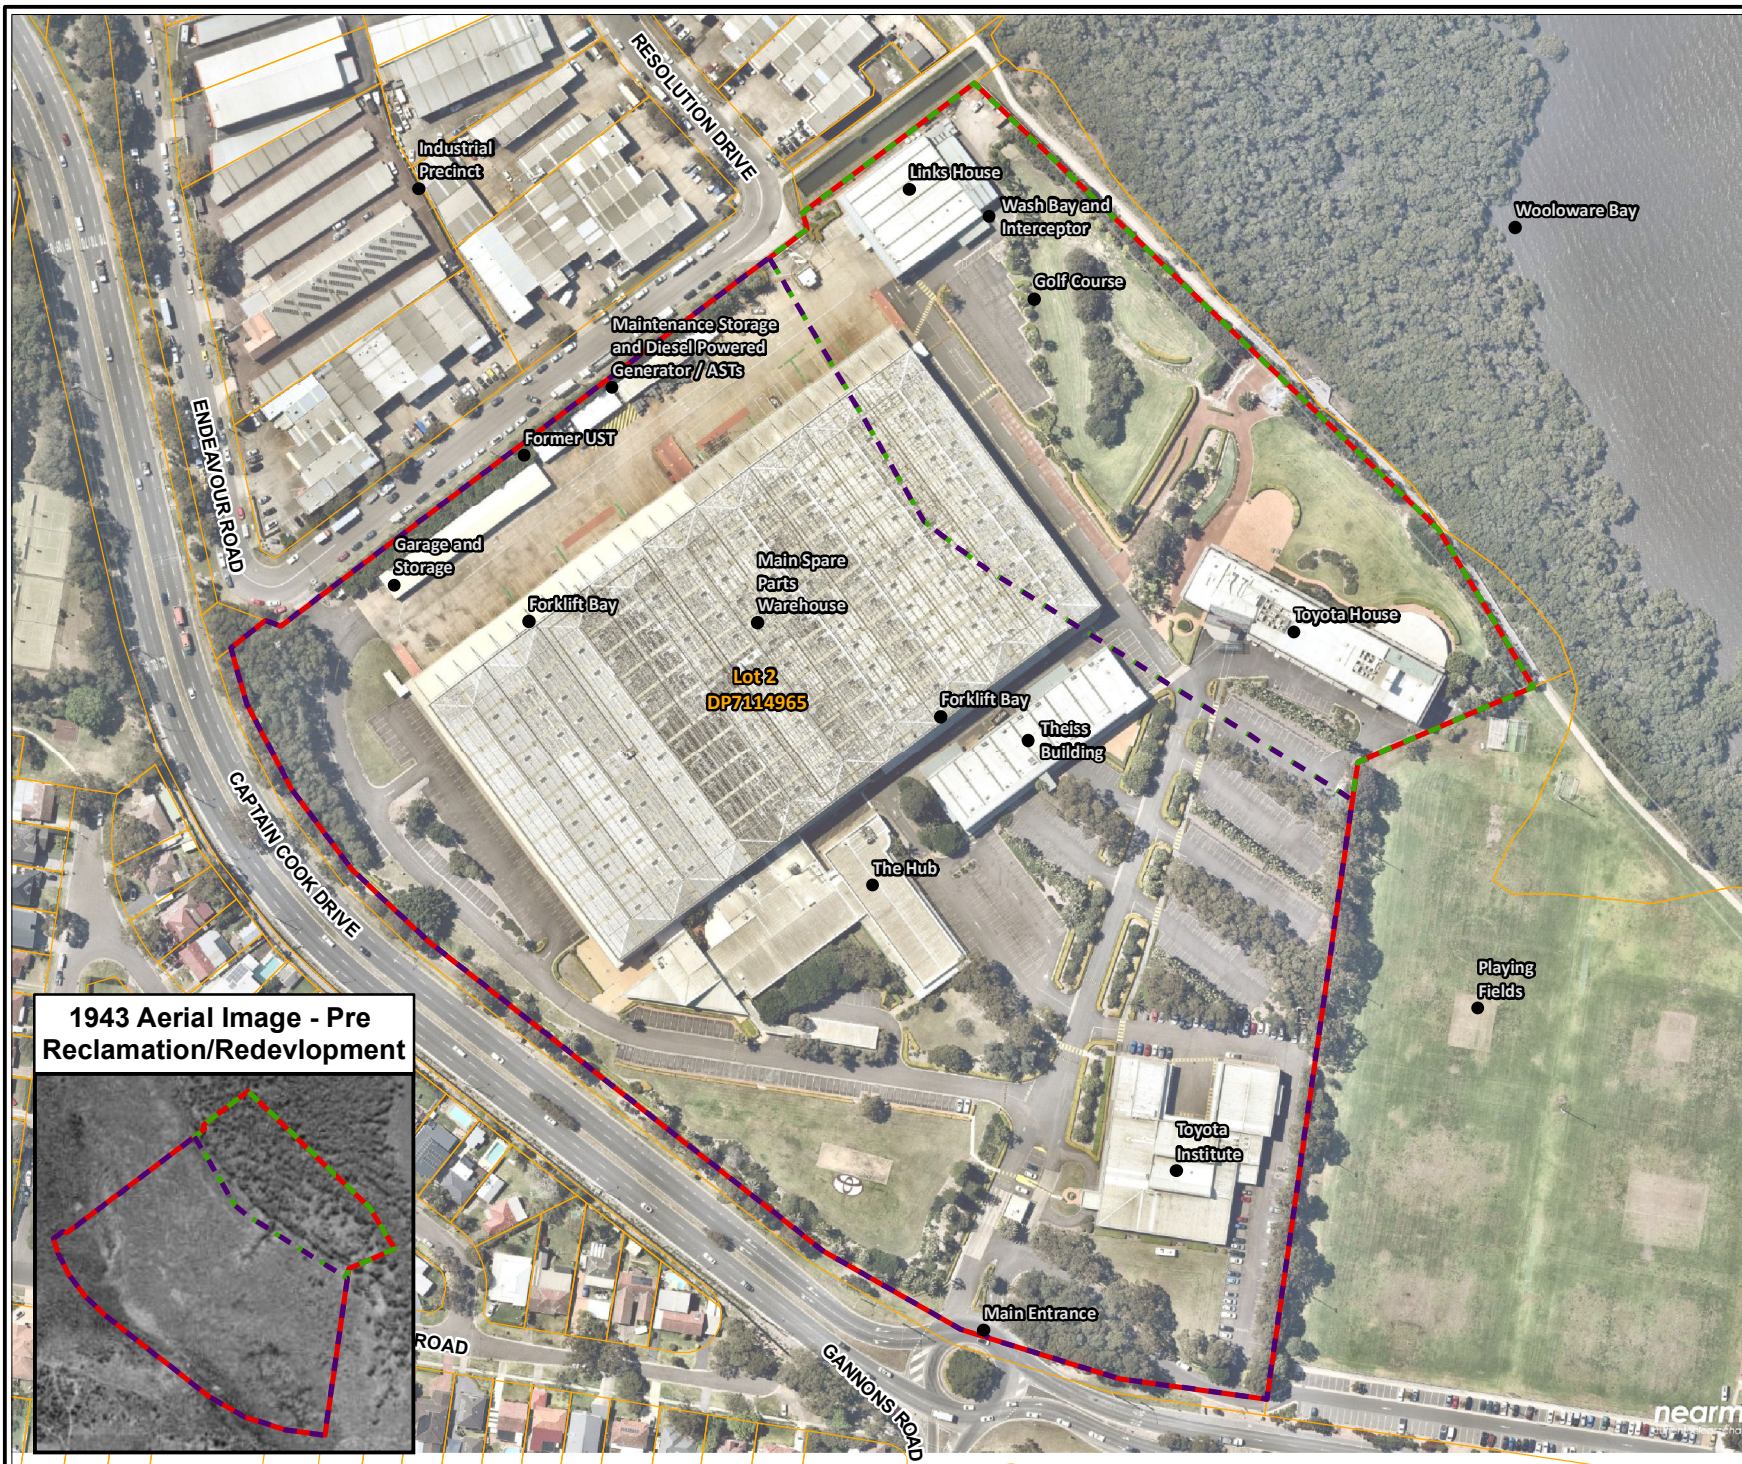
FIGURE 2

- Approximate Site Boundary
- Cadastre (NSW LPI, 2019)
- Southern Portion of the Site: Reclaimed Alluvial Deposits
- Northern Portion of the Site: Reclaimed Tidal Mangrove Swamp
- Site Features

SITE LAYOUT

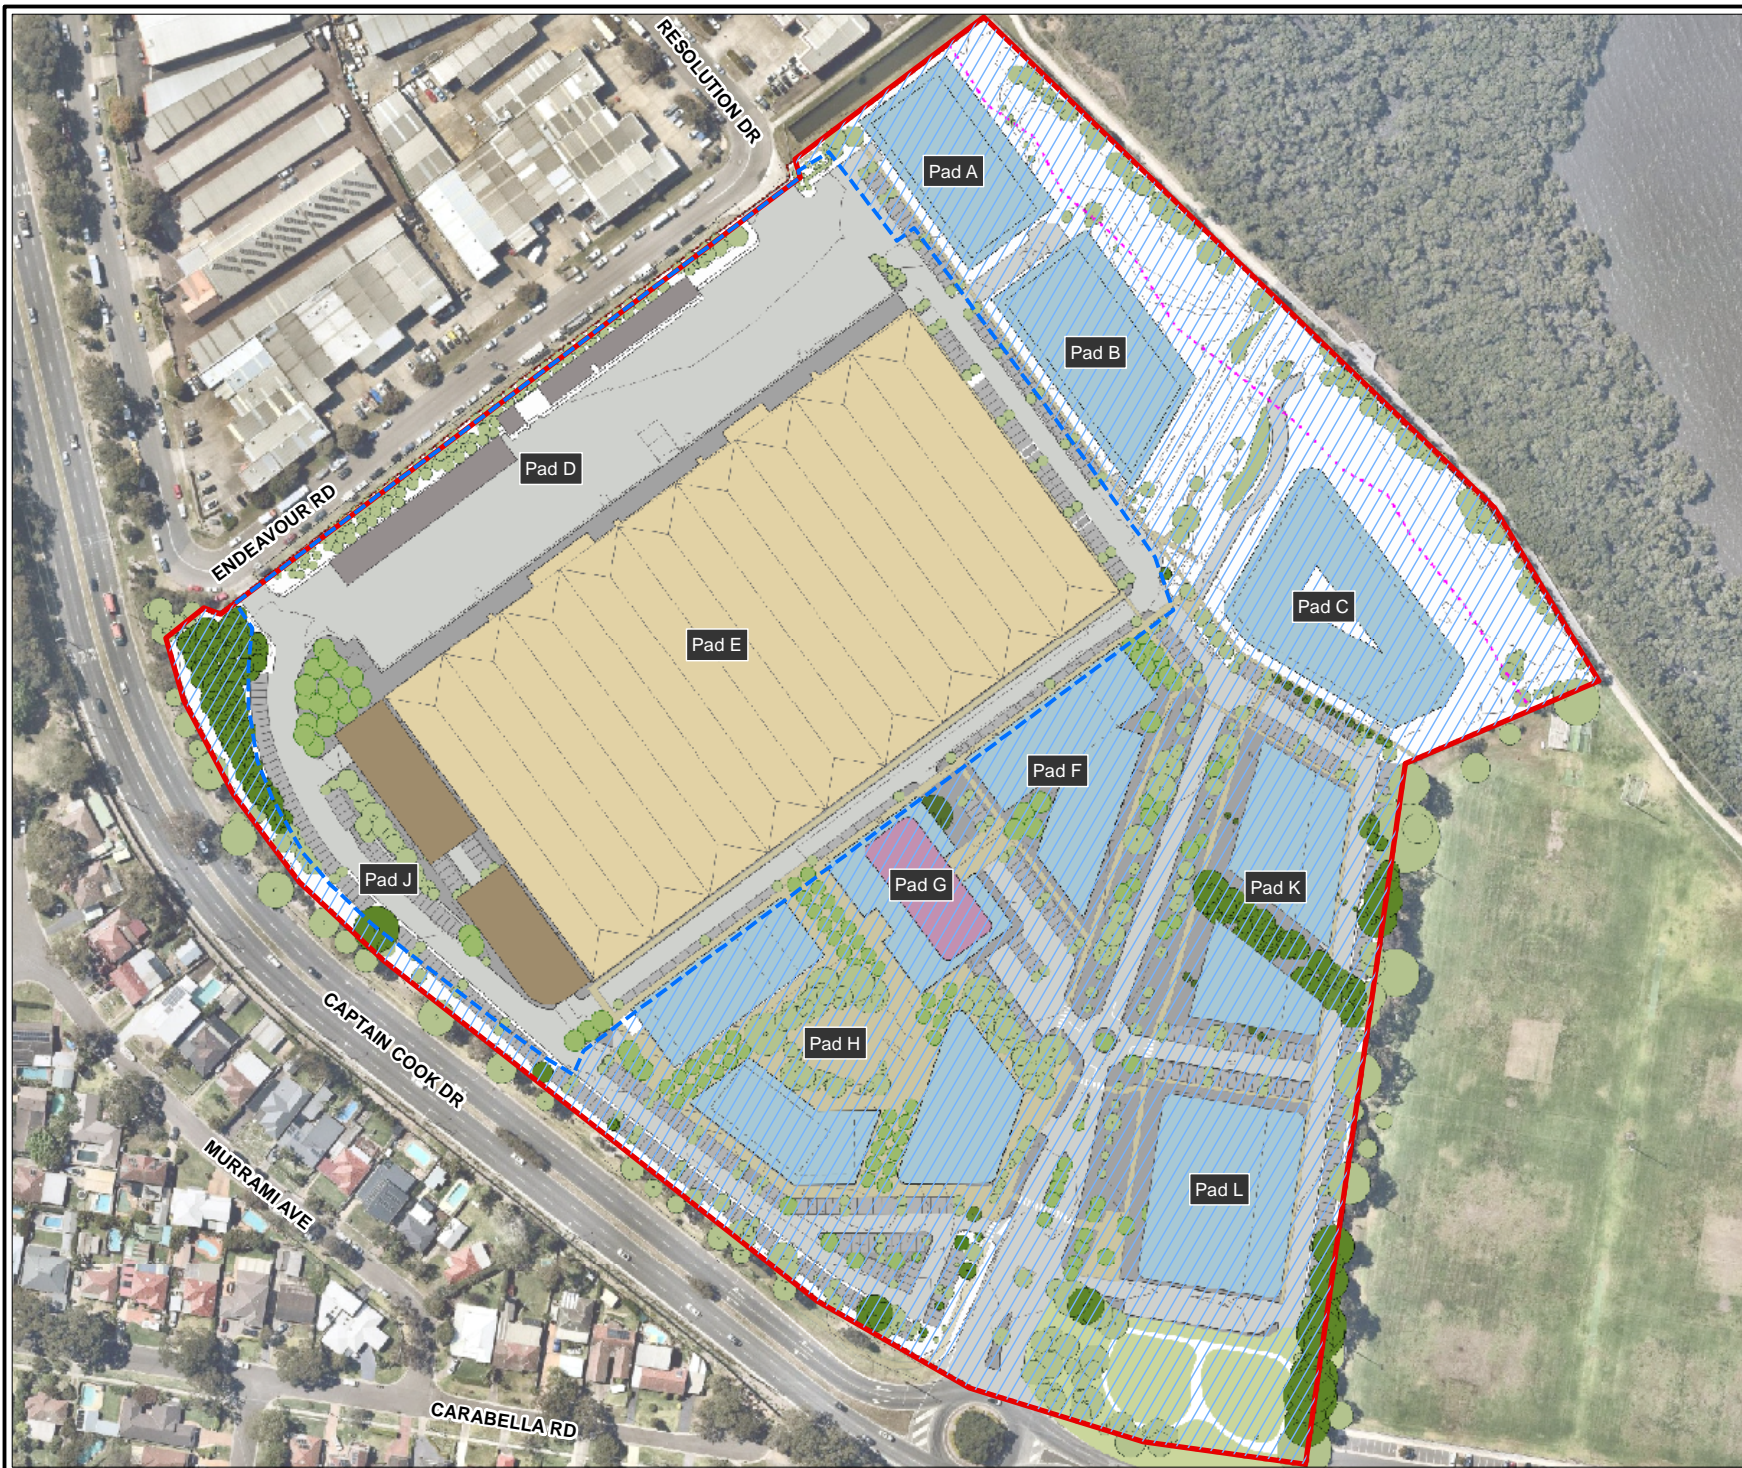
FIGURE 3

PROPOSED LAYOUT

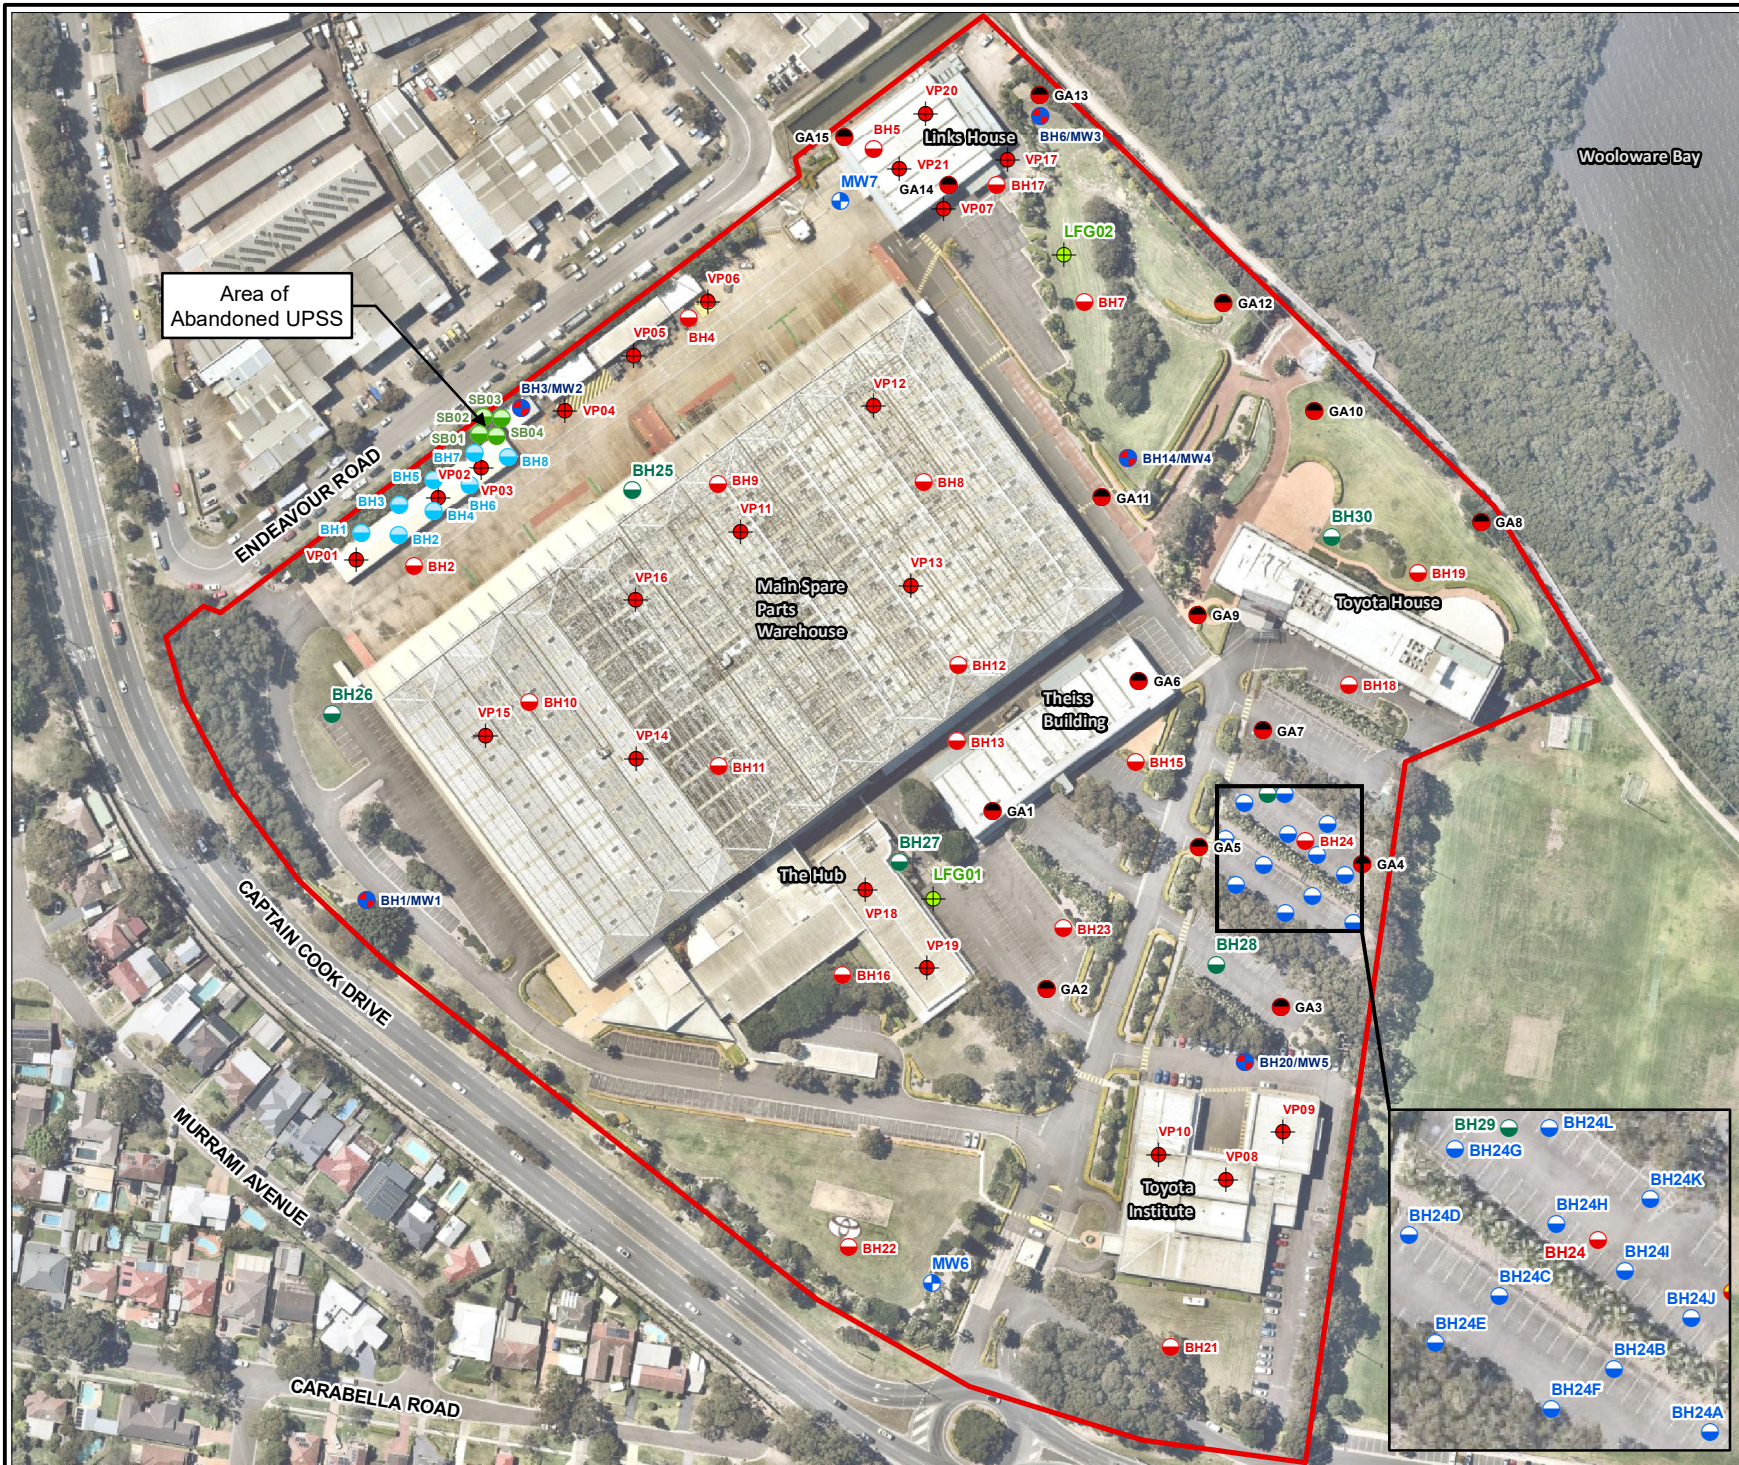
FIGURE 4

SAMPLE LOCATIONS

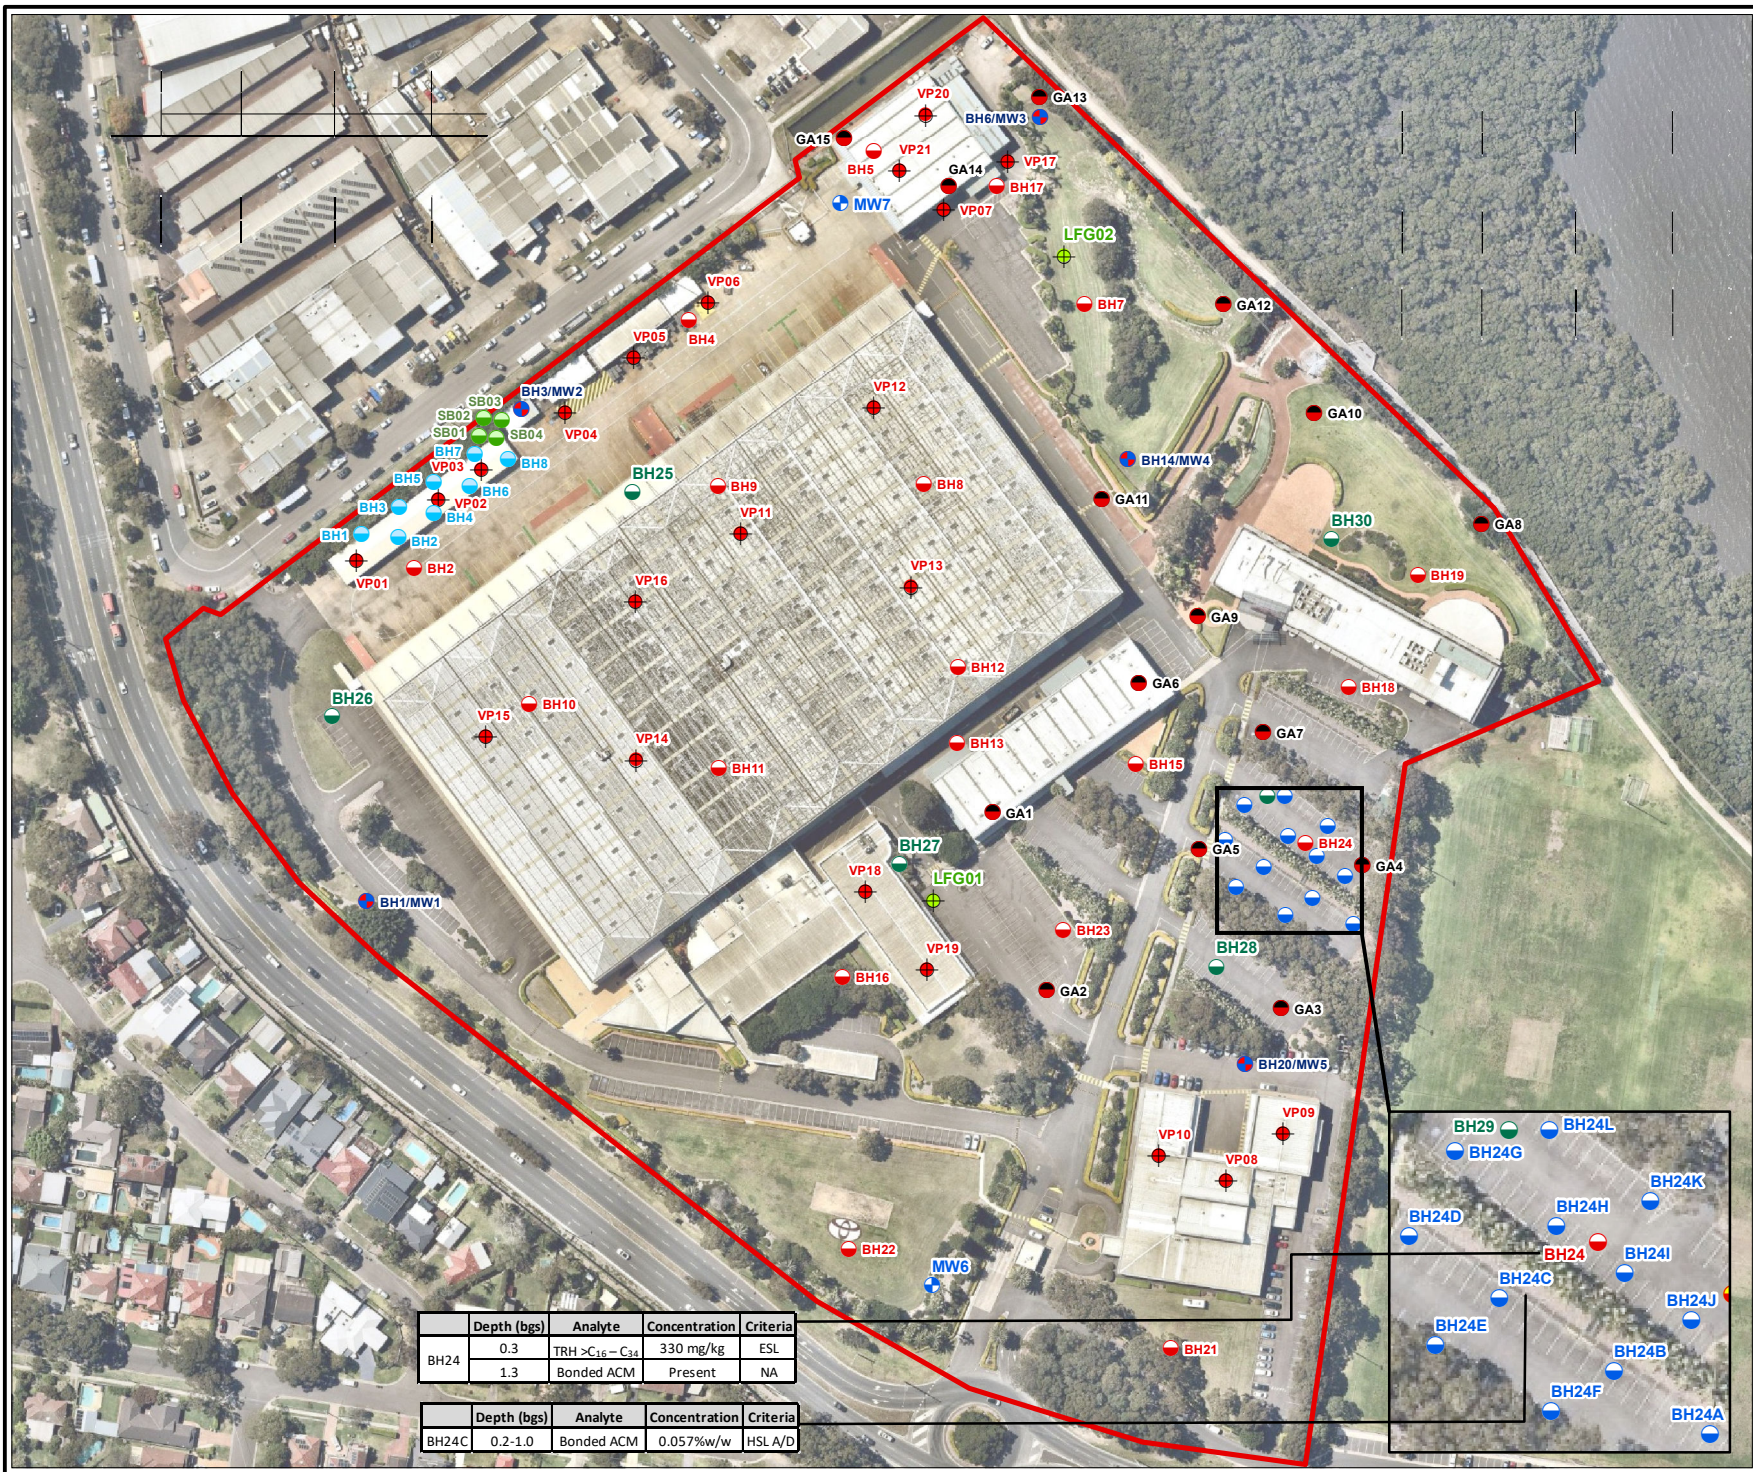
Depth (bgs)	Analyte	Concentration	Criteria
BH24	0.3	TRH >C ₁₆ -C ₃₄	330 mg/kg	ESL
	1.3	Bonded ACM	Present	NA

Depth (bgs)	Analyte	Concentration	Criteria
BH24C	0.2-1.0	Bonded ACM	0.057%w/w	HSL A/D

All soil and groundwater concentrations were reported within the human health and ecological site criteria for commercial/industrial land (NEPC 2013). ACM fragments observed at location BH24 were reported to contain the presence of chrysotile, amosite and crocidolite asbestos. However, laboratory certificates were not included in AECOM (2019) to verify their discussion and summary tables of analytical data.

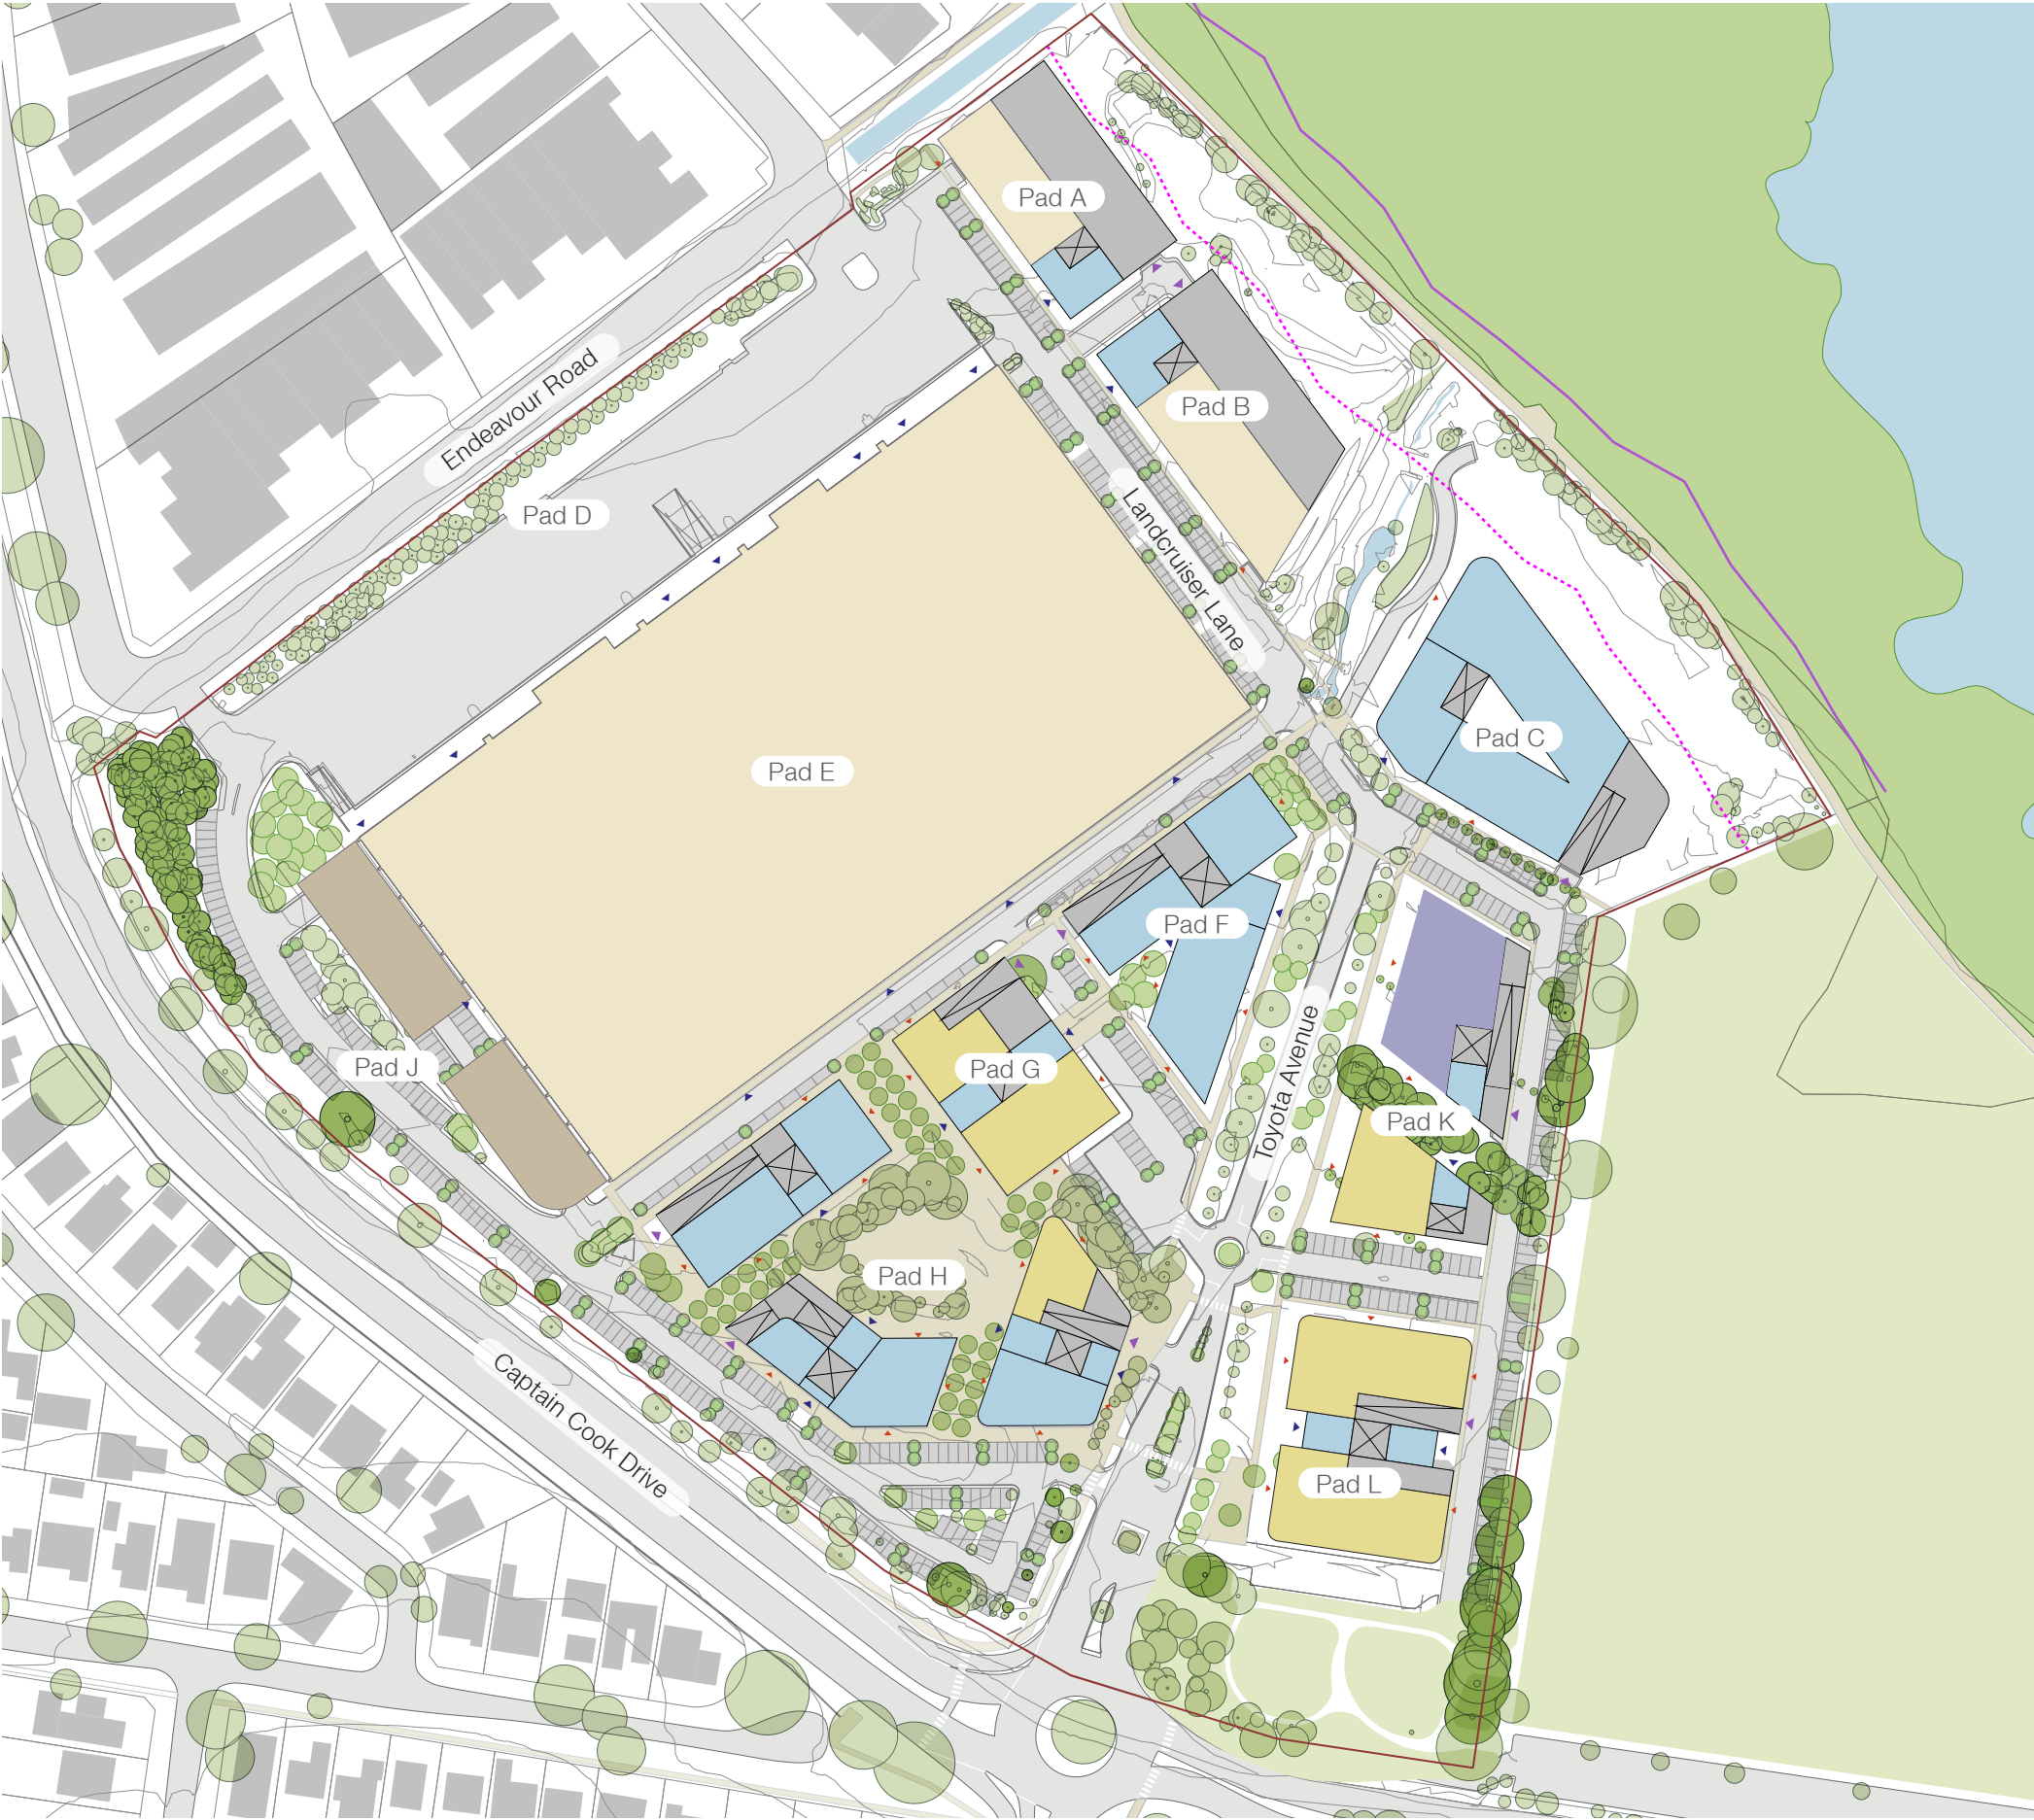
CUT:	FILL:
-5.0 TO -2.5m	0.0 TO 0.1m
-2.5 TO -1.5m	0.1 TO 0.25m
-1.5 TO -1.0m	0.25 TO 0.5m
-1.0 TO -0.75m	0.5 TO 0.75m
-0.75 TO -0.5m	0.75 TO 1.0m
-0.5 TO -0.25m	1.0 TO 1.5m
-0.25 TO -0.1m	1.5 TO 2.5m
-0.1 TO 0.0m	2.5 TO 5.0m

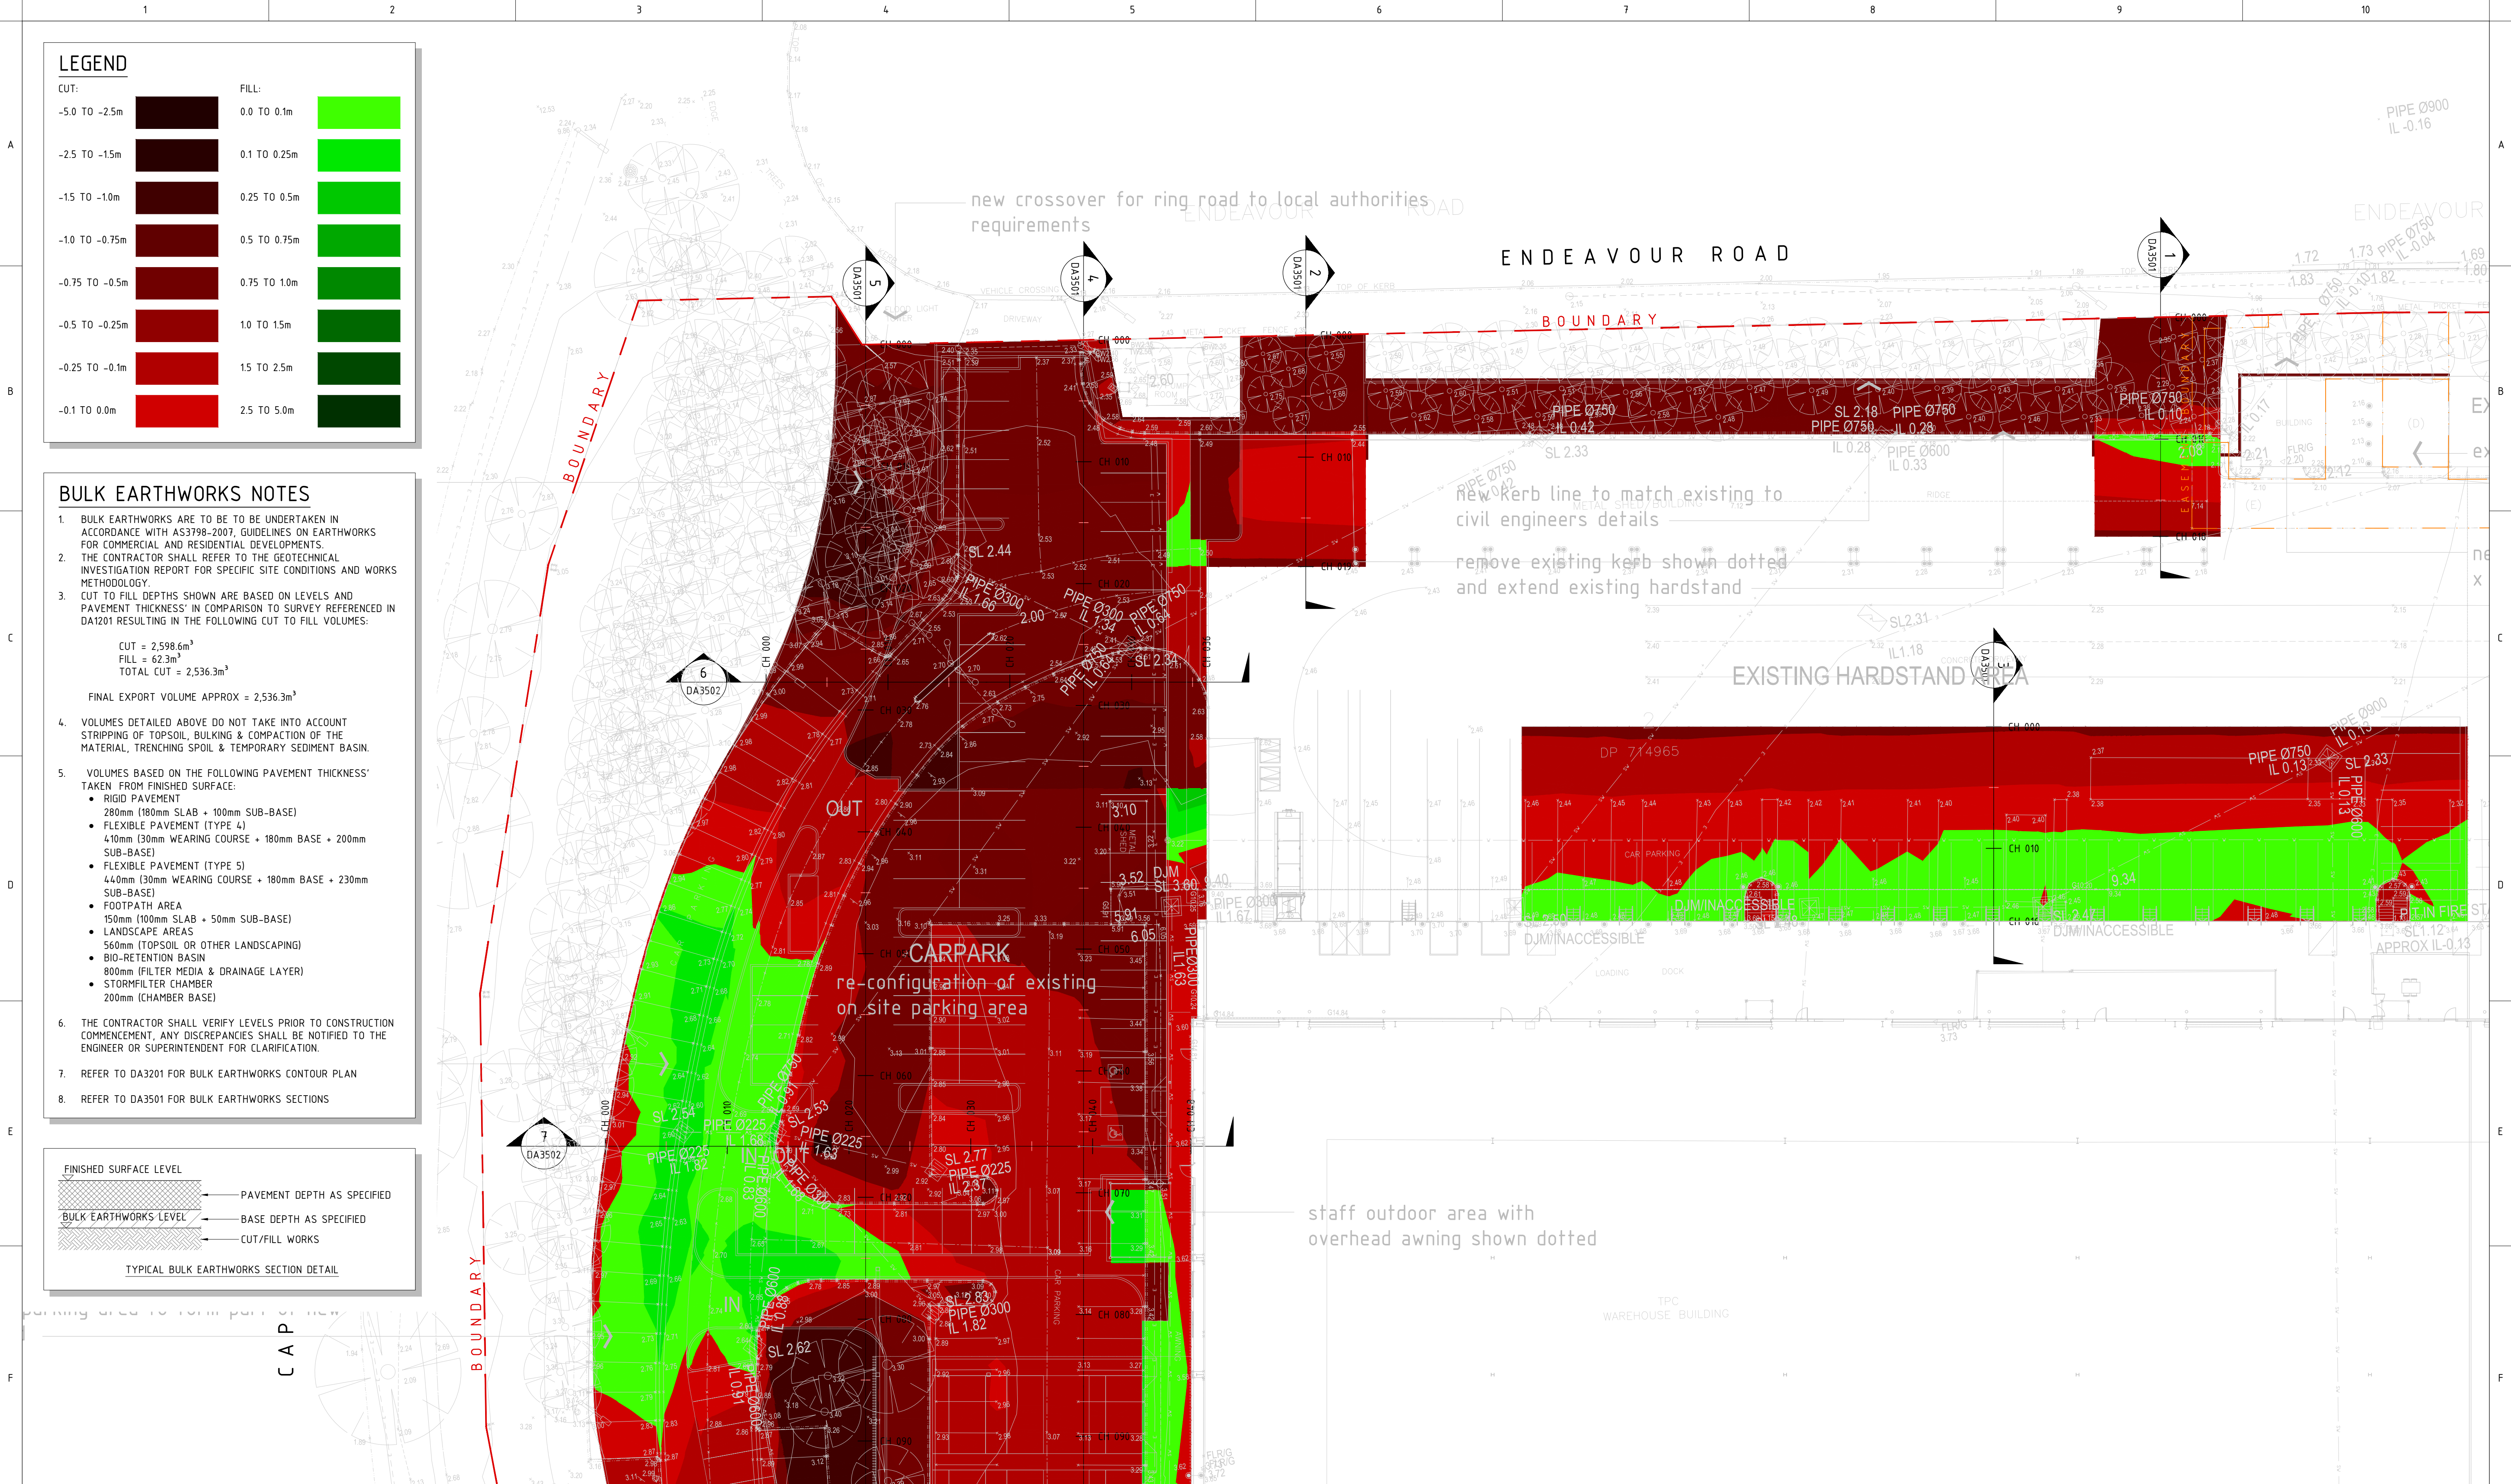
- BIO-RETENTION BASIN
800mm (FILTER MEDIA & DRAINAGE LAYER)
 - STORMFILTER CHAMBER
200mm (CHAMBER BASE)
 - THE CONTRACTOR SHALL VERIFY LEVELS PRIOR TO CONSTRUCTION COMMENCEMENT, ANY DISCREPANCIES SHALL BE NOTIFIED TO THE ENGINEER OR SUPERINTENDENT FOR CLARIFICATION.

DRAWING TITLE			
DA CONCEPT BULK EARTHWORKS CUT TO FILL PLAN - SHEET 4			
DATE	DRAWN	DESIGNED	CHECKED
AUG 2021	JK	JK	BB
PROJECT No	SCALE	SIZE	REVISION
21087	1:250 @ A1	A1	
DRAWING No	DA3104		5
