Our Ref: PSM4025-005L REV2

**RE: 13 ENDEAVOUR ROAD, CARINGBAH - PLANNING PROPOSAL STAGE  
RESULTS OF GEOTECHNICAL INVESTIGATION**

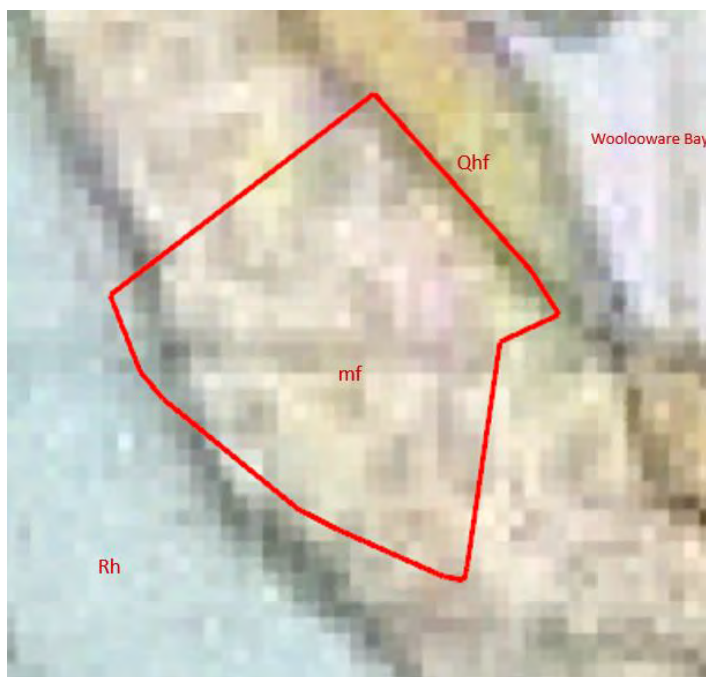
**Inset 1: Geological Map of the Site**

Inset 1 shows the boundary of the site with respect to the geological setting.

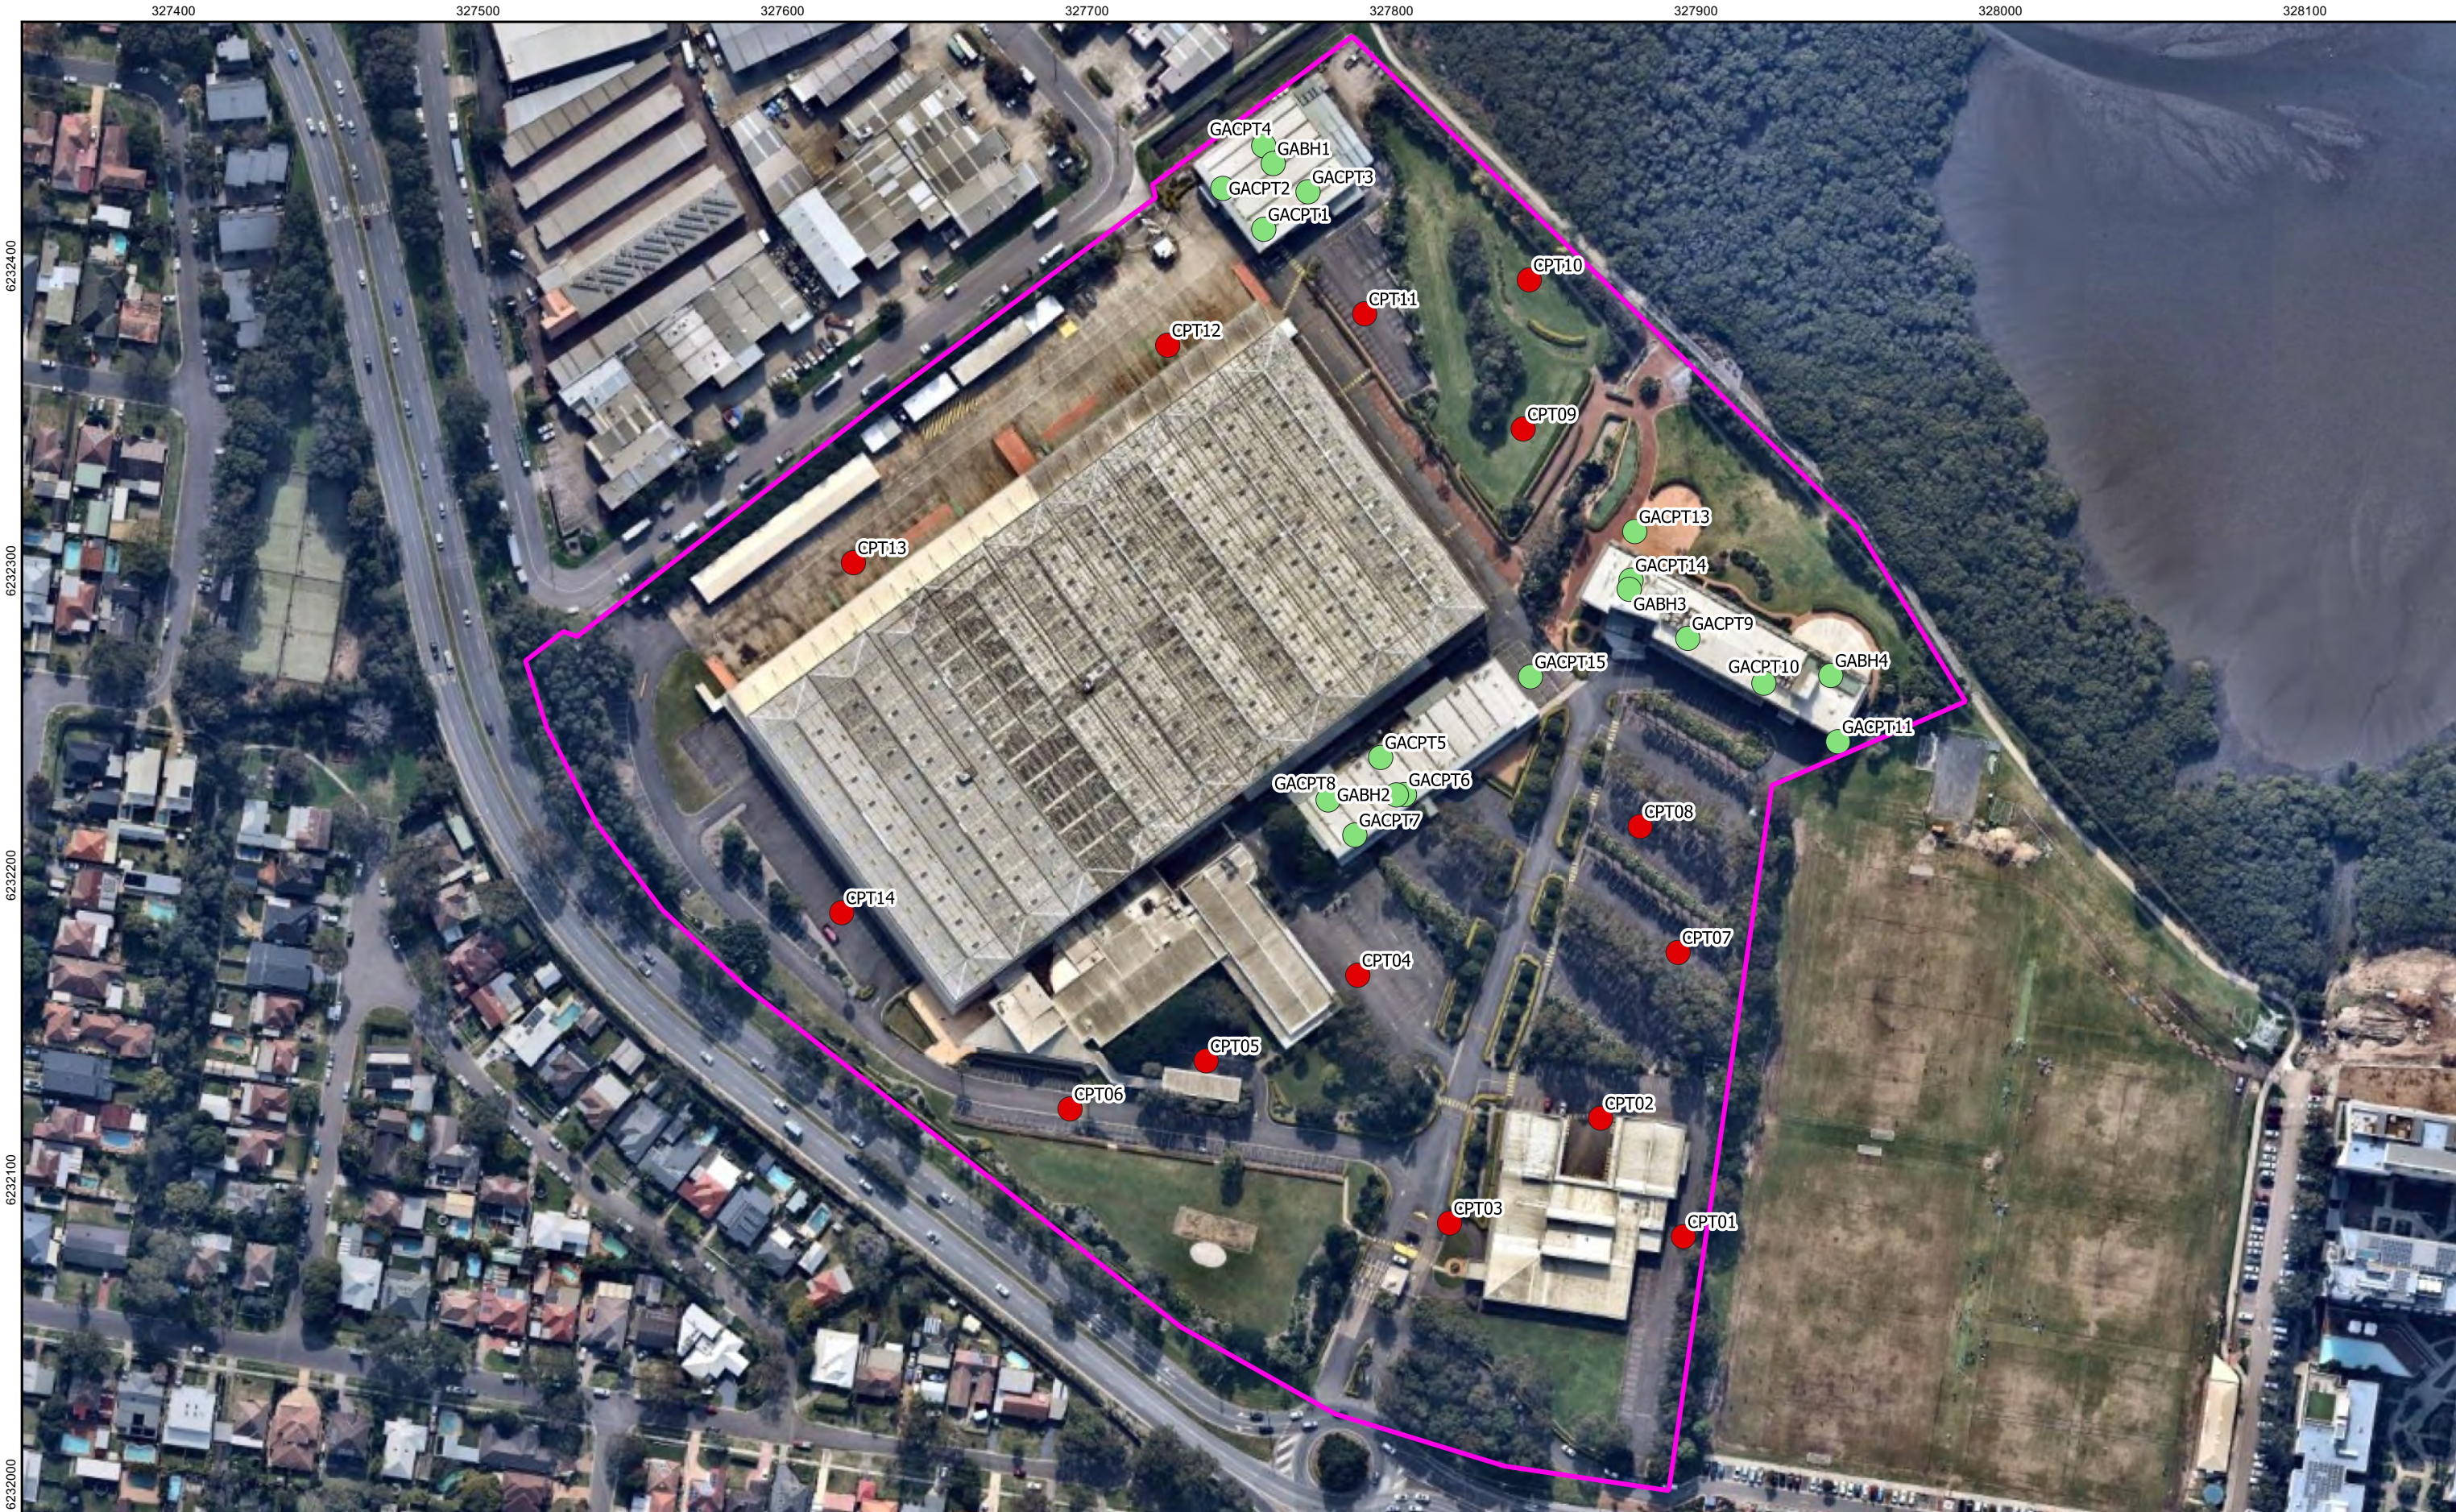
**GEOTECHNICAL INVESTIGATION  
LOCALITY PLAN (1 OF 2)**

Figure 1 presents the investigation locations conducted by PSM described above and the investigation locations conducted by Golder Associates in 1998. Figures 3 and 4 present selected site photographs.

Figure 1 presents the surface conditions of the site on 2 August 2020.

Figure 1 presents the locality plan.

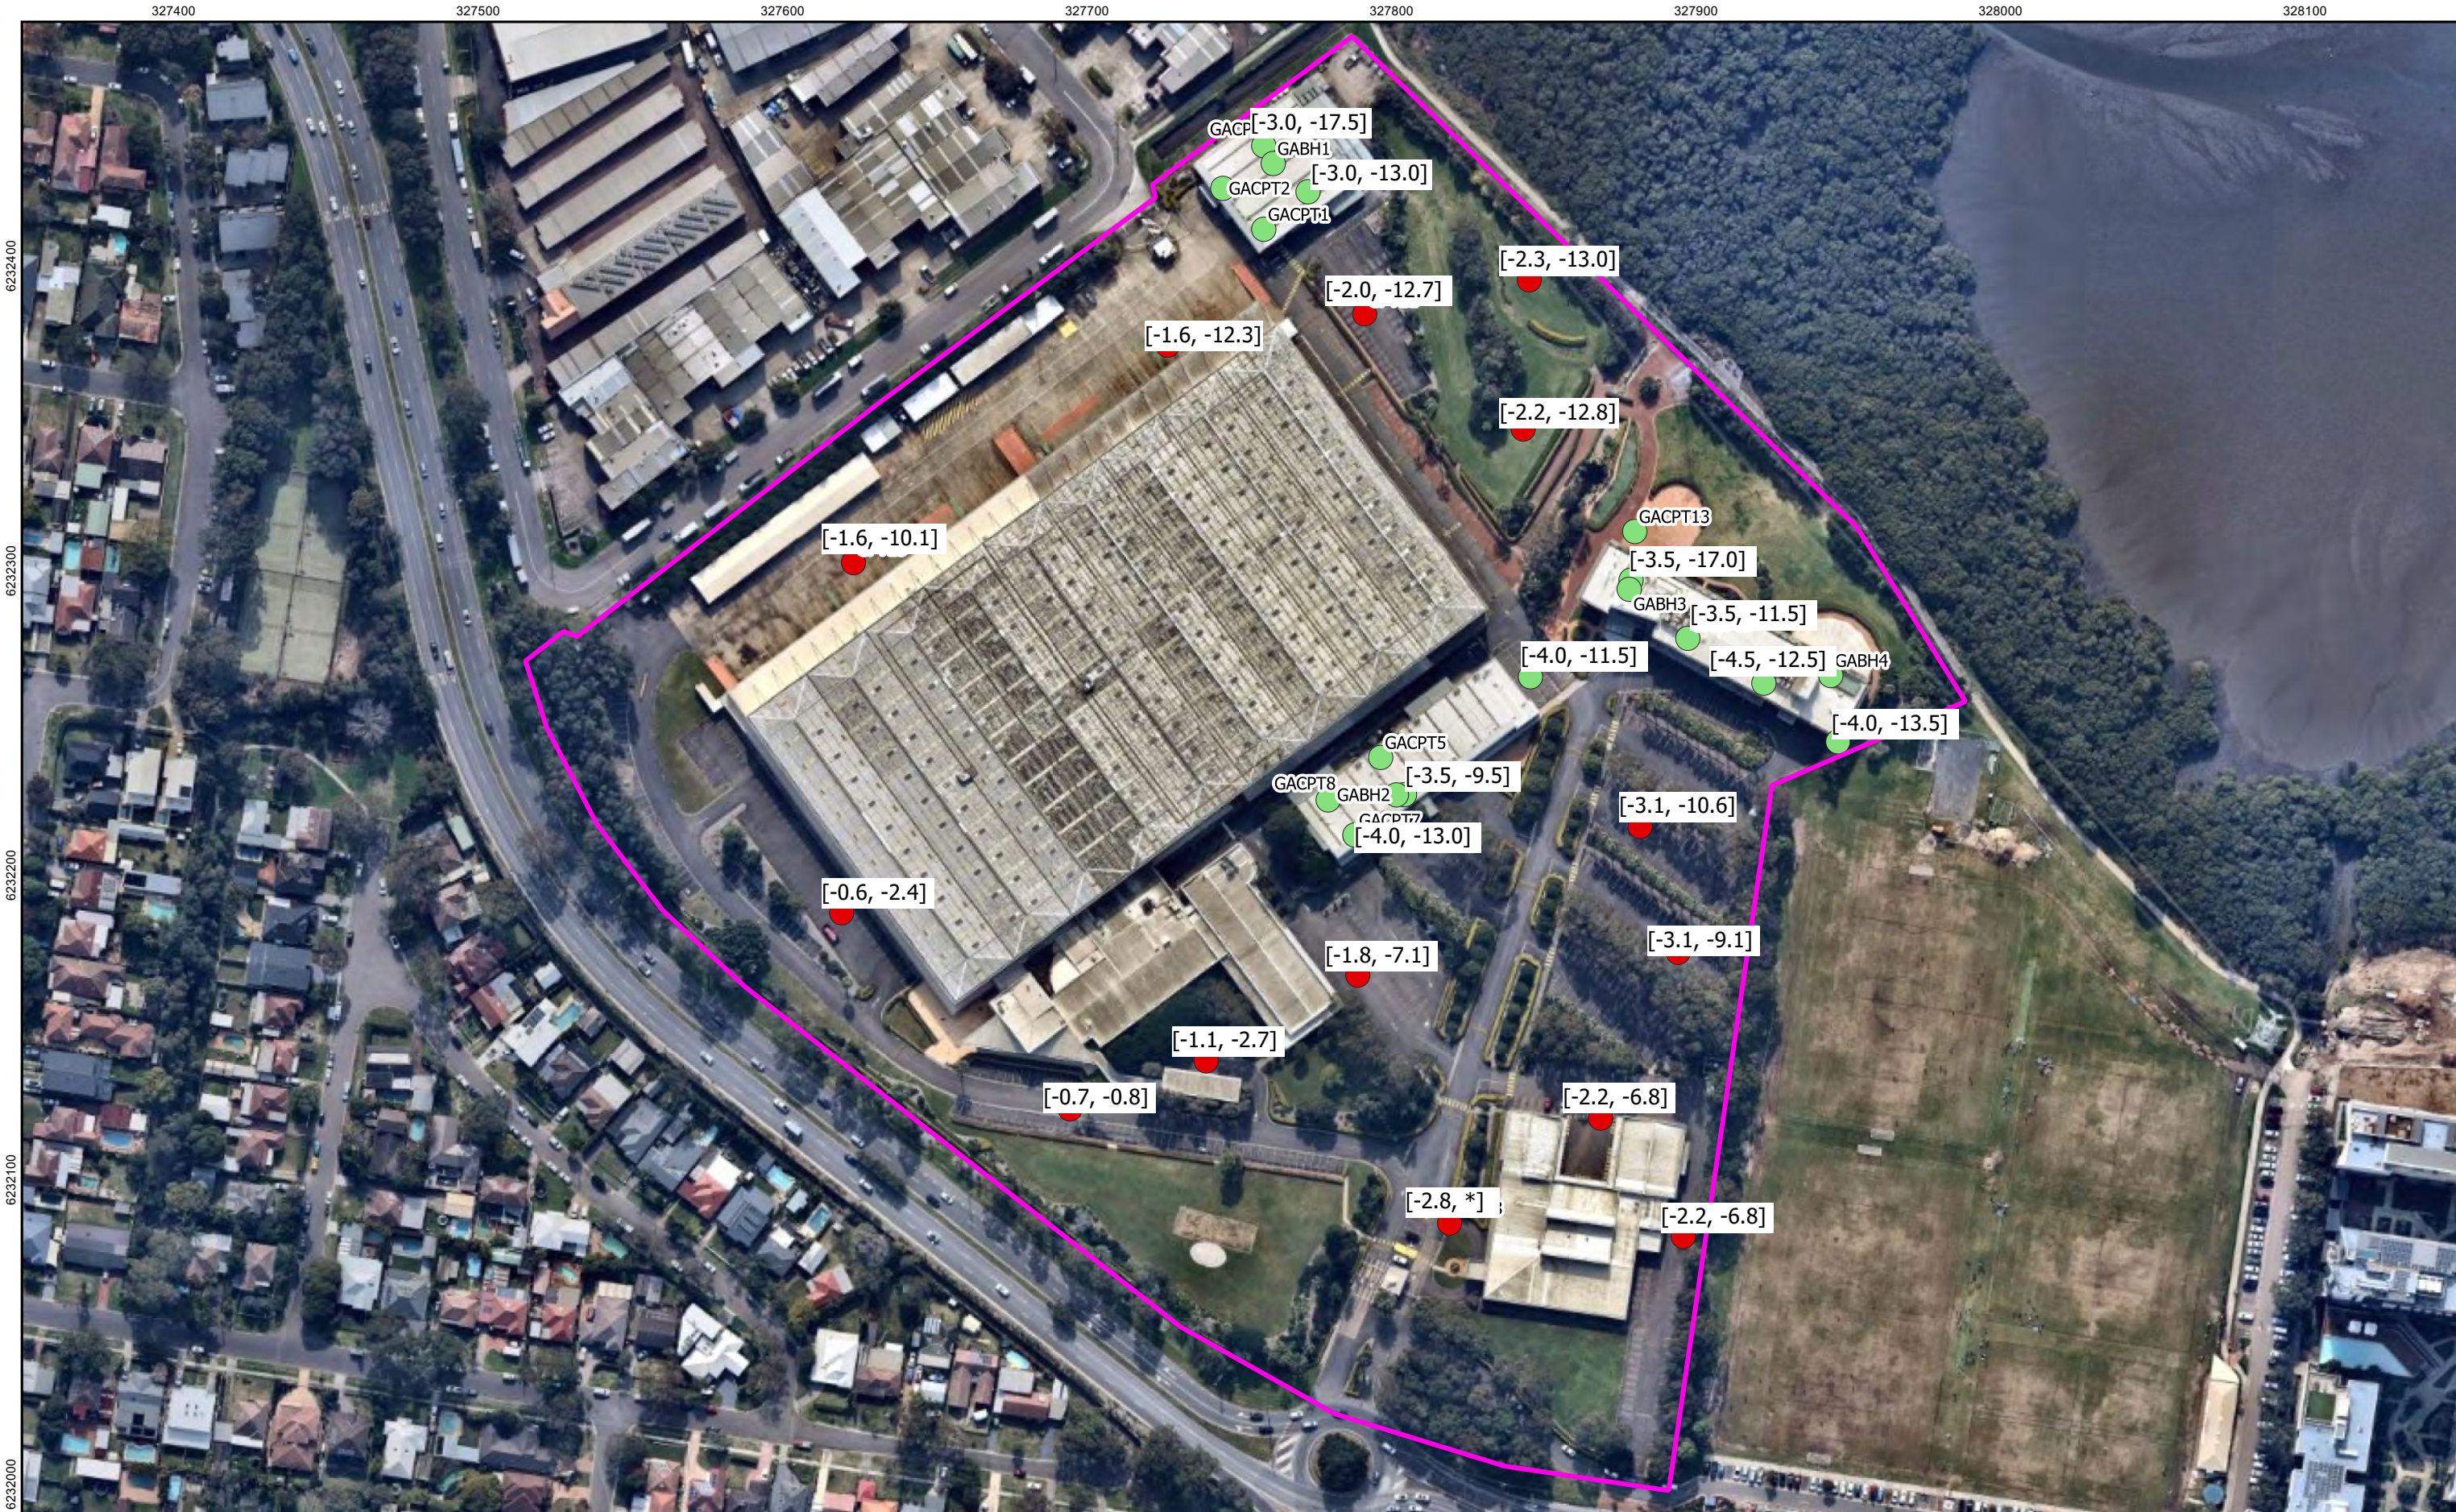
**GEOTECHNICAL INVESTIGATION  
LOCALITY PLAN (2 OF 2)**

Table 2 presents the approximate elevation of the top of the inferred geotechnical units encountered in the CPT investigation. Figure 2 presents a plan view of the elevation of the top of ALLUVIUM B unit and top of BEDROCK unit encountered.

Notes:  
1. Values in brackets indicate [Top of ALLUVIUM B, Top of BEDROCK] in RL AHD (m).

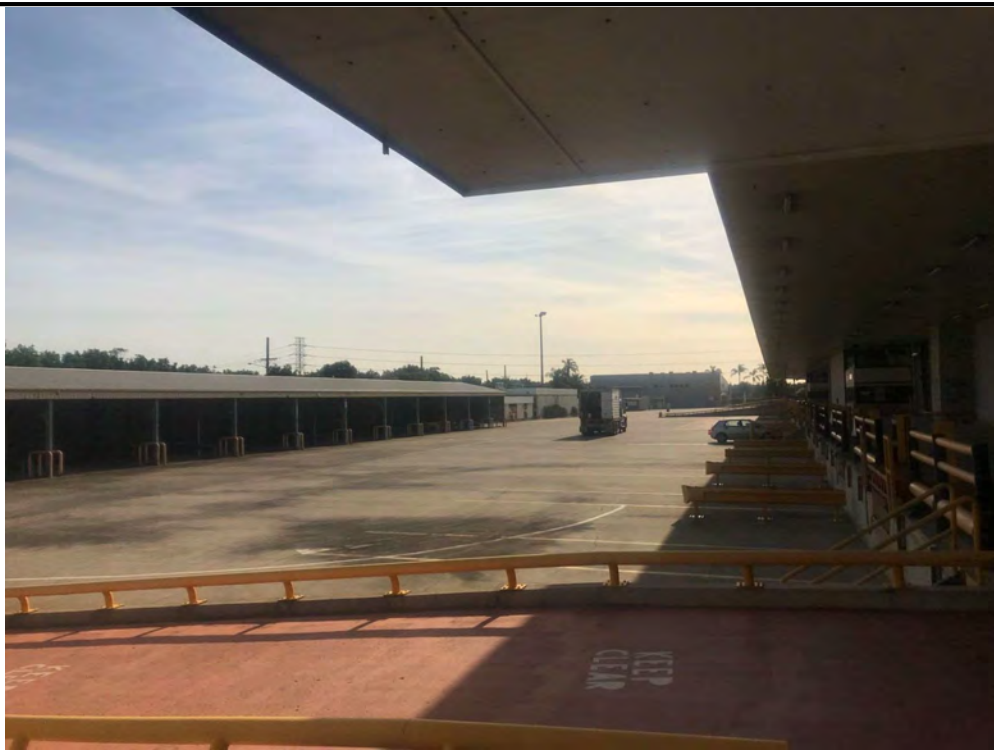
Photo 1 - General site conditions along northern side of the site facing east (2/09/2020)

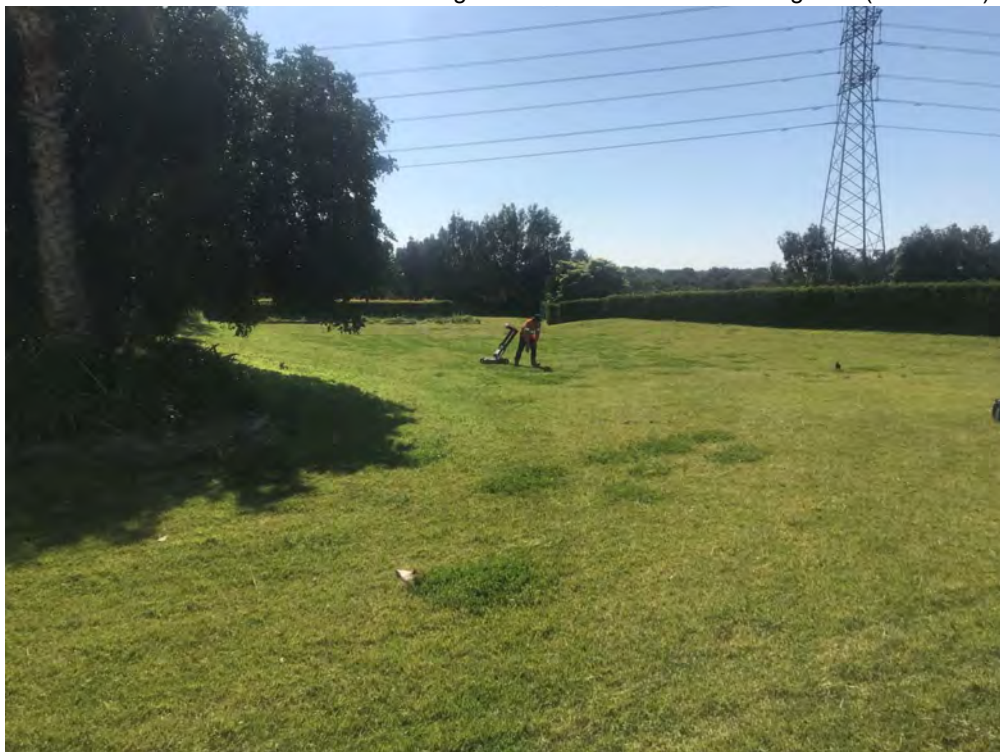
Photo 2 - General site conditions along southern side of the site facing east (1/09/2020)

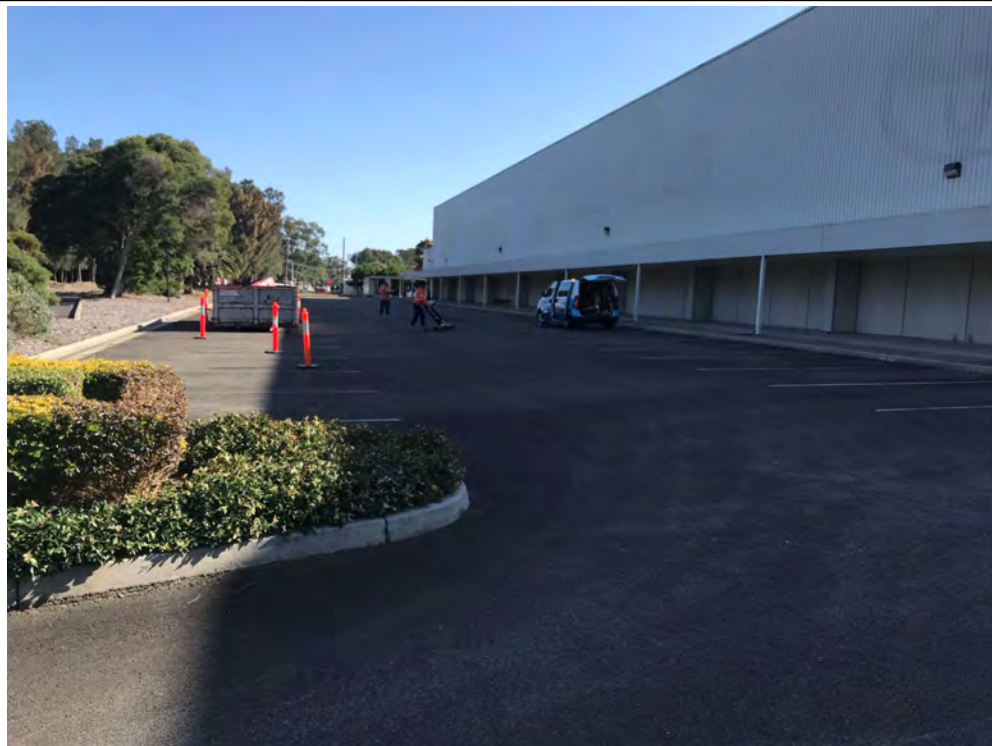
Photo 3 - General site conditions along western side of the site facing north (1/09/2020)

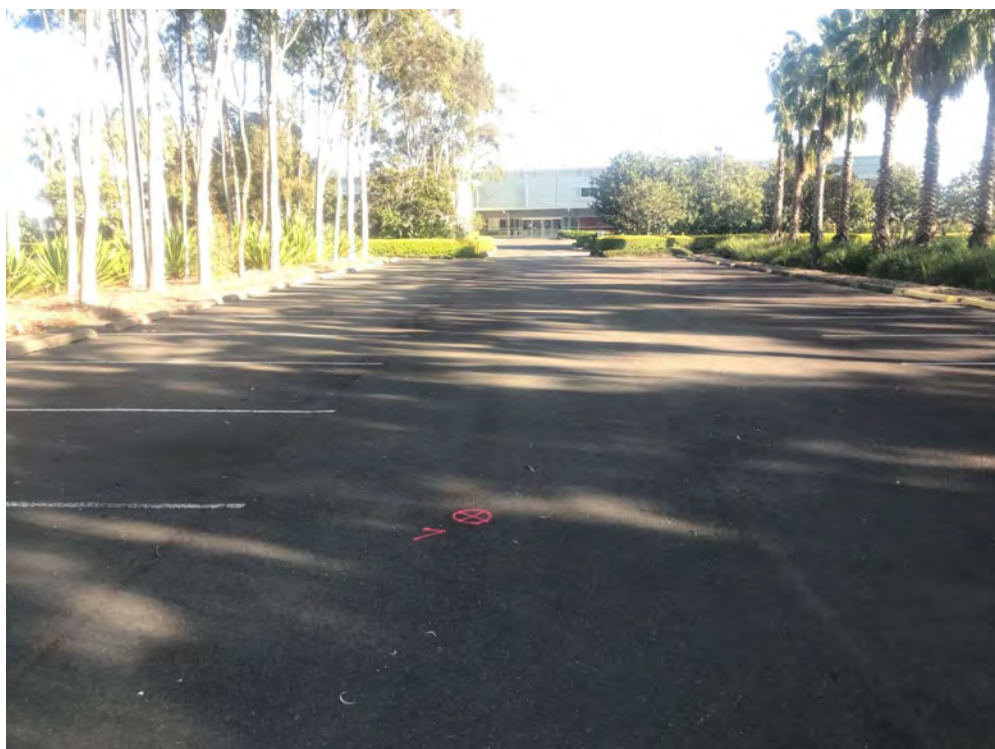
Photo 4 - General site conditions along southern side of the site facing north (1/09/2020)

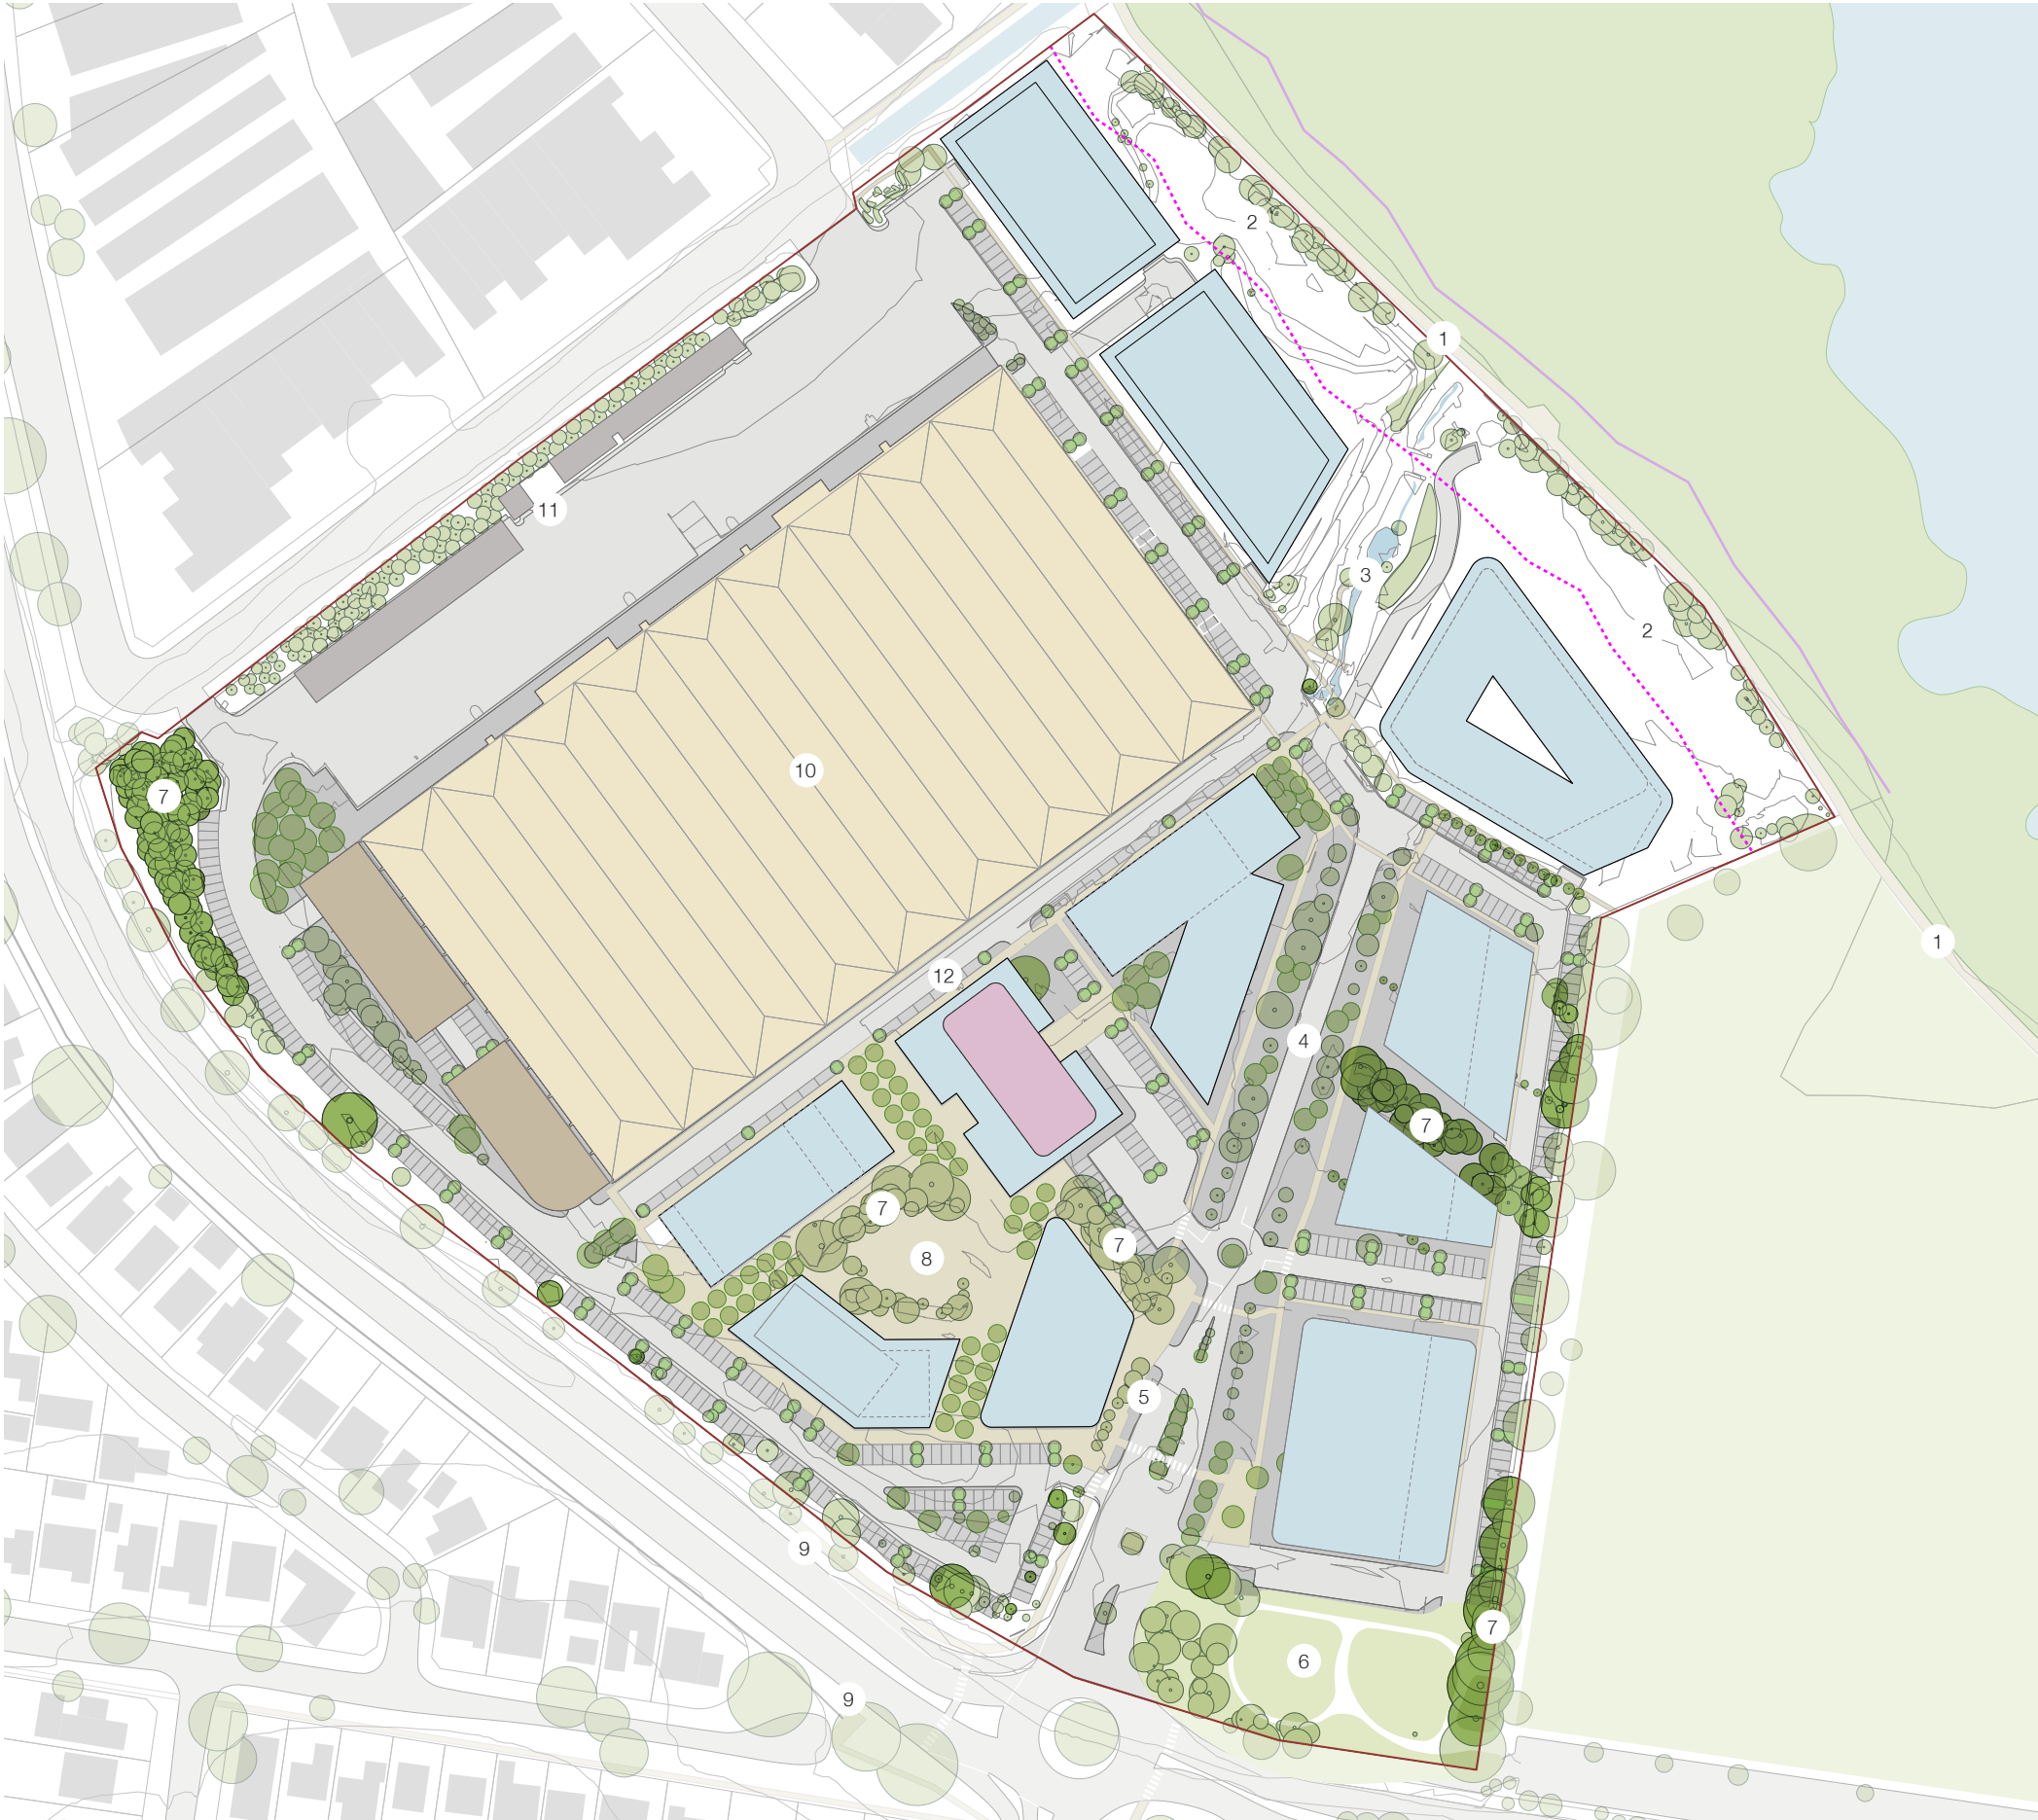
5.4 Indicative Masterplan

The indicative masterplan is structured around the extant built form and existing road network to allow the project to be staged and be flexible in its delivery.

KEY

- ① Pedestrian & Cycle Shared Path
- ② 40m Mean High Water Mark Setback
- ③ Bio-Swale / Overland Flow Path
- ④ Embellished Toyota Avenue
- ⑤ Private Shuttle Bus Drop Off Bay
- ⑥ New Open Space
- ⑦ Significant Stands of Existing Trees Retained
- ⑧ New Public Plaza
- ⑨ Potential New Public Bus Stops
- ⑩ Existing Main Warehouse Building Retained
- ⑪ Service Area
- ⑫ New Internal Service Road
