**Proposed Rezoning**

**Weemala Development Stage E2**

**Geotechnical Assessment**

Report No. RGS50006.1 - AC

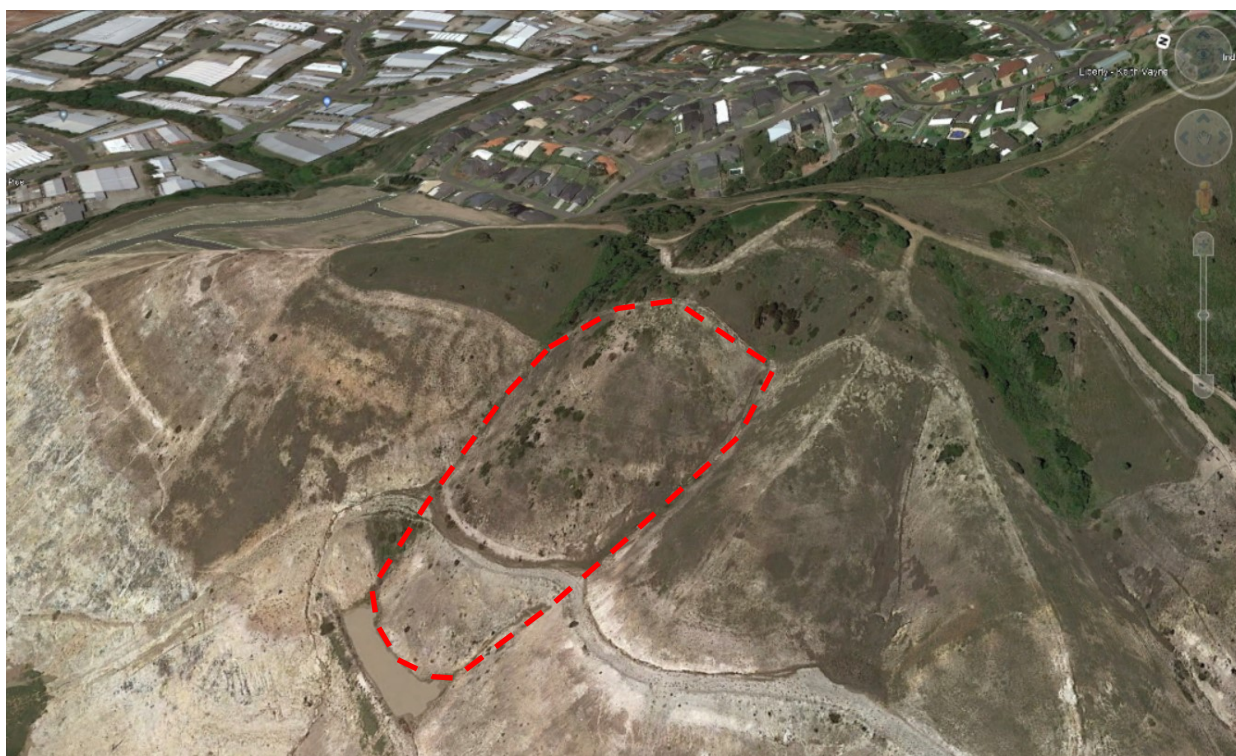
**Diagram 2:** Google Earth image that illustrates geomorphology of the site. The map has been oriented in a west-northwest direction.

The spur generally falls to the west-northwest at grades of up to 15°. It is bound by gullies on either side of the spur that are also running down the western face of the main ridge in a west northwest direction. The sides of the spur fall towards the gullies at grades of about 25°, with some localised steeper slopes falling at grades of up to 40° that were in areas generally approaching the centre of the gullies.

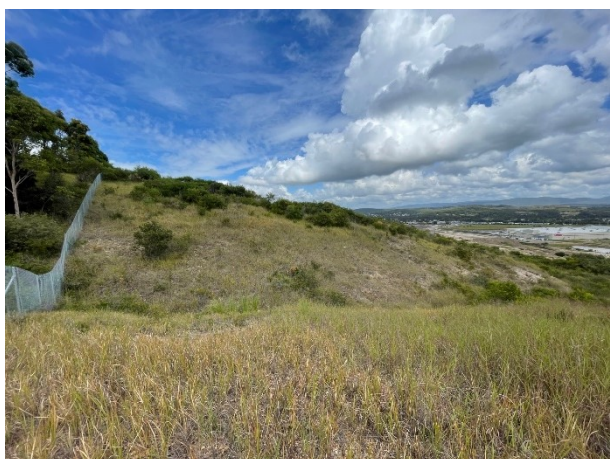
*Looking south over the upper portion of E2.*

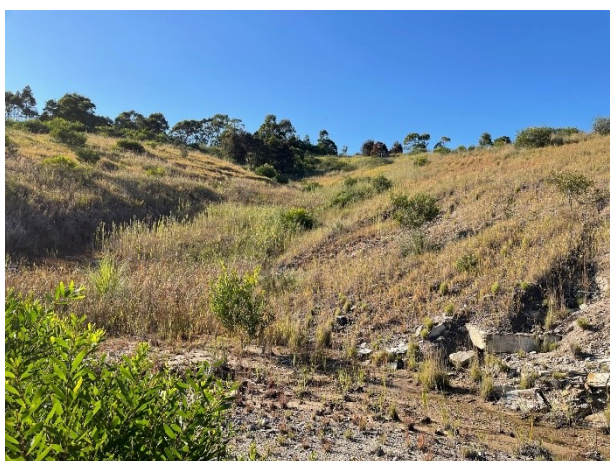
*Looking up the gully on the northern side of E2*

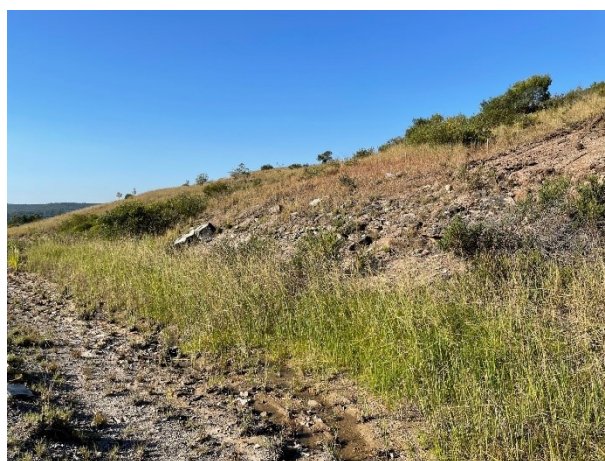
The track is 8.5m wide and the batter has been constructed at about 1.5:1 (about 35°). The track is constructed over the gully that runs along the southwest boundary of the section. Surface water flows from the gully are diverted along the track and directed into the next gully to the north. Some ponding was observed along the track.

*Access track constructed through the site with water pooling.*

As discussed above, the access track constructed through the site has filled over the gully that runs along the southeast boundary of E2 impeding the natural flow path of surface waters. It is recommended that this is cleared or where filling of these gullies is required a drainage blanket must be incorporated. The blanket should comprise a geofabric wrapped drainage blanket of durable hard crushed rock placed in the base of the gully.

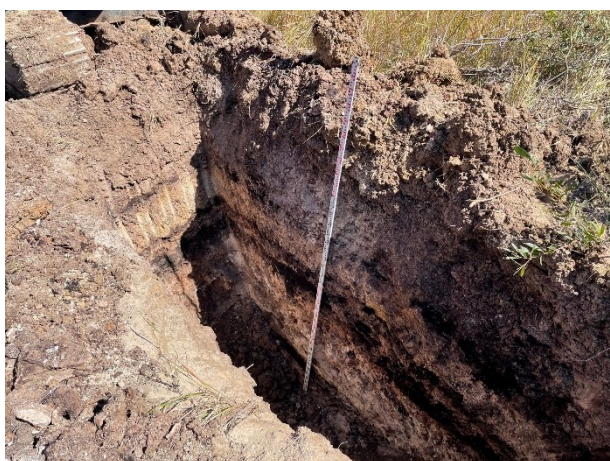
*TP3 was excavated in the upper slope of the spur and encountered colluvial/residual soil overlying tuffaceous sandstone with interbedded coal layers.*

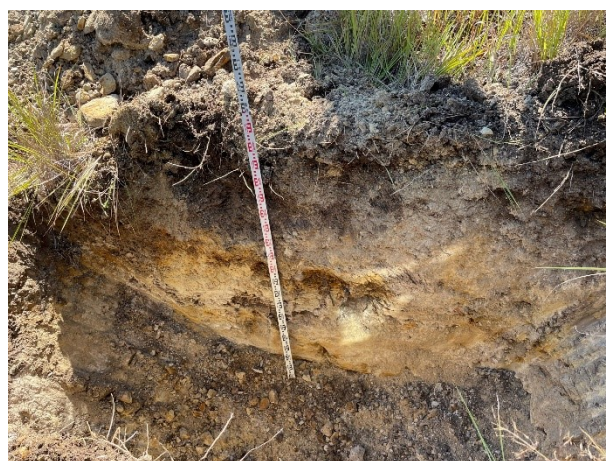
*TP 4 was excavated about 20m downslope of TP3 and did not encounter coal seams. The test pit encountered practical refusal at 1.9m*

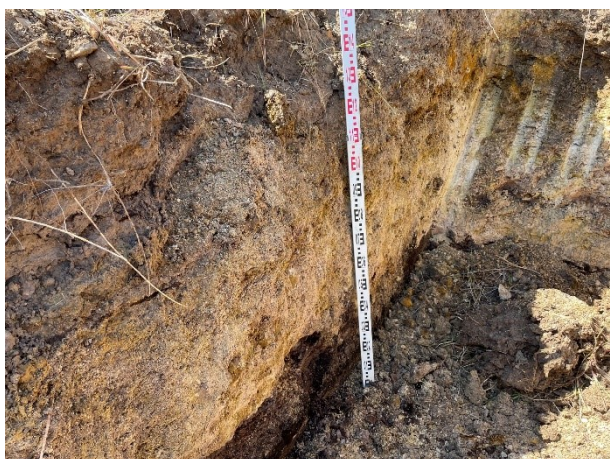
*TP6 was excavated in the mid slope of the spur above the access track and encountered a low strength coal layer followed by practical refusal at 1.6m*

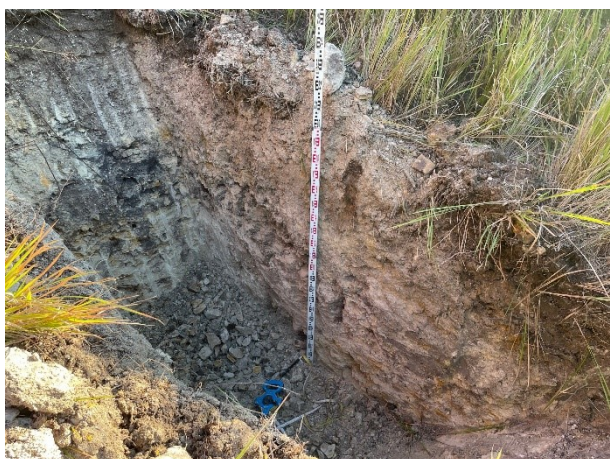
*TP11 was excavated on the upper slope of the northern face of the spur and encountered colluvial soil overlying very low strength tuffaceous material overlying medium strength sandstone.*

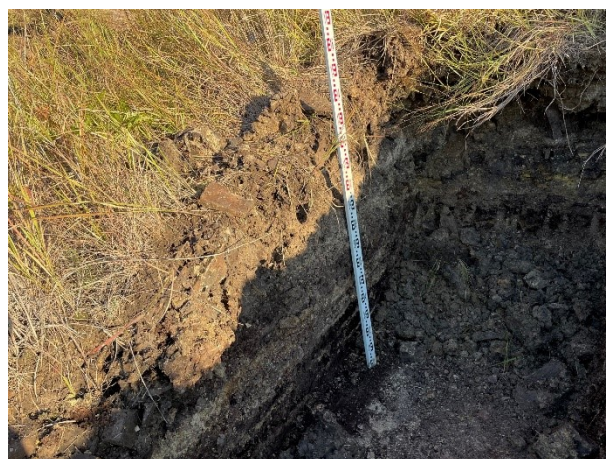
*TP12 was excavated about 20m downslope of TP11 and encountered colluvial soil overlying tuffaceous material overlying interbedded claystone/coal followed by practical refusal at 1.3m.*

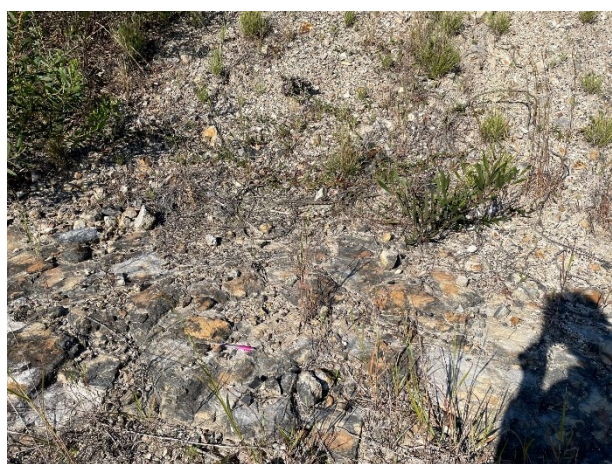
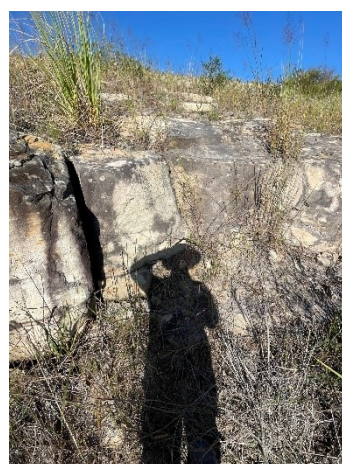
Weathered rock outcrops exposed below the access track

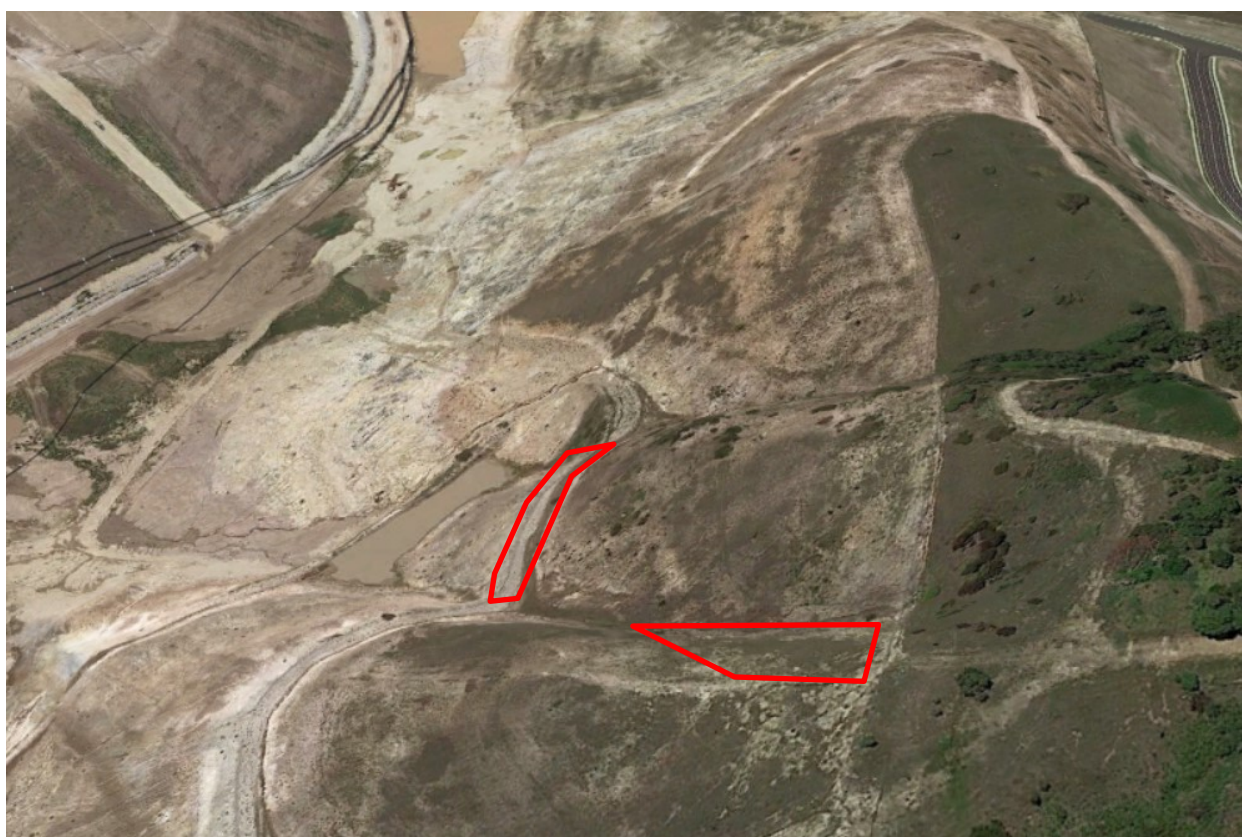
- Steep gully walls in particular within the northern face of the spur to the south of E2; and
- Over steep batter of track constructed through the site.

**Diagram 4:** Identified slope risk areas outlined red.

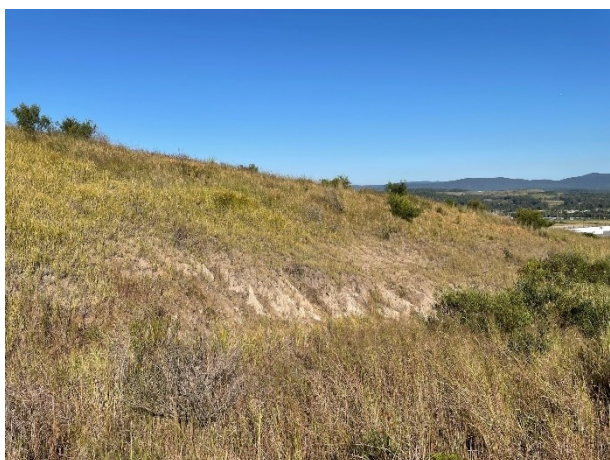
*Steep gully walls within spur face south of E2.*

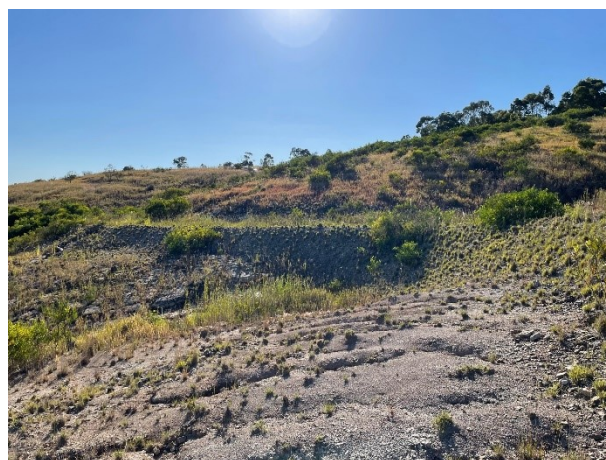
*Access track bisecting site with a batter up to 35°.*

| Hazard | H1 – Large scale landslide and debris flow | H2 – Localised failure of poorly retained cuts/fill batters | H3 – Translational or rotational slide of profile along weak tuffaceous or coal layers |
|---|---|---|---|
| Proposed Mitigation | Install upslope drainage to divert water flows away from the face, install erosion protection. | Avoid or retain cuts >1m. Deep cuts constructed in accordance with Section 8 of this report. Remove or reconstruct access track with batt of up to 3:1 | Potential failure plane expected to be removed within proposed cut depth, if not further assessment required.<br><br>All structures should be founded within weathered rock. |

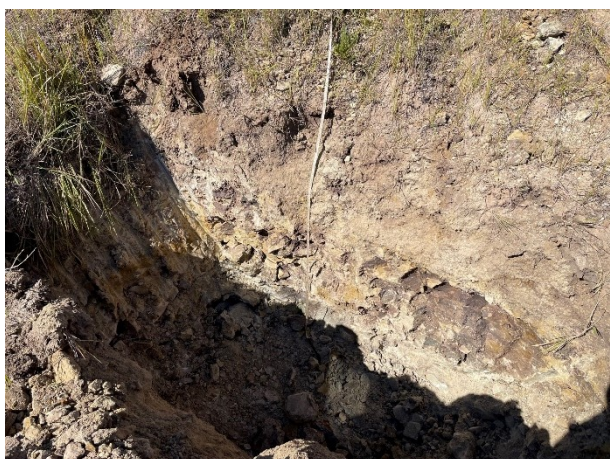
*Material encounter in spur face (TP1).*

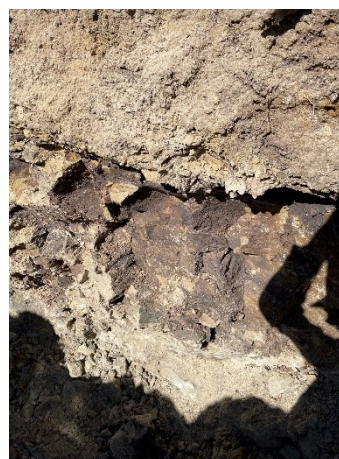
*Fractured rock with clay coating encountered in TP1.*
