Preliminary Contamination Assessment

4029-4045 Nelson Bay
Road, Bobs Farm NSW

NEW22P-0199-AA.rev1
2 November 2022

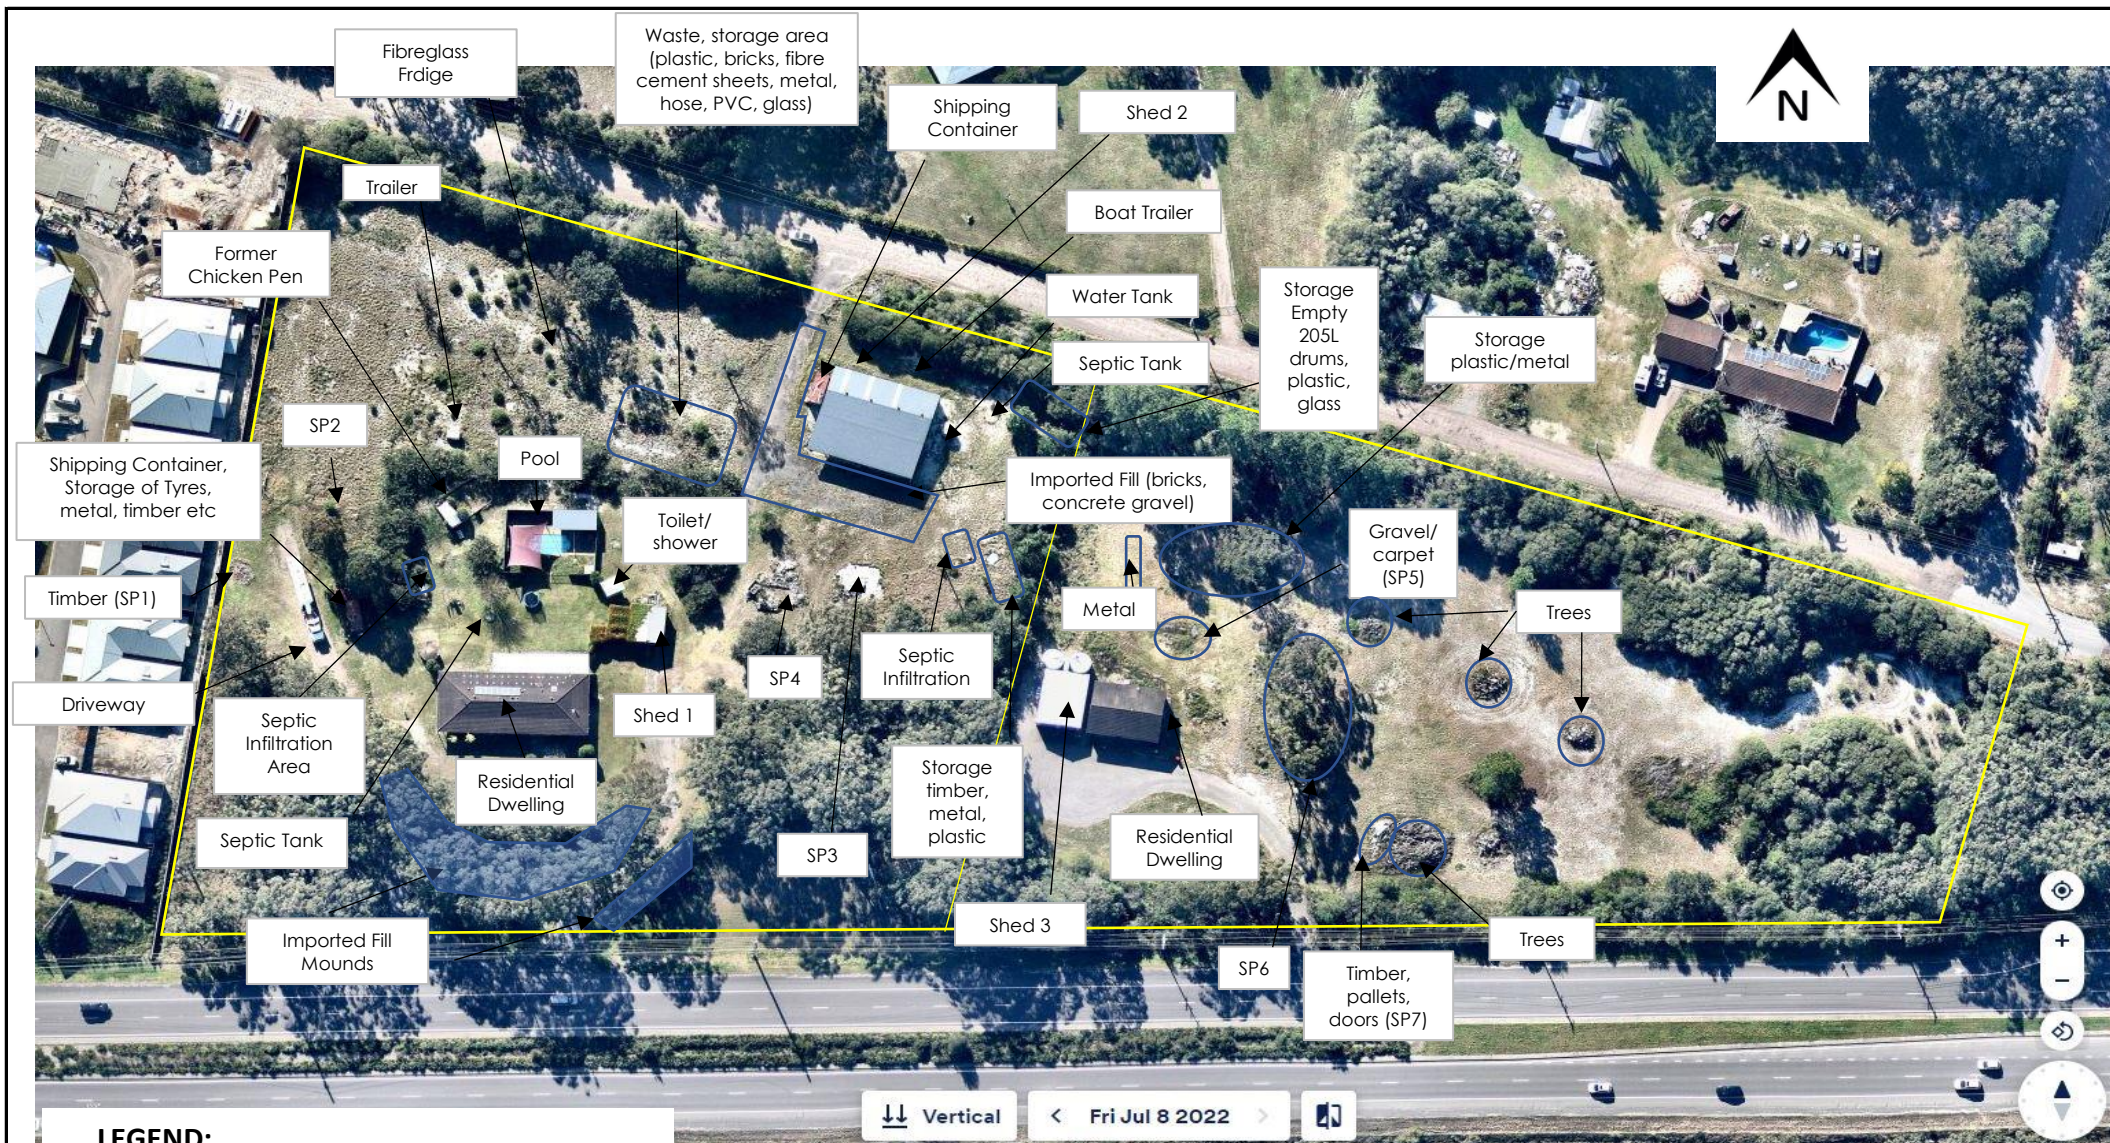
| Client: | Hometown Australia Holdings | Drawing No: | FIGURE 3 |

A Qualtest Environmental Scientist visited the site on 18 October 2022. Selected site photographs are presented in Appendix E. The location of site features is shown on Figure 3, Appendix A. A summary of the site features is outlined below:

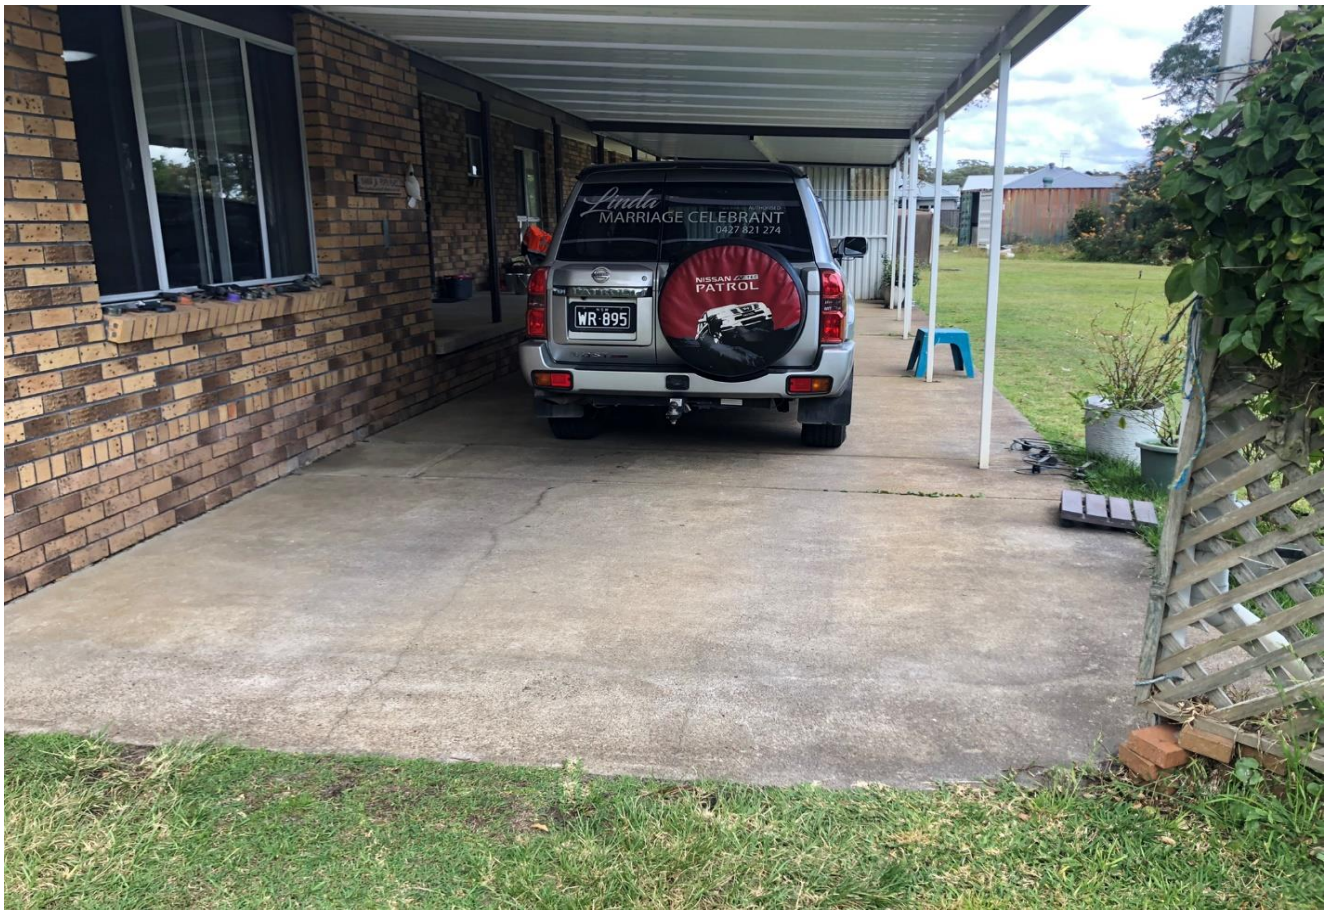
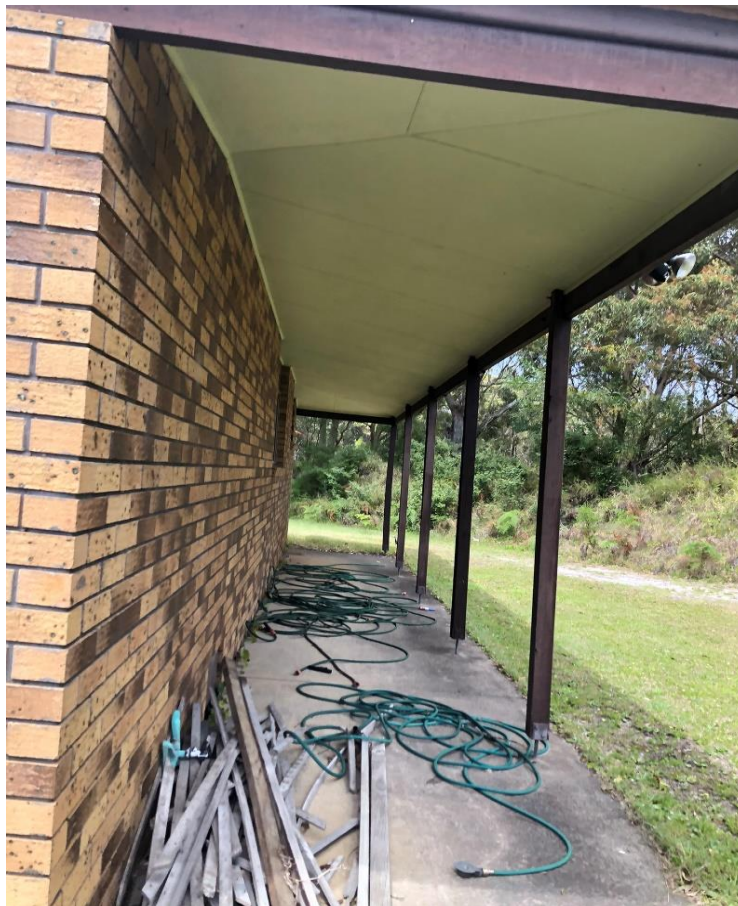
- A residential dwelling was observed in the central south of the lot. The dwelling was observed to have been constructed with brick and a tile roof. Potential Asbestos Containing Materials (PACM) were observed in the eaves of the dwelling (see Photograph 1 and 2).

Photograph 1 - Residential Dwelling - 4029 Nelson Bay Road

Photograph 2 - Residential Dwelling - 4029 Nelson Bay Road

| AEC | COPC | Likelihood of Contamination | Mechanism of Contamination | Potentially Affected Media | Human & Ecological Receptors | Potential mechanisms of exposure | Potential & Complete Exposure Pathways | Comments |
|---|---|---|--|---|---|--|--|---|
| 1. Current and former buildings across the site. <ul style="list-style-type: none"> Weathering of potentially hazardous materials (asbestos, lead paint, galvanised metals) Use of pesticides around building Demolition of structures over time | Metals, Asbestos, OCPs | Medium to High | <ul style="list-style-type: none"> Top-down leaks/spills, flakes/fibres onto soil. Leaching of soil contaminants to surface water and groundwater. | <ul style="list-style-type: none"> Surface Soils Surface water Groundwater Sediments | <ul style="list-style-type: none"> Current site visitors Future construction workers & site users Soil biota/plants and transitory wildlife Surface and ground water depended ecosystems Offsite surface water – unnamed swamp, located 200m north of the site. Offsite groundwater discharge point – Bobs Farm Creek located approximately 800m north of the site or Tiligerry Creek, located approximately 2.2km north of the site. | <ul style="list-style-type: none"> Direct dermal contact with contaminated soil and/or surface water Ingestion of contaminated soil and/or surface water Inhalation of asbestos fibres, or contaminated soil (as dust) Leaching of soil contaminants to surface water and/or groundwater Surface water discharge to unnamed swamp, located 200m north of the site and potential groundwater discharge to Bobs Farm Creek or Tiligerry Creek located approximately 0.8km to 2.2km north of the site. | <ul style="list-style-type: none"> Potentially complete exposure pathway for current site visitors, future construction workers and site users. Potentially complete exposure pathway for ecological receptors. Potentially complete exposure pathway for soil contaminants to leach to surface water. Potentially complete exposure pathway for soil contaminants to leach to groundwater due to sandy soils. | Exposure pathways would be incomplete if soils are found to not be contaminated via sampling & analysis. It is recommended that a Hazardous Materials Survey is carried out on the existing site building. |

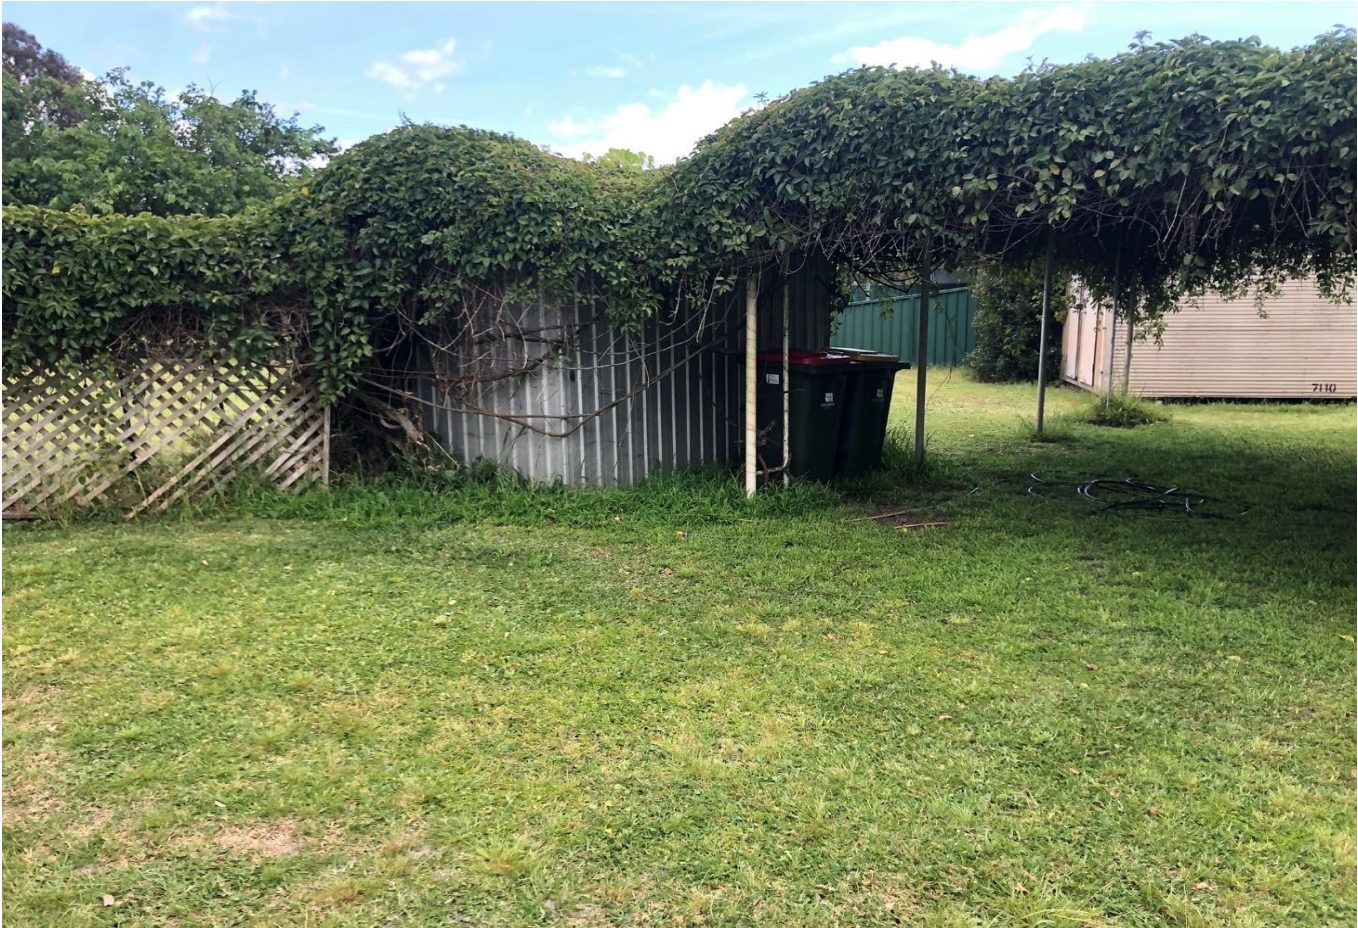
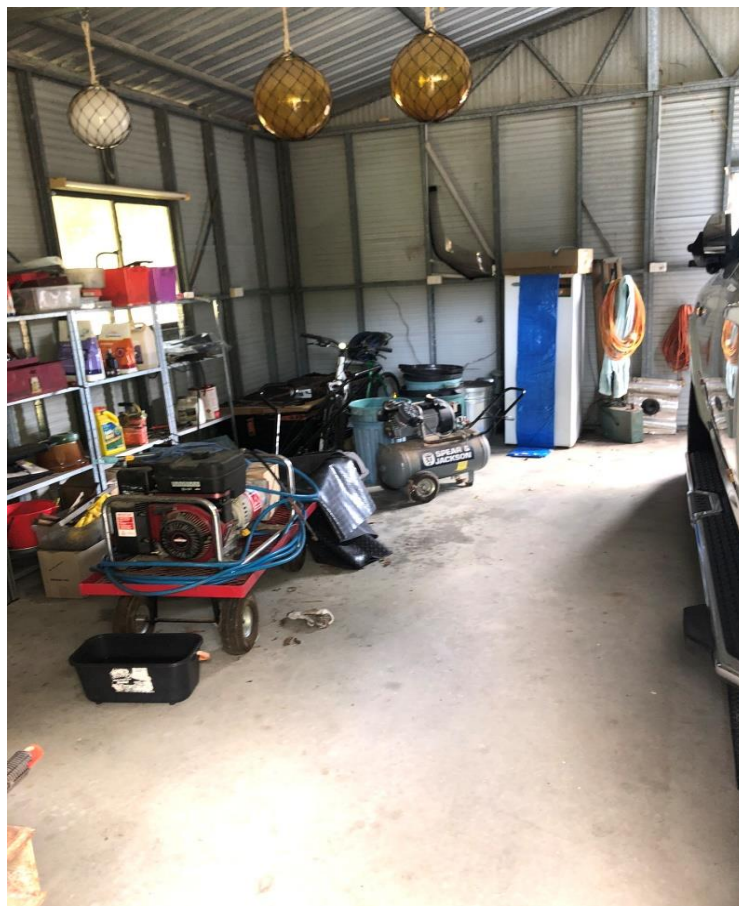
- A shed (Shed 1) was observed to the north east of the residential dwelling. The shed was constructed with metal and a concrete floor in good condition (no major cracks, some minor staining). Shed 1 was used to store a vehicle, lawn mower, compressors, equipment and minor quantities of fuels, fertilisers, pool chemicals, paints, lubricants and detergent (less than 100L total). A metal car port and garden shed were also located adjacent to Shed 1. The carport had an earthen floor and was empty at the time of inspection. The garden shed had a concrete floor and was also empty at the time of inspection (see Photographs 3 to 4).

Photograph 3 - Shed 1/carport - 4029 Nelson Bay Road

Photograph 4 -Shed 1 - 4029 Nelson Bay Road

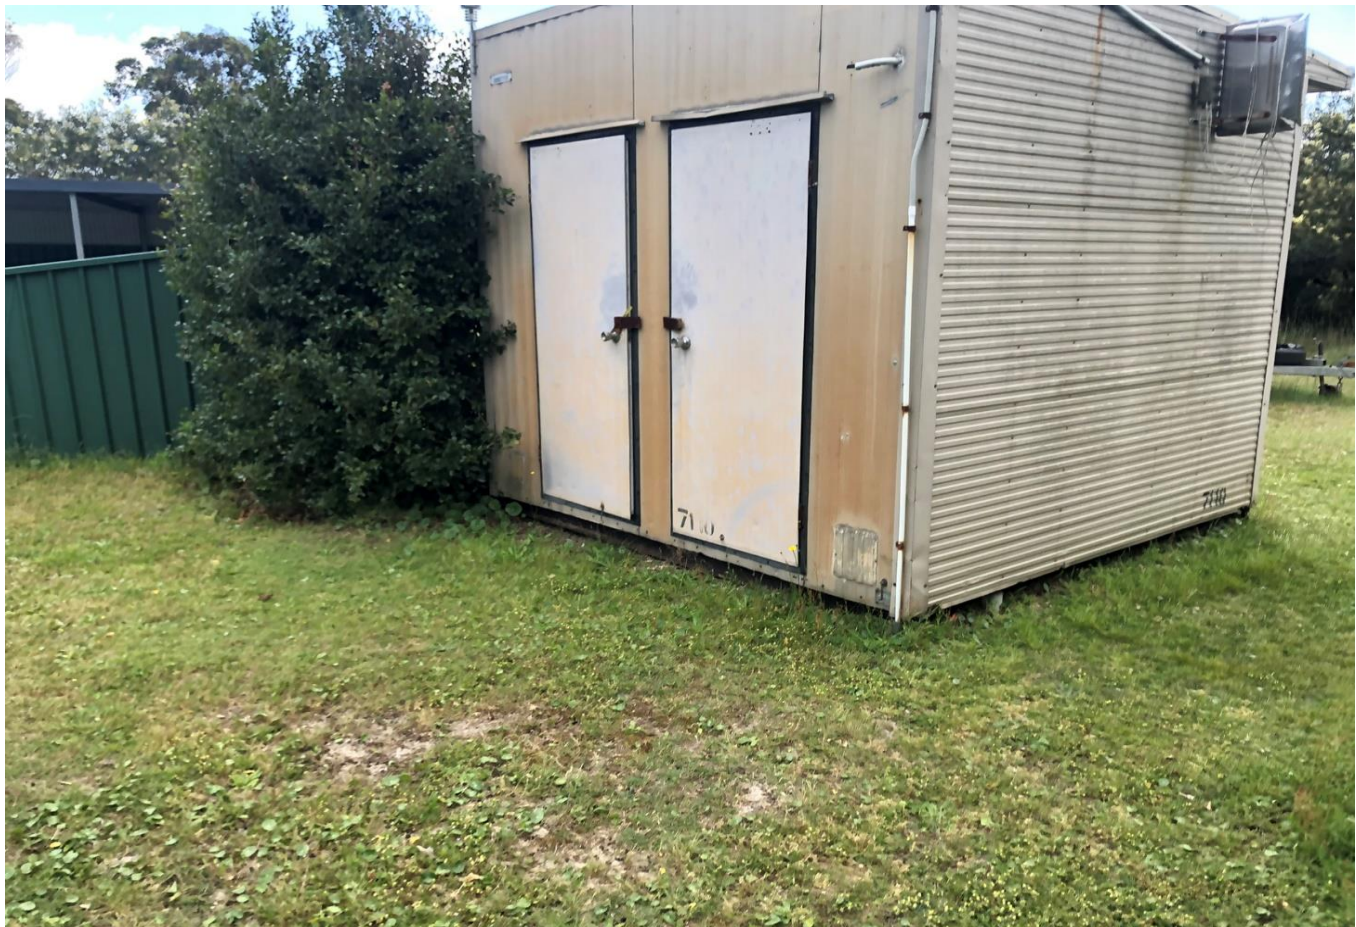
- A portable shower/toilet block was observed to the north of Shed 1. The shower/toilet block was constructed from metal (see Photograph 5).
- A metal fenced pool area was observed to the north of the residential dwelling. The pool was surrounding by grass and pavers. A small pool pump shed was located in the south eastern portion of the pool area (see Photograph 6).

Photograph 5 - Portable shower/toilet block - 4029 Nelson Bay Road

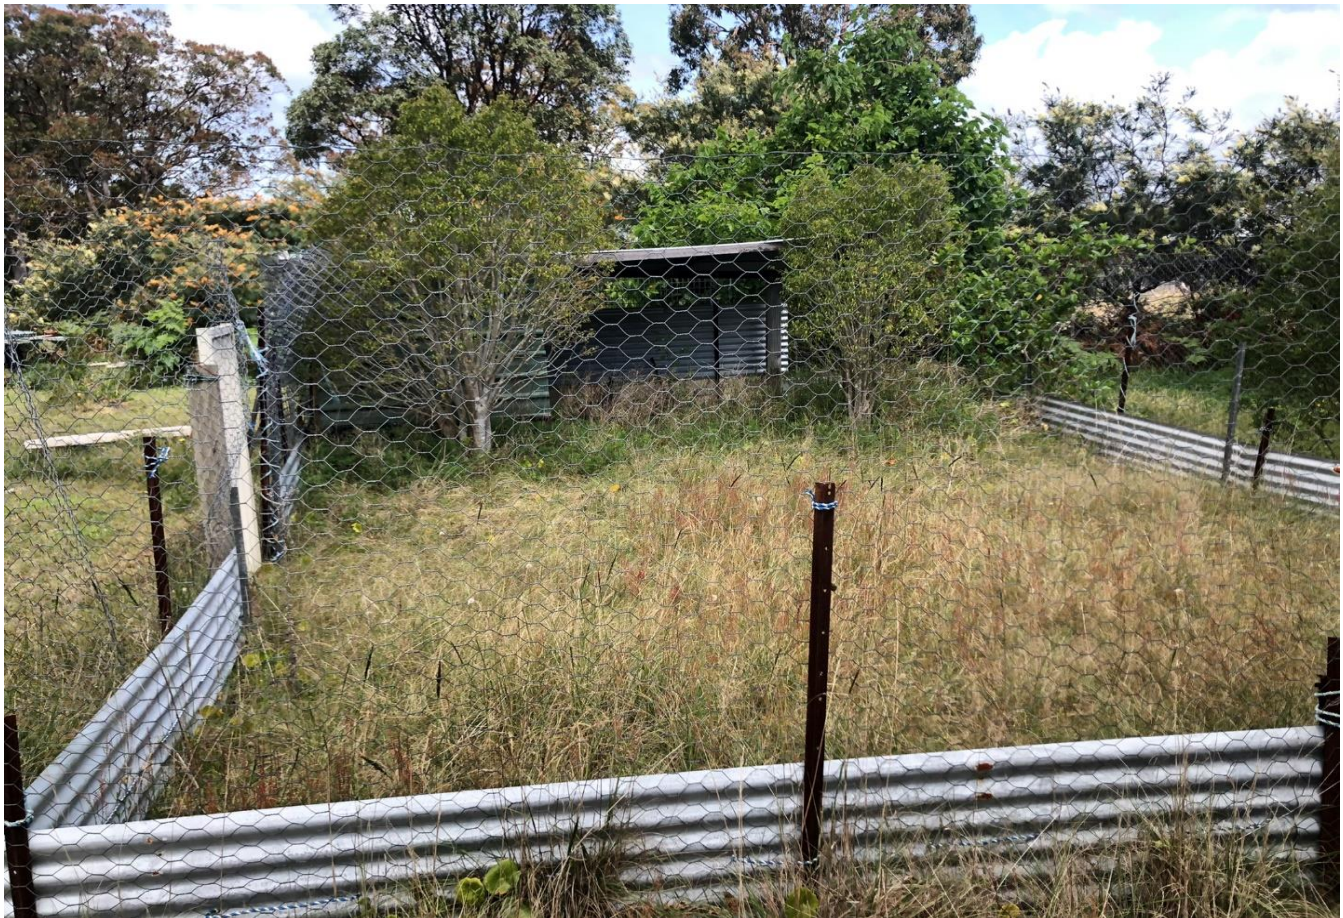
Photograph 7 - Former Chicken Pen - 4029 Nelson Bay Road

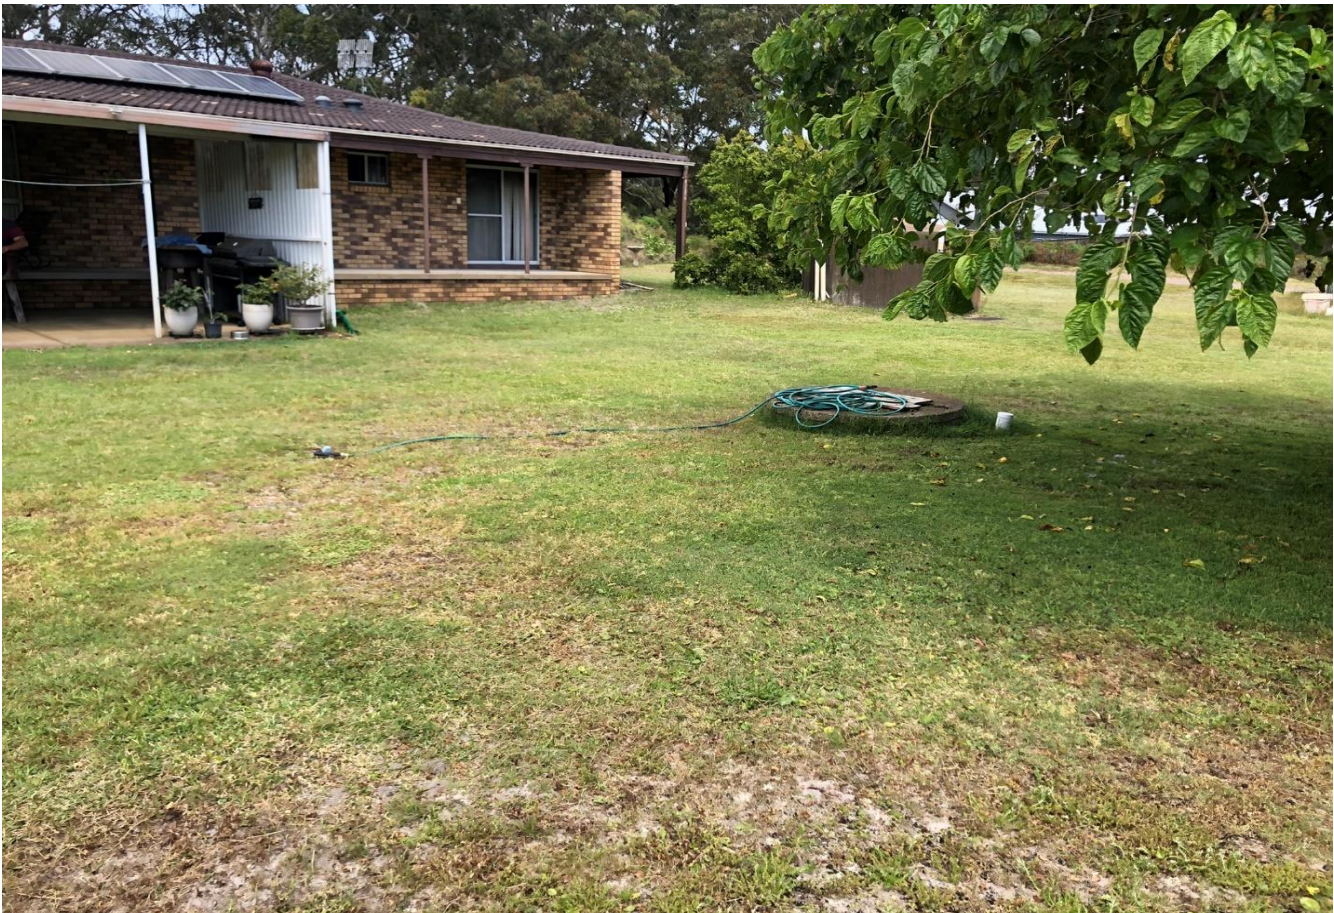
- A septic tank was observed to the north of the residential dwelling. The infiltration area of the septic was observed within vegetation to the north west of the septic tank (see Photograph 8).

Photograph 8 - Septic Tank - 4029 Nelson Bay Road

| AEC | COPC | Likelihood of Contamination | Mechanism of Contamination | Potentially Affected Media | Human & Ecological Receptors | Potential mechanisms of exposure | Potential & Complete Exposure Pathways | Comments |
|---|---|---|--|--|---|---|--|---|
| 4. Septic tank located in centre of the site <ul style="list-style-type: none"> Septic tank soak aways and adsorption trenches, potential leaks of effluent | Microbiological | Low | <ul style="list-style-type: none"> Subsurface leaks from tank Subsurface & surface leaks from pipes and/or trenches | <ul style="list-style-type: none"> Soil Surface water Sediment Groundwater | <ul style="list-style-type: none"> Current site visitors Future construction workers & site users Soil biota/plants and transitory wildlife Surface and ground water depended ecosystems Offsite surface water – unnamed swamp, located 200m north of the site. Offsite groundwater discharge point – Bobs Farm Creek located approximately 800m north of the site or Tiligerry Creek, located approximately 2.2km north of the site. | <ul style="list-style-type: none"> Direct dermal contact with contaminated soil and/or surface water Ingestion of contaminated soil and/or surface water Leaching of soil contaminants to surface water and/or groundwater Surface water discharge to unnamed swamp, located 200m north of the site and potential groundwater discharge to Bobs Farm Creek or Tiligerry Creek located approximately 0.8km to 2.2km north of the site. | <ul style="list-style-type: none"> Potentially complete exposure pathway for current site visitors, future construction workers and site users. Potentially complete exposure pathway for ecological receptors. Potentially complete exposure pathway for soil contaminants to leach to surface water. Potentially complete exposure pathway for soil contaminants to leach to groundwater due to sandy soils. | Exposure pathway would be incomplete if soils and surface water are found to not be contaminated via sampling & analysis. |

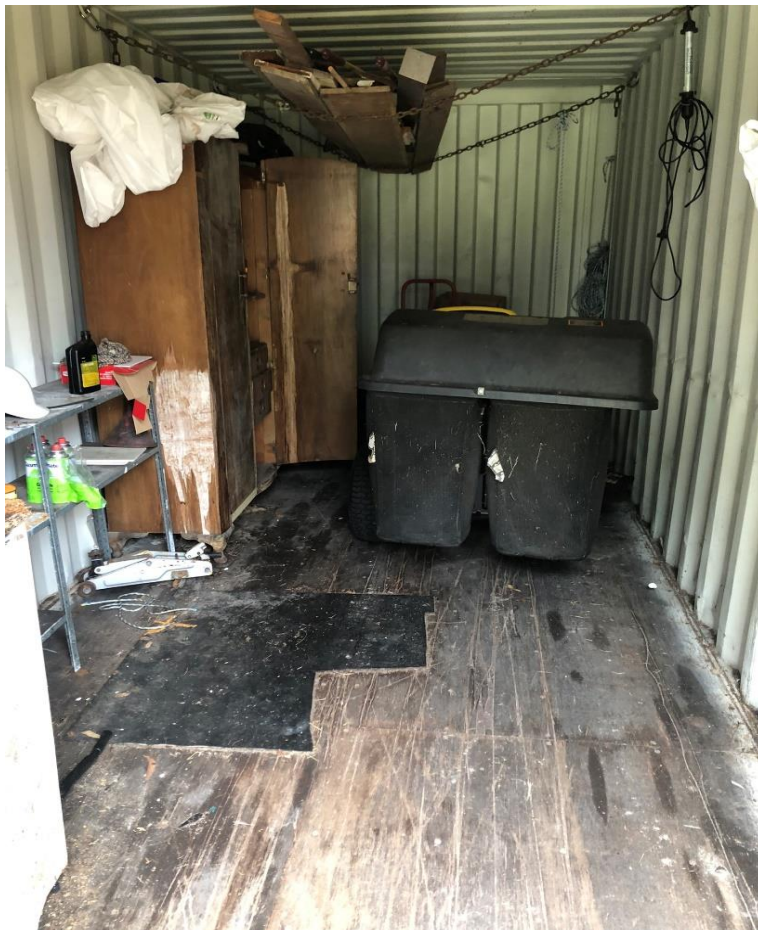
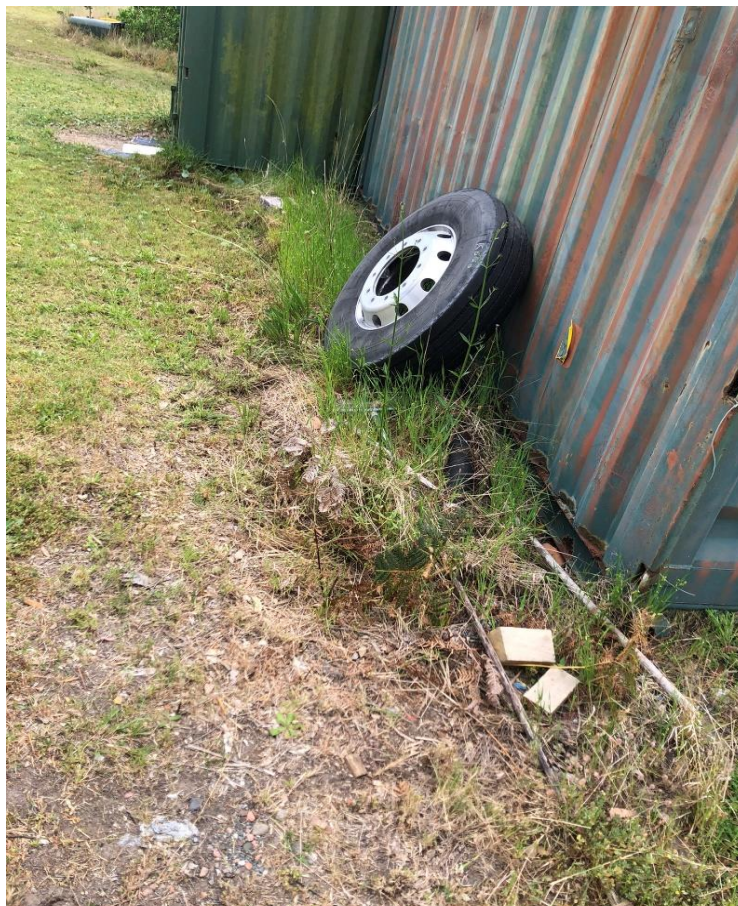
- A metal shipping container with timber flooring, in good condition, was observed to the north west of the residential dwelling. The shipping container was observed to store a lawn mower, timber, metal equipment and small quantities of degreasers/oils (<5L). Some timber, tyres and plastics were observed surrounding the shipping container (see Photographs 9 and 10).

Photograph 9 - Shipping Container - 4029 Nelson Bay Road

Photograph 10 - Storage of metal, timber, tyres - 4029 Nelson Bay Road

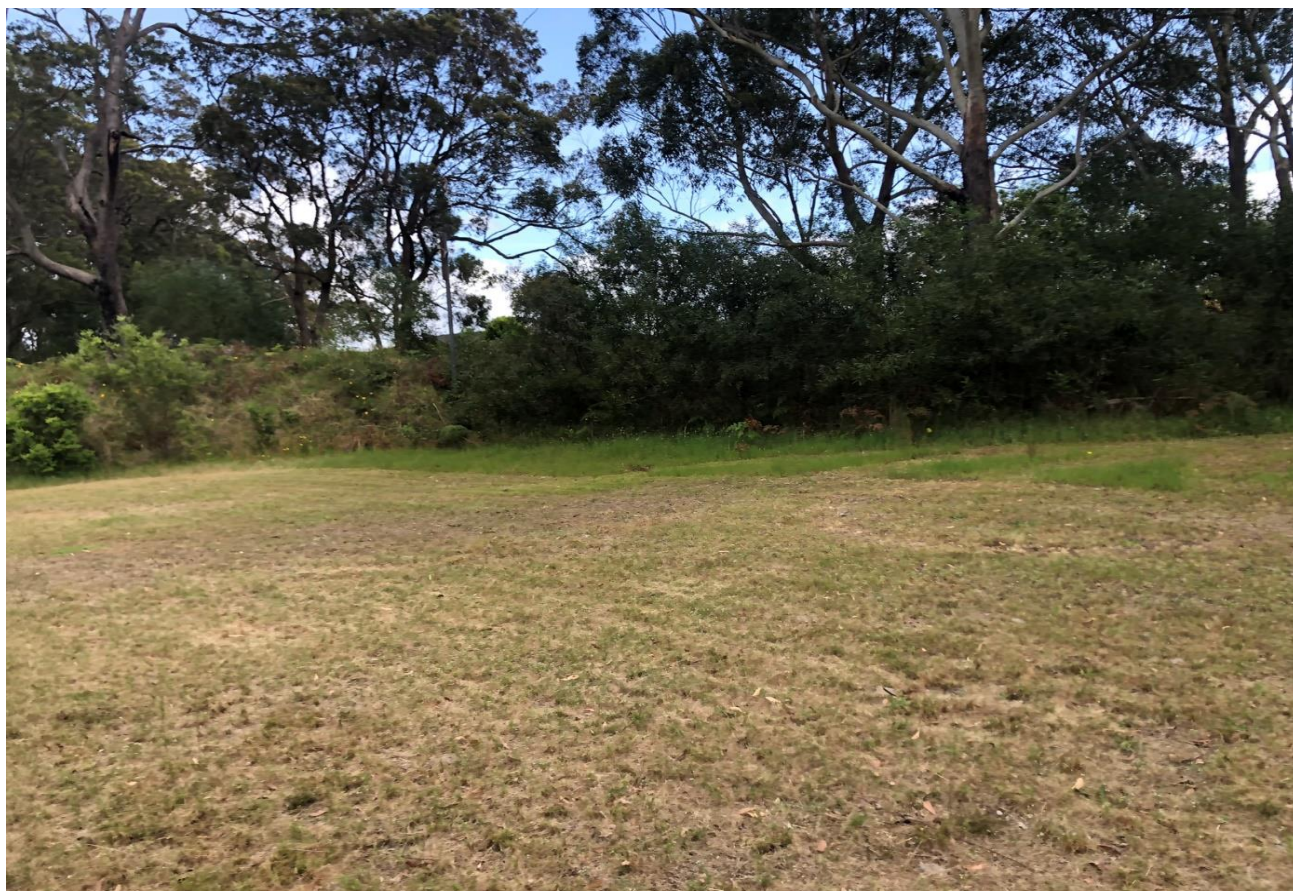
- Two large fill mounds (approximately 250m³) were observed along the southern boundary of the lot. The fill mounds were observed to consist of sand and overgrown with vegetation. (See Photograph 11).

Photograph 11 - Imported Fill Mounds - 4029 Nelson Bay Road

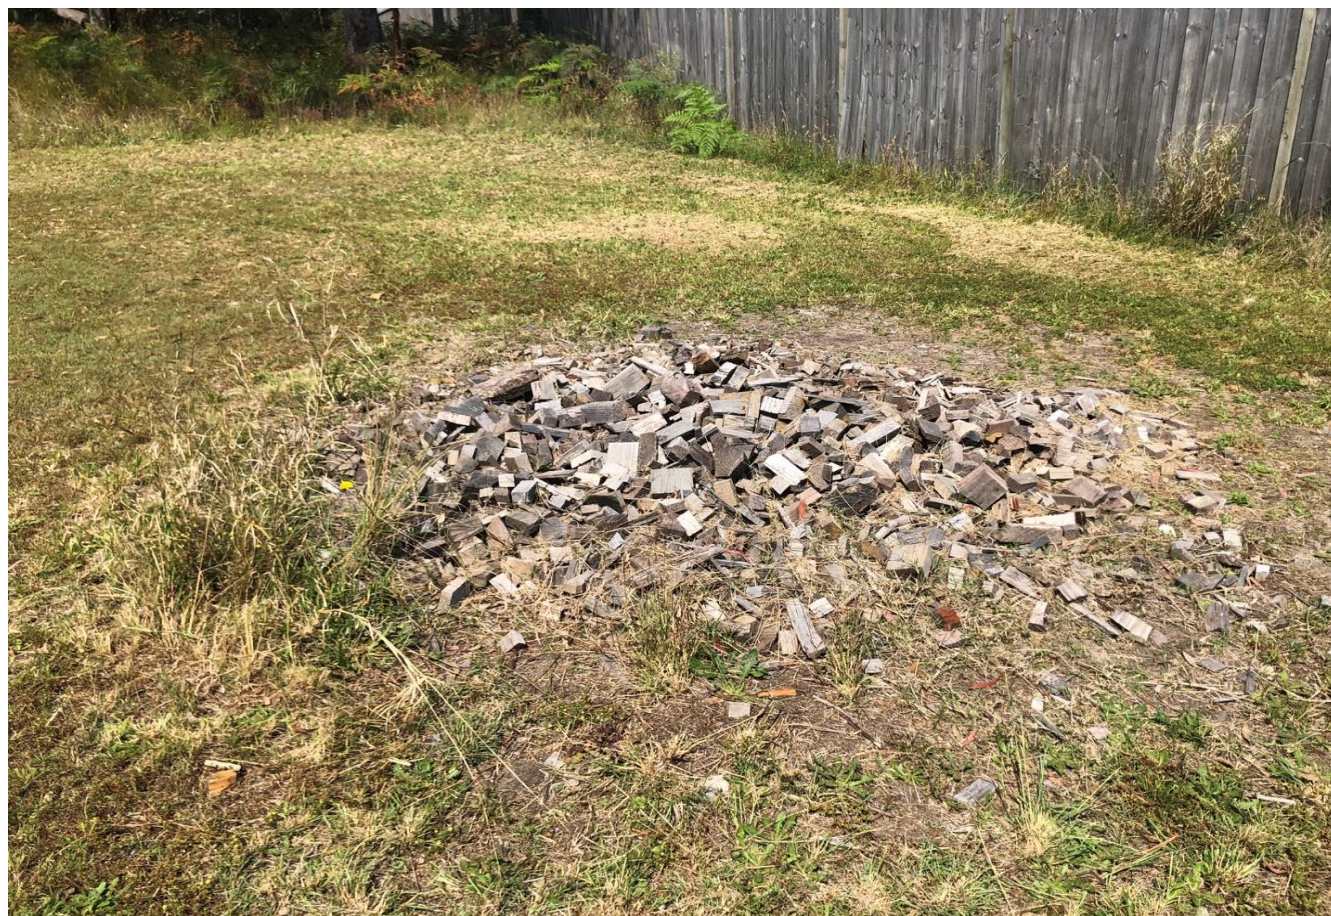
- A small stockpile of timber offcuts (1m³) was observed in the central west of the site (see Photograph 12).
- A small stockpile (1m³) of roadbase/sandy gravel was observed to the north of the shipping container (see Photograph 13).

Photograph 12 - SP1 - Timber off cuts - 4029 Nelson Bay Road

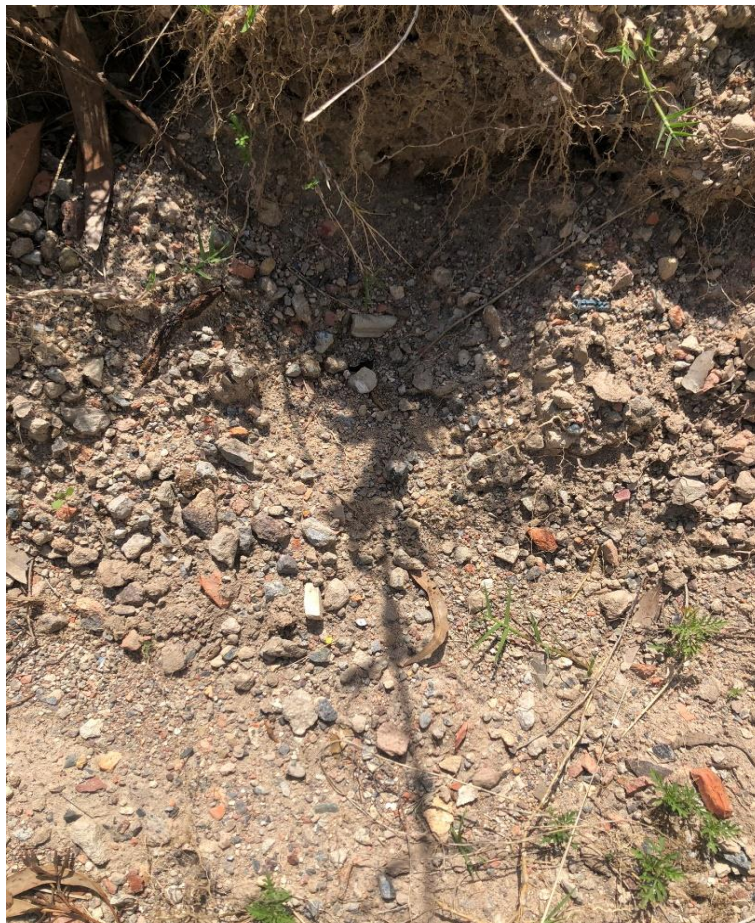
Photograph 13 - SP2 - Sandy Gravel - 4029 Nelson Bay Road

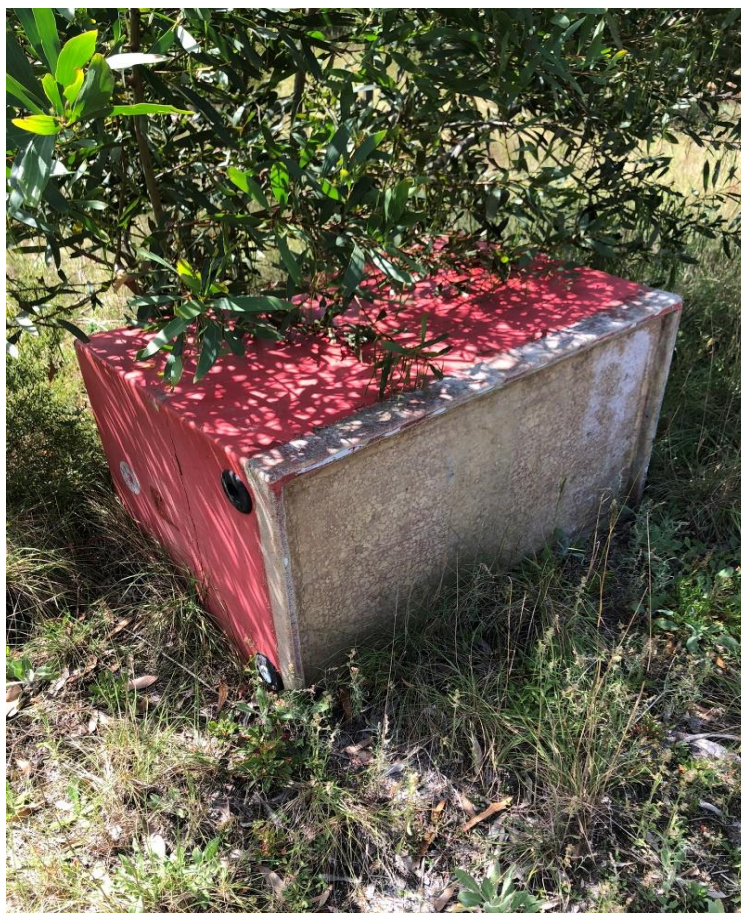
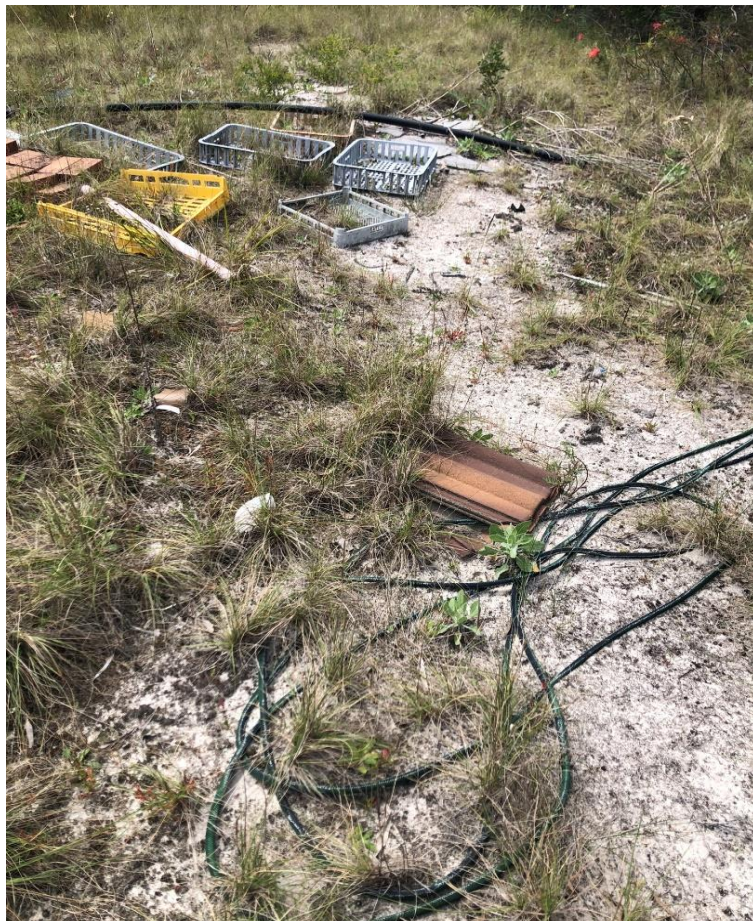
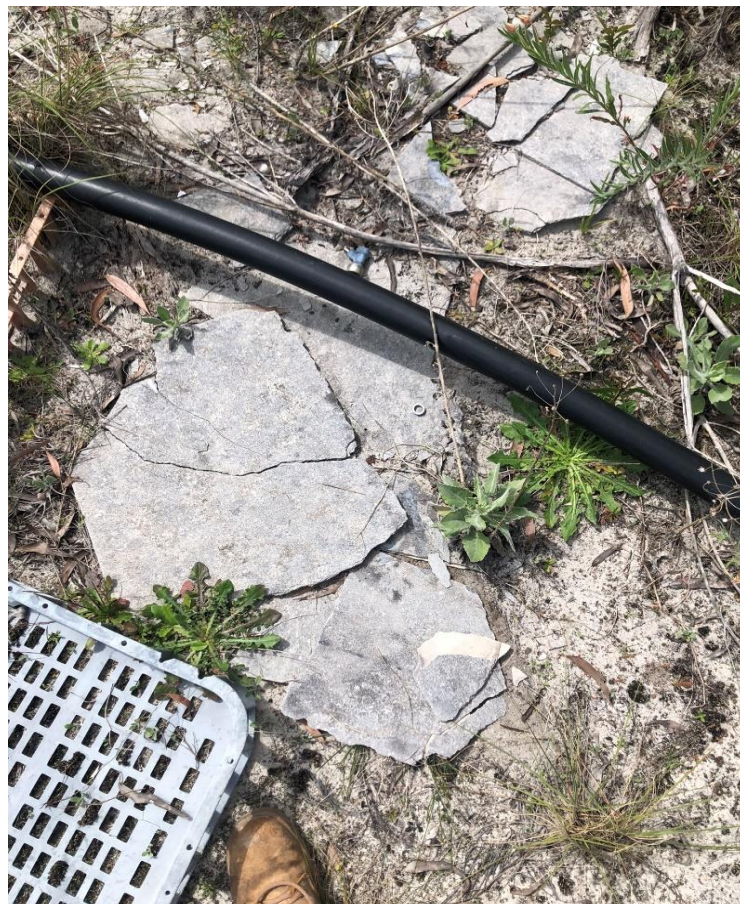
- A trailer, fibreglass fridge and waste storage area (plastics, bricks, fibre cement sheets, hose, PVC, glass) were observed in the central north and north western portion of the lot (see Photographs 14 to 16).

Photograph 14 - Fibreglass fridge - 4029 Nelson Bay Road

Photograph 15 - Waste Storgae Area - 4029 Nelson Bay Road

Photograph 16 - Waste Storgae Area - 4029 Nelson Bay Road

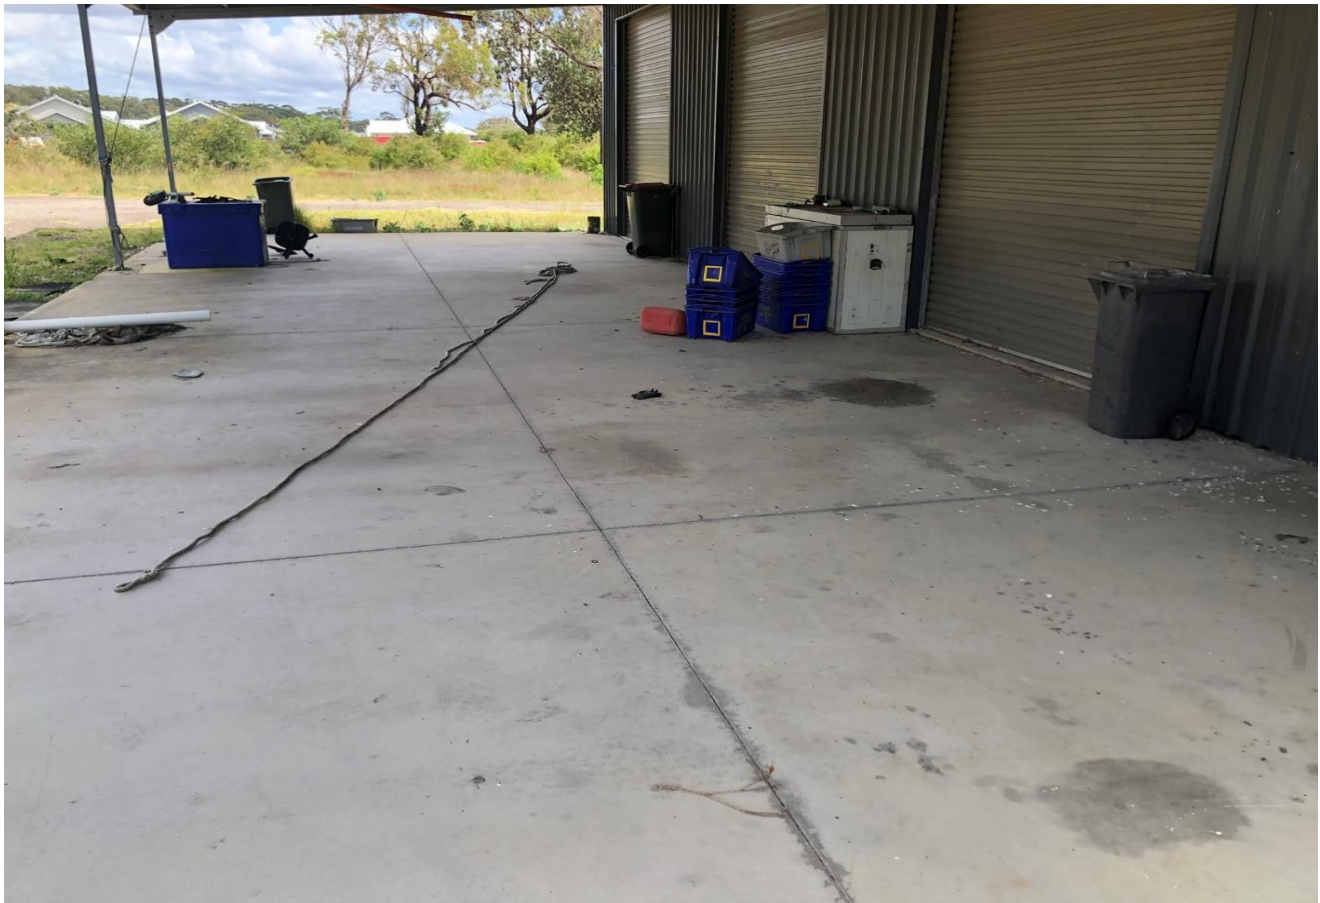
- A large metal shed/covered area (Shed 2) on a concrete slab was observed in the north eastern portion of the lot. The concrete was observed to be in good condition with no major cracks with some staining. No access was provided inside the shed. Stored on the concrete (covered area) was large eskies, rope, plastic bins, plastic tubs, timber desk, LPG gas bottles (see Photograph 17).

Photograph 17 - Shed 2 - 4029 Nelson Bay Road

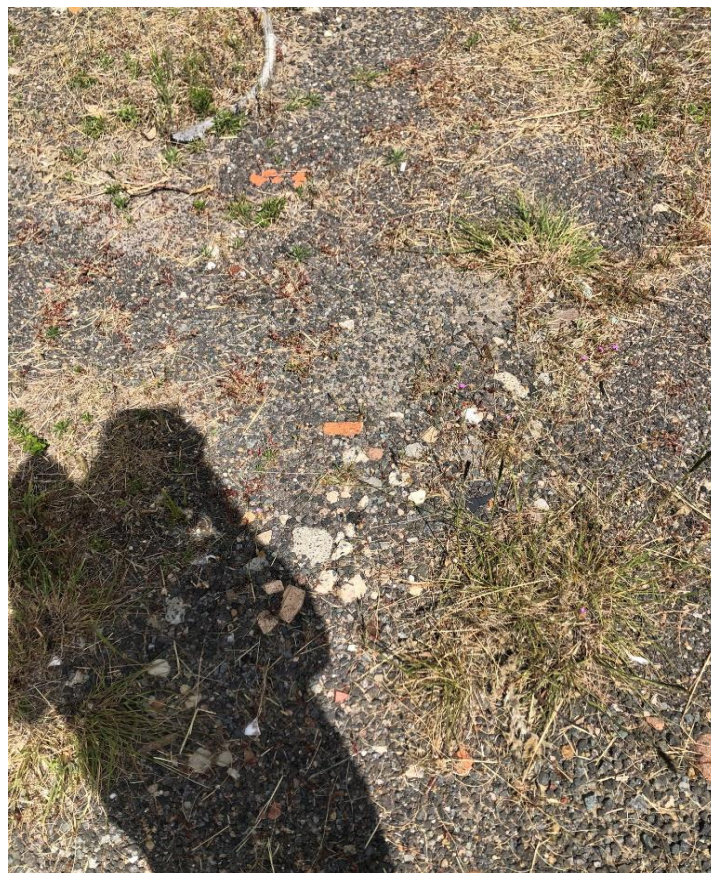
- An area of fill/driveway was observed to the south and west of shed 2. The fill material was observed to consists of asphalt, gravel, crushed bricks and concrete (See Photograph 18).

Photograph 18 - Area of fill (concrete/bricks/gravel) - 4029 Nelson Bay Road

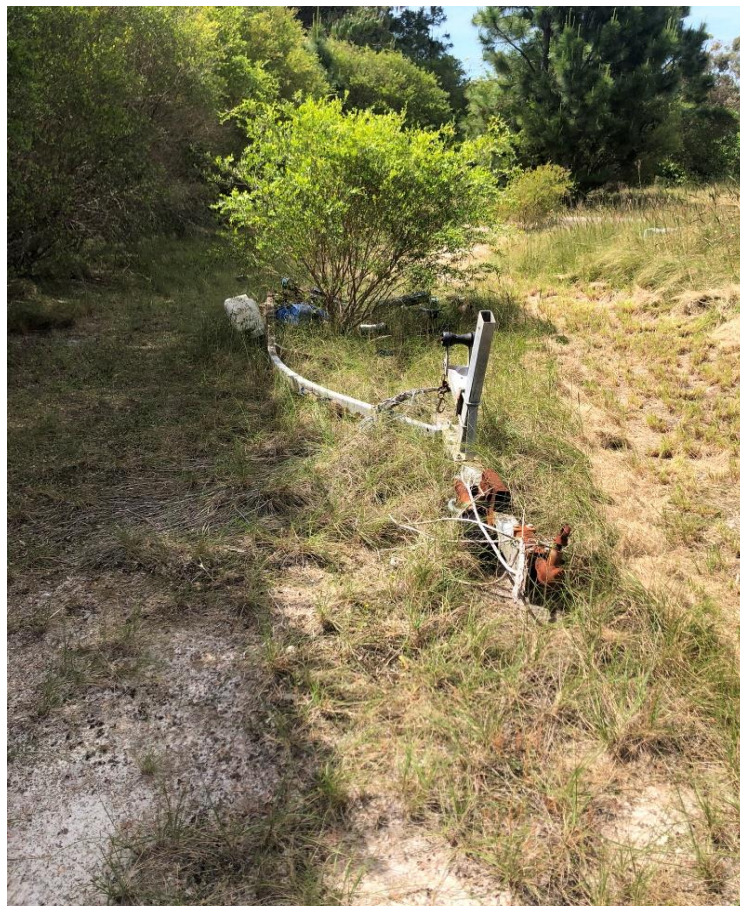
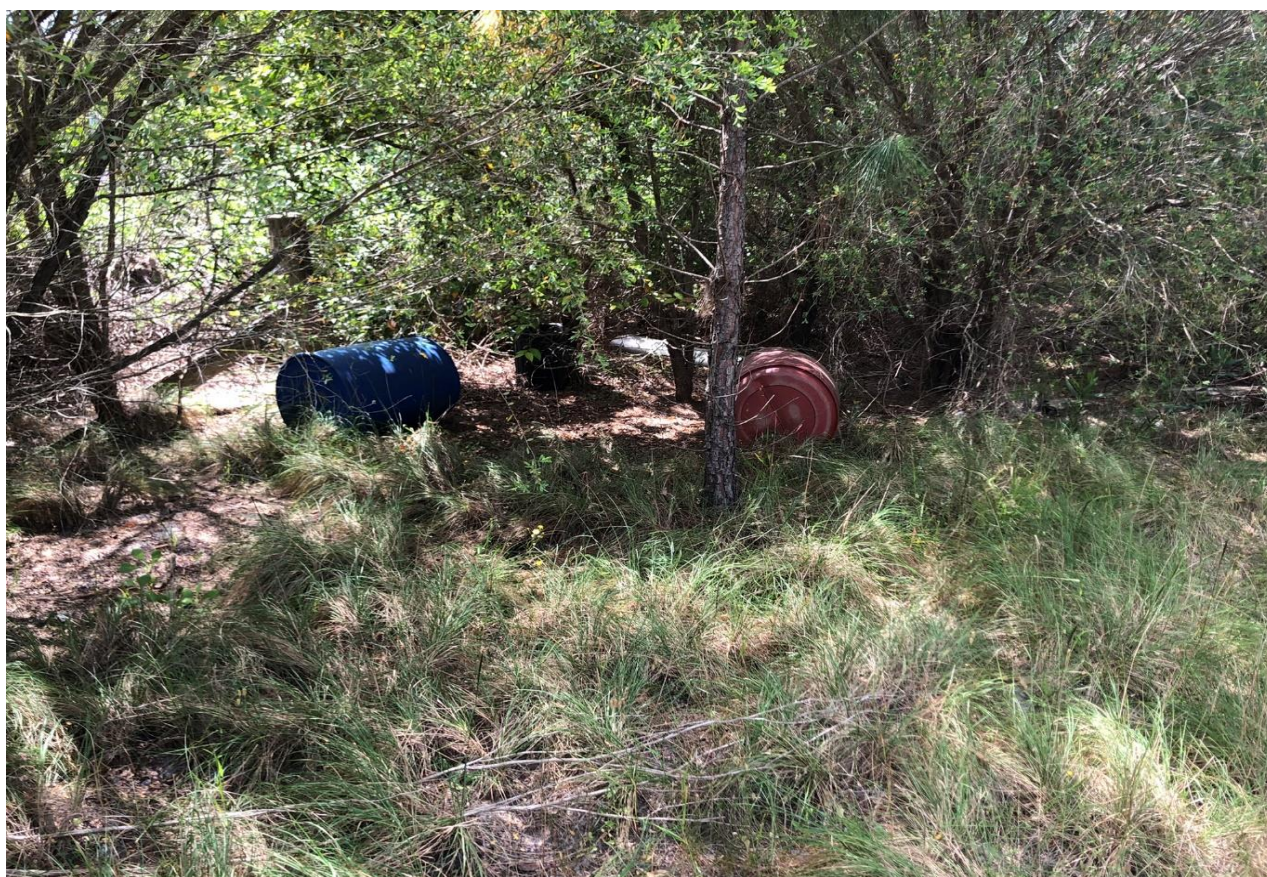
- A metal shipping container was observed to the west of Shed 2. No access was provided to the shipping container.
- A dilapidated boat trailer was observed to the north of Shed 2. Empty 205L drums, plastics and glass were also observed to the north of Shed 2 (See Photographs 19 and 20).

Photograph 19 - Boat Trailer - 4029 Nelson Bay Road

Photograph 20 - Storage of waste (205L drums, plastics, glass) - 4029 Nelson Bay Road
