Preliminary Contamination Assessment

4029-4045 Nelson Bay
Road, Bobs Farm NSW

NEW22P-0199-AA.rev1
2 November 2022

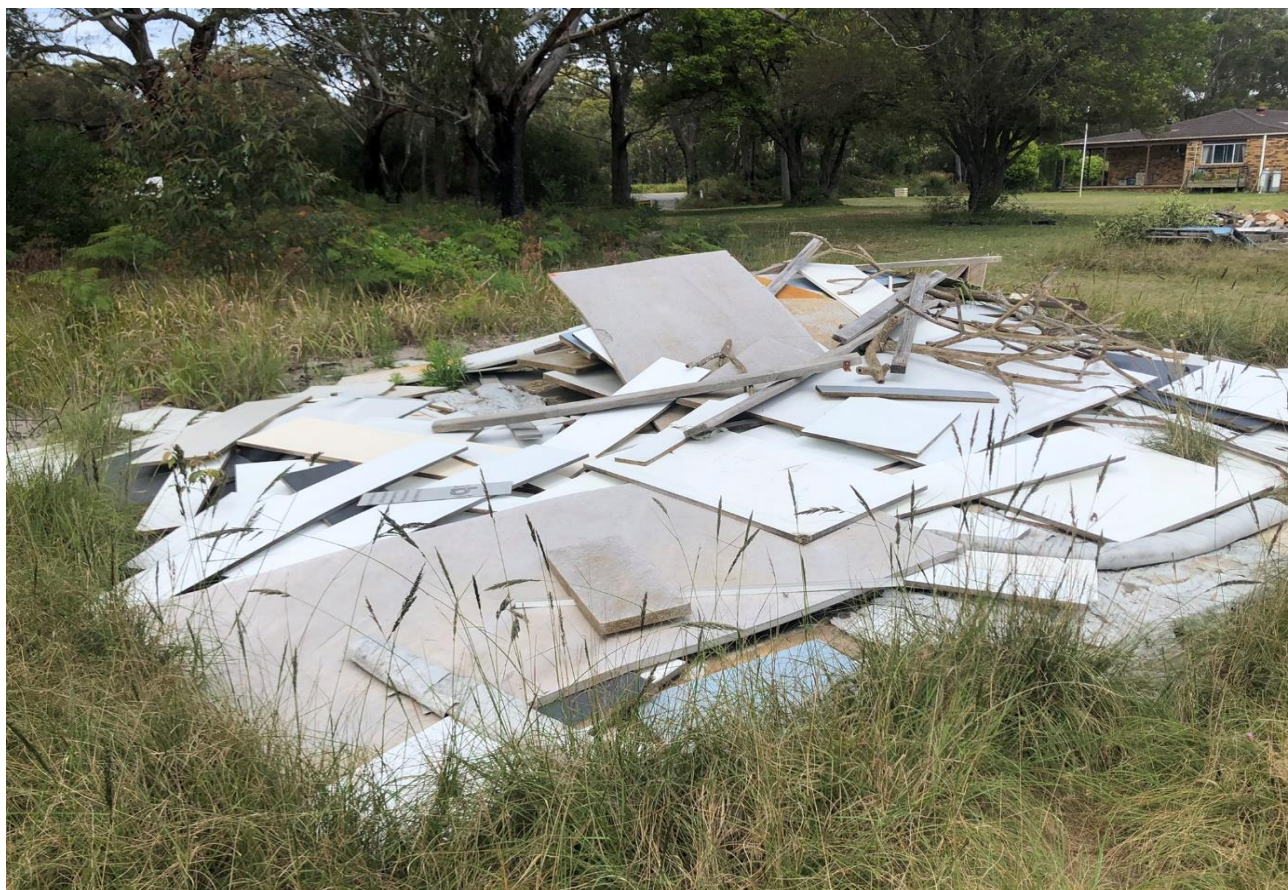
- A storage area (timber, metal, plastics) was also observed along the eastern boundary of the lot (see Photograph 21).
- A stockpile SP3 was observed to the south of Shed 2. SP3 was approximately 15m³ and contained timber chip board (see Photograph 22).
- A stockpile (SP4) was observed to the west of SP3. SP4 was approximately 20m³ and contained timber, plastics, pallets, tyres, metal (see Photograph 23).
- Two driveways were observed running generally north south from Nelson Bay Road. The driveways were observed to contain gravel.

Photograph 22 - SP3 - Timber chipboard - 4029 Nelson Bay Road

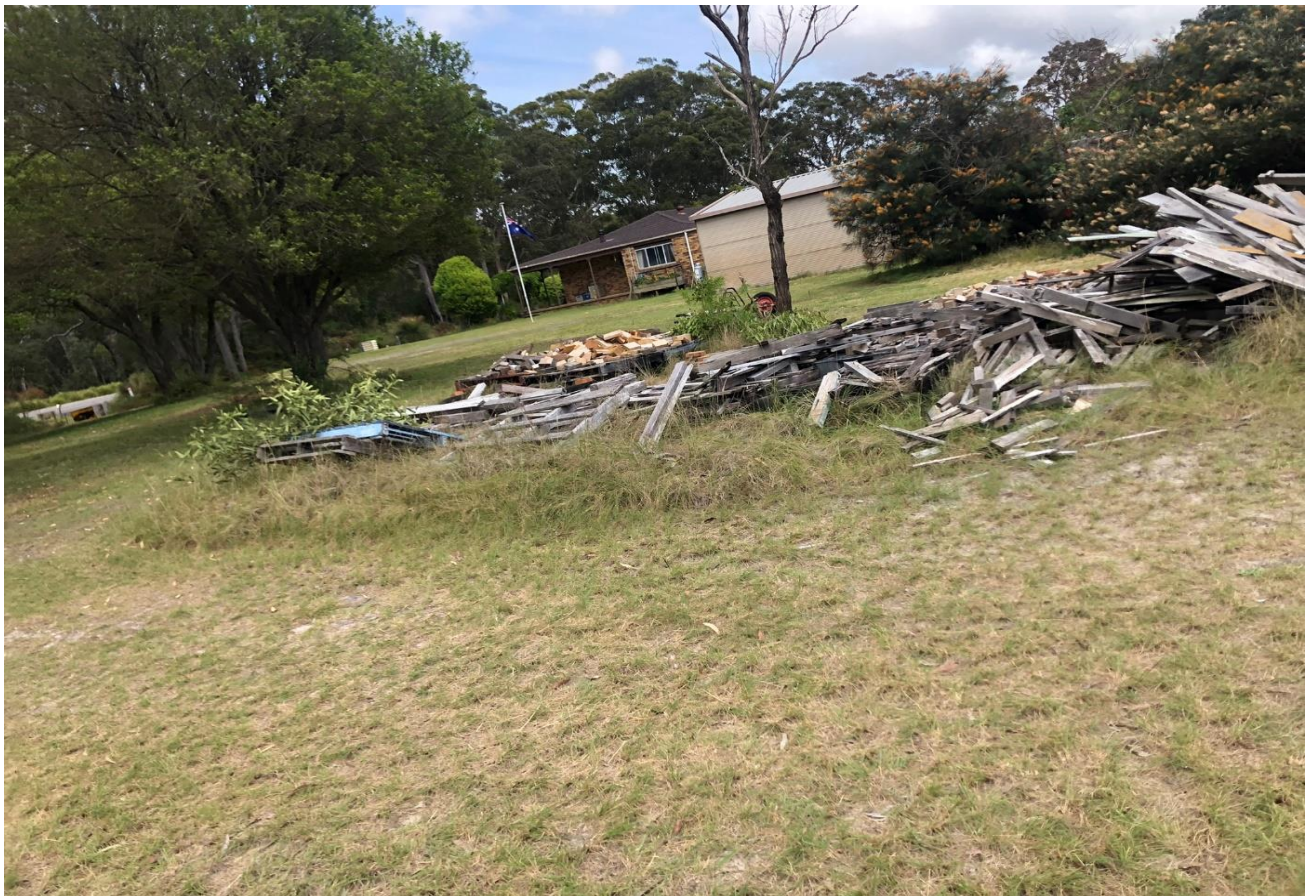
Photograph 23 - SP4 - timber, plastics, pallets, tyres, metal - 4029 Nelson Bay Road

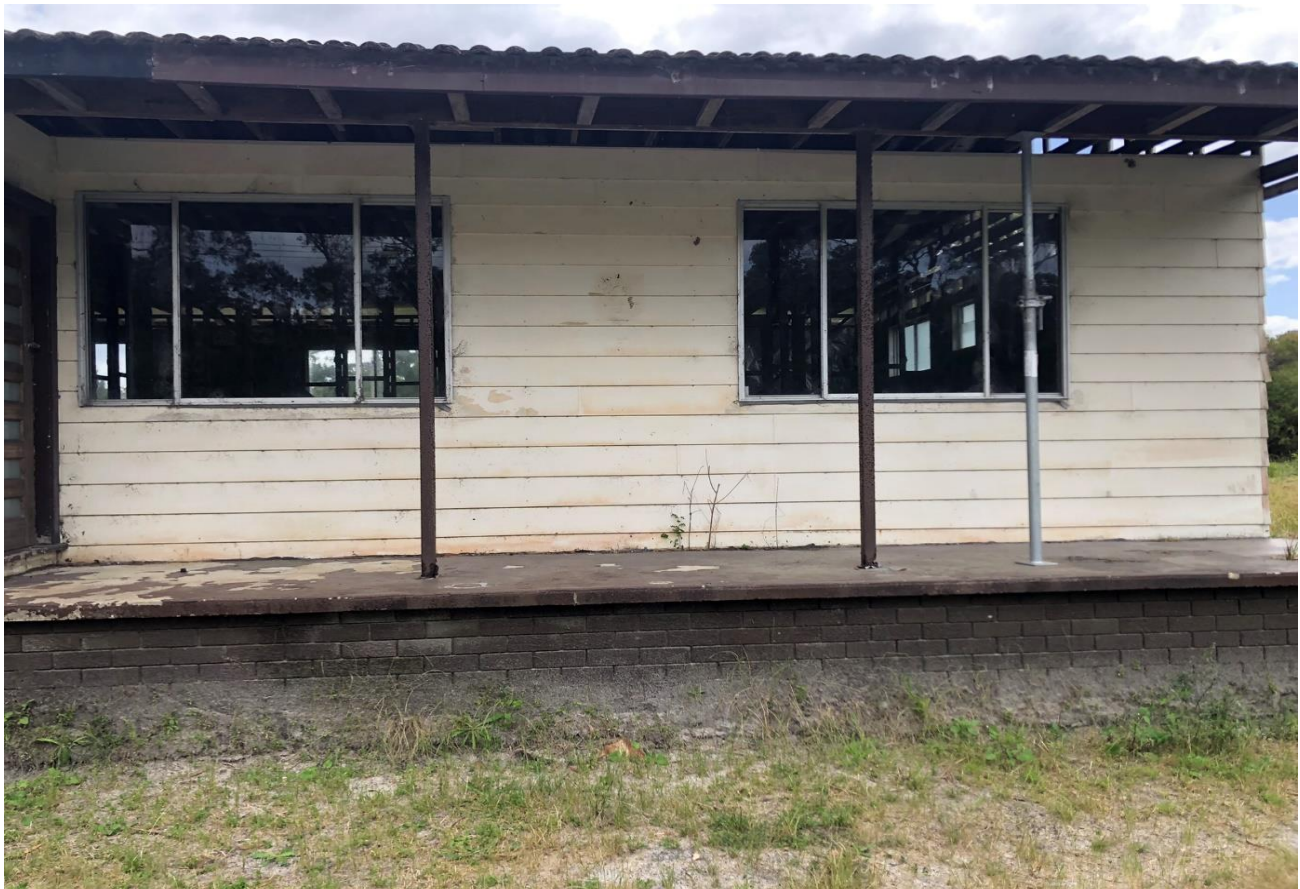
- A dilapidated residential dwelling was observed in the south western portion of the lot. The building was observed to have been constructed with fibre cement cladding, brick and a tile roof. The eave lining and internal walls had been removed from the building. Fragments of potential Asbestos Containing Materials (PACM) were observed beneath the building (see Photograph 24).

Photograph 24 - Residential dwelling - 4045 Nelson Bay Road

| AEC | COPC | Likelihood of Contamination | Mechanism of Contamination | Potentially Affected Media | Human & Ecological Receptors | Potential mechanisms of exposure | Potential & Complete Exposure Pathways | Comments |
|---|---|---|--|---|---|--|--|---|
| 1. Current and former buildings across the site. <ul style="list-style-type: none"> Weathering of potentially hazardous materials (asbestos, lead paint, galvanised metals) Use of pesticides around building Demolition of structures over time | Metals, Asbestos, OCPs | Medium to High | <ul style="list-style-type: none"> Top-down leaks/spills, flakes/fibres onto soil. Leaching of soil contaminants to surface water and groundwater. | <ul style="list-style-type: none"> Surface Soils Surface water Groundwater Sediments | <ul style="list-style-type: none"> Current site visitors Future construction workers & site users Soil biota/plants and transitory wildlife Surface and ground water depended ecosystems Offsite surface water – unnamed swamp, located 200m north of the site. Offsite groundwater discharge point – Bobs Farm Creek located approximately 800m north of the site or Tiligerry Creek, located approximately 2.2km north of the site. | <ul style="list-style-type: none"> Direct dermal contact with contaminated soil and/or surface water Ingestion of contaminated soil and/or surface water Inhalation of asbestos fibres, or contaminated soil (as dust) Leaching of soil contaminants to surface water and/or groundwater Surface water discharge to unnamed swamp, located 200m north of the site and potential groundwater discharge to Bobs Farm Creek or Tiligerry Creek located approximately 0.8km to 2.2km north of the site. | <ul style="list-style-type: none"> Potentially complete exposure pathway for current site visitors, future construction workers and site users. Potentially complete exposure pathway for ecological receptors. Potentially complete exposure pathway for soil contaminants to leach to surface water. Potentially complete exposure pathway for soil contaminants to leach to groundwater due to sandy soils. | Exposure pathways would be incomplete if soils are found to not be contaminated via sampling & analysis. It is recommended that a Hazardous Materials Survey is carried out on the existing site building. |

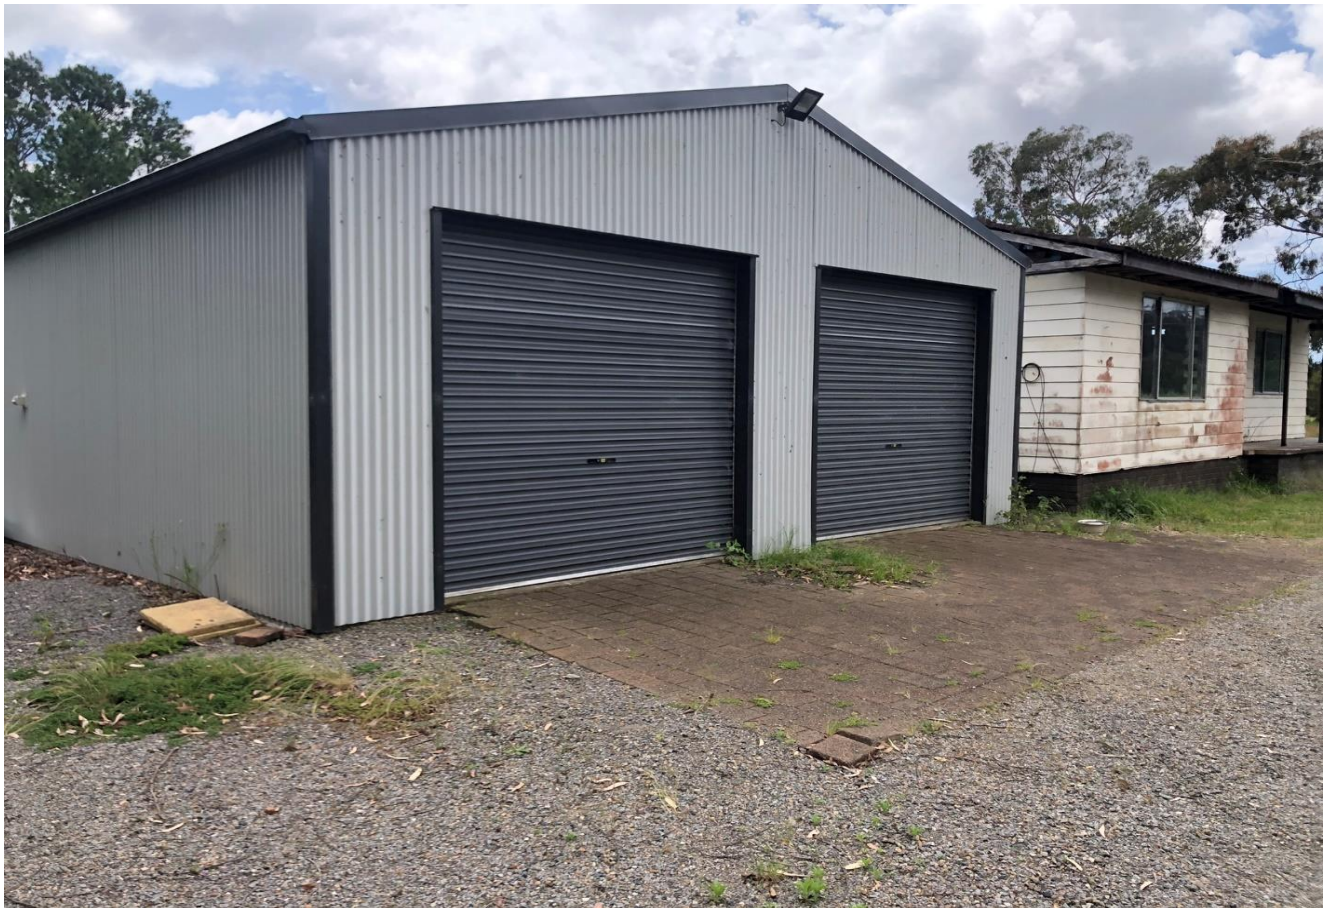
- A shed (Shed 3) was observed to the west of the residential dwelling. The shed was observed to be in good condition on a concrete slab. No access was provided to the shed at the time of the site inspection. Two PVC water tanks were observed to the north of the shed (see Photograph 25).

Photograph 25 - Shed 3 - 4045 Nelson Bay Road

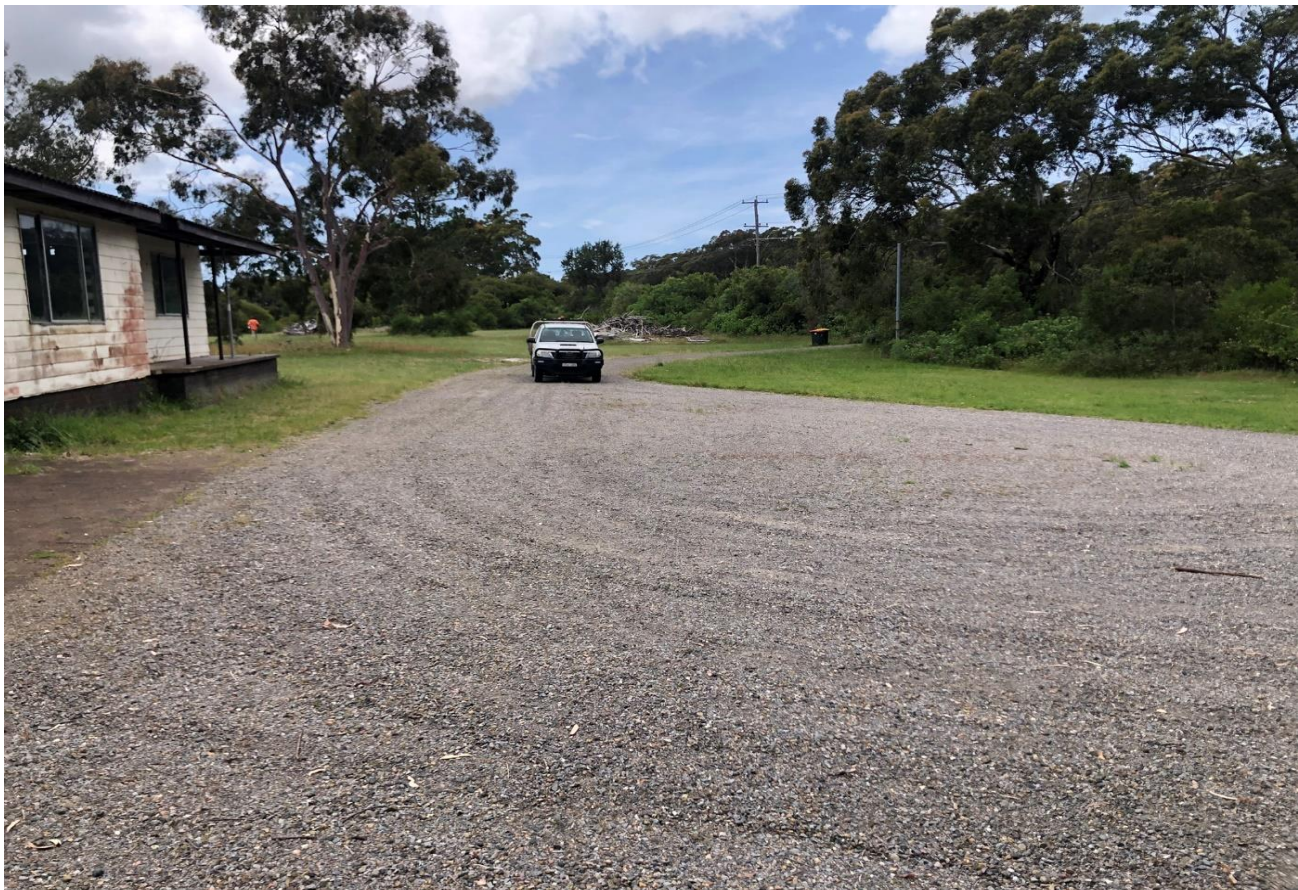
- A gravel driveway was observed to the south of the shed, entering from Nelson Bay Road (see Photograph 26).
- A hose and possible groundwater bore pump was observed to the north east of the residential dwelling (see Photograph 27).

Photograph 26 - Gravel driveway - 4045 Nelson Bay Road

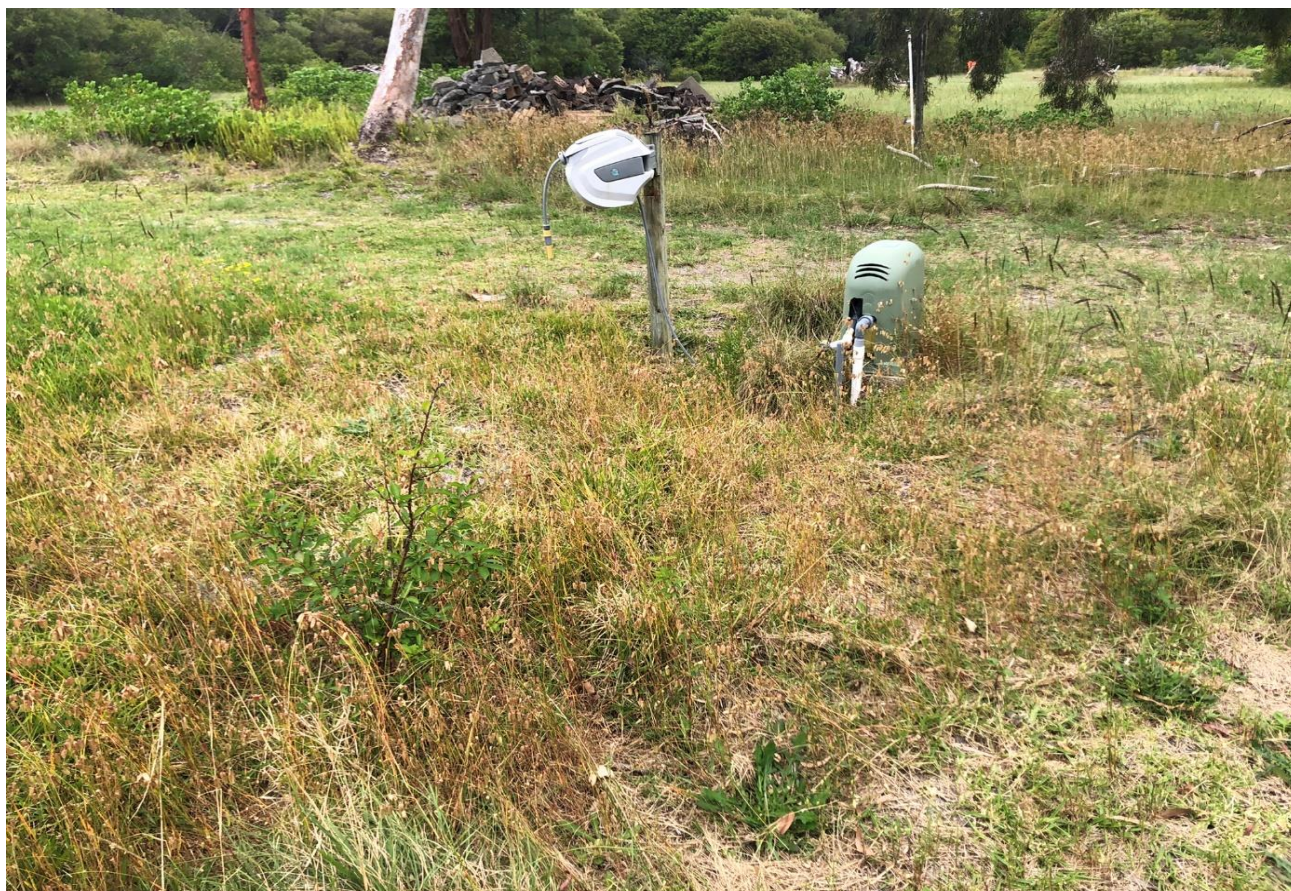
Photograph 27 - Hose and potential groundwater bore pump - 4045 Nelson Bay Road

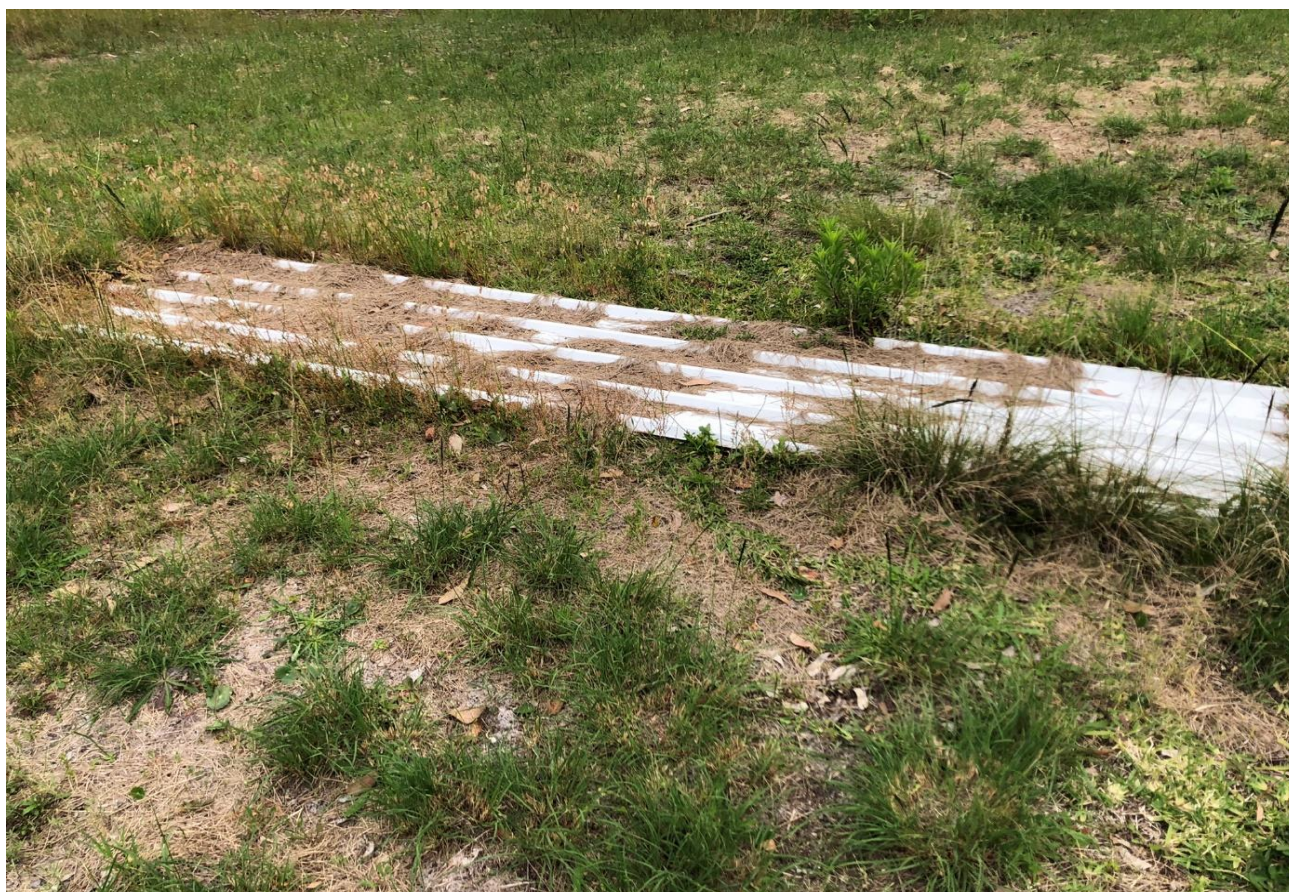
- A stockpile of gravel and carpet (SP5) (<2m³) and metal sheets were observed to the north of the residential dwelling (see Photographs 28).
- A waste storage area of plastic and metals was observed in the north western portion of the lot and a stockpile (SP6) (approx. 30m³) of concrete bricks and tiles were observed to the east of the residential dwelling (see Photographs 29 and 30).

Photograph 28 - Metal Storage - 4045 Nelson Bay Road

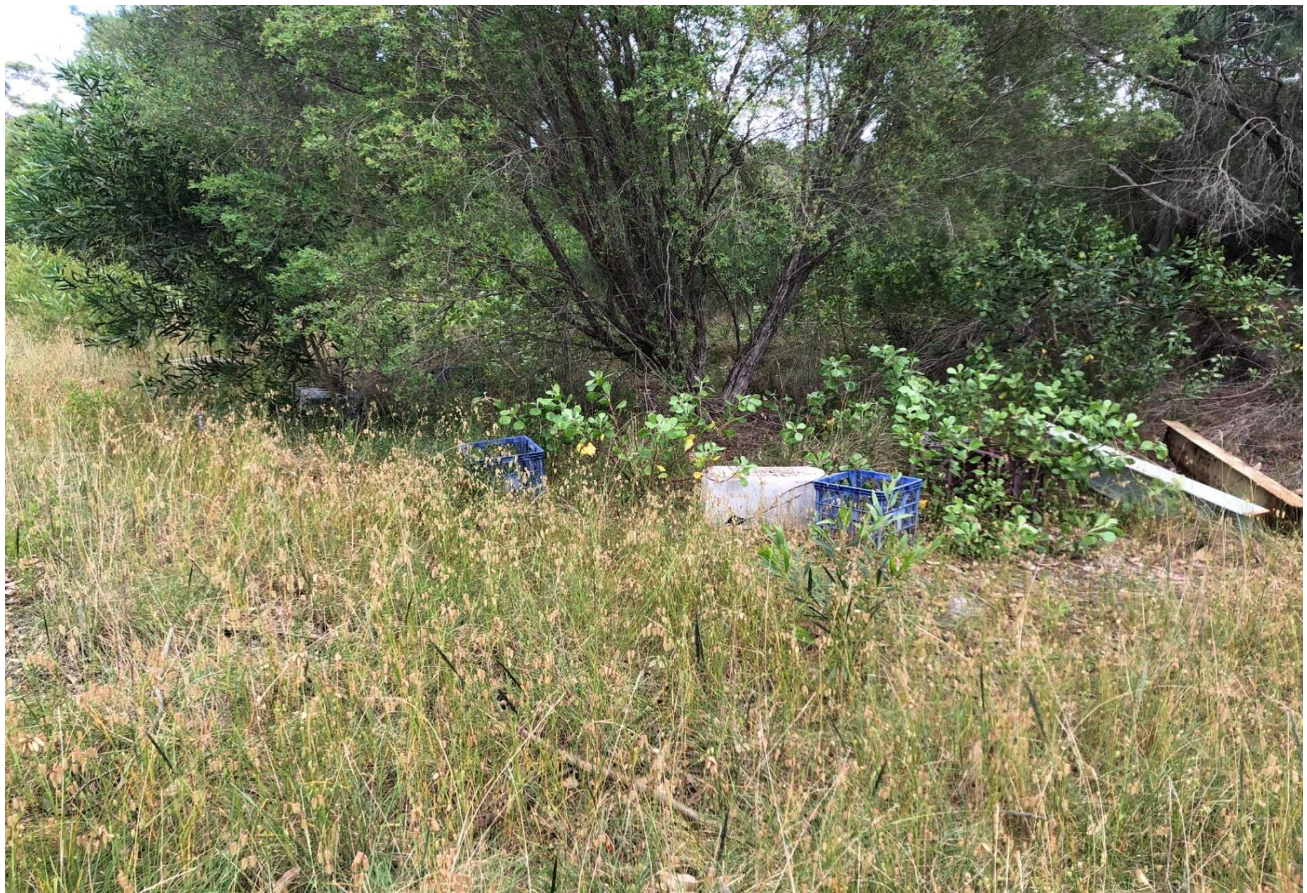
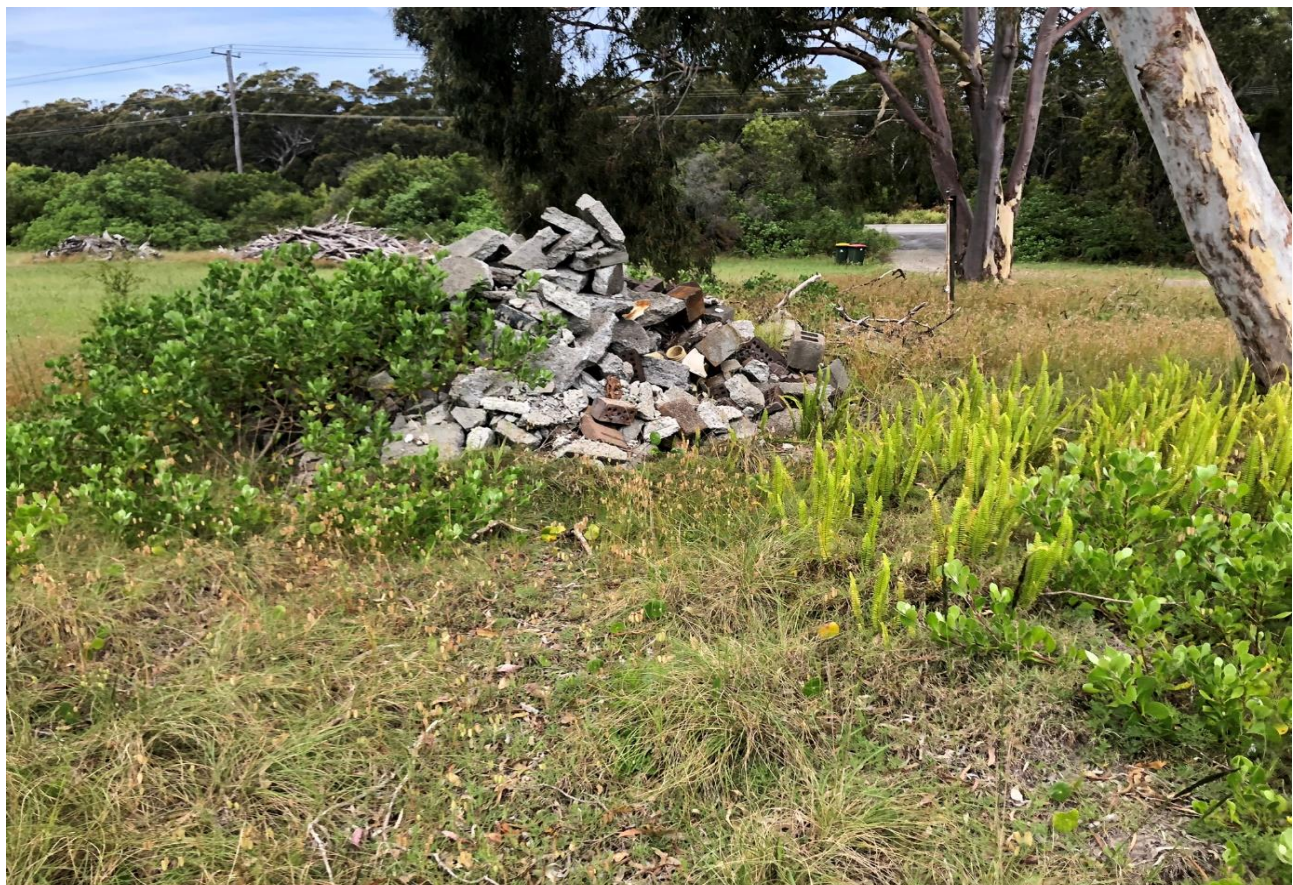
Photograph 29 - Waste storage area - 4045 Nelson Bay Road

Photograph 30 - SP6 - 4045 Nelson Bay Road

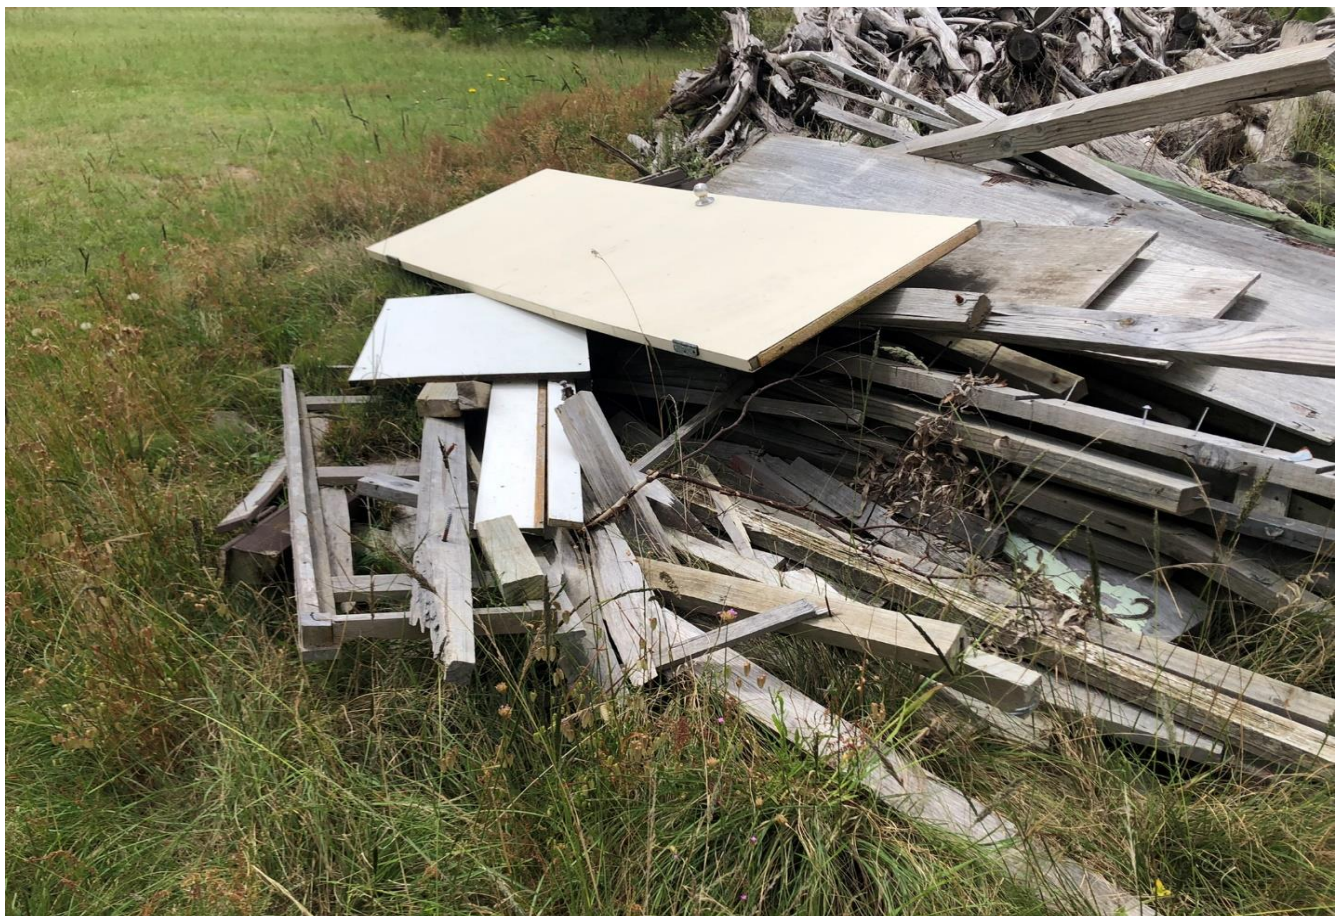
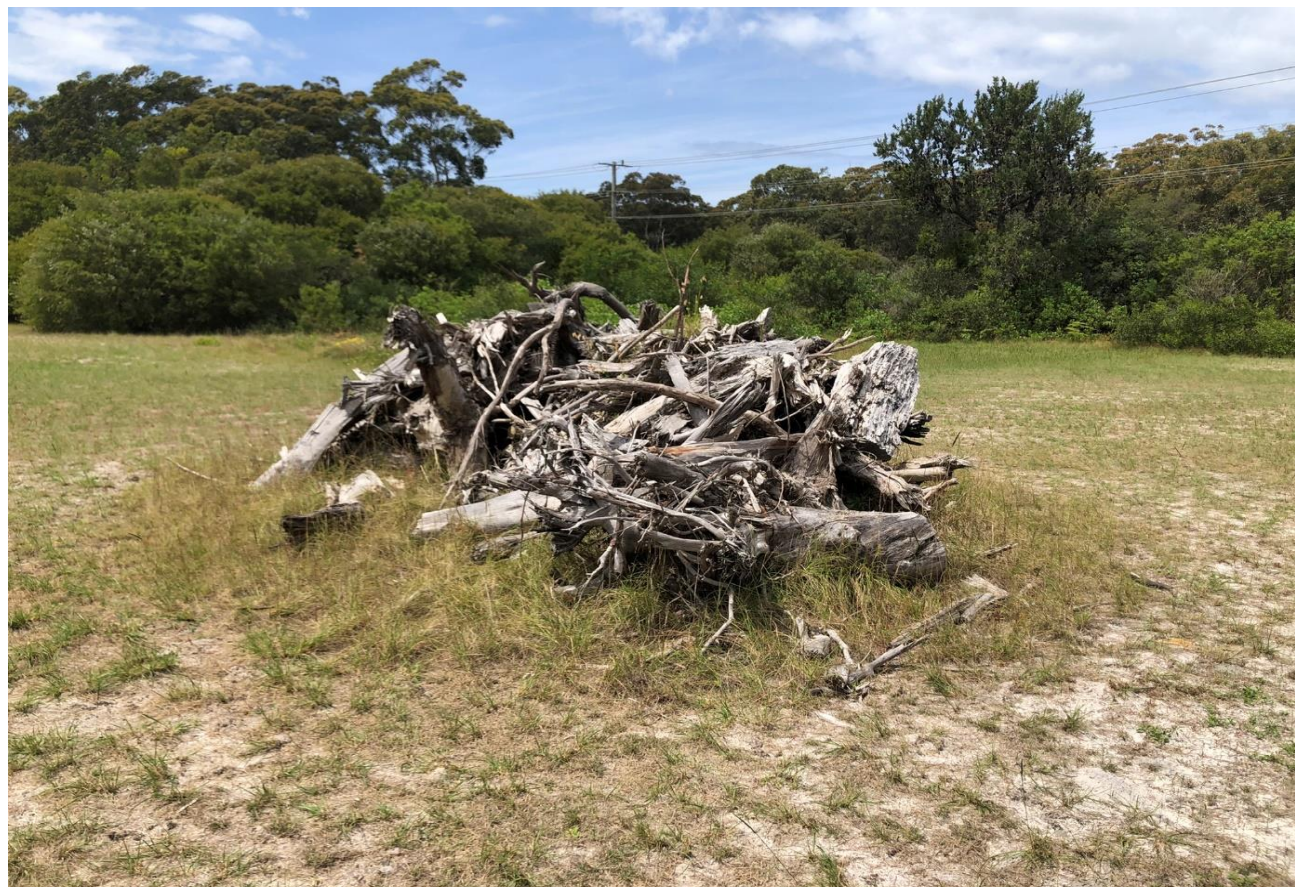
- A stockpile (SP7) of timber pallets/timber doors was observed in the central south of the lot. Stockpiles of fallen trees were also observed adjacent to SP7 and in the central portion of the lot (See Photographs 31 and 32).

Photograph 31 - SP7 - 4045 Nelson Bay Road

Photograph 30 - Tree/vegetation stockpiles - 4045 Nelson Bay Road
