Report on  
Geotechnical Assessment

Gilead Rezoning  
Gilead, NSW

Prepared for  
Lendlease Communities (Figtree Hill) Pty Limited

Project 76649.31  
June 2022

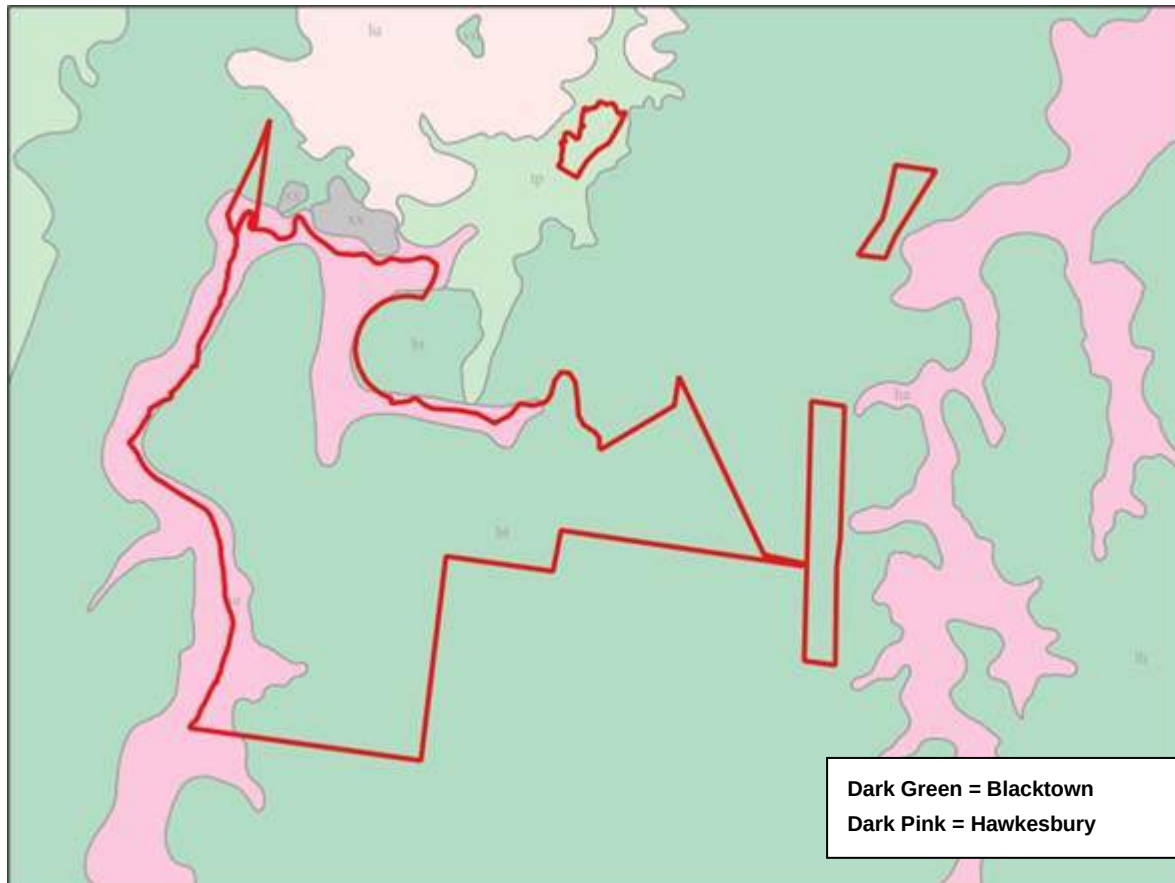
**Figure 2: Soil Landscapes**

Mapping indicates that most of the site comprises soils of the Blacktown soil landscape (mapping unit bt), which is characterised by topography of gently undulating rises on Wianamatta Group Shale, with local relief to 30 m and slopes usually less than 5%, typically represented by broad rounded crests and ridges with gently inclined slopes. This is a residual soil landscape, which the mapping indicates comprises multiple soil horizons that range from shallow red-brown podzolic soils comprising mostly

clayey soils on crests and upper slopes, to deep brown to yellow clay soils on mid to lower slopes and in areas of poor drainage. These soils are typically of low fertility, are moderately reactive, highly plastic and generally have a low wet strength.

Whilst the Blacktown soil group is typically associated with Wianamatta shales on this site, it is mapped as overlying the Hawkesbury Sandstone. This is common at the interface zones between the shale and the sandstone.

Soil conditions were relatively uniform across the site and were generally as indicated by the soil landscape map (refer Figure 2). Sandstone was present at lower elevations about the site perimeter, whereas shales were present in the central, elevated areas of the site. This is consistent with the geology map for the site (refer Figure 1).

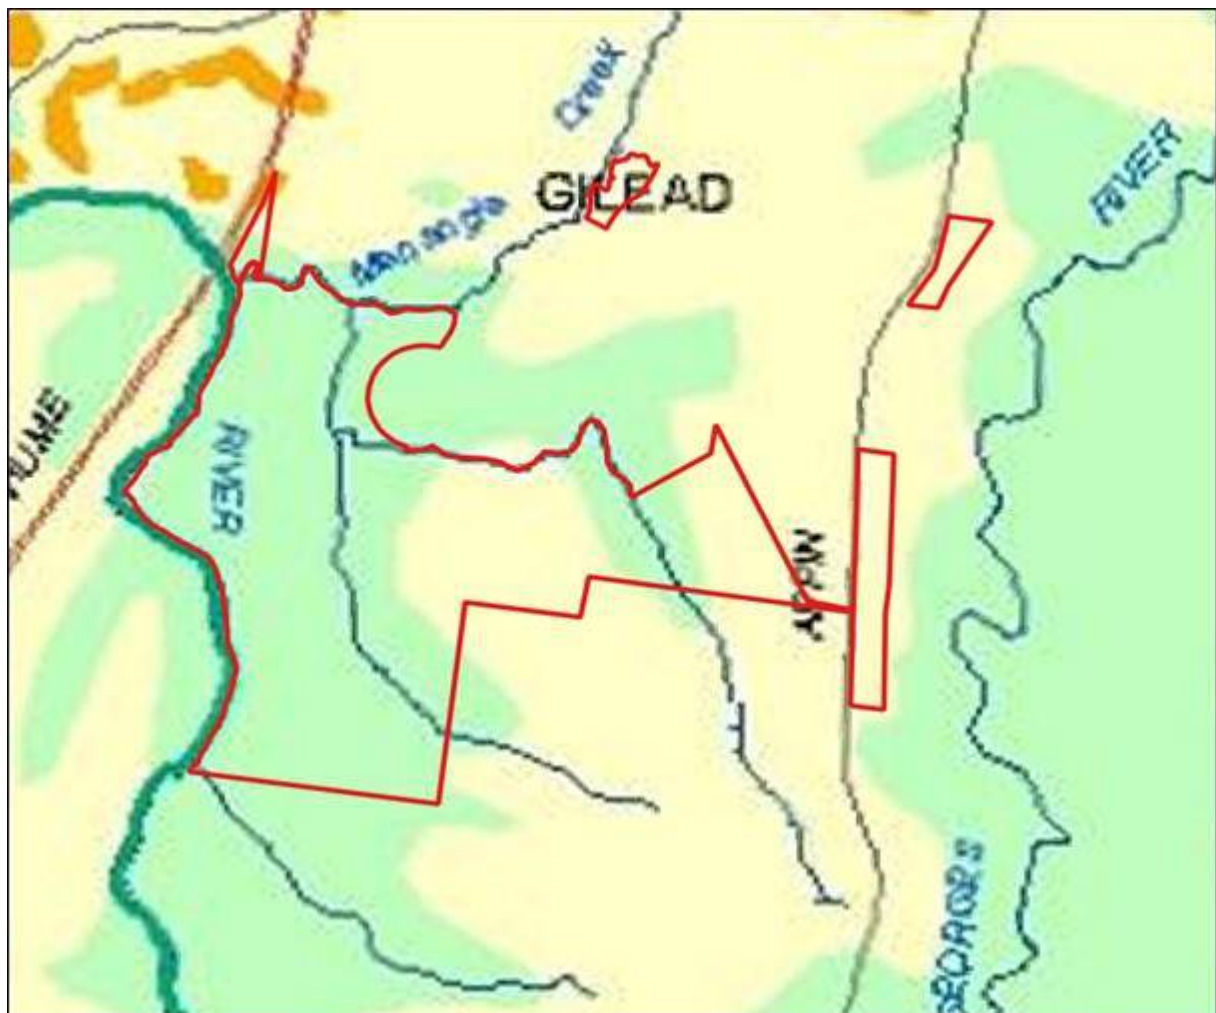
Figure 4: Western Sydney Salinity Potential

The former Department of Environment Climate Change (DECC), now the NSW Environment Protection Authority (EPA), infers a low salinity potential for the site on their salinity hazard map extracted from the Soil and Land Resources of the Hawkesbury Nepean Catchment (DECC 2008) (Ref 4). The mapping is based on soil type, surface level and general groundwater considerations but is not generally ground-truthed, hence actual soil salinity needs to be assessed to confirm the DECC potential salinity mapping indication.

Approximate salinity potential boundaries, as shown on the salinity potential map, are shown on Figure 4.
