## Detailed Investigation

Lachley Estate,

Forbes, NSW, 2871

Report No: 26835R01

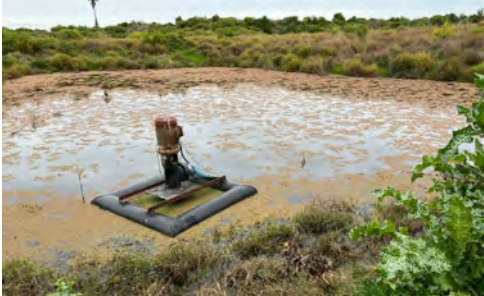
<b>DS/W1</b>  Dry settling pond - No Standing Water Organic dark soil Dark silty settled Material sodium Organic burnt silt?  Soil Sample

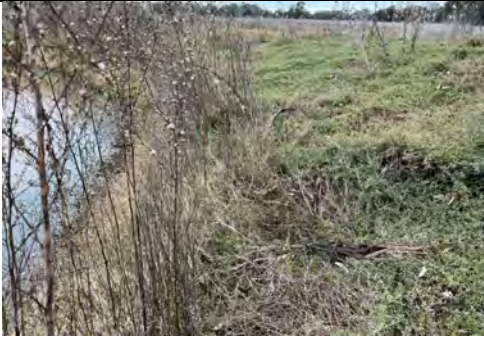
<b>FD5</b>  Overgrown damn, Low lying swamp area around damn, Lots of good vegetation  Burnt out car in swampy area near FD5  Clay excavated down

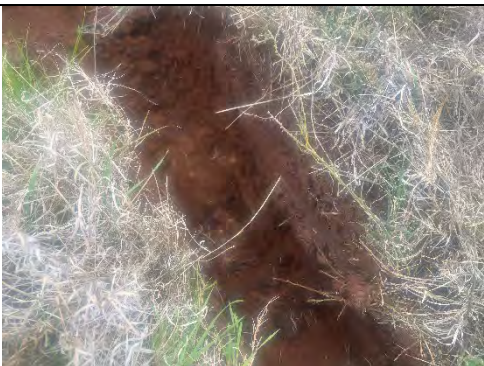
33° 20.900'S, 148° 1.733'E	Landfill Area – south west of landfill edge	<b>TP1</b> Natural Orange Brown Sandy Clay
28/07/2022

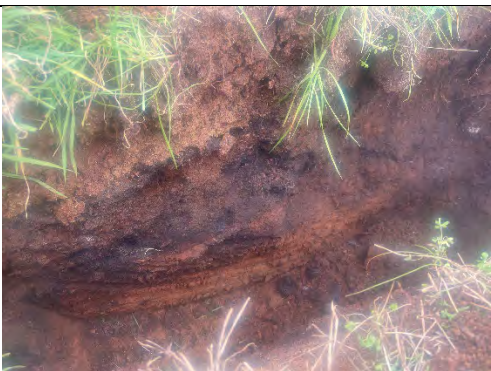
33° 20.899'S, 148° 1.745'E	Landfill Area – natural material encountered at approximately 0.7m bgs	<b>TP2</b> Side profile of test pit indicating uncontrolled fill (including ACM Fragments) and waste materials overlying natural orange brown clay

Deeper excavation undertaken in the north of the site within the former landfill area, indicated that landfill to depths greater than 2m was present in this area. Four test pits (TP1 to TP4) were excavated in this area and samples were collected at varying depths. TP1 and TP2 encountered natural materials at surface and at 0.7m bgs respectively. TP3 and TP4 did not encounter natural materials due to hole collapse greater than 2m below surface. Traces of asbestos debris were collected at locations TP2, TP3 and TP4, these suspect asbestos containing materials were analysed and found to contain chrysotile, amosite, and crocidolite asbestos (as shown in lab report A26835R1).

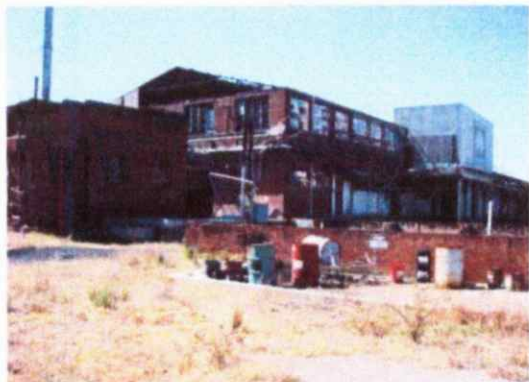
Photograph looking north west over former AST bunded area

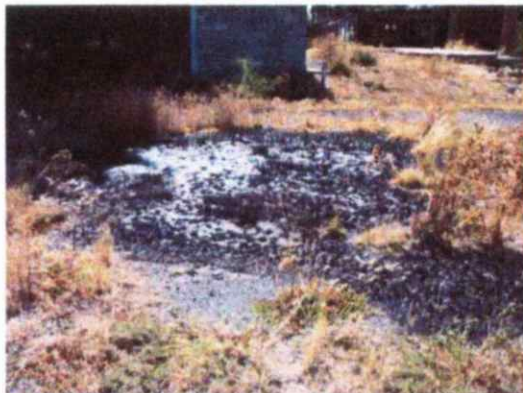
Photograph of staining near the former AST

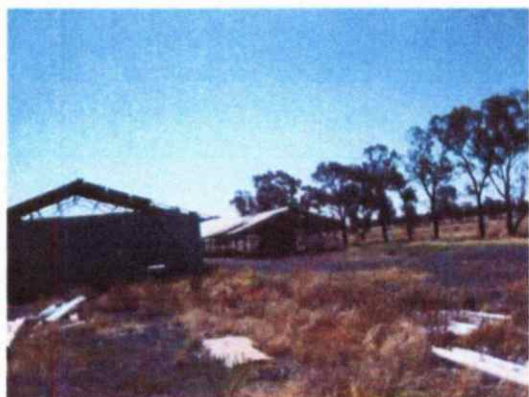
Photograph looking west over skin sheds

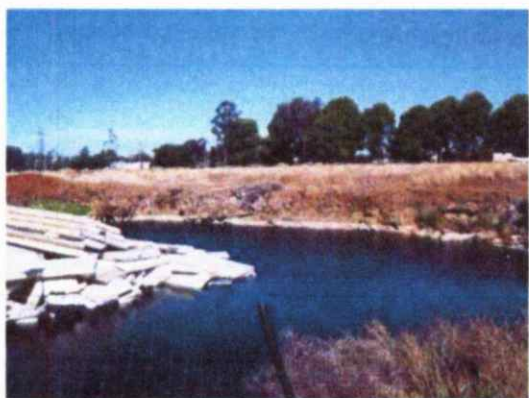
Photograph looking east over former quarry

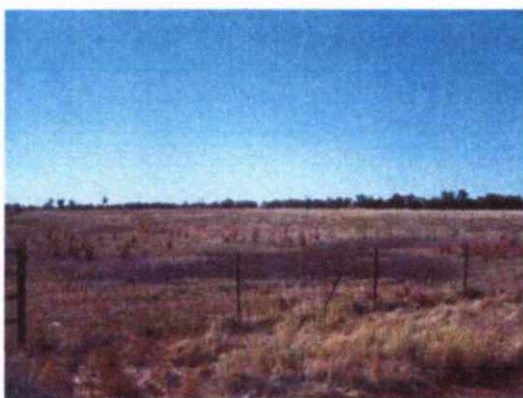
Photograph looking north west over area of salinity
