Preliminary Site Investigation:
Tallowood Stage 2, Proposed
Residential Development
21 Vincents Road, Kurrajong, NSW

P2007700JR05V01
September 2020

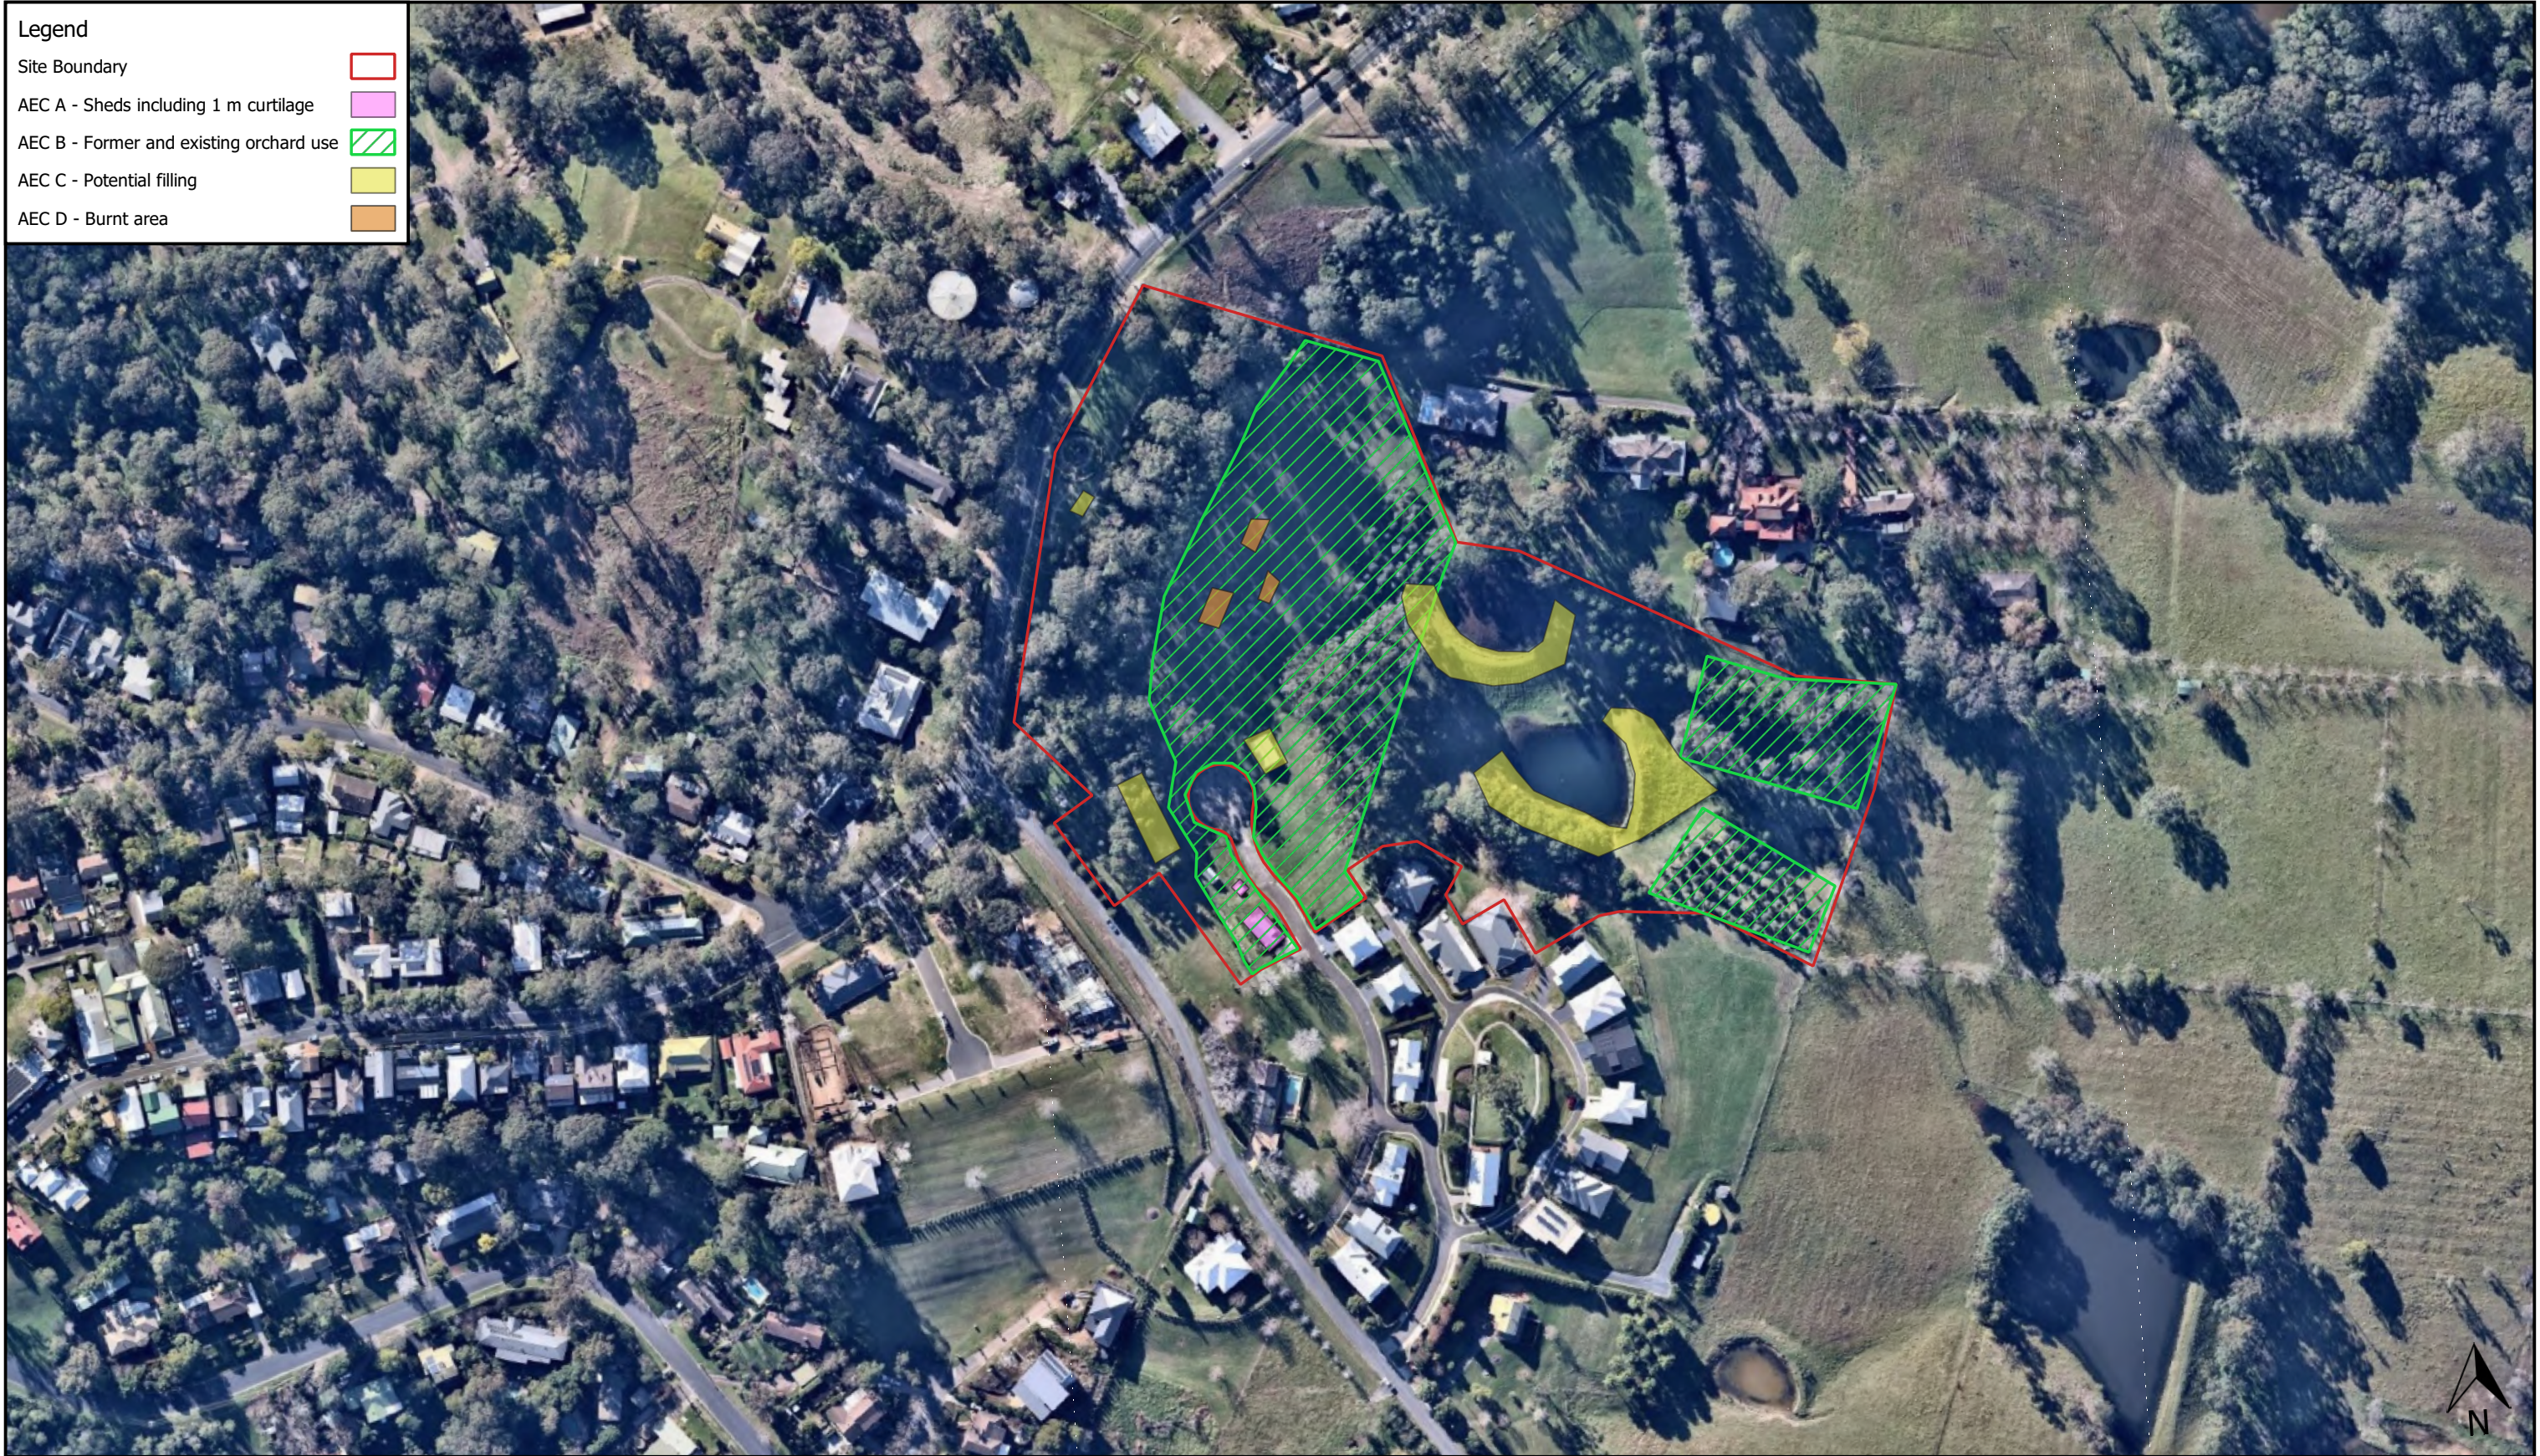
Map Title / Figure:
AEC Map

AEC	Potential for Contamination	COPC
AEC A Sheds including 1 m curtilage	Pesticides and heavy metals may have been used underneath existing sheds for pest control. Building construction may include PACM, zinc treated (galvanised) metals, and lead based paints. Sheds may have previously stored fuels, oils and chemicals.	HM, TRH, BTEXN, PAH, OCP / OPP and asbestos
AEC B Former and existing orchard use	Application of agricultural chemicals, use of pesticides and heavy metals for pest control during site use as rural uses.	HM and OCP / OPP
AEC C Potential filling	Site walkover observations have identified areas where cut and fill activities may have occurred. This process may have introduced fill from unknown origins.	HM, TRH, BTEXN, PAH, OCP / OPP and asbestos
AEC D Burnt areas	Areas where timber, rubbish and other materials may have been burnt may have introduced contamination to the soil.	HM, TRH, BTEXN and PAH

AEC A - Sheds including 1 m curtilage

AEC B - Former and existing orchard use

AEC C - Potential filling

AEC D - Burnt area

To address potential identified AEC and associated COPC, a Detailed Site Investigation (DSI) including intrusive soil sampling and analysis of COPC is recommended.

The DSI is to be developed in accordance with NSW EPA (1995) *Sampling Design Guidelines* and a risk based assessment. Assessment shall address each of the identified AEC and associated COPC identified in Table 5. Results of the site testing shall be assessed against site acceptance criteria (SAC) developed with reference to ASC NEPM (2013).

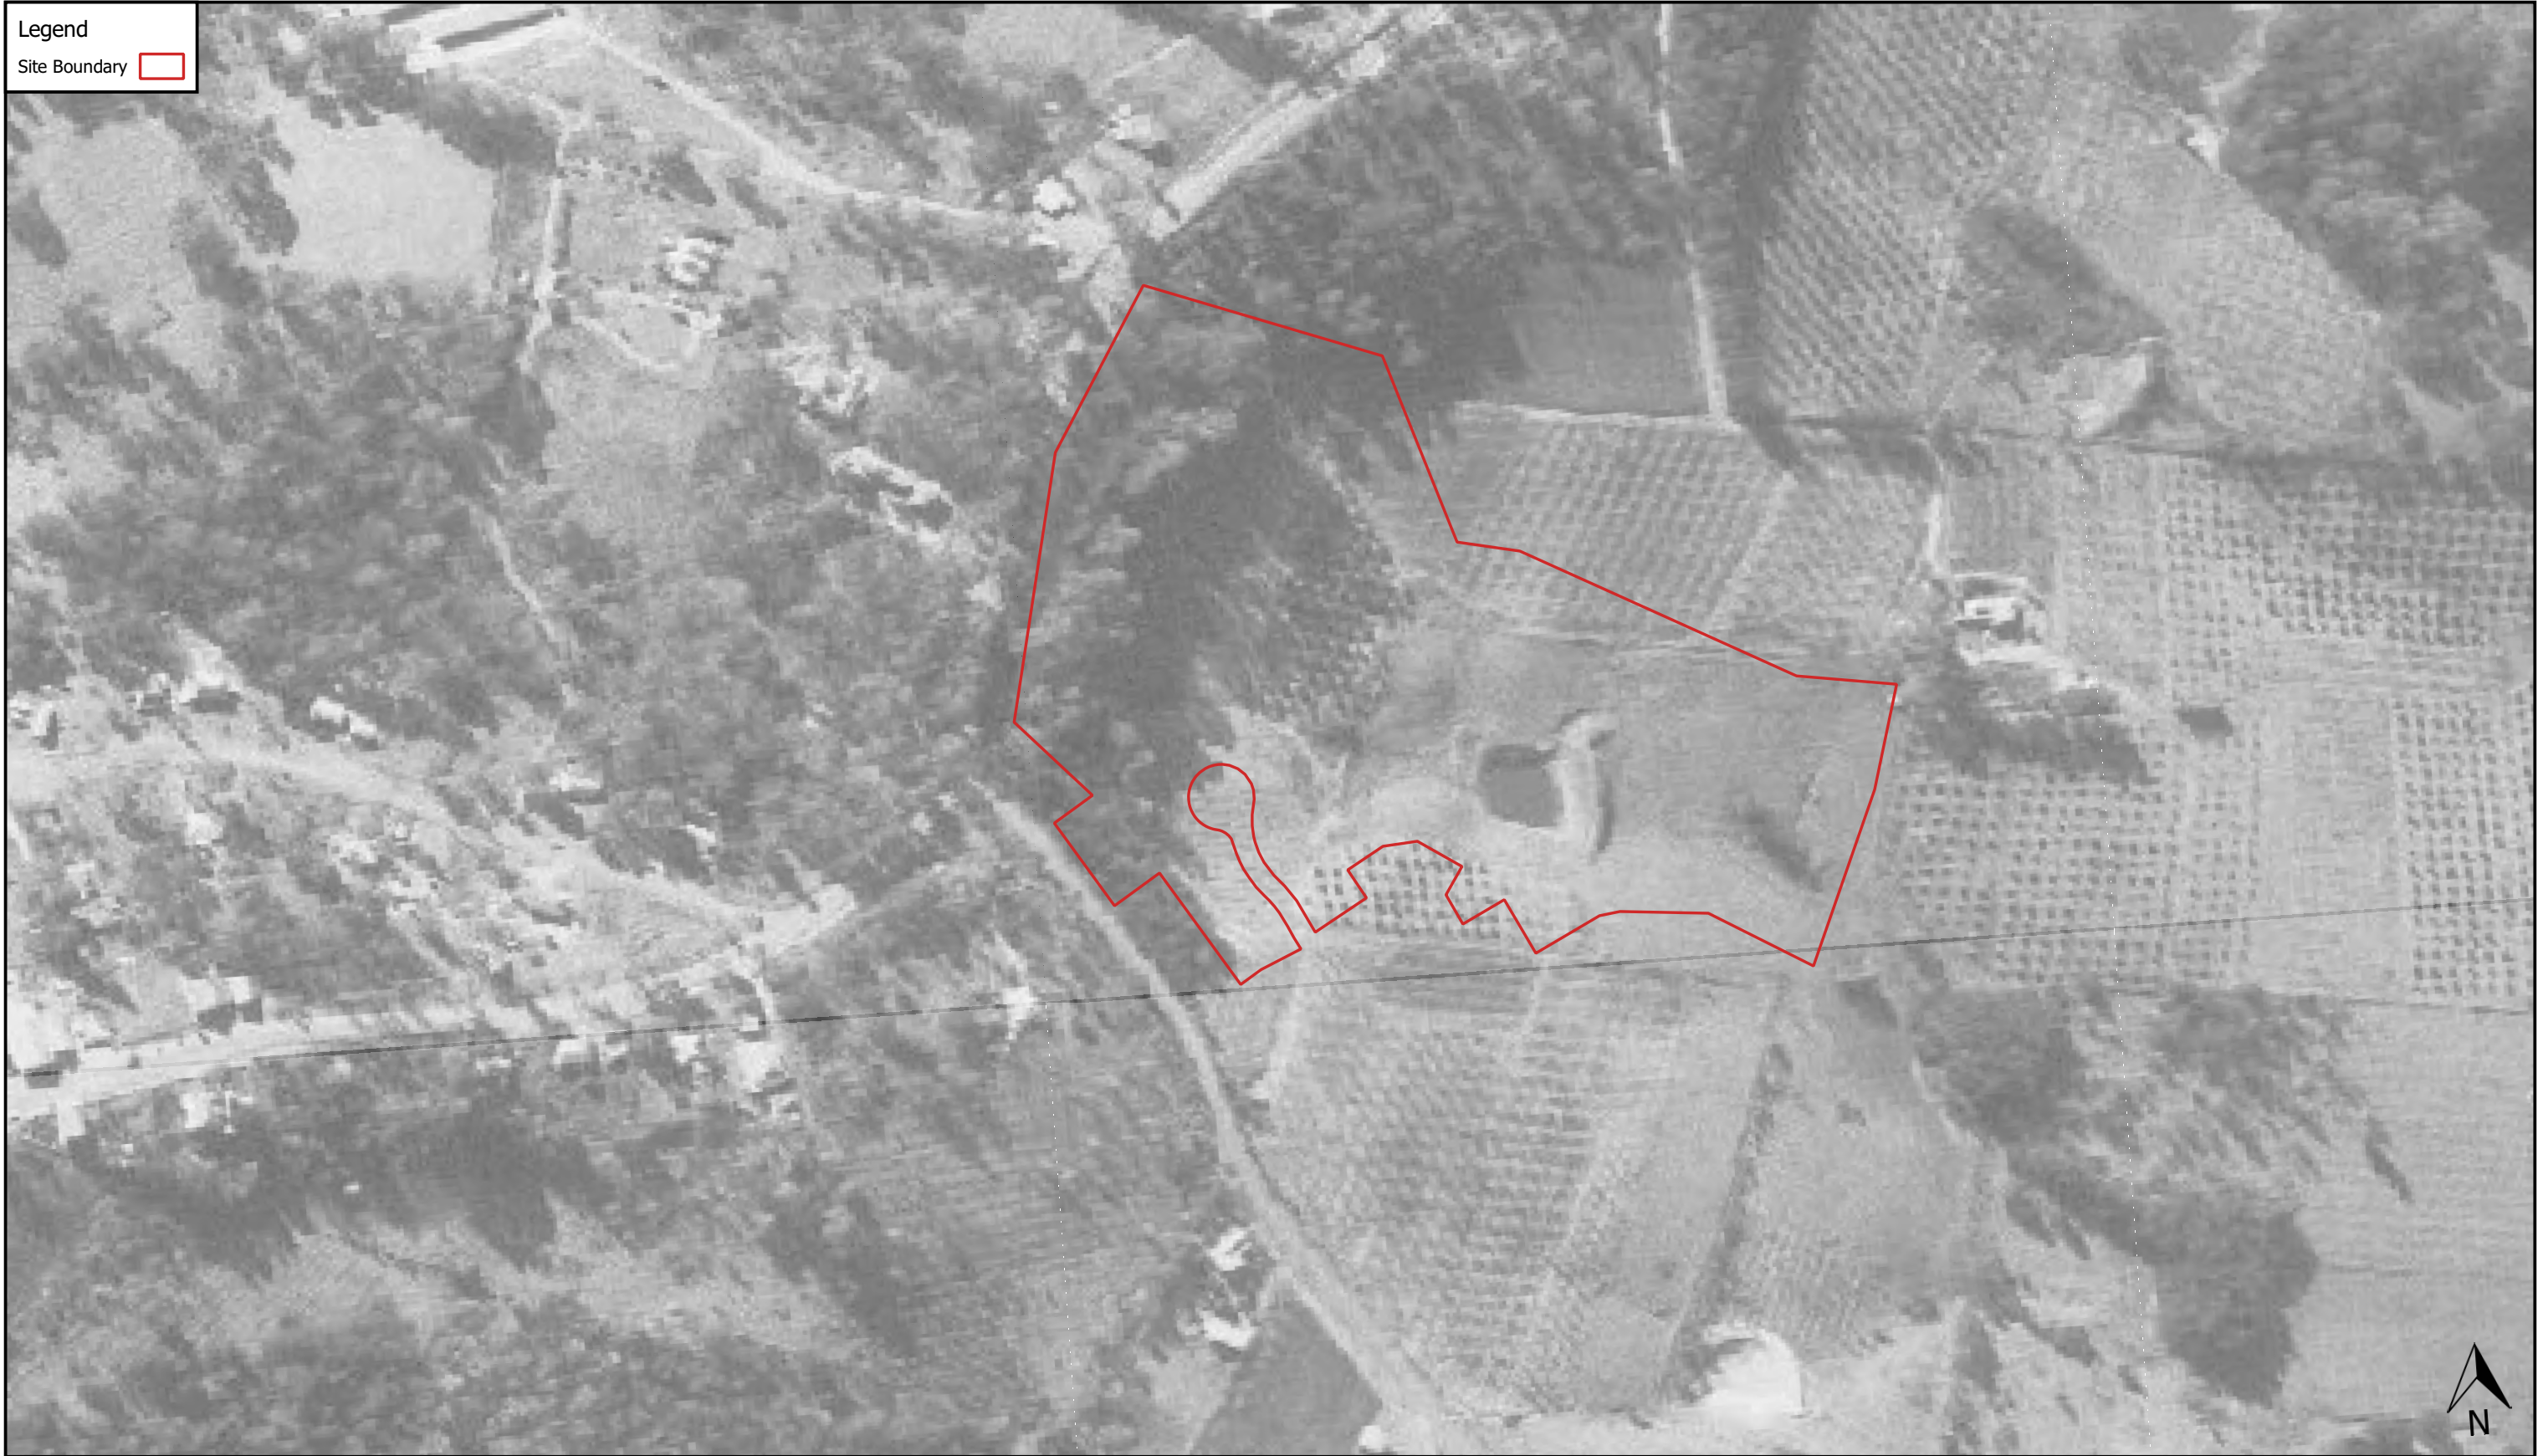
HISTORICAL AERIAL 1966

Year (Source)	Site Activity	Surrounding Land Use
1966 ¹ – 1970 (NSW Government)	Orchards in the north, west and south of the site. The current central dam is visible. No other site infrastructure is visible.	Orchards and rural residential lands in all direction. A dwelling to the northeast of the site.
1978 (NSW Government)	The northern most dam has now been established. Small galvanised steel pump house constructed adjacent to central dam. Little other changes.	A dwelling to the south of the site.
1984 ¹ – 1986 (NSW Government)	Most orchards have been removed and are no longer visible.	Removal of orchards from adjacent lands. Additional shed to the south of the site. Extension of a pool to the existing dwelling to the south side.

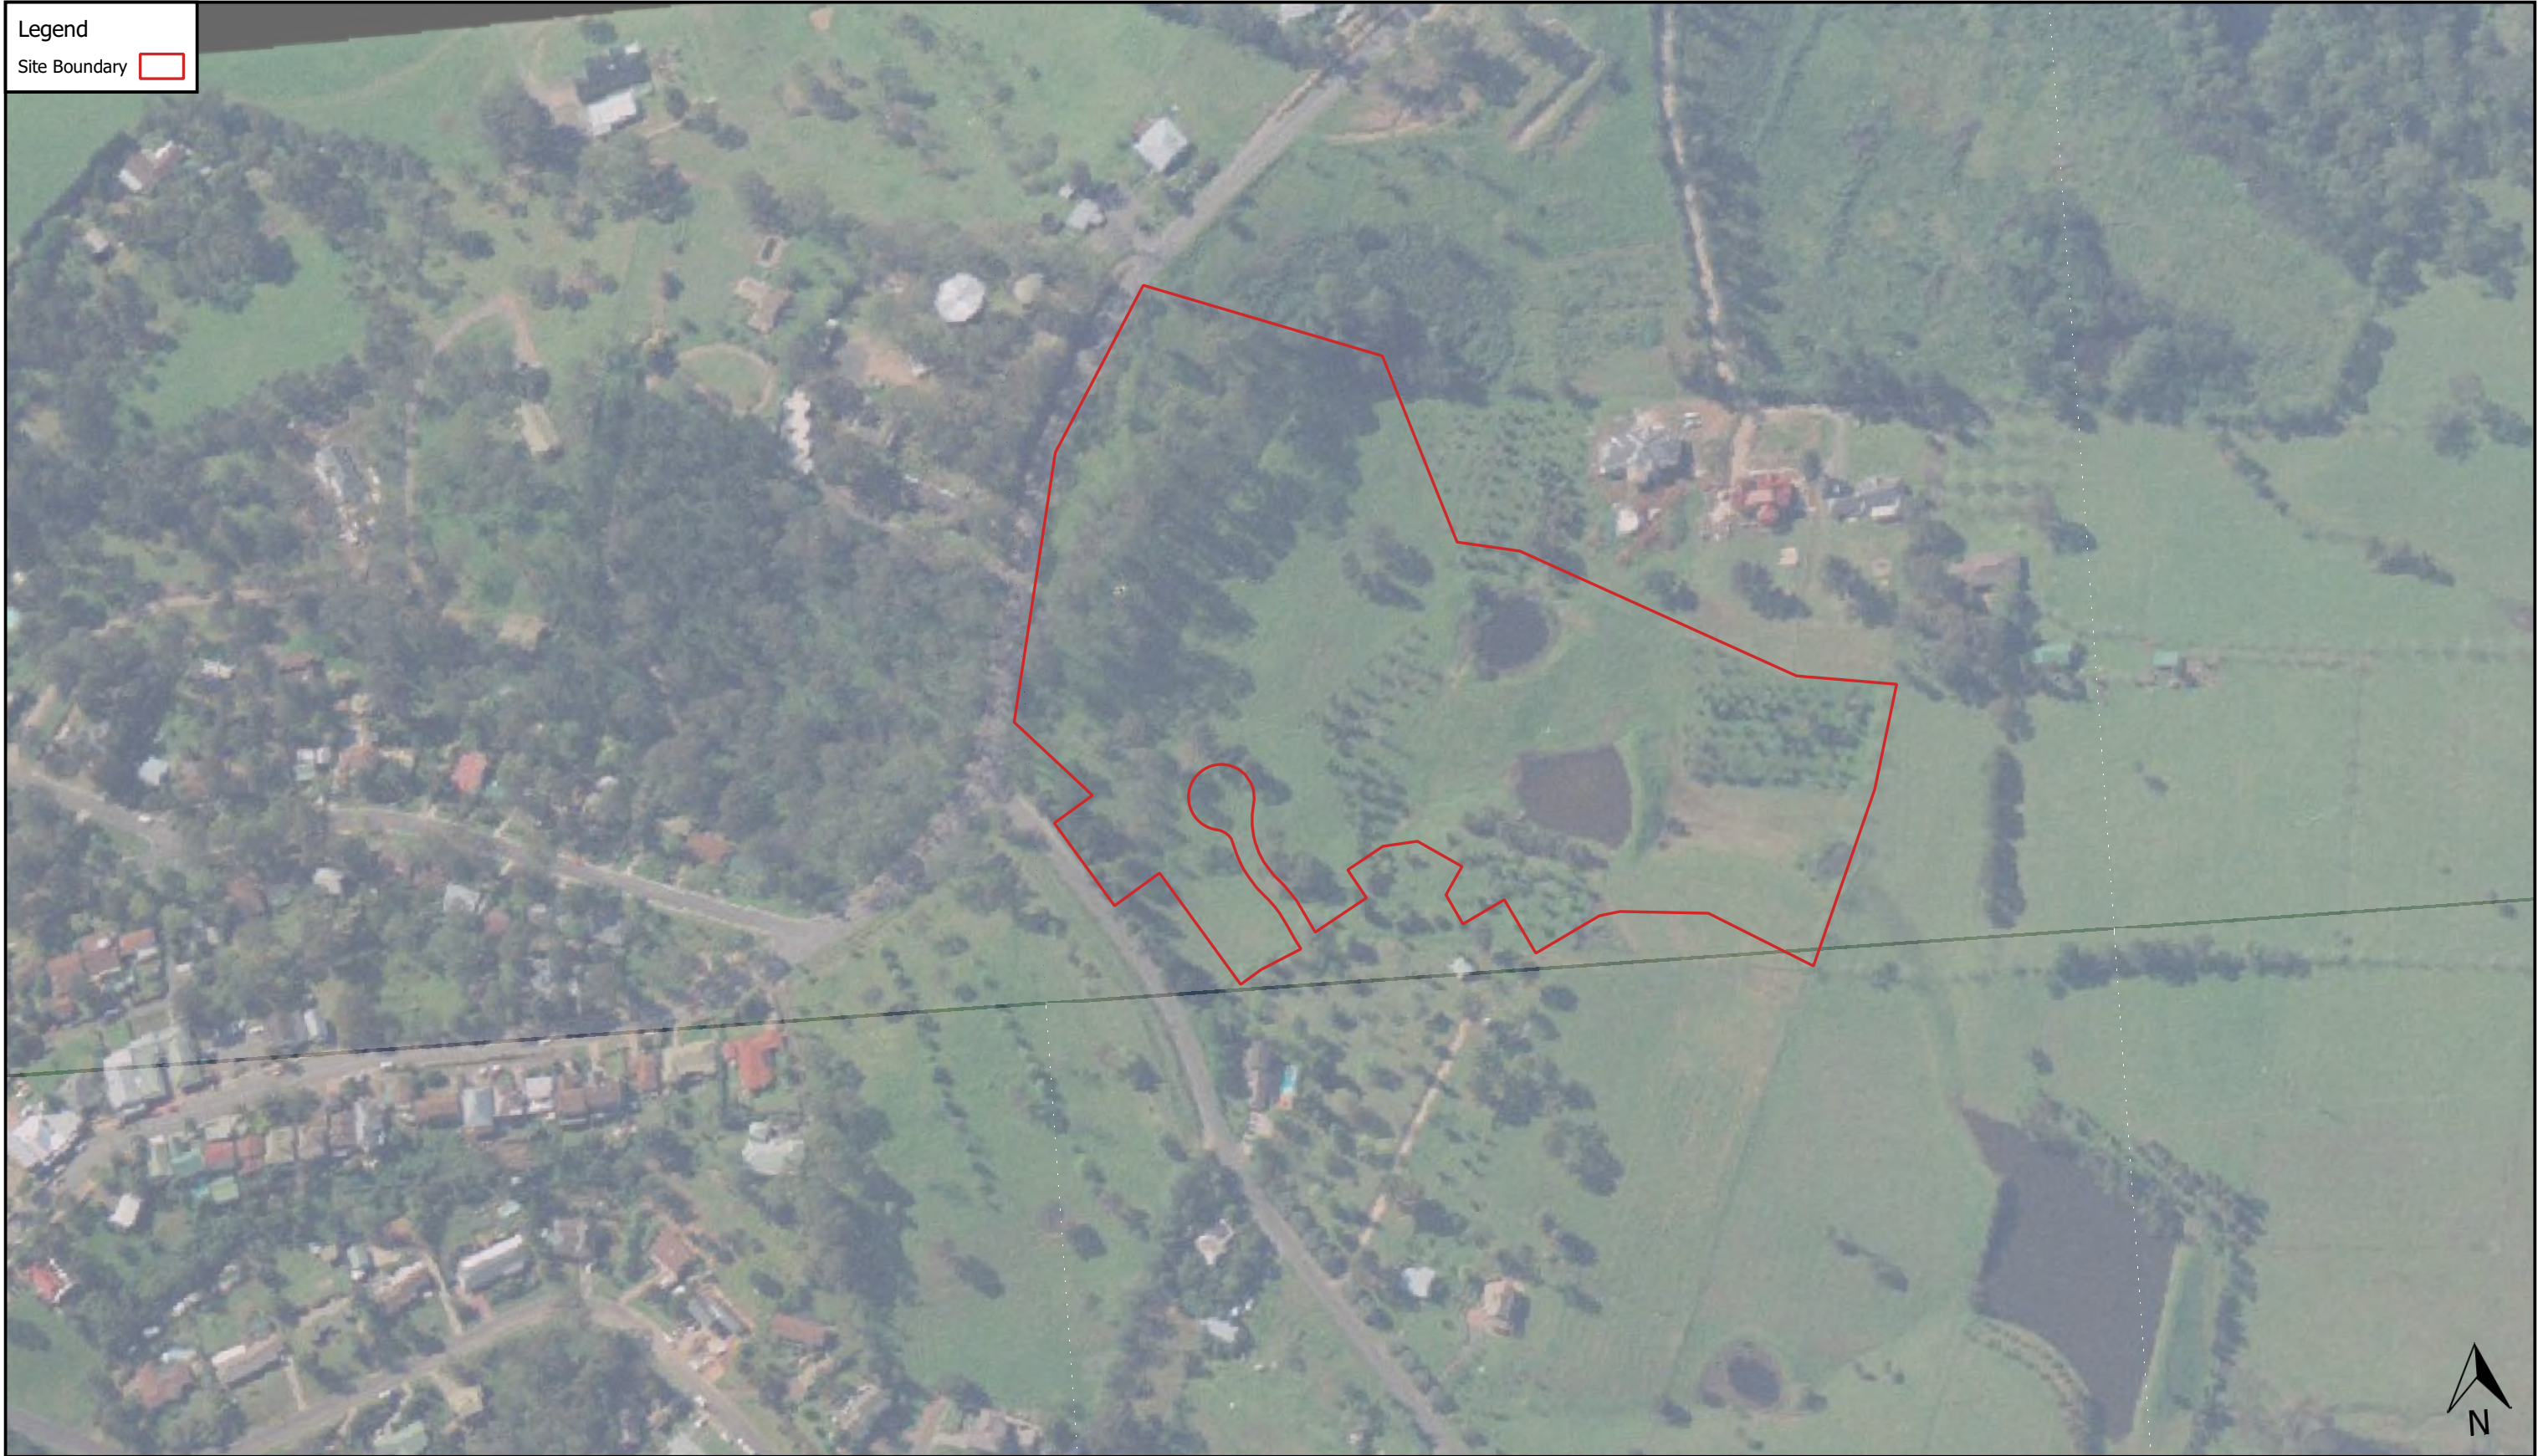
HISTORICAL AERIAL 1998

Year (Source)	Site Activity	Surrounding Land Use
1994 – 1998 (NSW Government)	New orchards observed in the central and eastern portions of the site.	A large dam constructed to the southeast. More construction to the northeast of the site.
2002 – 2005 (NSW Government)	Two sheds (the current large wooden and metal) have been established.	Little to no change from the previous.
2010 (NSW Government)	Vegetation clearing and establishment of the memorial garden along the north west site boundary.	Little to no change from the previous.
2016 – 2020 (NSW Government)	The small shed and chicken coop in south of site adjacent to dwelling are now visible. Row of trees observed on east and northern central areas of the site.	Additional dwellings and earth works to the south of the site.

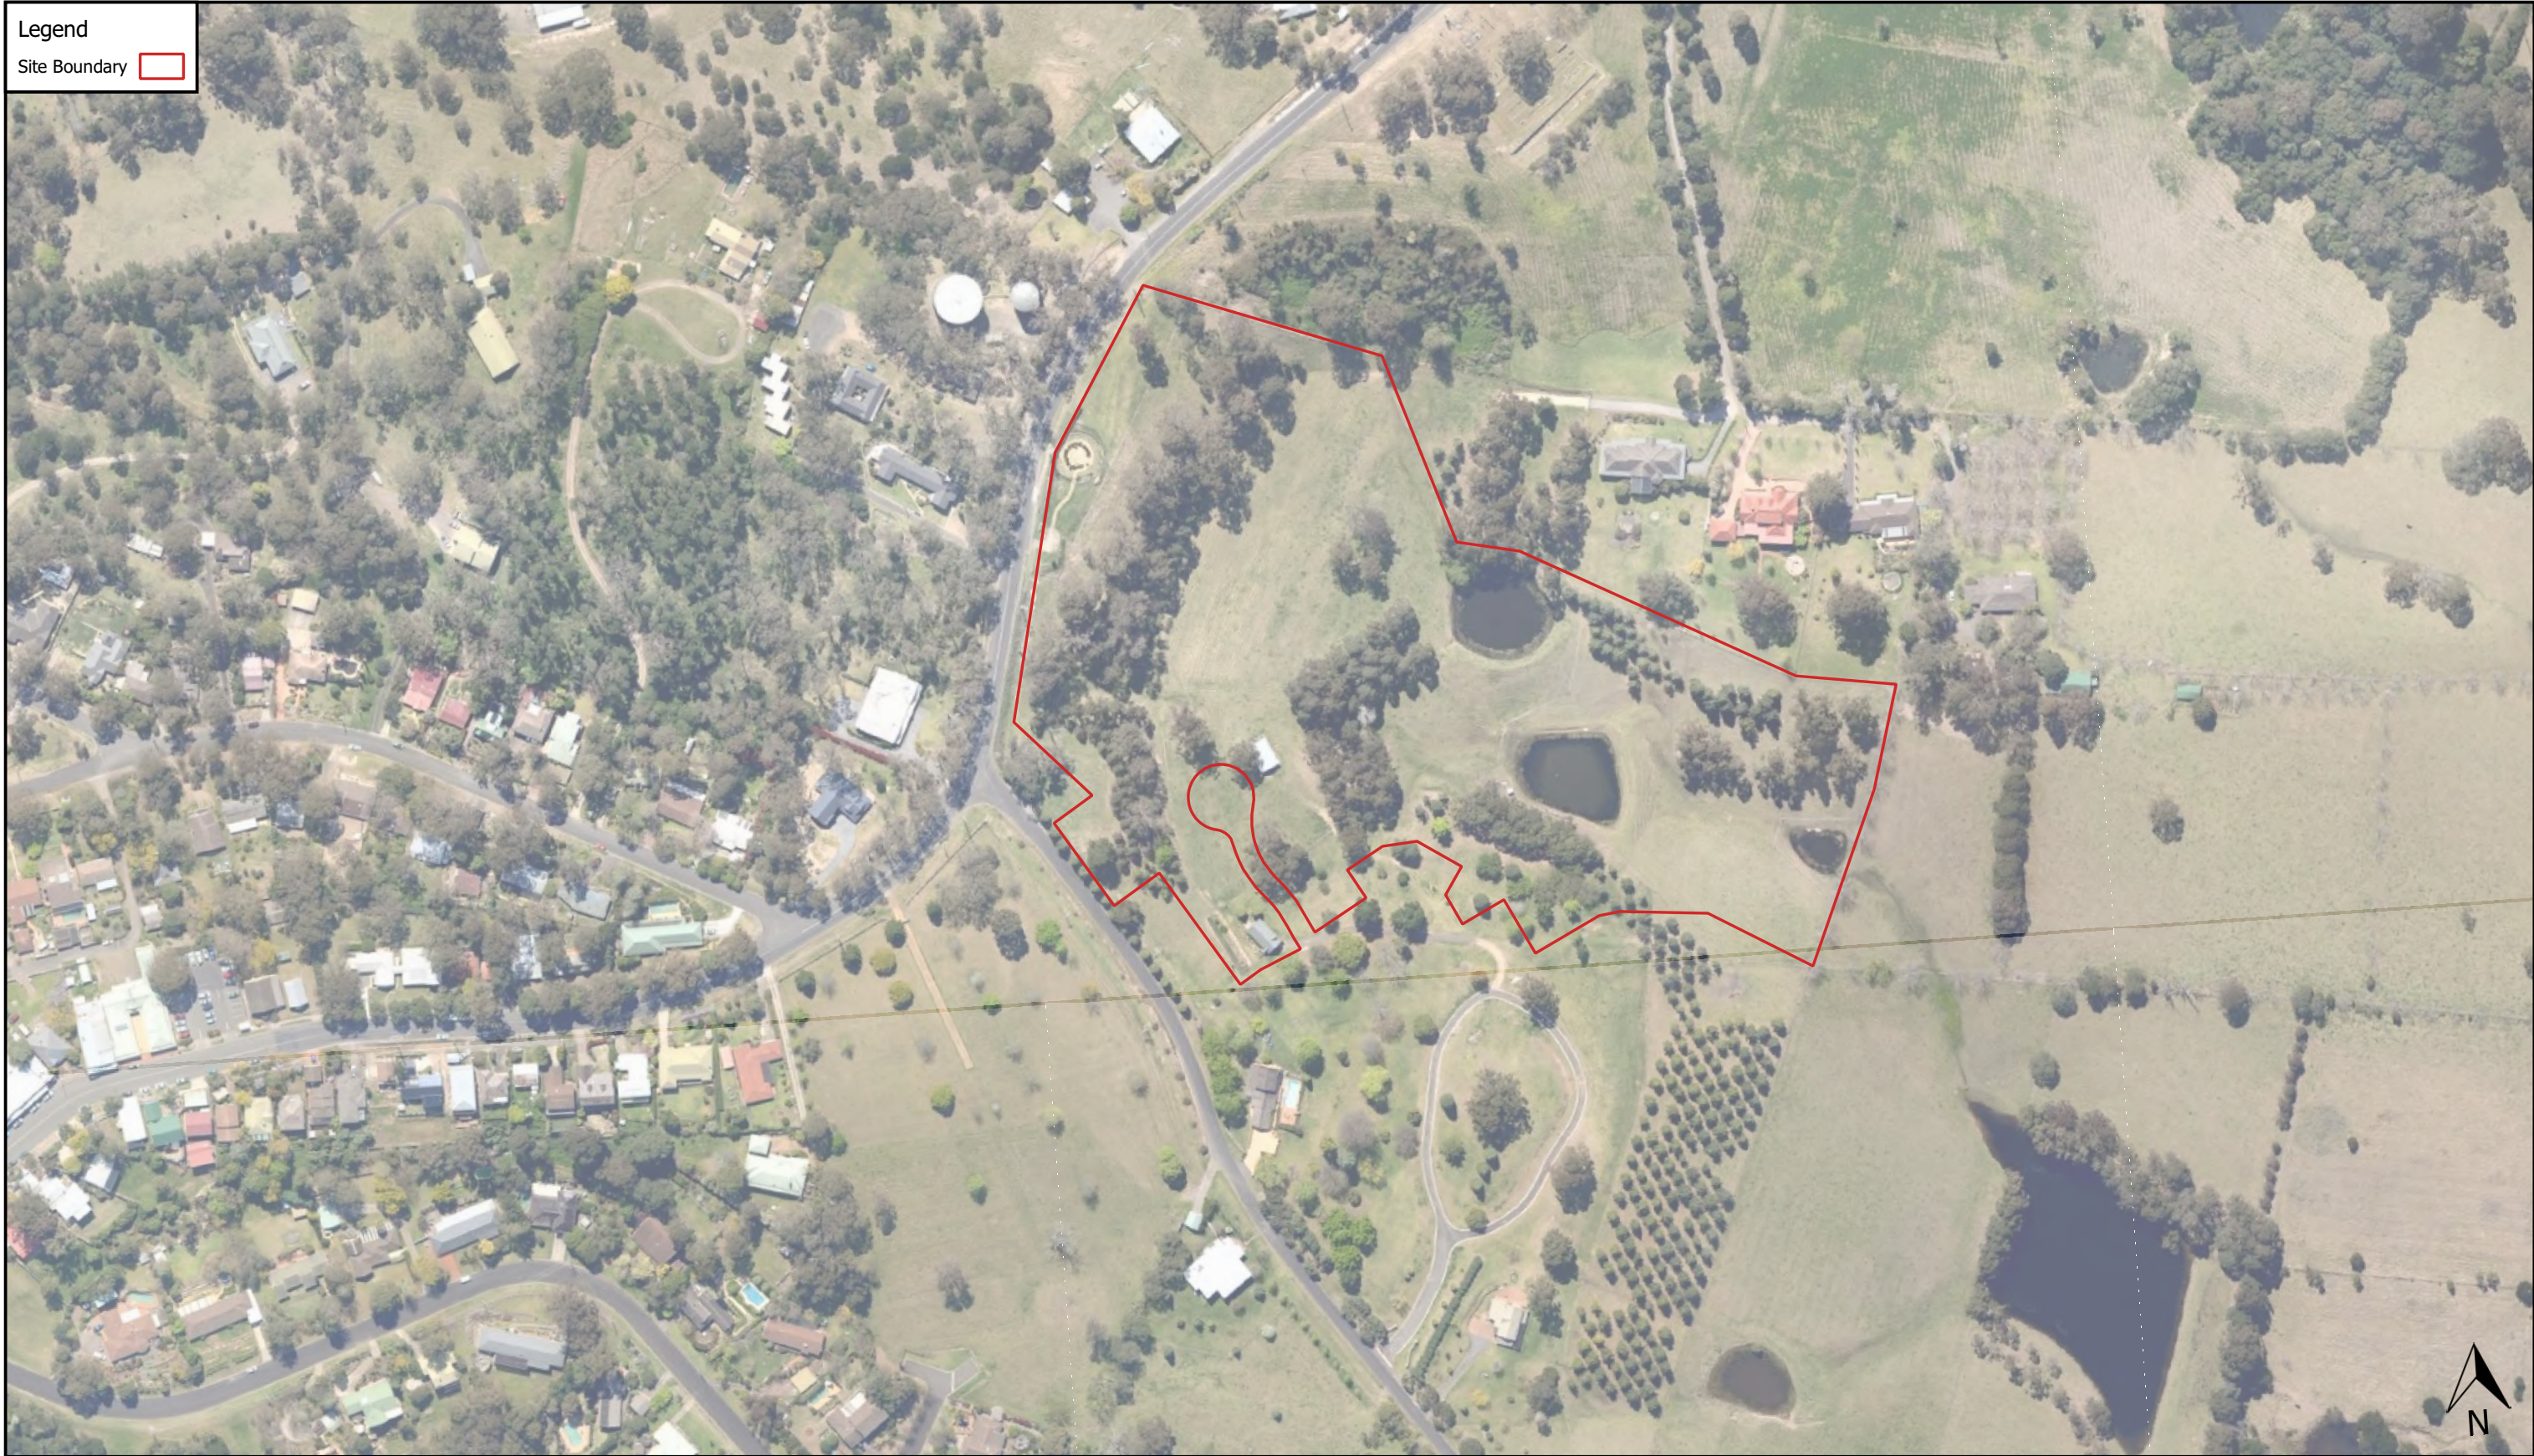
HISTORICAL AERIAL 2010

The aerials indicated that the land has been used for orchards and rural purposes and the current site condition has been established from 2010.
