93 CAMPBELLS LANE COOLAMON NSW 2701

DETAILED SITE INVESTIGATION

FOR A PROPOSED LAND REZONING (24 LOT RESIDENTIAL SUBDIVISON)

REPORT NO: 9005

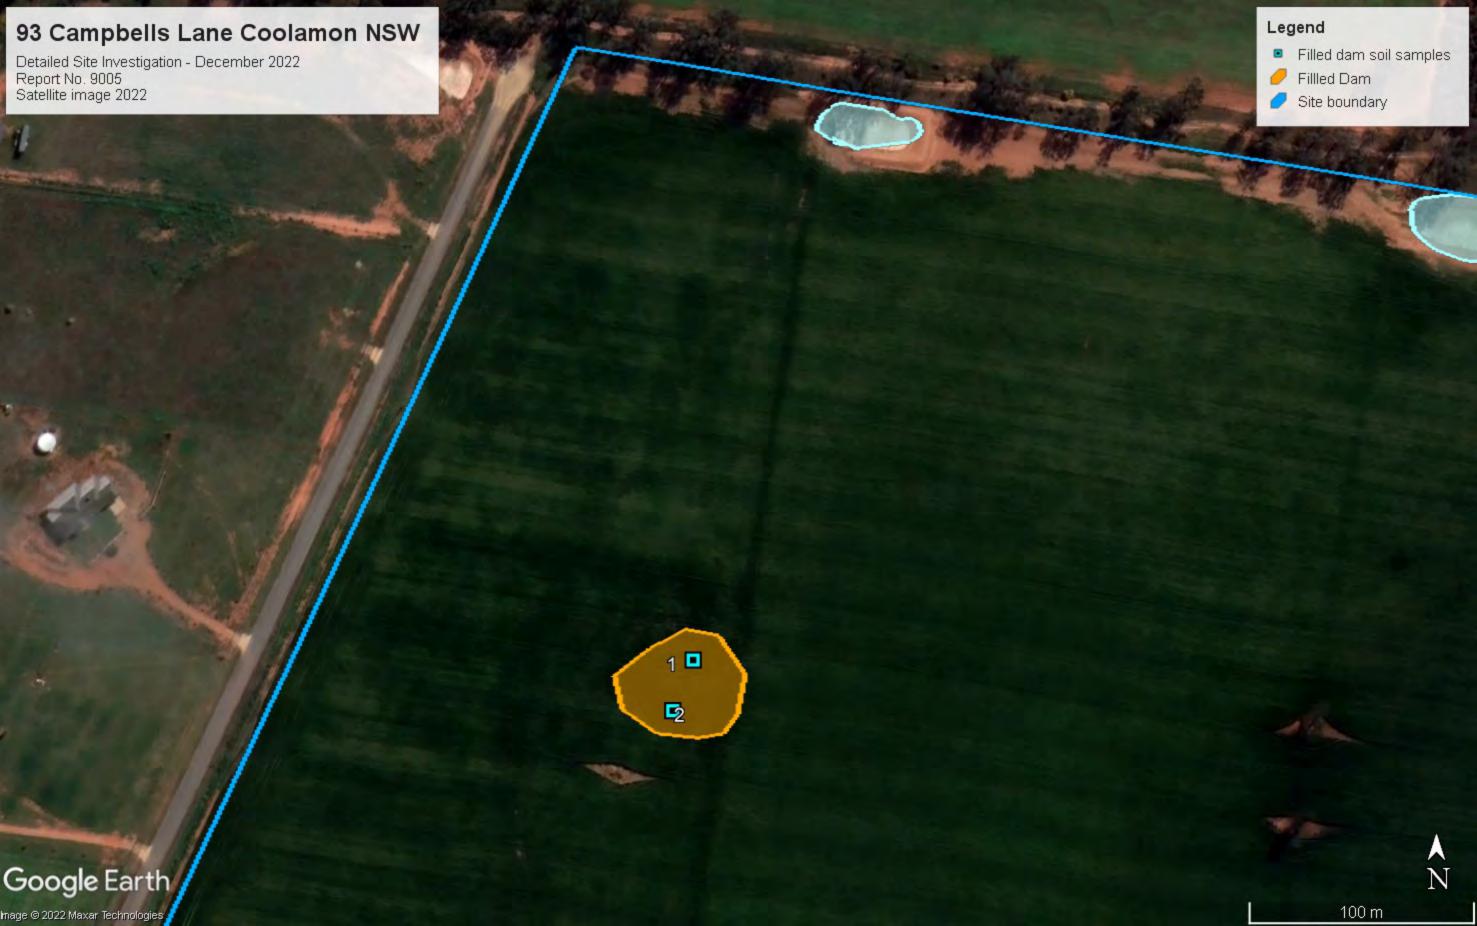
Attachment B : Sampling maps

- Two samples (0.5m and 1.5m) in judgmental locations within the filled dam.
- Eighteen samples to 0.3m depth) taken from within the demolished house and garage footprint at double the density recommended by the WA DoH (2021) as some isolated asbestos was found during the PSI (since removed). A 10 litre sample will be sieved (<7mm) at each location for bonded ACM and a sieved 500g sample will be taken for trace analysis.
