Report on
Geotechnical Investigation

Proposed Mixed Used Development
9 Albert Street and 31 O'Connell Street, North
Parramatta

Prepared for
Peterose Pty Ltd

Project 209535.00
February 2024

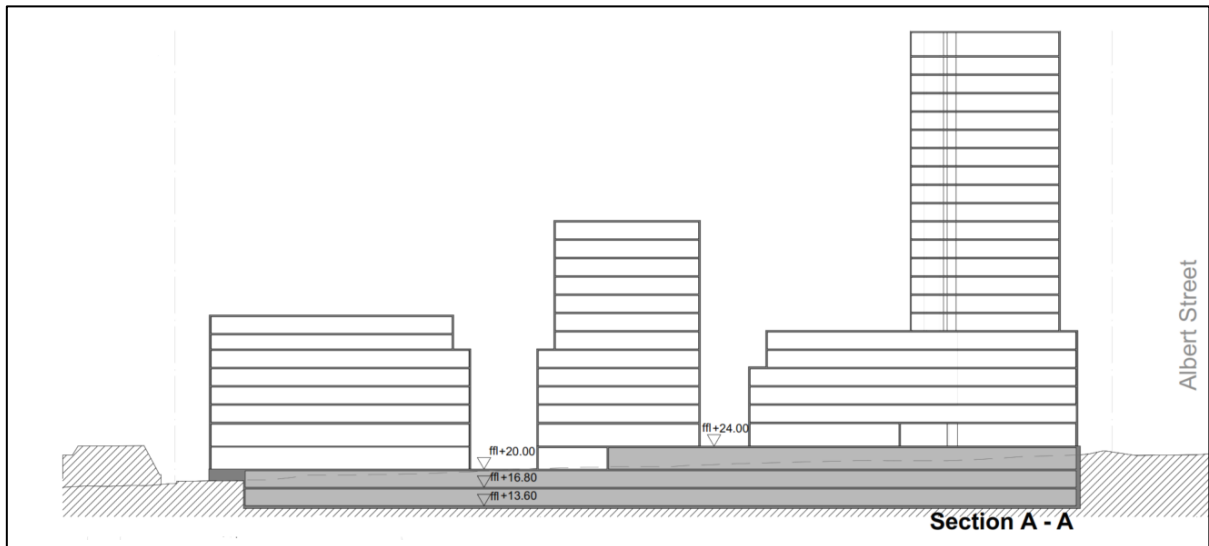
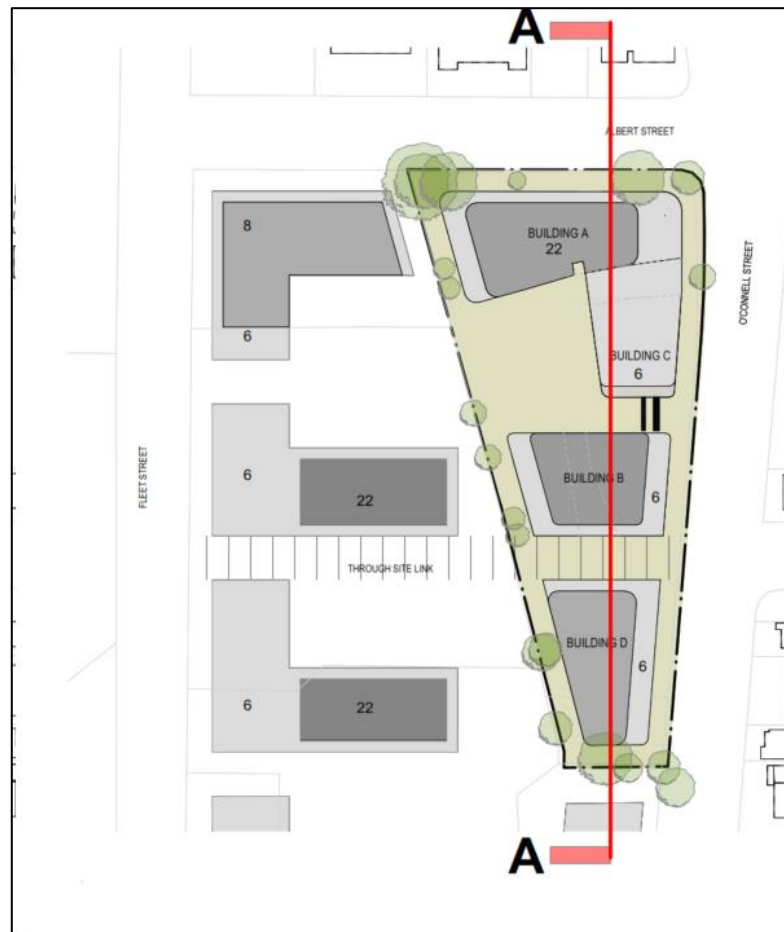
Figure 2: Cross-Section (top) of site from the DKO Architecture drawings.

As per the architectural drawings provided (refer to Appendix E), it is understood that the proposed development will consist of demolition of the existing building and associated structures on the site and subsequent construction of a residential complex comprising approximately 370 apartments and ground floor retail spaces with two-levels of basement car parking. The drawings provided by Ceerose and prepared by DKO Architecture show the deepest finished floor level (FFL) is RL 13.6 AHD (see Figure 2 below). DP assumes that detailed excavation for lift cores and footings will be no deeper than approximately RL 9 AHD.

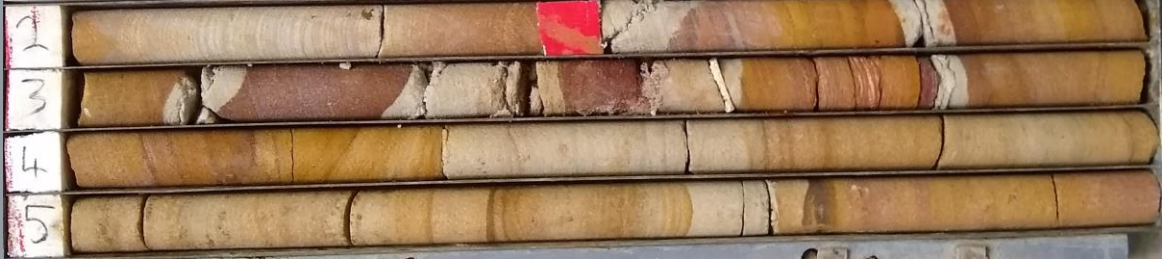
1.80 - 6.00m

209535.00 BH 01 START CORING@ 1.8m

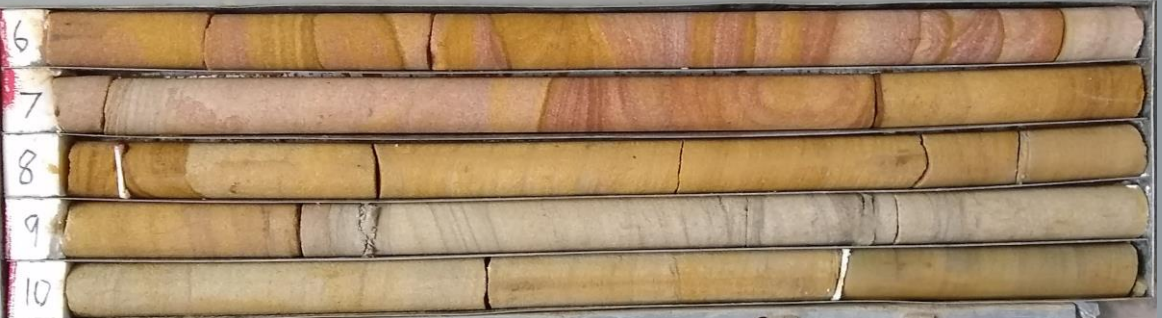
6.00 - 11.00m

Project No: 209535.00
BH ID: BH 101
Depth: 6.00 - 11.00 m
Core Box No.: 2/3

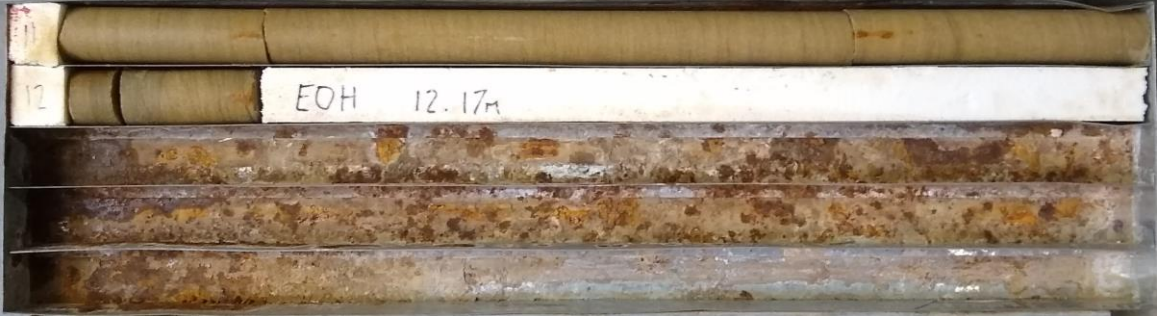
Project No: 209535-00
BH ID: BH 101
Depth: 11.00 - 12.17m
Core Box No.: 3/3

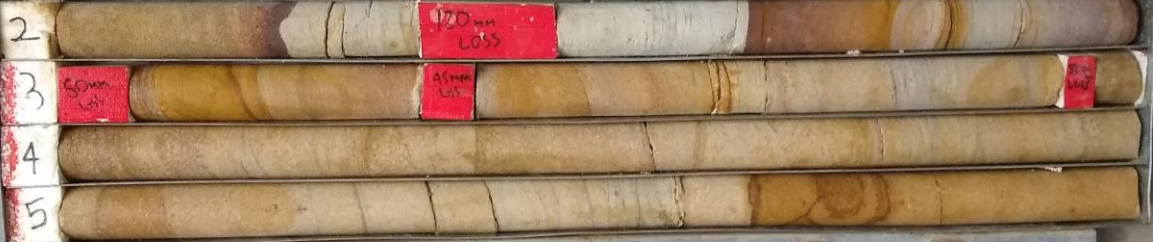
1.70 - 6.00m

NORTH PARRAMATTA 209535.00 BH102 30-11-21 START 1.7M

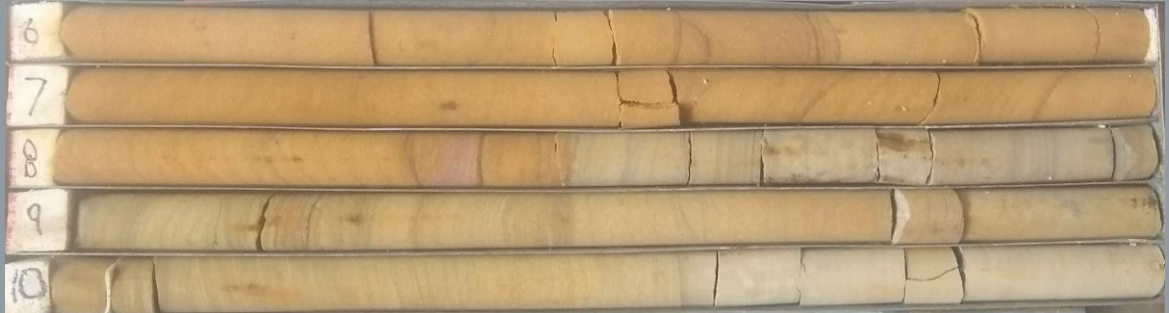
Project No: 209535.00
BH ID: BH 102
Depth: 6.00 - 11.00m
Core Box No.: 2/3

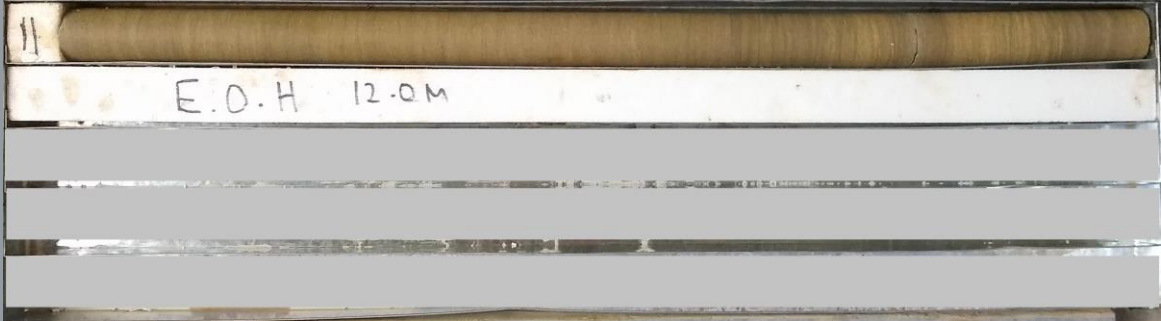
11.00 - 12.00m

Project No: 209535.00
BH ID: BH 102
Depth: 11.00 - 12.00
Core Box No.: 1/3

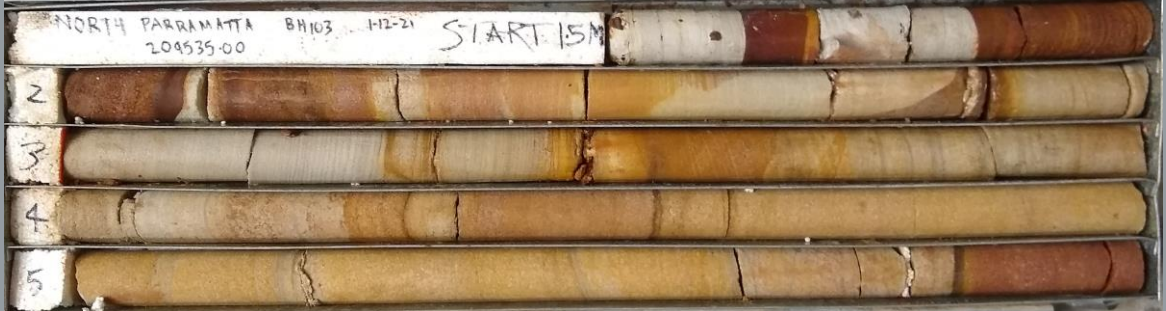
1.50 - 6.00m

Depth: 1.50 - 6.00 m

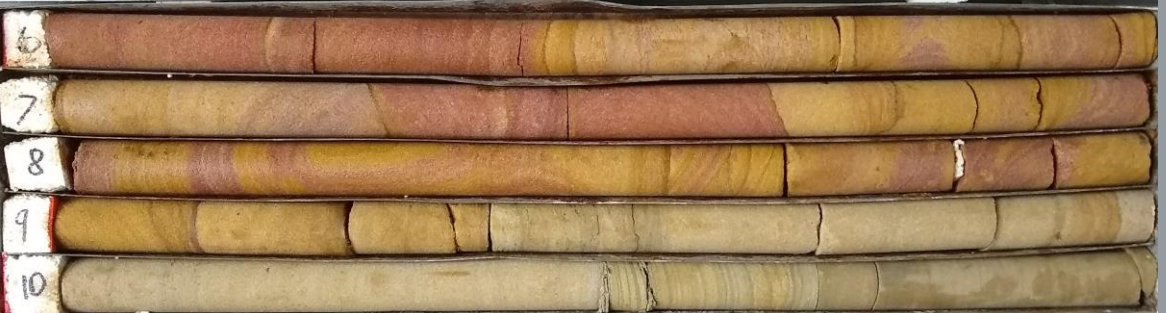
6.00 - 11.00m

Depth: 6.00 - 11.00 m

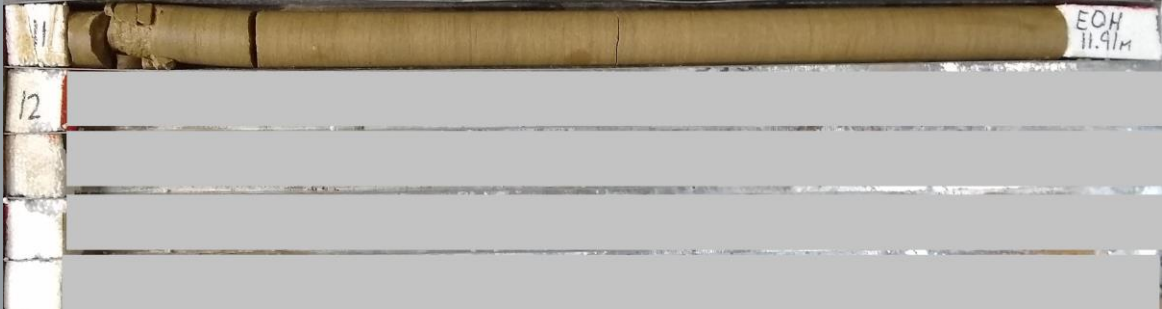
Project No: 209535.00
BH ID: BH 103
Depth: 11.00 - 11.91 m
Core Box No.: 3/3

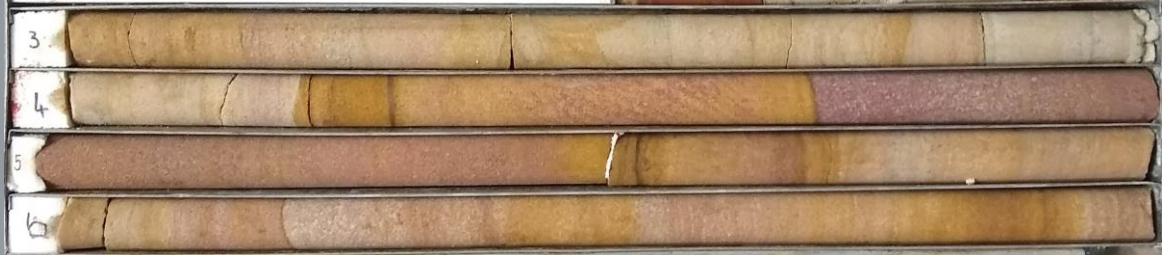
2.50 - 7.00m

NORTH
GRAHAMATTA BH104
START 2.5m

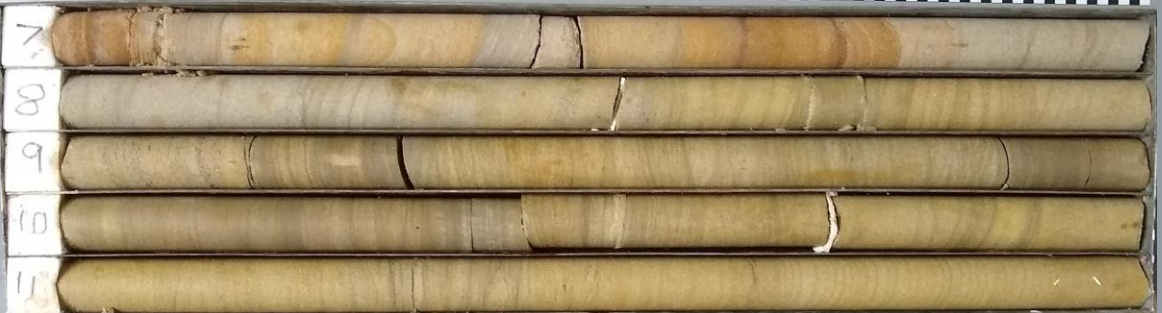
7.00 - 12.00m

Depth: 7.00 - 12.00 m
