**ANGEL PLACE
LEVEL 8, 123 PITT STREET
SYDNEY NSW 2000**

21 November 2022

RE: PLANNING PROPOSAL - HERITAGE LISTING OF HEADFORT HOUSE, 95 STANHOPE ROAD, KILLARA (REFERENCE NO# S13801-1)

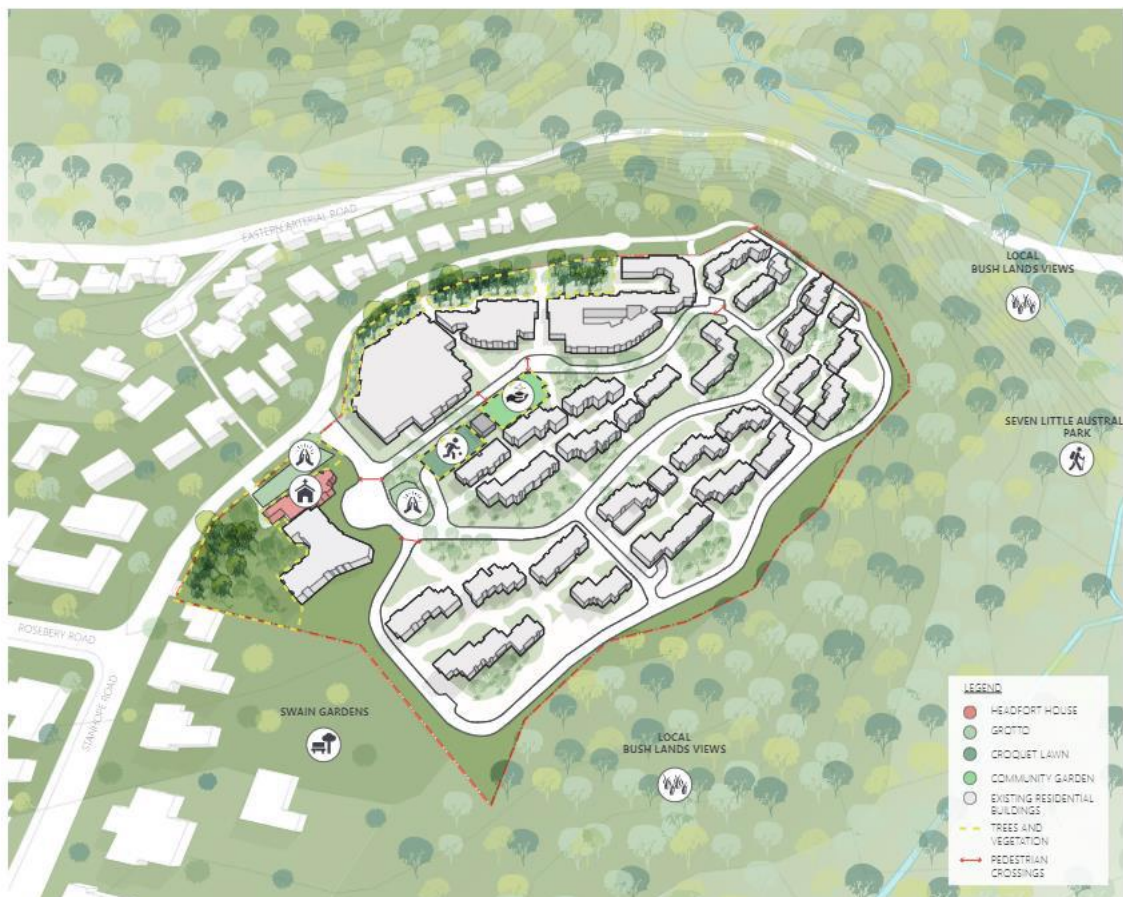
Figure 1 Plan of the Lourdes Retirement Village, with the subject Headfort House shown in pink.

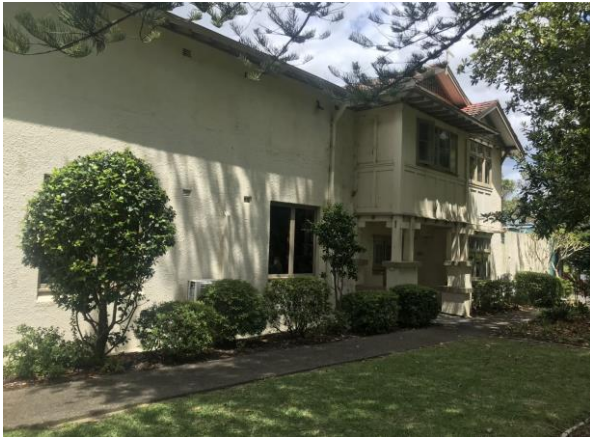
Figure 2 The principal northern façade

The north elevation of the main part of the building faces Stanhope Road. It has a double roof gable and features an entry porch which provides access to the building's original front door. The framed walls feature expressed vertical timber battens, which are also used on the building's gables. Although the timber battens are currently painted to match the walls, early photographs show that the expressed timber elements and window frames were originally painted or stained to be dark coloured, to contrast with the light-coloured broad walls. The recessed entry porch (north elevation) has two half-height stuccoed masonry piers with smooth rendered pediments and twin timber columns above. The eastern wing, now used as a chapel, has masonry external walls with painted stucco finish, built on sandstone footings (visible on the north elevation). The pitched roof is tiled, and eaves are timber boarded with expressed timber rafters. A comparison of the building's current condition with external photographs indicate that the overall size and form of the wing remains unchanged, although there have been changes to the fenestration.

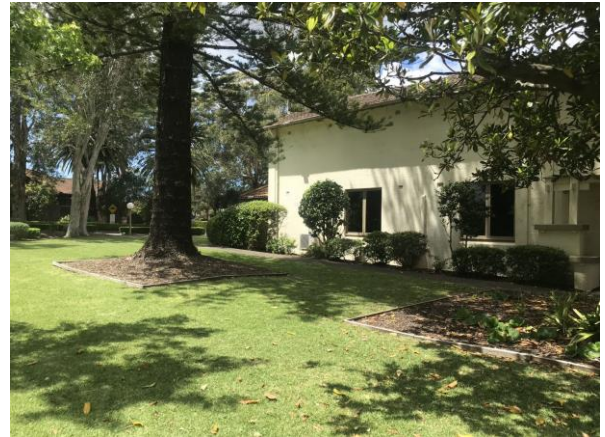
Figure 3 The northern façade of the chapel wing and grounds.

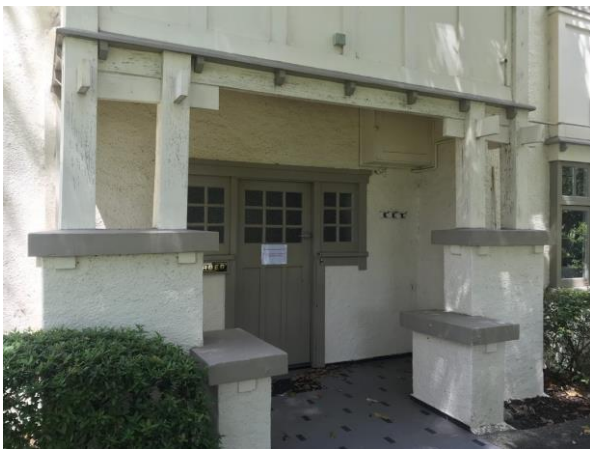
Figure 4 The principal entry /recessed northern verandah

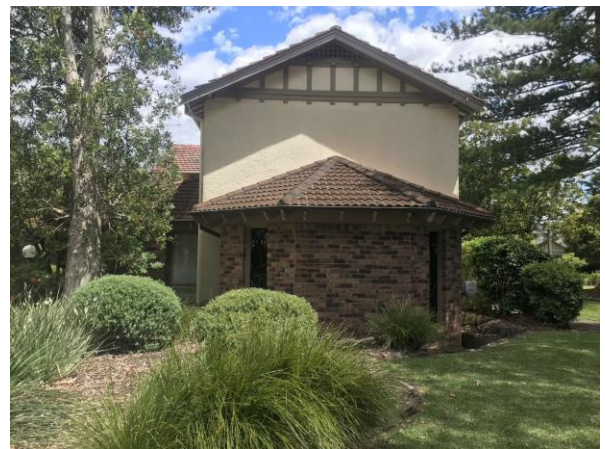
Figure 5 Eastern elevation of the chapel wing and single storey brick addition (1980s)

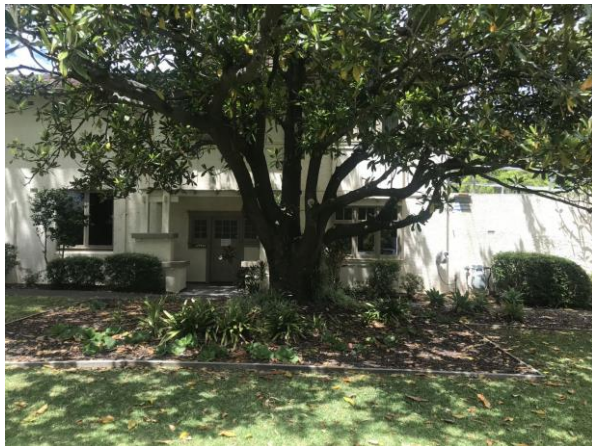
Figure 6 The principal façade and Moreton Bay Fig in front of the building

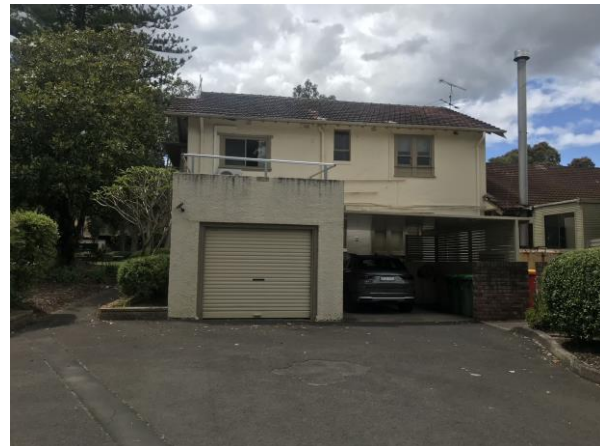
Figure 7 Western façade and early garage

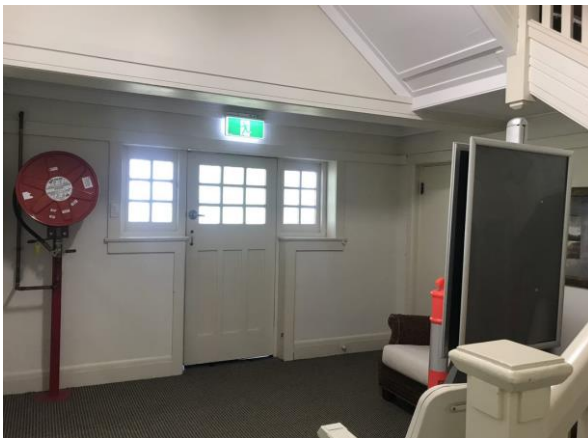
Figure 9 The ground floor entry

The ground floor consists of an entry lobby with stairs to the upper floor, a library, a storeroom for the café, an office and a bathroom. The upper floor is a residential flat, with bedroom, bathroom, large living/kitchen, and hall. The former verandah, now enclosed, is used as a storeroom. There are some original features internally, including the timber stair and decorative joinery in the main entry and ground floor office area, although these reflect typical and unremarkable interiors.

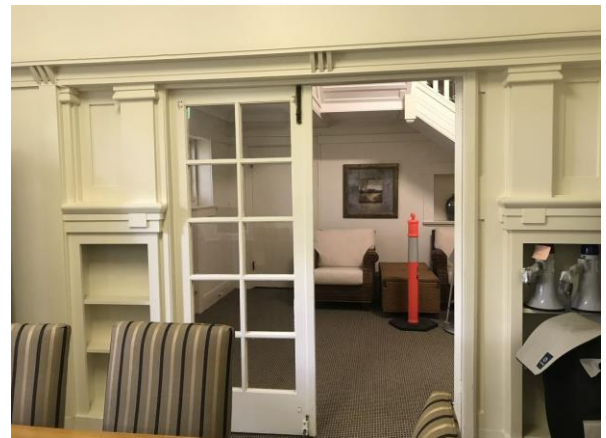
Figure 10 Joinery in the ground floor office adjacent to the main entry.

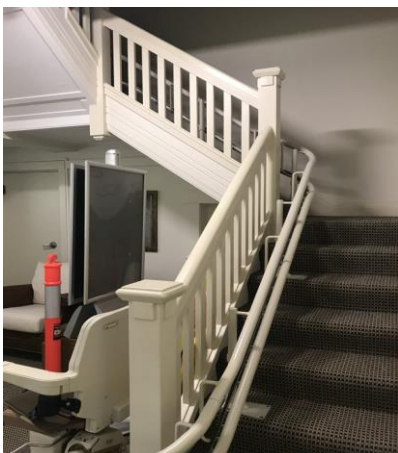
Figure 11 Detail of the original stair

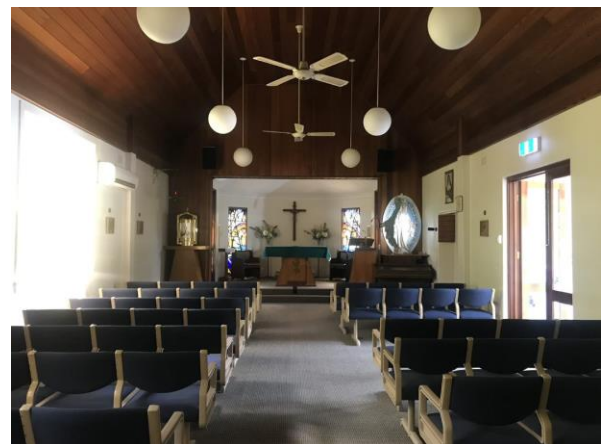
Figure 12 Interior of the chapel wing (1980s)

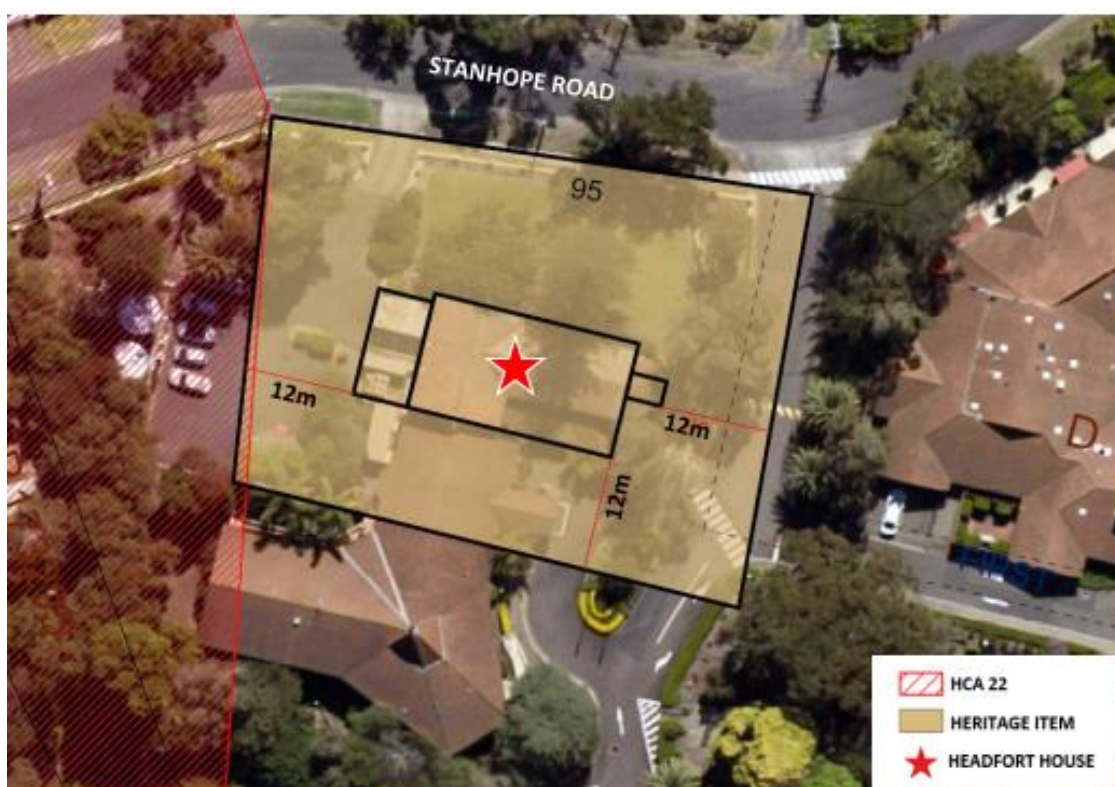
A setback of 12m is proposed to the east, south and west, aligning with Council's established policy for 12m setbacks for new development of heritage items in the Development Control Plan

Figure 14 Heritage curtilage as identified in the KRG Heritage Assessment Review (2022)

KRG Heritage Assessment Review (2022) has recommended a reduced lot curtilage for the proposed heritage item. This is considered appropriate in the absence of relevant historical lot boundaries. The curtilage provided for the proposed heritage item in the Council report was intended to capture:

- an appropriate curtilage for the setting of Headfort House, historically and currently, viewed in the round from the larger non-residential complex
- Headfort House in full including interiors, garage and chapel additions
- Visual and physical connection of Headfort House to Stanhope Road, the main entrance drive and turning circle,
- Garden setting and former tennis court near Headfort House and mature early trees within the vicinity of Headfort House

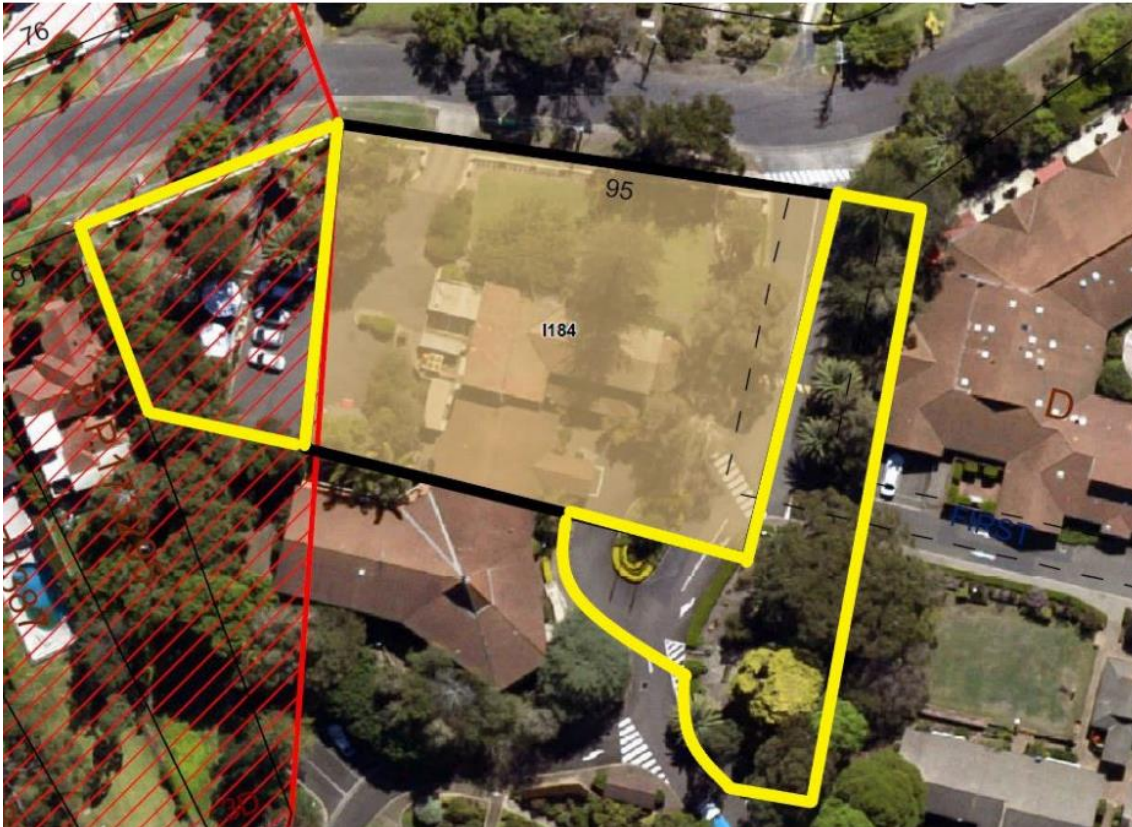
An alternative curtilage was also provided that captured a broader landscape setting and included the full width of the entrance road, the full turning circle, and the avenue of palm trees to the east of this road, and grotto to the south-east of Headfort House.

Figure 15 Alternate heritage curtilage as identified in the KRG Heritage Assessment Review (2022)

The proposed curtilage and certainly the alternate curtilage nominated by Council are considered excessive and should be reduced. Whilst a physical and visual curtilage is important for heritage items, it must be recognised that the building sits within an almost entirely contemporary landscape, (albeit a sympathetic one) that is the product of the redevelopment for the Lourdes Retirement Village and does not reflect its historical subdivision or setting. The curtilage as nominated captures fabric and features that are not of heritage significance such as driveways and hardstand parking areas as well as part of the 1980s additions to the rear. This may unreasonably limit works and otherwise sympathetic change within these areas. In a practical capacity it may also necessitate consent for otherwise minor works, such as roadworks or interior fitout of the 1980s additions.
