## ASSESSMENT OF SIGNIFICANCE

'STEPHENVILLE', 122 ATKINSON STREET, LIVERPOOL NSW 2170

for  
LIVERPOOL CITY COUNCIL

prepared by  
**FORM architects (aust) Pty Ltd**  
NOVEMBER 2020

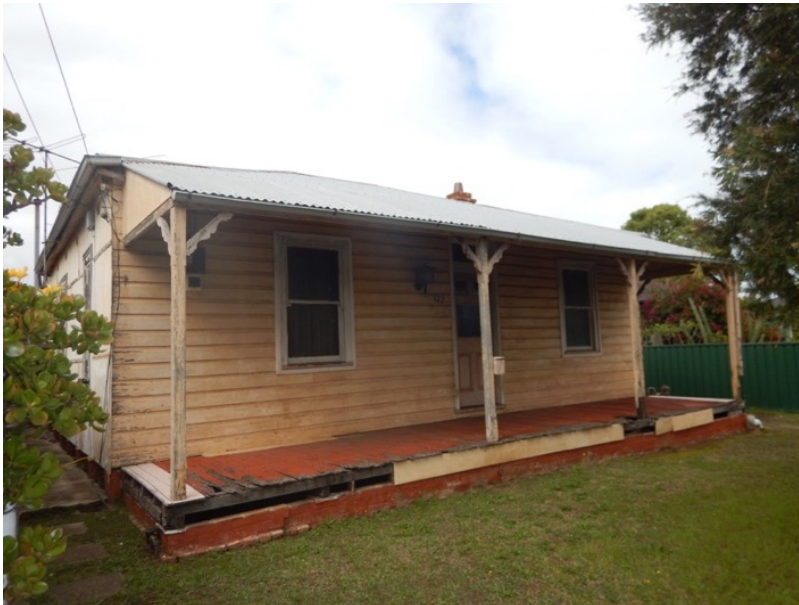
Figure 3 Front verandah of 122 Atkinson Street – all weatherboard and window frames are original. The deck condition is due, primarily, to weather and exposure generally. The verandah construction is visible through the and is in reasonable condition. The verandah posts have had their lower sections replaced. However, the post shaft is original and retains its tapered champher detail above the scarfed joint connecting the new base section of the post. (FORM 9/11/2020).

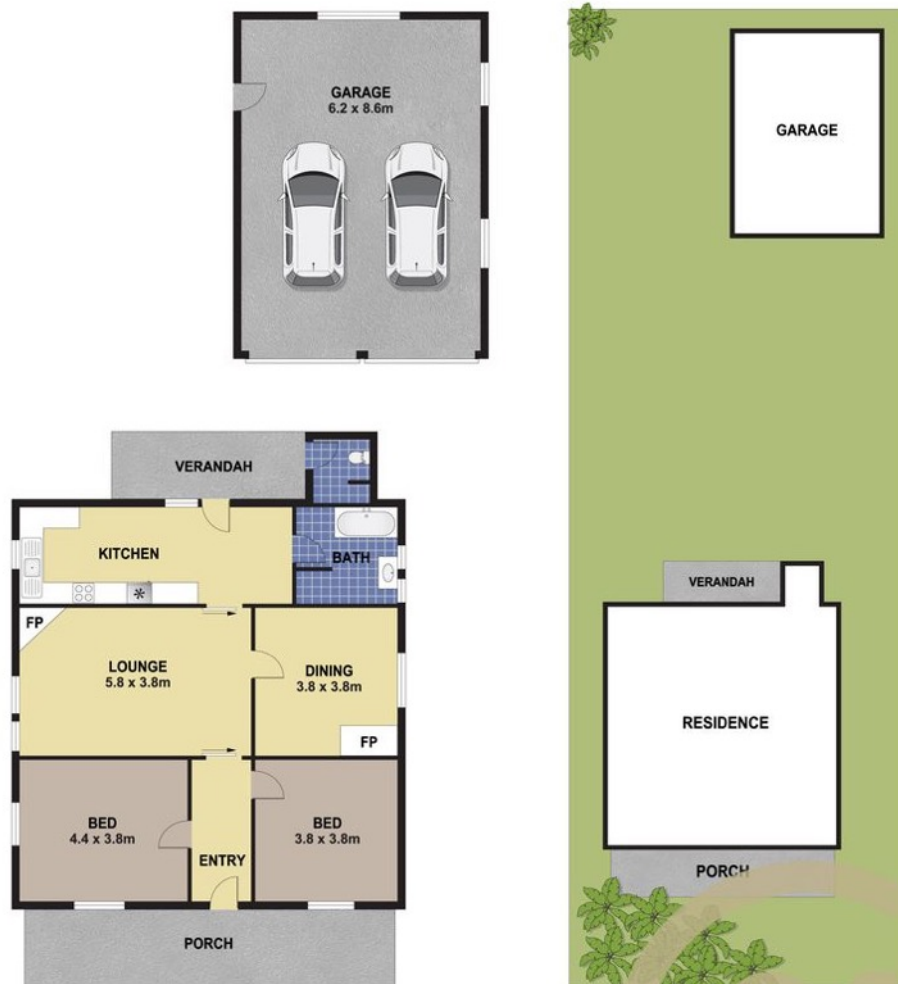
Figure 14 Existing floor plan of 122 Atkinson Street, Liverpool – Century 21

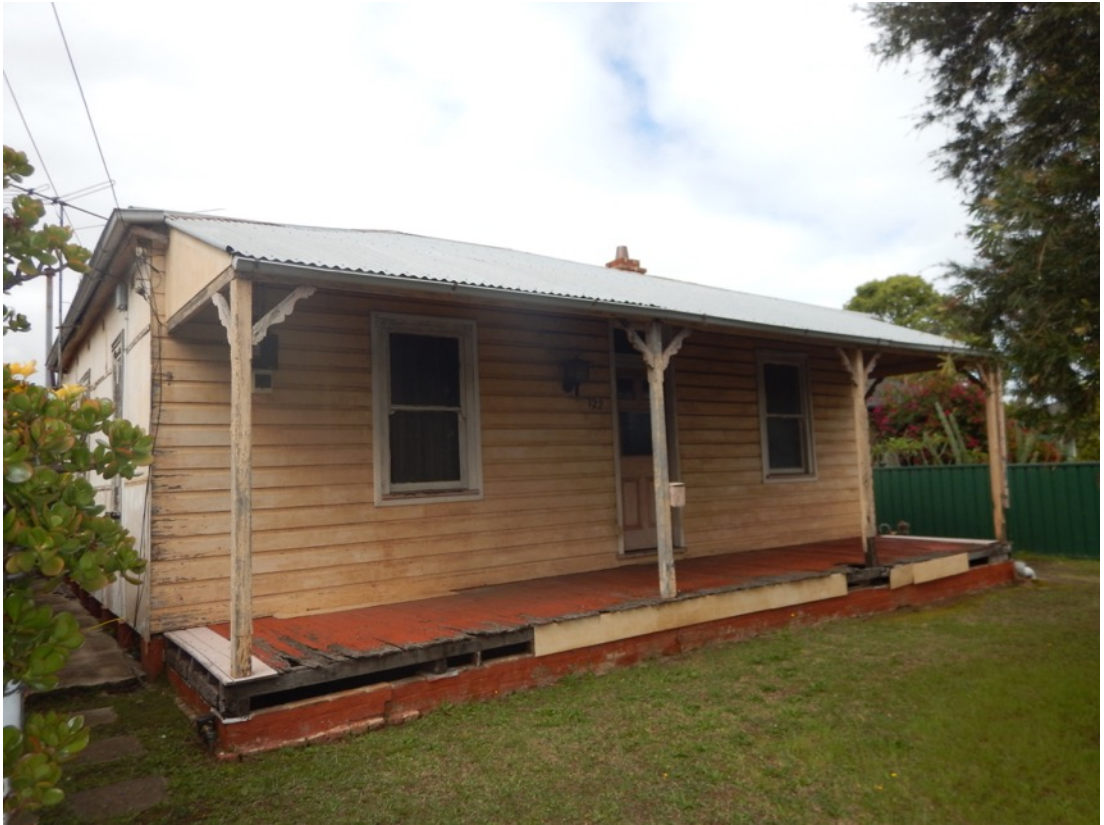
Figure 15 Despite initial appearances, the house is in quite good condition. The veranda decking has deteriorated due to age and weathering. The lower sections of each of the posts have been replaced with new sections that have been scarfed to the original chamfered posts.

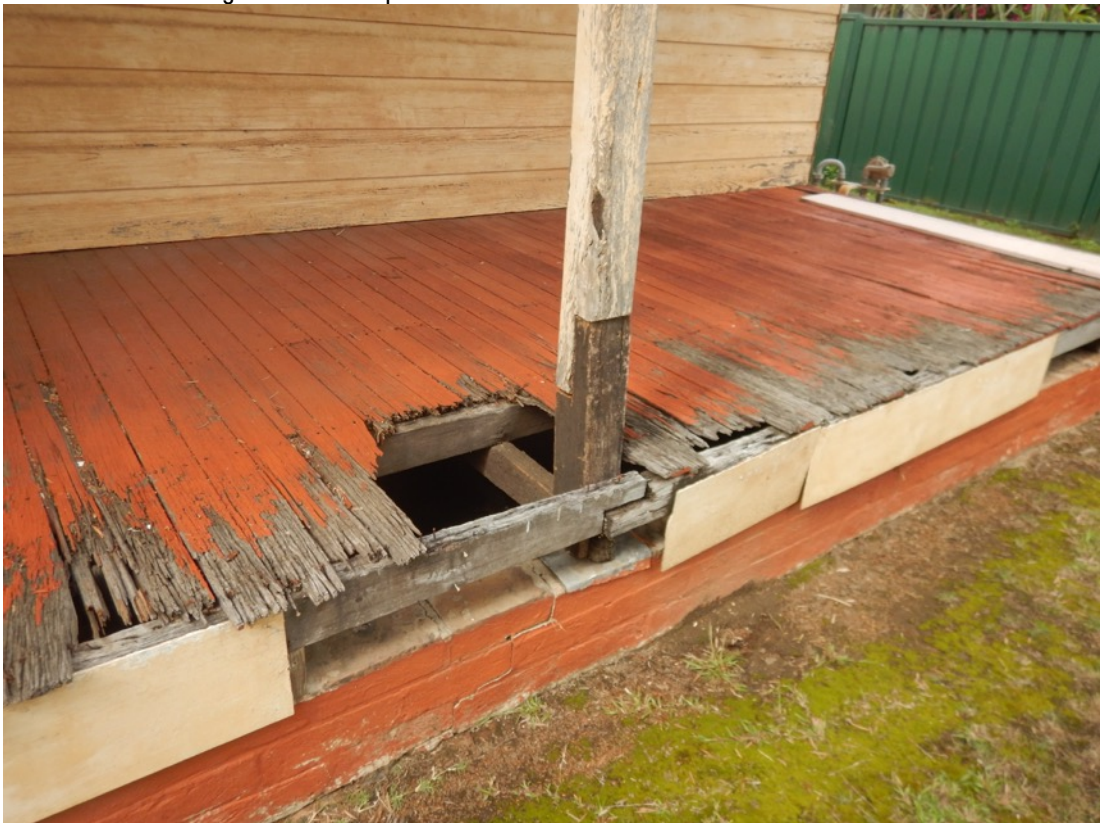
Figure 16 Detail of the repaired post and original construction exposed. Fibre cement sheet fascia is not original.

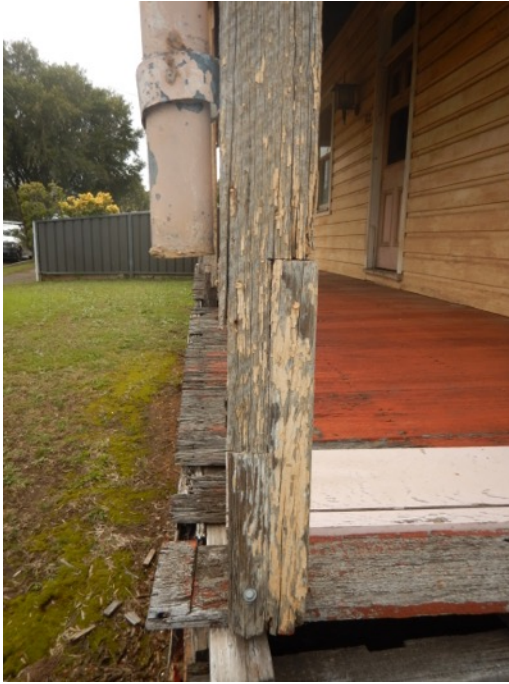
Figure 17 Every post has been repaied in the same manner.

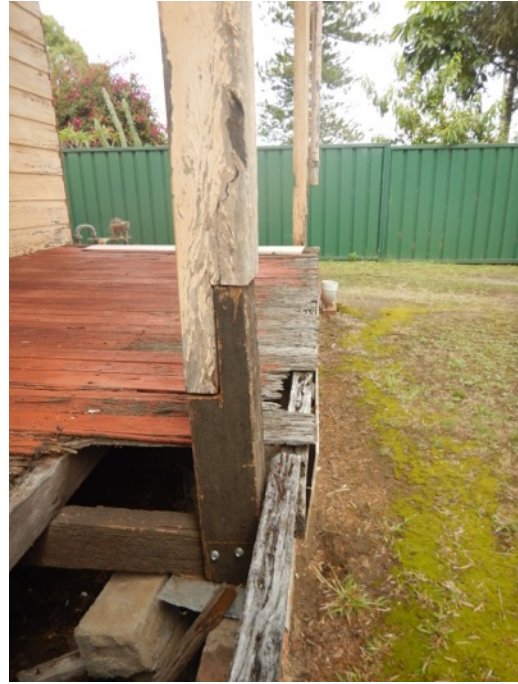
Figure 18 Detail of the scarfed joint.

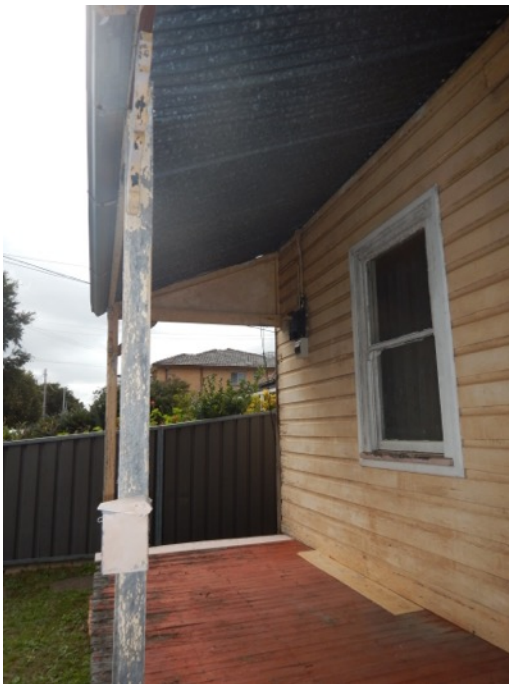
Figure 19 Front weatherboarding is original and has been protected from sun by the veranda and weather from being on the north rather than south.

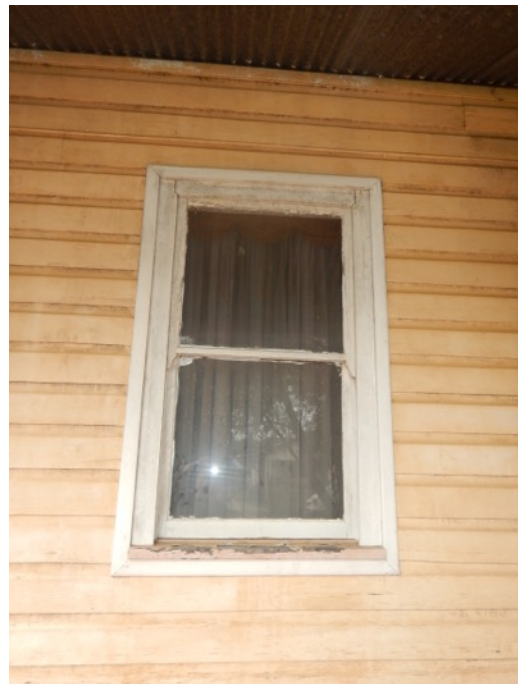
Figure 20 The box frame double hung windows, throughout the house are original. The only perceptible change is the added beading around the window frame, possibly to allow installation of flyscreens.

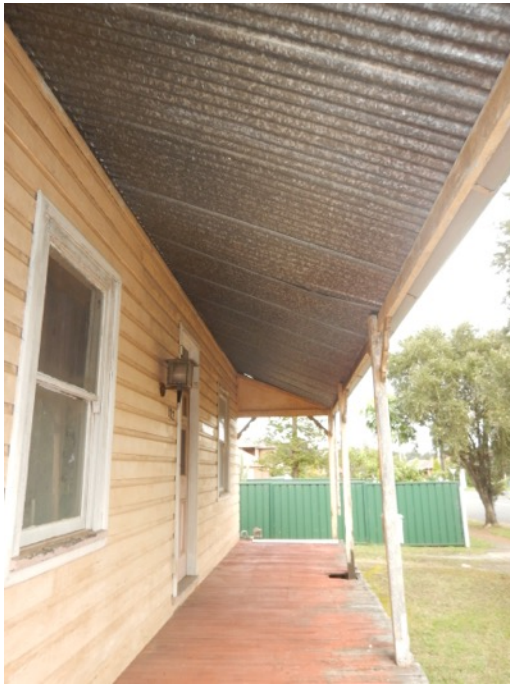
Figure 21 The structural simplicity and economy of the veranda frame is testament to its endurance.

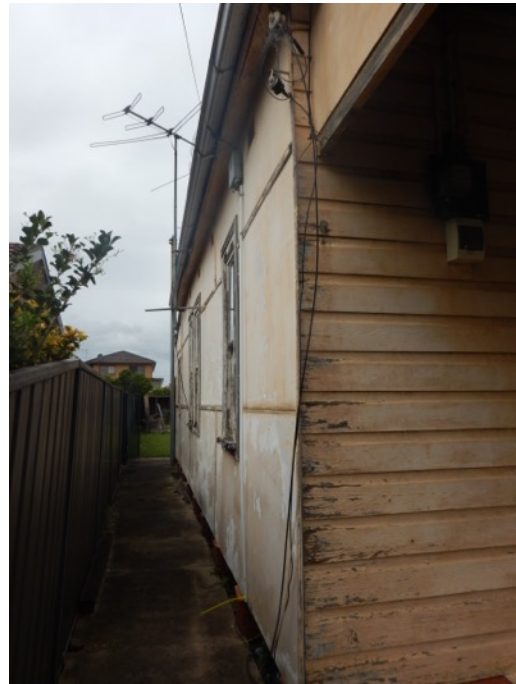
Figure 22 The fibre (asbestos) cement sheet cladding to the side walls may not be original. However, it is possible that it is. But, internal FC cladding is, certainly, a later addition.

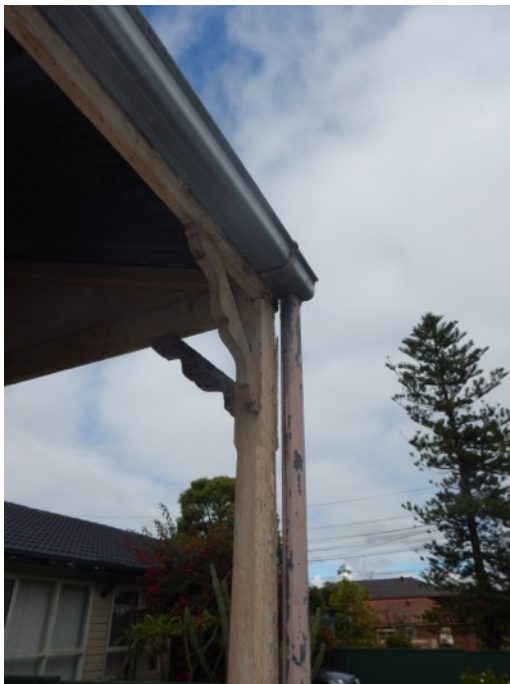
Figure 23 The veranda post to plate brackets are original and can be seen in the 1917 photo taken at the handover ceremony, at Plate 5.

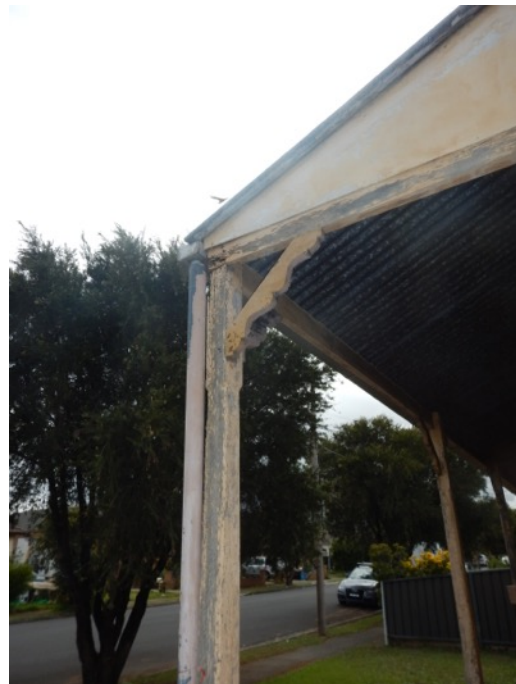
Figure 24 The simple, but effective and economic, detailing of the housed connection between posts, plate and brackets.

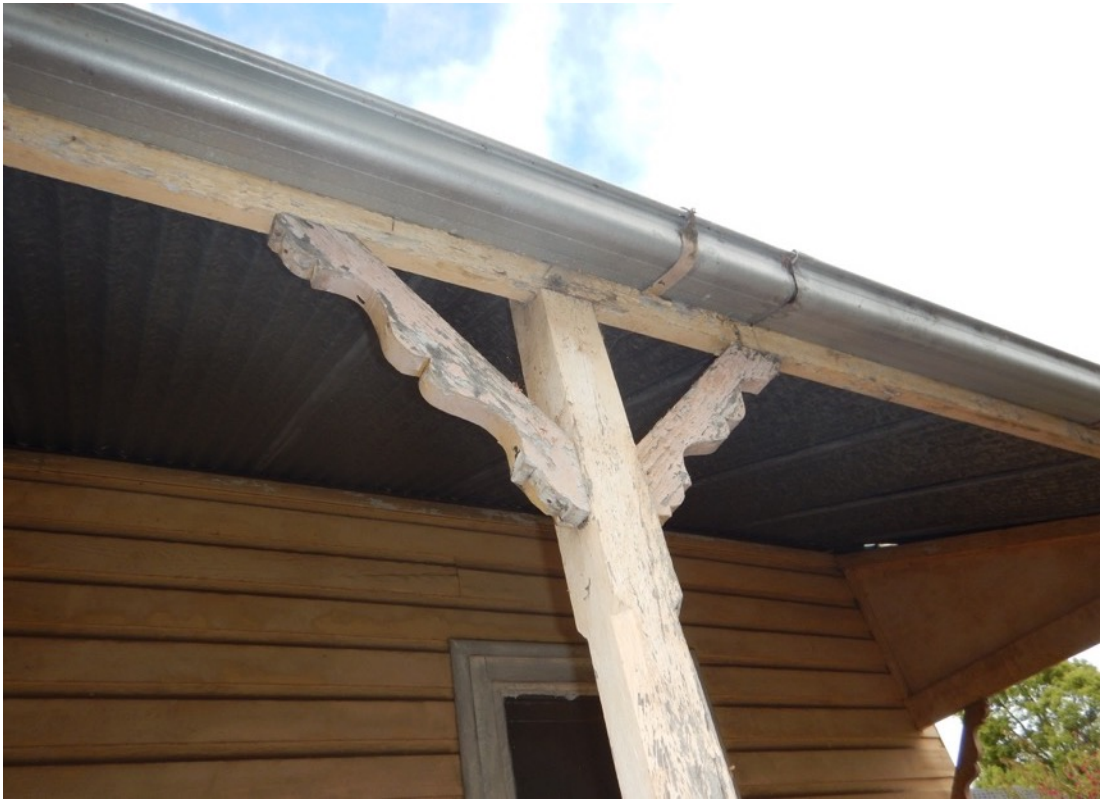
Figure 25 Detail of the post, plate and bracket connections is instructive. Note the chamfering of the post, it is tapered to give an appearance of 'entasis' to the post. The quadrant gutter is, relatively, new but, is likely a replacement of an original gutter of the same profile that was modern for the time.

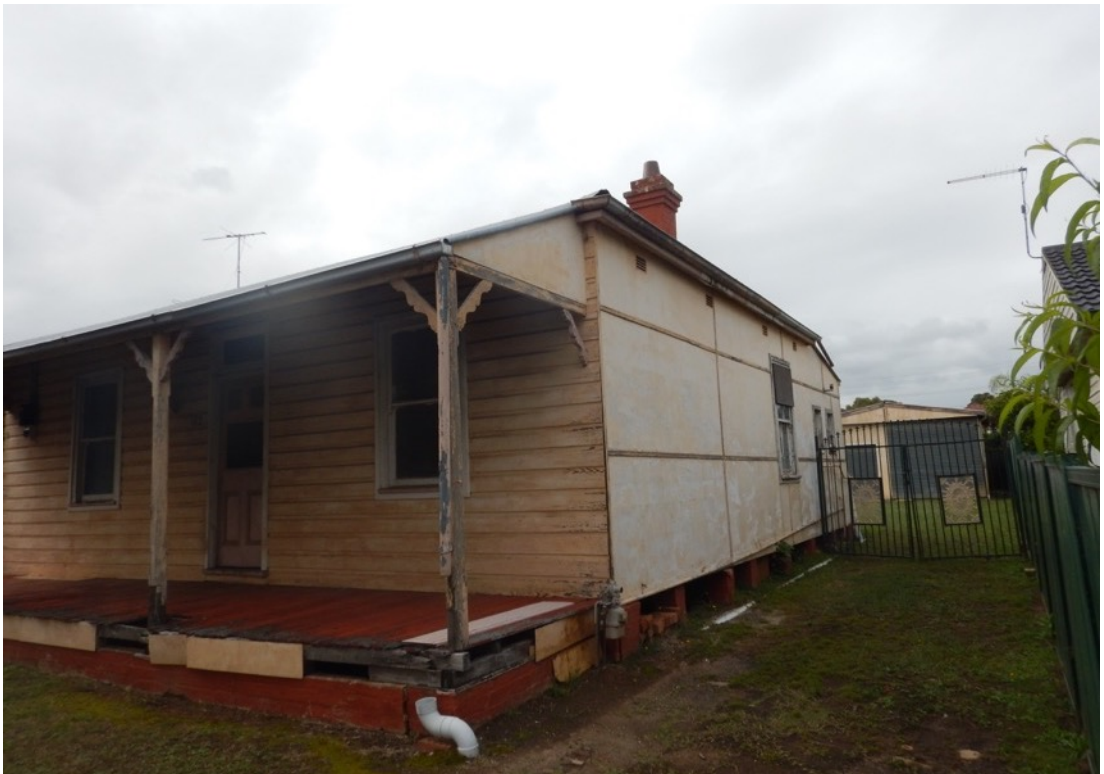
Figure 26 Whilst the Fibre cement cladding to the side walls seems incongruous they may be original as a cost effective cladding with the 'dress' weatherboard cladding limited to the front. However, the rear veranda, also, has weatherboard cladding.

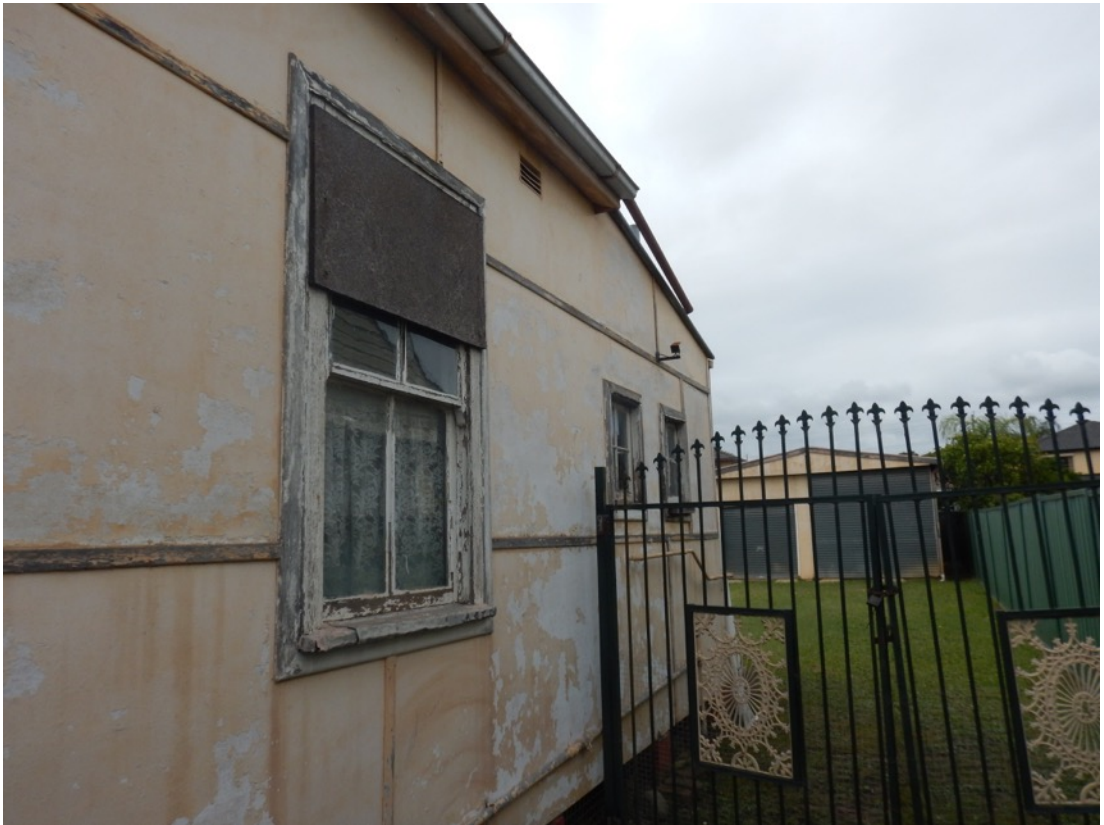
Figure 27 The fibre cement cladding extends over the rear addition to the house with no joint visible. This indicates that it is not the original cladding.

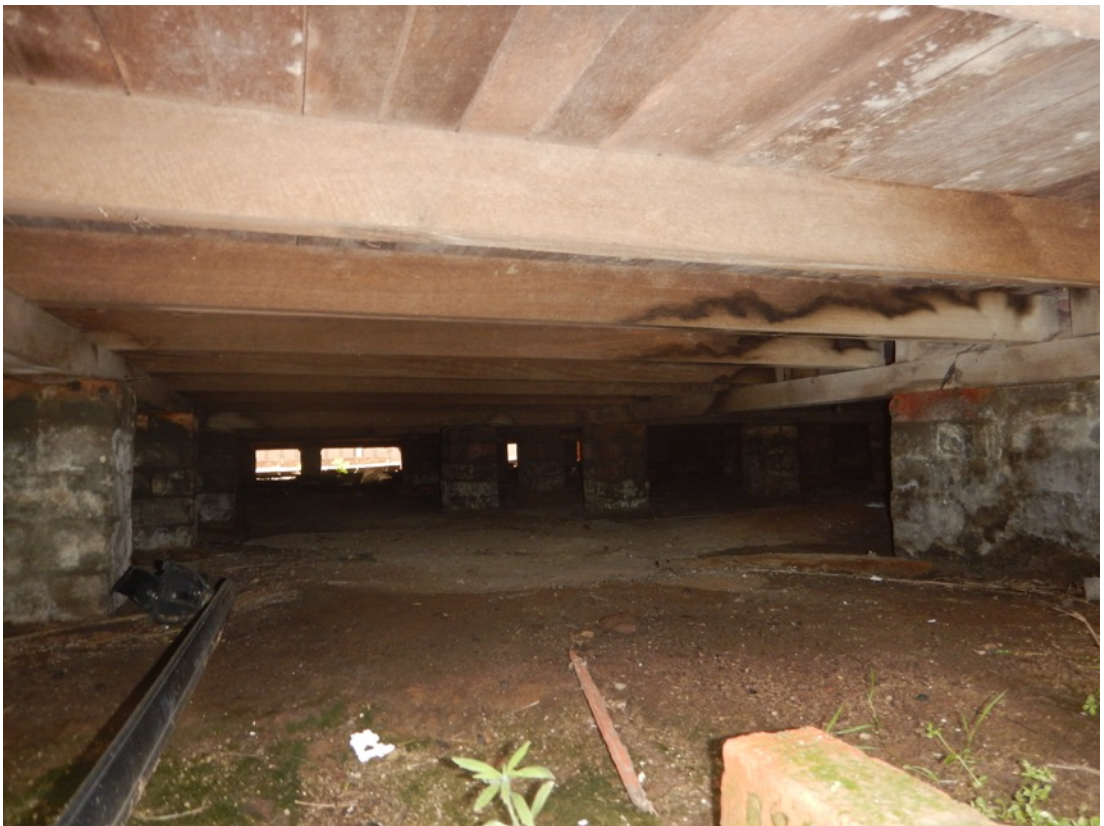
Figure 28 The foundation space shows the construction of the floor as joists over bearers on brick piers. It is in very good condition despite its 103 year age. The cleanliness of the foundation space is a testament to the care and maintenance that the house has received.

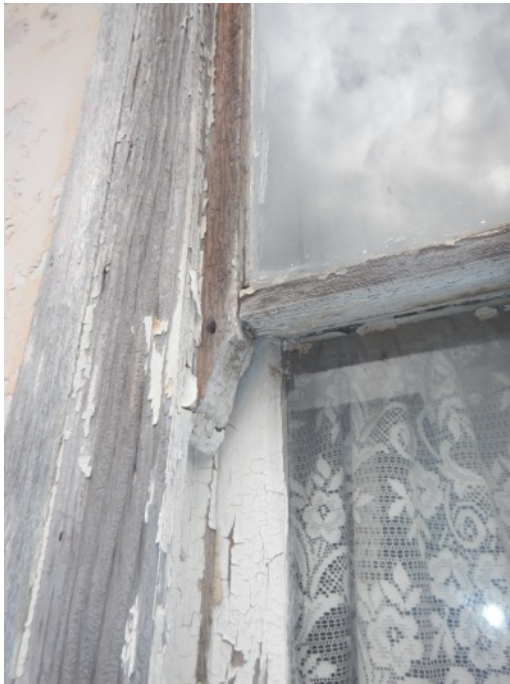
Figure 29 Timber, australian cedar, window frames and sashes are, generally, in workable condition that could be restored without replacement of much of the original fabric.

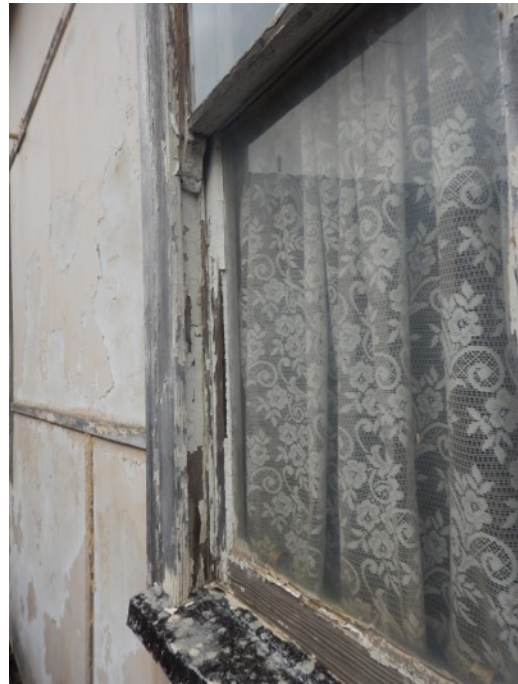
Figure 30 Most of the, apparent, deterioration, is due to exposure to the elements and weather for 103 years.

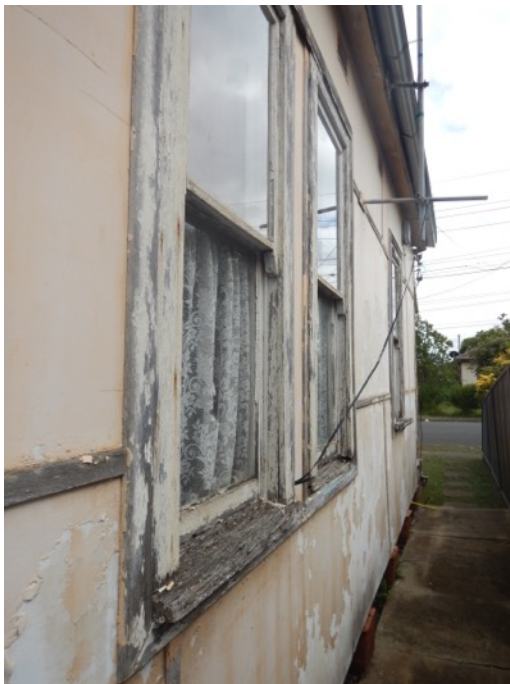
Figure 31 All of the extant box frame windows and sashes are in similar condition.

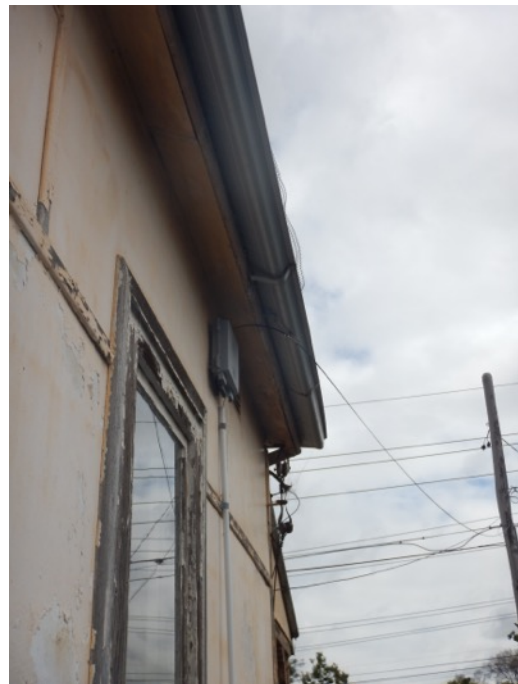
Figure 32 Weathering has had an impact on the house but not to the point of dilapidation.

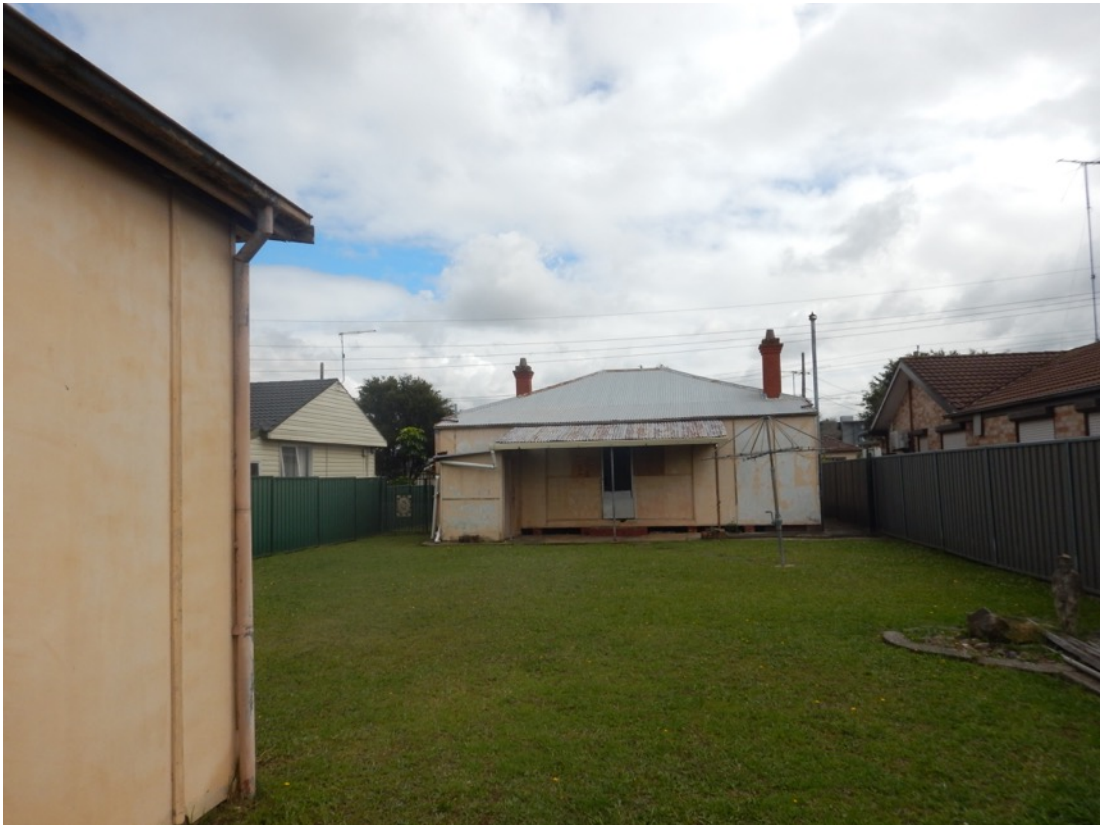
Figure 33 The rear of house still has its original form. Even with the enclosure of the veranda it is possible to imagine the former rooms at each end. The 'outhouse' on the left and the canopy to the concrete plinth replace the rooms that have been absorbed into the house and, are later additions.

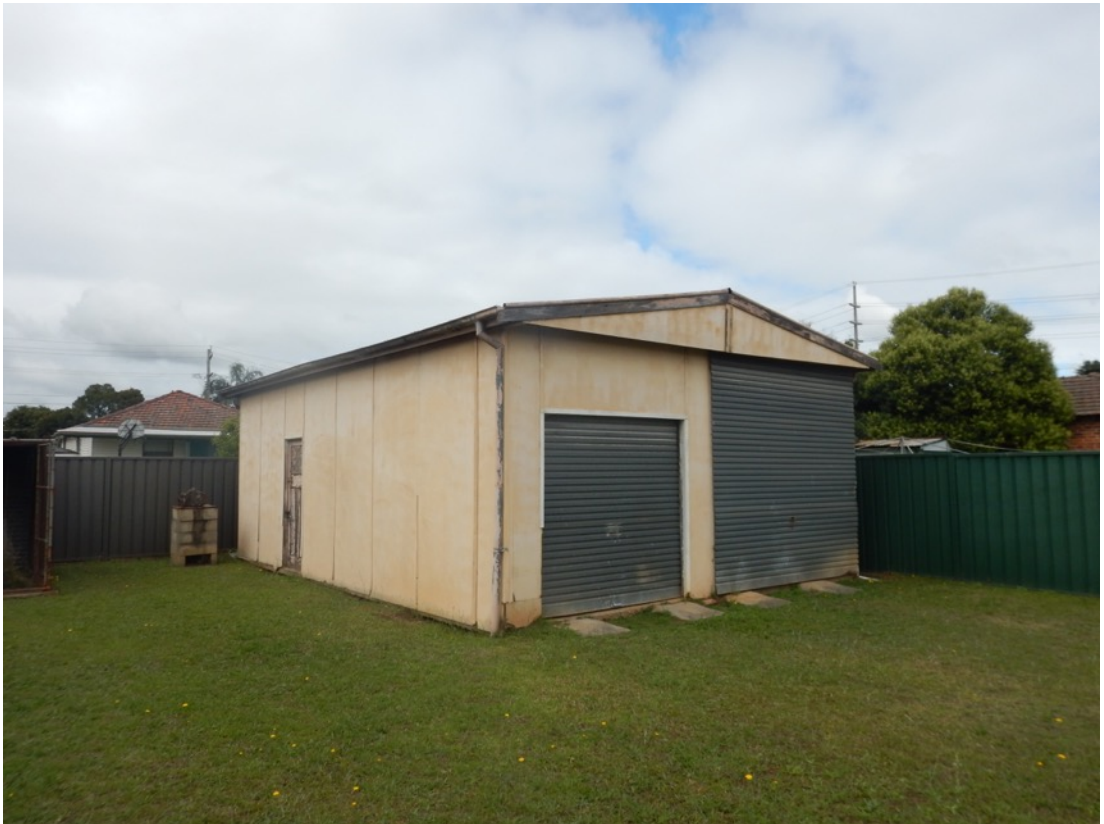
Figure 36 The Garage/Shed/Workshop is a later, undated, addition but, a great example of the type of structure that served for storage, garaging and family entertainment in the interwar and post WW2 years that is, generally, discouraged under modern planning laws.

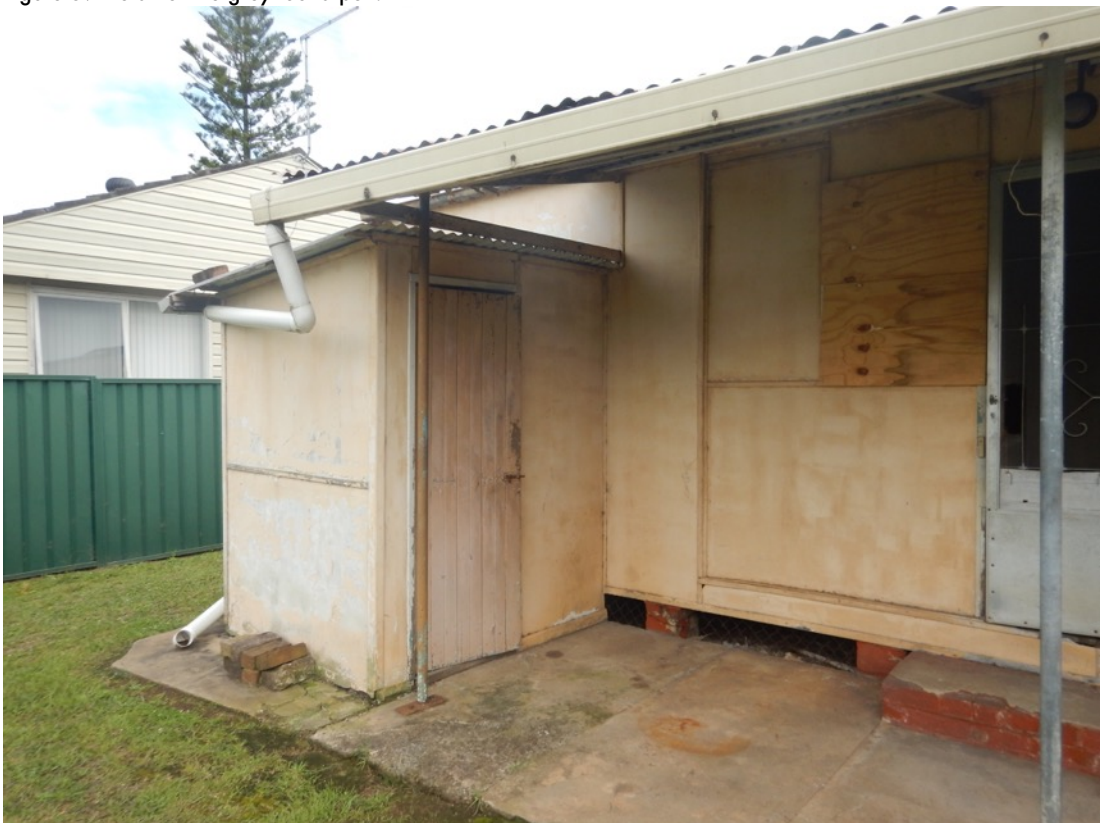
Figure 40 Installation of the sewer to the area obviated the freestanding outhouse/lavatory with pan service. The original outhouse appears to hve been extended to connect to main structure of the house. Evidence of the veranda infill is seen in the exposure of the edge of the floor and the recess of the infill walls.

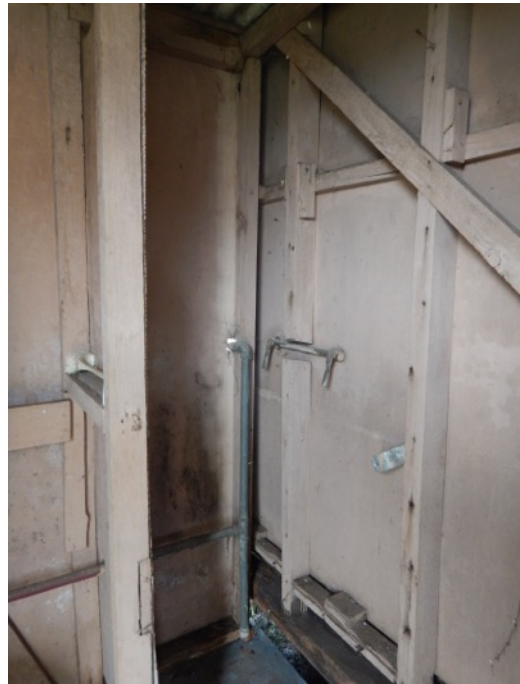
Figure 42 The extension of the toilet to connect to the house appears to have included plumbing, for a basin?

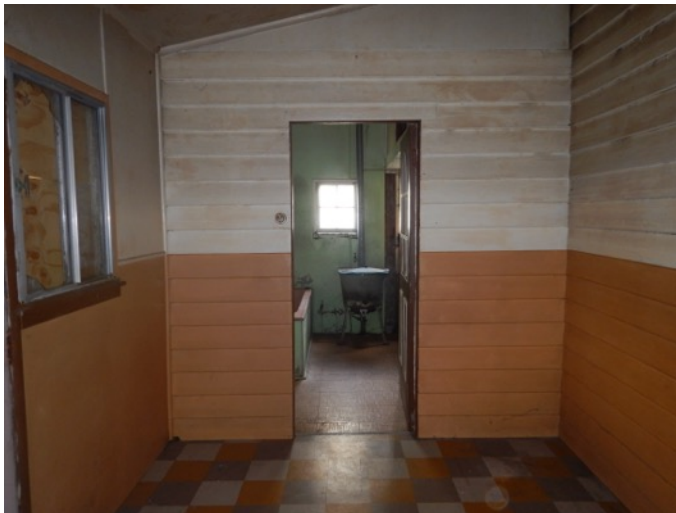
Figure 46 The former Laundry (?) is now the Bathroom but, the original Copper has been retained. The wall lining confirms that this was an external wall, to the veranda. The profile at the rear is a simpler splayed profile that would be cheaper than the scalloped weatherboarding to the front wall. It is likely that the side walls were clad with this profile.

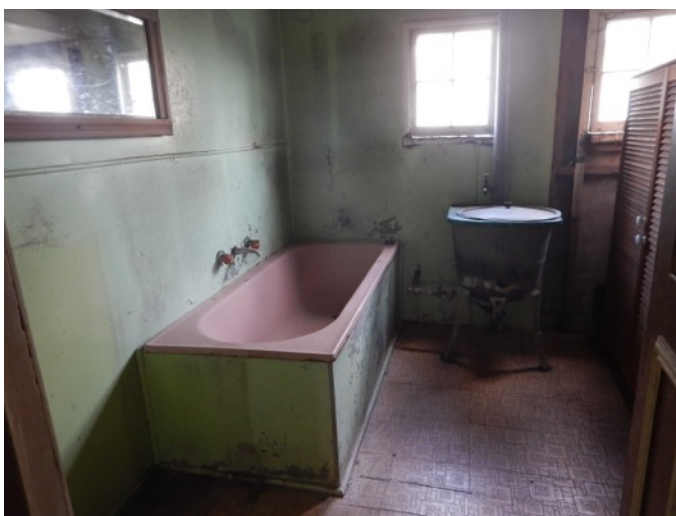
Figure 47 All of the alterations to the house indicate that it, generally, occurred in the 1950s, including the pink cast iron bath tub. The louvre cupboards would, most likely, be later – perhaps 1970s? The Linoleum floor and fire cement linings would date from the time that the upgrade of facilities occurred. Often, this sort of upgrade coincided with the introduction of the sewer that, broadly, occurred in the late 1950s and through 1960s in Sydney's western suburbs.

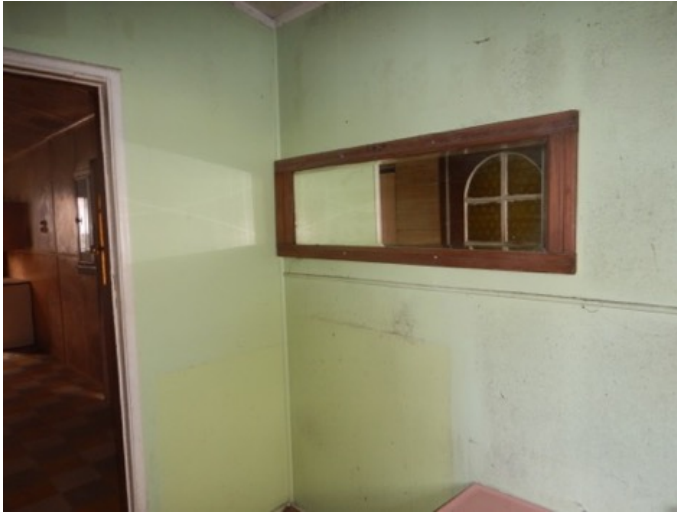
Figure 51 The internal walls of the Bathroom are clad with fibre cement, possibly laid over an original lining.

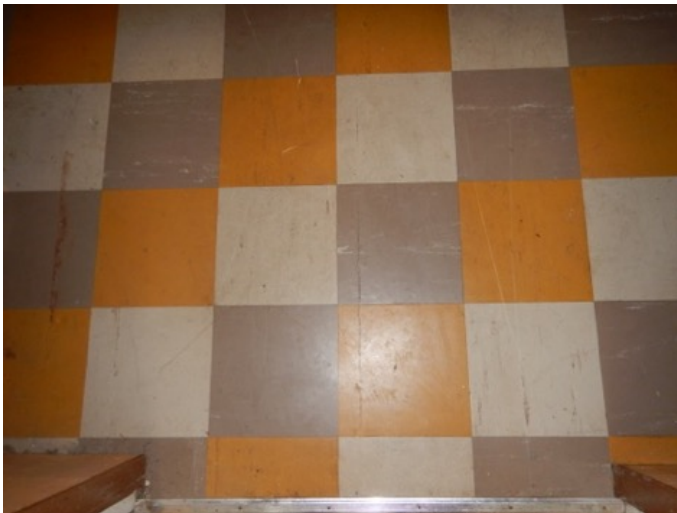
Figure 53 The linoleum or vinyl floor of the Kitchen, probably, dates from the 1950s but is as fresh as the day it was laid.

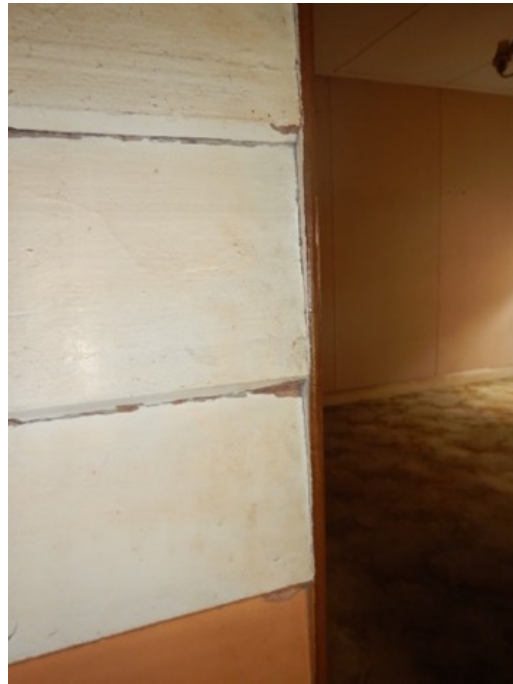
Figure 55 Detail of the weatherboard junction with the reveal of the doorway to the Living Room displays extremely fine craftsmanship.

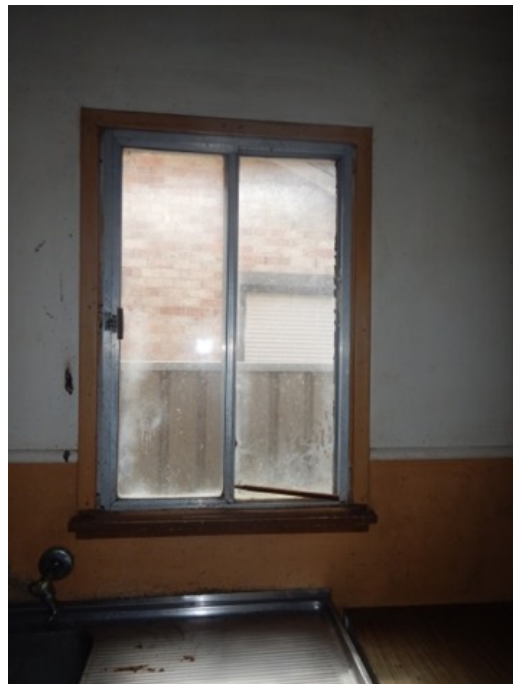
Figure 57 The only aluminium, and non original, window in the house.

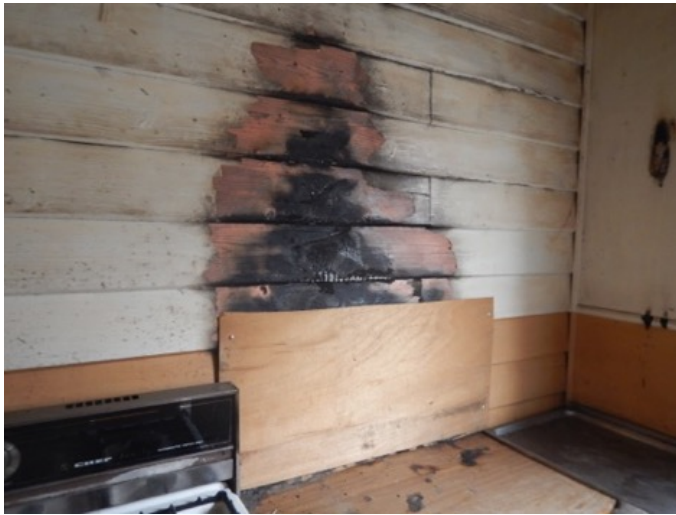
Figure 58 The Kitchen wall has been damaged by a cooking mishap but exposes the timber panelling as pine.

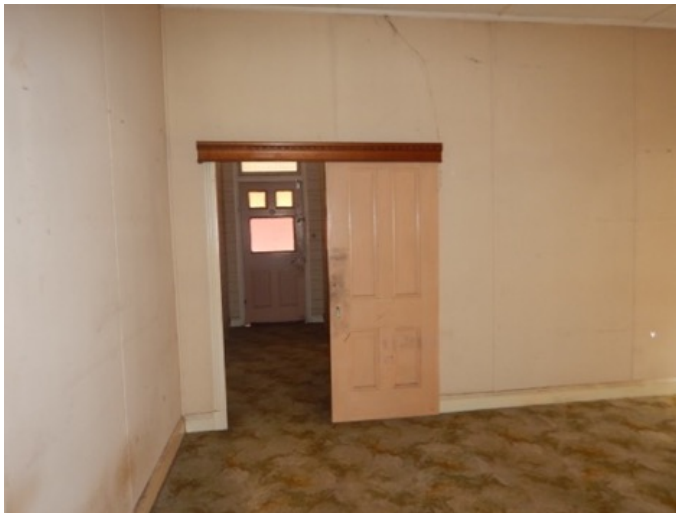
Figure 59 A sliding door is not original and it is probable that this opening did not have a door. The door in the distance is the front door to the house.

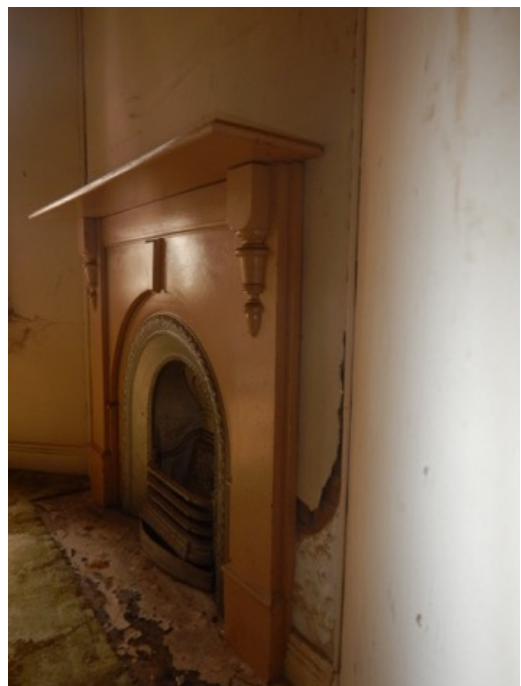
Figure 66 Detail of mantelpiece with loose render exposing brickwork of the chimney breast.

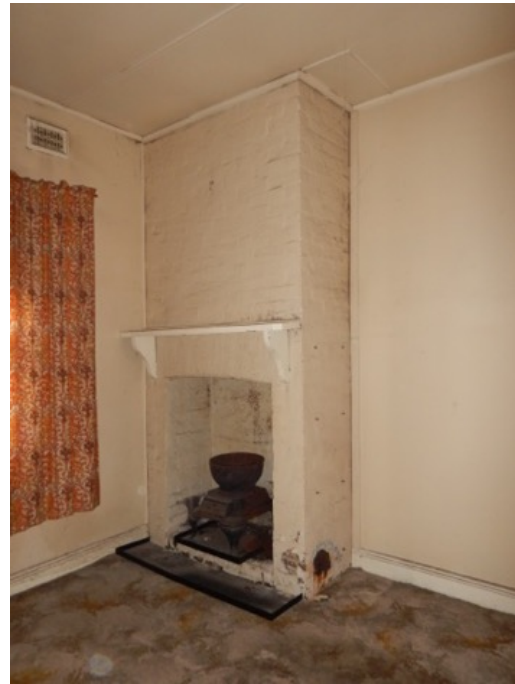
Figure 68 Hearyh for original Kitchen containing a rare wood chip/coke fuel stove of a type that I have not come across before.

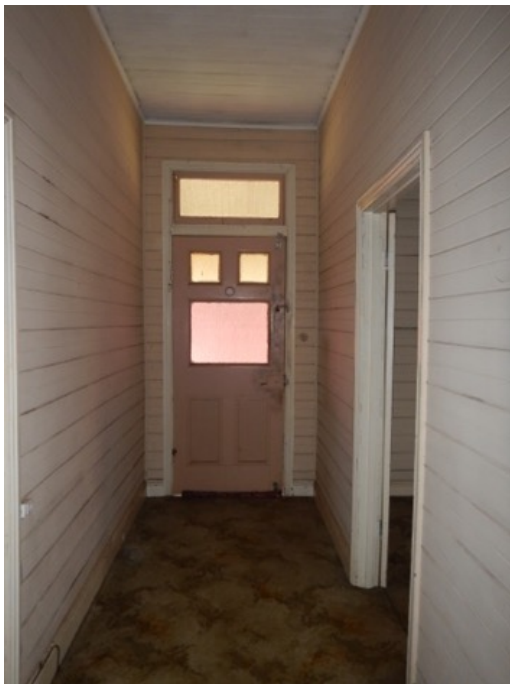
Figure 73 The hallway appears to have been created after completion of the house as the boarding of the passage walls do not match the boarding of the primary walls of the house.

The fact that the boards are the same profile indicates that the passage walls were added, relatively, soon after completion of the original house.

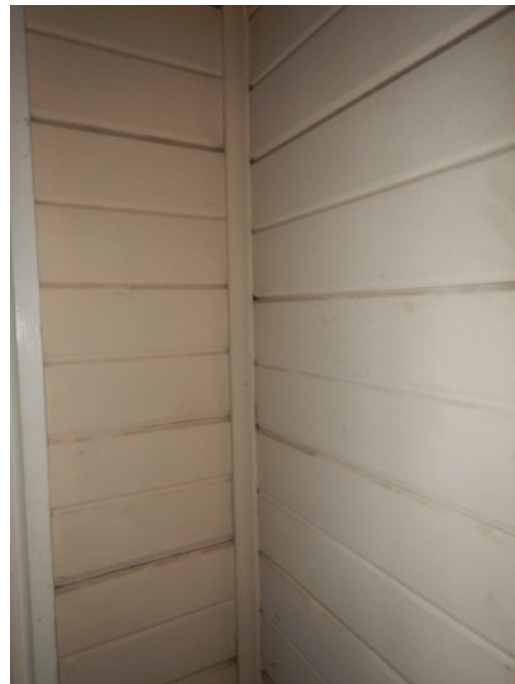
Figure 74 Wall boarding is 'v' jointed tongue and groove profile with a scored 'v' at the centre of the board.

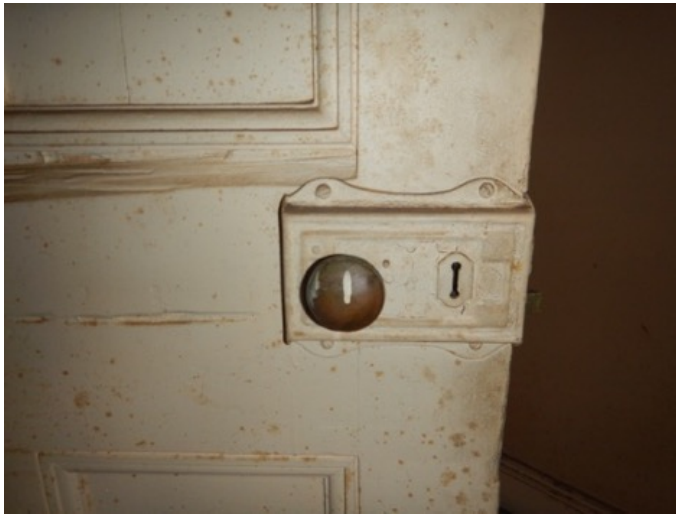
Figure 75 The mortice latch on the former Kitchen door dates from the original house.

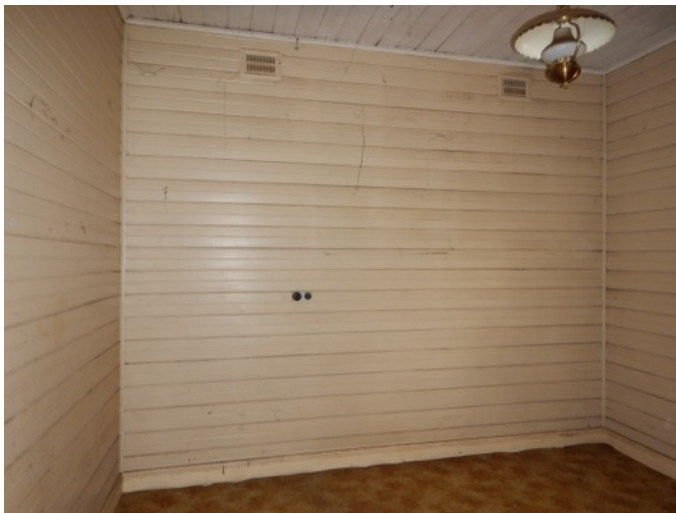
Figure 77 The walls of the front, western side, Bedroom showing the timber boarded walls and ceiling. Note the cavity vents in the outside wall. It is possible that boarded timber walls were oiled rather than painted, as was common at this time.
