**Stage 1 Site Contamination Assessment**

**Proposed Rezoning**

**Lot 2 DP 601094 and Lot 4 DP 825704, 11 and 33 Mumford Street, Port  
Macquarie**

Report No. RGS20683.1-AC\_Rev1

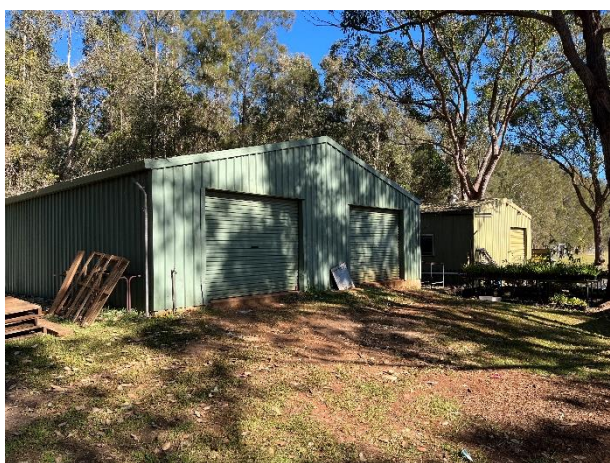
*Lot 4 (TP3): Metal sheds located on the southern boundary that appear to be used for storage of maintenance equipment. The sheds are constructed on a 0.5m high fill embankment.*

It is noted that a fragment of asbestos containing material (ACM) was encountered near the maintenance sheds in the school (Lot 4). An Asbestos Management Plan should therefore be prepared for the site and further investigation is recommended in this vicinity to delineate the potential extent of ACM.

Based on the results obtained in this investigation Lot 4 is considered likely to be suitable for primary school land use with regard to the presence of soil contamination provided the recommendations and advice of this report are adopted, specifically with regards to the presence of asbestos encountered near the maintenance sheds and site preparation works are conducted in accordance with appropriate site management protocols and legislative requirements. Further investigations by a suitably accredited environmental professional is recommended to assess the extent of ACM in the vicinity of the maintenance sheds .

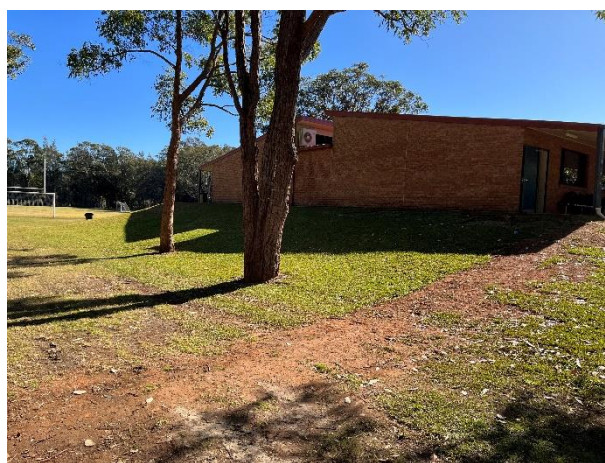
*Lot 4: Single storey brick classrooms in east of Lot 4, constructed on 2m high fill embankment. Red clay soils exposed in embankment.*

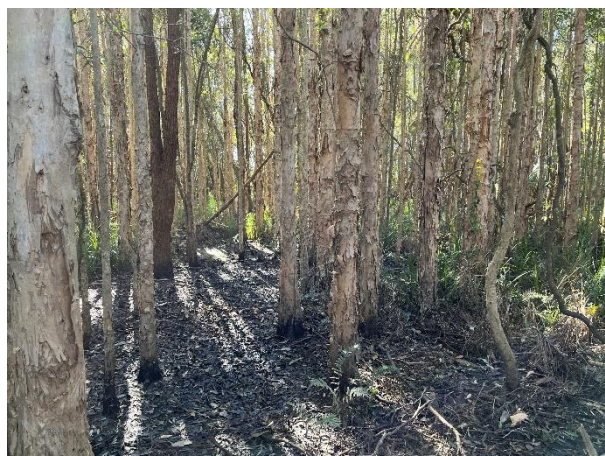
*Lot 4: Low-lying swamp environment to the west of the site.*

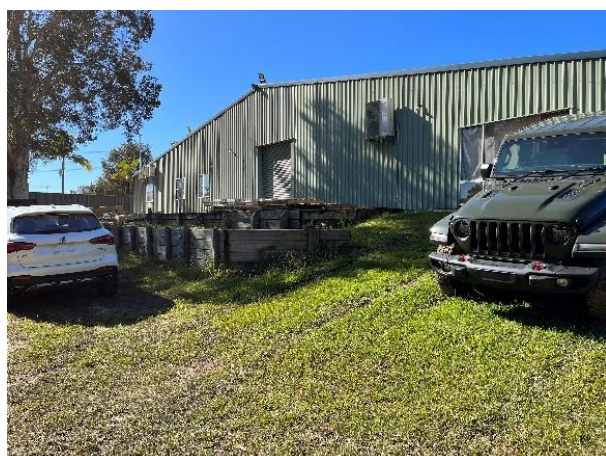
*Lot 2: Large metal clad building on raised fill platform.*

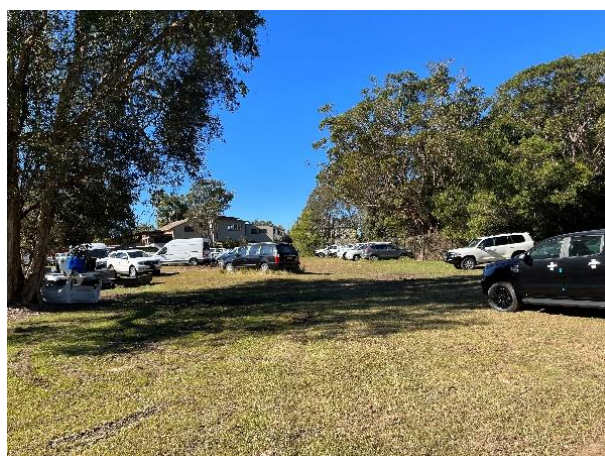
*Lot 2: Various cars being stored on site.*

Since 2017, Lot 2 has been used as a temporary storage facility for new vehicles that are sold from the adjacent car dealership (Andrew Miedecke Hyundai) to the north of Mumford Street. It is understood that there are some trade in cars also present, some of which are in poor condition and are being stored temporarily before being sent off site for disposal. The building is being used to prepare new cars for sale which includes some polishing and cleaning. It is understood that no repairs or car maintenance is being undertaken on site.

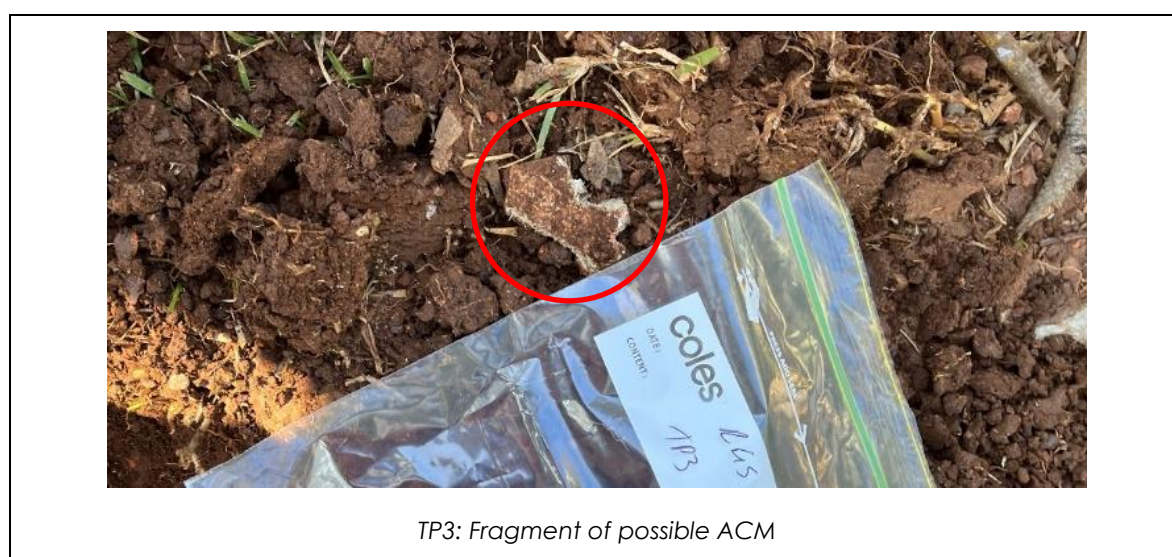
A fragment of fibre cement sheeting product was observed in TP3 and submitted for asbestos analysis. An image of the sample is presented below.

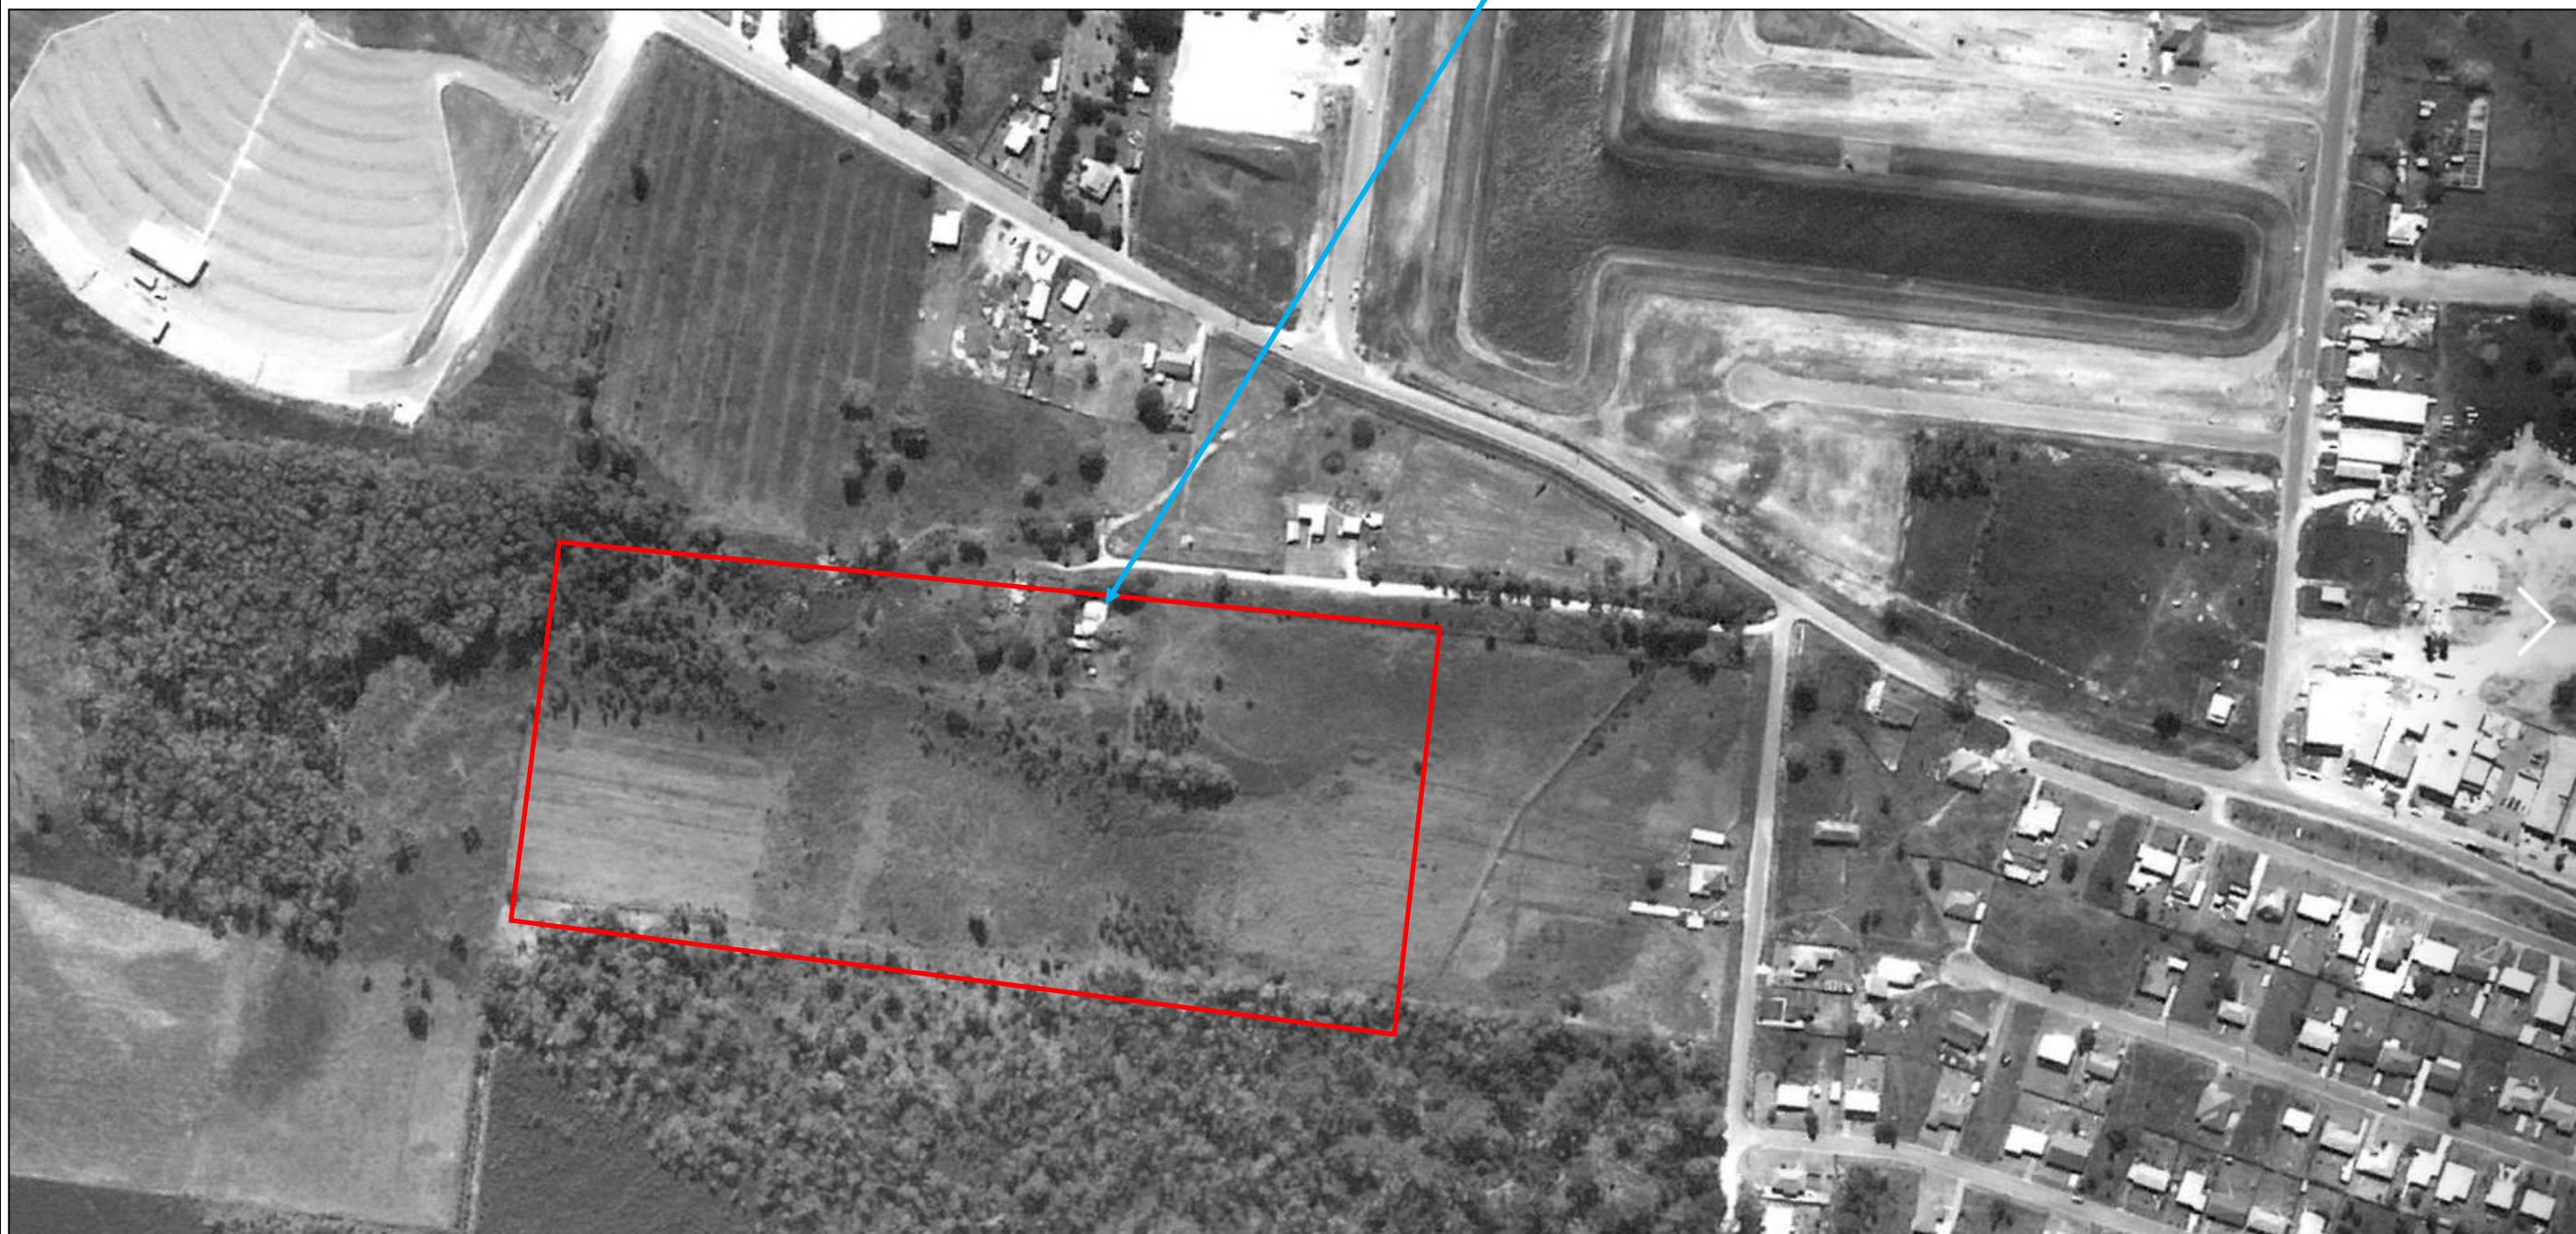
| | | Figure No. | 4 |

| Year | Site | Surrounding Land |
|---|---|---|
| 1975<br>Figure 4 | Vegetation in the south-west corner has been cleared. The farm dwelling and possibly two associated sheds present in north of the site, accessed via Mumford Road. | Mumford Street has been formed as a gravel access place along the northern boundary.<br><br>A caravan park is present to the north west of the site.<br><br>Several structures including a dwelling and surrounding sheds are observed in the adjacent lot to the east. |

Farmhouse demolished and  
filling works being undertaken

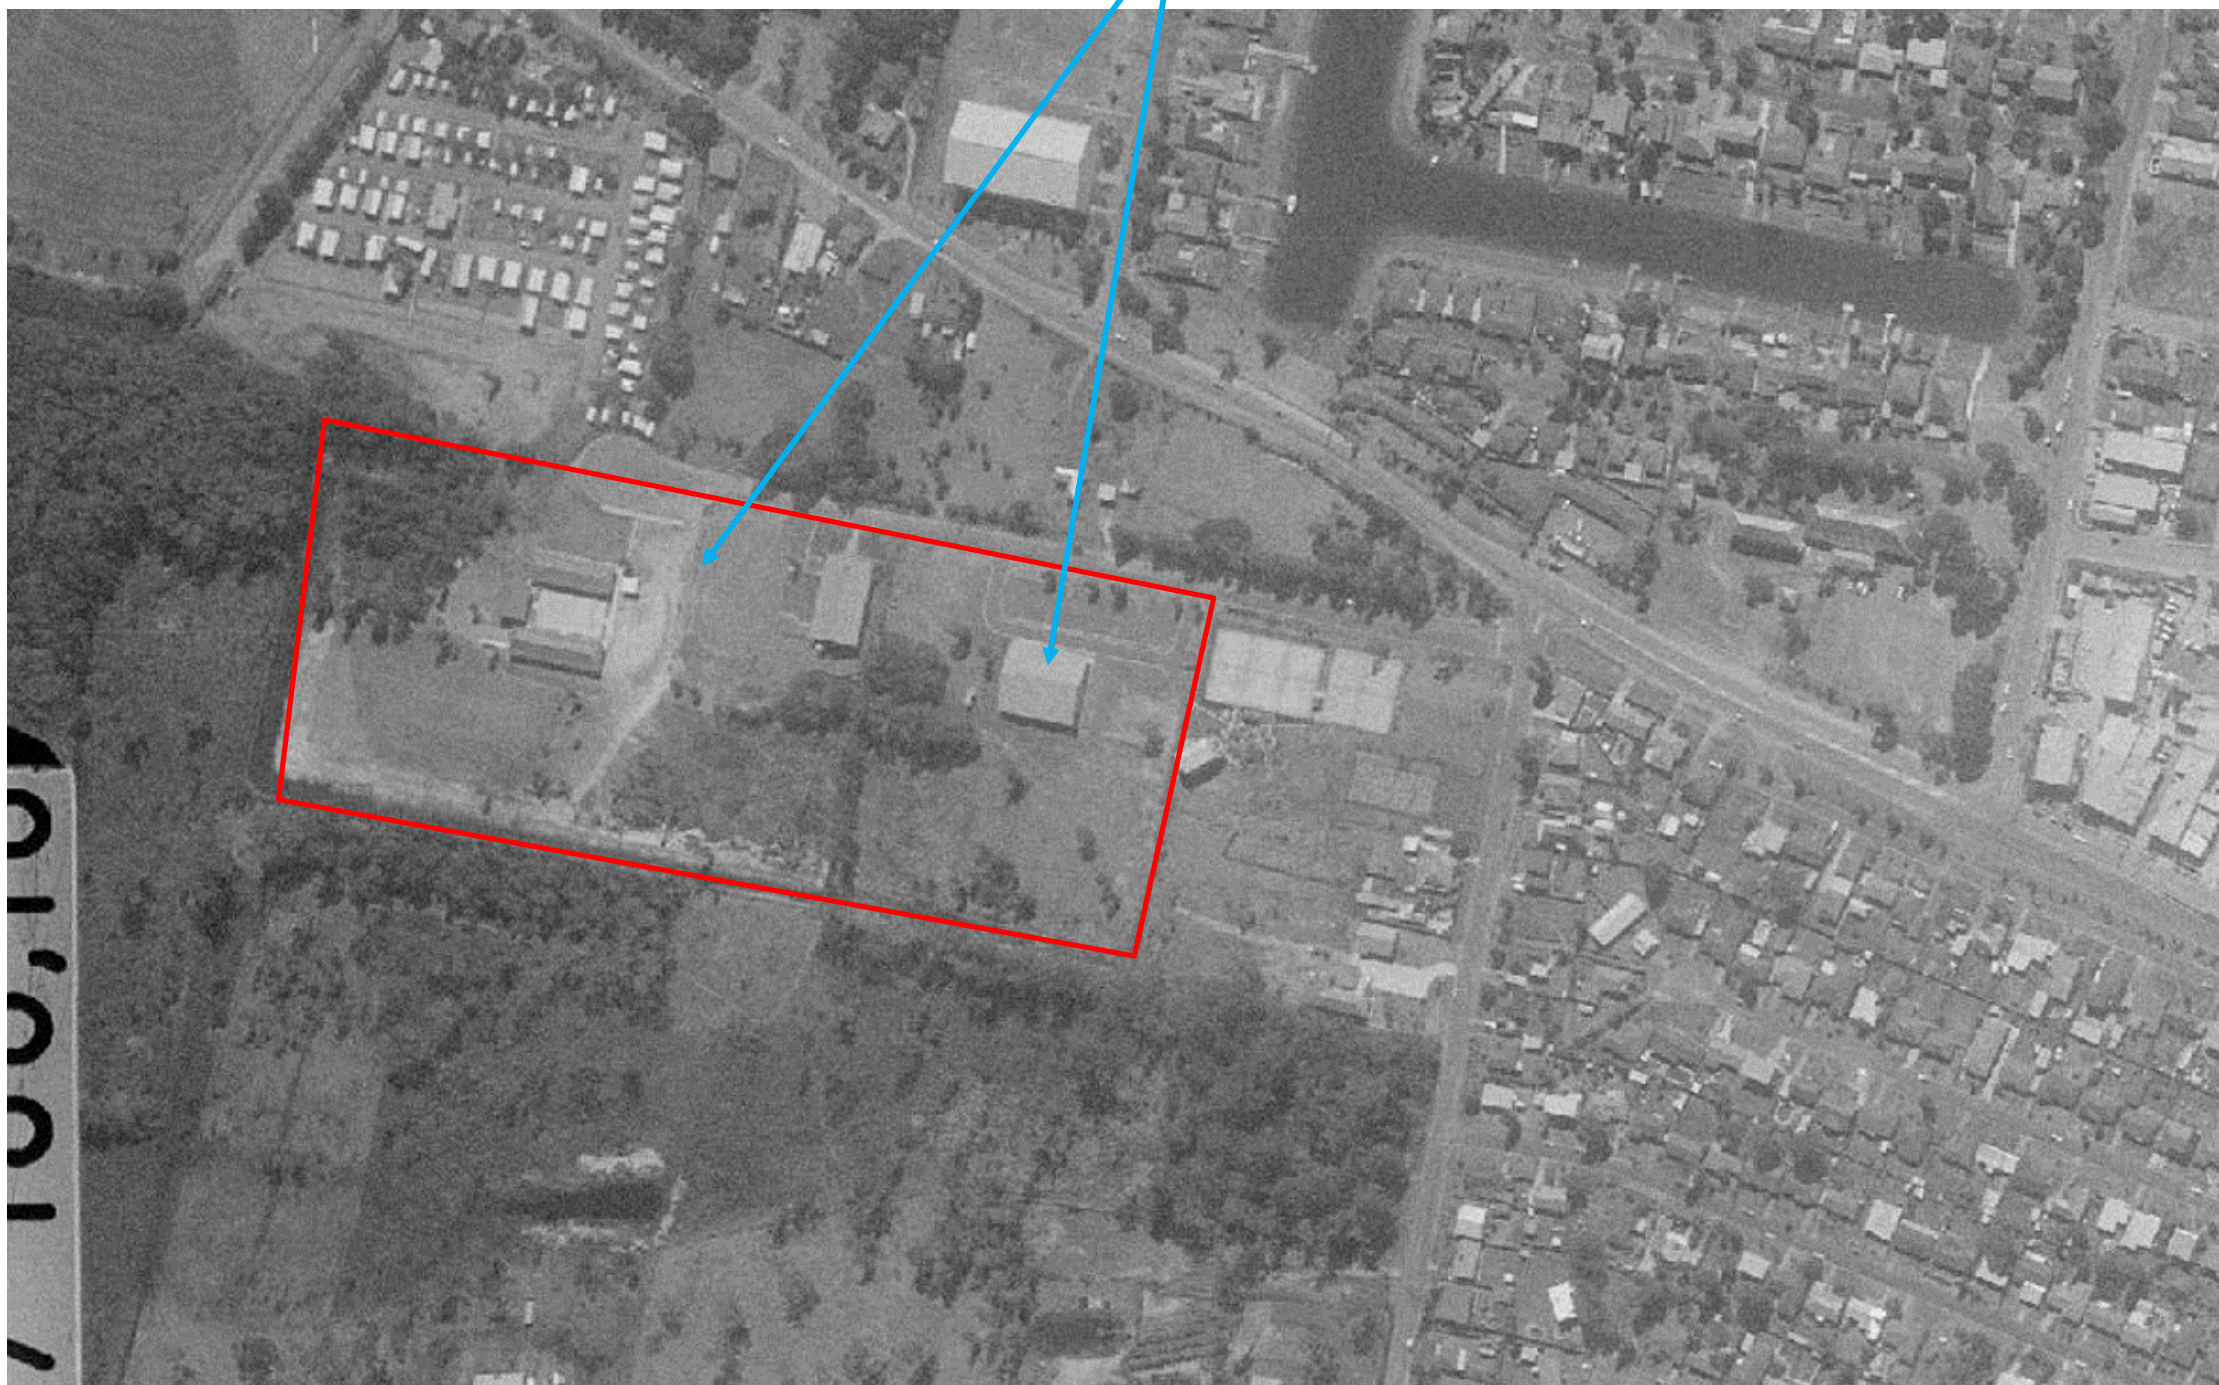
| | | Figure No. | 6 |

School buildings present in Lot 4 and  
large building present in Lot 2

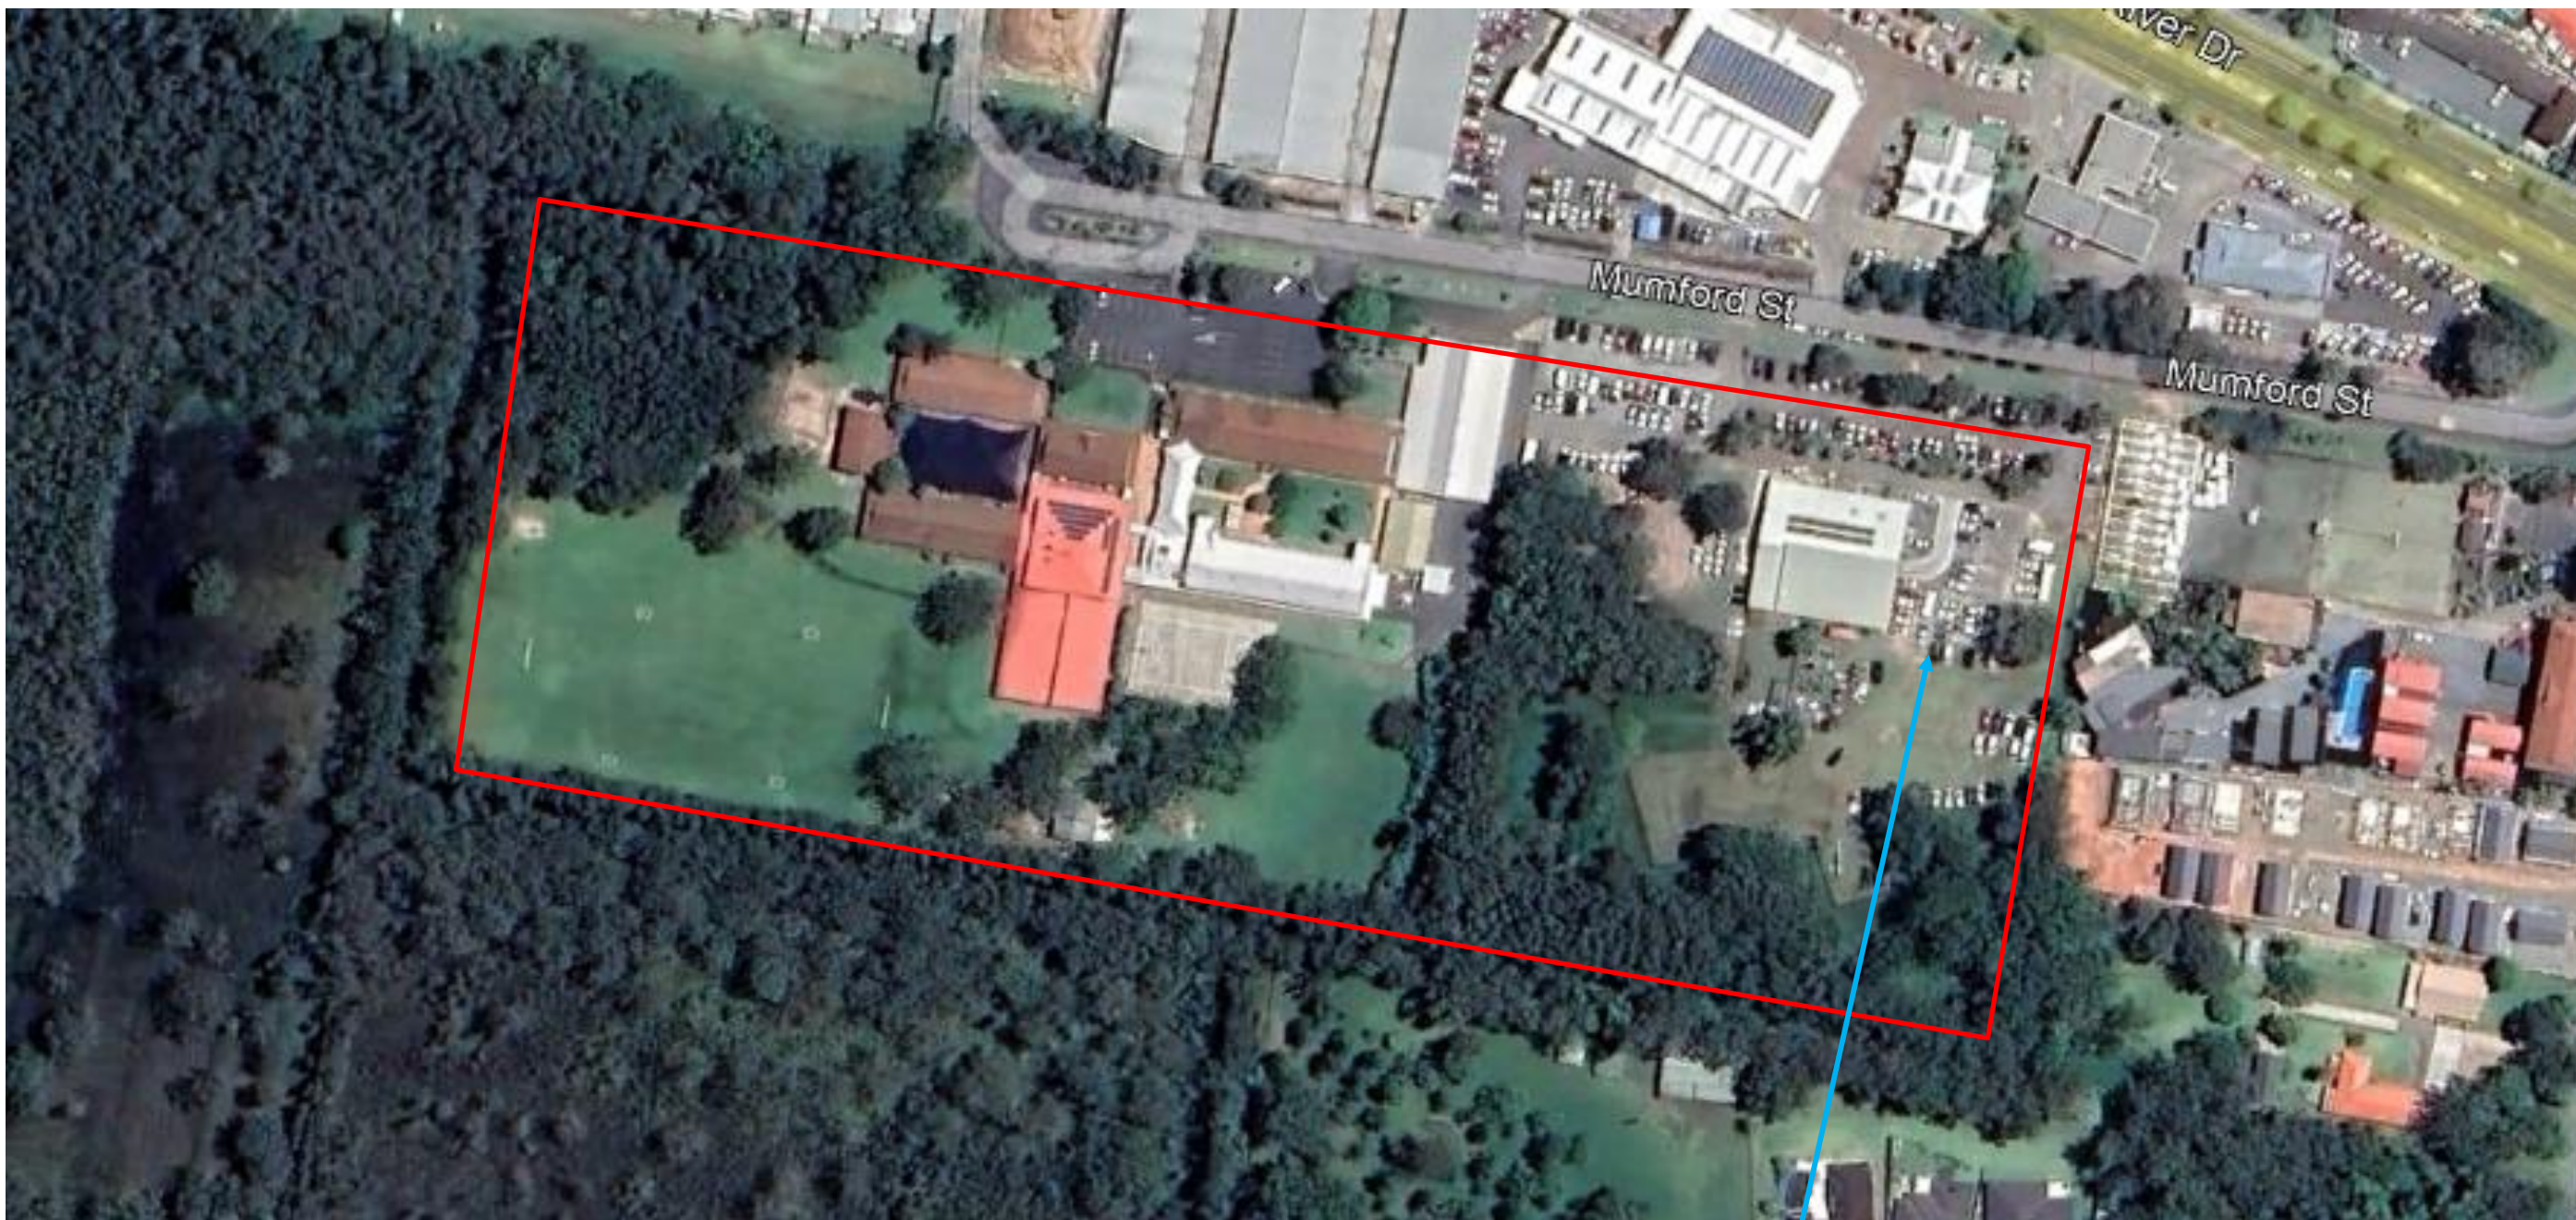
Cars from car dealership being temporarily stored onsite
