# Detailed Site Investigation Report

## 44 Middle Arm Road, Middle Arm

Reference No:	DSI2023-219
Report Date:	26 April 2023
Prepared by:	CSH Consulting Pty Ltd

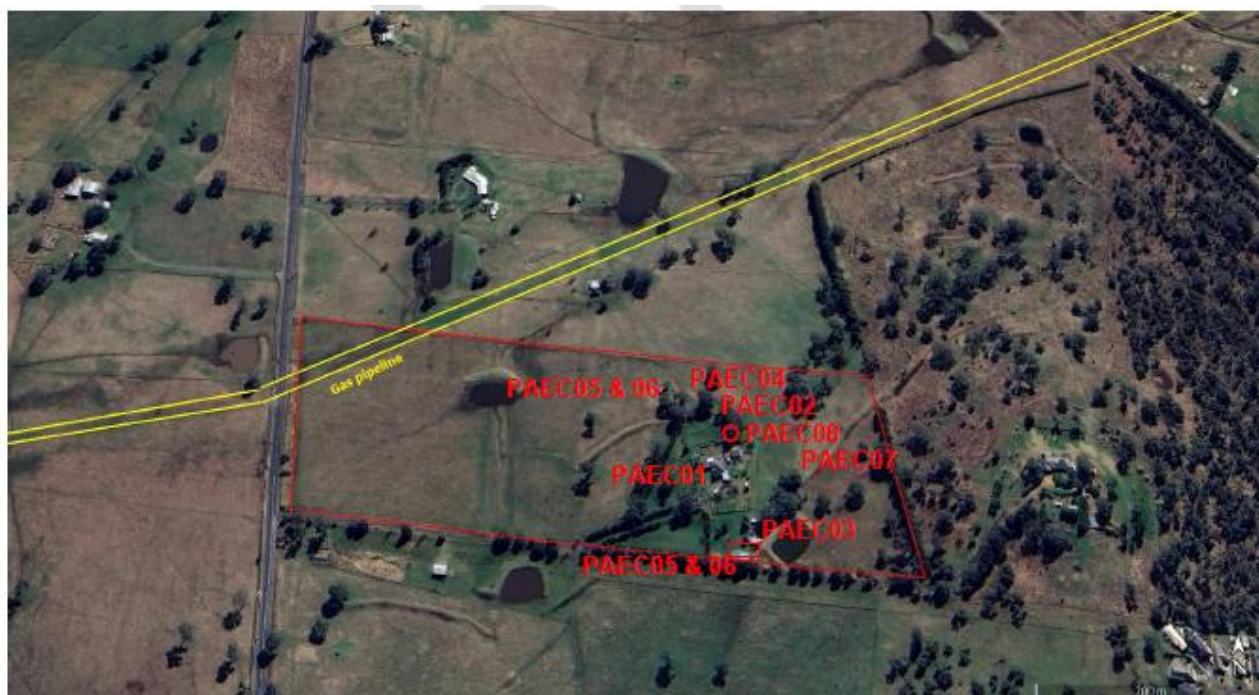
Figure 3: Approximate locations of potential areas of environmental concern (PAEC).

Table 3: Potential areas of Environmental Concern (PAEC) identified during investigation of site		
PAEC No	Area descriptor	Potential contaminants
PAEC01	Residential house	Asbestos; SMF; lead (paint) and polychlorinated biphenyls (PCBs)
PAEC02	Under concrete cricket pitch	Metals; total recoverable hydrocarbons (TRH); benzene, toluene, ethylbenzene, xylene (BTEX); polycyclic aromatic hydrocarbons (PAHs); PCB; Organochlorine pesticides (OCP); phenols and asbestos
PAEC03	Holding pen at rear of house	TRH; BTEX; PAH; OCP and other herbicides
PAEC04	Rubble in North East corner of yard	Asbestos and lead (paint)
PAEC05	Chemical containers behind shed next to fireplace to the South of the house and shed North West to house	TRH; BTEX; PAH; OCP and other herbicides
PAEC06	Internal sections of sheds to the South and North West of the house	TRH; BTEX; PAH; OCP; asbestos; lead (paint) and other herbicides
PAEC07	Area where dam was filled in, East of the house	Metals; TRH; BTEX; PAH; PCB; OCP; phenols and asbestos

PAEC08	Septic tank to the North of the House	Metals; TRH; BTEX; PAH; PCB; OCP; phenols and asbestos

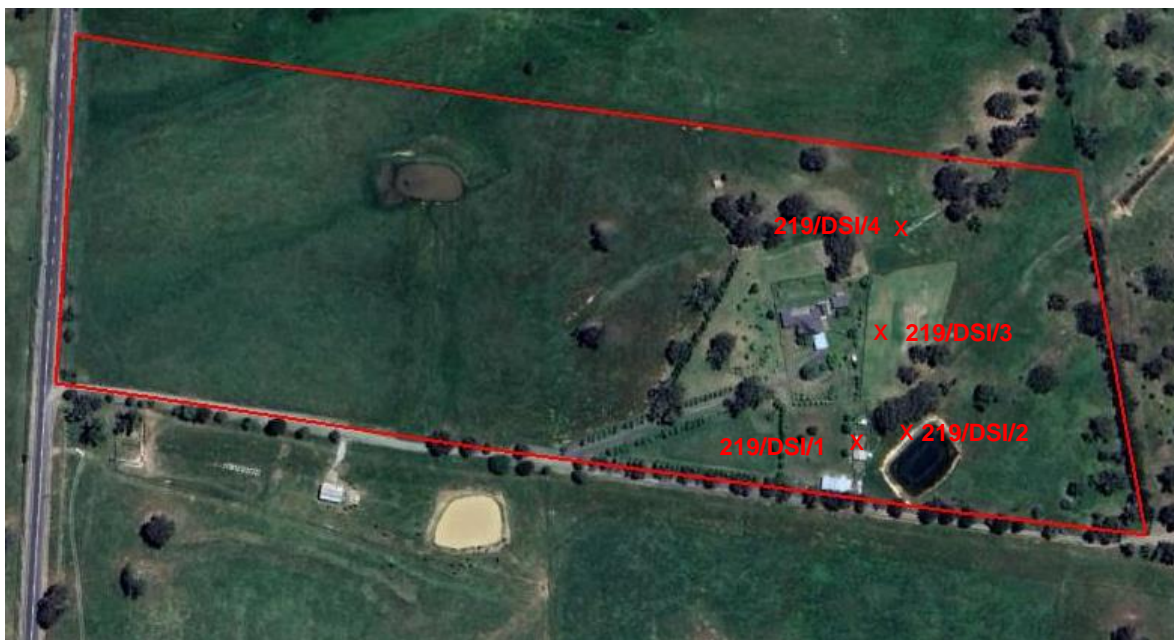
**Figure 2: sample locations**

One sample from locations PEAC03: Holding pen (219/DSI/1), wall of dam (219/DSI/2), PEAC07: filled in dam East of house (219/DSI/3 and PAEC02: cricket pitch (219/DSI/4) were taken by digging a hole at the surface level (see figure 2 for sampling locations). Soils were collected using a stainless steel shovel cleaned after every sample, and contained in virgin high strength plastic sample bags, 250 mL virgin glass jar with Teflon sealed screw caps and virgin asbestos sample bags. All samples were labelled at the time they were taken. Samples were immediately stored in cooled storage bins prior to being delivered to the environmental laboratory under strict Chain-of-Custody conditions.

Based on the analysis report No 319626 by Envirolab, all values reported are below the relevant criteria from the documents above. A summary of results in comparison to the assessment/investigation criteria can be found in Appendix A. The Analysis results for Report No 319626 can be found in Appendix B.
