1 King St, Concord West

Aboriginal Heritage Due Diligence Report

Draft Report

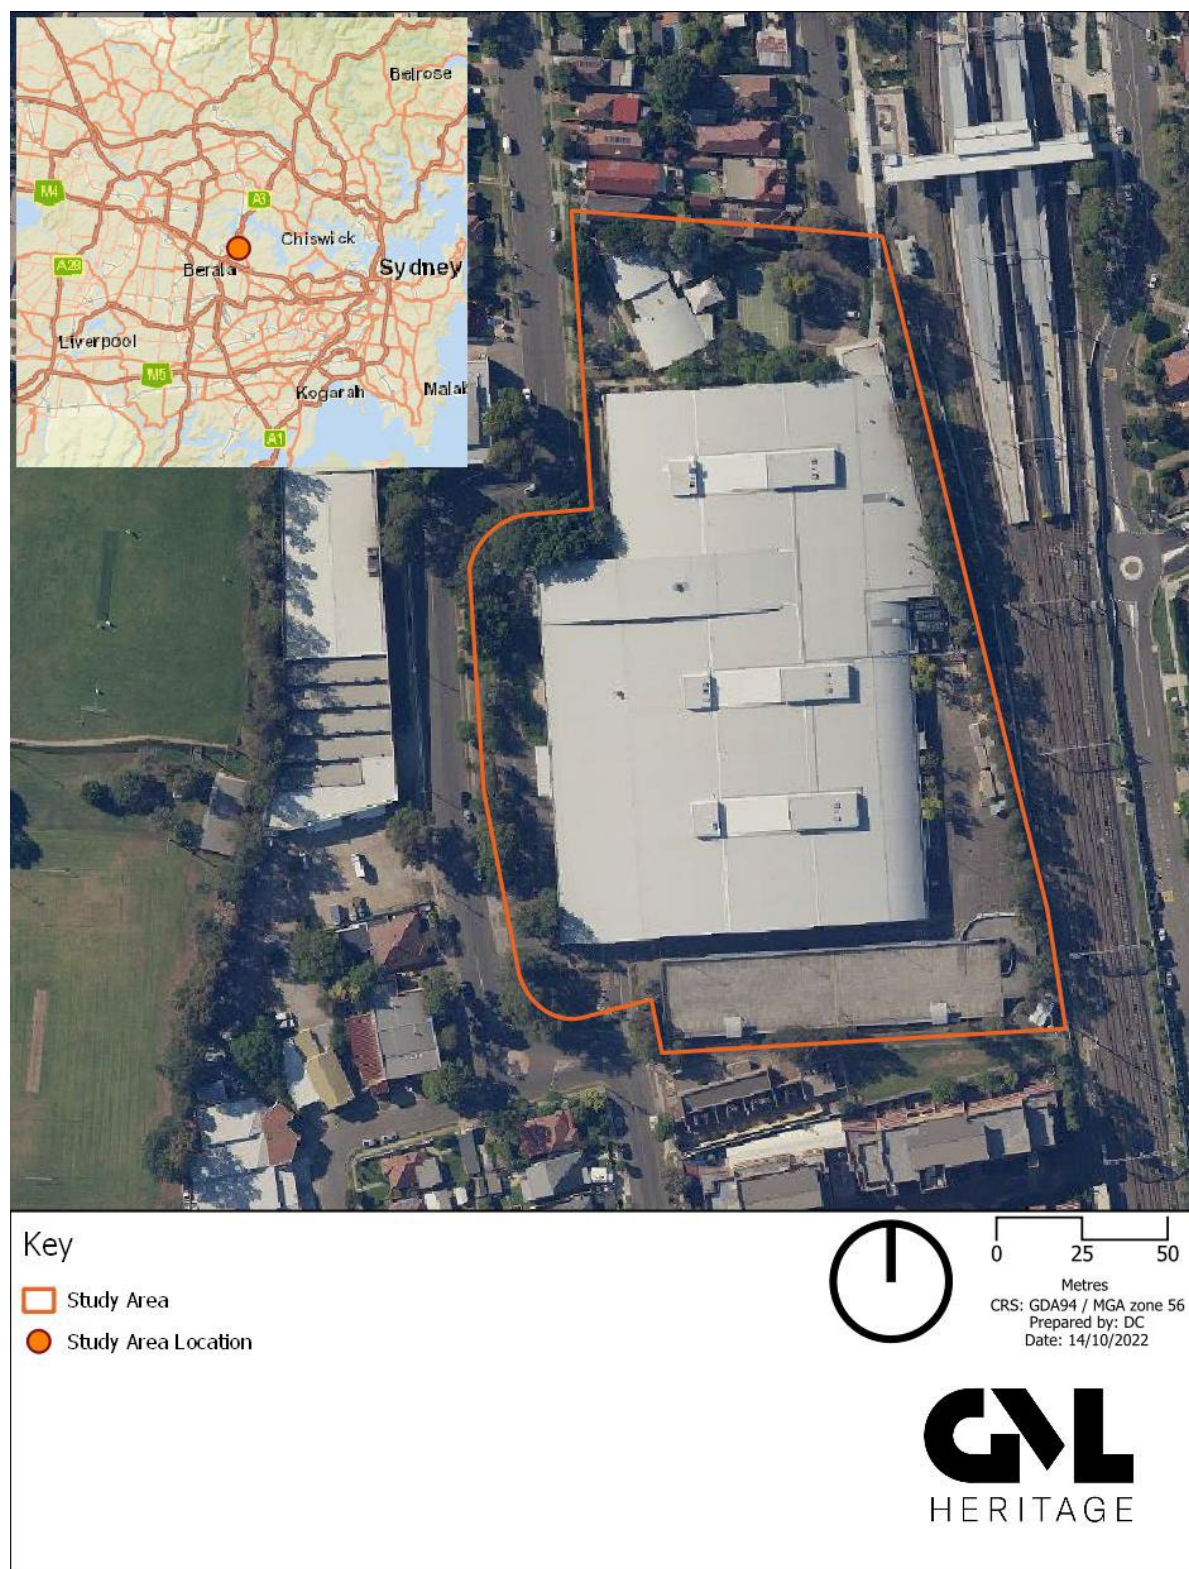
Figure 1.1 The study area. (Source: GML 2022, over NSW Land Registry Services imagery)

The study area is 1 King Street, Concord, Sydney, NSW. The study area comprises Lot 101 of DP791908. The study area is bound by George Street on its west, a railway corridor to its east, and residential lots north and south. The study area is shown in Figure 1.1.

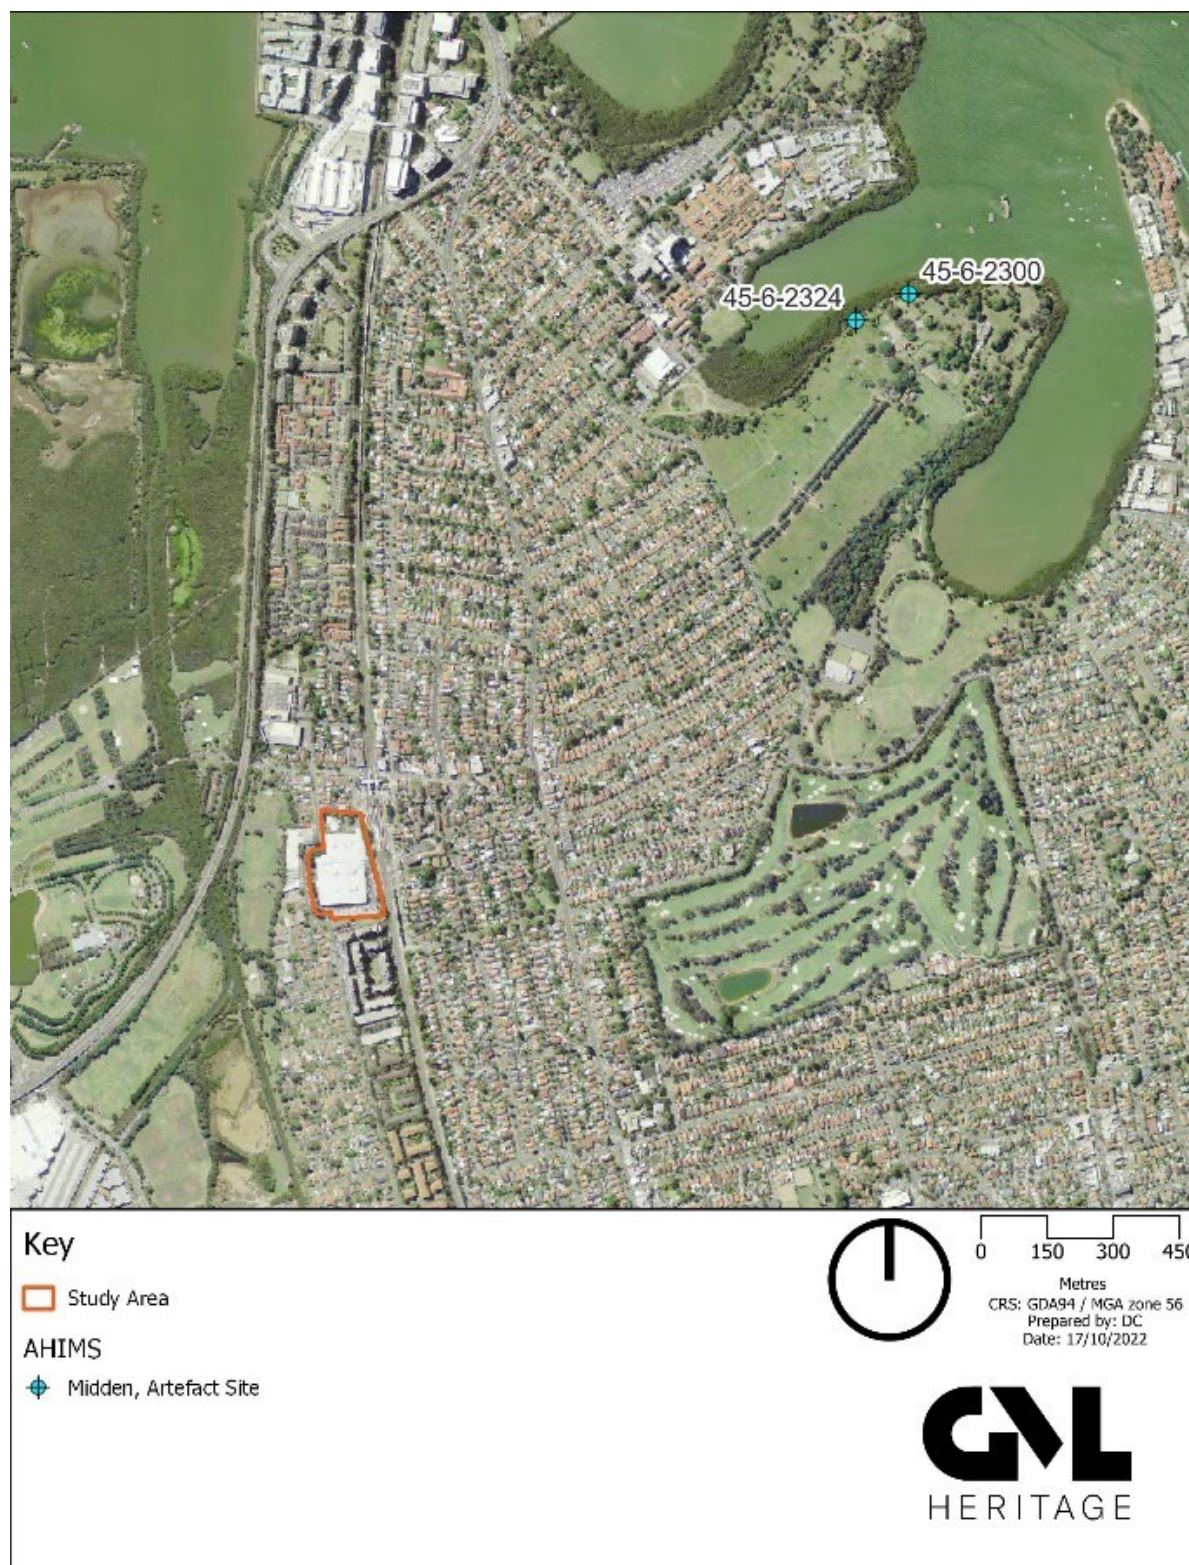
Figure 2.2 Detail of the AHIMS search results. (Source: GML 2021, over Nearmap)

A search of the Heritage NSW Aboriginal Heritage Information Management System (AHIMS) database was undertaken on 14 October 2022 (reference number 22-0363_v2; Appendix A). The search covered a zone from E317406 to 328206 to N6247438 6258238 with no buffer. The results of the search are shown in Table 2.1, Figure 2.1 and Figure 2.2. A total of 102 Aboriginal sites/places were identified.

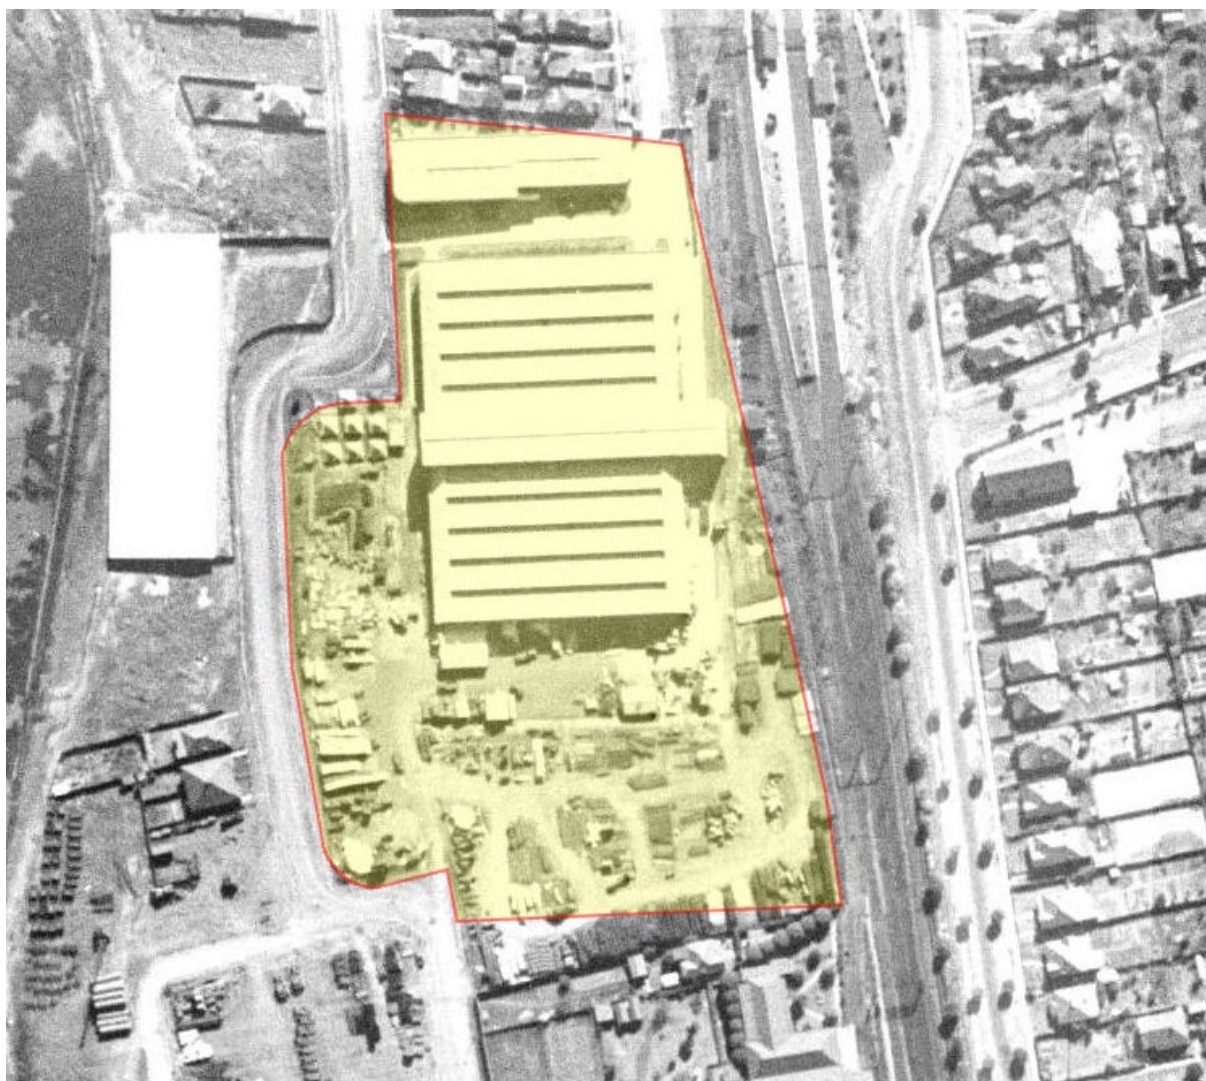
The study area is surrounded by gently undulating low-lying hills with a modal terrain slope of 3–4% south-westwards. Current and historical aerial imagery (Figure 2.4) shows that these landforms have been extensively modified or even removed by previous development. Most notable of these is the rail corridor to the east of the study area where the landform has been removed.

The study area itself and developments to the west also show evidence of this development. By 1943 the study area and the area to the west had been cleared of all vegetation, and a commercial building had been constructed in the study area (Figure 2.4). Over the following decades a carpark was constructed in the study area and, to the west of the study area, a road and several further buildings were constructed. The construction process would have involved the levelling, and thus partial removal, of soil horizons.

Figure 2.4 1943 aerial photograph, showing the extent of works and development across the study area. (Source: GML 2021, over SIX Maps viewer)

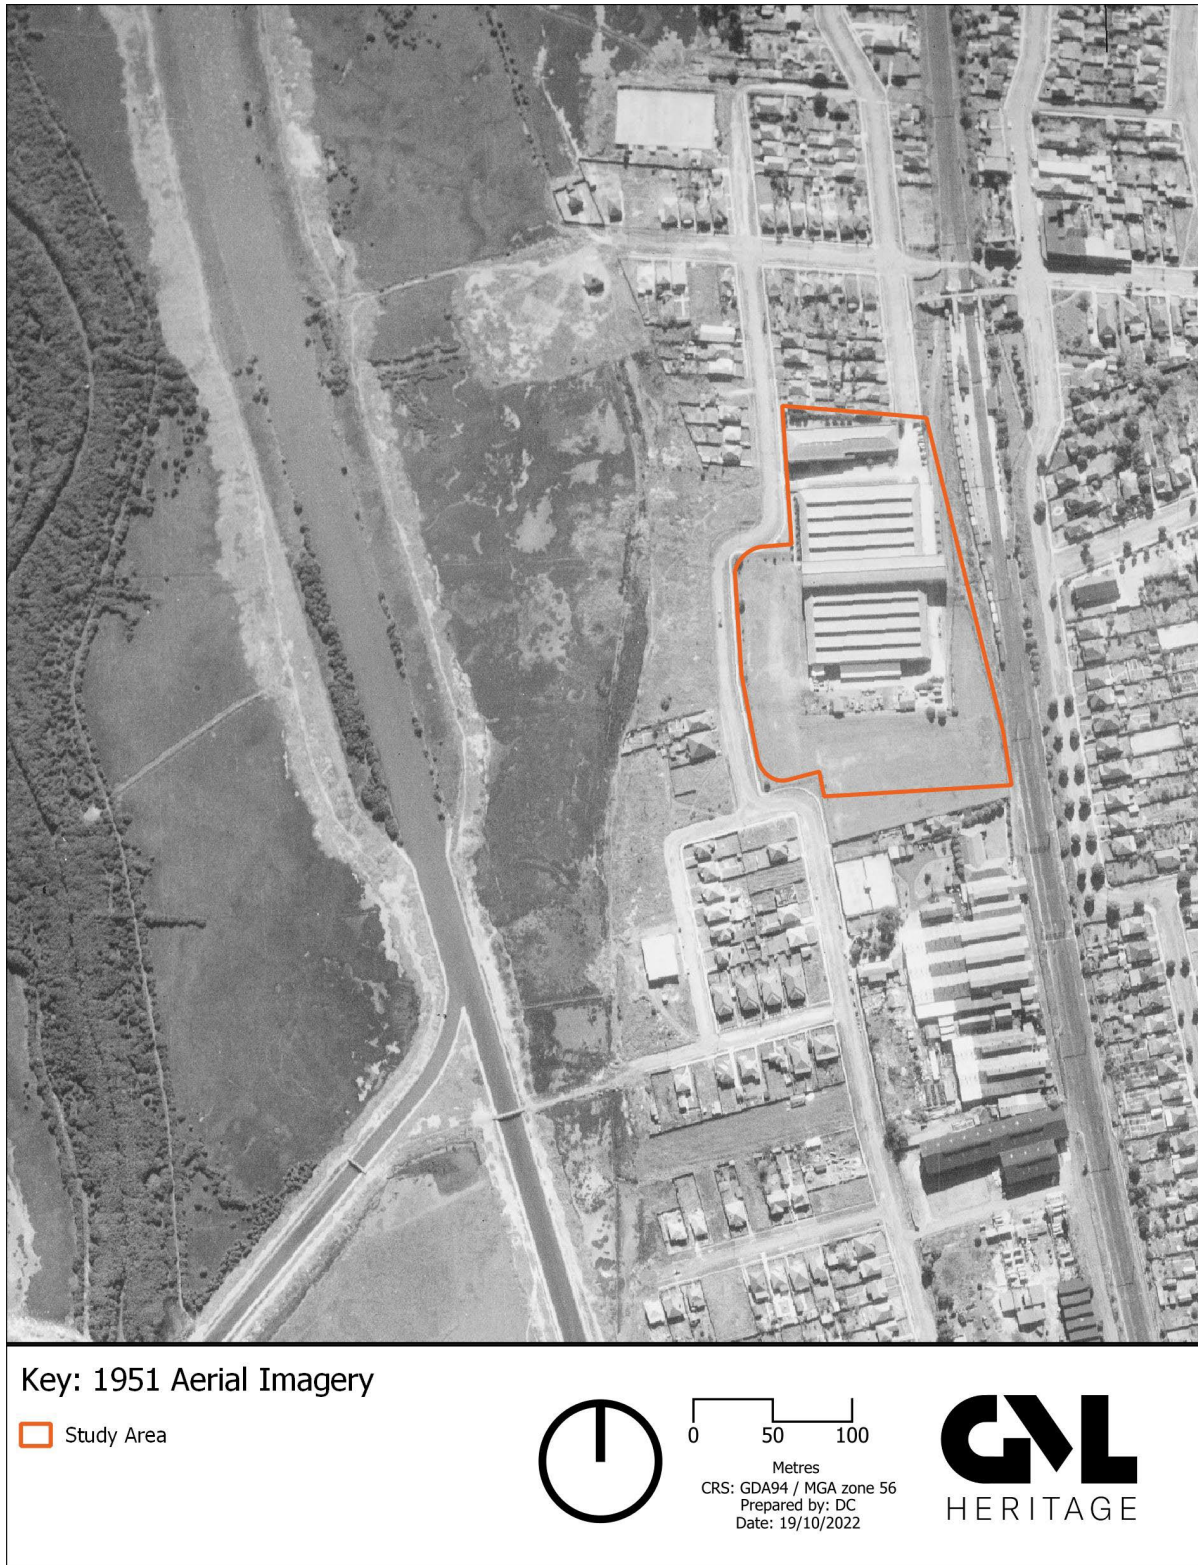
Figure 3.1 1951 aerial photograph. (Source: GML 2022 over NSW Historical Imagery Viewer)

Reclamation projects continued through the late twentieth century, including the installation of a bund wall in the wetlands. Mangroves began to dominate the wetlands, and saltmarsh was largely restricted to a spoil pile from dredging activity in Homebush Bay (Figures 3.1 to 3.3).⁵ By 2000, most of the southern portion of the wetlands had been reclaimed. The canal that restricted Powells Creek has since been removed north of the wetland boundary. The late twentieth century saw further development across Concord West. The study area has had permanent structures built on it since at least the 1940s and the current structure was built in 1987.

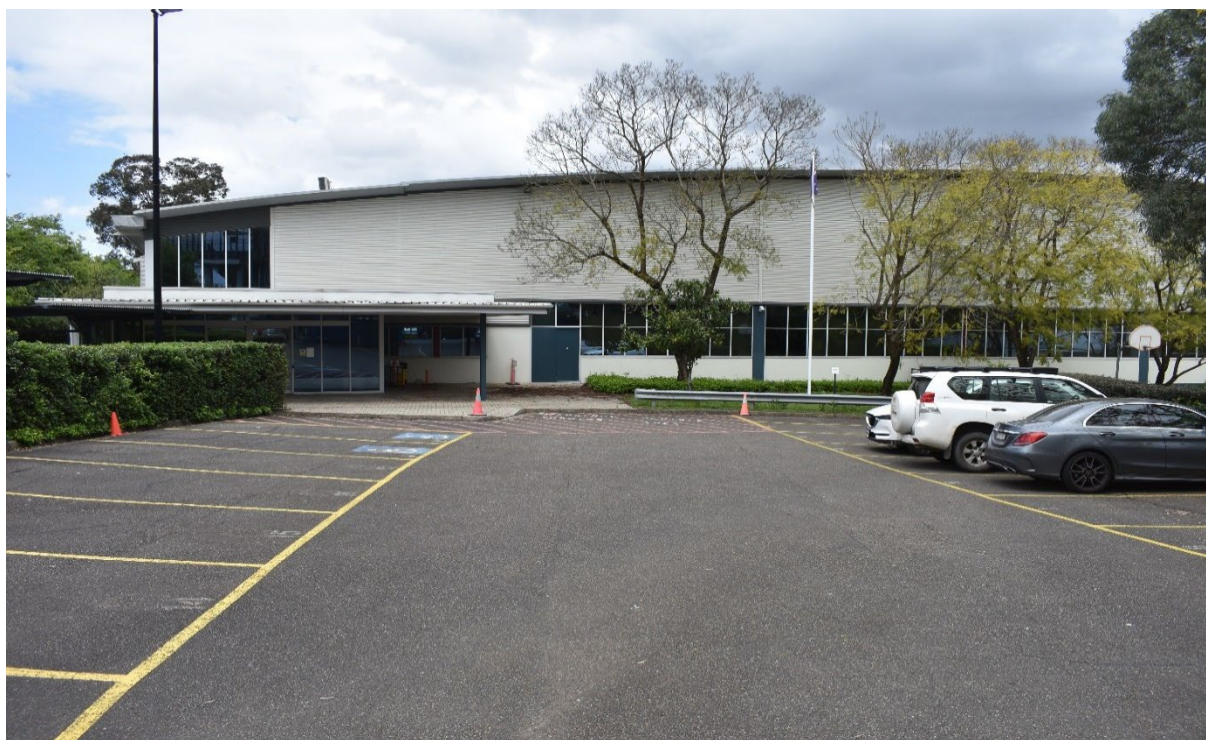
Most of the study area is occupied by a large commercial building (Figure 4.1). Impacts associated with the construction of this building would have removed original soil horizons, and thus any archaeological deposits within its curtilage. Around the exterior of this building further impacts were observed.

Figure 4.1 Carpark in northeast extent of study area.

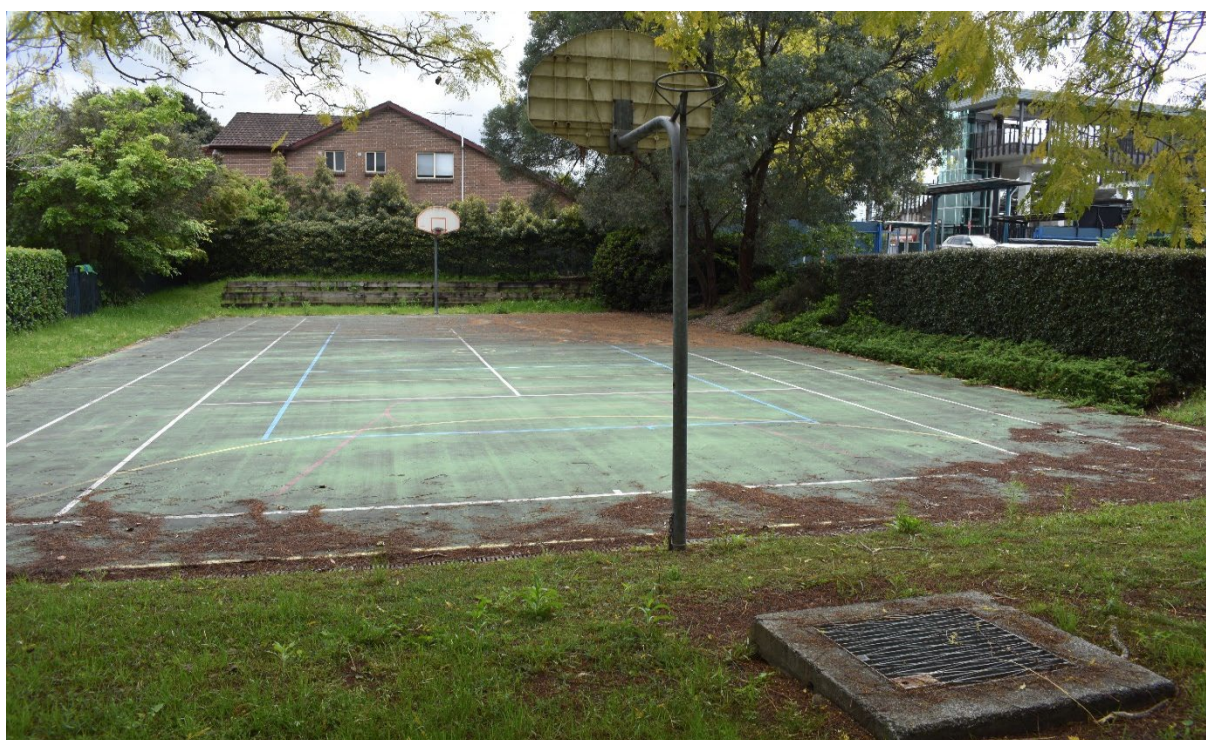
Figure 4.2 Sports field in north of study area.

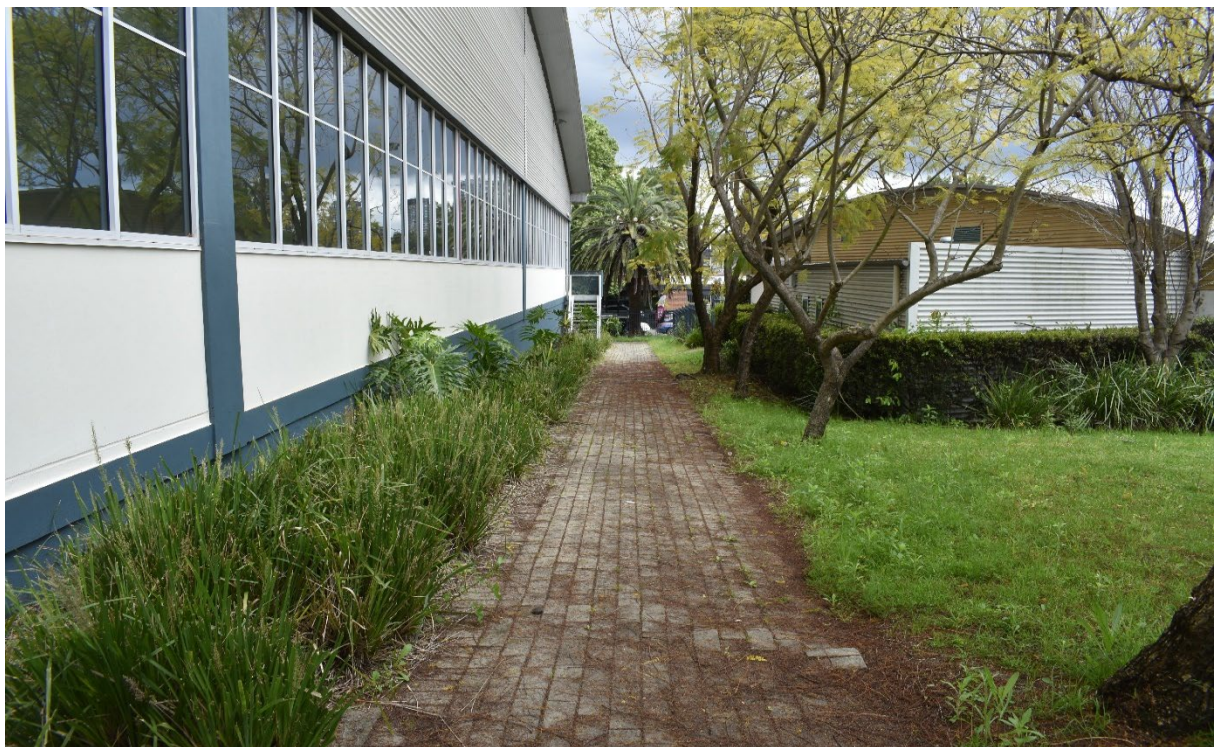
Figure 4.3 Warehouse and childcare centre in north of study area.

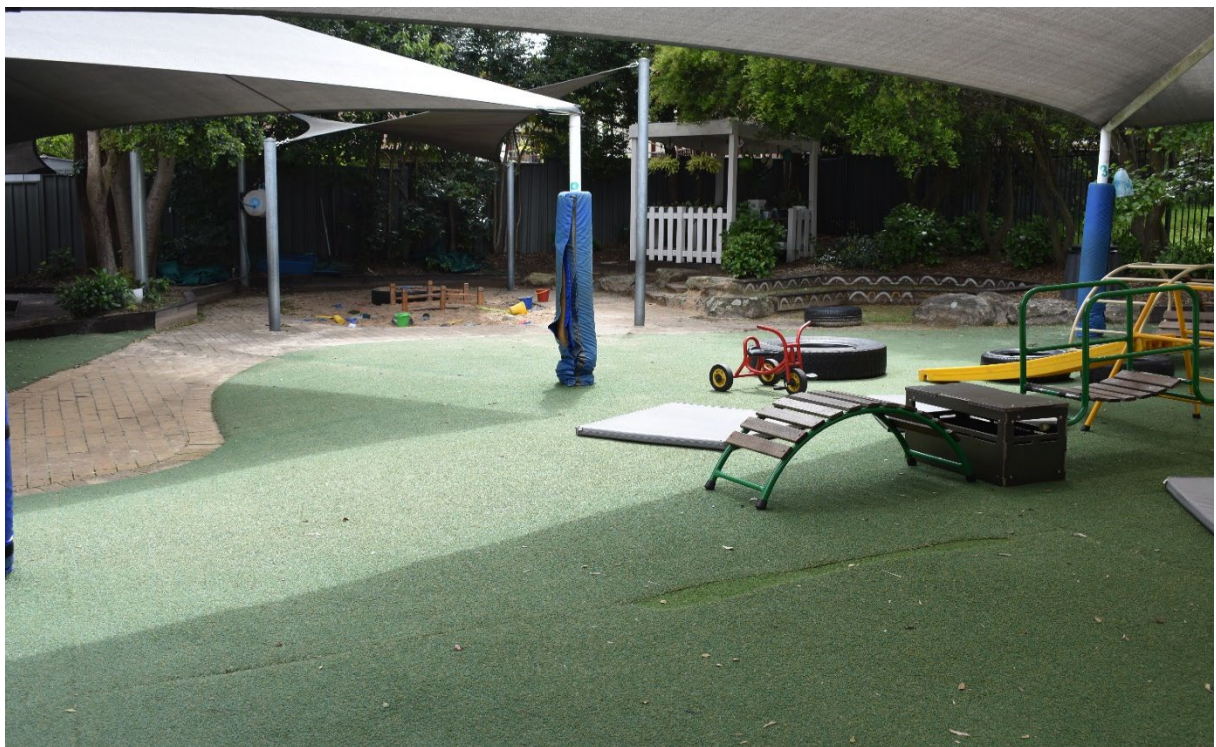
Figure 4.4 Modified ground surfaces in childcare centre.

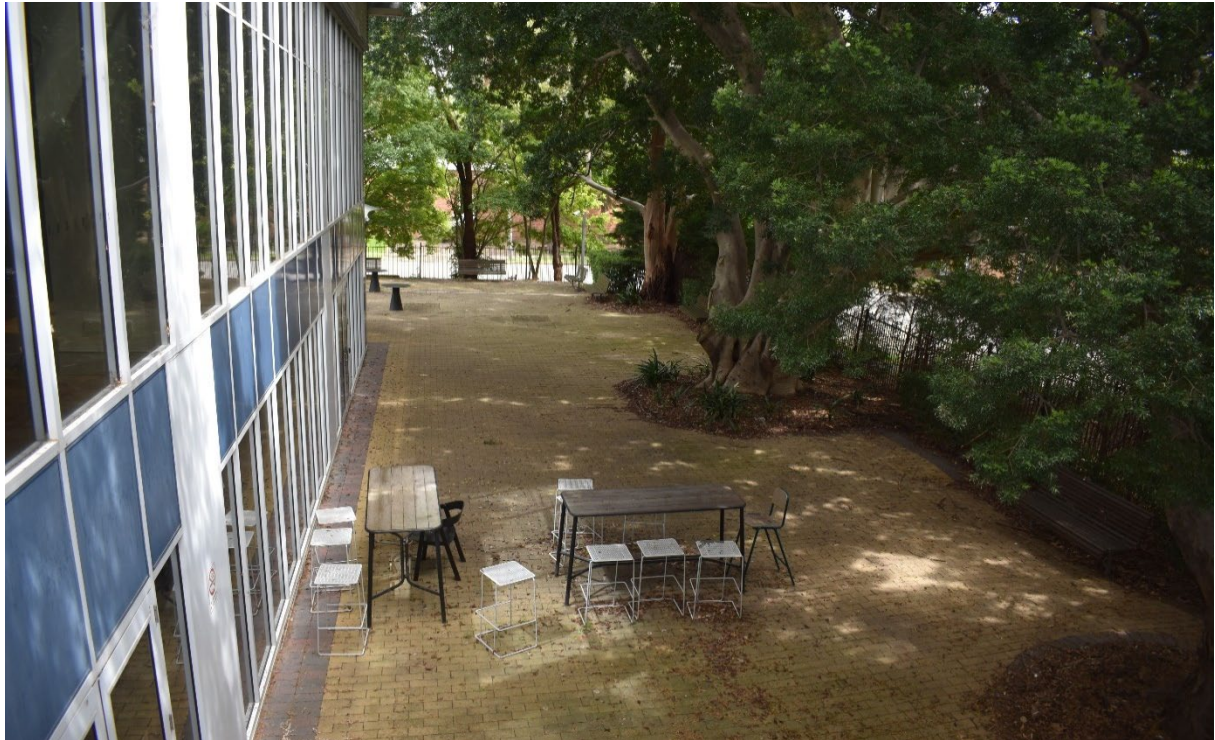
Figure 4.5 Exterior ground surfaces in west of study area.

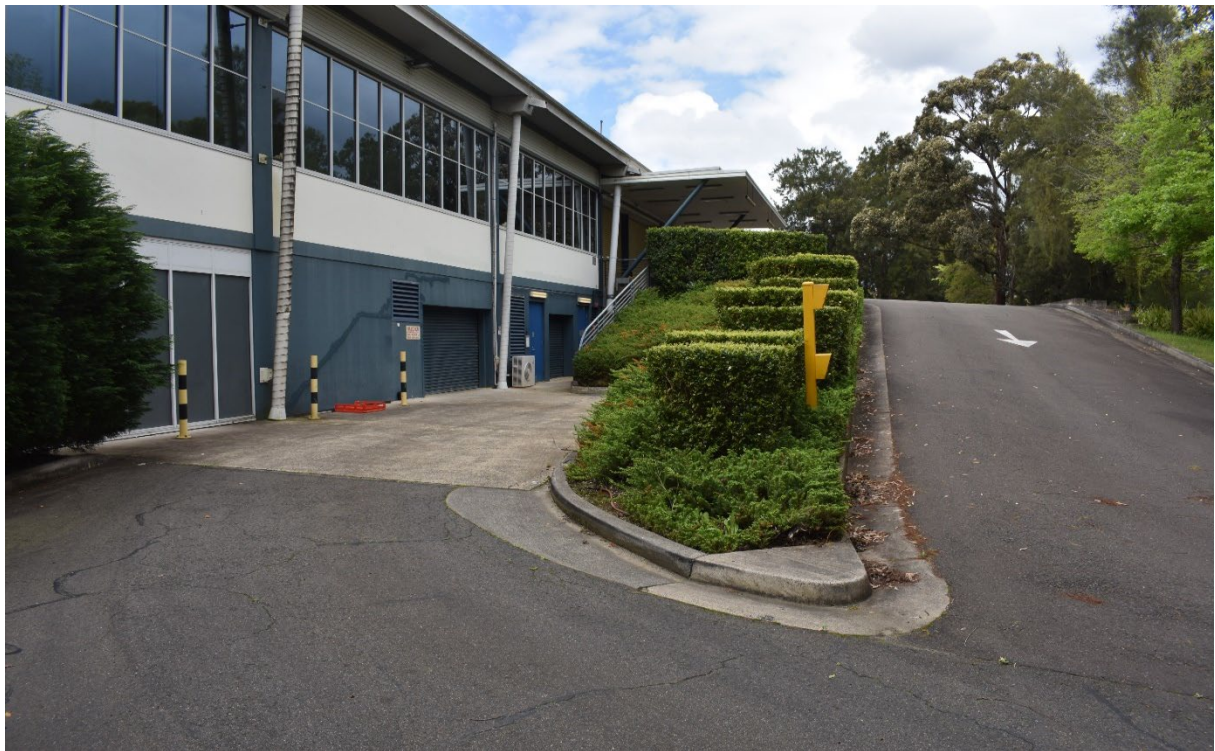
Figure 4.6 Extensive landscaping in southwest of study area.

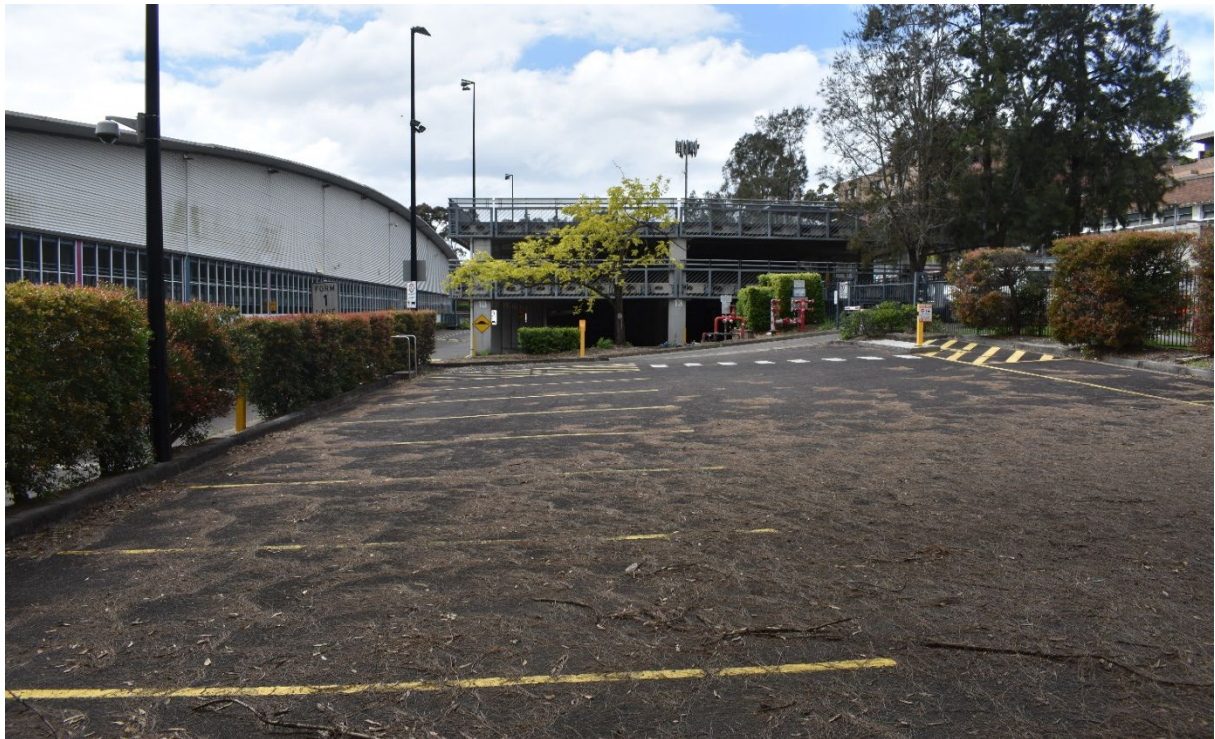
In the south of the study area the construction of exterior carparks and a large multistorey parking structure represent significant impacts to ground surfaces (Figure 4.7). These impacts are present in the southwest where modifications to the landform from the construction of the rail corridor can be observed (Figure 4.8).

Figure 4.7 Sealed road surfaces and multilevel parking structure in south of study area.

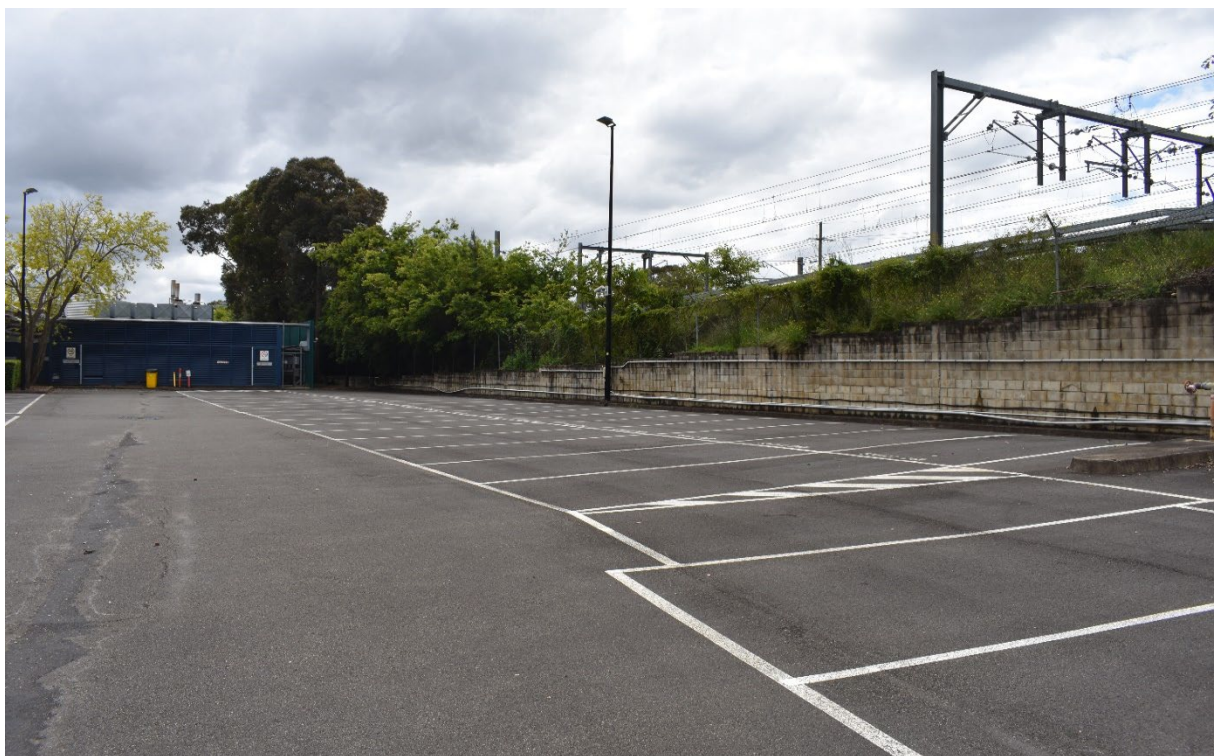
Figure 4.8 Ground surfaces in southwest of study area.

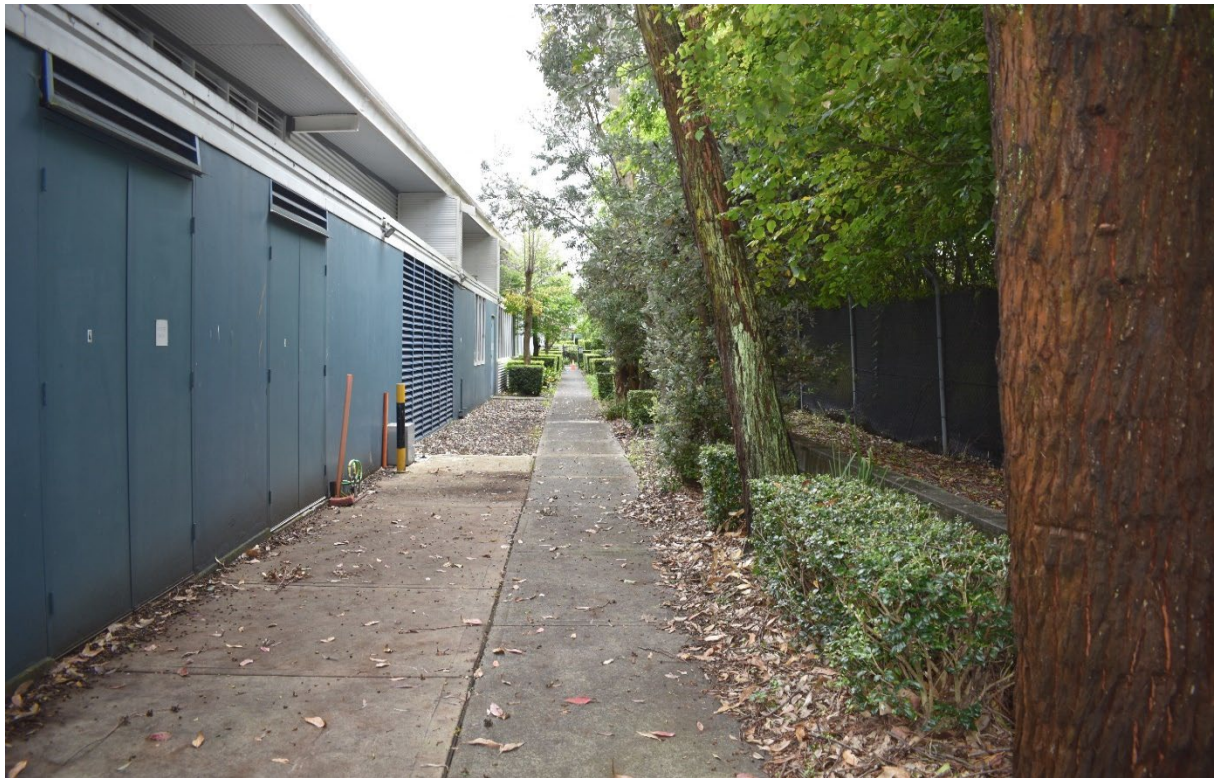
Along the western extent of the study area, paved surfaces and terraced landforms demonstrate significant impacts to any ground surfaces (Figure 4.9).

Figure 4.9 Ground surfaces along eastern extent of study area.

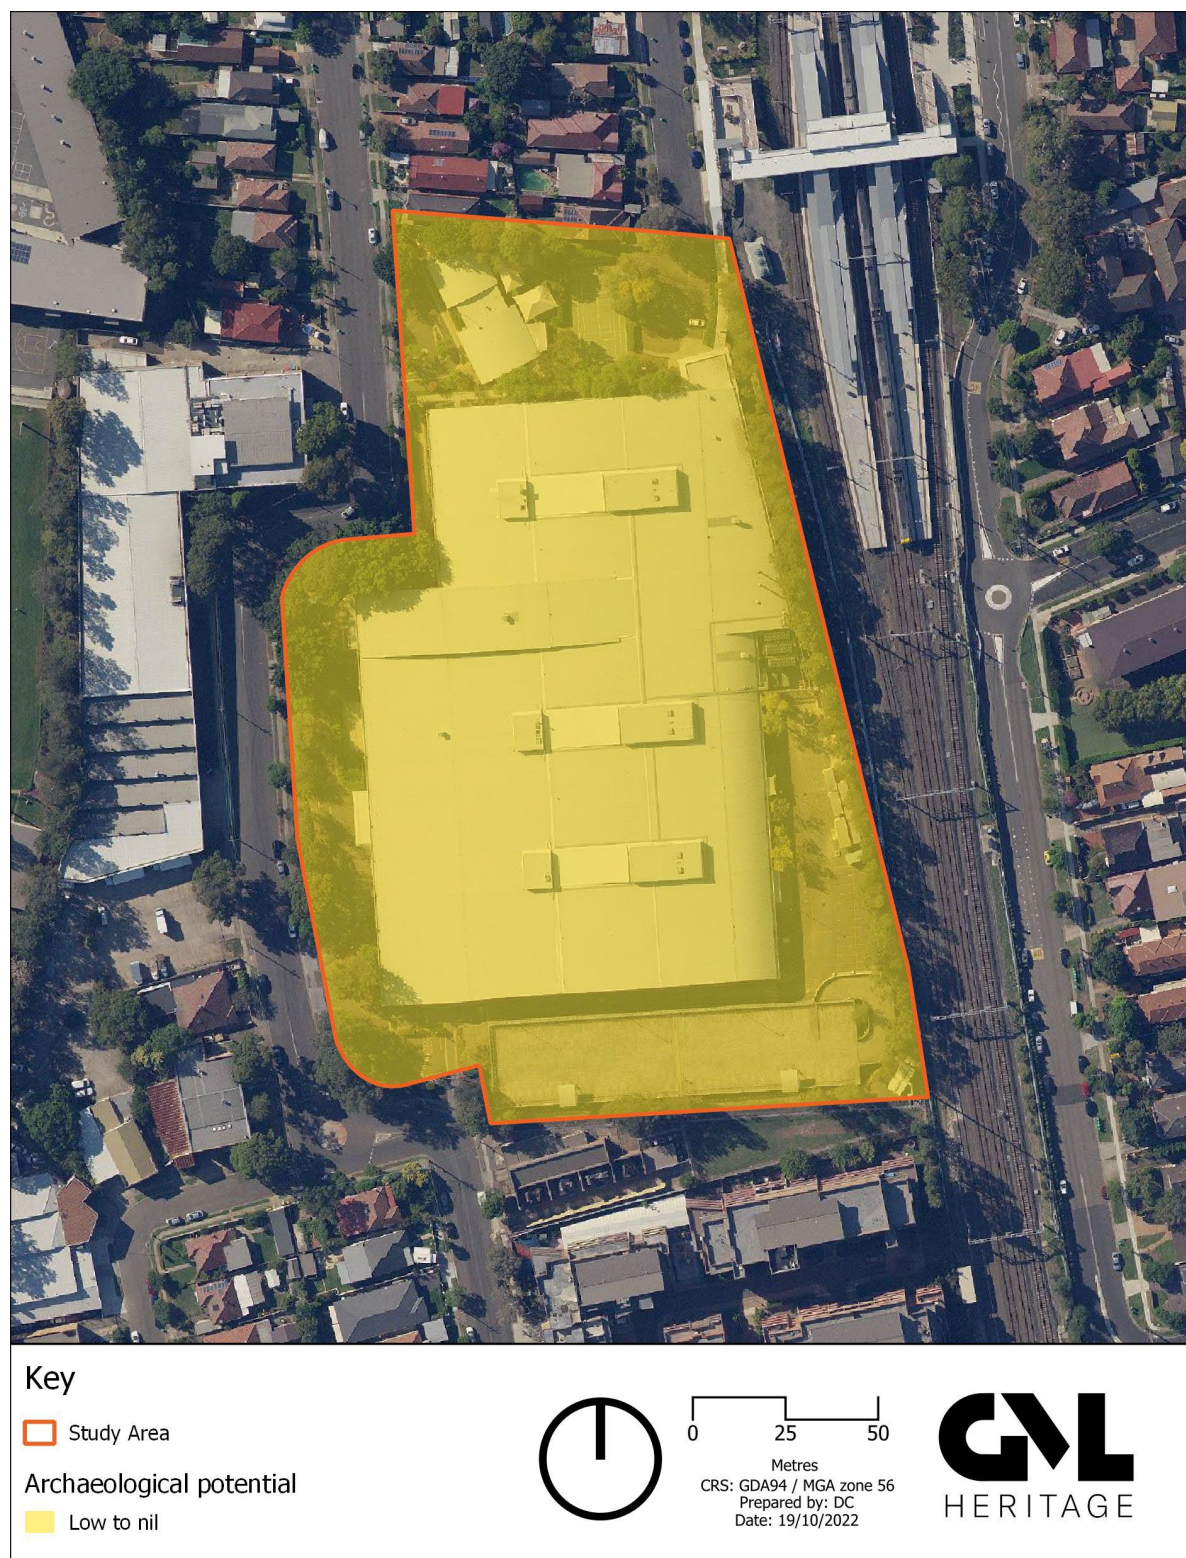
Whilst the exact scope of the impacts has not yet been finalised, this assessment has found that there is a low likelihood that Aboriginal objects could occur within the study area. Any Aboriginal objects present would likely be displaced items, moved from their original context. As such, any future proposed impacts are unlikely to harm Aboriginal objects.

Figure 5.1 Archaeological sensitivity. (Source: GML 2022 over SIX Maps)
