8-10 NEW MCLEAN STREET, EDGECLIFF NSW

Reference: P2868_ 01

1 INTRODUCTION

Morrow Geotechnics Pty Ltd has undertaken a Geotechnical Desktop Study (GDS) for the proposed development at 8-10 New McLean Street, Edgecliff NSW (the site). This GDS report has been prepared to provide advice and recommendations to accompany a development application (DA) to Woollahra Municipal Council for the proposed development.

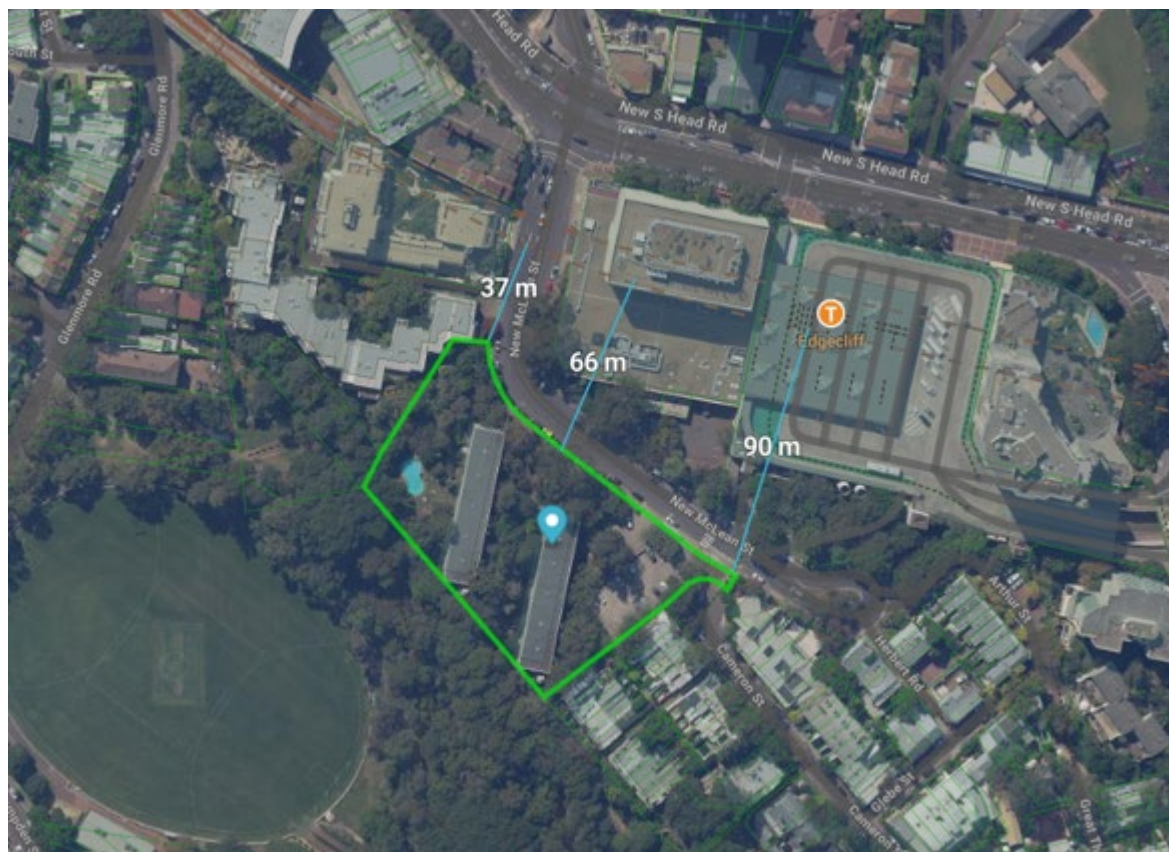
FIGURE 3: PROXIMITY TO EDGECLIFF RAILWAY STATION (SOURCE: MAPBOX; ACCESSED 13 SEPTEMBER 2023)

The site lies outside of the planning legislation’s 25 m impact radius from Edgecliffe Railway Station.

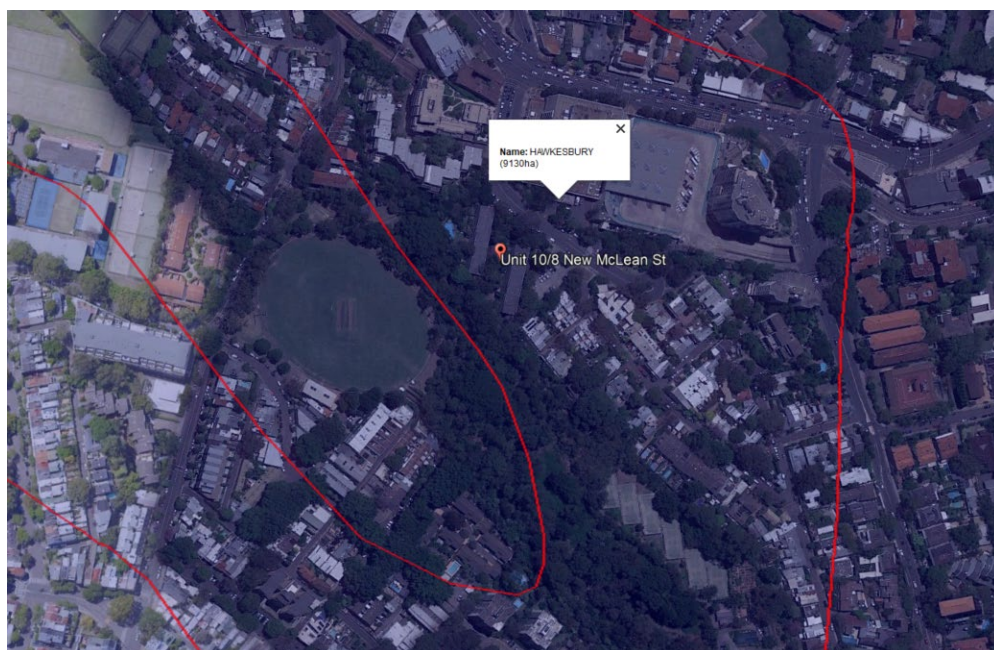
FIGURE 4: SOIL LANDSCAPE

The soil landscape likely comprises the Hawkesbury Landscape (Source: The Soil Conservation Service of NSW Sydney 1:100,000 Soil Landscapes Series Sheet 9130 [2nd Edition].)

Attribute	Description
Topography	Regional topography grades downwards to the southwest at an approximate gradient of 4-8° across the site.
Soil Landscapes	The Soil Conservation Service of NSW Sydney 1:100,000 Soil Landscapes Series Sheet 9029-9030 (2nd Edition) indicates that the erosional landscape at the site likely comprises the Hawkesbury Landscape. This landscape type typically includes rugged, rolling to very steep hills on Hawkesbury Sandstone with slopes of over 25 %. Soils are generally shallow (> 0.5 m) discontinuous lithosols/siliceous sands associated with rock outcrop, earthy sands, yellow earths and some yellow podzolic soils. These soils are noted to present extreme soils erosion hazard, steep slopes, rock outcrop, and shallow, stony, highly permeable soil. See Figure 4 .
Regional Geology	Information on regional sub-surface conditions, referenced from the Department of Mineral Resources Geological Map Sydney 1:100,000 Geological Series Sheet 9130 (DMR 1991) indicates the site to be underlain by (mf) man-made fill and (Qha) Quaternary Holocene deposits which are typically comprised of silty to peaty quartz sand, silt, and clay, with common shell layers. See Figure 5 .

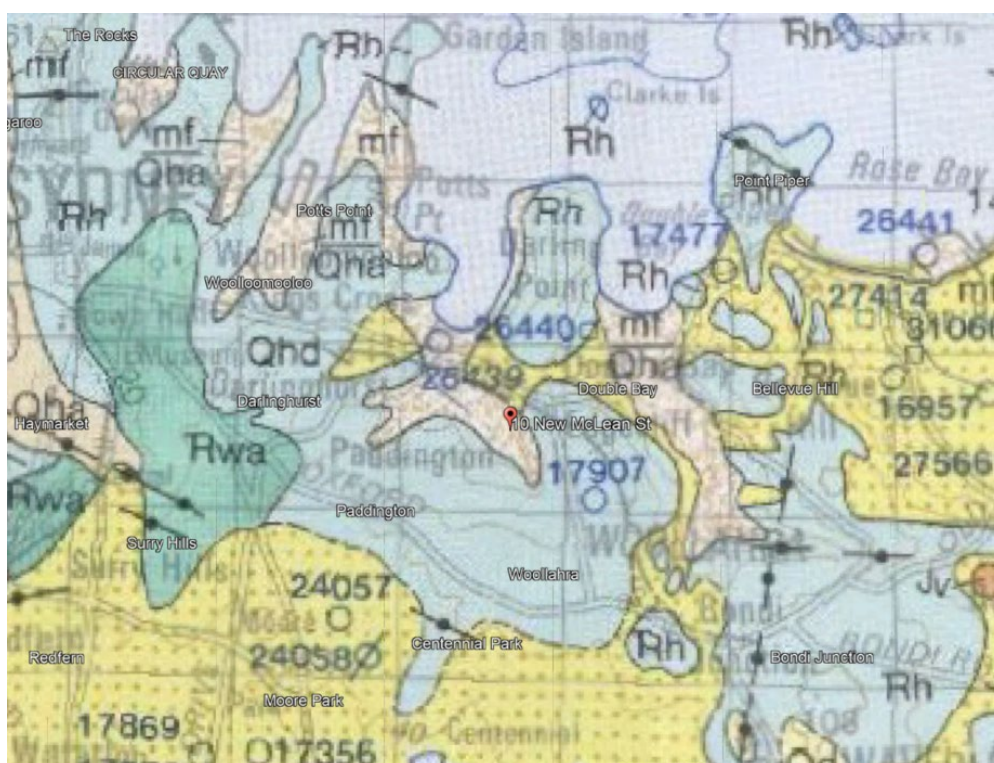
FIGURE 5: LITHOGRAPHY

The site likely overlies man-made fill and Quaternary Holocene deposits (Source: Sydney 1:100,000 Geological Series Sheet 9130; minview.geoscience.nsw.gov.au; accessed 23 March 2023)

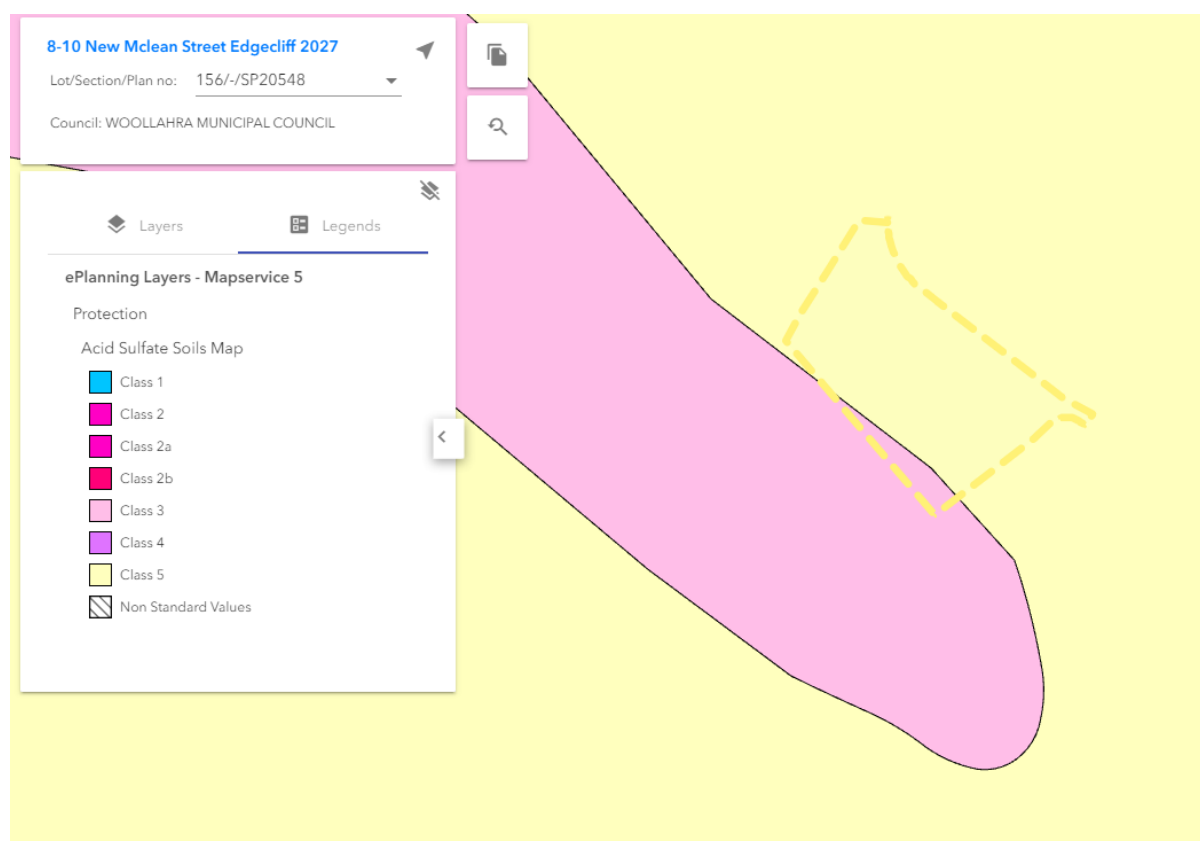
FIGURE 6: ACID SULFATE SOILS

The property is in an area zoned as Class 3 and Class 5 Acid Sulfate Soils in accordance with Council mapping. (Source: planningportal.nsw.gov.au; accessed 28 March 2023.)

Acid Sulfate Soils (ASS)	In accordance with the Marrickville Local Environmental Plan 2011 Acid Sulfate Soils Map, the site is not classified for Acid Sulfate Soils. See Figure 6 .

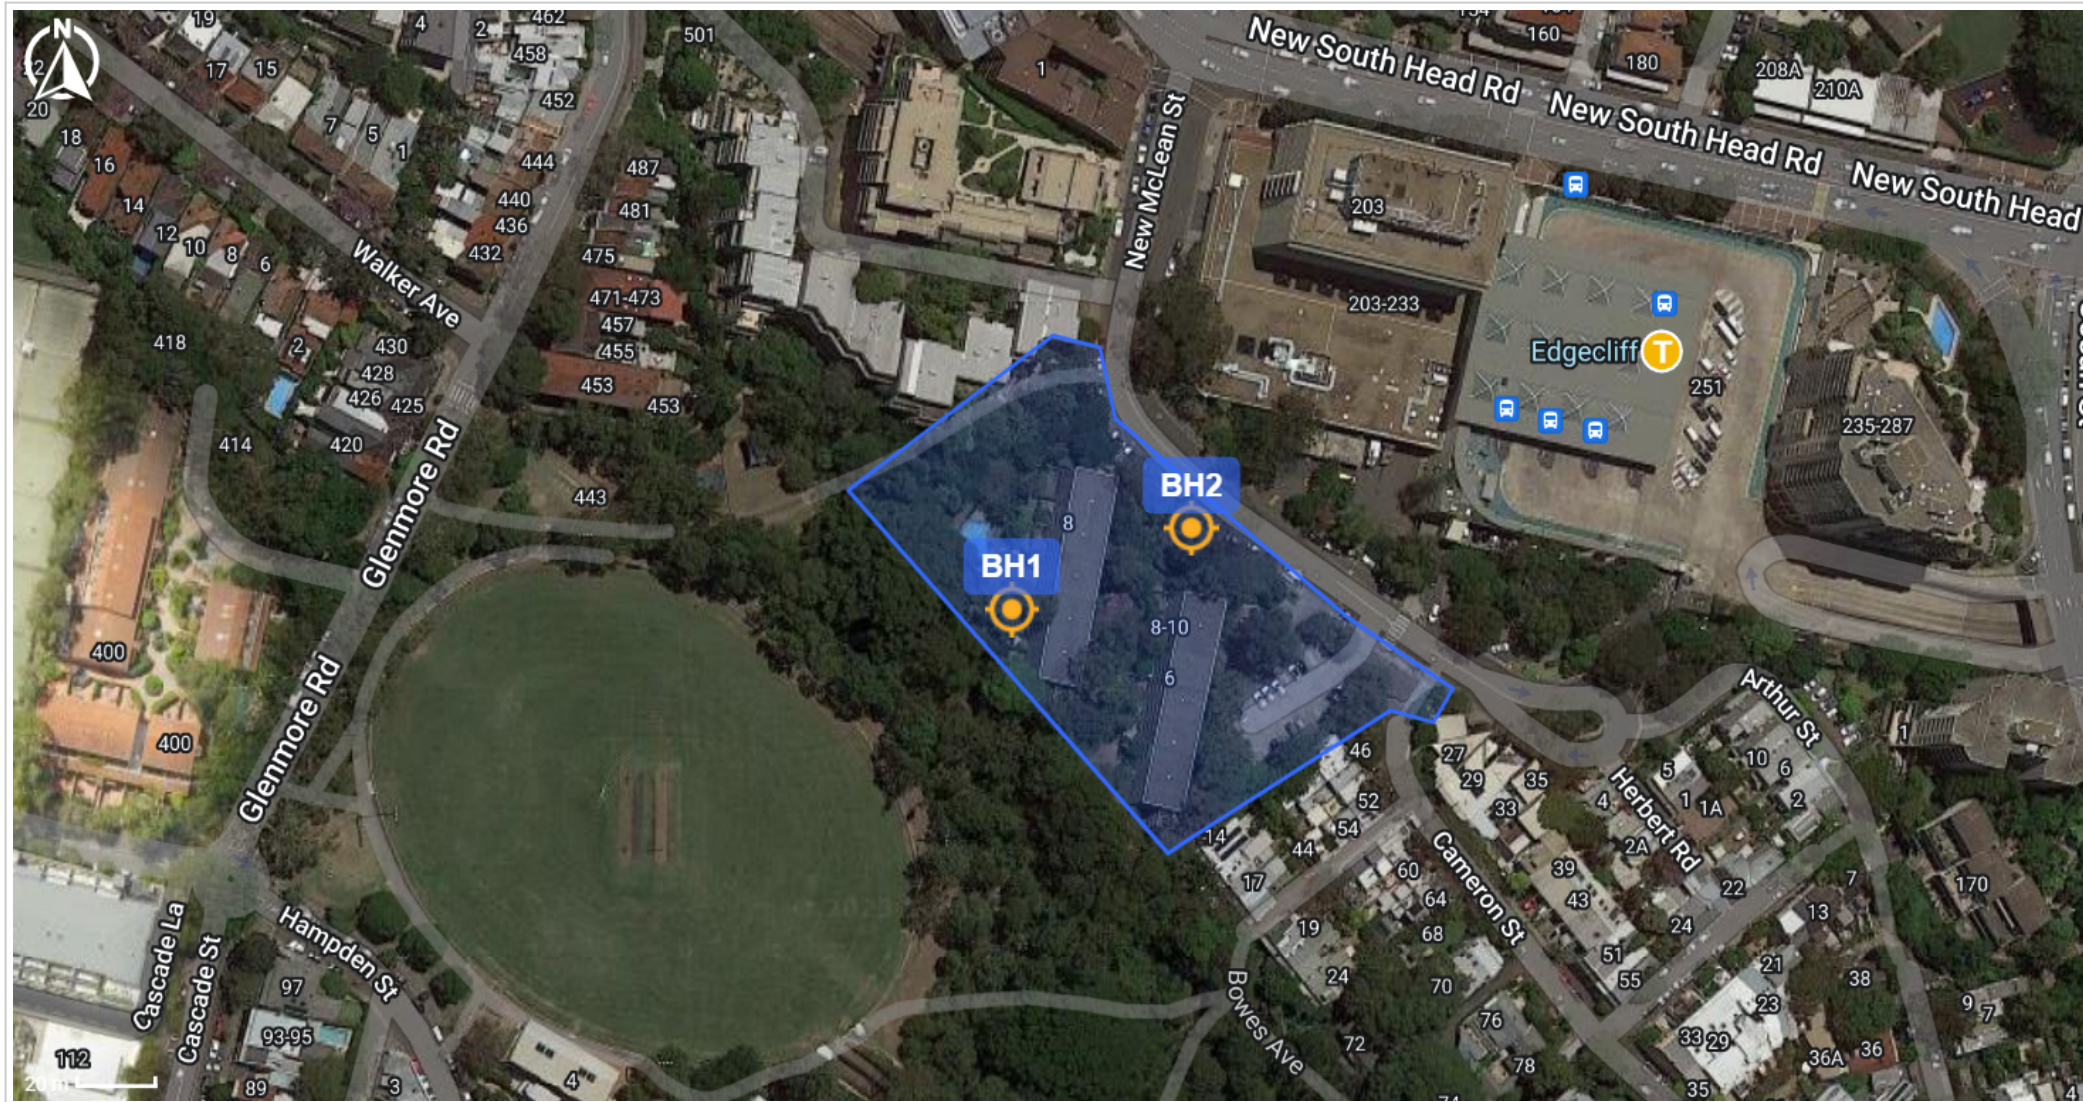
Site Plan

Site location

8-10 New McLean St, Edgecliff NSW
