Preliminary Site Investigation

8-10 New McLean Street, Edgecliff NSW

Mount St 4 Pty Ltd
7 May 2025
AU123019

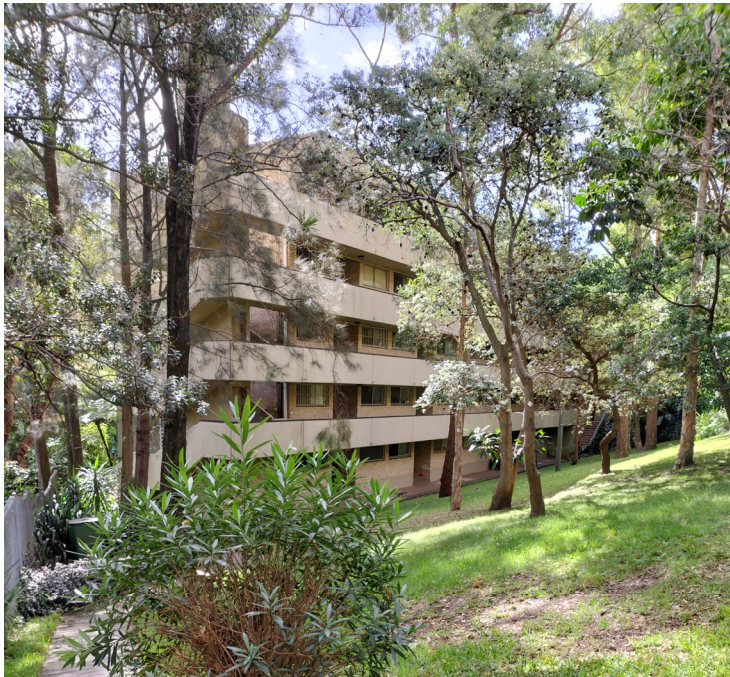
1	13/04/23	
Description:

Western residential apartment building and south-western site boundary bordering Trumper Park.

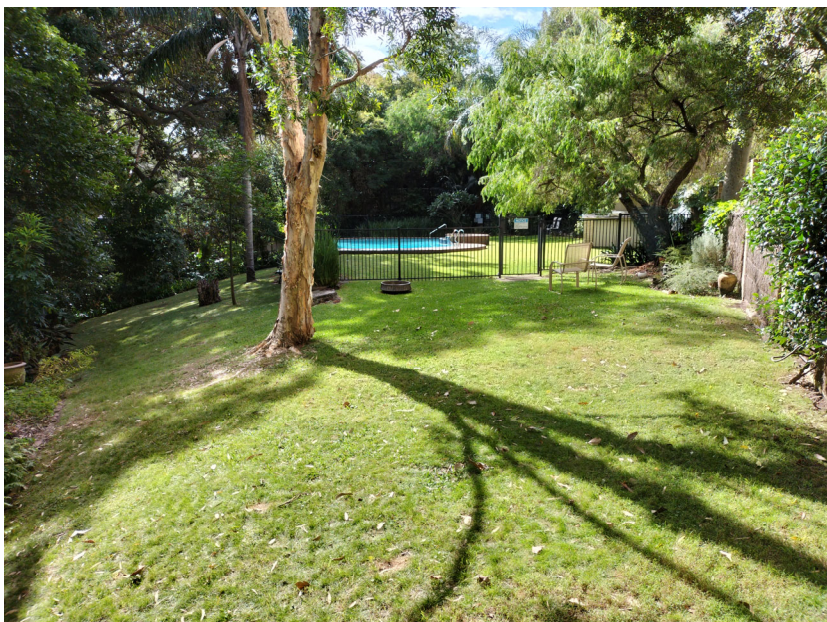
2	13/04/23	
Description:

Pool and western area of the site. Vegetation appears healthy.

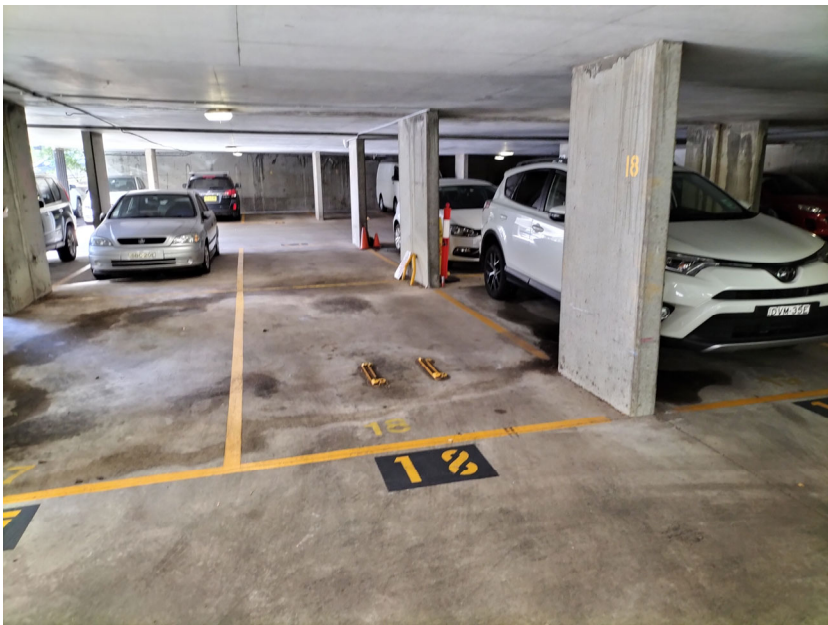
- A two-storey concrete carpark is located on the eastern side of the site. Concrete slab flooring is in good condition. Minor surface staining from vehicles is present on the bottom level.

3	13/04/23	
Description: Bottom level of car park. Darker staining trail apparent on sealed concrete surface.

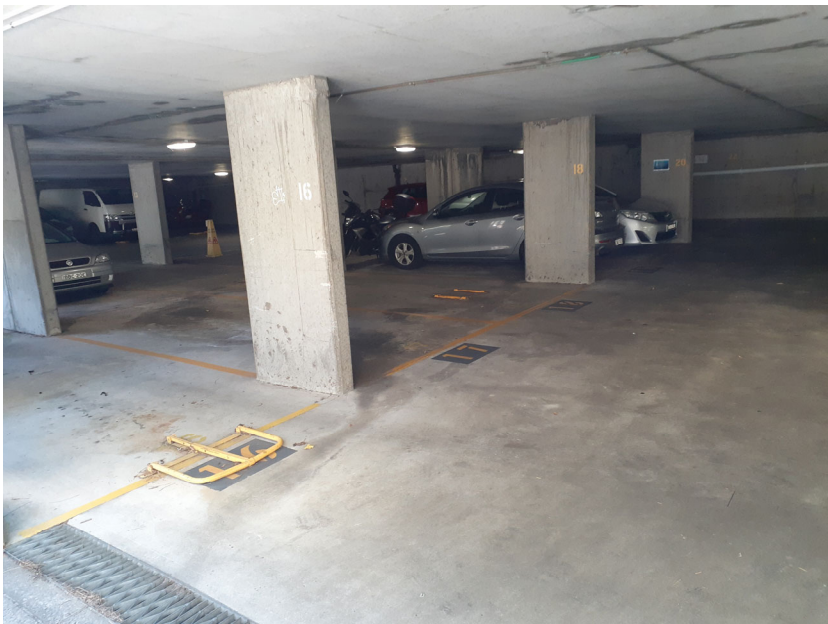
4	17/02/22	
Description: Bottom level of car park. Staining trail can be seen leading into carpark stormwater drain.

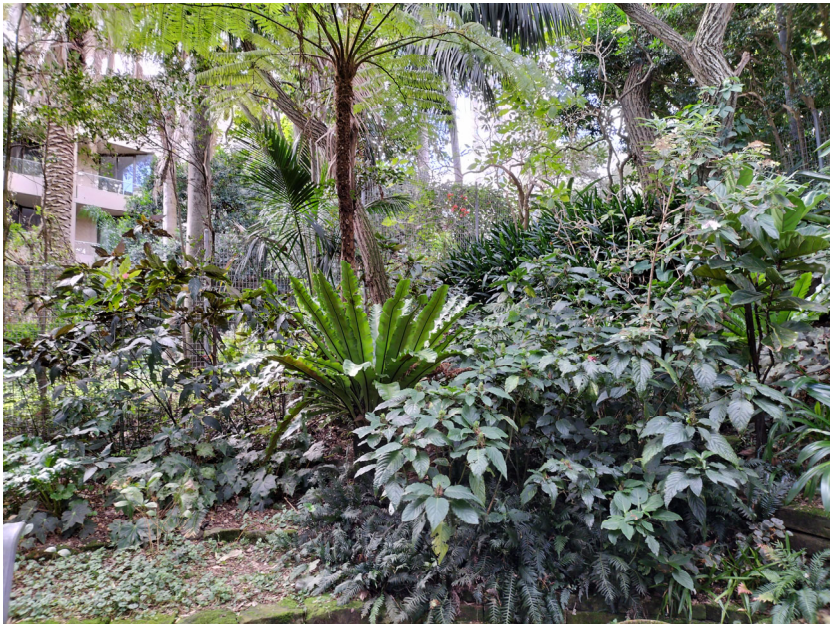
5	13/04/23	
Description:		
Dense and healthy vegetation present on the northern corner of the site. Neighbouring residential apartments behind.

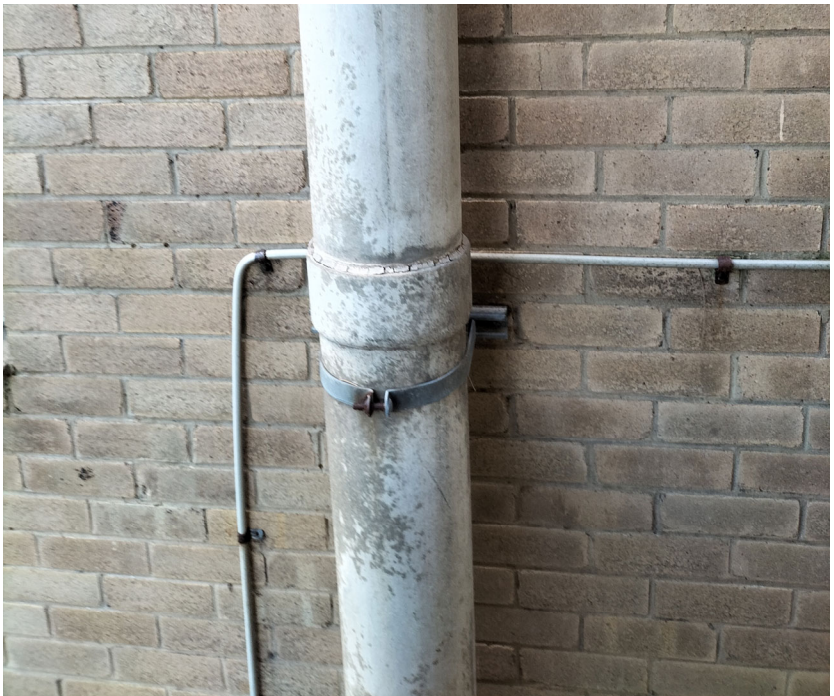
- The site area was occupied predominantly by 2 residential apartment buildings parallel to each other spanning the north-eastern to south-western border. The buildings were 5-stories with walkway balconies on each floor. Buildings were constructed with brick and concrete. Considering the date of construction and an observed fibre cement stormwater pipe, it is likely that the building contains asbestos containing materials (ACM).

6	13/04/23	
Description:		
Fibre cement materials used on drainage pipes. Pipe located on residential apartment buildings.

It is very likely that the apartment buildings were built with hazardous materials. It is recommended that the current Asbestos Management Plan is sourced from the site owners to determine the extent of hazardous material identification and management.
