Heritage Assessment Culvert 1 and Culvert 2

Final | January 2024

Prepared for CVC

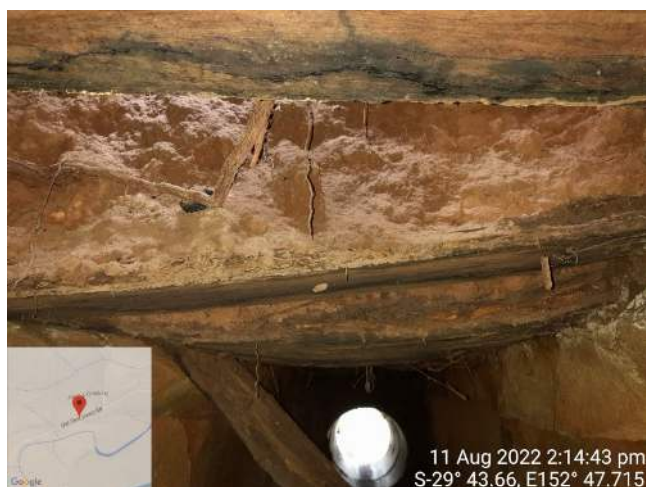
View through the culvert from east.

Old Glen Innes Rd, Chambigne [Culvert (Clvert), 4433, 1200x900 mm box, 1 cell(s), (CS) (Trnsprt) (FIN:SW)]

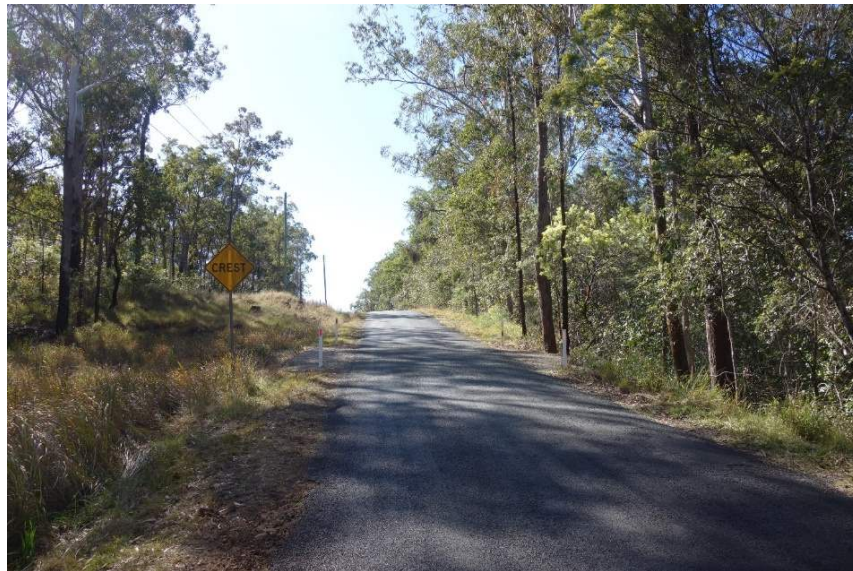
Figure 2: View to east on the Old Grafton Road at the culverts location, Chambigne locality.

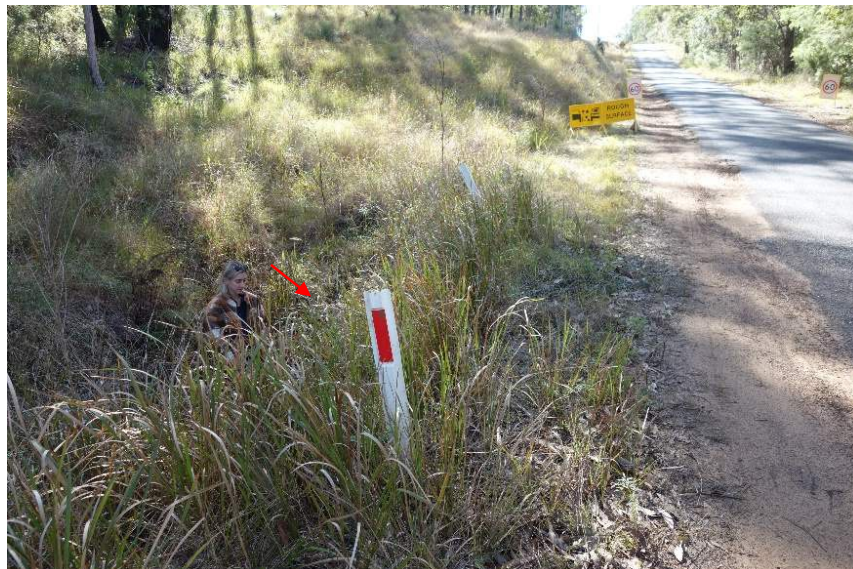
Figure 3: View to northeast of the first culvert location, refer to arrow.

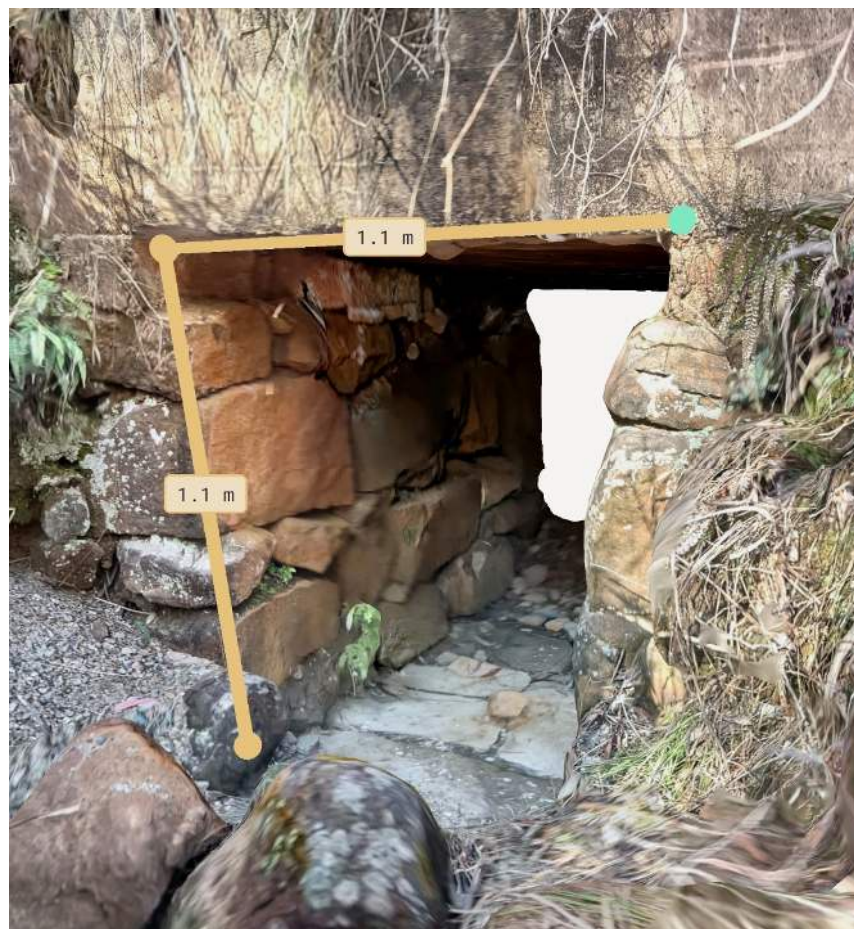
Figure 4: LiDAR captured image of the culvert with measurements (P. Fowler), compare with Figure 5 overleaf.

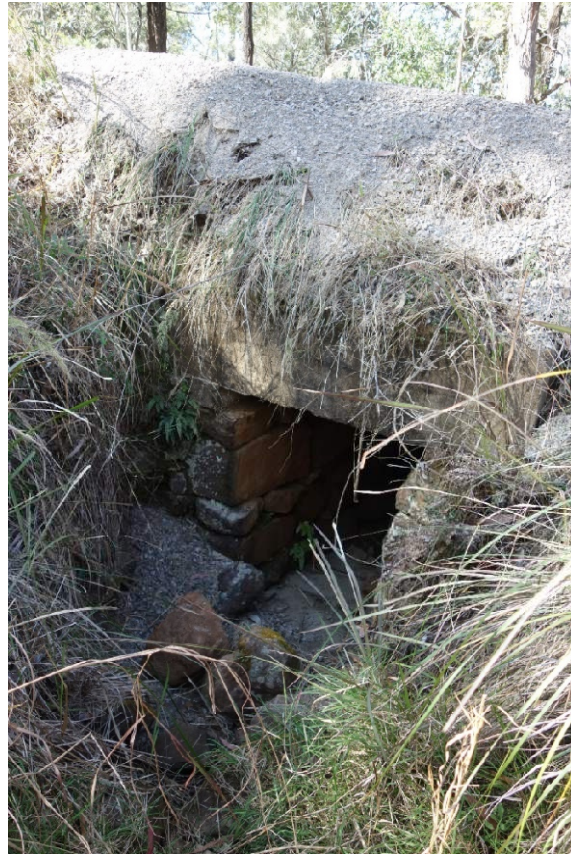
Culvert # 1 was located slightly lower in the valley than Culvert #2. It had five courses of stone on each side (the wing walls) of the drain. The culvert's arrangement was a rectangular shape, with a flat base also composed of sandstone flat blocks and two wing walls of sandstone blocks. The lintel appeared to be a large block of concrete and no roof timbers were visible externally. The timbers forming the roof of the culvert were partially visible internally. Some of these timber planks appeared termite damaged, refer to the photographs in this section.

Figure 5: Photograph of Culvert #1, northern end.

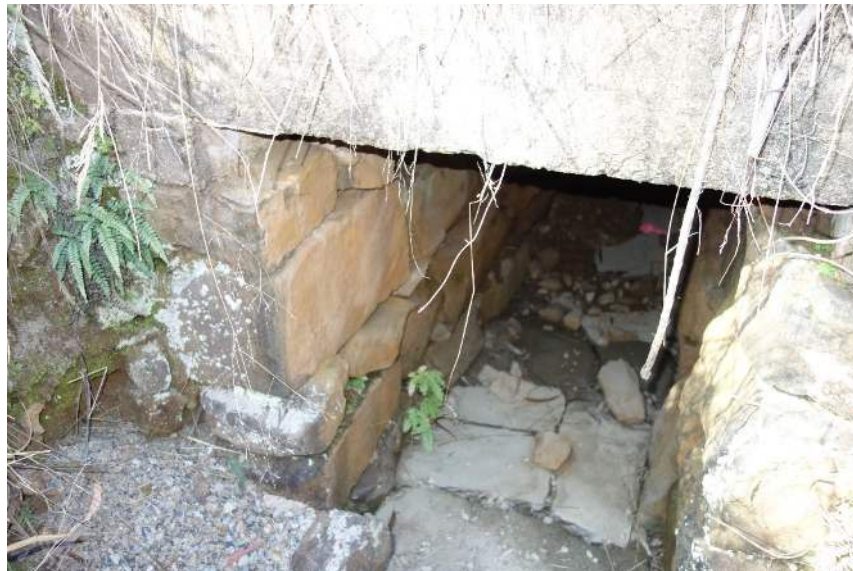
Figure 6: View into Culvert #1 at the northern end, showing courses of sandstone forming the wing walls and a flat base of sandstone 'pavers'.

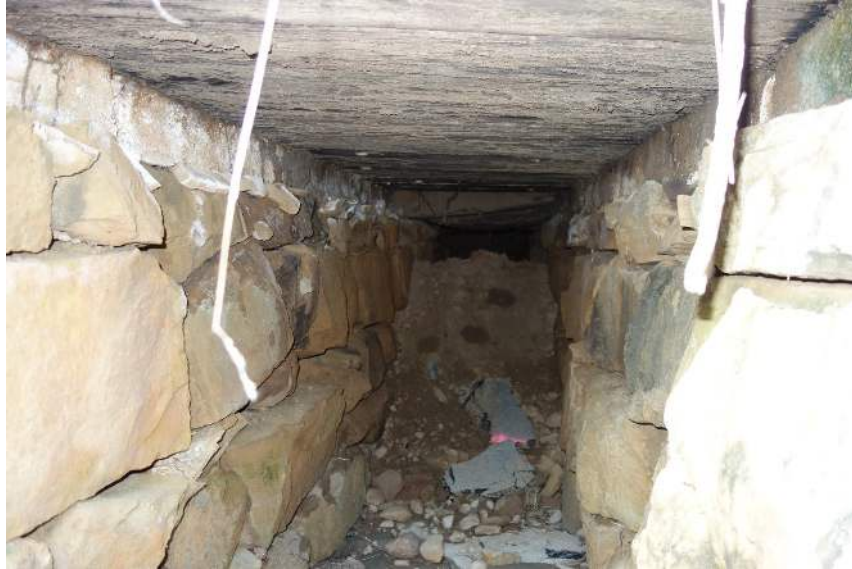
Figure 7: Culvert #1 is blocked at the southern end by soil. Note the collapsing timber roof at that end (the termite damage?). The timber roof visible here and below appears to be hardwood planks, but with no visible thickness.

- Both of the culverts have a partial timber deck /roof visible, supporting the road above. Some of the timbers appear in reasonable condition, others appear to be termite affected. Culvert #1 has fallen timbers at its southern end.

| CVC request | Virtus response |
|--|--|
| The heritage assessment is to address the following: timber deck members are laid on a header course of different blocks and there is termite damage. Your advice on the likely age and significance of the timber is needed, and whether it could be removed or need to be reinstated to match. | The timbers appear to be hardwood, likely local timber and possibly Tallow wood, although this was not possible to identify. Replacement if possible with similar would be the best method, however given the termite damage, refer below to the use of concrete in relation to road support, which could be undertaken with suitable engineering advice. This is recommended due to: <ul style="list-style-type: none"> the culverts forming part of a busy road and concrete has previously been added to reinforce the northern side roof of both culverts. The visible concrete does not detract from the heritage values of the culverts. |

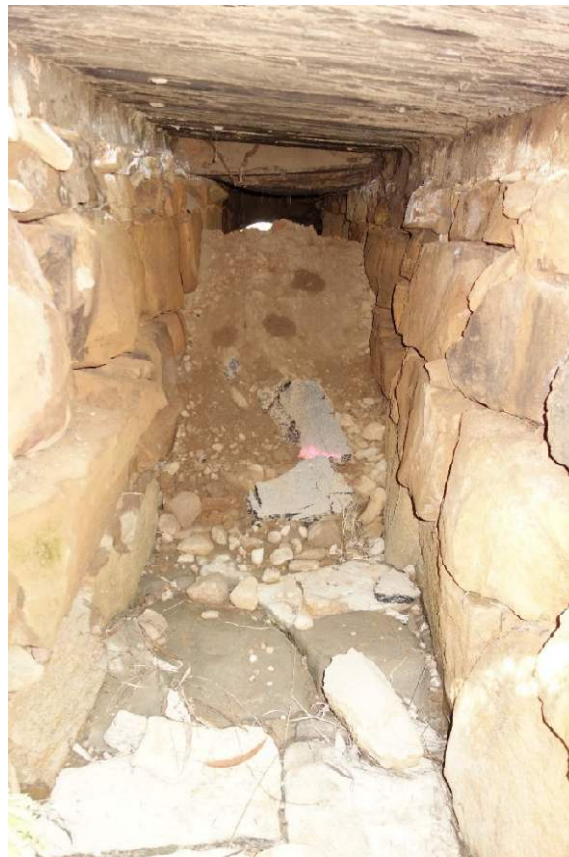
The culvert drain appeared clear throughout, and the pipe visible at the far southern end must have been partially cleared by the CVC road crew prior to Virtus Heritage inspection. However, it was hard to see past the spoil / earth pile, and therefore the material of the pipe is not identified herein.

Figure 8: View through Culvert #1 showing mounded debris in front of what appears as a round opening, for a drainage pipe, at the southern end.

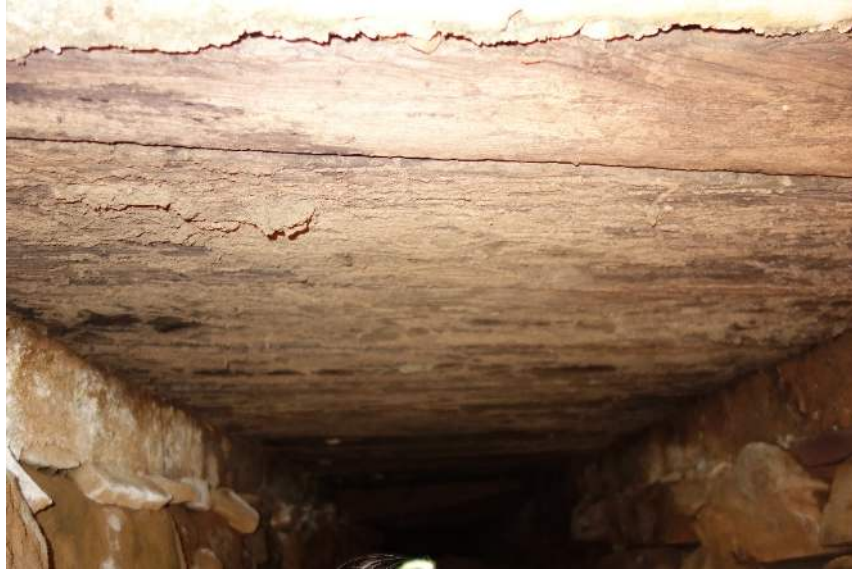
Figure 9: View along the roof of Culvert #1 shows timbers at the northern end and continuing to the southern end, above the round opening.

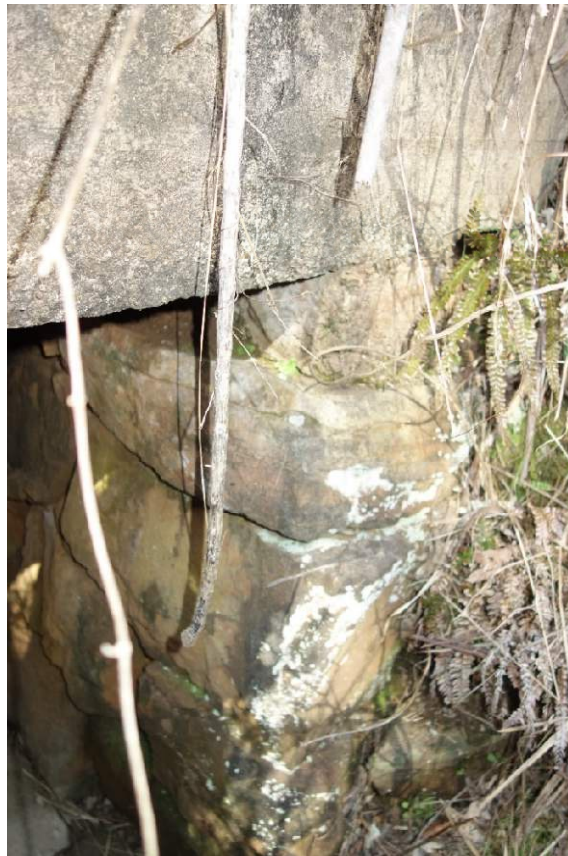
Figure 10: View to the northwestern wing wall, the courses of sandstone with some moss or fungus below the concrete lintel/roof to the box culvert.

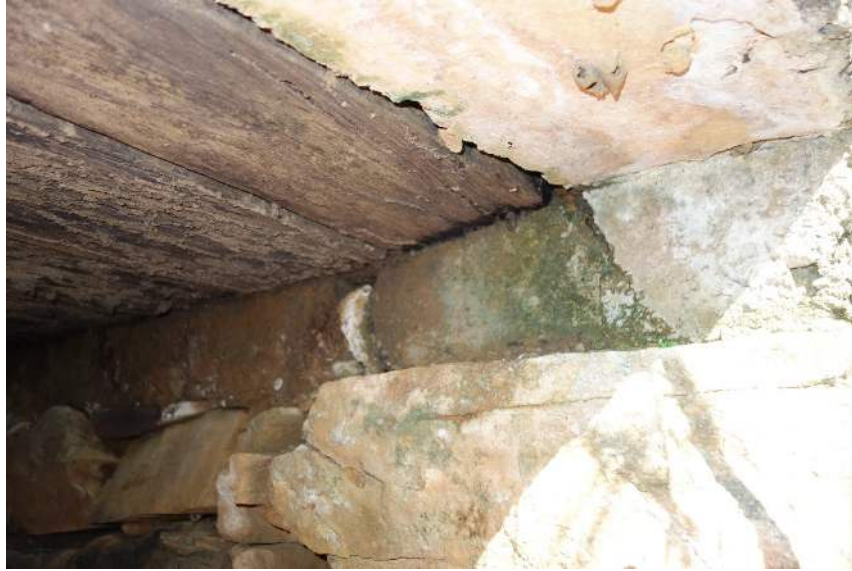
Figure 11: View to the timber planks (no thickness observed) forming the culvert roof and above the northwestern sandstone wing wall.

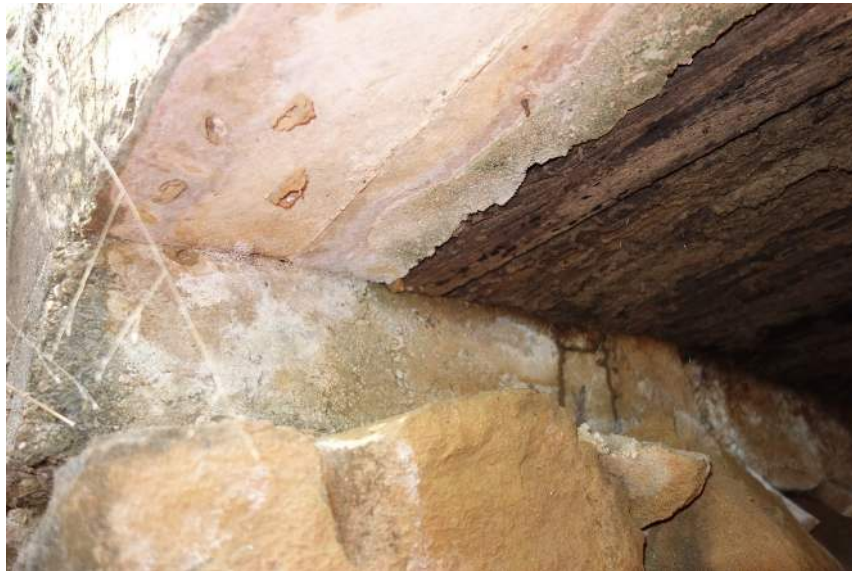
Figure 12: View to the northeastern sandstone wall, showing the concrete slab edge adjacent to and overlapping the timber plank roofing.

- Each culvert roof has been replaced in part with a concrete slab which is visible from the northern side and forms part of the headwall (above the timber opening). The timber planks were visible in detail in Culvert #2 and while identification of the timbers was not possible, based on the viewing, hardwood local timber possibly Tallow wood would have been used.

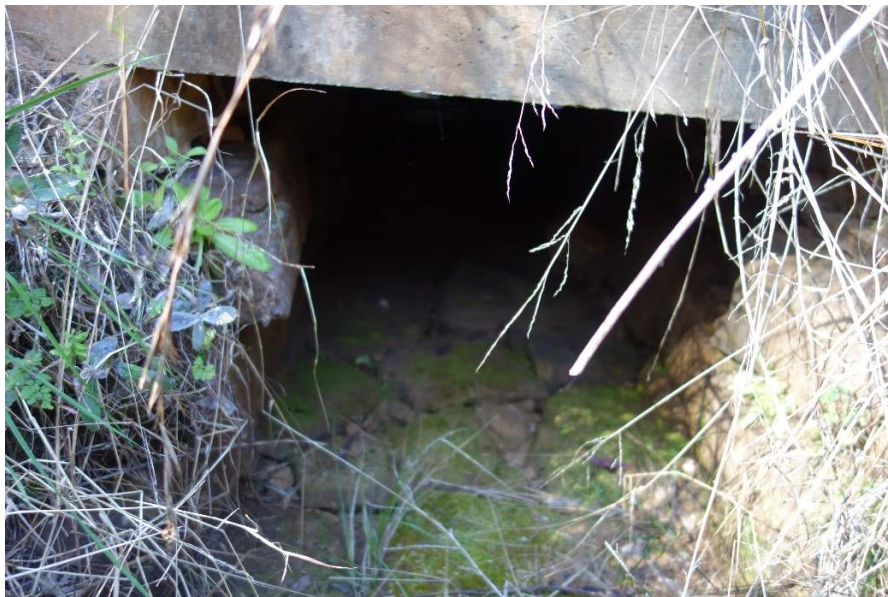
This box culvert was three courses of sandstone blocks high internally on the eastern side wing wall and four courses – one comprising flat stones – on the western side wing wall. Internally, these sandstone courses appeared in good and sound condition. Externally, they were covered by vegetation and what appeared to be a concrete slab forming a lintel at the visible northern edge.

Figure 13: : View into the culvert on the northern side, showing the mossy, flat sandstone base.

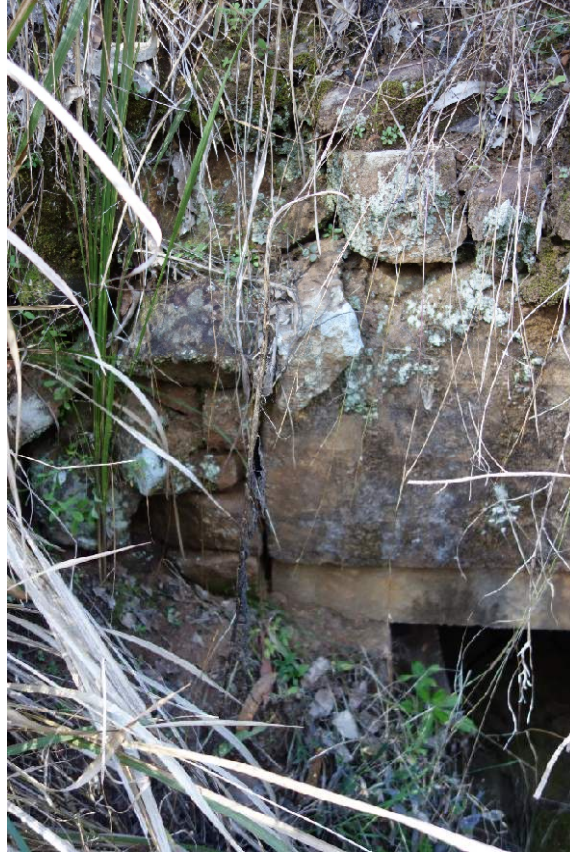
Figure 14: View to the NE top corner and lintel outside Culvert #2. Note the slab of concrete and sandstone blocks above (headwall) it measure c.1.5m thick.

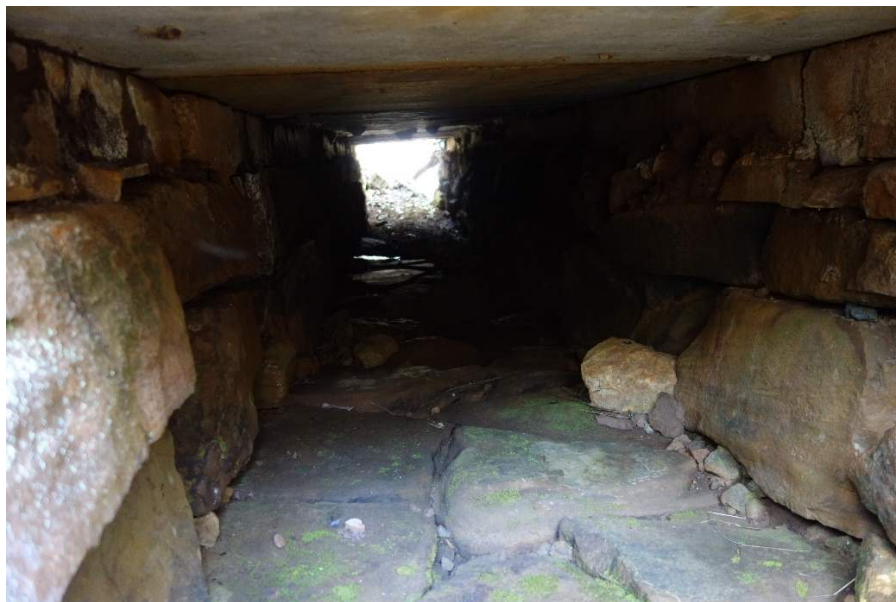
Figure 15: view along the interior of Culvert #2 from north to south. Note the flat edged wing walls, concrete roof and flat sandstone base. Visible at the end is the fallen timber post, seen in the CVC photograph.

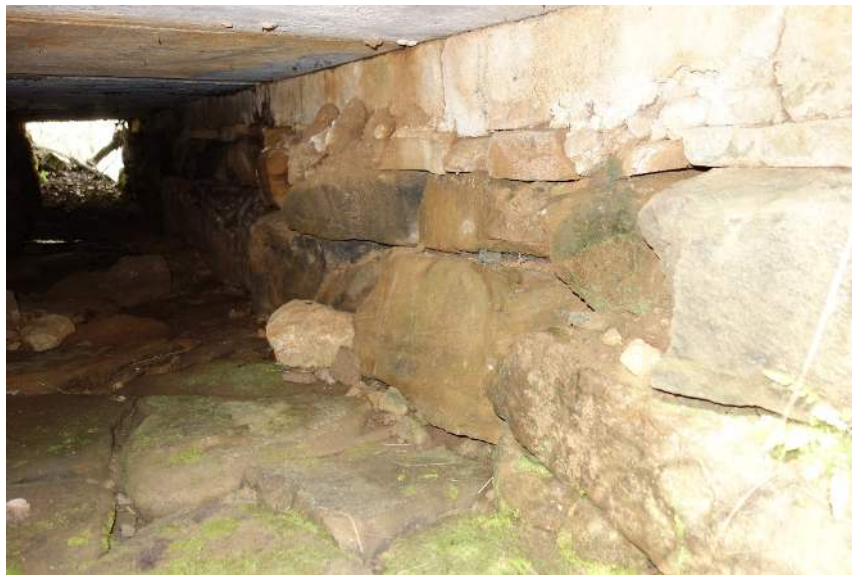
Figure 17: View to the northwestern wingwall and roof, three sections of concrete slab roofing are visible, and the culvert / drain is clear.

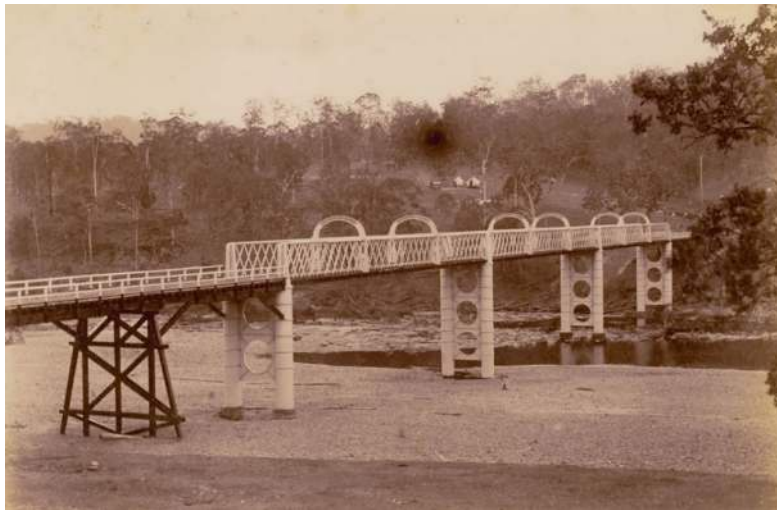
Figure 18: Buccarumbi Bridge, Grafton Glen Innes Road c.1900-1910 – prior to collapse. (State Library of NSW ML PXE 711 / 618)

seven years of building. The bridge with its huge cylinders was 754 feet (230m) long and 45 feet (13.7m) high. However, it collapsed in a March 1946 flood, when the Nymboida River rose to a record height of 52 feet (16m) (Cosmos Archaeology, 2018). Today there are remains of the old bridge pillars visible in the river waters and on the southern bank.

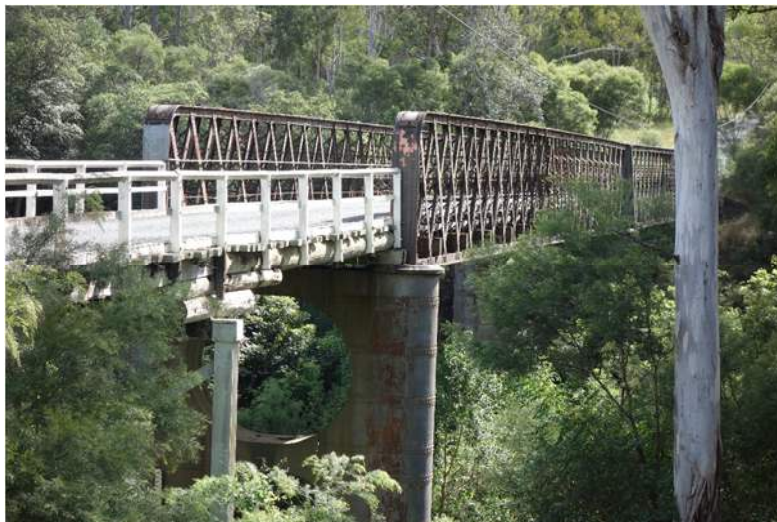
Figure 19: Bawden Bridge over Orara River (Gina Scheer April 2018).

The second historical bridge was the Bawden Bridge (named after Thomas Bawden the local Parliamentary Member), constructed over the Orara River in 1874. It is one of the oldest lattice truss design bridges in NSW, 77 metres long with timber beam approaches (Cosmos Archaeology, 2018). It is a decorative structure which can only be appreciated from below the road surface. Crossing a deep gorge, it is supported by three tall piers made from pairs of tubes fabricated from curved and shaped wrought iron plates riveted together, and with cross ties shaped to form a vertical set of elliptical holes. At one stage there was a hotel (The Urara Hotel) sited adjacent to the bridge crossing and operated by a Mr Thomas Aish (*Clarence and Richmond Examiner and New England Advertiser* Saturday 2 October 1880).

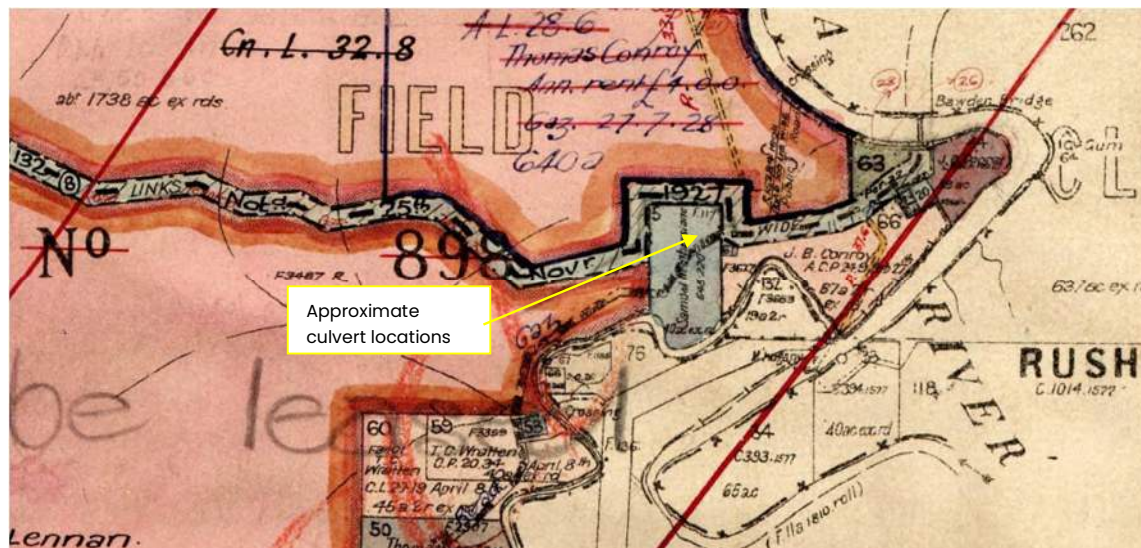
Figure 20: 1926 Parish Name: Chambigne, Sheet reference: 1, Edition number: 4 (NSW Lands and Registry Services, Historical Lands Record Viewer, accessed at <https://hlrv.nswlrs.com.au/>)

A 1927 parish map shows the alignment of the road through Chambigne, refer to Figure 20 and compare this with the current map of the road, refer to Figure 21. It is defined here as a 'T.S.R.' (Travelling Stock Reserve) and a road 500 links wide. The date of notification for the road in this location is 25 November 1927. It is interesting that two earlier parish maps, 1903 and 1918 do not show the road at all.

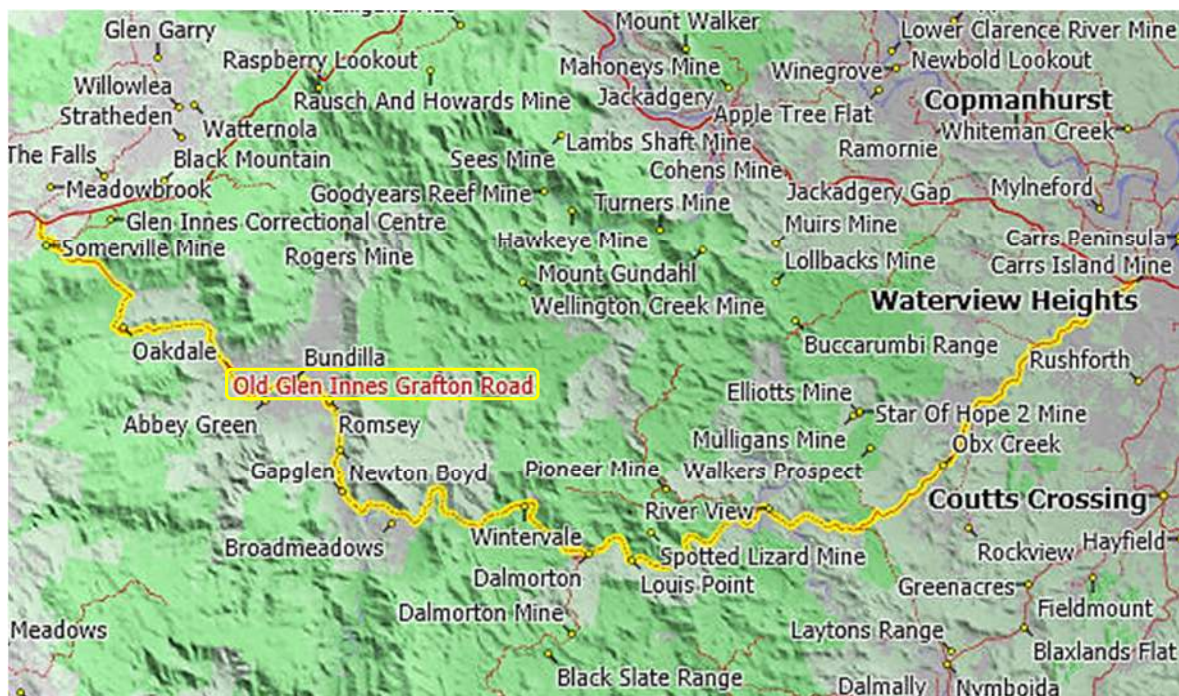
Figure 22: The extent of the Old Grafton Glen Innes Road, shown in yellow on this map (Map of old Glen Innes Grafton Road, NSW, Bonzle.com accessed at <http://www.bonzle.com/c/a?a=p&p=172689&cmd=sp>)

The full alignment of the Old Grafton Glen Innes Road runs from the Gwydir Highway intersection near Bald Knob at Glen Innes and ends at Waterview Heights at South Grafton refer to, Figure 22:
