## Item Details

Two Sandstone Culverts

Old Glen Innes Road CHAMBIGNE NSW 2460

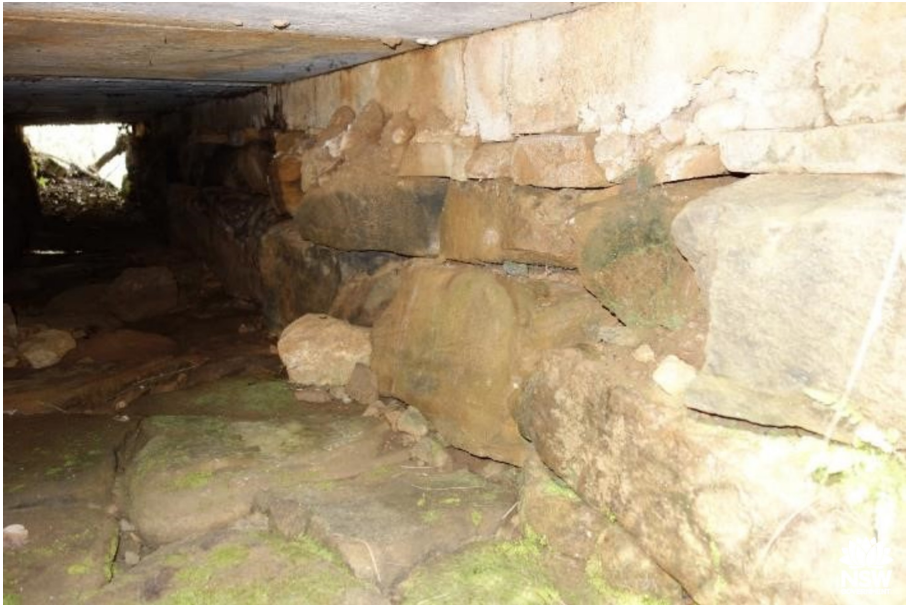
Caption: Culvert 2 northwest view

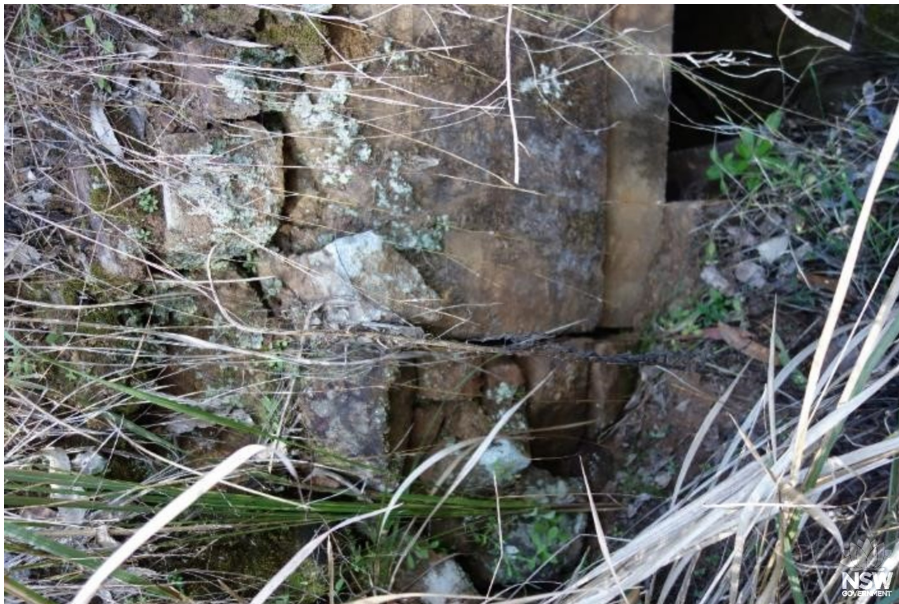
- ☑ Each culvert roof has been replaced in part with a concrete slab which is visible from the northern side and forms part of the headwall (above the timber opening). The timber planks were visible in detail in Culvert #2 and while identification of the timbers was not possible, based on the viewing, hardwood local timber possibly Tallow wood would have been used.

Caption: Culvert 2 view to NE top corner and lintel

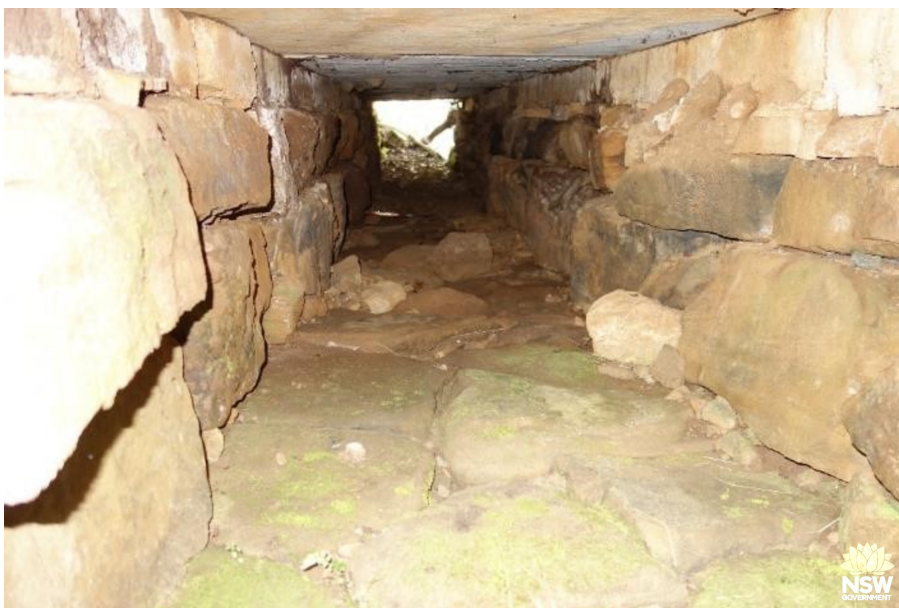
- ☑ Both of the culverts have a partial timber deck /roof visible, supporting the road above. Some of the timbers appear in reasonable condition, others appear to be termite affected. Culvert #1 has fallen timbers at its southern end.

Caption: Culvert 2 interior 2

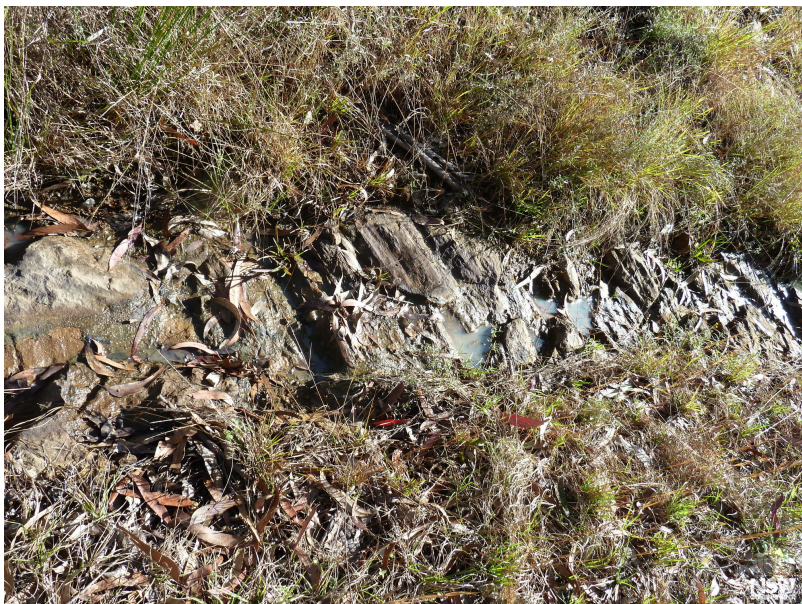
Caption: Rock drainage on northern side of road

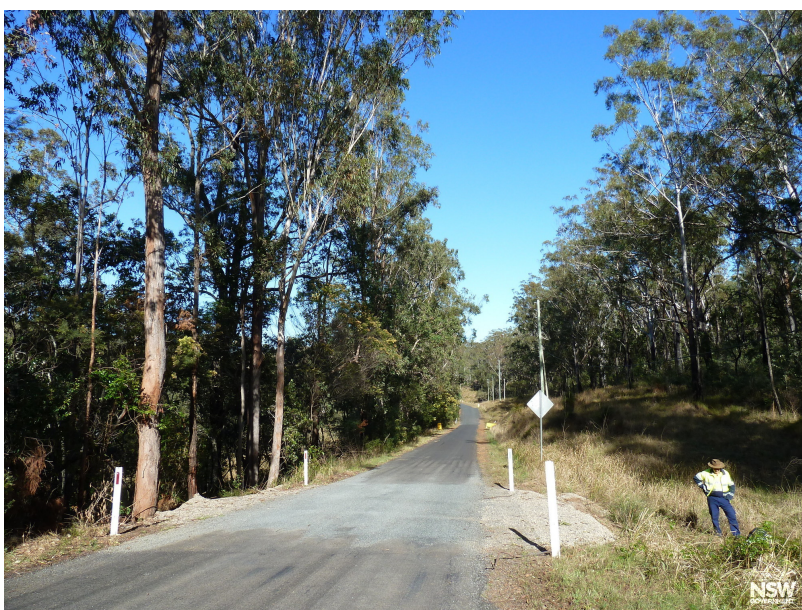
Caption: Location on Glen Innes Road Sandstone Kerb and Gutter

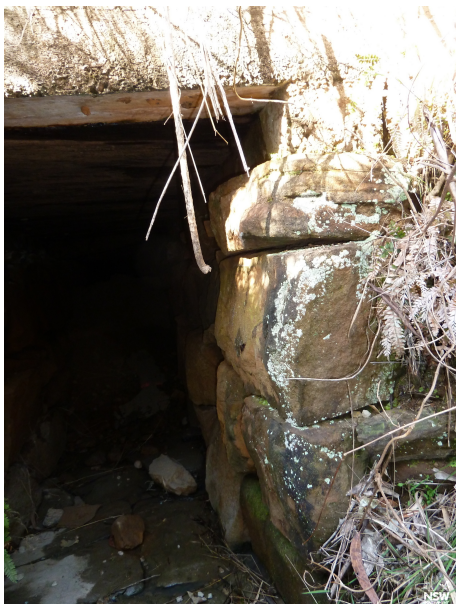
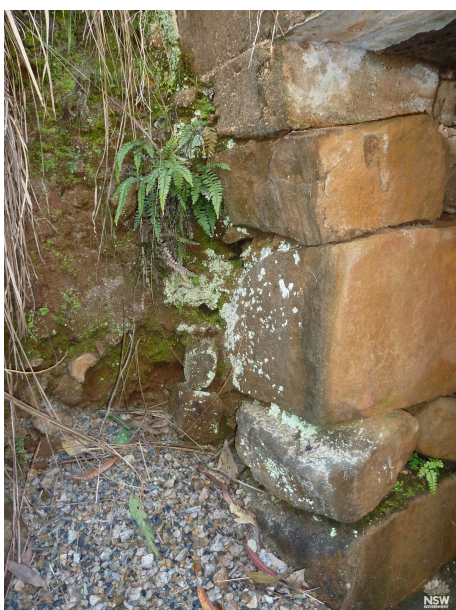
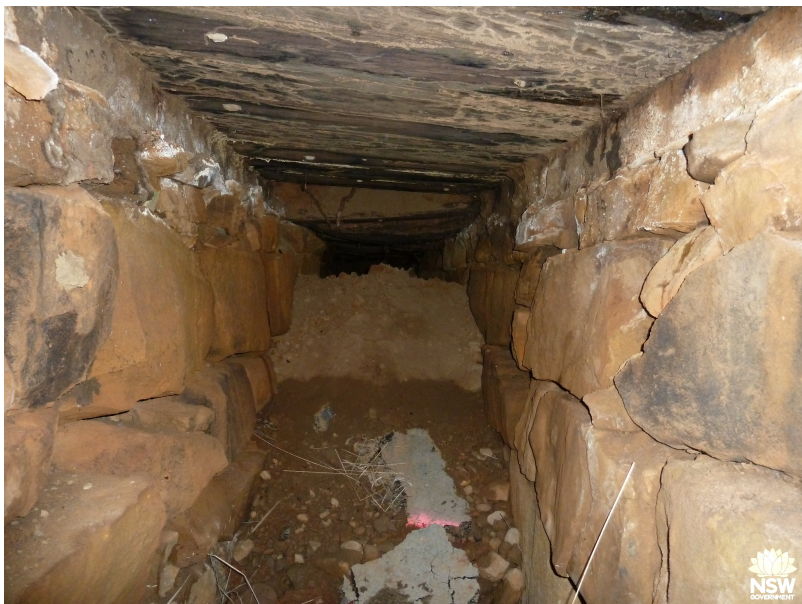
Culvert # 1 was located slightly lower in the valley than Culvert #2. It had five courses of stone on each side (the wing walls) of the drain. The culvert’s arrangement was a rectangular shape, with a flat base also composed of sandstone flat blocks and two wing walls of sandstone blocks measuring approximately 1.1m tall and 1.1m wide. The lintel appeared to be a large block of concrete and no roof timbers were visible externally. The timbers forming the roof of the culvert were partially visible internally. Some of these timber planks appeared termite damaged, refer to the photographs in this section. The culvert drain appeared clear throughout, and the pipe visible at the far southern end must have been partially cleared by the CVC road crew prior to Virtus Heritage inspection. However, it was hard to see past the spoil / earth pile, and therefore the material of the pipe is not identified herein.

- ☑ The road report referred to the road above sinking into the top of the culvert #1 via a pothole, and that this had obviously caused damage to the roof of the culvert. Apart from this problem, the condition of both culverts in relation to the sandstone blocks and concrete roof/lintel appears to be sound.

Caption: Sandstone Culvert #1 Old Glen Innes Road

- ☐ The culverts should be retained and repaired, so that they remain operational.
  - ☐ No replacement of sandstone is to take place.
  - ☐ Reinforcement of the road deck above the culverts, will need to follow the advice of suitable structural engineers.
