# Geotechnical Desktop Study Leumeah Hotel, 80 O'Sullivan Road, Leumeah

Report Ref: P21599-R-001-Rev0

<b>Site Address:</b>	Leumeah Hotel, 80 O'Sullivan Road, Leumeah	
<b>Project Type:</b>	Proposed Commercial and Residential Buildings	
<b>Project no</b>	<b>Report type</b>	<b>Report no</b>
P21599	R	001

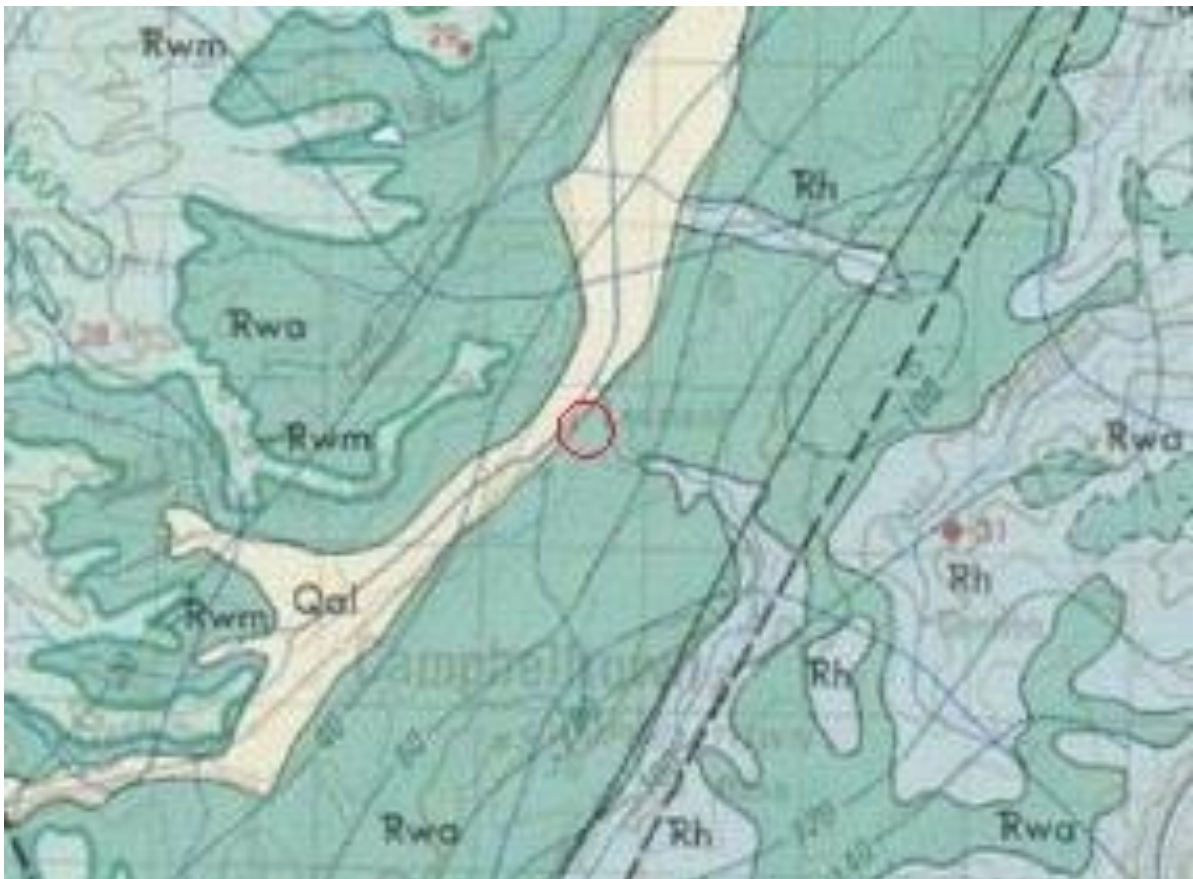
**Figure 2** - Site location on Wollongong – Port Hacking 1:100,000 map

Reference to the 1:100,000 Wollongong – Port Hacking Geological Map indicates that the site lies within a sub-group of the Wianamatta Group, consisting of laminate and dark-grey siltstone. The site however lies close to the boundary of Quaternary Alluvium material in the northwest, consisting of quartz and lithic “fluvial” sand, silt, and clay. There also appears to be no noted geological fault lines within the immediate area.

Refer to **Figure 2** for approximate location of geological landscapes.

The desktop study indicated that the site lies within the Wianamatta geological landscape.

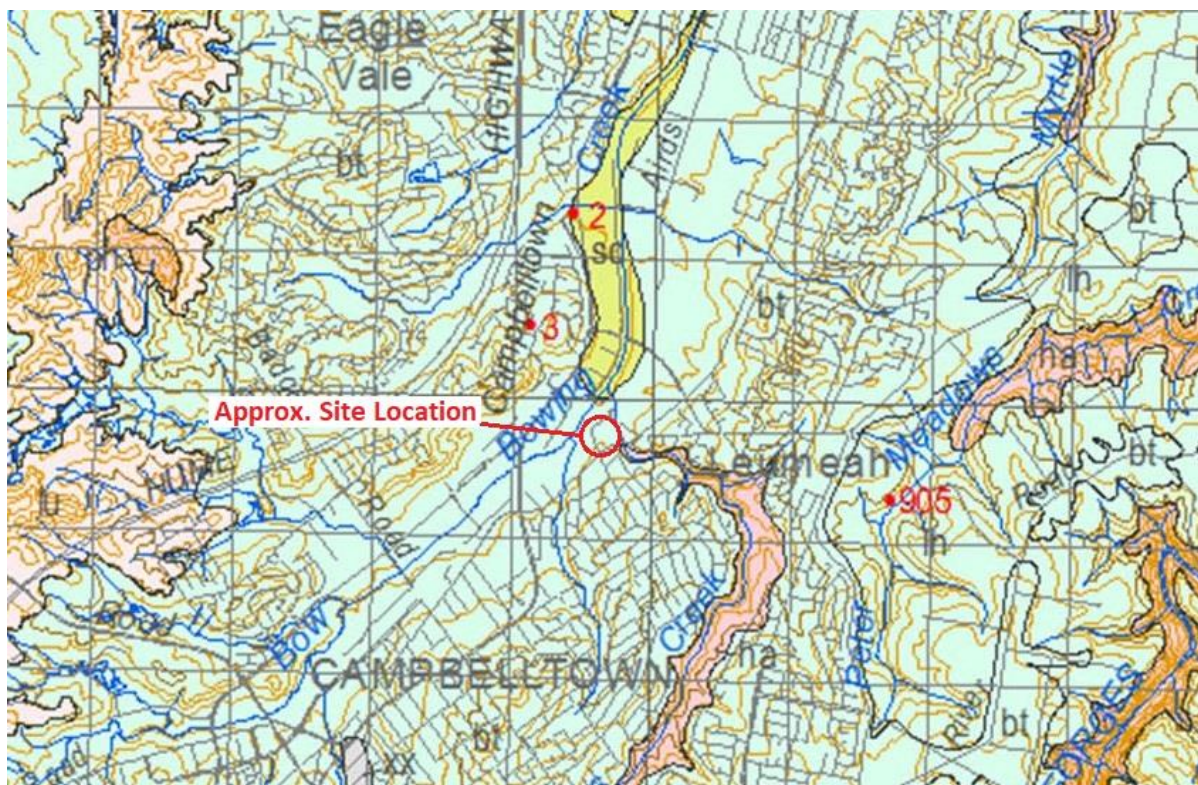
**Figure 3** - Approximate extent of soil landscapes at the site

Reference to the 1:100,000 Wollongong – Port Hacking Soil Landscape Map indicates that the site is located within the Blacktown soil landscape with the Hawkesbury soil landscape close to the site towards the southeast.

The Blacktown soil landscape is characterized by gently undulating rises on Wianamatta Group shales and broad rounded crests and ridges with gently inclined slopes. Local slopes are generally >5% on local reliefs of up to 30m. Soils generally consist of shallow to moderately deep hard setting mottled texture contrast soils, red and brown podzolic soils on crests grading to yellow podzolic soils on lower slopes and in drainage lines. Vegetation consists of cleared eucalypt woodland and tall open-forest.

The Hawkesbury soil landscape is characterised by rugged, rolling to very steep hills on Hawkesbury Sandstone. Local slopes are generally >25% on local reliefs of 40-200m with rock outcropping >50%. Topography is usually narrow crests and ridges, narrow incised valleys, steep side slopes with rocky benches, broken scarps and boulders. Vegetation is mostly uncleared eucalypt open-woodland and tall open-forest. Soils for the landscape consist of shallow, discontinuous lithosols/siliceous sands associated with rock outcrops, earthy sands, yellow earths and some yellow podzolic soils on inside of benches and along joints and fractures, localised yellow and red podzolic soils associated with shale lenses and secondary yellow earths along drainage lines.

Refer to **Figure 3** below for the approximate boundary of the Blacktown (green) and Hawkesbury (pink) soil landscapes.

The desktop study indicated that the site lies within the Blacktown soil landscape.
