Preliminary Site Investigation

Lot 1 DP85924, Gale Street, Woolwich NSW 2110

Project No. 23180
Version 1

24 July 2023

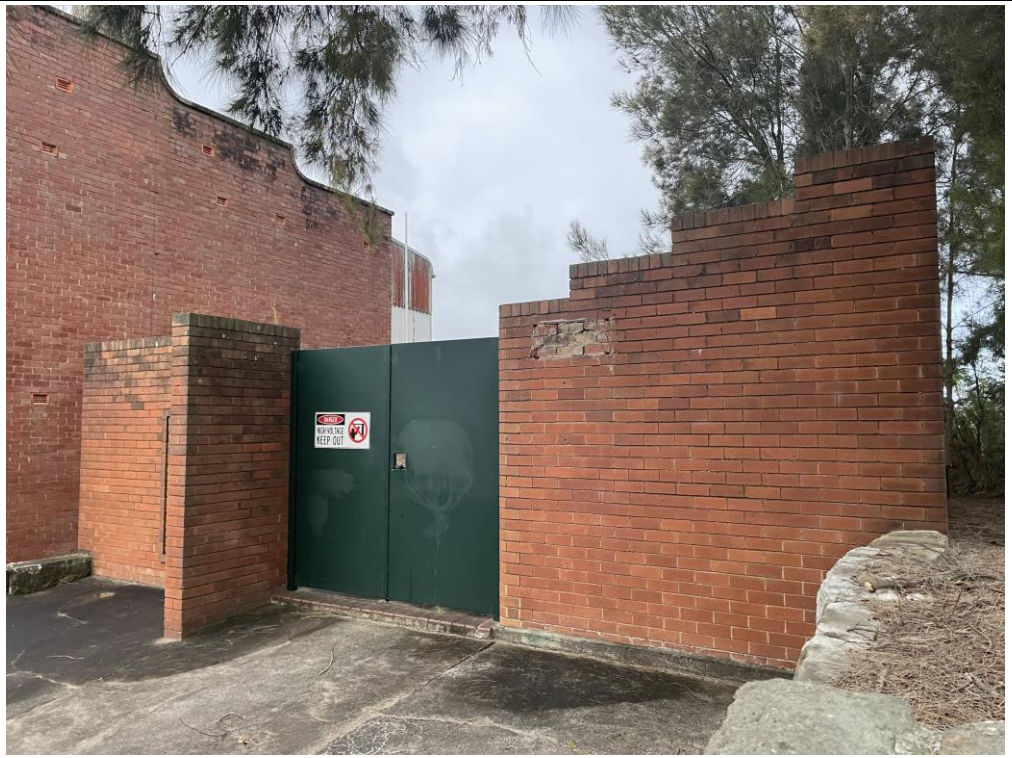
Photo No.	Date
1	16 July 2023
<p>Direction Facing</p> <p>Northeast</p>	
<p>Description</p> <p>The disused substation occupying the site at Lot 1 DP85924 Gale Street, Woolwich NSW 2110.</p>

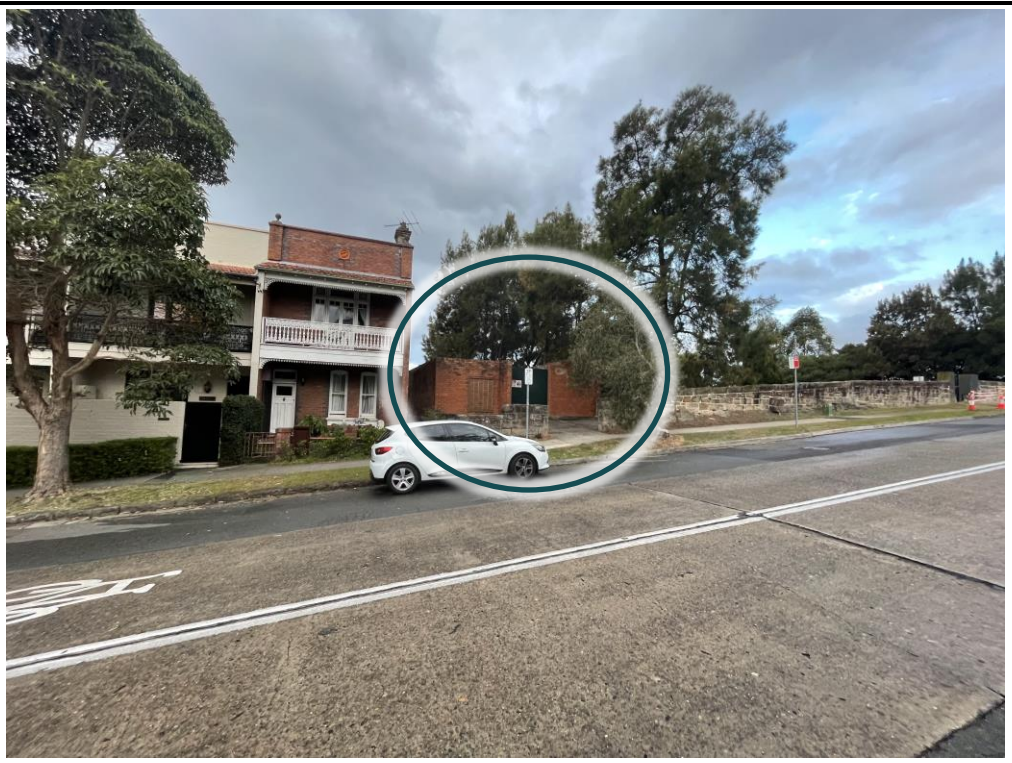
Photo No.	Date
2	16 July 2023
<p>Direction Facing</p> <p>Southeast</p>	
<p>Description</p> <p>Location of the site in relation to Gale Street and the adjoining residential property (1 Gale Street).</p>

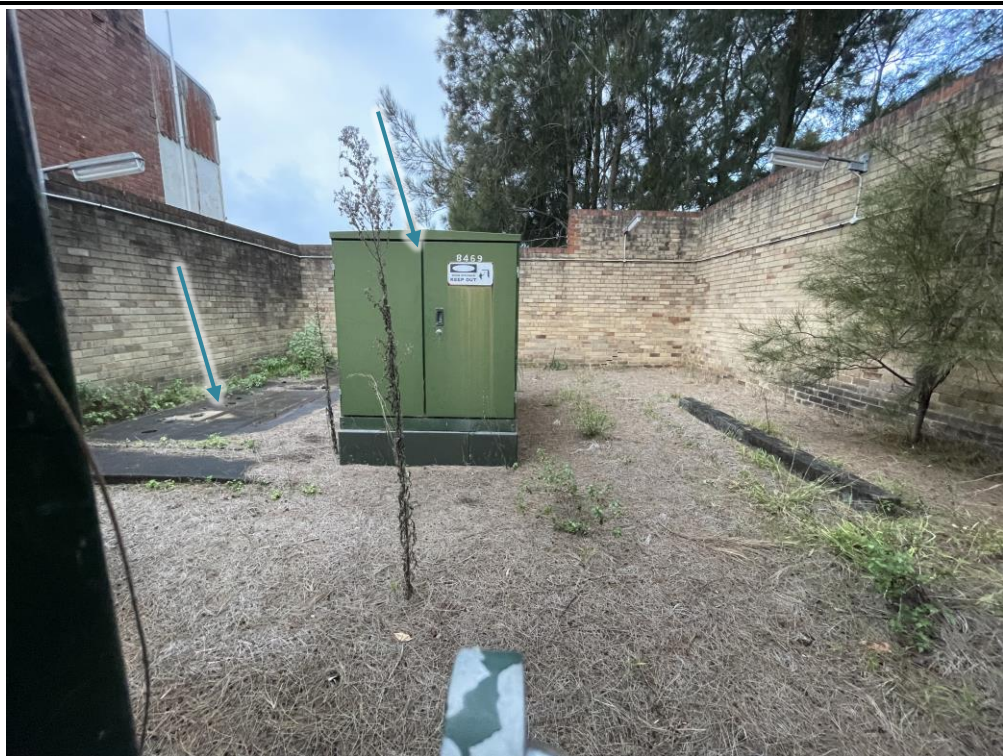
Photo No. 4	Date 16 July 2023
Direction Facing East	
Description Disused concrete pad and electrical transformer.

A photograph showing an outdoor area with a green electrical transformer in the center. To the left, there is a brick wall and a disused concrete pad. A blue arrow points to the concrete pad, and another blue arrow points to the transformer. The ground is covered with dry grass and weeds. A brick wall is visible in the background, and a small tree is in the foreground.

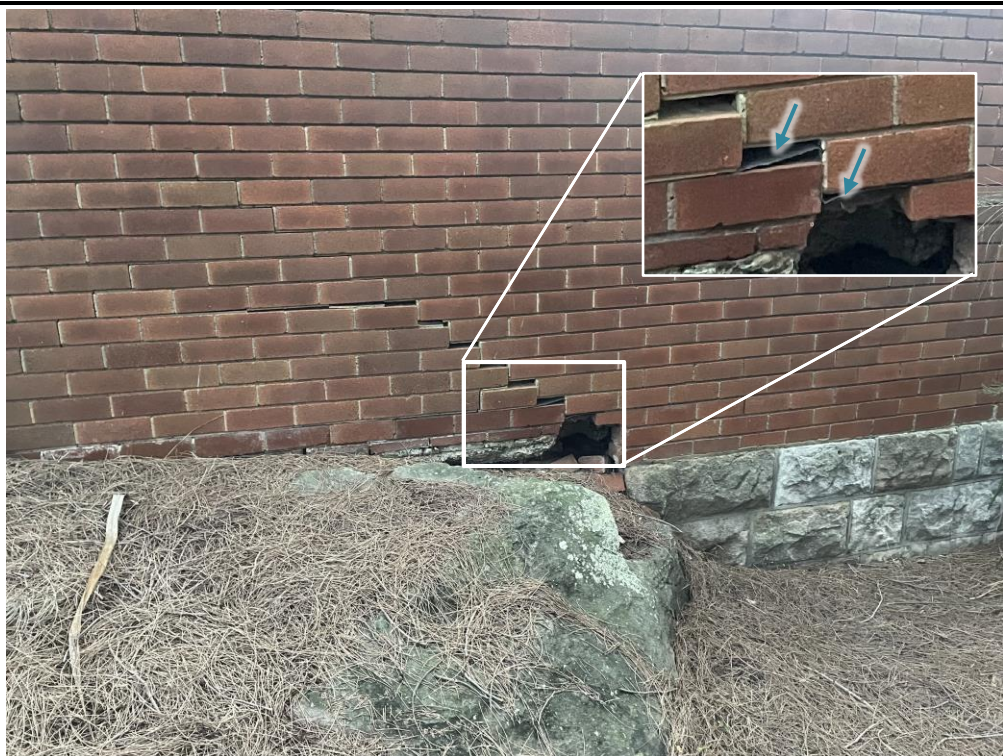
- The disused substation was secured by a brick wall greater than 2.5 m high. The brick wall was observed to be cracking along the southwest corner of the site. The cracked retaining wall had exposed a water-proofing membrane in the wall which was observed to be intact and in fair condition.

Photo No. 6	Date 16 July 2023
Direction Facing West	
Description Cracked brick wall. Water proofing membrane exposed by the cracked wall was observed.

A photograph of a red brick wall with a significant horizontal crack. An inset image provides a close-up view of the crack, showing a dark, irregular opening where the water proofing membrane is exposed. The wall is situated above a stone foundation, and the foreground is covered with dry pine needles and a large, mossy rock.

- Completion of a pre-demolition hazardous materials (HAZMAT) survey in accordance with Australian Standard AS2601-2001 *Demolition of Structures*. Hazardous building materials such as waterproofing membranes, sealant, mastics or disused electrical equipment may be detected within the site structures.

- If hazardous materials are identified, they should be removed prior to demolition of structures in accordance with the NSW WHS Act, Chapter 8 of the WHS Regulation and SafeWork NSW Codes of Practice and preparation of an Asbestos Management Plan to inform the removal of asbestos containing building materials and potential lead paint in accordance with SafeWork NSW requirements including clearance certificates provided by a SafeWork NSW Licensed Asbestos Assessor or "Competent Person" as defined by the Code of Practice.
