Macarthur Grange - Riparian Constraints Assessment

Toscuz Investments

Project Name	Macarthur Grange - Riparian Constraints Assessment
Project Number	20WOL-15319
Project Manager	Katherine Lang
Prepared by	Emily Messer
Reviewed by	Ian Dixon and Katherine Lang
Approved by	Katherine Lang
Status	Final
Version Number	v3
Last saved on	28 May 2020

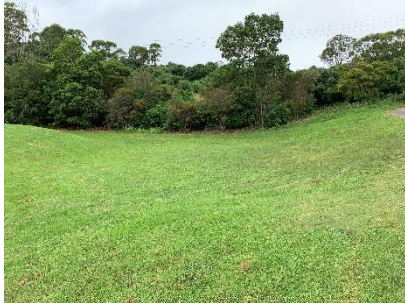
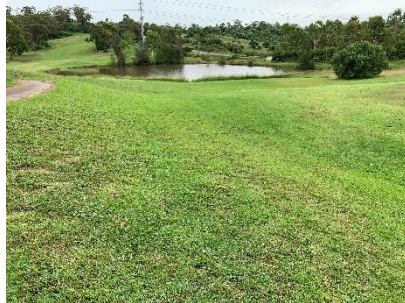
Reach name	Strahler stream order	Likely WM Act status (to be confirmed with NRAR)	Description	Upstream photo	Downstream photo
1A	1st	Not a 'river'	No defined bed or bank. Part of golf course fairway.

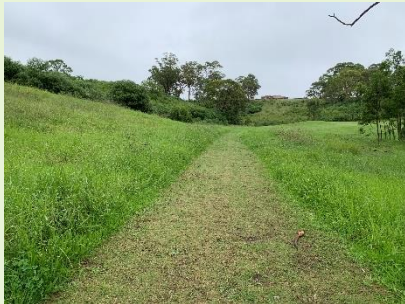
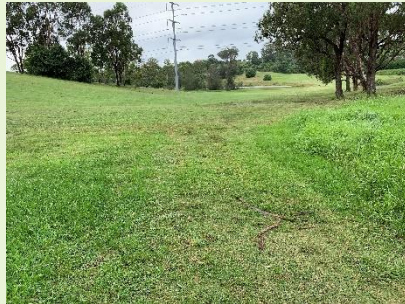
1B	1st	Not a 'river'	No defined bed or bank. Part of golf course fairway.

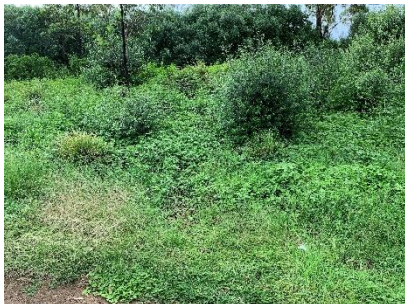
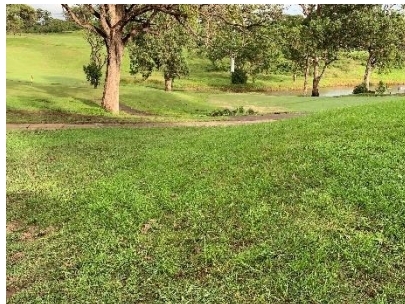
1C	1st	Not a 'river'	No defined bed or bank. Part of golf course fairway.

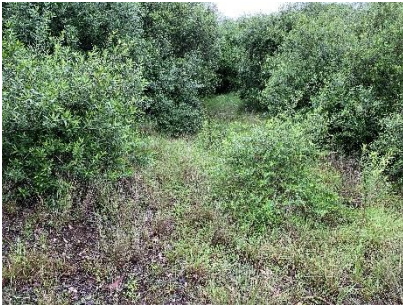
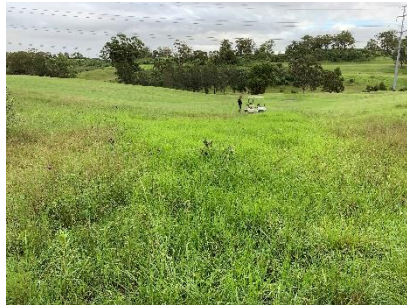
Reach name	Strahler stream order	Likely WM Act status (to be confirmed with NRAR)	Description	Upstream photo	Downstream photo
1G	1st	Not a 'river'	No defined bed or bank. Part of golf course fairway.

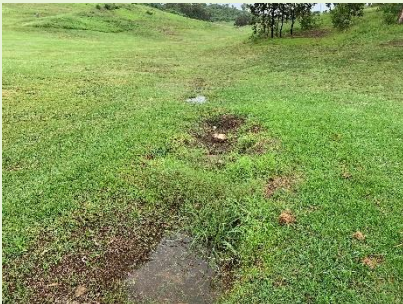
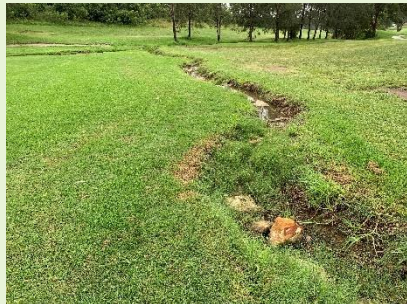
1H	1st	River	No defined bed or bank for majority of mapped creek. Defined bed and banks 35 m upstream of the confluence with 2A. Channel is 0.5 m wide, meandering through fairway. Benthic habitat was clay with pebbles/gravel overlaid.

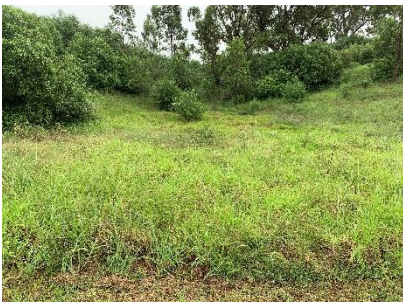
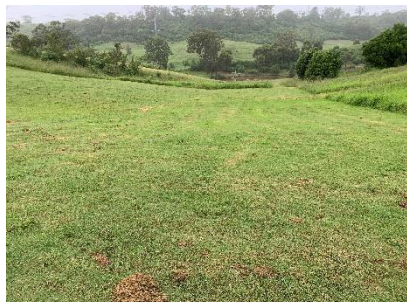
1I	1st	Not a 'river'	No defined bed or bank. Part of golf course fairway.

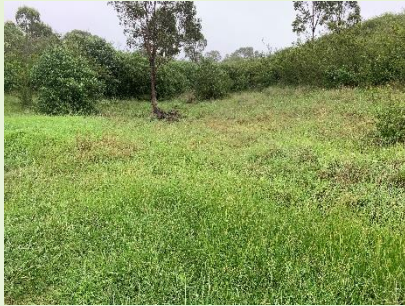
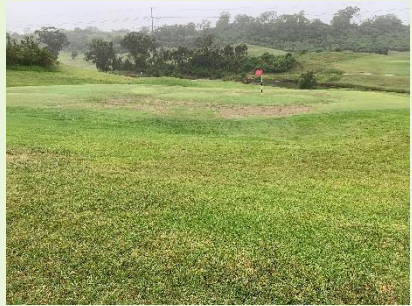
Reach name	Strahler stream order	Likely WM Act status (to be confirmed with NRAR)	Description	Upstream photo	Downstream photo
1J	1st	Not a 'river'	No defined bed or bank. Part of golf course fairway.

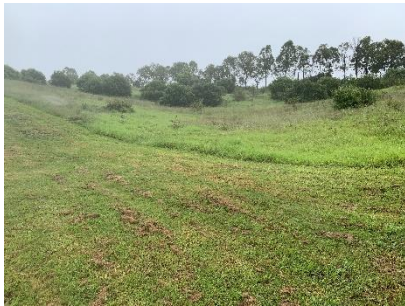
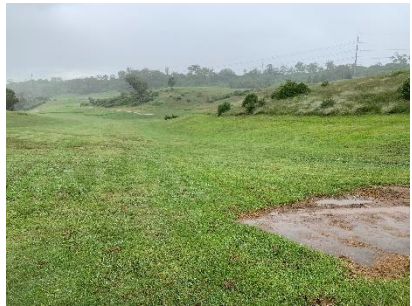
1K	1st	Not a 'river'	No defined bed or bank. Part of golf course fairway.

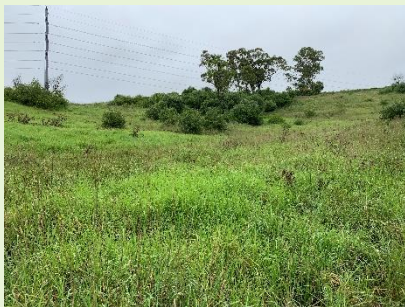
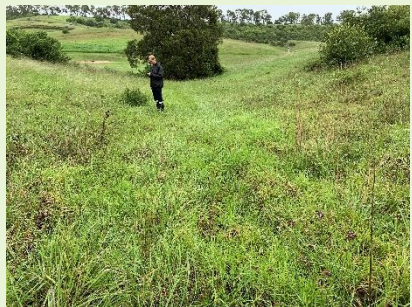
1L	1st	Not a 'river'	No defined bed or bank. Part of golf course fairway.

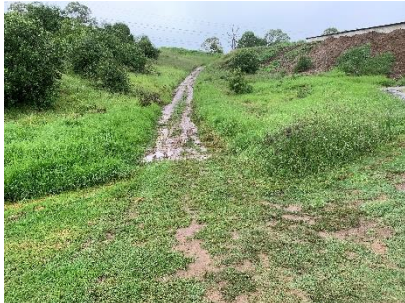
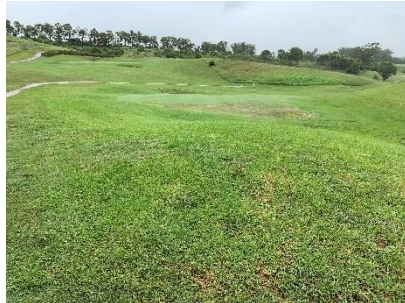
Reach name	Strahler stream order	Likely WM Act status (to be confirmed with NRAR)	Description	Upstream photo	Downstream photo
1M	1st	Not a 'river'	No defined bed or banks. Upstream was a golf cart track and downstream was fairway.

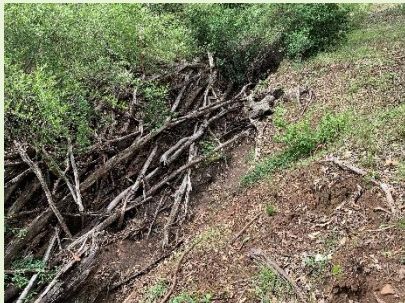
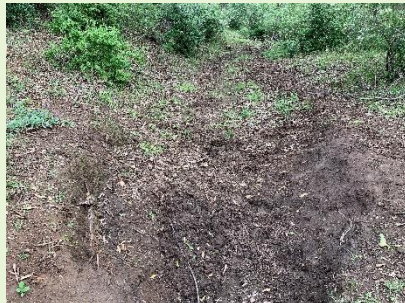
1N	1st	River	Channel began at a head cut and quickly became deeply incised. Banks were 3 m high and 4 m wide with severe undercutting. Woody debris was dense in the channel, with numerous trees and logs present. There were small pools of turbid water in the head cuts. No aquatic vegetation was present.

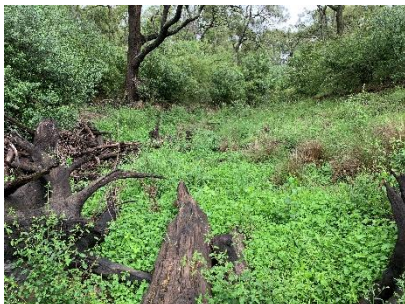
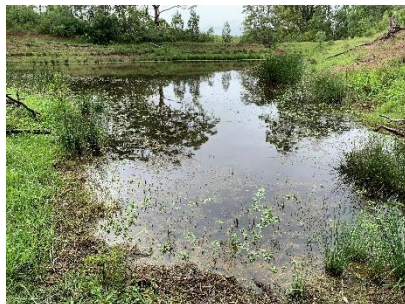
10	1st	River	The channel was filled with rubbish and woody debris. Both banks were densely vegetated, with no active erosion evident. The bed was dry, with no pooling water. No aquatic vegetation was observed. The downstream extent of the creek flowed into a dam.

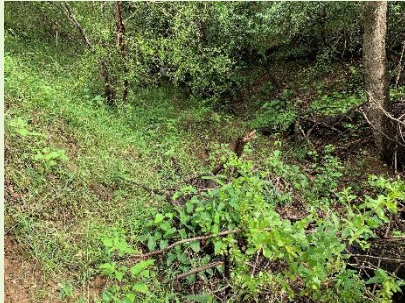
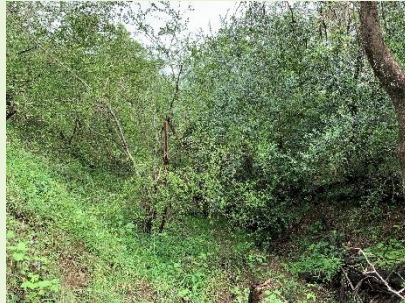
Reach name	Strahler stream order	Likely WM Act status (to be confirmed with NRAR)	Description	Upstream photo	Downstream photo
1P	1st	River	Channel was 1 m wide, with gently sloping vegetated banks. There was no active erosion evident. No aquatic vegetation was observed, and the bed had scattered Box Thorn, Prickly Pear and grass,

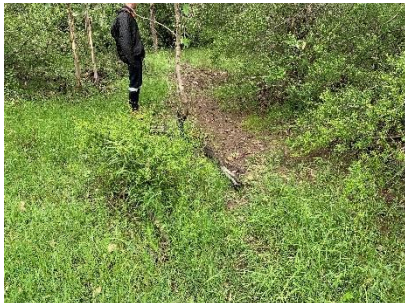
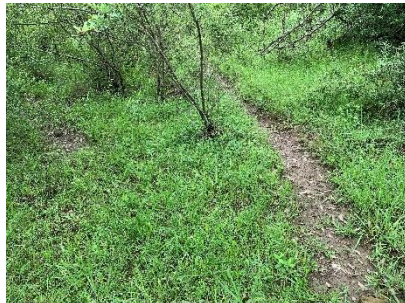
1Q	1st	Not a 'river' upstream of dam. Mapped as 'river' in dam.	No defined bed or banks. A cattle track was the low point of the grassy swale and would increase flow of water into the dam.

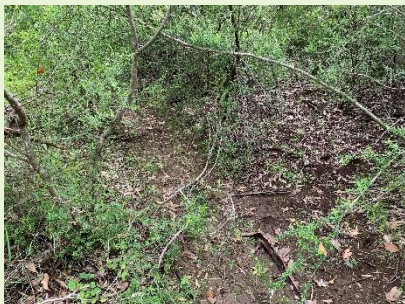
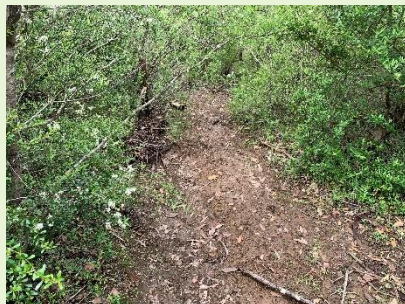
1R	1st	River	Defined bed and banks evident in vegetated area. Channel was 0.5 m wide and dry. The benthic composition was silty clay and scattered gravel. No aquatic vegetation was present. Channel became a grassy swale where it flowed over a paddock, before entering two connected dams.

There will be some offsetting of encroachments into riparian corridors likely for reaches 1R and 1S, this would be further assessed during future DA stages. The current Masterplan shows that there is capacity to accommodate a variety of averaging and offsetting options for the retained riparian corridors on site. An example for reach 2A and 1R are included in Figure 8 and Figure 9 respectively.

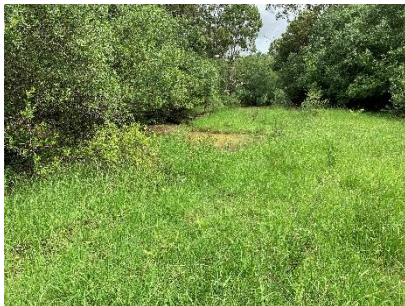
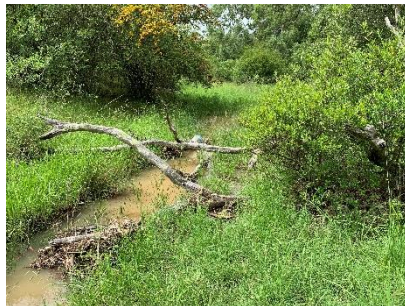
Reach name	Strahler stream order	Likely WM Act status (to be confirmed with NRAR)	Description	Upstream photo	Downstream photo
1S	1st	River	The broader channel was approximately 10 m wide and flat. There was a smaller channel meandering through the wider channel with low areas with shallow turbid pools. The bed was clay silt with <i>Cyperus</i> sp. the dominate species. Common Eastern Froglet was heard throughout the reach. Woody debris was common throughout. Both banks were gently sloped and densely vegetated.

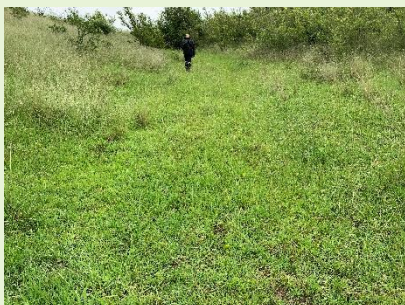
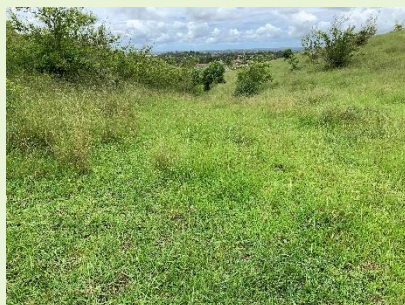
1T	1st	Not a 'river'	No defined bed or banks. Grassy overland flow only.

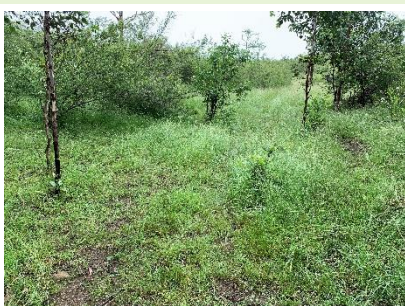
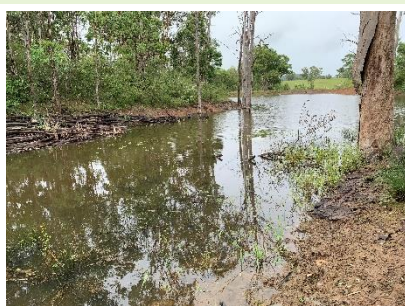
1U	1st	Not a 'river' upstream of dam. Mapped as River in dam and downstream.	No defined bed or banks upstream of the dam. Grassy overland flow only. In the dam, Common Eastern Froglets were heard calling. Downstream of the dam was a small spill channel before the water dispersed through the vegetation and no channel was evident.

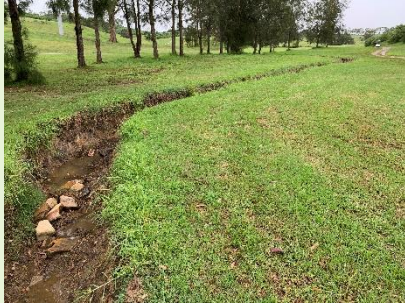
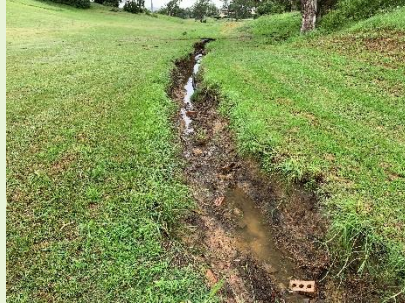
Reach name	Strahler stream order	Likely WM Act status (to be confirmed with NRAR)	Description	Upstream photo	Downstream photo
2A	2nd	Not a 'river' upstream of dam. Mapped as River in dam and downstream.	No defined bed or banks upstream of dams. Golf course fairway only. Downstream of the dams the channel, which meandered along the centre of the golf course, was incised with eroding vertical banks. The benthic habitat was clay with gravel/pebbles. There was no woody debris or aquatic plants observed. Pipes exiting periodically from banks funnelled water from surrounding fairways into the creek. No frogs were heard calling.

Reach 2A is the central riparian corridor which is planned to be retained and included as a feature in the future landscape. The two large dams adjacent to Raby Road likely to be removed and a natural creek line and corridor restored in their place. This reconstruction will occur north of the proposed road crossing and extend up to Raby Road. The proposed riparian corridor width is 42m (20m either side of future TOB and a 2m bed width). This width is in-line with the stream order 2 guidelines.

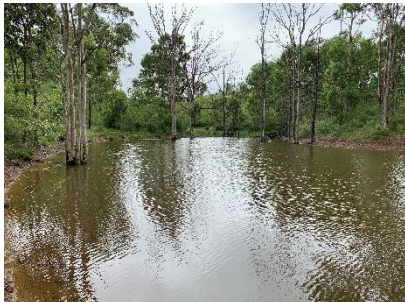
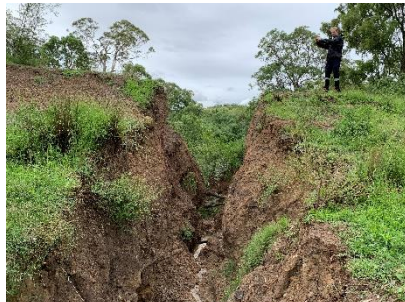
2B	2nd	River	The channel was mapped as the dam, which began at the confluence of 1N and 1U. The dam overflowed, to the east, through a large, deeply incised channel with significant erosion before dispersing into a wider grassy channel offsite.

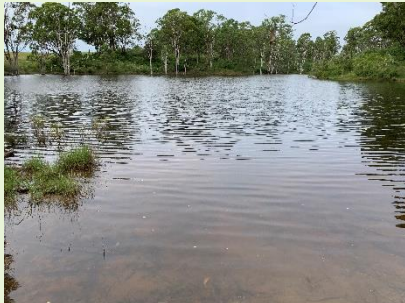
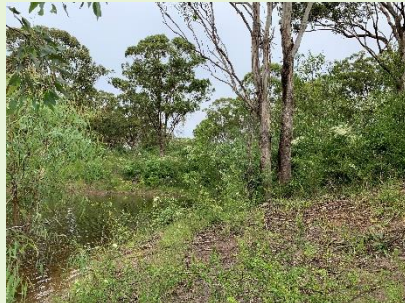
2C	2nd	River	The channel was mapped as the downstream portion of the dam, north of the confluence of 1P and 1Q. The dam overflowed to the north, through a shallow grassy channel, before flowing offsite.

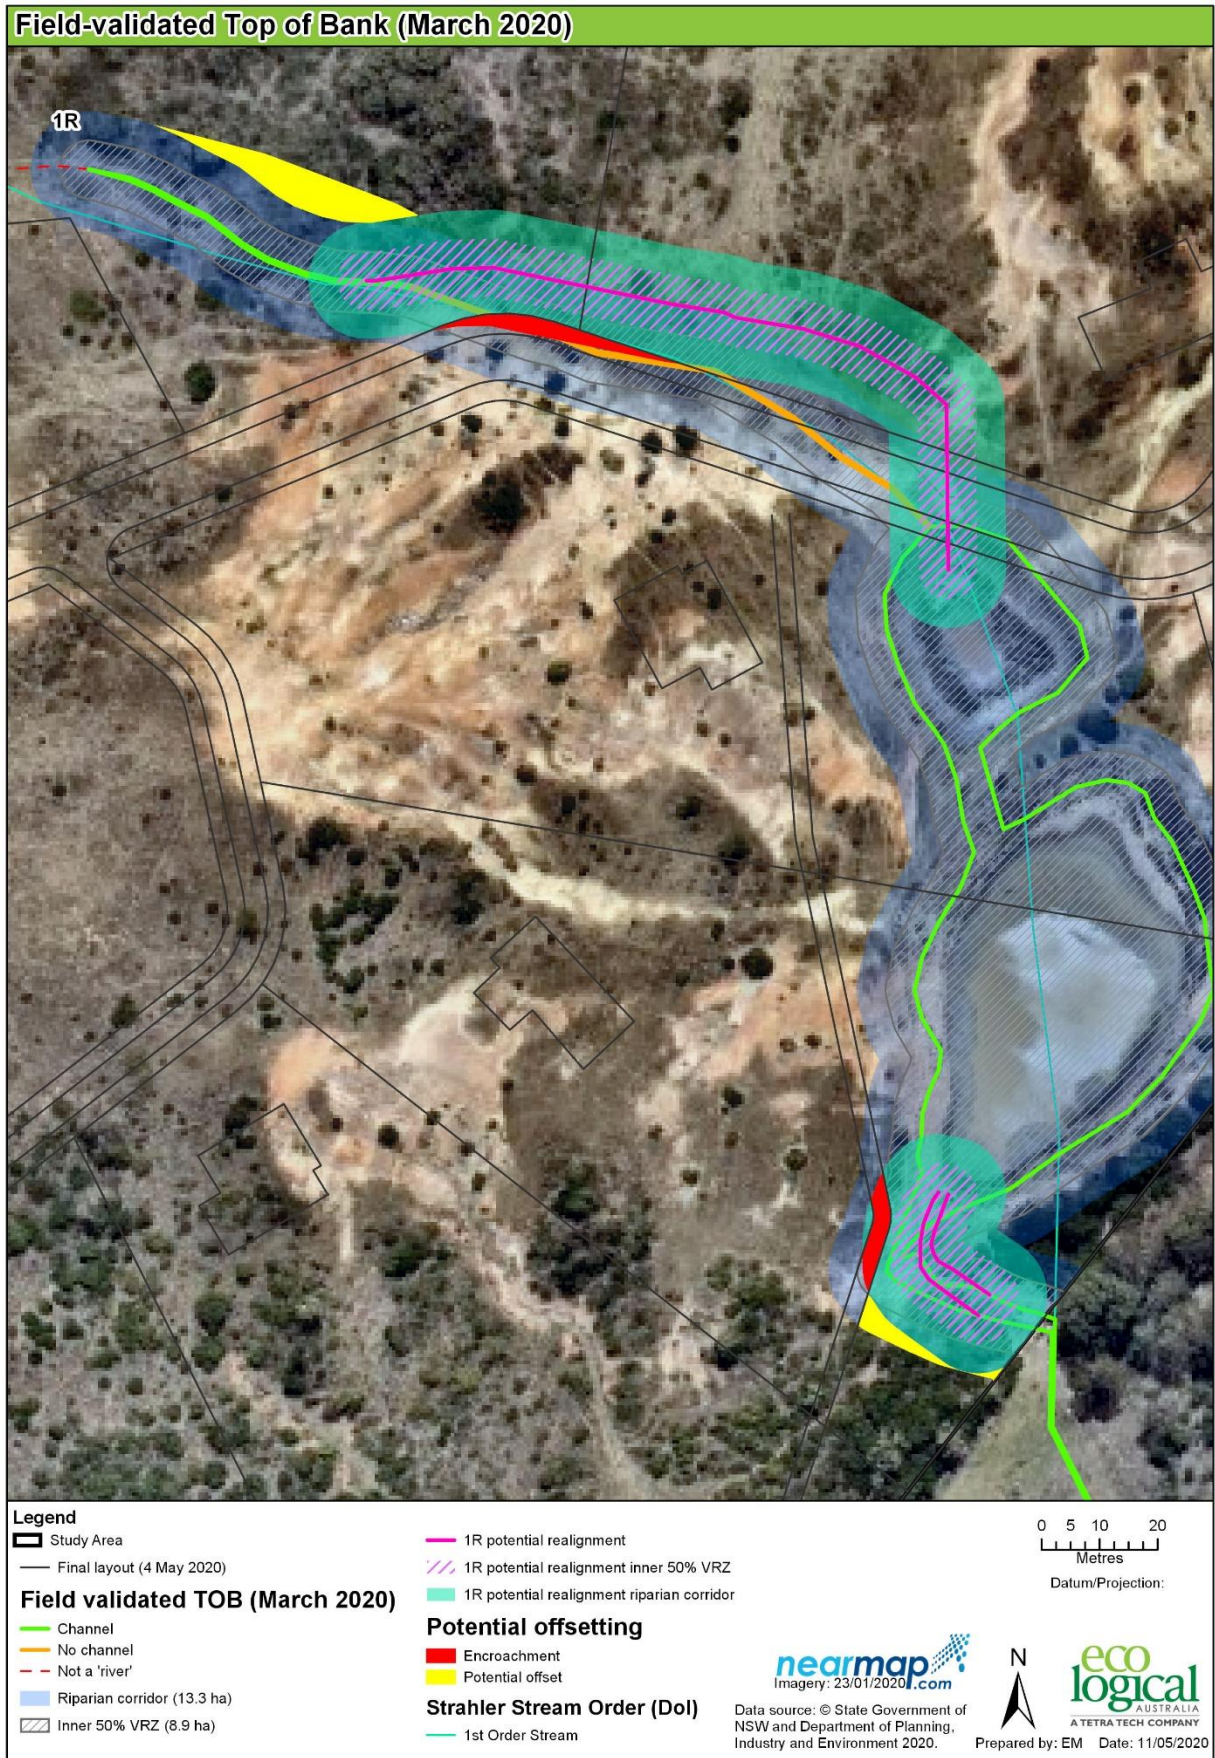
Figure 9: Potential offsetting for areas of encroachment
