Macarthur Grange - Riparian Constraints Assessment

Toscuz Investments

Project Name	Macarthur Grange - Riparian Constraints Assessment
Project Number	24WOL-7666
Project Manager	Joseph Gleeson
Prepared by	Lily Tonks and Erin Hodgkin
Reviewed by	Ian Dixon
Approved by	Ian Dixon
Status	Draft
Version Number	v5
Last saved on	7 June 2024

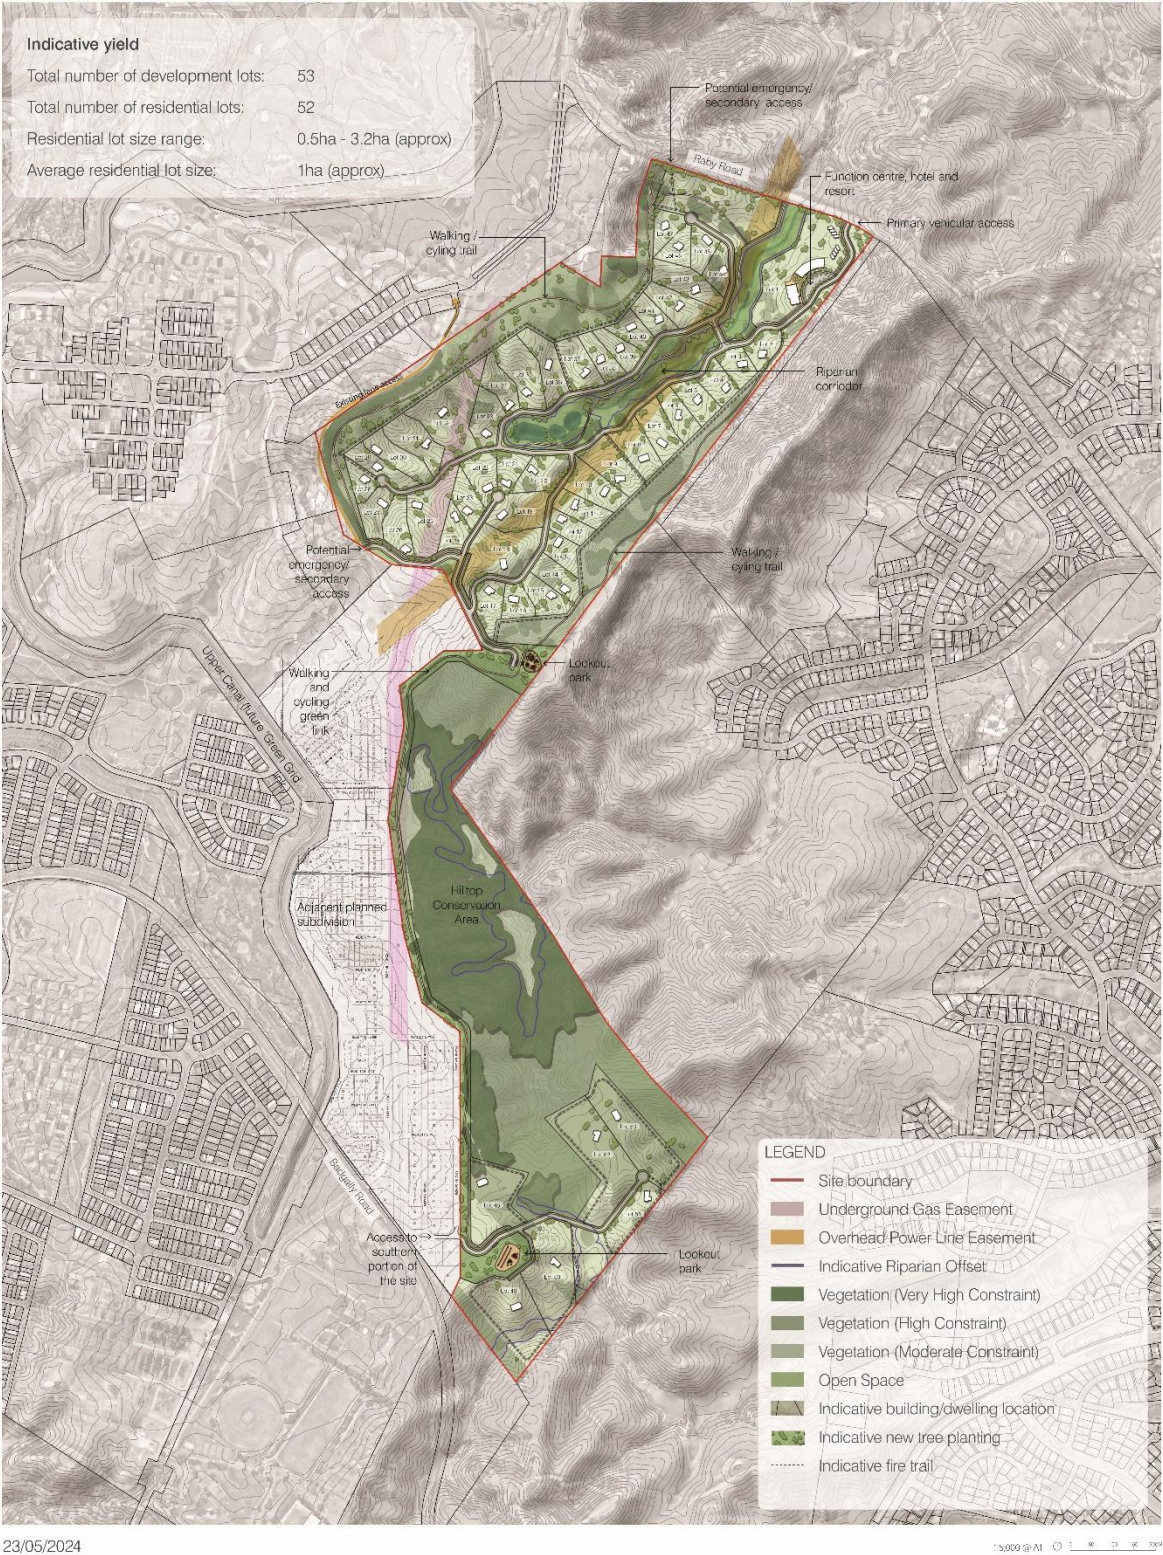
Figure 1: Proposed lot layout and rezoning (Architectus 2024)

Review of the Indicative Masterplan (Figure 1) found that the current proposal will retain the majority of the watercourses on site and keep corresponding riparian corridors in place. Potential watercourse realignment is proposed for portions of reaches 2A and 1R (Figure 8).

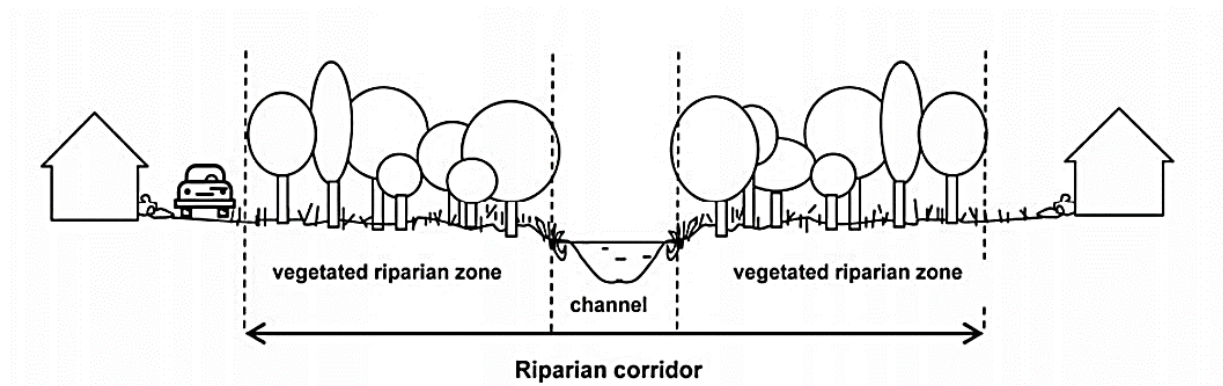
Figure 3: Vegetated Riparian Zone and watercourse channel comprising the riparian corridor (DCCEEW 2022a)

The DCCEEW – *Water Controlled activities – Guidelines for riparian corridors on waterfront land* (DCCEEW 2022a) outlines the need for a Vegetated Riparian Zone (VRZ) adjacent to the channel to provide a transition zone between the terrestrial environment and watercourse. This vegetated zone helps maintain and improve the ecological functions of a watercourse whilst providing habitat for terrestrial flora and fauna. The VRZ plus the channel (bed and banks of the watercourse to the highest bank) constitute the 'riparian corridor' (Figure 3). To be consistent with the guidelines VRZ widths should be based on watercourse order as classified under the Strahler System of ordering watercourses and using Hydroline Spatial Data which is published on the department's website (Table 2).

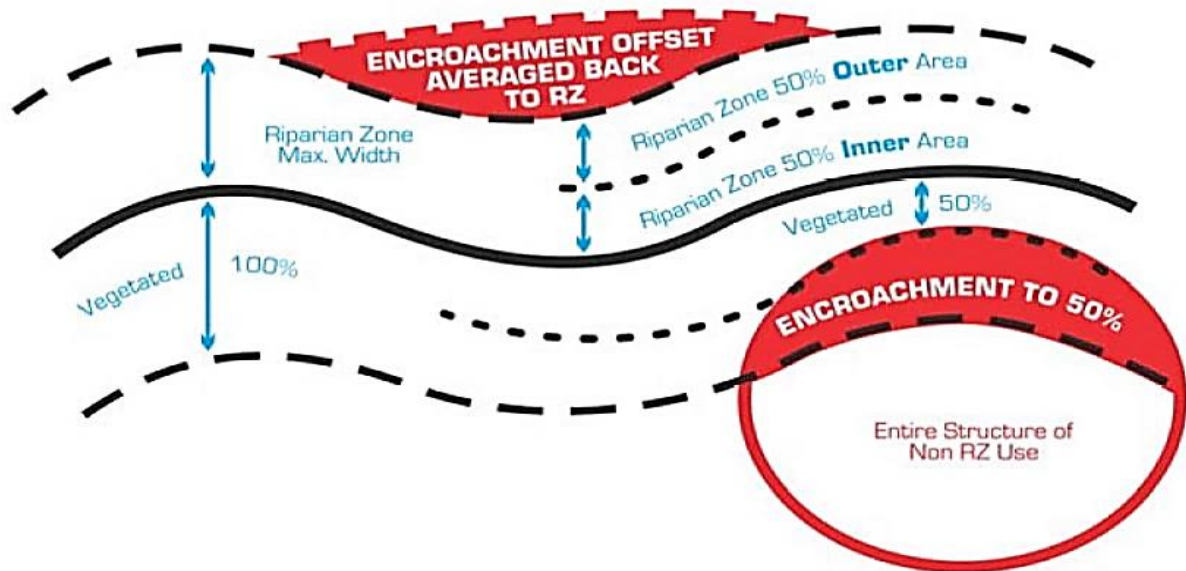
Figure 4: Riparian 'averaging rule' for offsetting encroachment into the outer 50% of the VRZ (DCCEEW 2022a)

Certain works are permissible within the riparian zone (Table 3). Non-riparian uses are consistent with DCCEEW's guidelines in the outer 50% of the VRZ as long compensation (1:1 offset) is achieved within the site. The outer VRZ that is impacted must be offset elsewhere on site using the 'averaging rule' (Figure 4). Section 5 further outlines how the proposed rezoning relates to the WM Act objectives and guidelines.

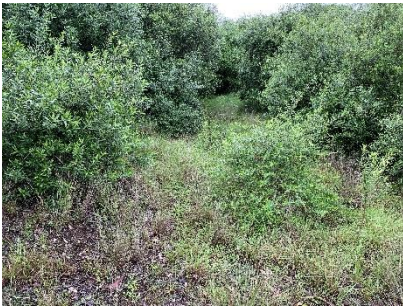
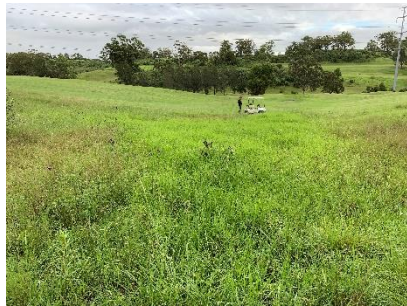
1H	1 st	River	No defined bed or bank for majority of mapped creek. Defined bed and banks 35 m upstream of the confluence with 2A. Channel is 0.5 m wide, meandering through fairway. Benthic habitat was clay with pebbles/gravel overlaid.

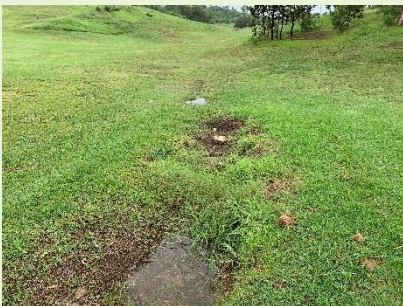
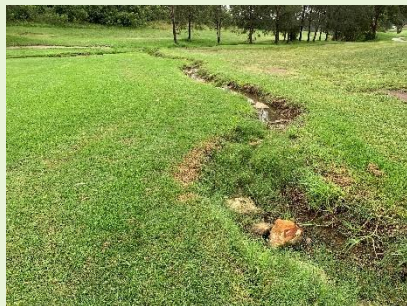
1I	1 st	Not a 'river'	No defined bed or bank. Part of golf course fairway.

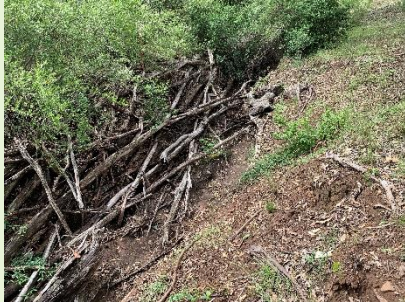
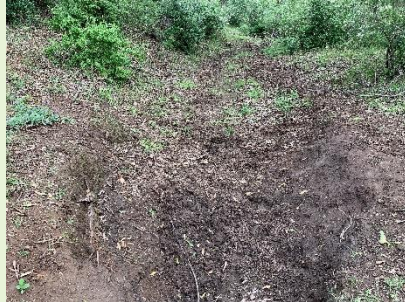
10	1 st	River	The channel was filled with rubbish and woody debris. Both banks were densely vegetated, with no active erosion evident. The bed was dry, with no pooling water. No aquatic vegetation was observed. The downstream extent of the creek flowed into a dam.

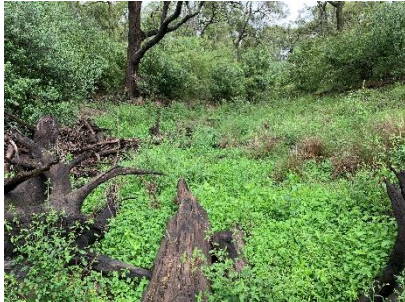
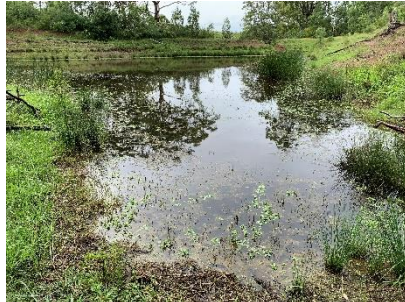
Reach name	Strahler stream order	Likely WM Act status (to be confirmed with DCCEEW – Water)	Description	Upstream photo	Downstream photo
1P	1 st	River	Channel was 1 m wide, with gently sloping vegetated banks. There was no active erosion evident. No aquatic vegetation was observed, and the bed had scattered Box Thorn, Prickly Pear and grass,

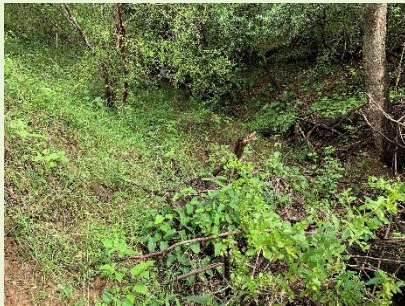
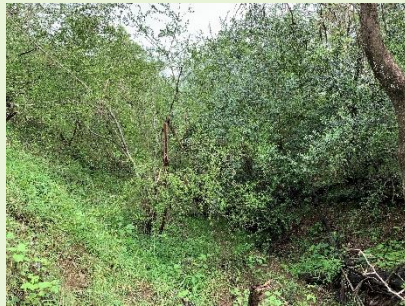
1Q	1 st	Not a 'river' upstream of dam. Mapped as 'river' in dam.	No defined bed or banks. A cattle track was the low point of the grassy swale and would increase flow of water into the dam.

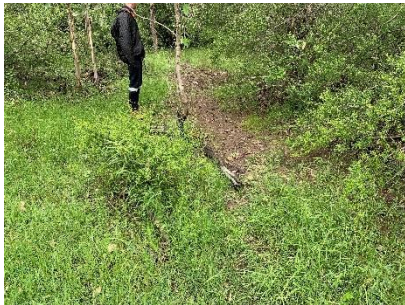
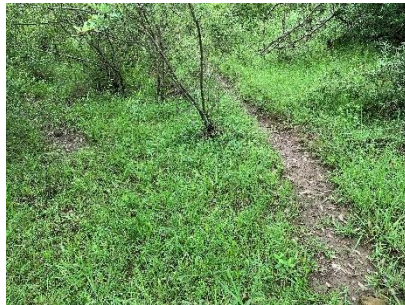
1R	1 st	River	Defined bed and banks evident in vegetated area. Channel was 0.5 m wide and dry. The benthic composition was silty clay and scattered gravel. No aquatic vegetation was present. Channel became a grassy swale where it flowed over a paddock, before entering two connected dams.

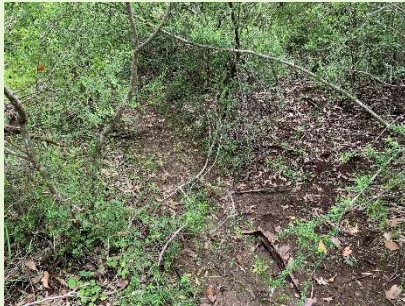
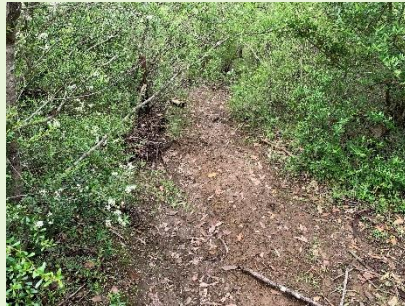
Reach name	Strahler stream order	Likely WM Act status (to be confirmed with DCCEEW – Water)	Description	Upstream photo	Downstream photo
1S	1 st	River	The broader channel was approximately 10 m wide and flat. There was a smaller channel meandering through the wider channel with low areas with shallow turbid pools. The bed was clay silt with <i>Cyperus</i> sp. the dominate species. Common Eastern Froglet was heard throughout the reach. Woody debris was common throughout. Both banks were gently sloped and densely vegetated.

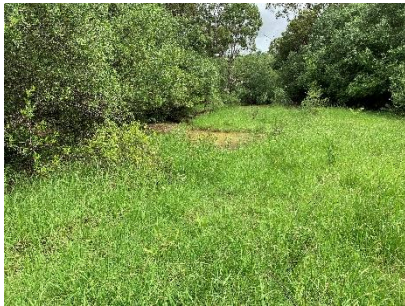
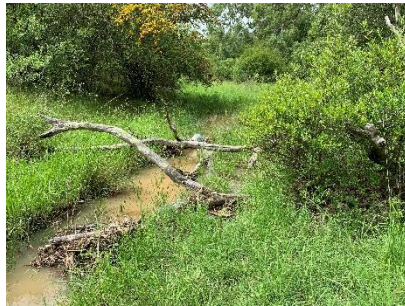
1T	1 st	Not a 'river'	No defined bed or banks. Grassy overland flow only.

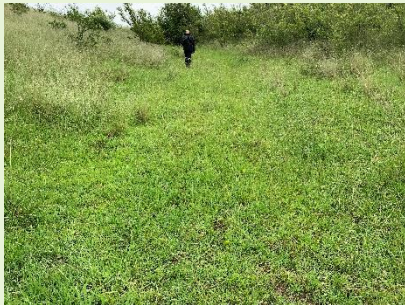
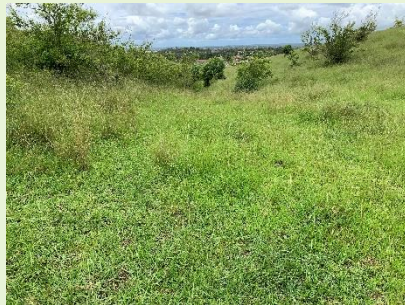
1U	1 st	Not a 'river' upstream of dam. Mapped as River in dam and downstream.	No defined bed or banks upstream of the dam. Grassy overland flow only. In the dam, Common Eastern Froglets were heard calling. Downstream of the dam was a small spill channel before the water dispersed through the vegetation and no channel was evident.

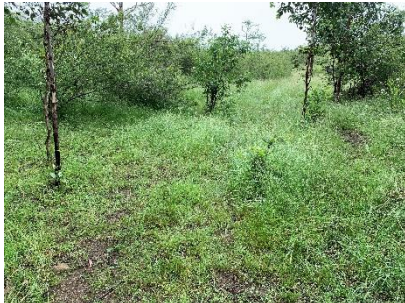
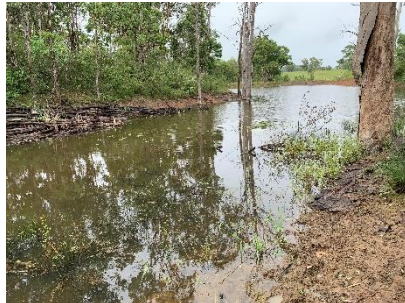
Reach name	Strahler stream order	Likely WM Act status (to be confirmed with DCCEEW – Water)	Description	Upstream photo	Downstream photo
2A	2 nd	Not a 'river' upstream of dam. Mapped as River in dam and downstream.	No defined bed or banks upstream of dams. Golf course fairway only. Downstream of the dams the channel, which meandered along the centre of the golf course, was incised with eroding vertical banks. The benthic habitat was clay with gravel/pebbles. There was no woody debris or aquatic plants observed. Pipes exiting periodically from banks funnelled water from surrounding fairways into the creek. No frogs were heard calling.

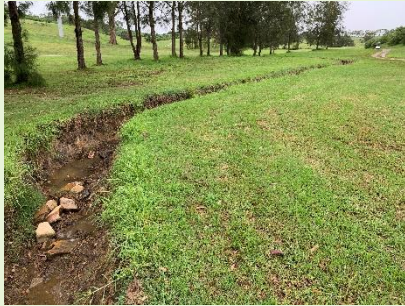
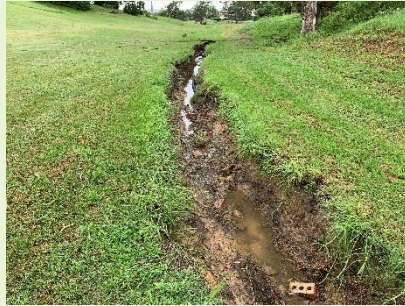
2B	2 nd	River	The channel was mapped as the dam, which began at the confluence of 1N and 1U. The dam overflowed, to the east, through a large, deeply incised channel with significant erosion before dispersing into a wider grassy channel offsite.

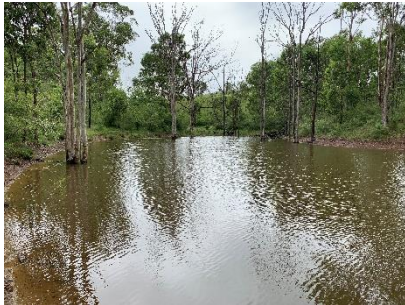
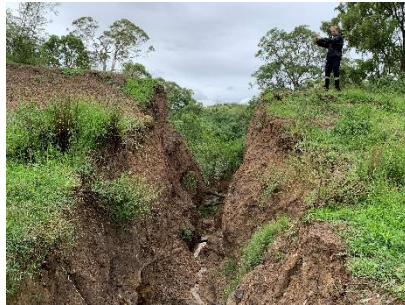
2C	2 nd	River	The channel was mapped as the downstream portion of the dam, north of the confluence of 1P and 1Q. The dam overflowed to the north, through a shallow grassy channel, before flowing offsite.

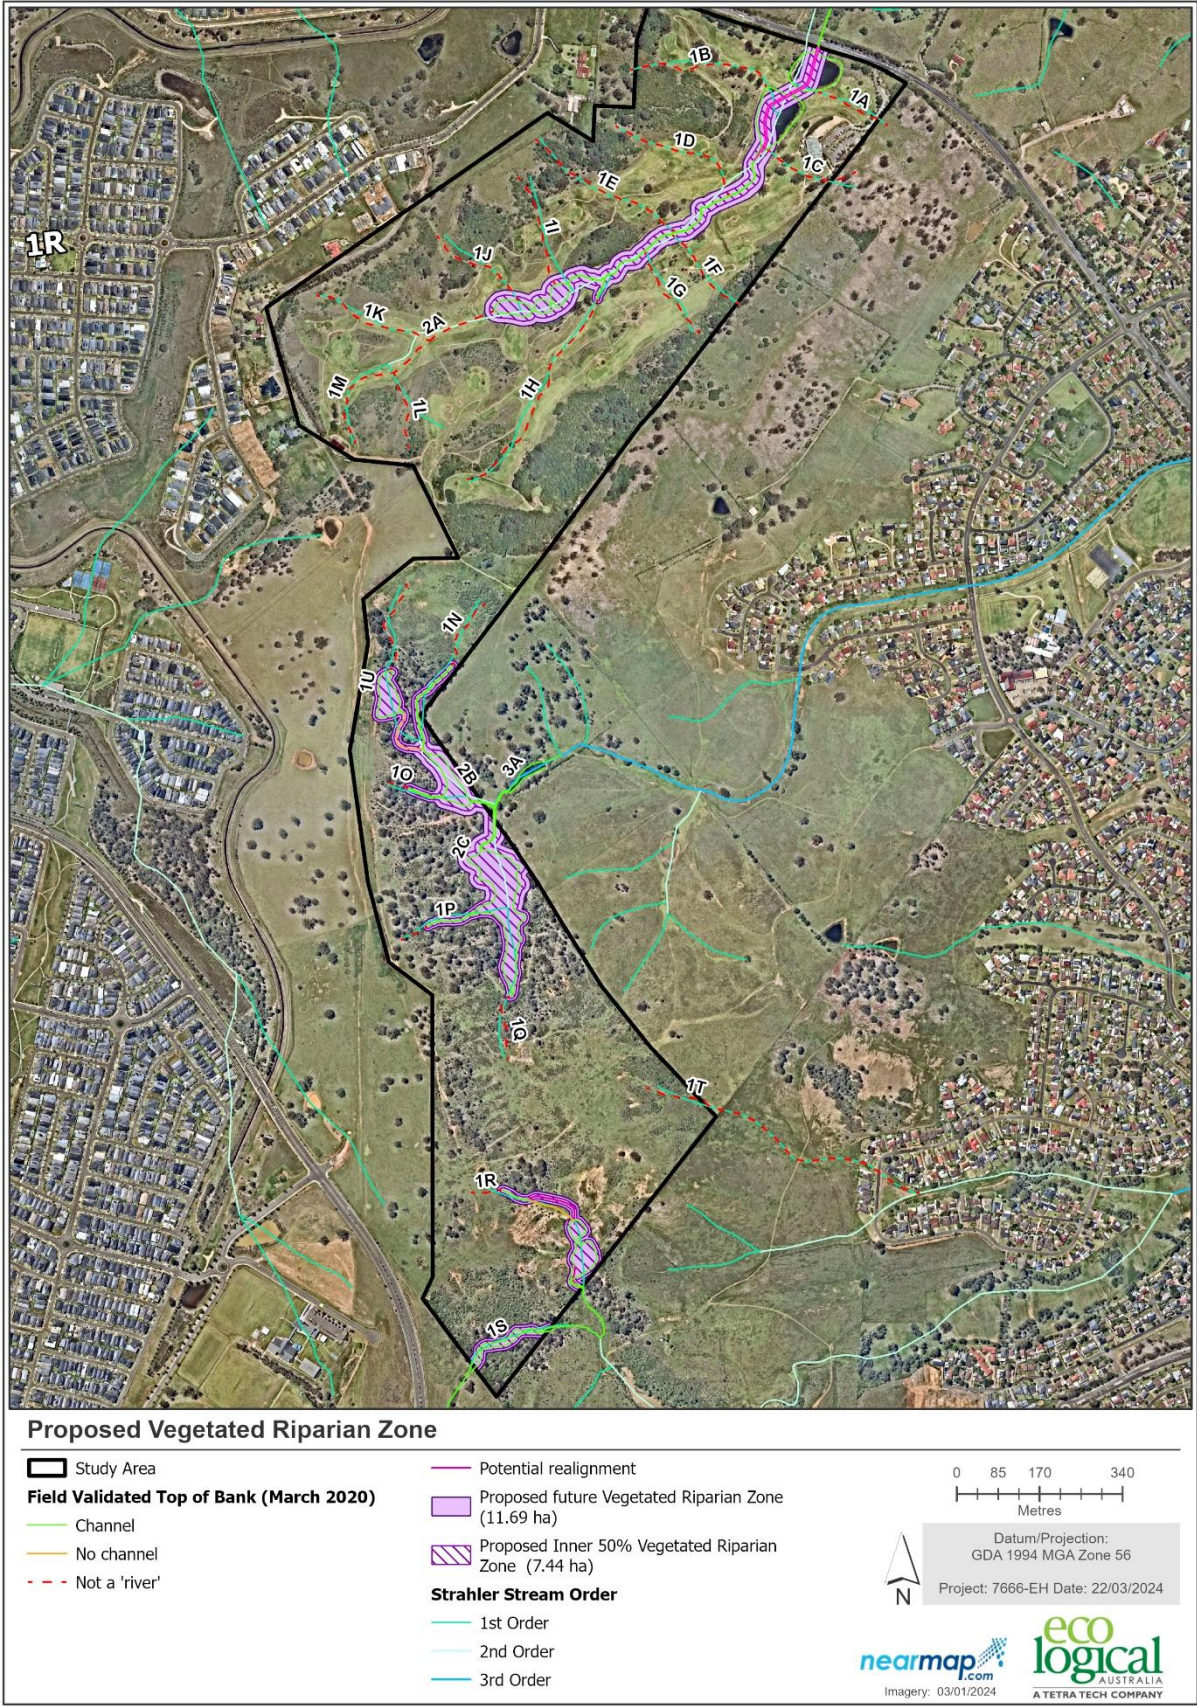
Figure 8: Proposed vegetated riparian zones for whole of development.

Reach 2A is the central riparian corridor which is planned to be retained and included as a feature in the future landscape. The two large dams adjacent to Raby Road are proposed to be removed and a natural creek line and corridor restored in their place. This reconstruction will occur north of the proposed road crossing and extend up to Raby Road. The proposed riparian corridor width is 42m (20m either side of future TOB and a 2m bed width). This width is in line with the stream order 2 guidelines.

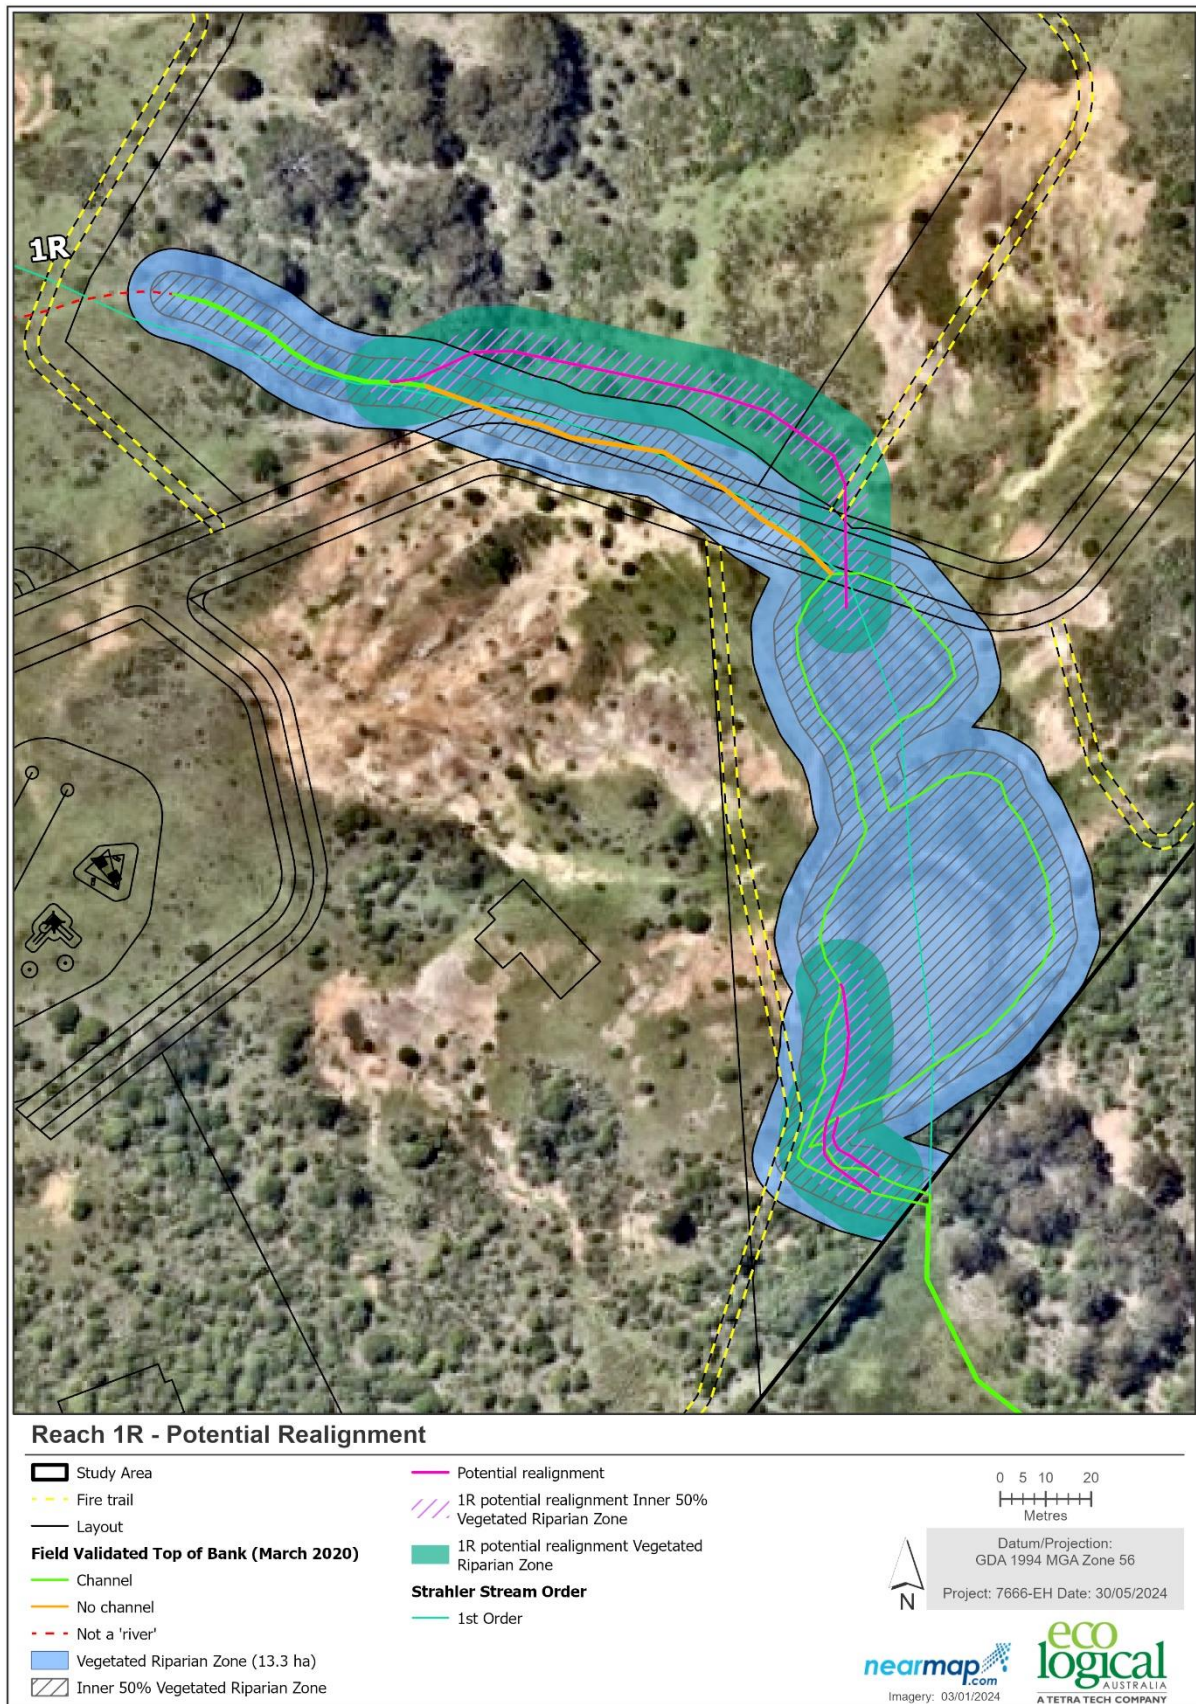
Figure 10: Reach 1R potential realignment.

The portion of reach 1R identified as overland flow with no defined channel is proposed to be realigned to ensure the road does not impact on the outer 50% of the VRZ, negating the need for offsetting (Figure 10). The fire trail that encroaches on the riparian corridor (RC) of reach 1R is assumed to have a total

disturbance footprint of no greater than 4 metres wide, which is permitted in the outer 50% VRZ according to the guidelines (DCCEEW 2022a). However, this assumption is based on fire trail width in the indicative masterplan design. Crossings for the fire trails that intersect reach 1S must also be in line with the DCCEEW guidelines (2022b) and fish passage requirements for waterway crossings (Fairfull and Witheridge 2003).
