# Heritage Significance Assessment

'Bayview' 28 Carlton Crescent, Kogarah Bay

July 2023  
EHC2023/0158

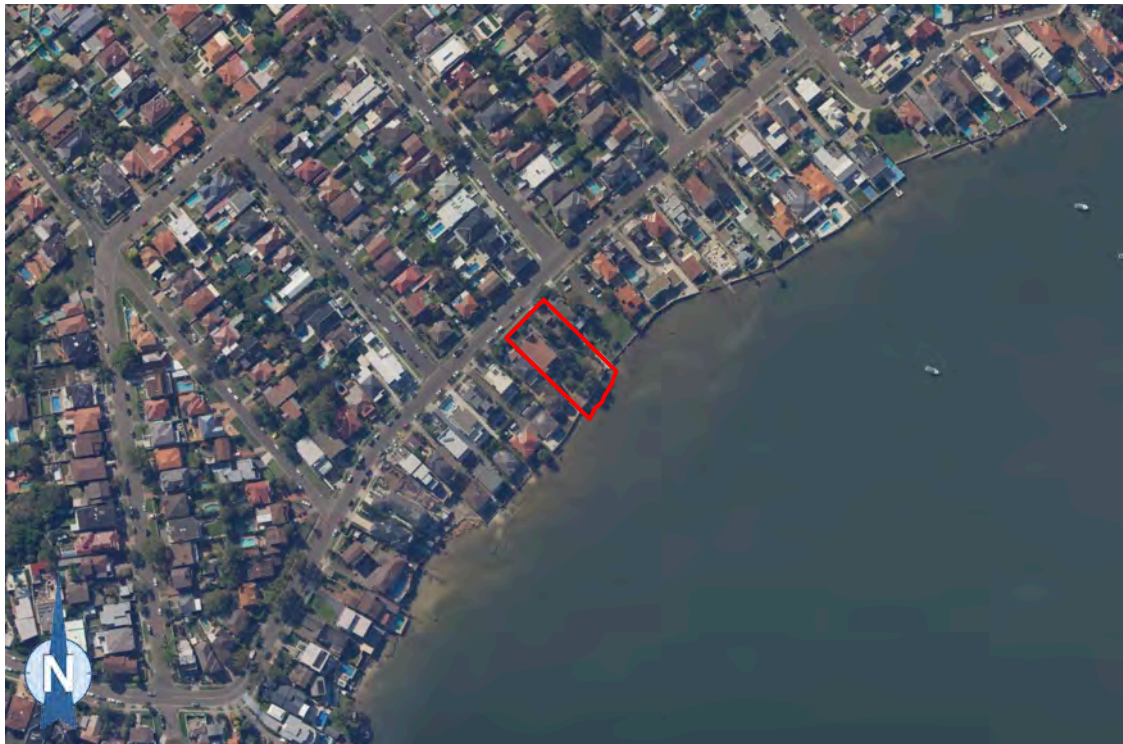
**Figure 1:** Aerial view of the site, subject site denoted in red.  
[Source: NSW Land and Property Information, 2023, with EHC overlay]

The subject site is situated within the Georges River Council local government area and in the locality of Kogarah Bay, which is 16 kilometres south of Sydney city. The site comprises Lots 21 & 22 of Section 15 in Deposited Plan 1963, commonly and collectively known as 28 and 28a Carlton Crescent, Kogarah Bay.

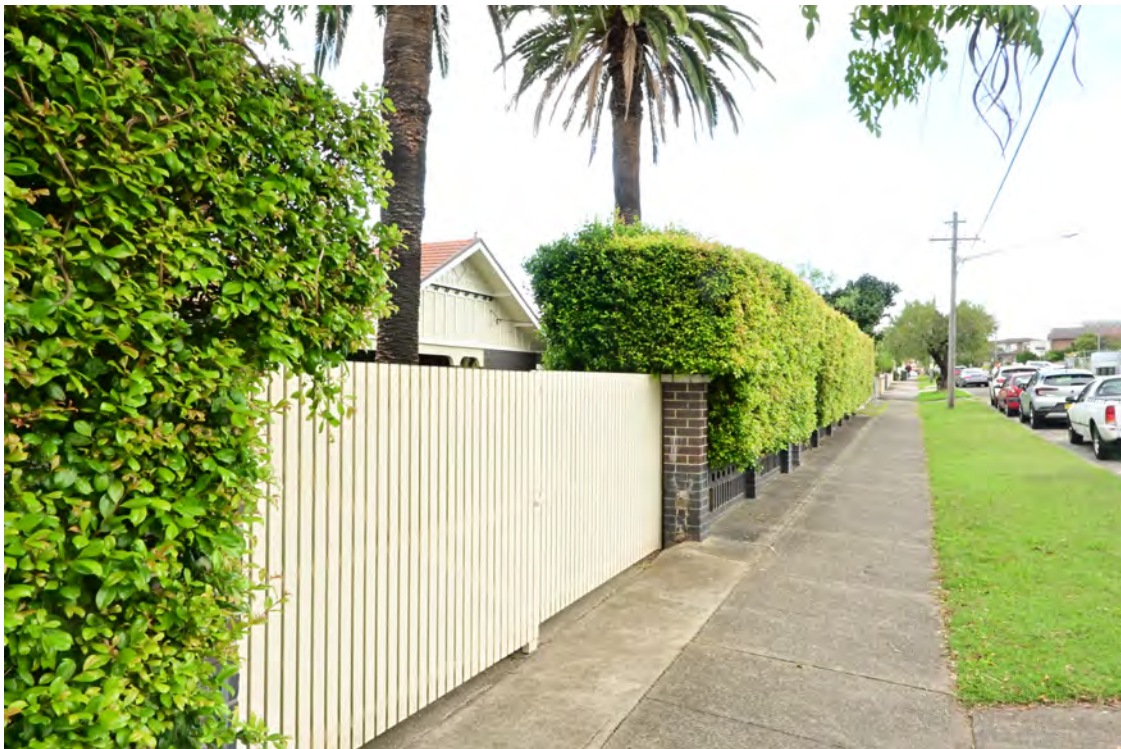
Figure 3: View of the site from Carlton Crescent.

The site itself comprises two separate but adjoining allotments (Lots 21 and 22). Individually and cumulatively, they have a mostly rectangular shape, with direct frontage to Carlton Crescent and an irregularly formed rear boundary that adjoins Kogarah Bay and defined by the mean high water mark.

The site falls from the street front boundary towards Kogarah Bay at the rear and has an undulating surface, with a near-level platform at the front of the site.

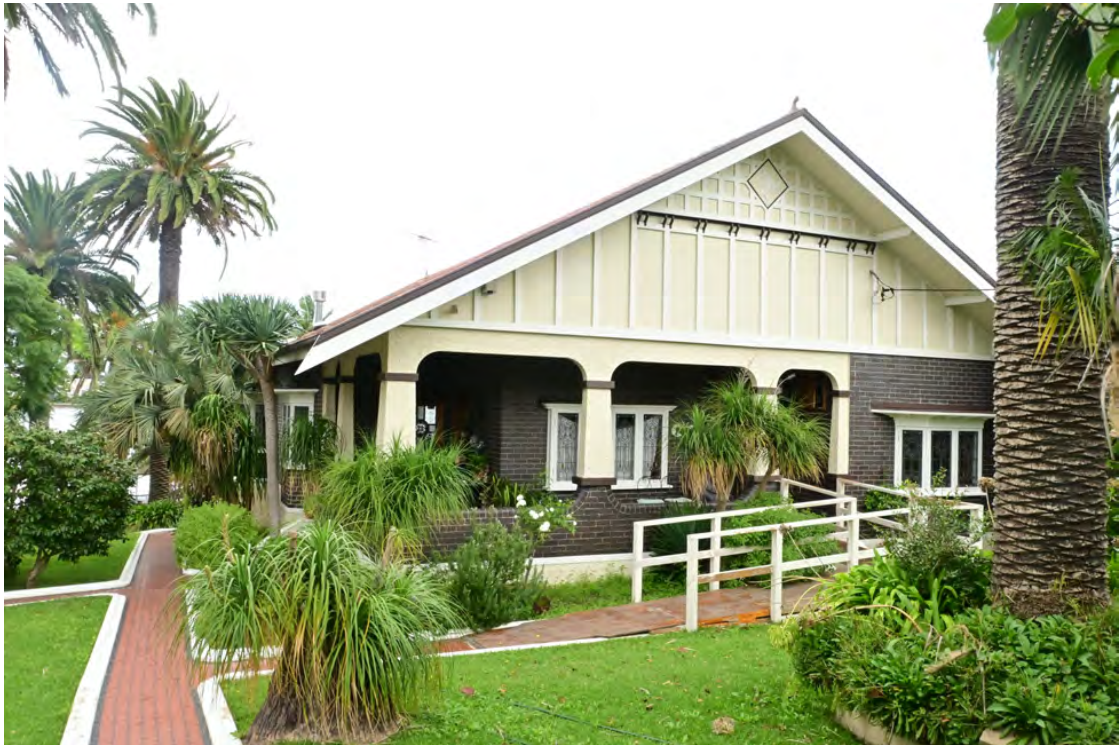
**Figure 4:** View of the dwelling from the front entry gate.

The dwelling is described as single storey and detached style. It is of brick construction typically of stretcher bond, sitting atop of a solid brick wall skirt that conceals the foundations. Owing to the fall in

In this manner, the dwelling displays characteristics that are attributed to the Inter-War period of the early 20<sup>th</sup> century and of the Californian Bungalow architectural style.

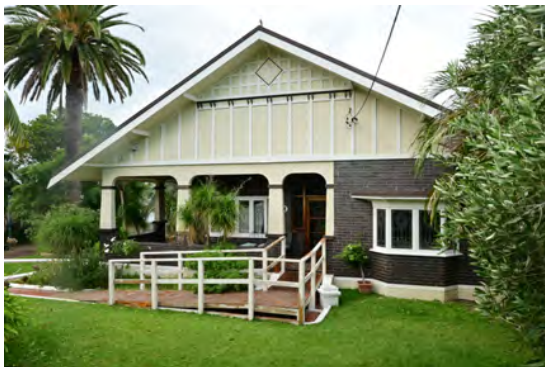
**Figure 5:** View of the dwelling from the front garden area.

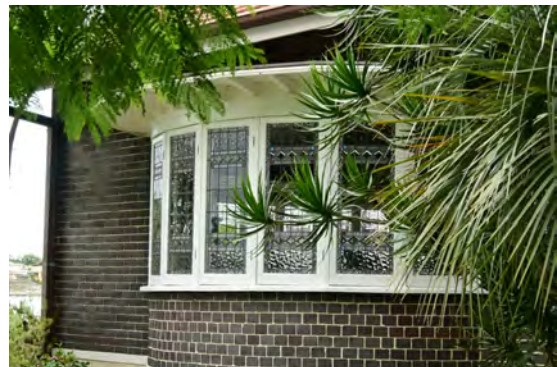
**Figure 6:** View of the eastern side elevation bay window.

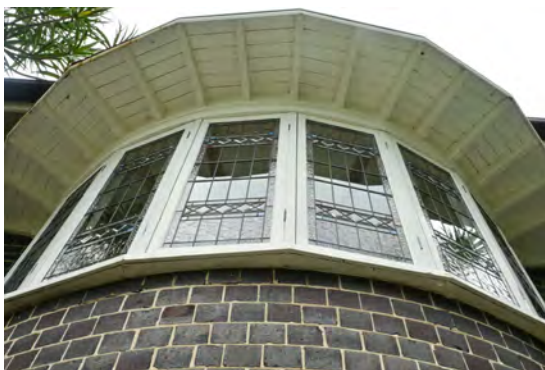
**Figure 7:** View of the bay window detailing to the eastern side elevation.

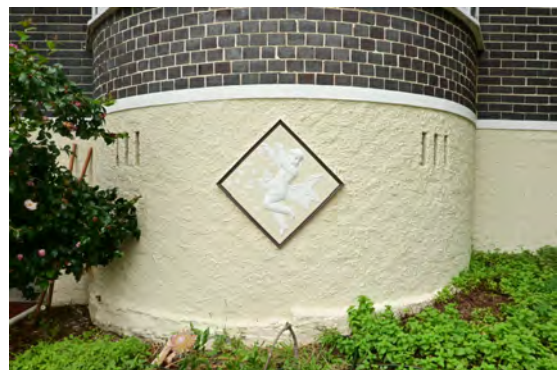
**Figure 8:** View of the cherub bas-relief panel applied beneath the bay window on the eastern side elevation.

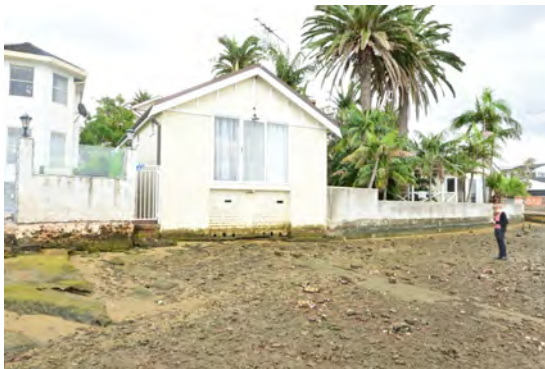
**Figure 9:** View of the boatshed from the Kogarah Bay shoreline.

Though utilitarian in form and function, the boatshed displays characteristics that are similar to the main dwelling and is also attributed to the Inter-War period of the early 20<sup>th</sup> century and of the Californian Bungalow architectural style.

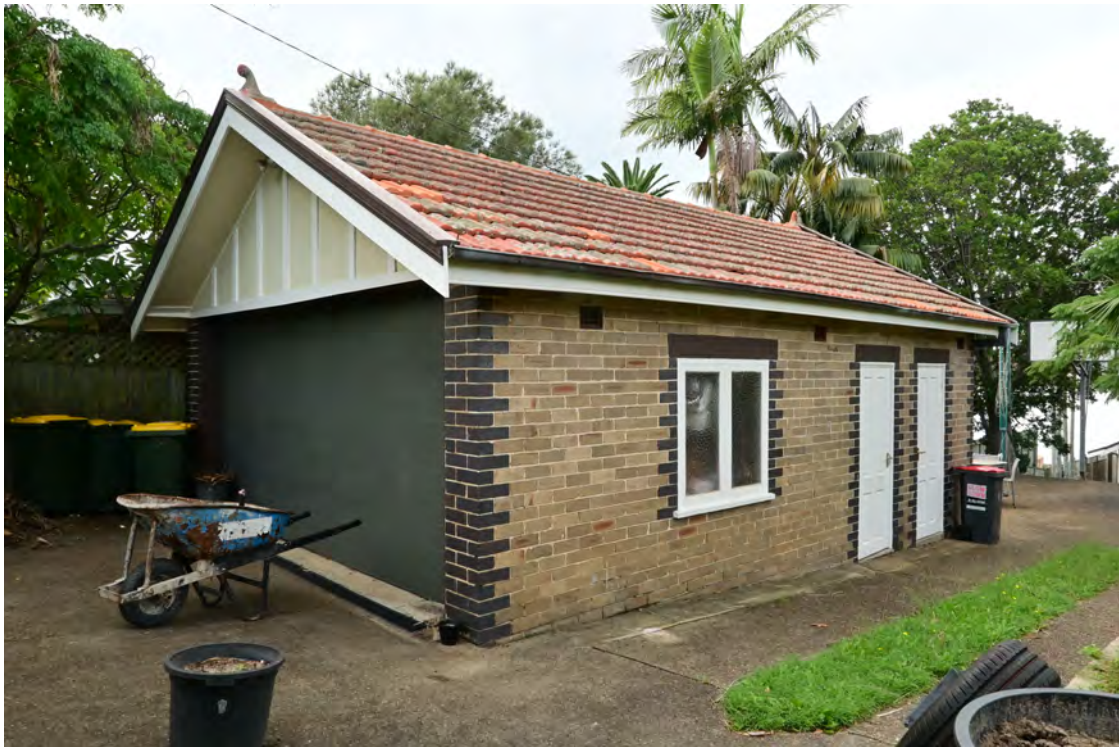
Figure 11: View of the garage from the front boundary.

Though utilitarian in form and function, the garage displays characteristics that are similar to the main dwelling and is also attributed to the Inter-War period of the early 20<sup>th</sup> century and of the Californian Bungalow architectural style.

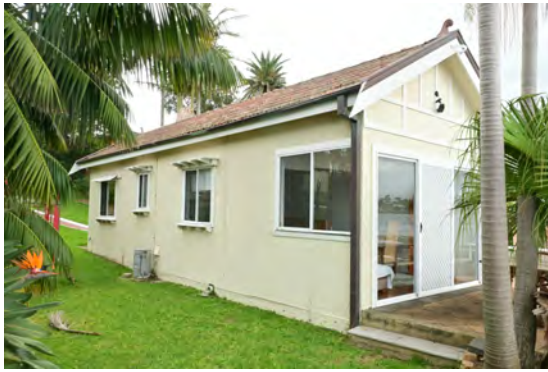
**Figure 12:** View of the summerhouse from the rear of the site.

The northern elevation is devoid of any windows or doors, while the two side elevations feature timber framed windows. The rear (waterfront) elevation features large aluminium framed sliding doors – presumably having originally been an open verandah to take advantage of the prevailing breeze.

The summerhouse displays characteristics that are similar to the main dwelling and is also attributed to the Inter-War period of the early 20<sup>th</sup> century and of the Californian Bungalow architectural style.

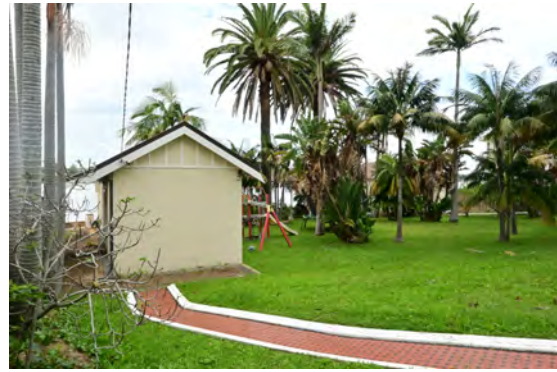
**Figure 13:** View of the northern elevation of the summerhouse facing towards Kogarah Bay.

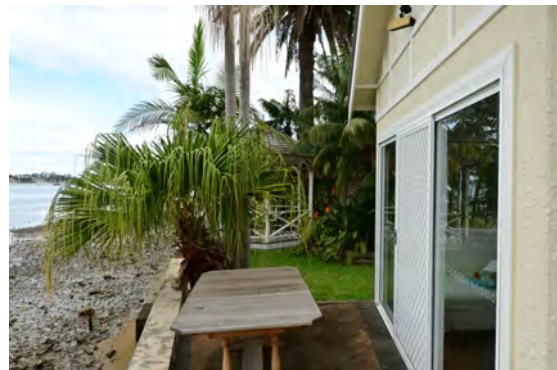
**Figure 15:** View of the southern (waterfront) elevation of the summerhouse, facing west.

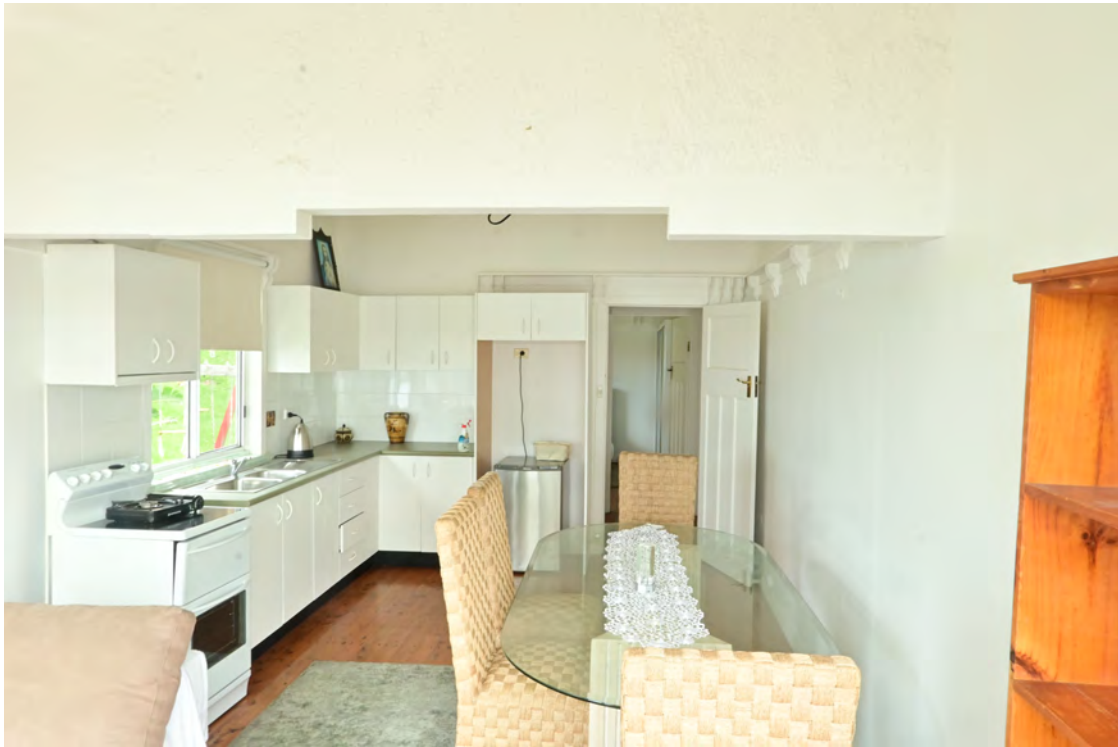
Figure 24: View of the interior of the summerhouse.

The Summerhouse has timber tongue-and-groove floorboards throughout, which appear Cyprus Pine. Walls are plastered and feature decorative timber plate-rails. The southern end of the current lounge room space has a corbelled bulkhead projecting from the ceiling level, suggesting the presence of windows and a centrally positioned door which have been removed to make the present singular opening.

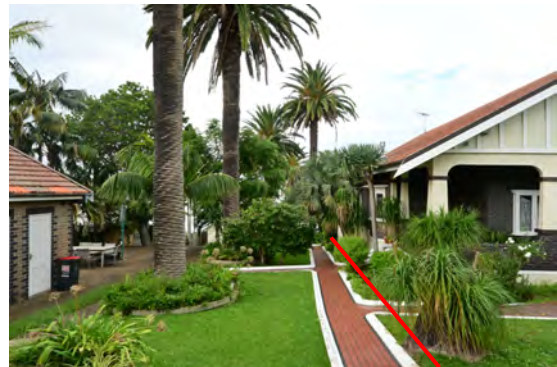
**Figure 28:** View of the gardens along the eastern side of the dwelling. The existing boundary between Lot 21 and Lot 22 is approximated by red outline.

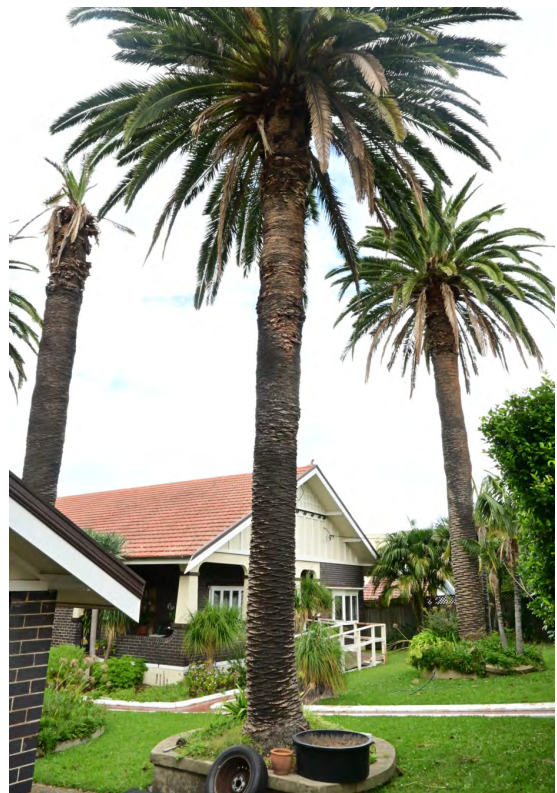
**Figure 31:** View of the mature-sized Canary Island Palms.

The Canary Island Palms are planted in a structured manner, with the majority planted in a straight line running parallel to the eastern side elevation of the dwelling. Two Canary Island Palms were originally planted immediately at the front of the dwelling, though only one remains.

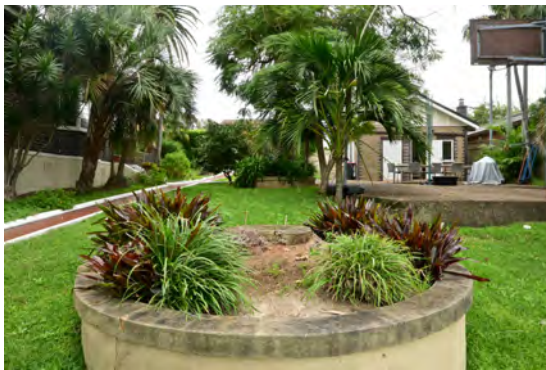
**Figure 34:** View of elevated garden bed of a removed Canary Island Palm, facing north.

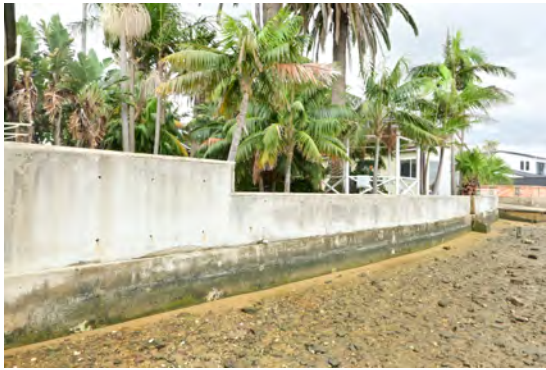
**Figure 37:** View of the concrete seawall facing northeast.

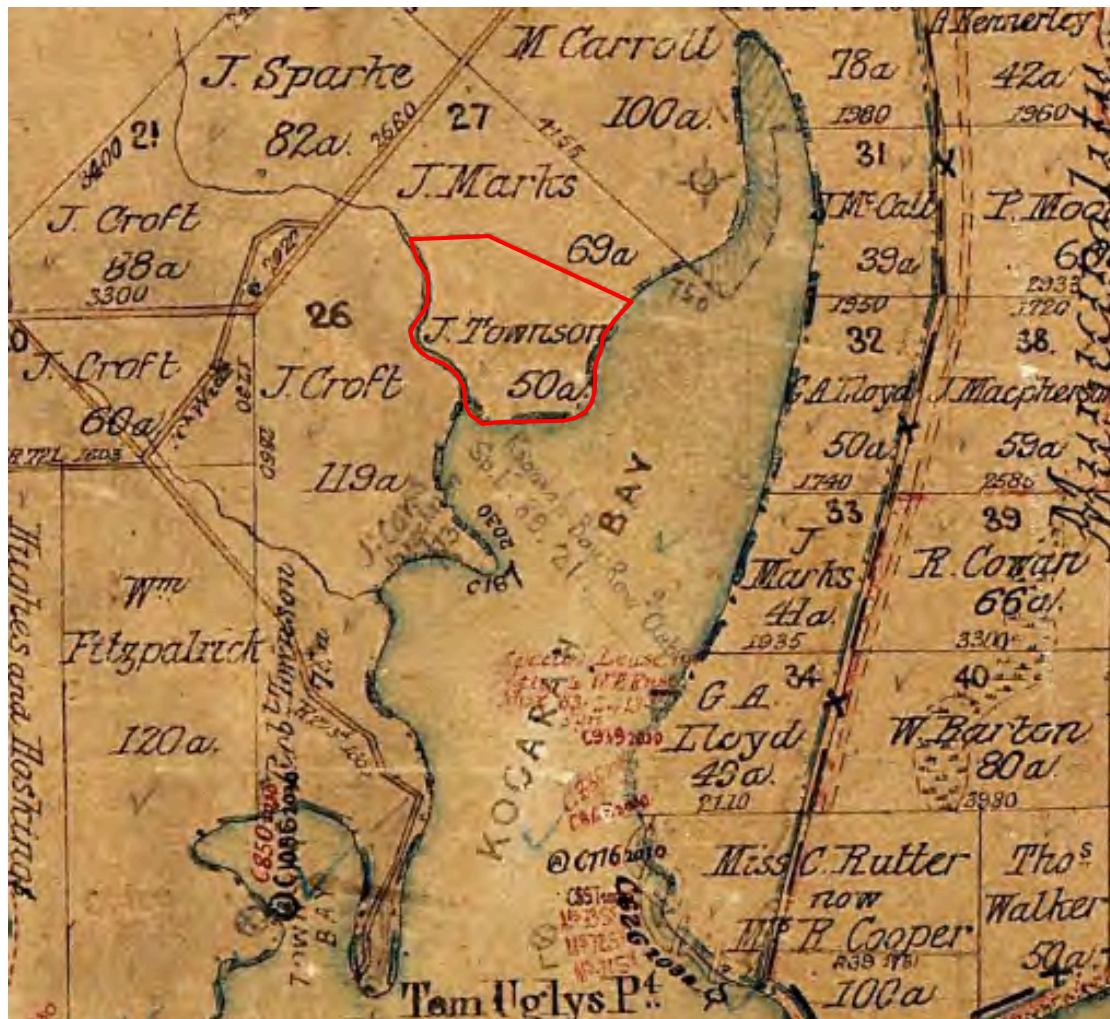
**Figure 38:** Extract of Parish of St George Map, John Townson's Portion 119 outlined in red c.1880s.  
[Source: NSW Land and Property Information, 2023]

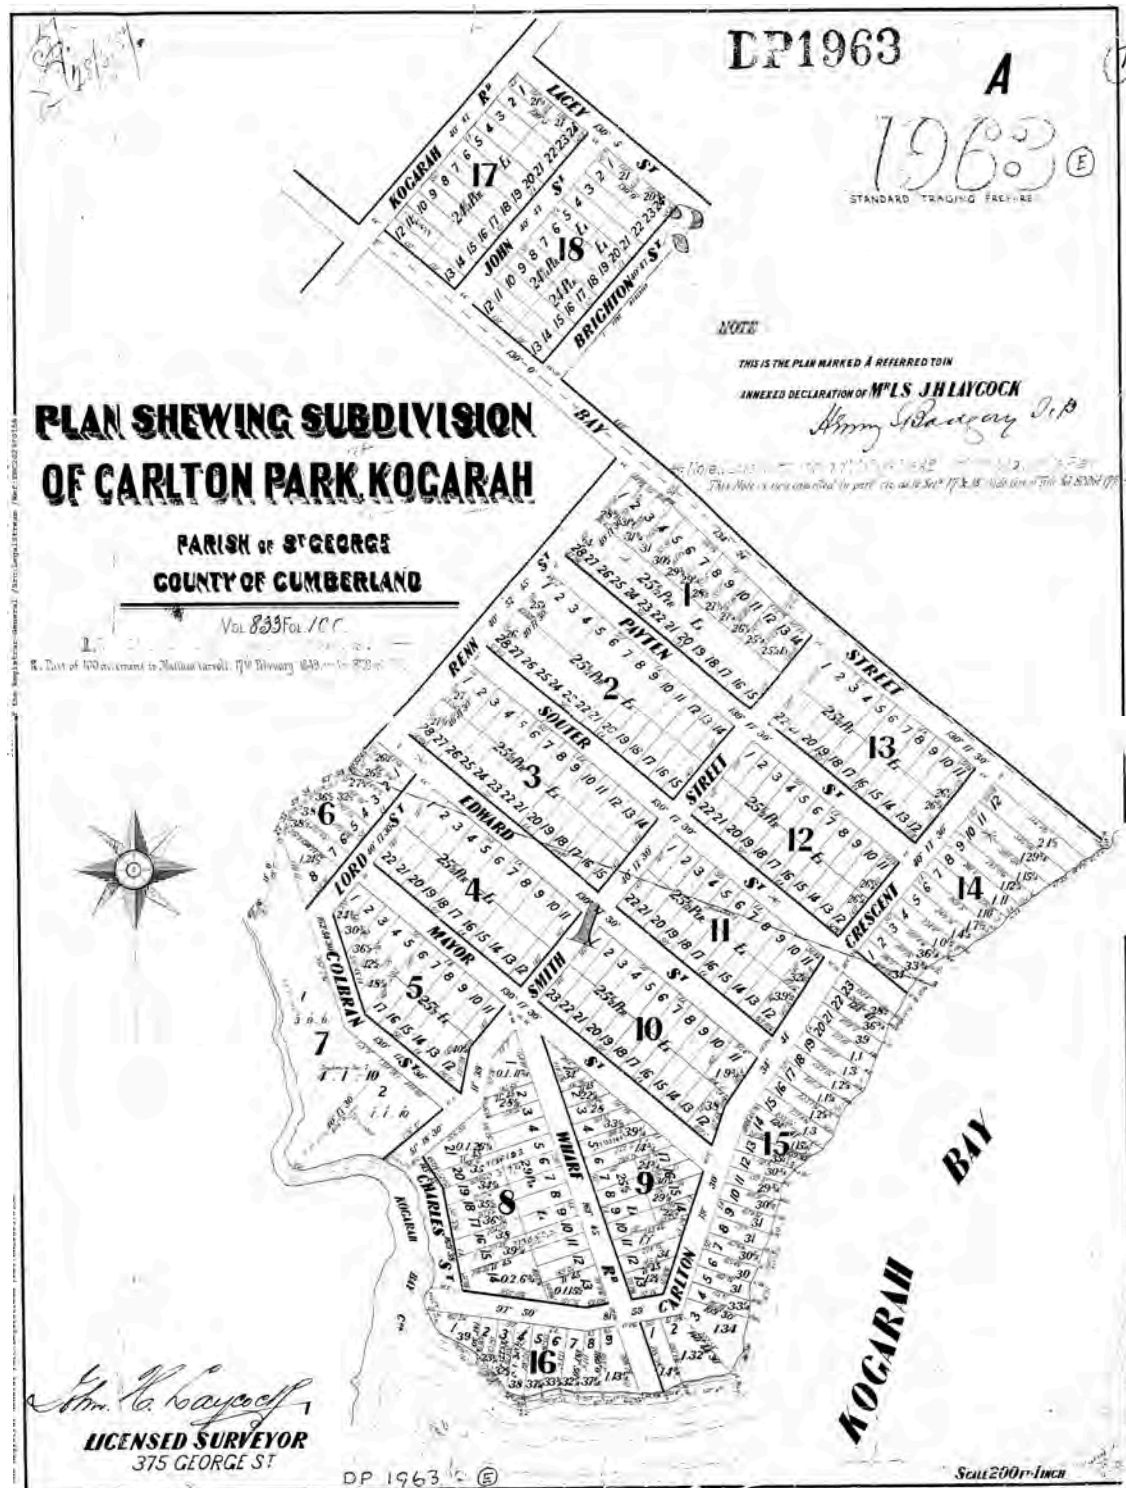
**Figure 39:** Plan of the Carlton Park subdivision.

[Source: NSW Land and Property Information, 2023. Deposited Plan 1963]

Known as 'Carlton Park', the first sale of the newly created allotments occurred in mid-December 1885 at an auction on the ground. In 1892, Lucy Jane Macmillan, wife of James Laker Macmillan, purchased Lots 2-20 (inclusive) of Section 11 of Deposited Plan 1963 (equating to 2 acres, three roods, 1 perch) as well as Lots 17-23 (inclusive) of Section 15 of Deposited Plan 1963 (1 acre 2 roods 2 perches). It was Lots 21 and 22 of Section 15 in Deposited Plan 1963 that were to become the subject site.

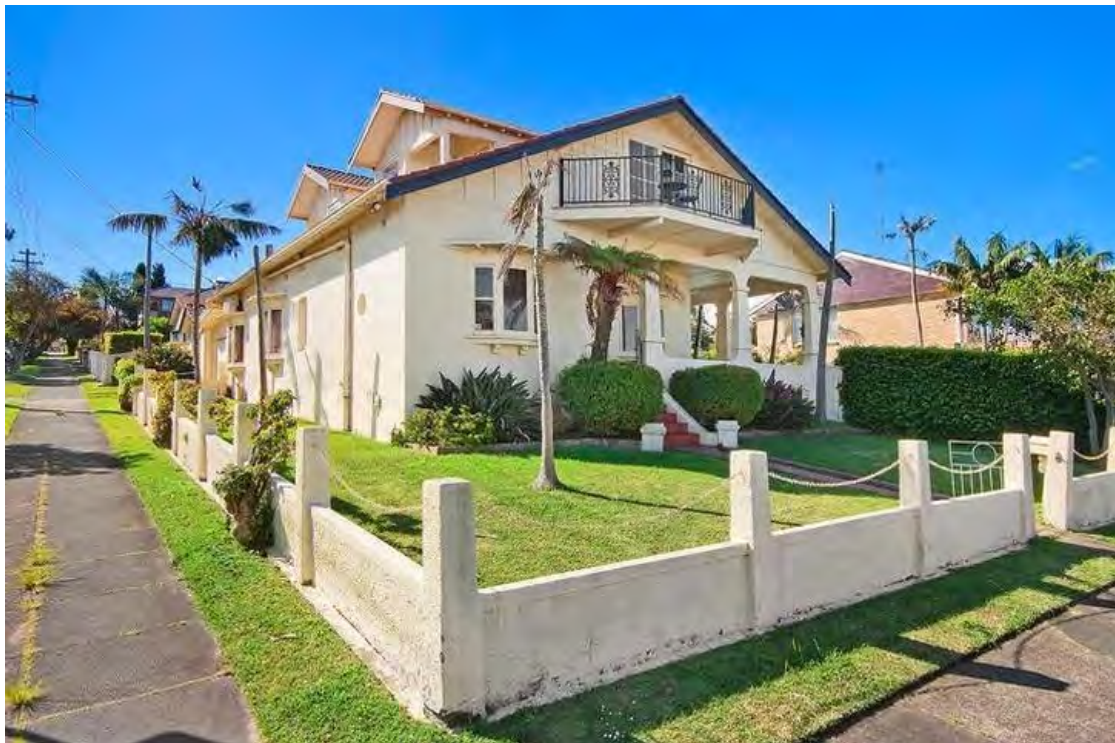
**Figure 42:** View of the dwelling built by Frederick Rowe at 9 Carlton Crescent in c2011. The dwelling was demolished sometime after 2015. The similarities to 28 Carlton Crescent are remarkable, with this dwelling largely presenting as a mirrored composition, yet lacking the defining bay windows.

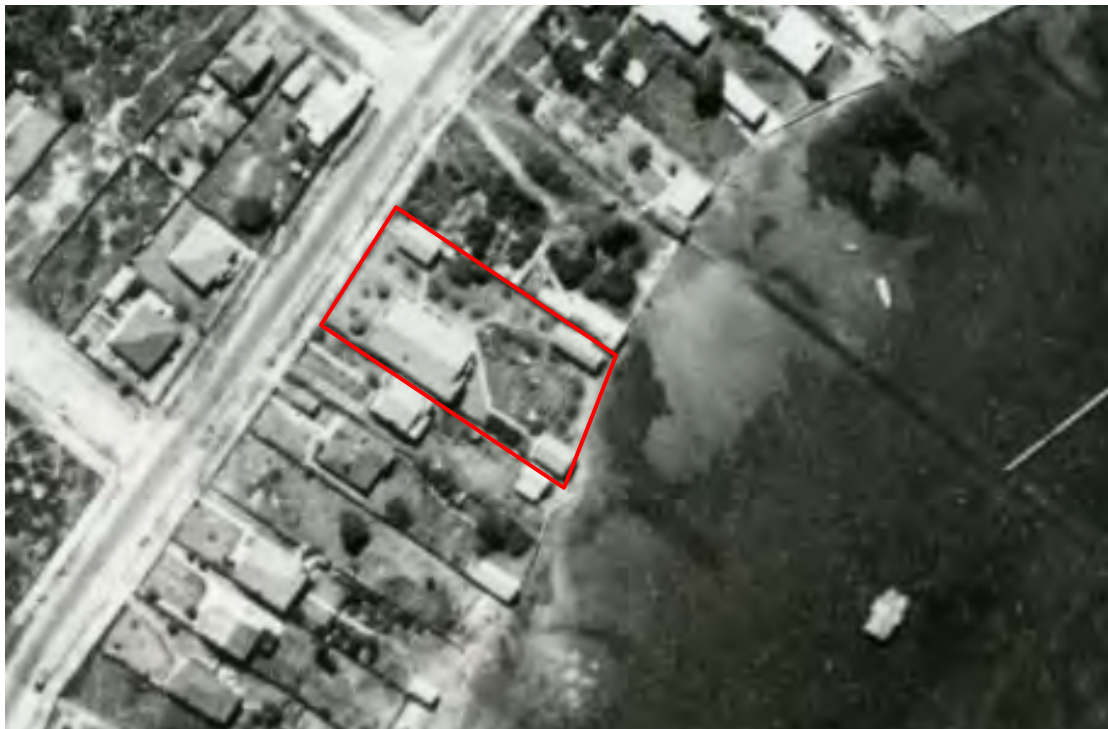
**Figure 44:** Aerial photo of the site from 1937 by Adastra Airways.

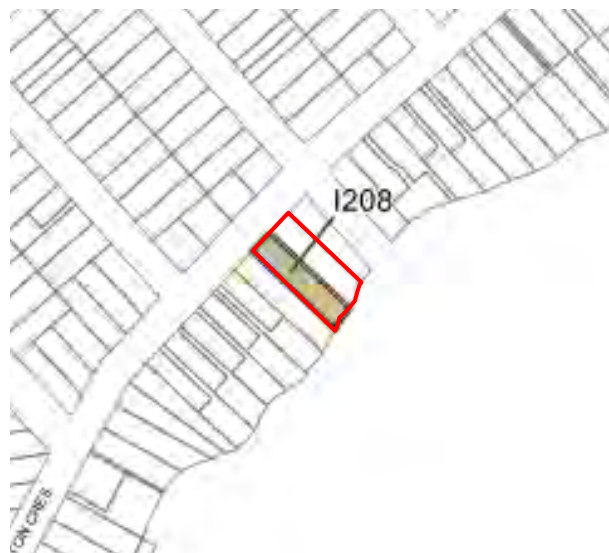
**Figure 52:** Map showing the heritage status of the subject site and surrounding allotments. The subject site is denoted by red outline. [Source: Georges River LEP 2021, Heritage Map HER\_011, with EHC overlay]

However, the listing of Item I208 (described as 'House and front garden, "Bayview"') relates only to Lot 21 in Section 15 of Deposited Plan 1963, with the listing referring to the property as 28A Carlton Crescent.

The site **is not** located within a Heritage Conservation Area (under Schedule 5 of the Georges River Local Environmental Plan 2021).
