Stage 1 Preliminary Site Investigation

ROAD CLOSURE LAND, HOBART STREET, RIVERSTONE, NSW 2765

Prepared for Blacktown City Council

Ref: 10791EV.P.408-R01.docx

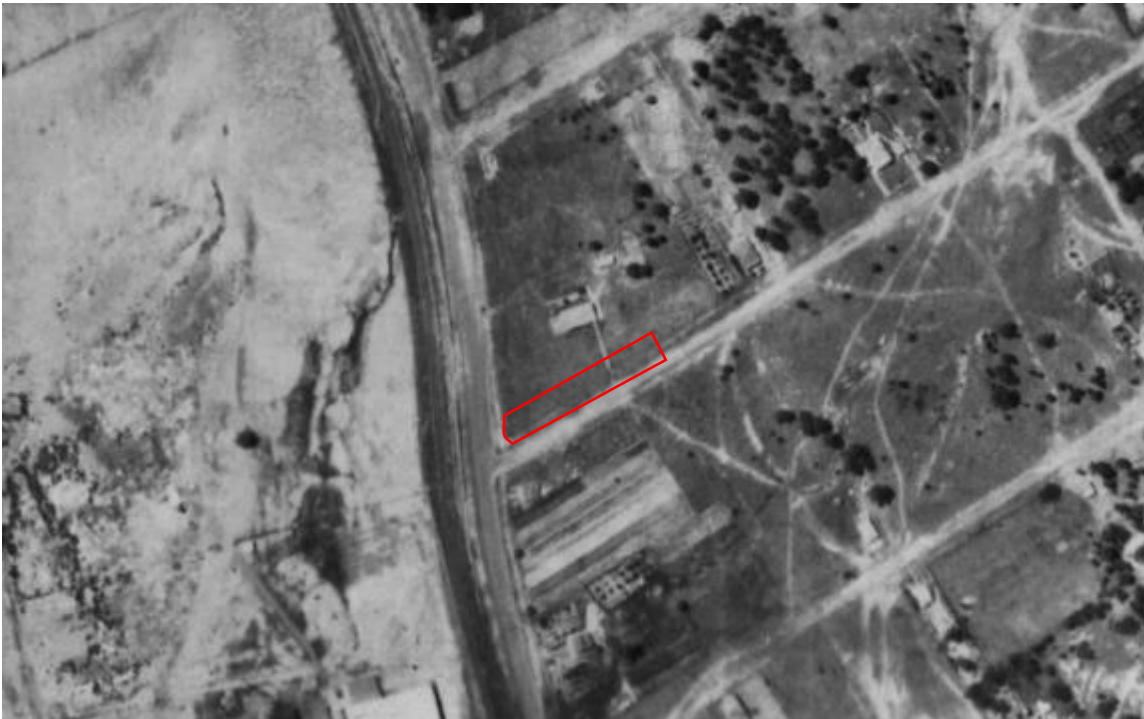
Image 5.1.1 View of 1947 historical photograph

Photo Date	Site Observations	Surrounding Land Observations
1947	The site appears undeveloped and forms a part of a larger residential property with a dwelling located to the north. A driveway is observed passing through the central portion of the site, providing access to the residential dwelling from Hobart Street.	North: rural residential. South: Hobart Street then agricultural / rural residential. East: Potential orchard / rural residential. West: Riverstone Parade, Railway line then undeveloped land. Commercial / industrial development observed towards the southwest of the site.
1955	A fence line appears to have been installed running parallel to the southern boundary of the site.	North: rural residential. South: Hobart Street then agricultural / rural residential. East: The potential orchard to the east seems to have disappeared. Rural residential beyond. West: Riverstone Parade, railway line then a dam. Commercial / industrial development observed towards southwest of the site.

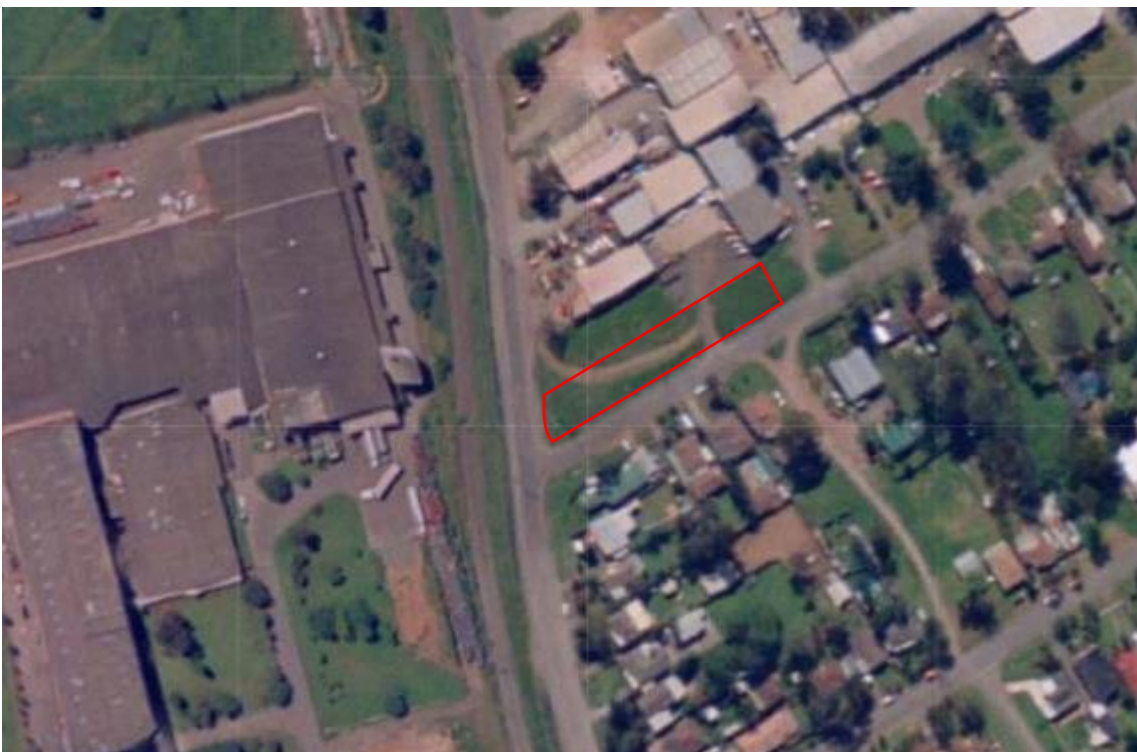
Image 5.1.8 View of 1998 historical photograph

1998	A new pathway / driveway is visible extending from east to west throughout the site.	No significant changes observed towards the north, south and west of the site. A new commercial building with a carpark can be observed to the northeast of the site.
2005	What appears to be a truck is parked in the central portion of the site.	No significant change since previous image.
2016	A potentially gravel driveway is observable in the eastern portion of the site.	No significant change since previous image.
2023	A new fence line is observed along the northern boundary of the site.	No significant change since previous image.

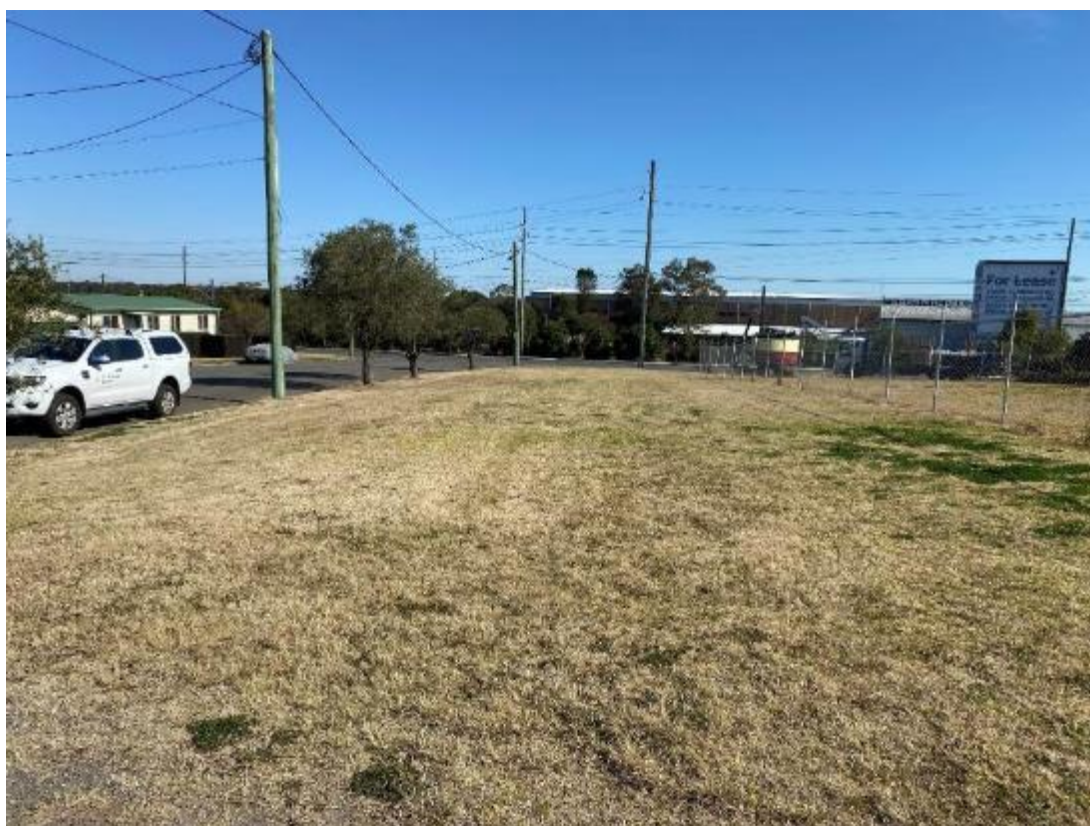
The site surface presented as predominantly grass covered with the exception of an unsealed gravel driveway in the eastern portion of the site.

Image 6.2.1 View of general site condition (facing west)

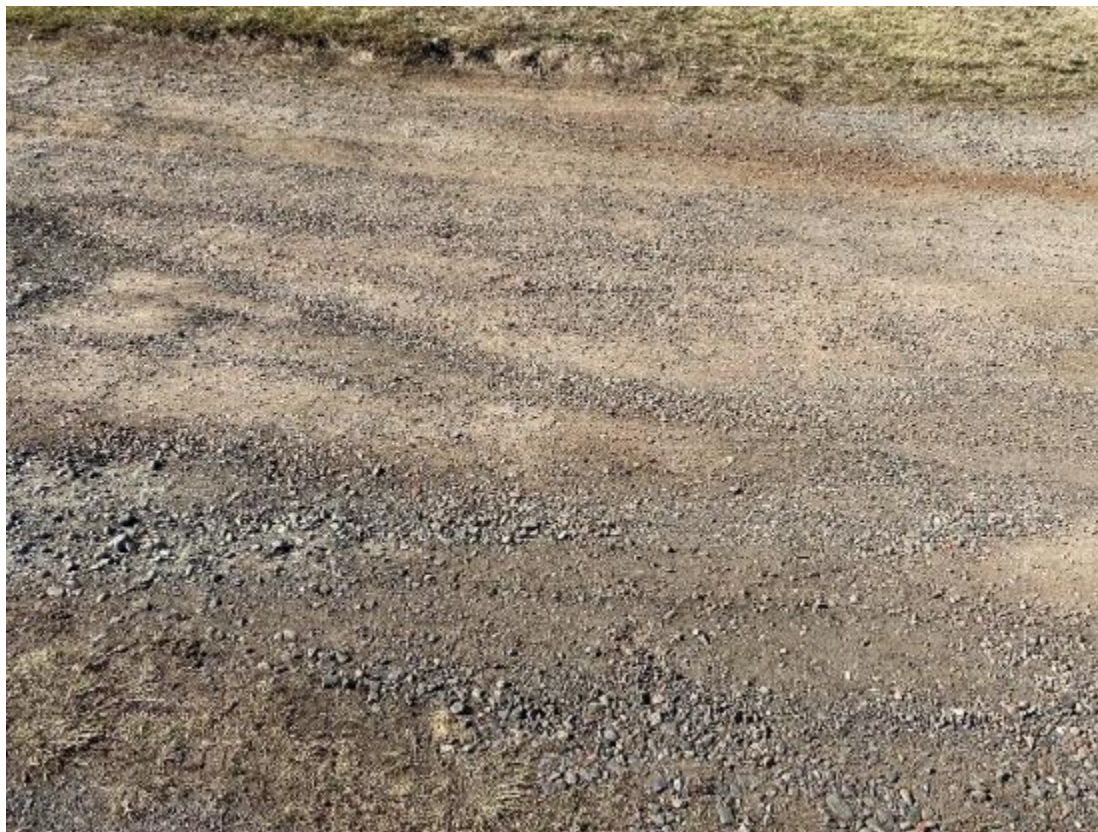
Image 6.2.2 View of unpaved gravel driveway located in the eastern portion of the site

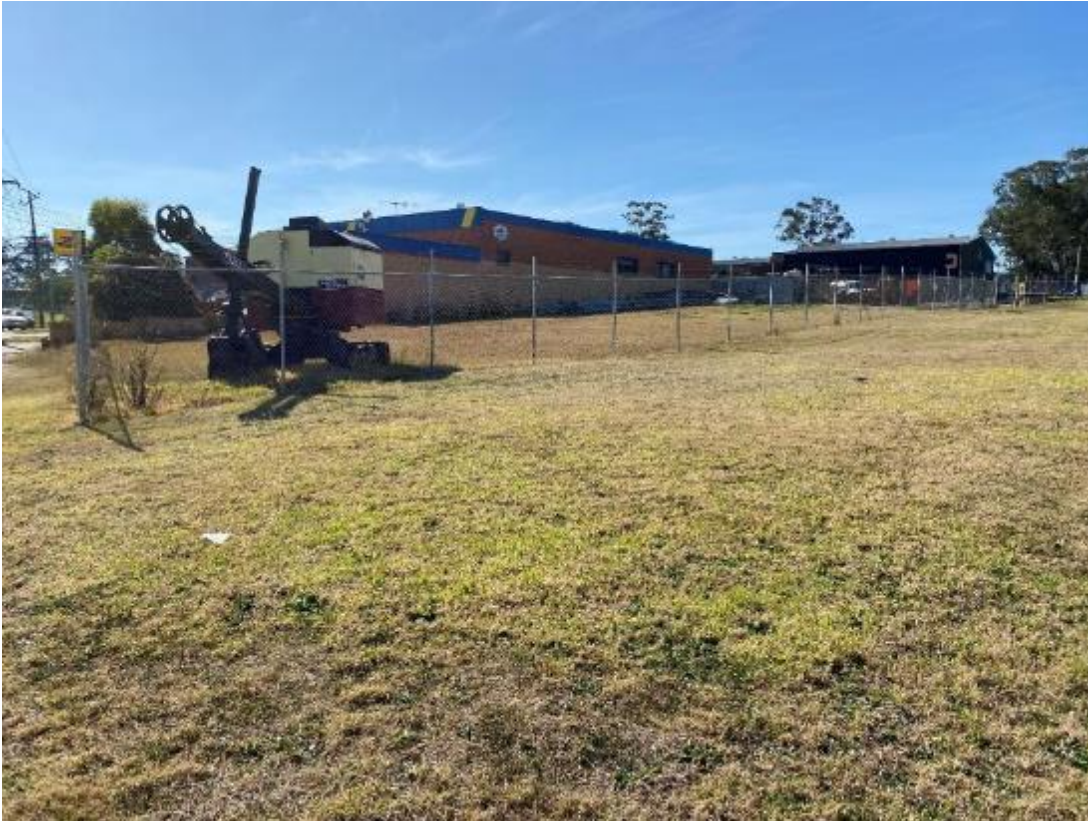
The northern site boundary was fenced. The eastern, western and southern boundaries were not fenced.

Image 6.3.1 View of fencing along the northern site boundary (facing northeast)

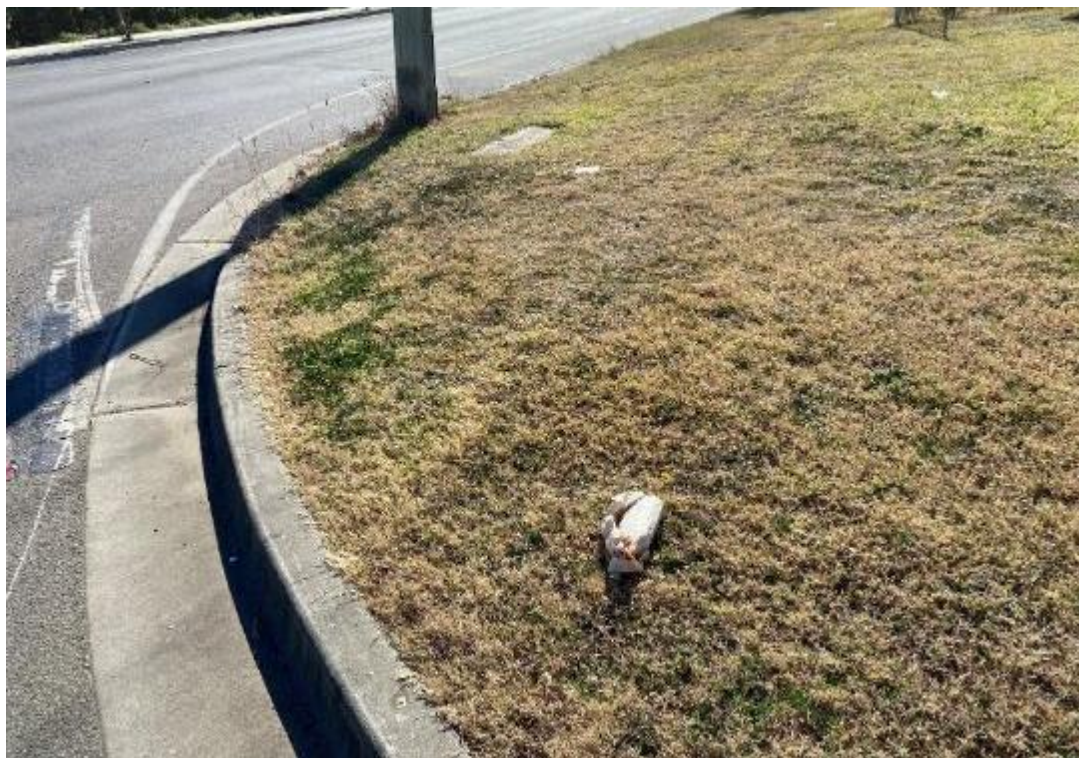
CS observed minor general waste items (i.e. litter) on the surface of site including glass, cardboard and plastic pieces. These items are considered likely to have been tossed from passing traffic or pedestrians. CS considers the pollution associated with this littering to be superficial and minor.

Image 6.9.1 View of litter on the site surface

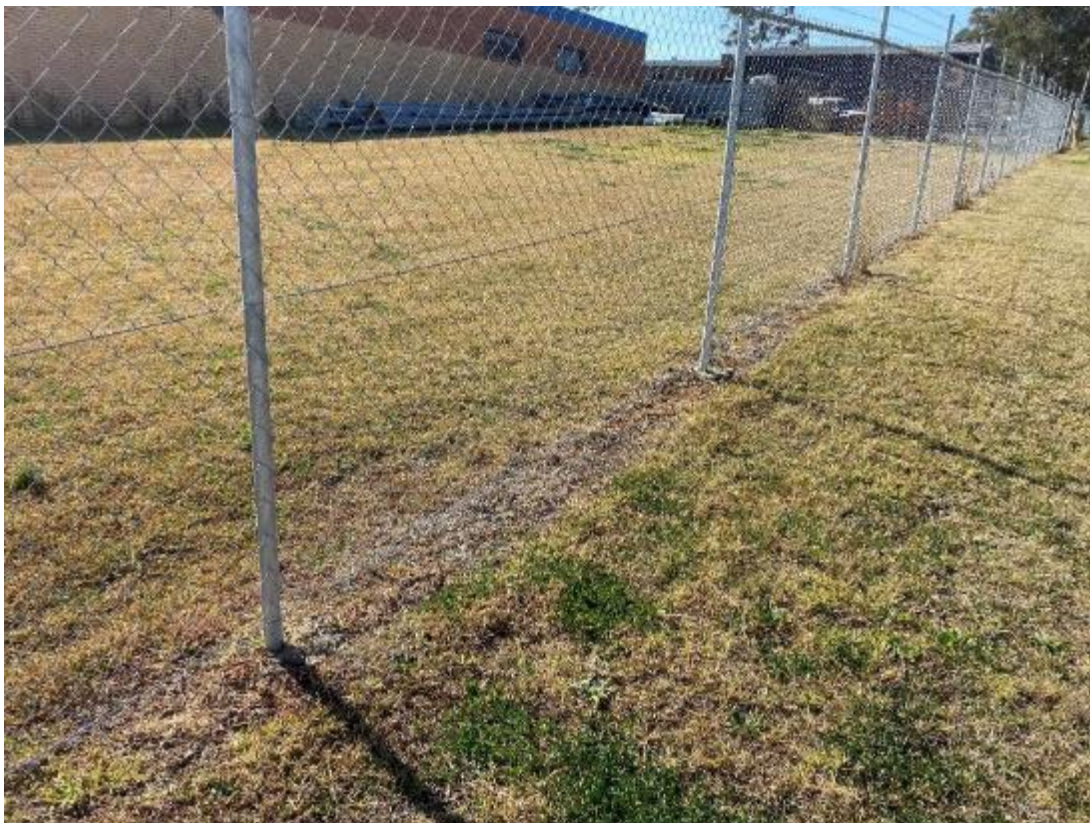
No visual evidence was observed to suggest widespread or significant phytotoxic impact in the form of plant stress and/or dieback in the vegetation present on the site. However, there appeared to be some discolouration in the vegetation along the northern fence line. CS believes that the discoloration of the grass along the northern fencing may have resulted from the recent spraying of the fence line along the northern boundary. Modern herbicides present negligible risk of residual contamination when applied in accordance with the manufactures recommended dosage rates. Risk presented by the observed vegetation controls are low and present negligible contamination risk in a commercial and industrial land-use scenario.

Image 6.12.1 View of discoloured grass along the northern fence line

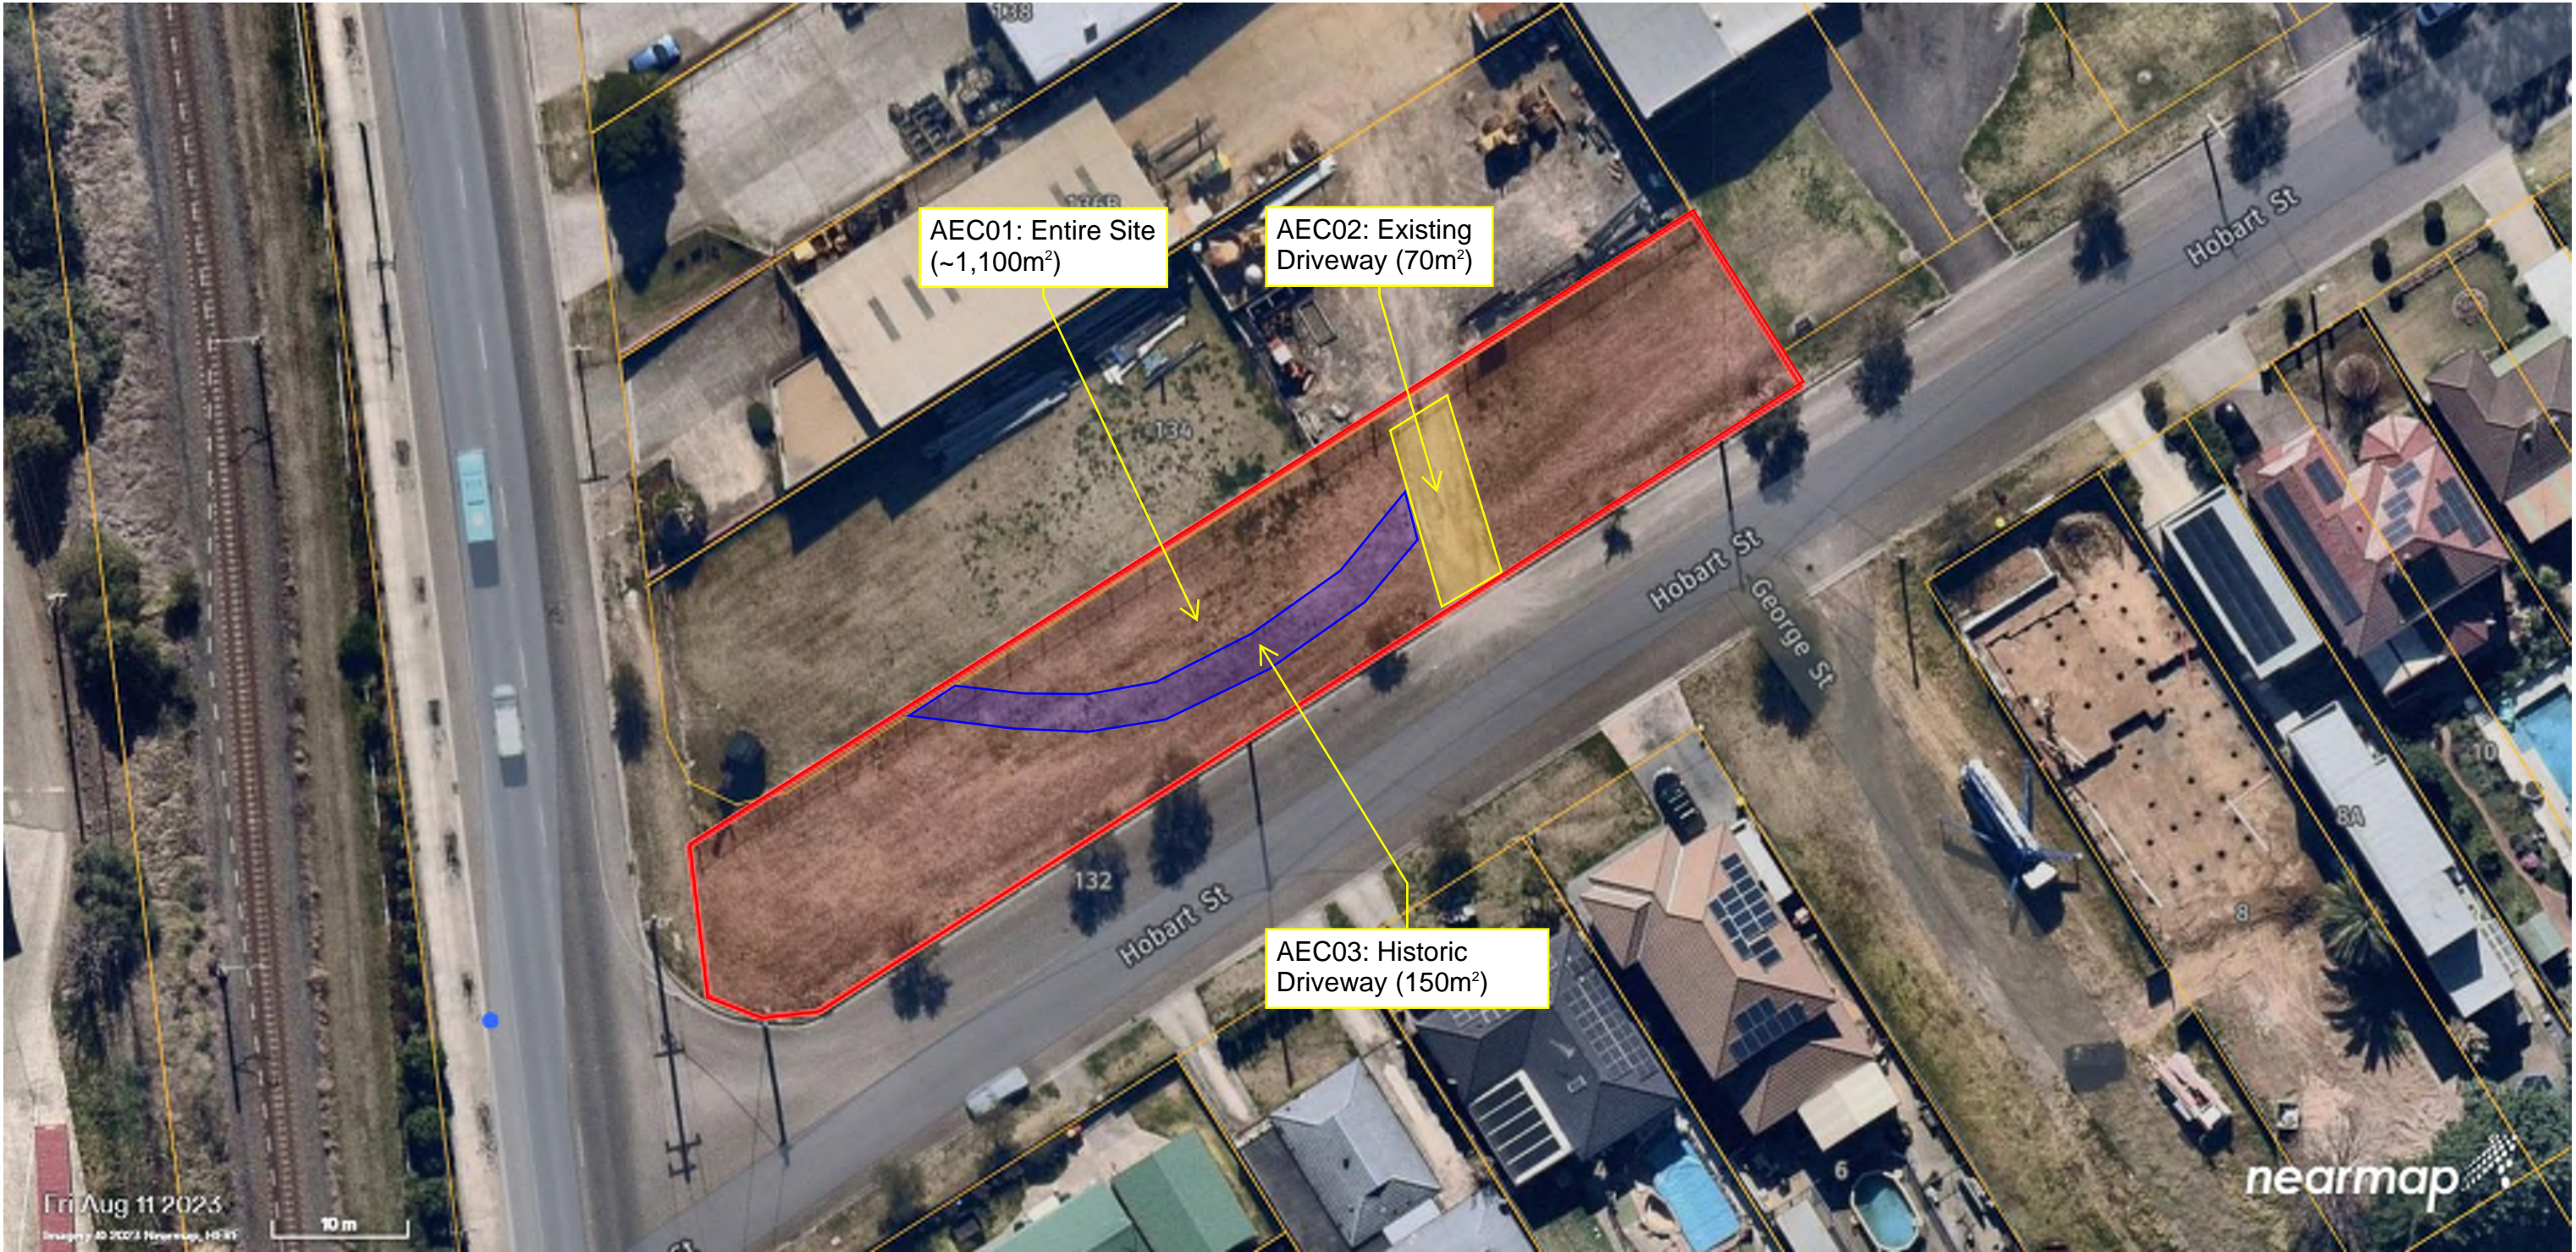
Client: Blacktown City Council	Job ref: 10791EV.P.408-P01
			Date: 1 August 2023		Project: Stage 1 Preliminary Site Investigation	
			Drawn By: AL		Location: Hobart Street, Riverstone NSW (Road Closure Land)	
			Drawing No: 2	Sheet: 1 of 1	Site Layout Plan
