43 DONNELLY ROAD
NAREMBURN

HERITAGE ASSESSMENT

PREPARED FOR
Willoughby City Council

22 AUGUST 2023

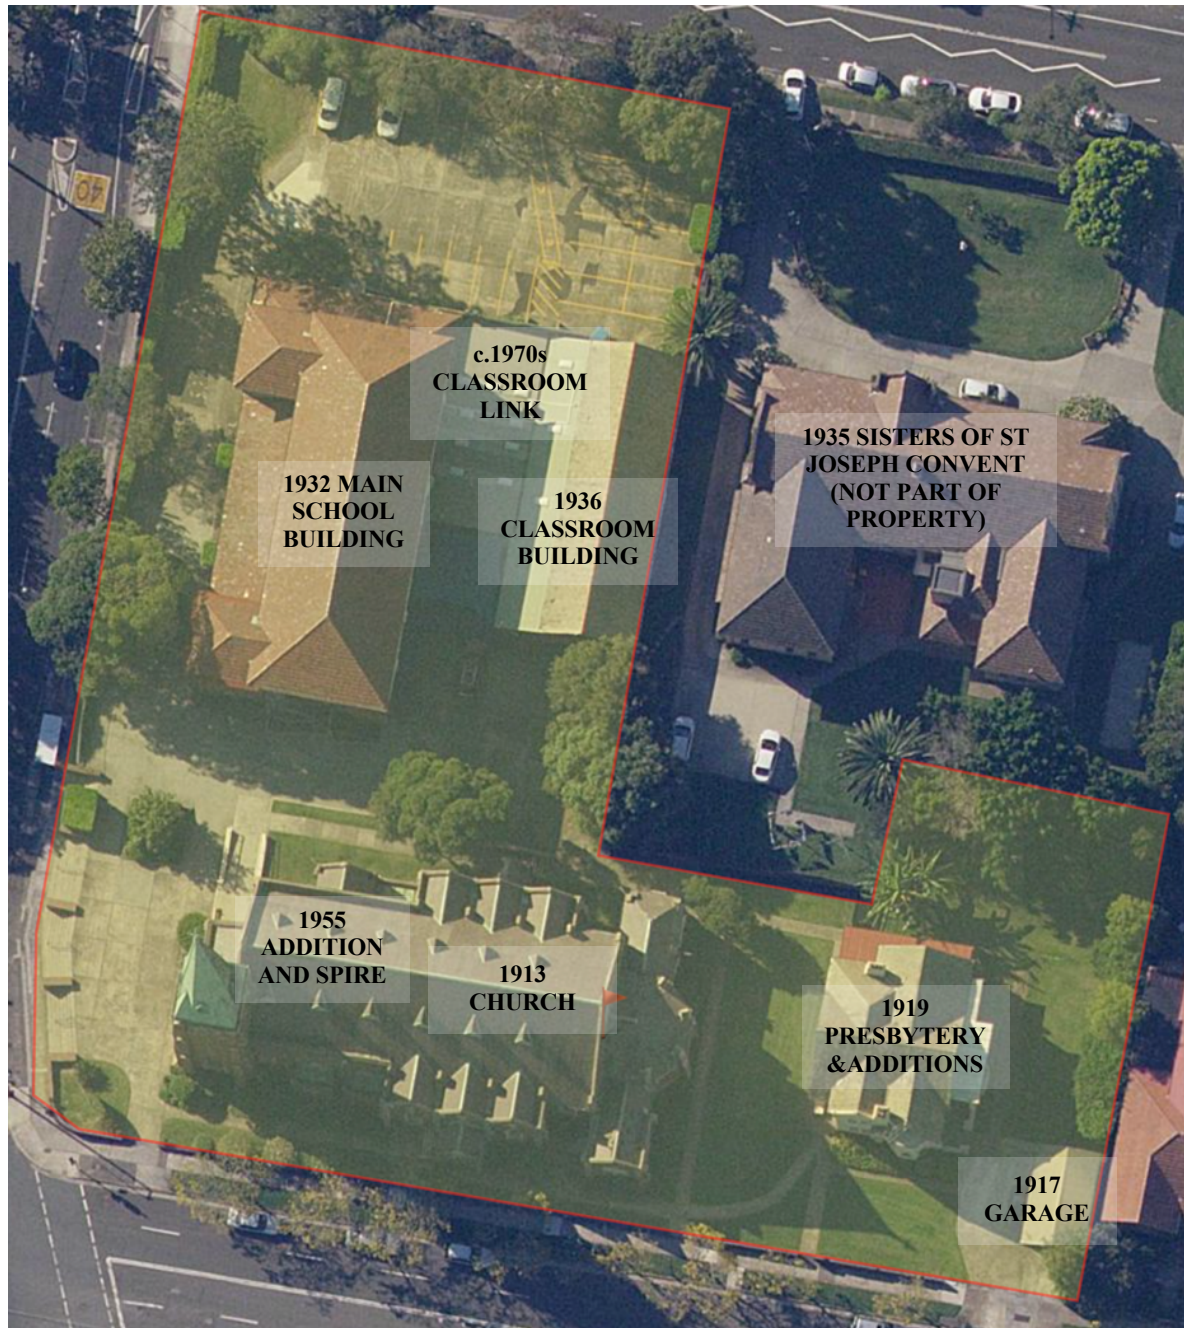
Figure 23 Extant elements of 43 Donnelly Road, Naremburn (source: www.sixmaps.nsw.gov.au)

Very few additions have been made to the built form on the subject property since 1943. It is evident that some accretions have been added to the northern end of the main school building as well as a linking element between this main building and the single storey classroom building to its east. The landscape appears to have evolved as would be expected with some early trees remaining. This may warrant further investigation by a specialist. Overall, the arrangement of buildings across the property and their overall forms and the way they address three different streetscapes remain the same and intact.

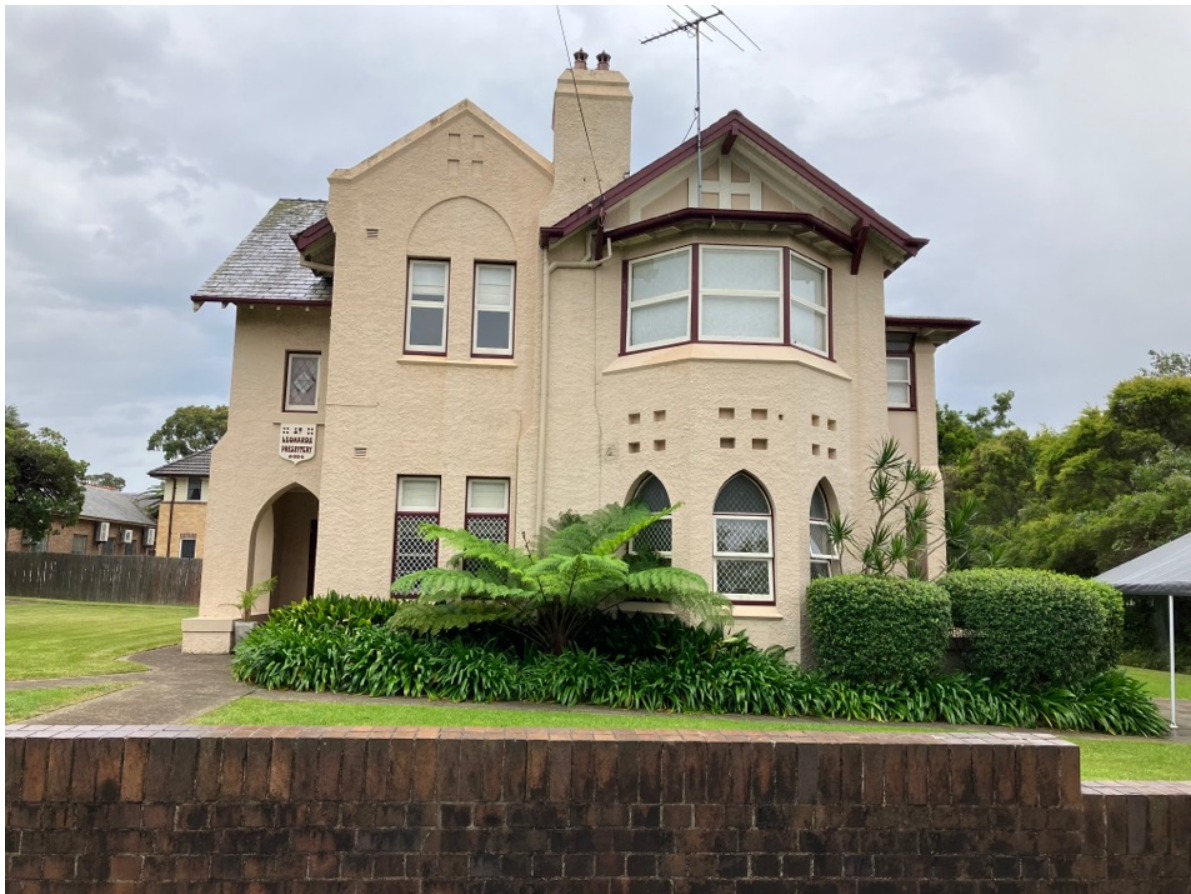
Figure 28 The presbytery viewed from Donnelly Road as a standalone building.

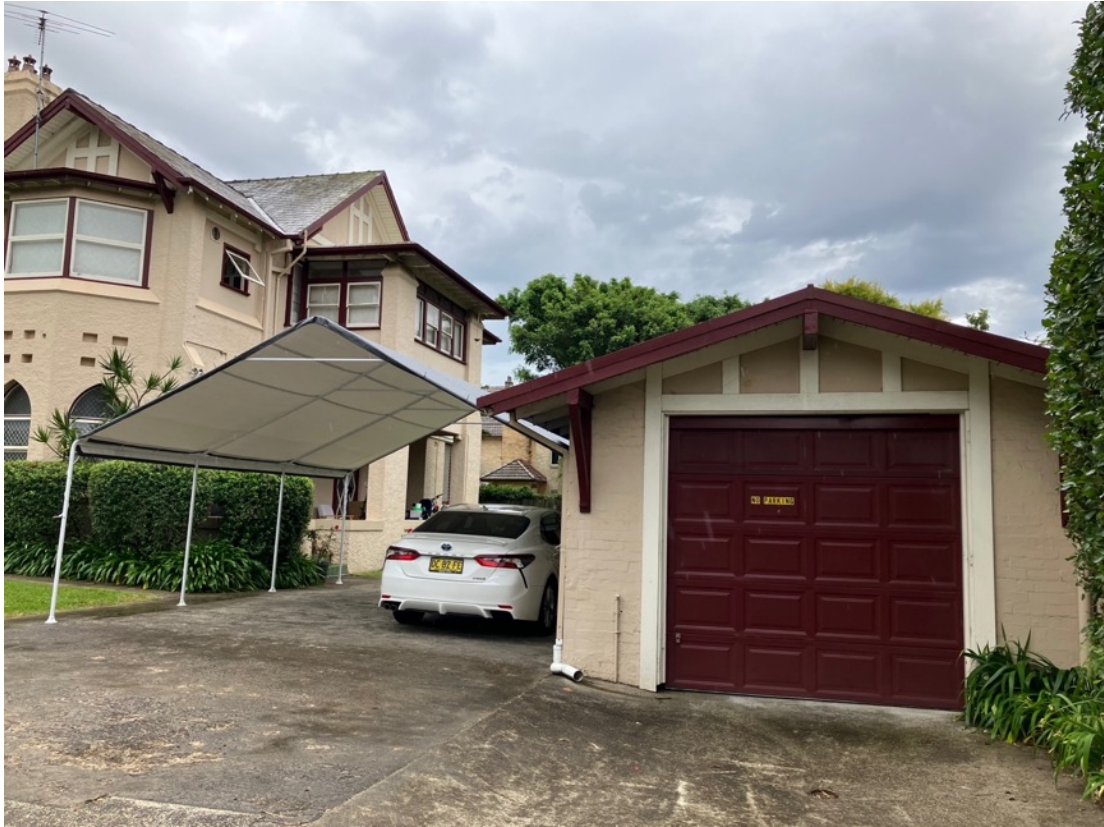
Figure 29 The 1917 garage, the second element in the sequence of construction after the church.

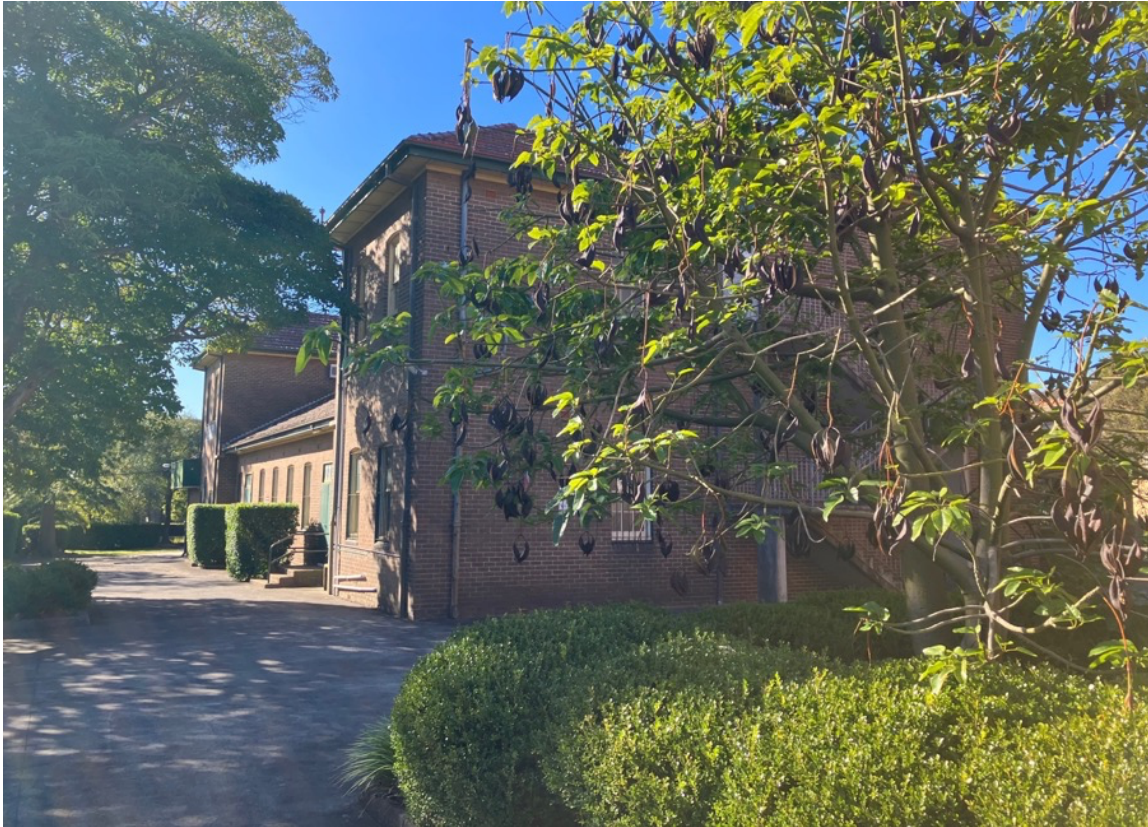
Figure 31 View of the southern elevation of the main school building from the church.

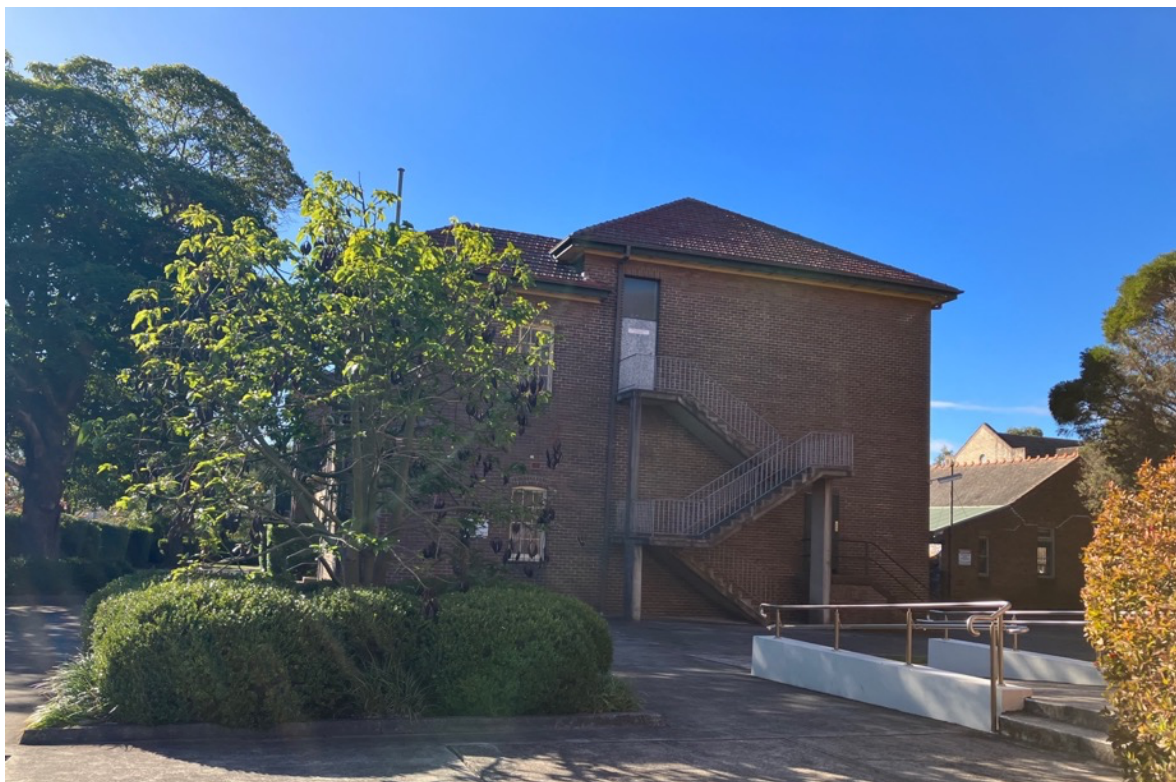
Figure 32 View of the southern elevation of the main school building with the profile of the smaller classroom building and adjoining convent building beyond evident to its east.

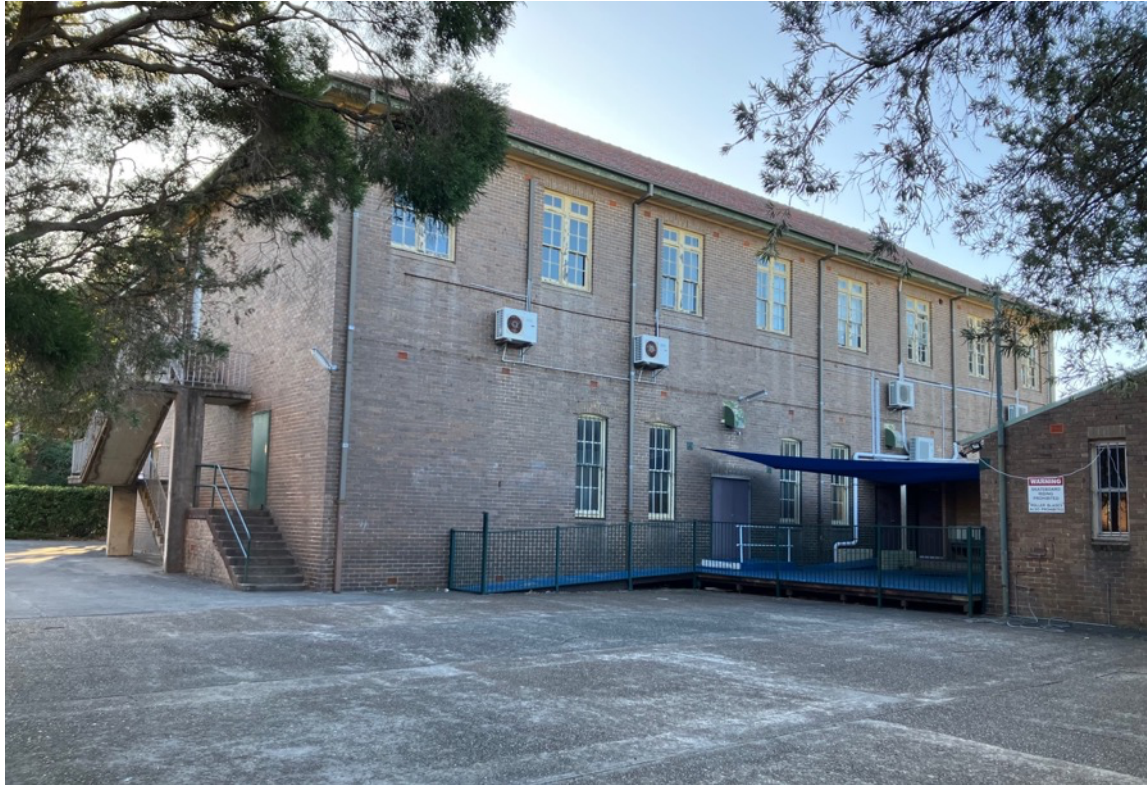
Figure 33 View of the eastern elevation of the main school building with the smaller classroom building and linking building in the foreground.

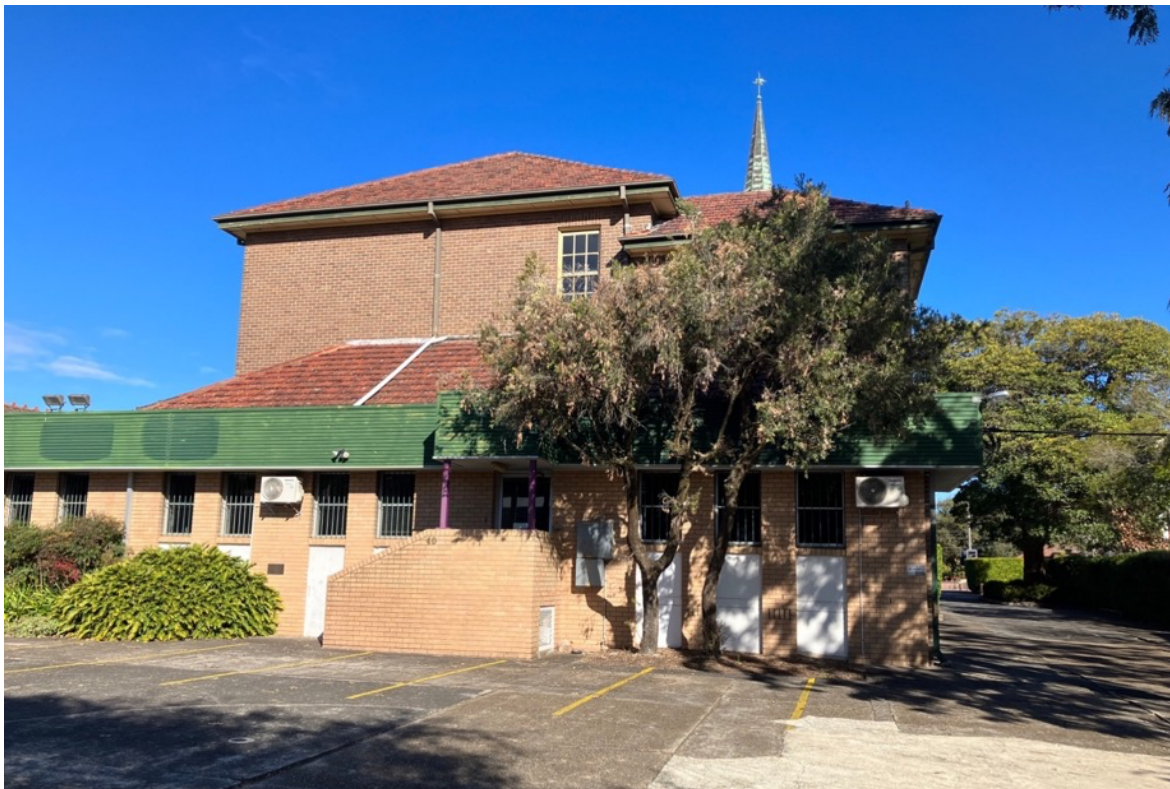
Figure 34 View of the northern elevation of the main school building showing the later modifications, possible verandah infill, green parapet and single storey link building.

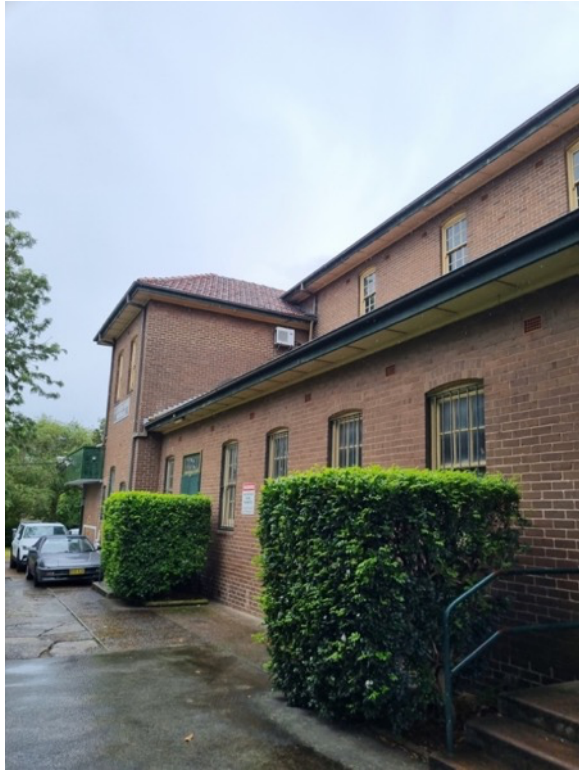
Figure 35 Western elevation 1932 main school building showing single storey vestibule area.

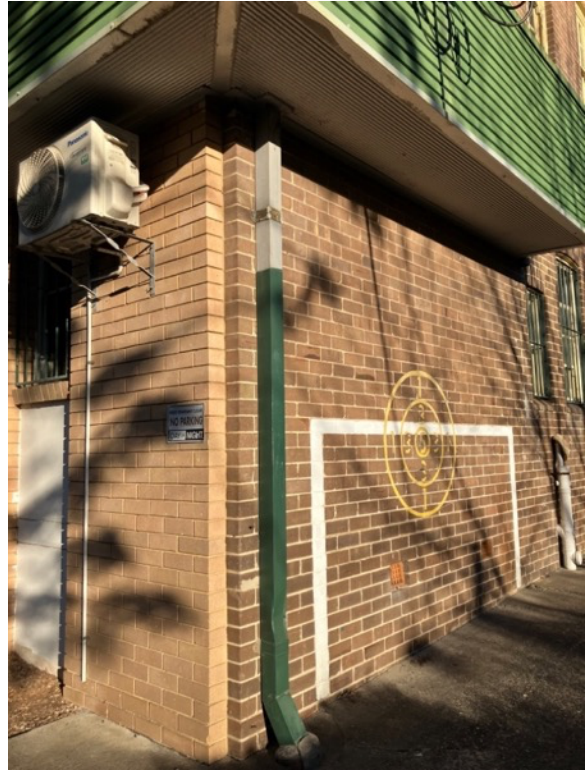
Figure 36 North-western corner of the main school building showing the blonde brick facing

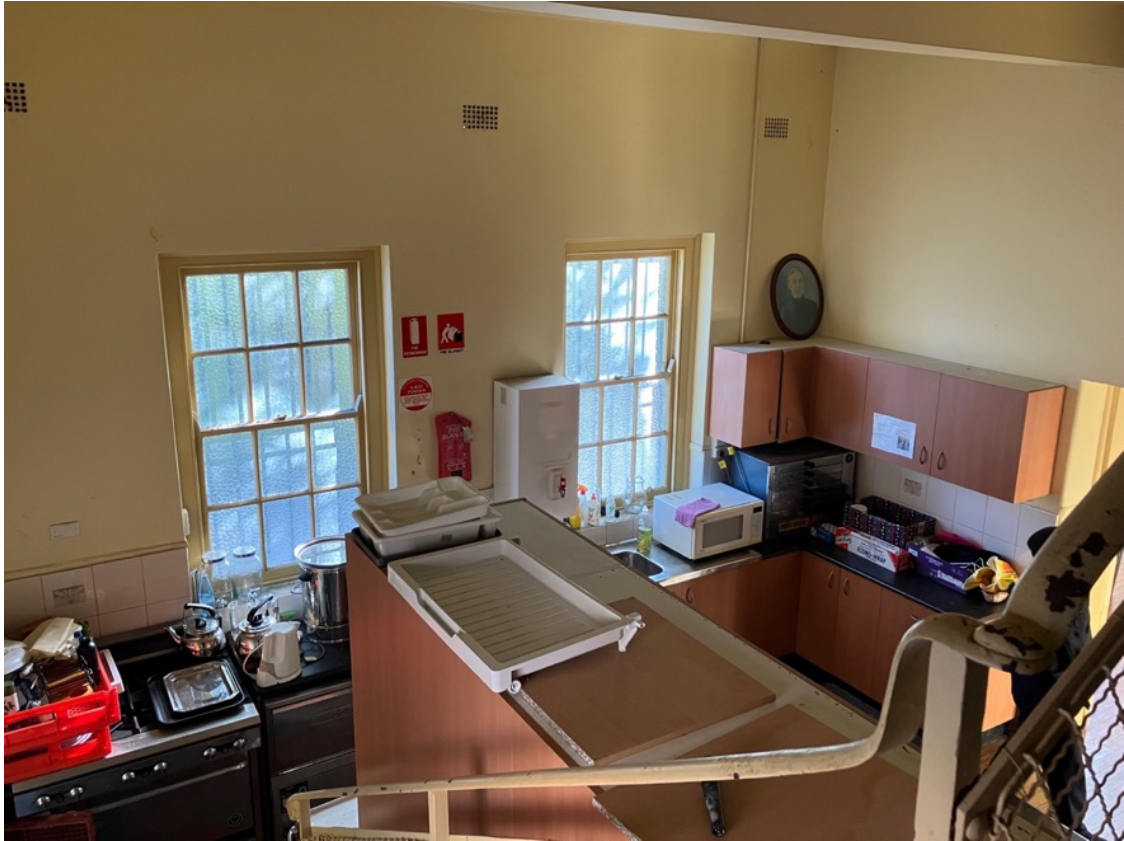
Figure 42 Kitchen on the ground floor of the southern projecting bay of the western elevation.

The hipped roof features two main hip projections at the first-floor level, which are linked along the western elevation of the building by a single storey vestibule and services area, which contains the kitchen. It is apparent that the single storey lean-to on the northern elevation, which was likely a previous verandah, has been infilled and extended to connect to the single storey classroom and an intrusive metal roof parapet has been constructed over. Notwithstanding this and the addition of some air-conditioning units, which are likely to be redundant, this building retains a high degree of integrity externally.

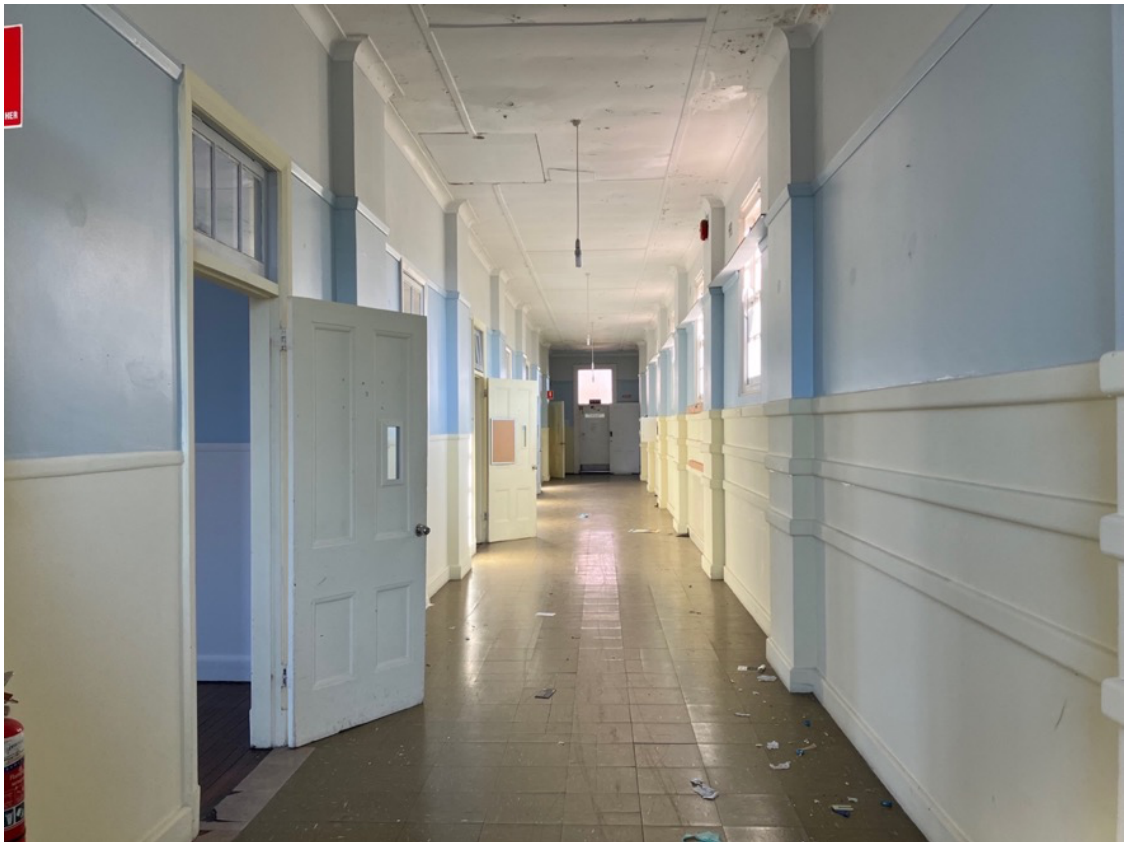
Figure 43 Vestibule running along the western edge of the first-floor classrooms.

The first floor appears to be highly intact with limited changes including painting. The first-floor vestibule is wide and leads to each of the classrooms, all of which have undergone limited changes. An inspection indicated spatial integrity, original windows including those internal, original dado/chair rails and picture rails, skirtings, and cornices. Again, it is possible that the ceilings on the first floor may be original with later light fittings however they are at least in their original location when considering their relationship to windows, external header courses, vents, and the eaves/soffit.

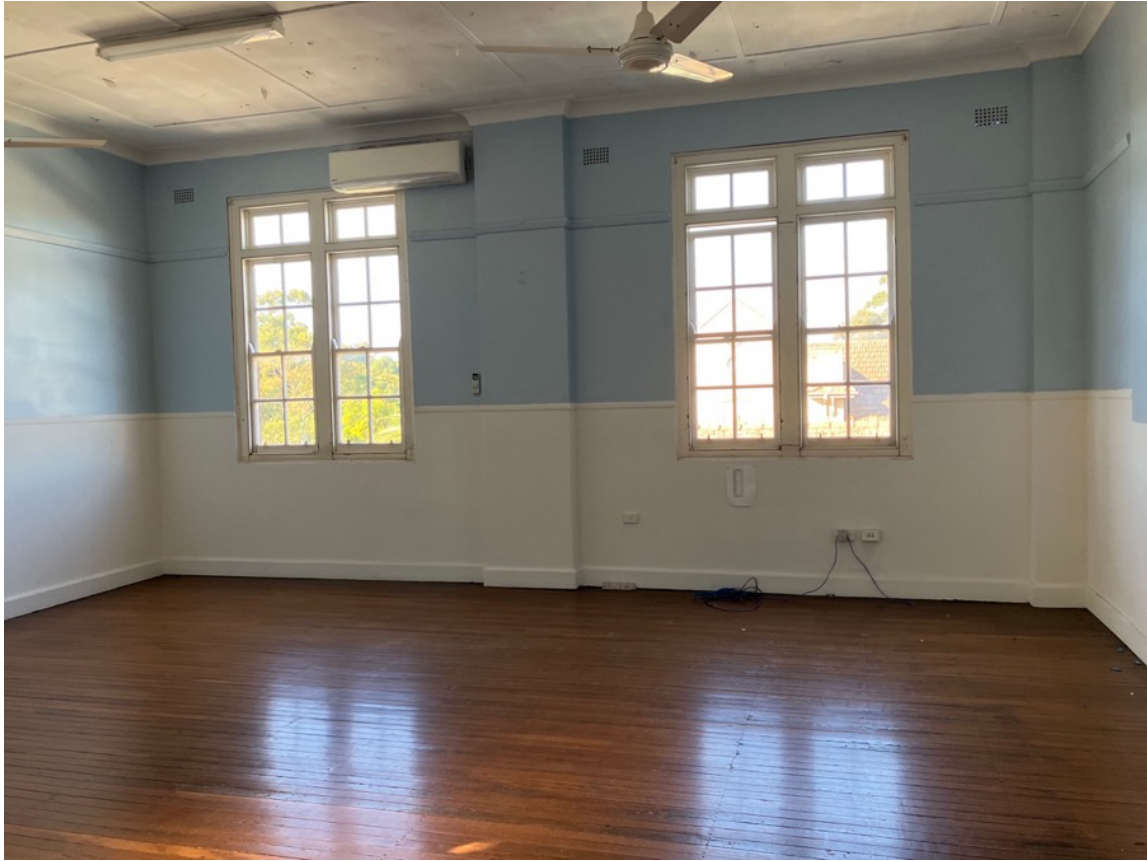
Figure 44 First floor classroom with evidence of original fabric.

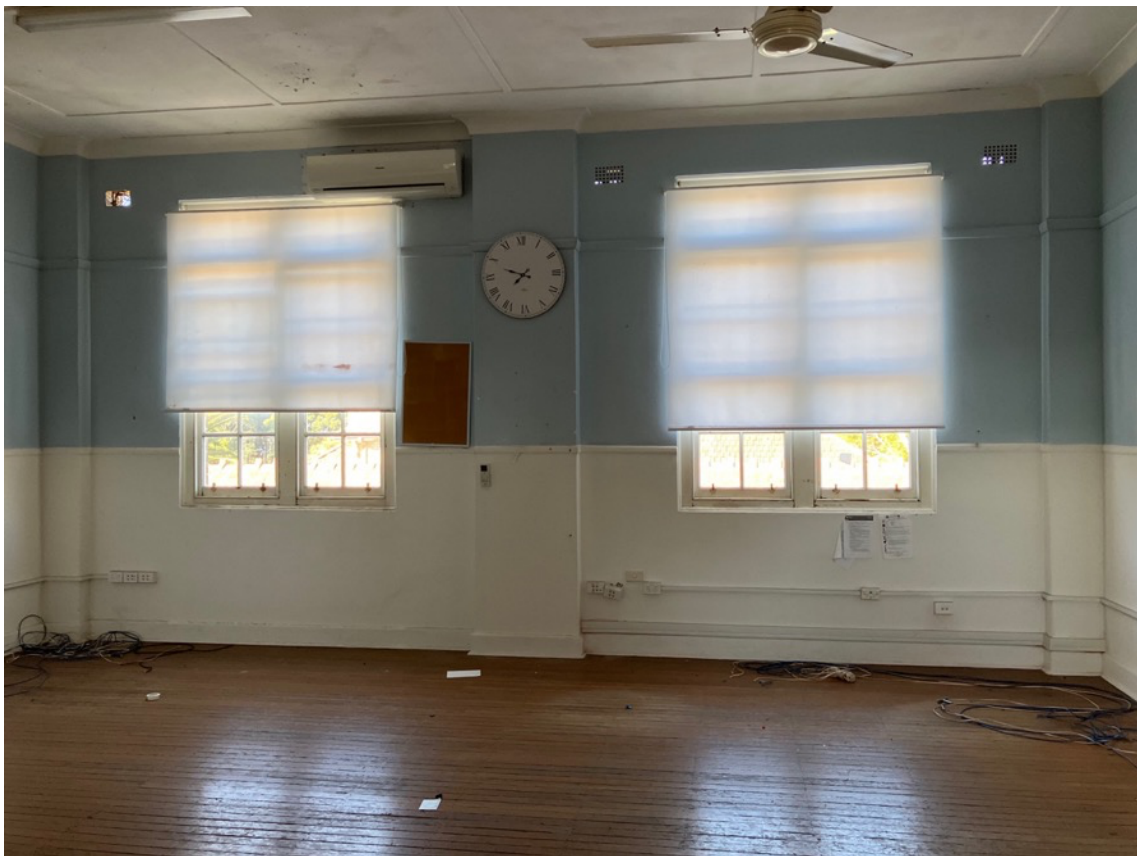
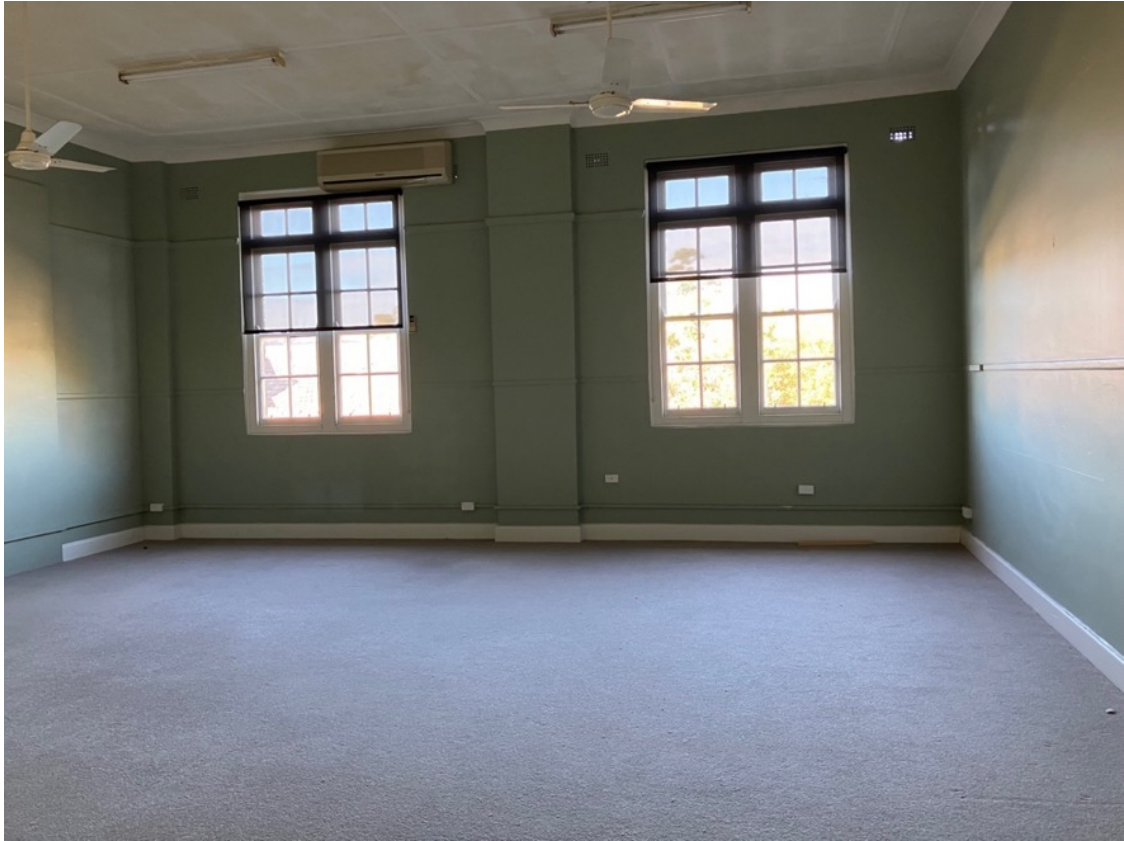
Figure 45 First floor classroom with evidence of original fabric.

Figure 46 First floor classroom with evidence of original fabric.

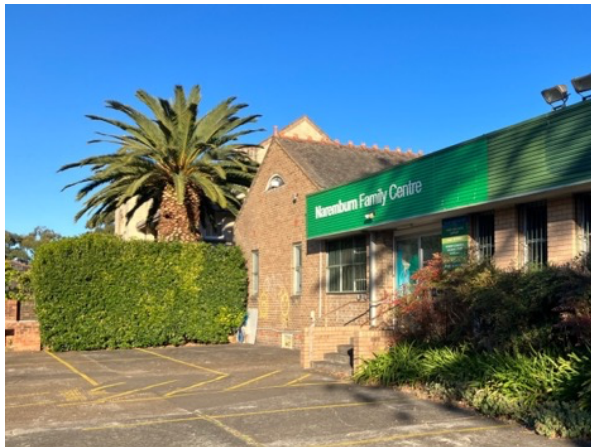
Figure 48 View to the classroom building, which has been connected to the main school building with single storey classroom link.

The single storey 1936 classroom building was also built in the late Inter-War period. Despite its decorative ridge capping and slate roof appearing too elaborate for its time and function, it is speculated that these materials, as well as the decorative vent covers were salvaged from the demolition of an adjoining building or from another site. This building features a simple gabled roof and double hung sash windows on three sides and substantial modifications along the western elevation around the link and addressing the central play area. Whilst evidence of the original verandah remains underneath painted bricks and timber ceiling, the integrity of this building is reduced through the extent of internal changes and the large crack on the southern elevation.

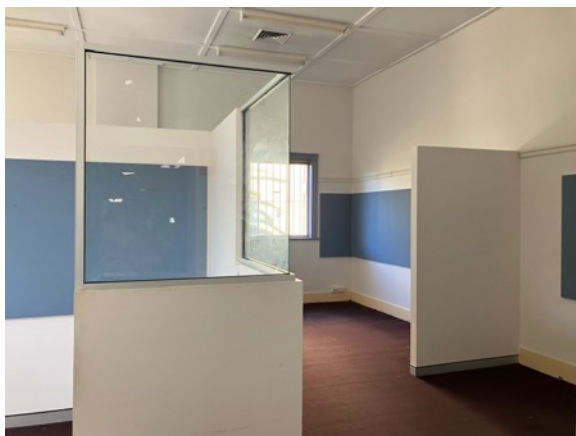
Figure 50 Internal fit-out of the classroom building.

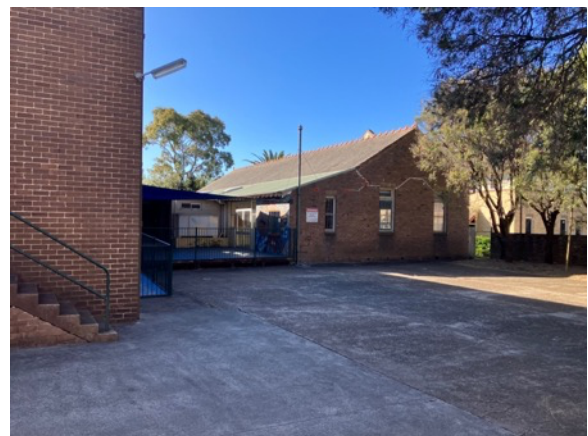
Figure 51 Southern elevation of single storey 1936 classroom building. Slate roof and decorative ridge capping likely salvaged.

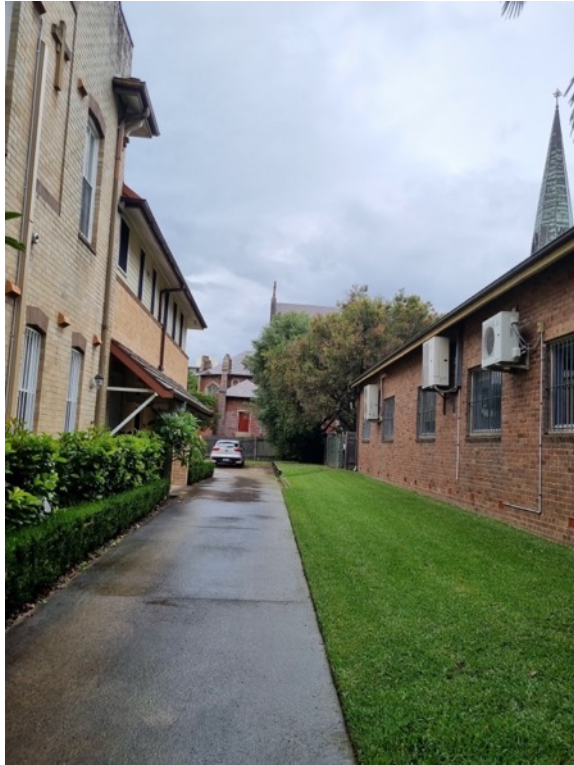
Figure 52 Eastern elevation of single storey 1936 classroom building and its relationship to the adjacent 1935 Sisters of St Joseph's building.

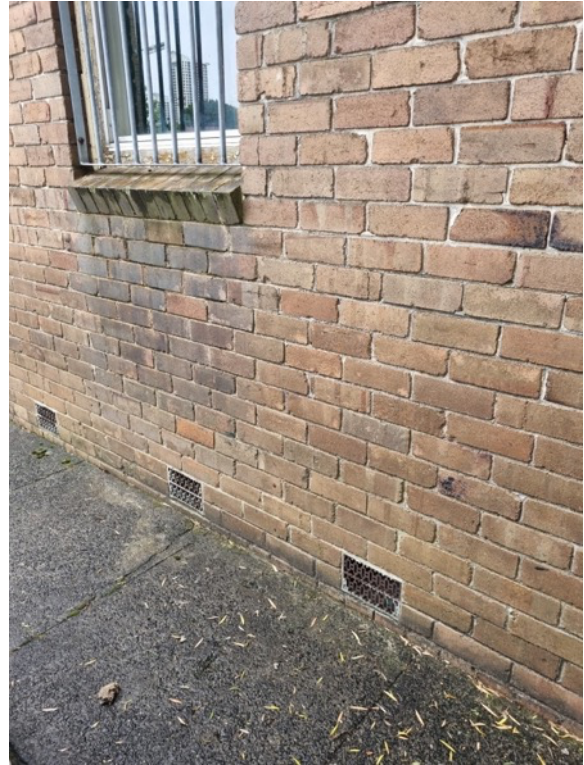
Figure 53 Decorative vents likely salvaged and re-used for this building.

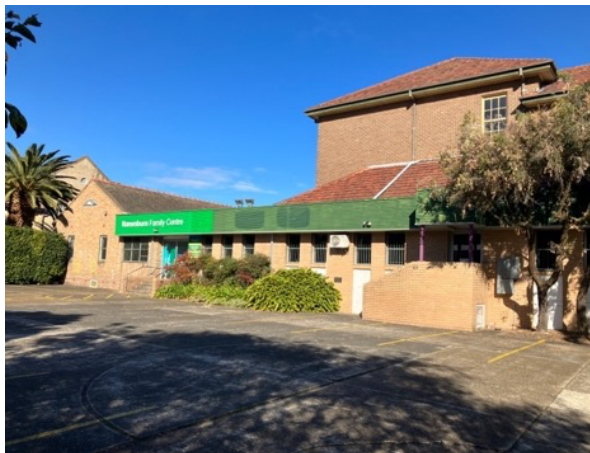
Figure 54 The single storey classroom link featuring green parapet roof element which ties the main school and classroom buildings together,

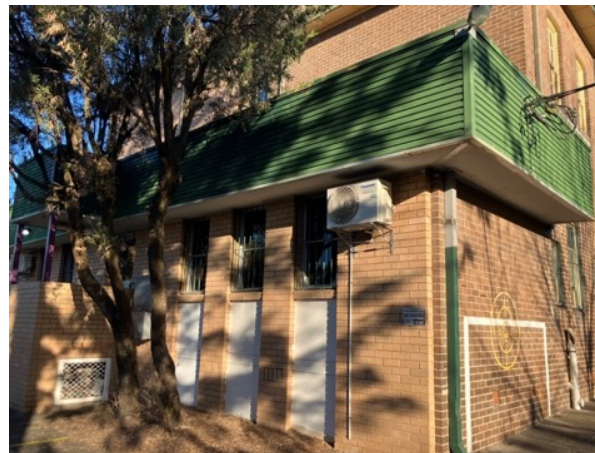
Figure 55 The original brick continues to the corner and the lighter brick facing is evident as a potential verandah enclosure along the north.

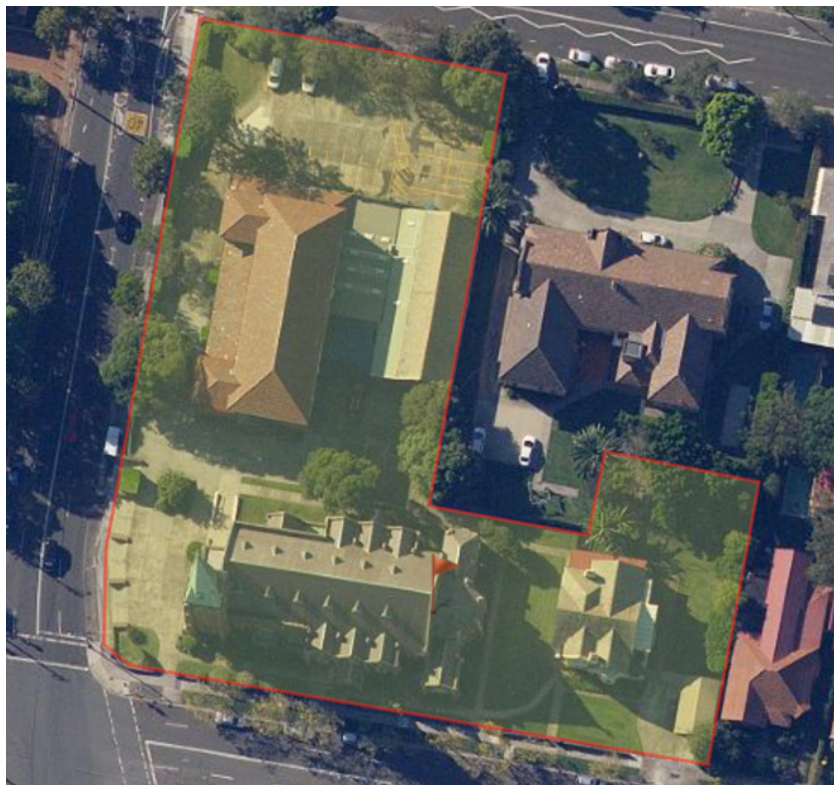
Figure 57: Suggested Lot Boundary Curtilage for 43 Donnelly Road, Naremburn.

It is recommended that the curtilage of the heritage item, described as *'St Leonard's Catholic Church, Presbytery and School Buildings'* in Section 5, should be re-defined by the existing property boundary, including the presbytery, school buildings and grounds.
