Report on
Preliminary Geotechnical and Salinity Assessment

Proposed Rezoning - Belmore Road Precinct
South Creek West, Bringelly, NSW

Project 92336.04
June 2022

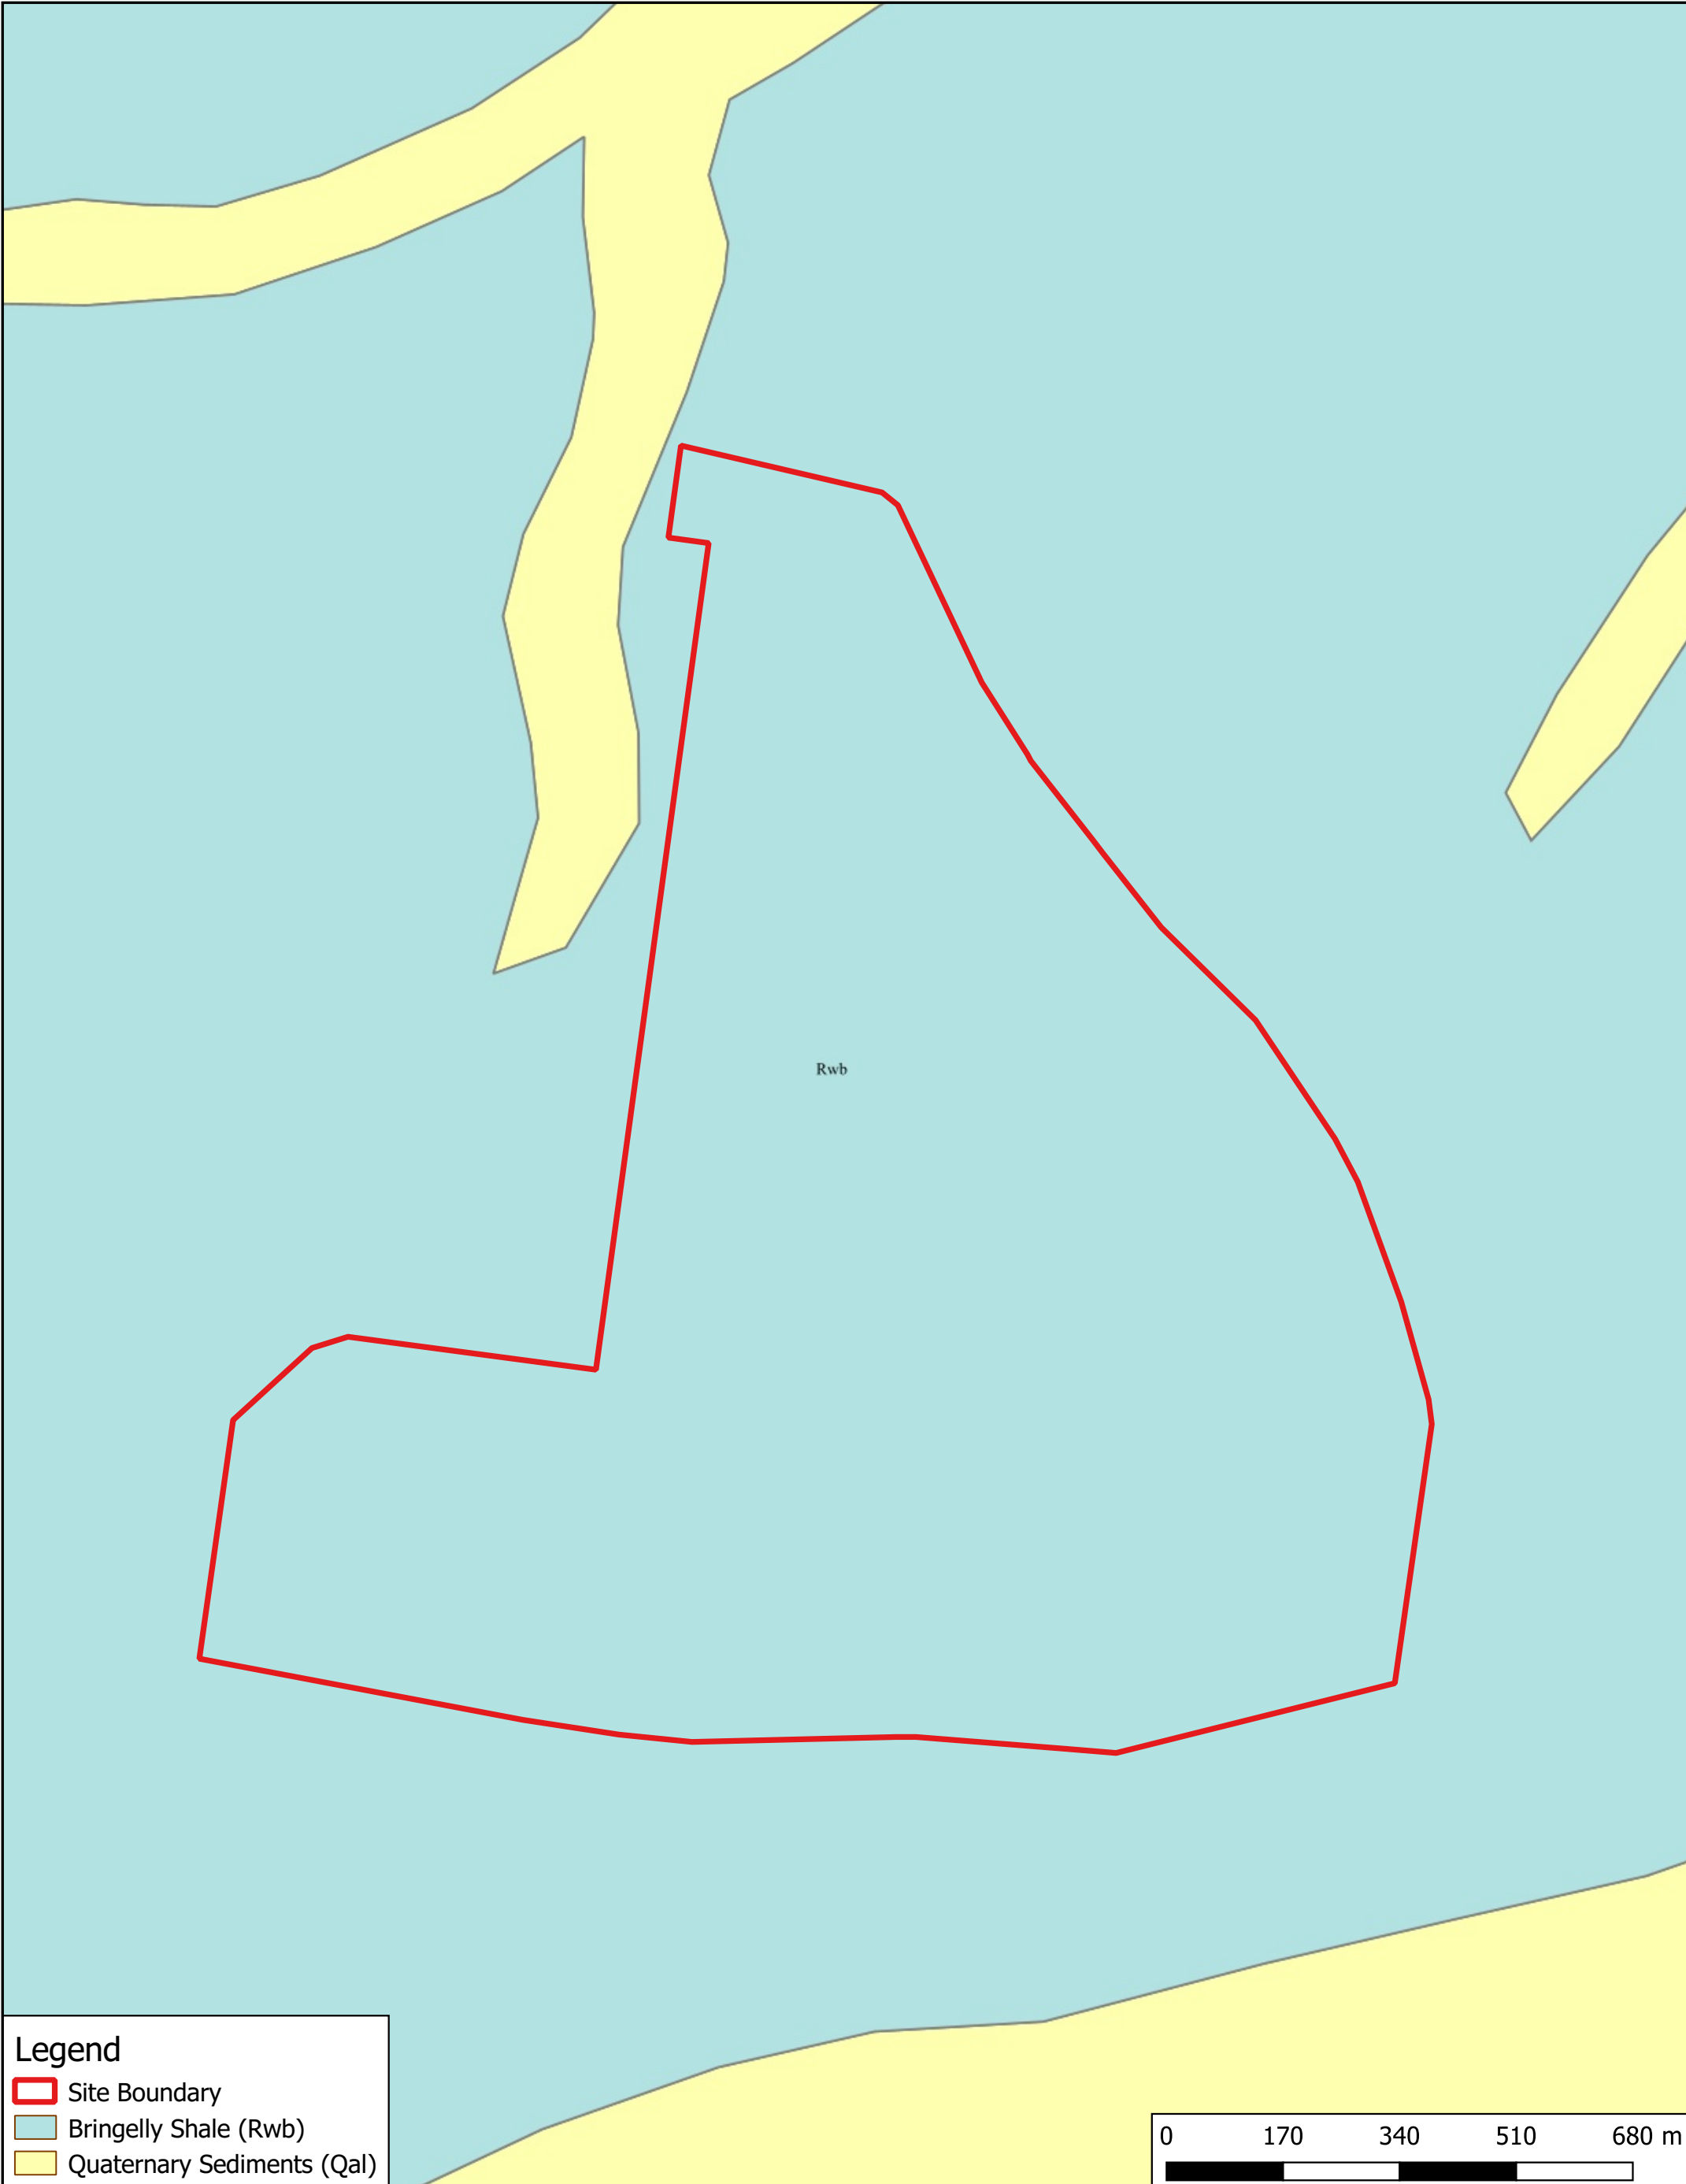
- Site Boundary
- Bringelly Shale (Rwb)
- Quaternary Sediments (Qal)

The results of the investigation were generally consistent with the broad-scale geological mapping with shale, siltstone and sandstone encountered in those test pits and boreholes that intersected rock. Sandstone outcrops were also observed at various locations across the site.

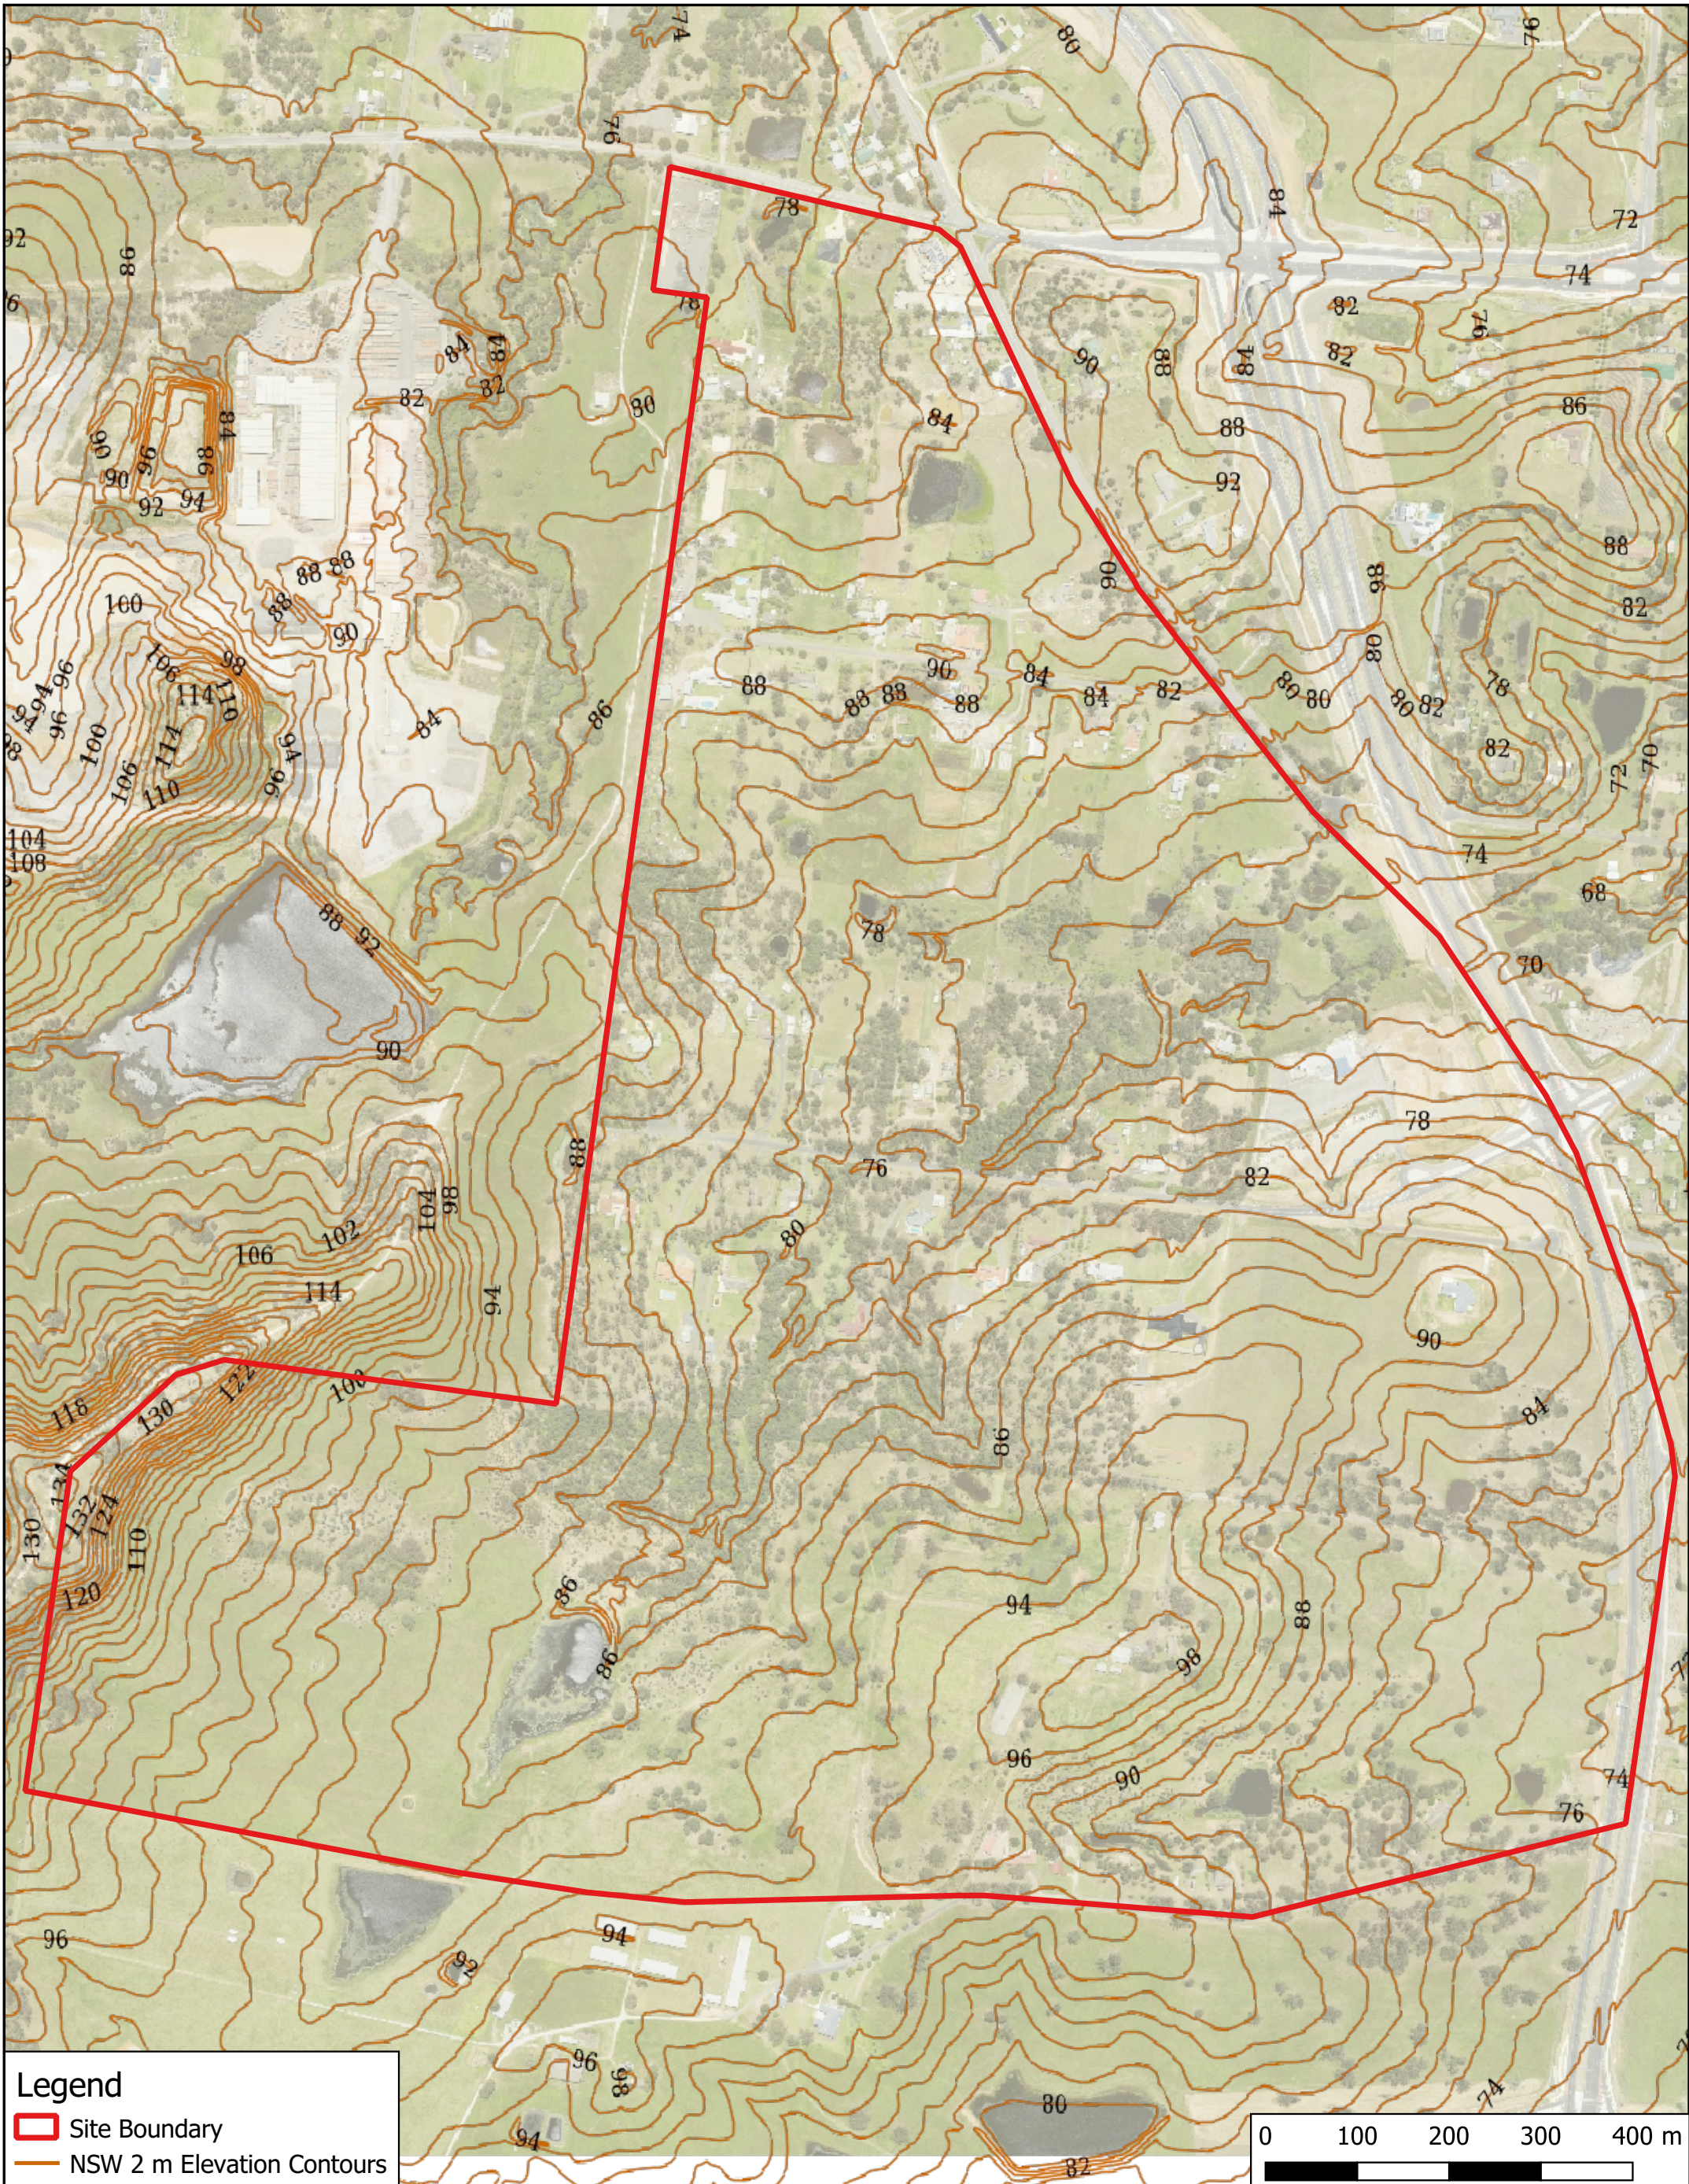
DRAWING No: 4

- Site Boundary
- NSW 2 m Elevation Contours

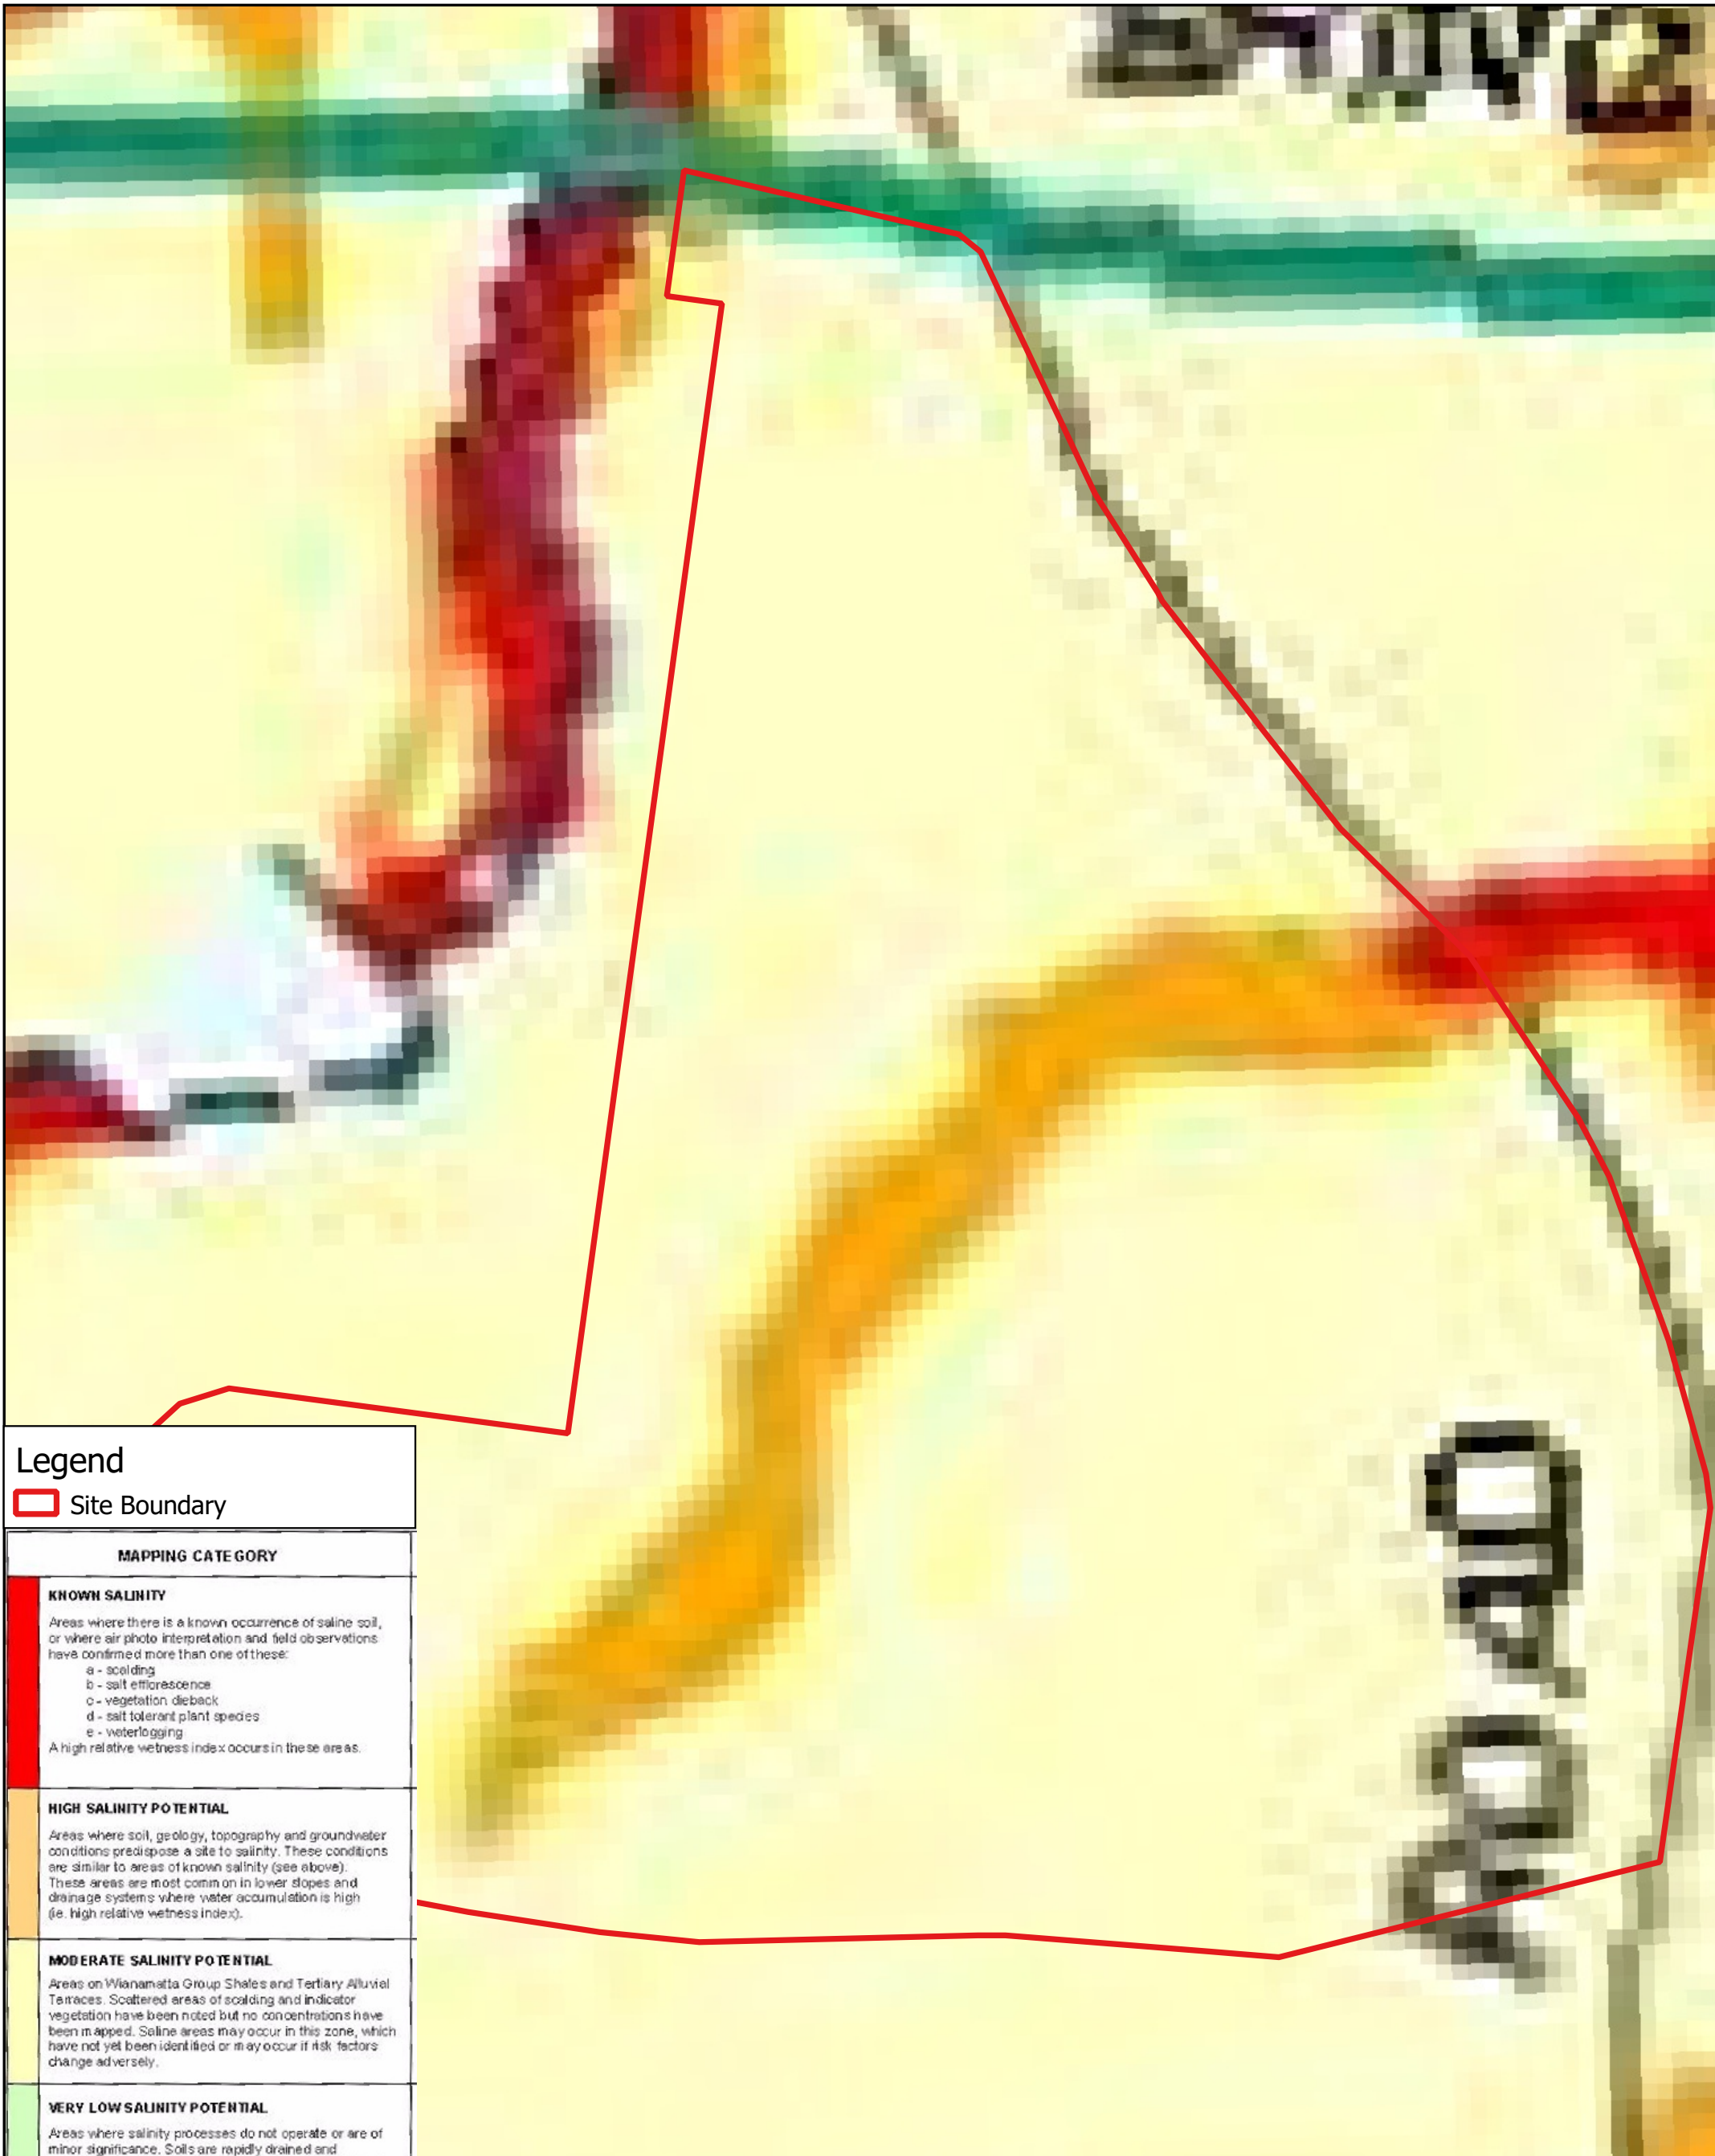
HIGH SALINITY POTENTIAL Areas where soil, geology, topography and groundwater conditions predispose a site to salinity. These conditions are similar to areas of known salinity (see above). These areas are most common in lower slopes and drainage systems where water accumulation is high (ie. high relative wetness index).

MODERATE SALINITY POTENTIAL Areas on Wianamatta Group Shales and Tertiary Alluvial Terraces. Scattered areas of scalding and indicator vegetation have been noted but no concentrations have been mapped. Saline areas may occur in this zone, which have not yet been identified or may occur if risk factors change adversely.

VERY LOW SALINITY POTENTIAL Areas where salinity processes do not operate or are of minor significance. Soils are rapidly drained and underlying strata (Hawkesbury/Narrabeen Sandstone) are highly permeable, resulting in continual flushing and removal of salts in the landscape. No salinity has been observed in these areas and is not expected to occur.

The former Department of Environment Climate Change (DECC), now the NSW Environment Protection Authority (EPA), infers a low salinity potential for the site on their salinity hazard map extracted from the Soil and Land Resources of the Hawkesbury Nepean Catchment (DEC 2009).

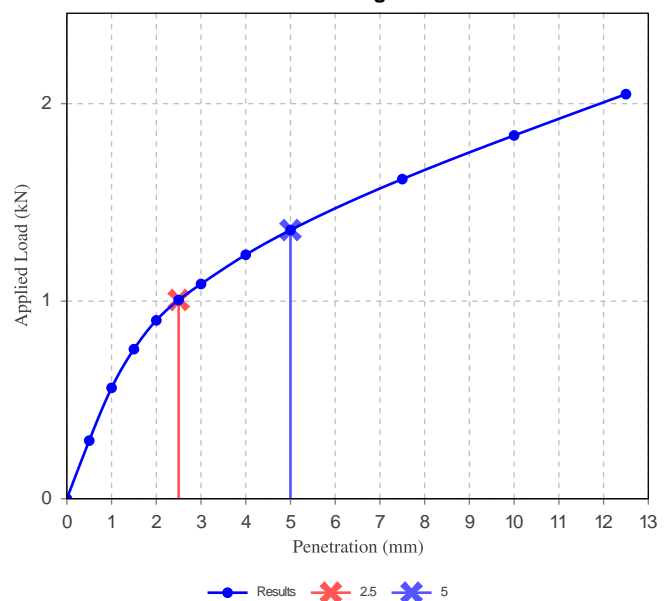
California Bearing Ratio

Report Number: 92336.00-1
Issue Number: 2 - This version supersedes all previous issues
Reissue Reason: change of client name
Date Issued: 04/03/2021
Client: CKDI Pty Ltd
Suite 703, North Tower, Chatswood NSW 2067
Contact: Tank Tan
Project Number: 92336.04
Project Name: South Creek West - North West Precinct
Project Location: NWP 1037 The Northern Road, Bringelly
Work Request: 2086
Sample Number: MA-2086BO
Date Sampled: 28/02/2020
Dates Tested: 12/02/2020 - 12/02/2020
Sample Location: TP12 (0.5m)
Material: Soil
