# The Belmore Road Precinct – Riparian Assessment

**CKDI Bringelly Pty Ltd atf**

<b>Project Name</b>	The Belmore Road Precinct – Riparian Assessment
<b>Project Number</b>	21SYD - 18177
<b>Project Manager</b>	Rebecca Ben-Haim
<b>Prepared by</b>	Claire Wheeler, Emily Messer and Rebecca Ben-Haim
<b>Reviewed by</b>	Ian Dixon and Rebecca Ben-Haim
<b>Approved by</b>	David Bonjer
<b>Status</b>	Final
<b>Version Number</b>	6
<b>Last saved on</b>	29 June 2022

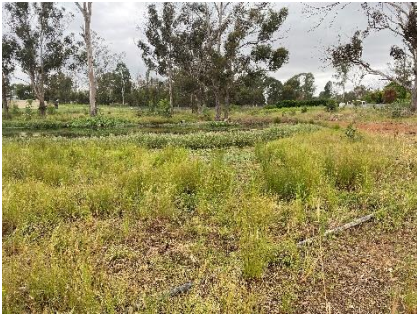
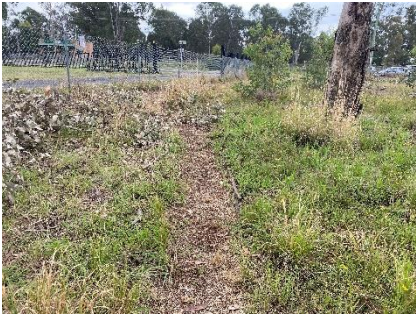
Reach	Proposed WM Act status (pending NRAR approval)	Description	Condition	Photo facing upstream	Photo facing downstream
1A	Not a river	No defined bed or banks. Overland flow path in times of overtopping dam	Poor

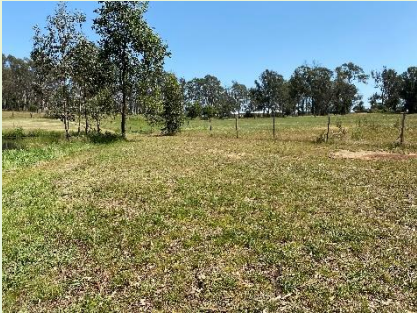
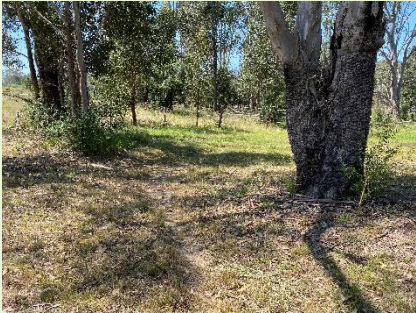
1B	Not a river	No defined bed or banks	Poor

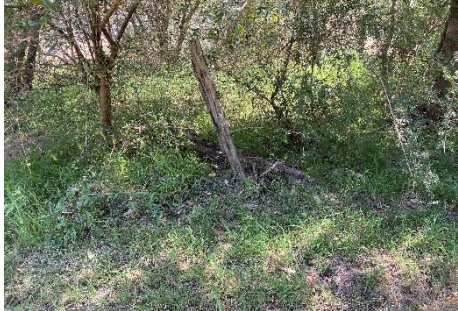
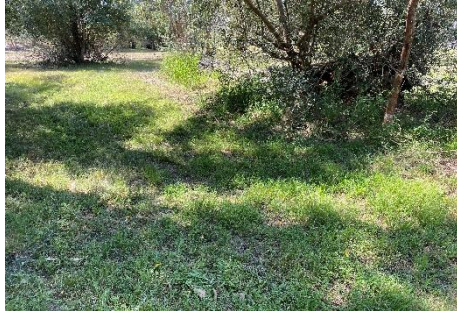
Reach	Proposed WM Act status (pending NRAR approval)	Description	Condition	Photo facing upstream	Photo facing downstream
1C	Not a river	No defined channel, bed or banks	Poor

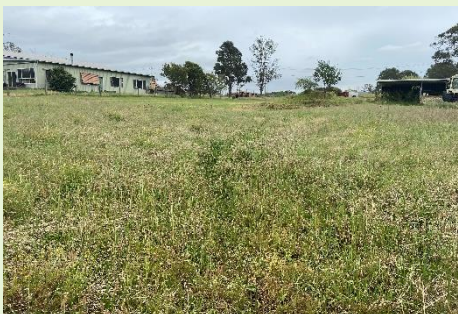
1D	Not a river	No defined bed or banks. Mown grass for almost entire length of mapped location.	Poor

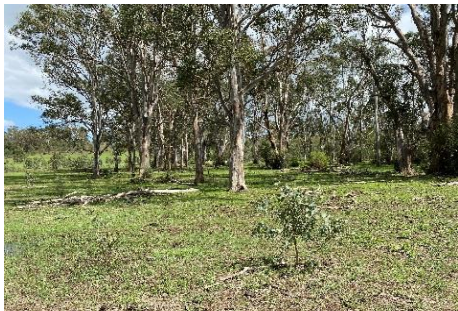
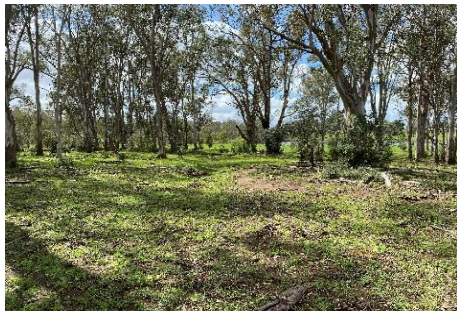
1F	Not a river	No defined bed or banks. Overland flow path at a low point only.	Poor

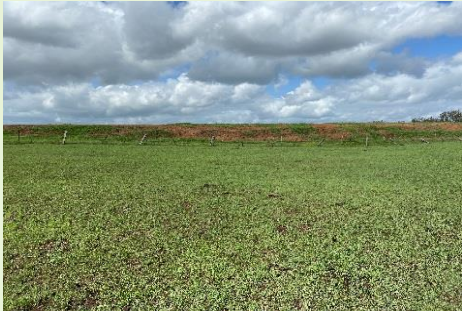
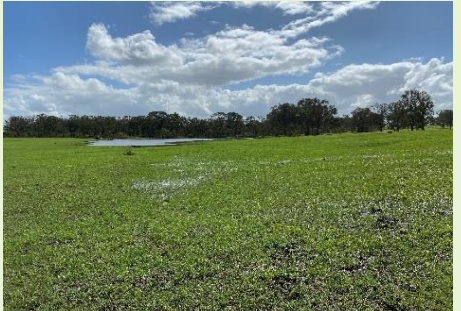
Reach	Proposed WM Act status (pending NRAR approval)	Description	Condition	Photo facing upstream	Photo facing downstream
1G	Not a river	No defined bed or banks. Areas of saturated soil following recent heavy rain.	Poor

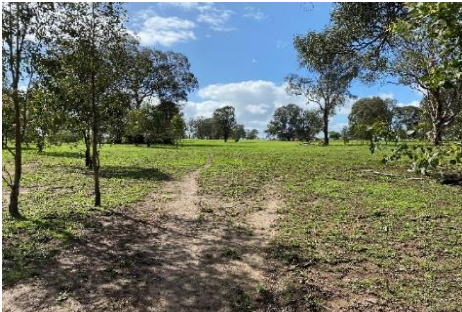
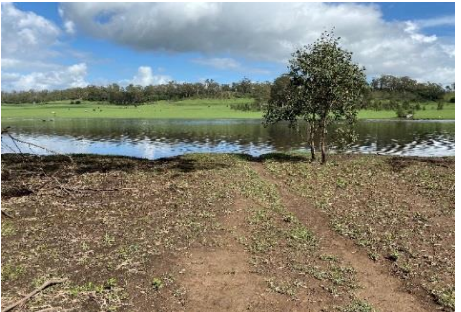
1H	Not a river	No defined channel. Informal track near mapped location of this watercourse, likely created by stock accessing dam.	Poor

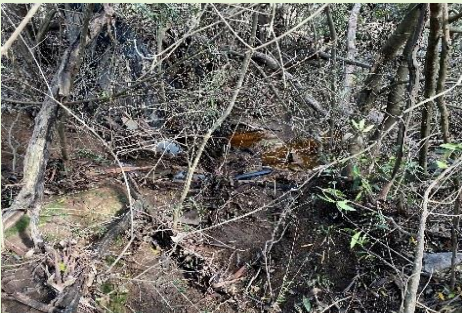
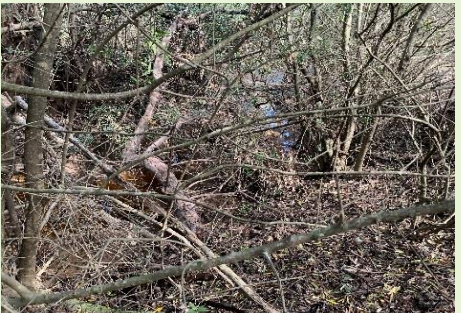
1I	River	Defined channel approximately 1 m wide that started at a headcut about 60 m to the south east of the main channel 2B. Densely covered in <i>Olea europaea</i> subsp. <i>cuspidata</i> (African Olive) and no groundcover vegetation, allowing for easy erosion of banks and bed of channel.	Poor

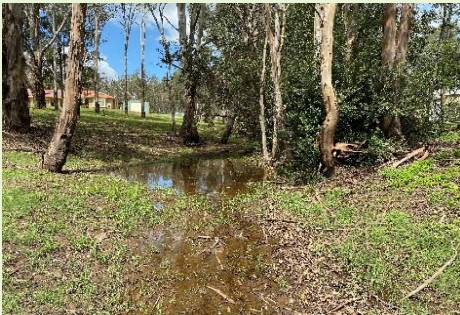
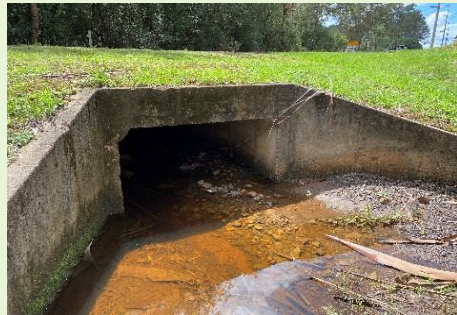
Reach	Proposed WM Act status (pending NRAR approval)	Description	Condition	Photo facing upstream	Photo facing downstream
		Right bank steeply sloped, approximately 0.5 m high. Household rubbish visible within this channel.			
1J - upper	Not a river	No defined channel upstream of the dam on this watercourse.	Poor	 	 
1J - lower	River	Defined channel at Belmore Road. Single concrete box culvert approximately 1.5 m wide and 0.75 m high carries flow under Belmore Road to confluence with 2B.	Moderate

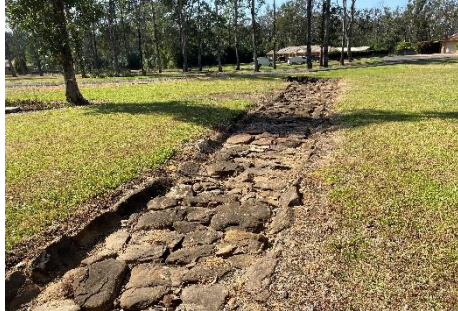
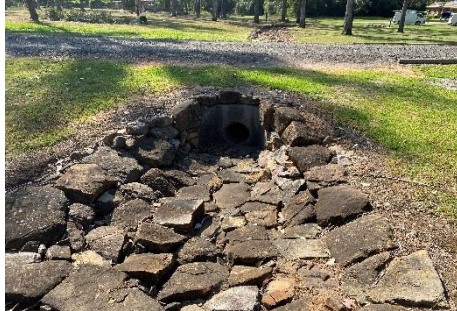
Reach	Proposed WM Act status (pending NRAR approval)	Description	Condition	Photo facing upstream	Photo facing downstream
1K	River	Near the top of this watercourse, the channel had been rock lined within multiple properties. The channel was less-defined as it neared the confluence with 2B.	Poor - moderate

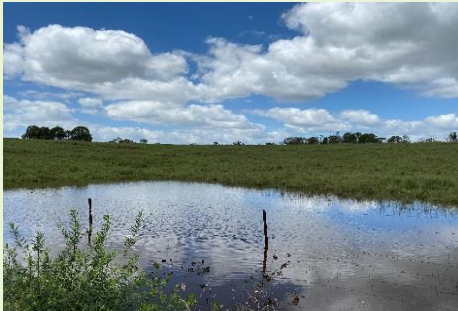
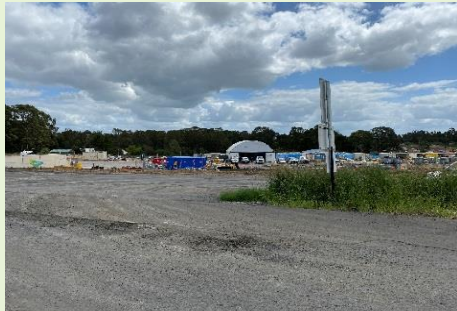
1L (at Belmore Road)	River	Upstream of Belmore Road there was no defined channel, however there appears to be a constructed drainage line within the property downstream of Belmore Road where access was restricted.	Poor

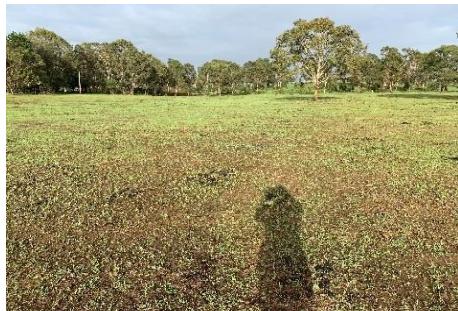
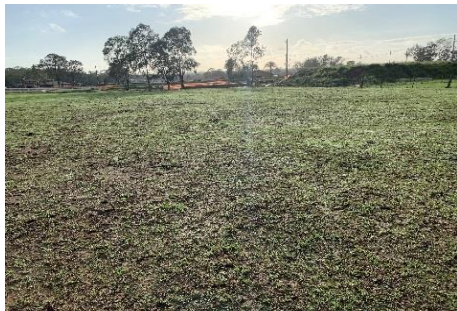
1M	Not a river	No defined channel. Overland flow paths across pasture were observed following recent rain.	Poor

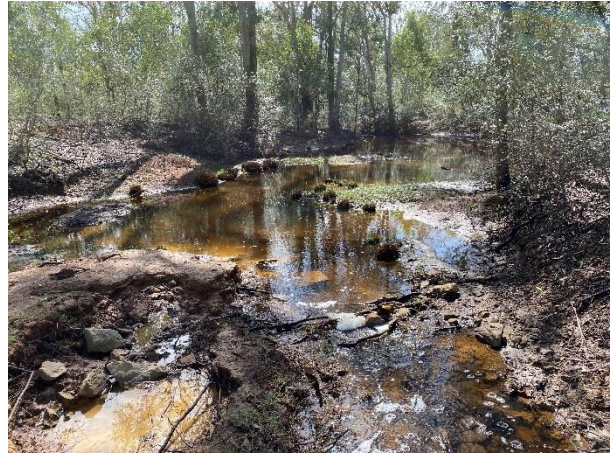
Approximately 100 m downstream of the dam on this reach, the dispersed flow converged at headcut within the channel. The headcut was shallow, in that it was approximately 0.3 m high, however erosion in this area had exposed large pieces of slate and tree roots. Water flowing over the headcut created a small riffle area and scattered *Juncus usitatus* was observed on the edge of the channel downstream of this riffle.

*Facing downstream – headcut*

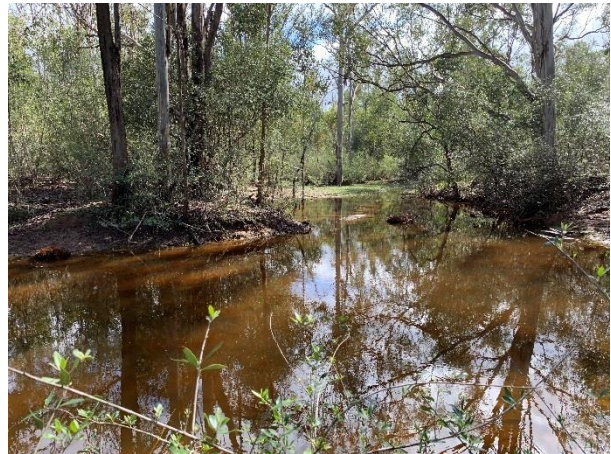
Upstream of the confluence of 2B and 1I, a headcut was observed on the right bank and a flood runner was evident parallel to the left bank. The channel was shallow, and the channel banks were low with a gentle grade. Leaf litter was observed on the channel bed and this litter was covered in a fine silty deposit. The channel was wide through this area, up to 15 m wide in some areas. The water was tannin-stained and still but not stagnant and there was a small amount of vegetation overhanging the edges of the channel. No aquatic vegetation was observed in this part of 2B.

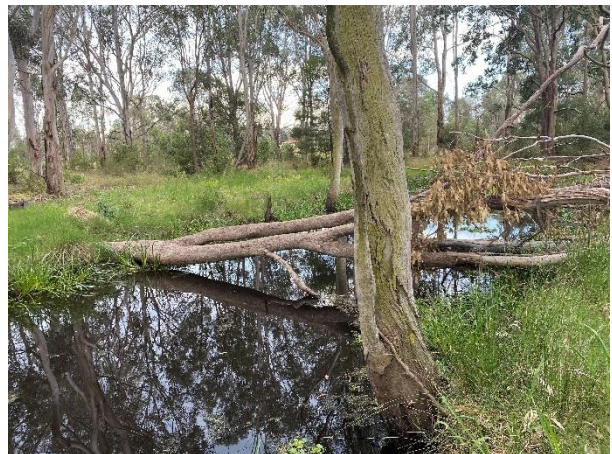
At the rear of properties along Belmore Road, 2B was a 10 m wide channel in some areas. Emergent macrophytes including *Ludwigia peploides* were observed growing on the edge of the channel and a number of large fallen trees have created good aquatic habitat within this area. Water in the channel was tannin-stained but not turbid. At the rear of 58 Belmore Road, the creek became a wetland up to 40 m wide and covered in dense *Typha orientalis* and *Azolla* sp. *Rubus fruticosus* (Blackberry) was observed in dense clumps along the right bank of the channel.

Facing downstream – large woody debris in channel

*Facing upstream – wetland area*

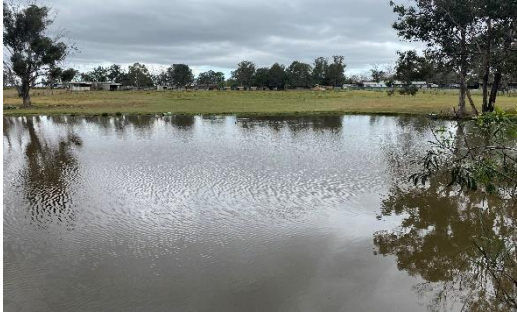
Reach	Dam number*	Description	Aquatic fauna observed	Aquatic flora observed	Representative photo
1A	1	Large dam near the upstream mapped extent of reach 1A. No defined spillway and a few sparse Eucalyptus moluccana on the edges of the dam.	<i>Platalea regia</i> (Royal Spoonbill) was observed near this dam.	No aquatic flora

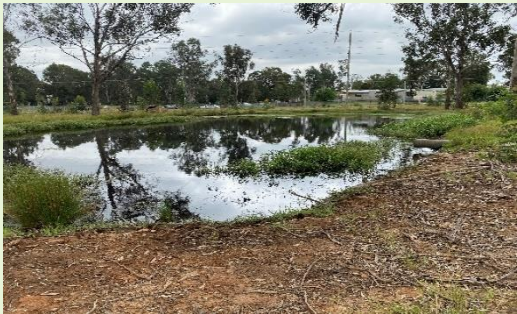
1A	2	Large dam near Greendale Road. At time of survey, water in the dam was clear with no oil sheen or odours.	No aquatic fauna observed.	Emergent macrophytes including <i>Persicaria strigosa</i>

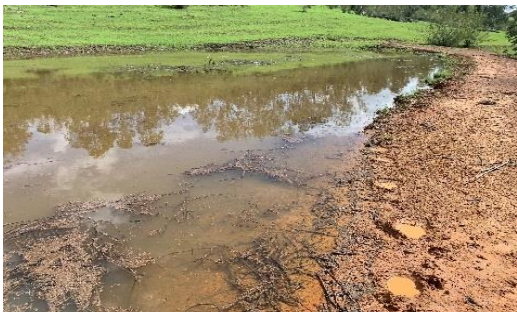
1F	1	No defined spillway but evidence of overflow after recent rain.	Frog eggs attached to submerged grasses.	Submerged <i>Typha orientalis</i> (Cumbungi).

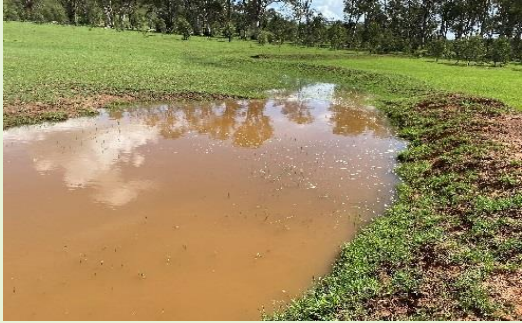
Reach	Dam number*	Description	Aquatic fauna observed	Aquatic flora observed	Representative photo
N/A		Small dam in between mapped reaches 1G and 1F. At capacity at time of site survey, overflowing to north behind artificial swale perpendicular to slope. Water was turbid and stagnant, with slight odour.	Frog eggs attached to submerged grasses.	No aquatic flora.

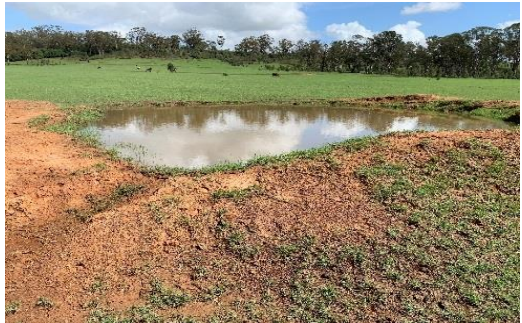
1G	1	Dam located to south west of mapped location of 1G. Small dam with no fringing vegetation and raised dam wall on eastern side of dam but no defined spillway. Turbid water with submerged pasture grasses and emergent macrophytes. Vegetative debris floating on surface of water.	Frog eggs attached to submerged grasses.	No aquatic flora.

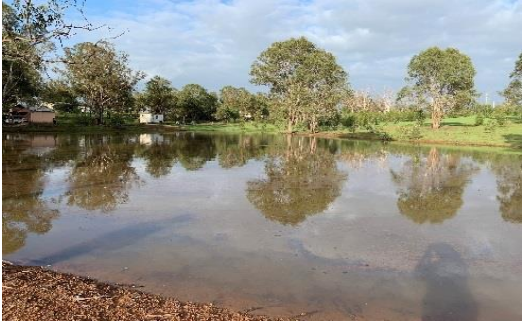
Reach	Dam number*	Description	Aquatic fauna observed	Aquatic flora observed	Representative photo
1M	2	Dam at capacity following recent rain, water slightly turbid and no fringing vegetation present. Clay substrate and no defined spillway on downstream side.	<i>Porphyrio porphyrio</i> (Purple Swamphen) and <i>Phalacrocorax sulcirostris</i> (Little Black Cormorant).	<i>Ludwigia peploides</i> .

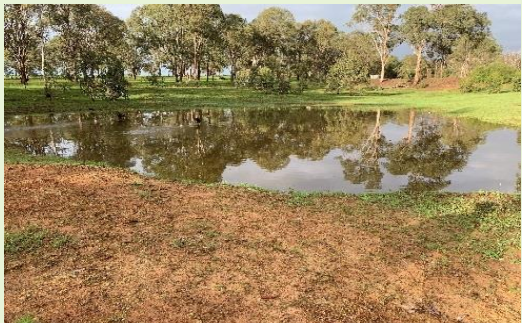
1M	3	There were no defined banks to this dam, which appeared to be nearing capacity. No macrophytes were observed in this dam and visibility through the water column was good.	<i>Porphyrio porphyrio</i> (Purple Swamphen), <i>Anas castanea</i> (Chestnut Teal) and <i>Phalacrocorax sulcirostris</i> (Little Black Cormorant).	No aquatic flora observed.

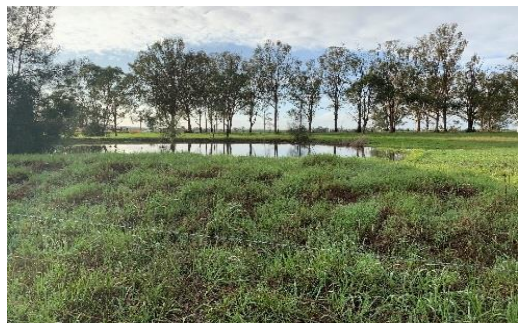
1M	4	Dam near bottom of mapped location of 1M, outside of accessible area. Dam nearing capacity and fringed by <i>Casuarina</i> sp.	<i>Porphyrio porphyrio</i> (Purple Swamphen) and <i>Litoria peronii</i> (Peron's Tree Frog).	No aquatic flora observed.

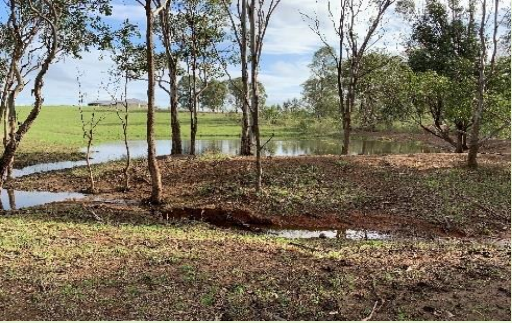
Reach	Dam number*	Description	Aquatic fauna observed	Aquatic flora observed	Representative photo
N/A		Dam within Lot 5 DP1216926, at base of grassy slope with cattle grazing on edges of dam. Dam overflowing to the south on day of survey, evidence of erosion in this area. Scattered <i>Eucalyptus</i> sp. around dam.	No aquatic fauna.	Floating macrophytes observed but species could not be identified due to access.

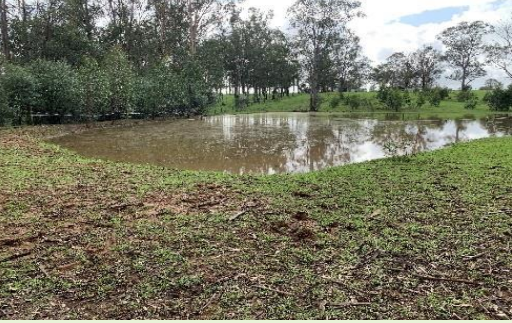
N/A		Dam located to south of driveway on Lot 6 DP 1216926. Not on a mapped watercourse, fenceline bisected dam with no fringing vegetation and a few scattered <i>Eucalyptus</i> sp. on western side of dam. Clay substrate with turbid water on day of survey.	No aquatic fauna.	No aquatic flora.	 
1J	1	No defined edges of dam and no defined channel upstream or downstream of dam. Turbid water observed and dam near capacity on day of site survey.	<i>Porphyrio porphyrio</i> (Purple Swamphen) and <i>Anas castanea</i> (Chestnut Teal).	<i>Lemna disperma</i> (Duckweed).

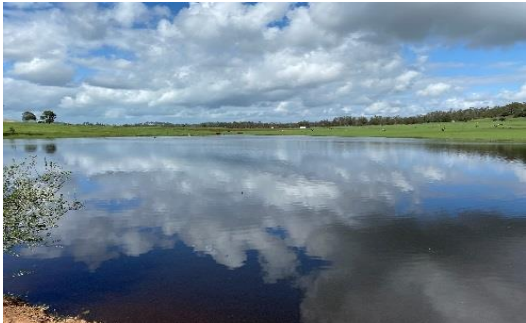
Reach	Dam number*	Description	Aquatic fauna observed	Aquatic flora observed	Representative photo
2B	1	<p>Large dam at capacity on day of site survey, overflowing at low point on north eastern side. No defined spillway. Visibility through the water column was approximately 0.5 m. The downstream edge of the dam had a few scattered <i>Olea europaea</i> subsp. <i>cuspidata</i>. There was no dense fringing vegetation around this dam. Cattle were in the south-western end of dam at time of site survey.</p>	<p><i>Cygnus atratus</i> (Black Swan), <i>Phalacrocorax sulcirostris</i> (Little Black Cormorant) and <i>Egretta novaehollandiae</i> (White-faced Heron).</p>	<p><i>Marsilea mutica</i> (Rainbow Nardoo), scattered sparse <i>Juncus usitatus</i>.</p>

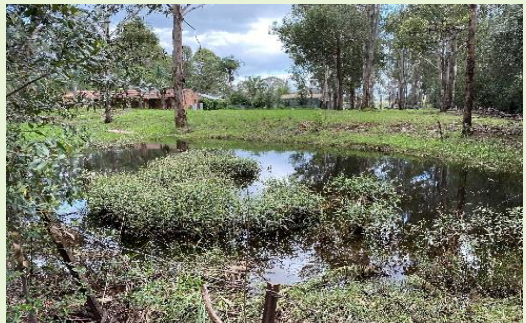
2B	2	<p>Small online dam within Lot 12 Section 8 DP2650. Good aquatic habitat, with emergent macrophytes present in dam.</p>	<p>No aquatic fauna observed.</p>	<p><i>Persicaria orientalis</i> (Slender Knotweed) and <i>Juncus usitatus</i>.</p>
