Report on
Preliminary Geotechnical and Salinity Assessment

Proposed Rezoning - Belmore Road Precinct
South Creek West, Bringelly, NSW

Prepared for
CKDI Bringelly Pty Ltd

Project 92336.04
September 2023

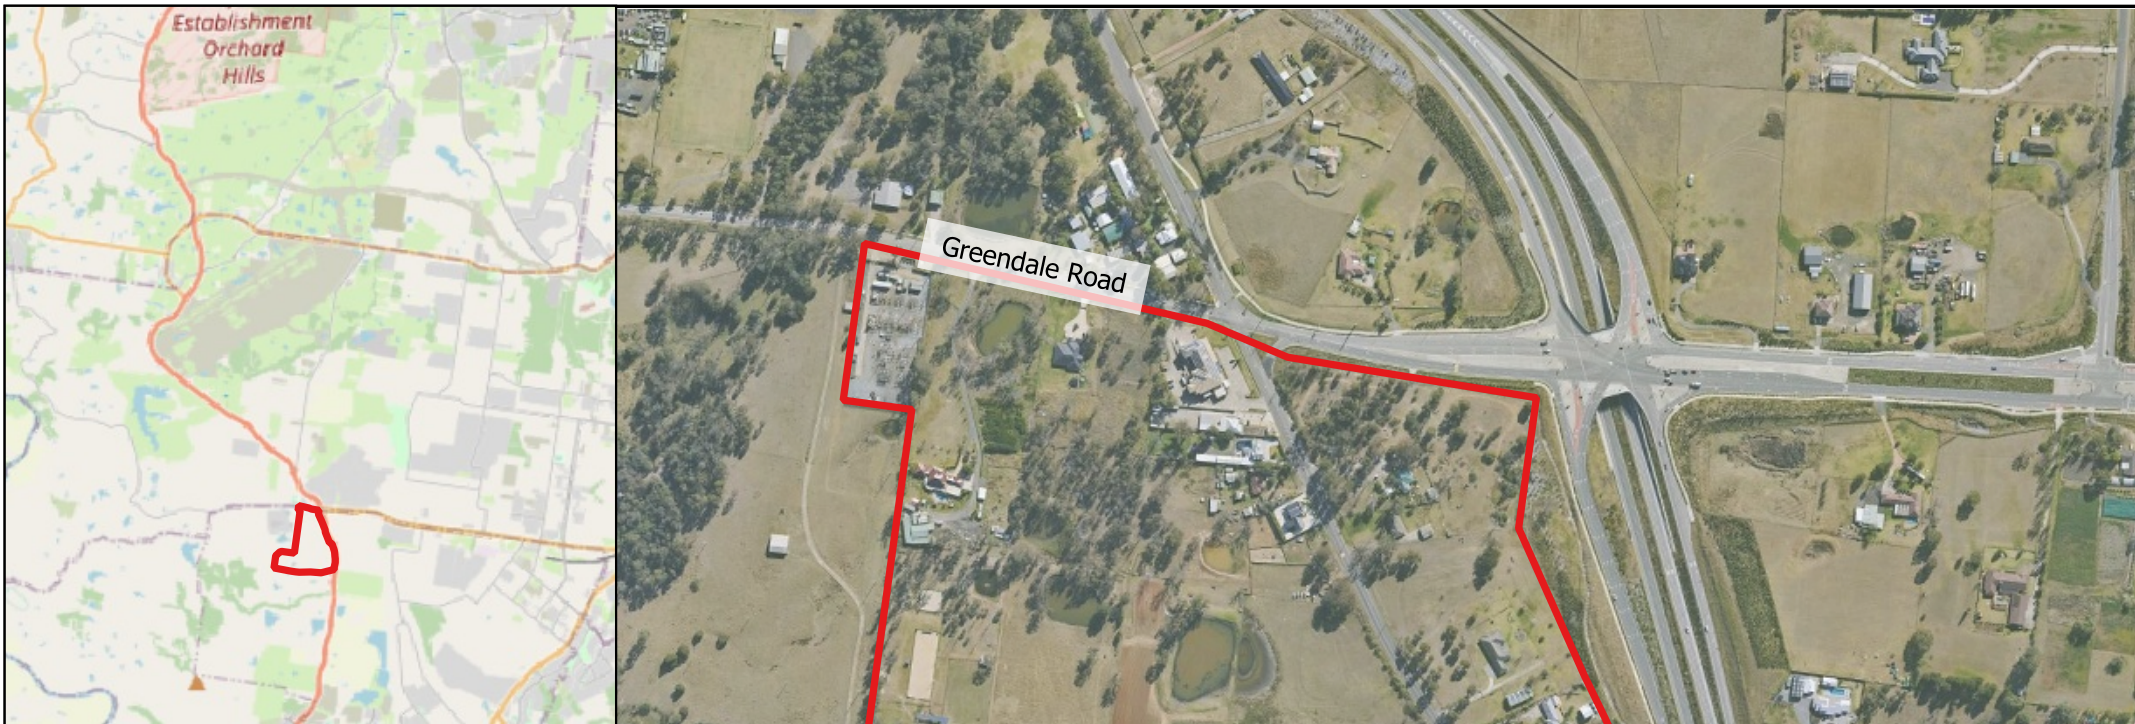
MGA	OFFICE: Macarthur
					DRAWN BY: L Clement
					DATE: 25/09/2023
					SCALE: As Shown
CLIENT: CKDI Bringelly Pty Ltd	PROJECT: 92336.04	DRAWING No: 1	REVISION: 1

- Site Boundary
- Borehole Locations
- Test Pit Locations

The site consists of 59 allotments (including Part Lots) comprising a total combined area of approximately 187 hectares with maximum north-south and east-west dimensions of 2100 m and 1700 m respectively. At the time of our investigation, the southern portion of the site was mostly covered with grass, with dense vegetation / trees present in areas that were mostly within the central and western parts of the site. Several farm dams were present scattered across the site. Residential dwellings and sheds were observed in the northern portion of the site, which has a fragmented land ownership. Several local roads are used to access these properties. The subject site is shown on Drawing 1 within Appendix C.
