Report on
Preliminary Site Investigation (Contamination)

Proposed Rezoning - Belmore Road Precinct
South Creek West, Bringelly, NSW

Prepared for
CKDI Pty Ltd

Project 92336.04
September 2023

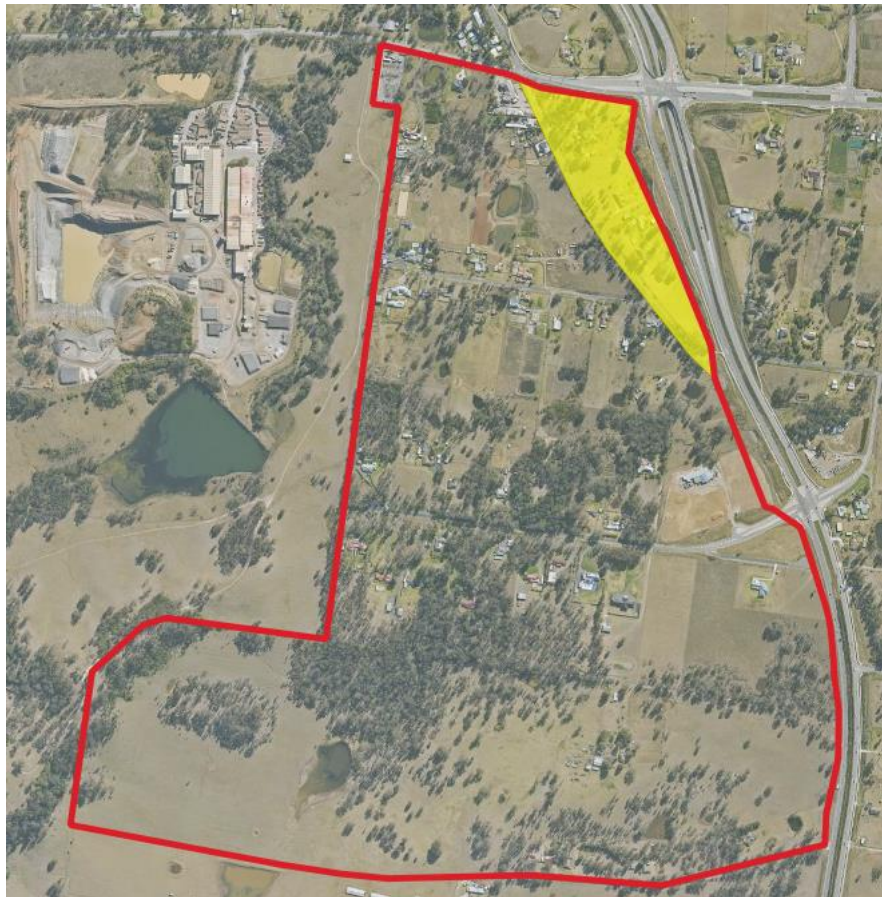
Figure 1: Revised site boundary (Red) and northeast portion not previously assessed (Yellow)

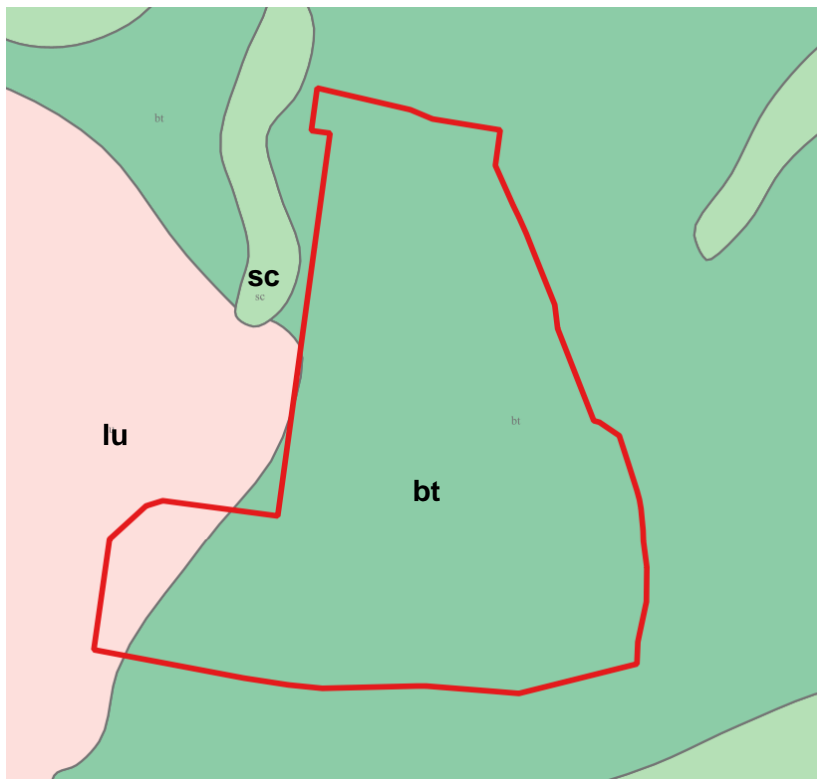
The Blacktown soil landscape is characterised by gently undulating rises on Wianamatta Group shales with slopes usually <5% and local relief to 30 m. Soils are shallow to moderately deep (<1.0 m) red and brown podzolic soils on crests, upper slopes and well drained areas, deep (1.5 - 3.0 m) yellow podzolic soils and soloths on lower slopes and in areas of poor drainage. Soils are moderately reactive with low fertility, poor soil drainage and highly plastic subsoil.

The Luddenham soil landscape is characterised by undulating to rolling low hills on Wianamatta Group shales with slopes usually 5% to 20% and local relief of 50 m to 80 m. Soils are shallow to moderately deep (<1.0 m) dark or red podzolic soils on crests and upper slopes and moderately deep (<1.5 m) yellow podzolic soils on lower slopes and drainage lines. Soils are moderately reactive with a high erosion hazard.

Figure 3: Penrith 1:100,000 Soils Landscape Sheet.

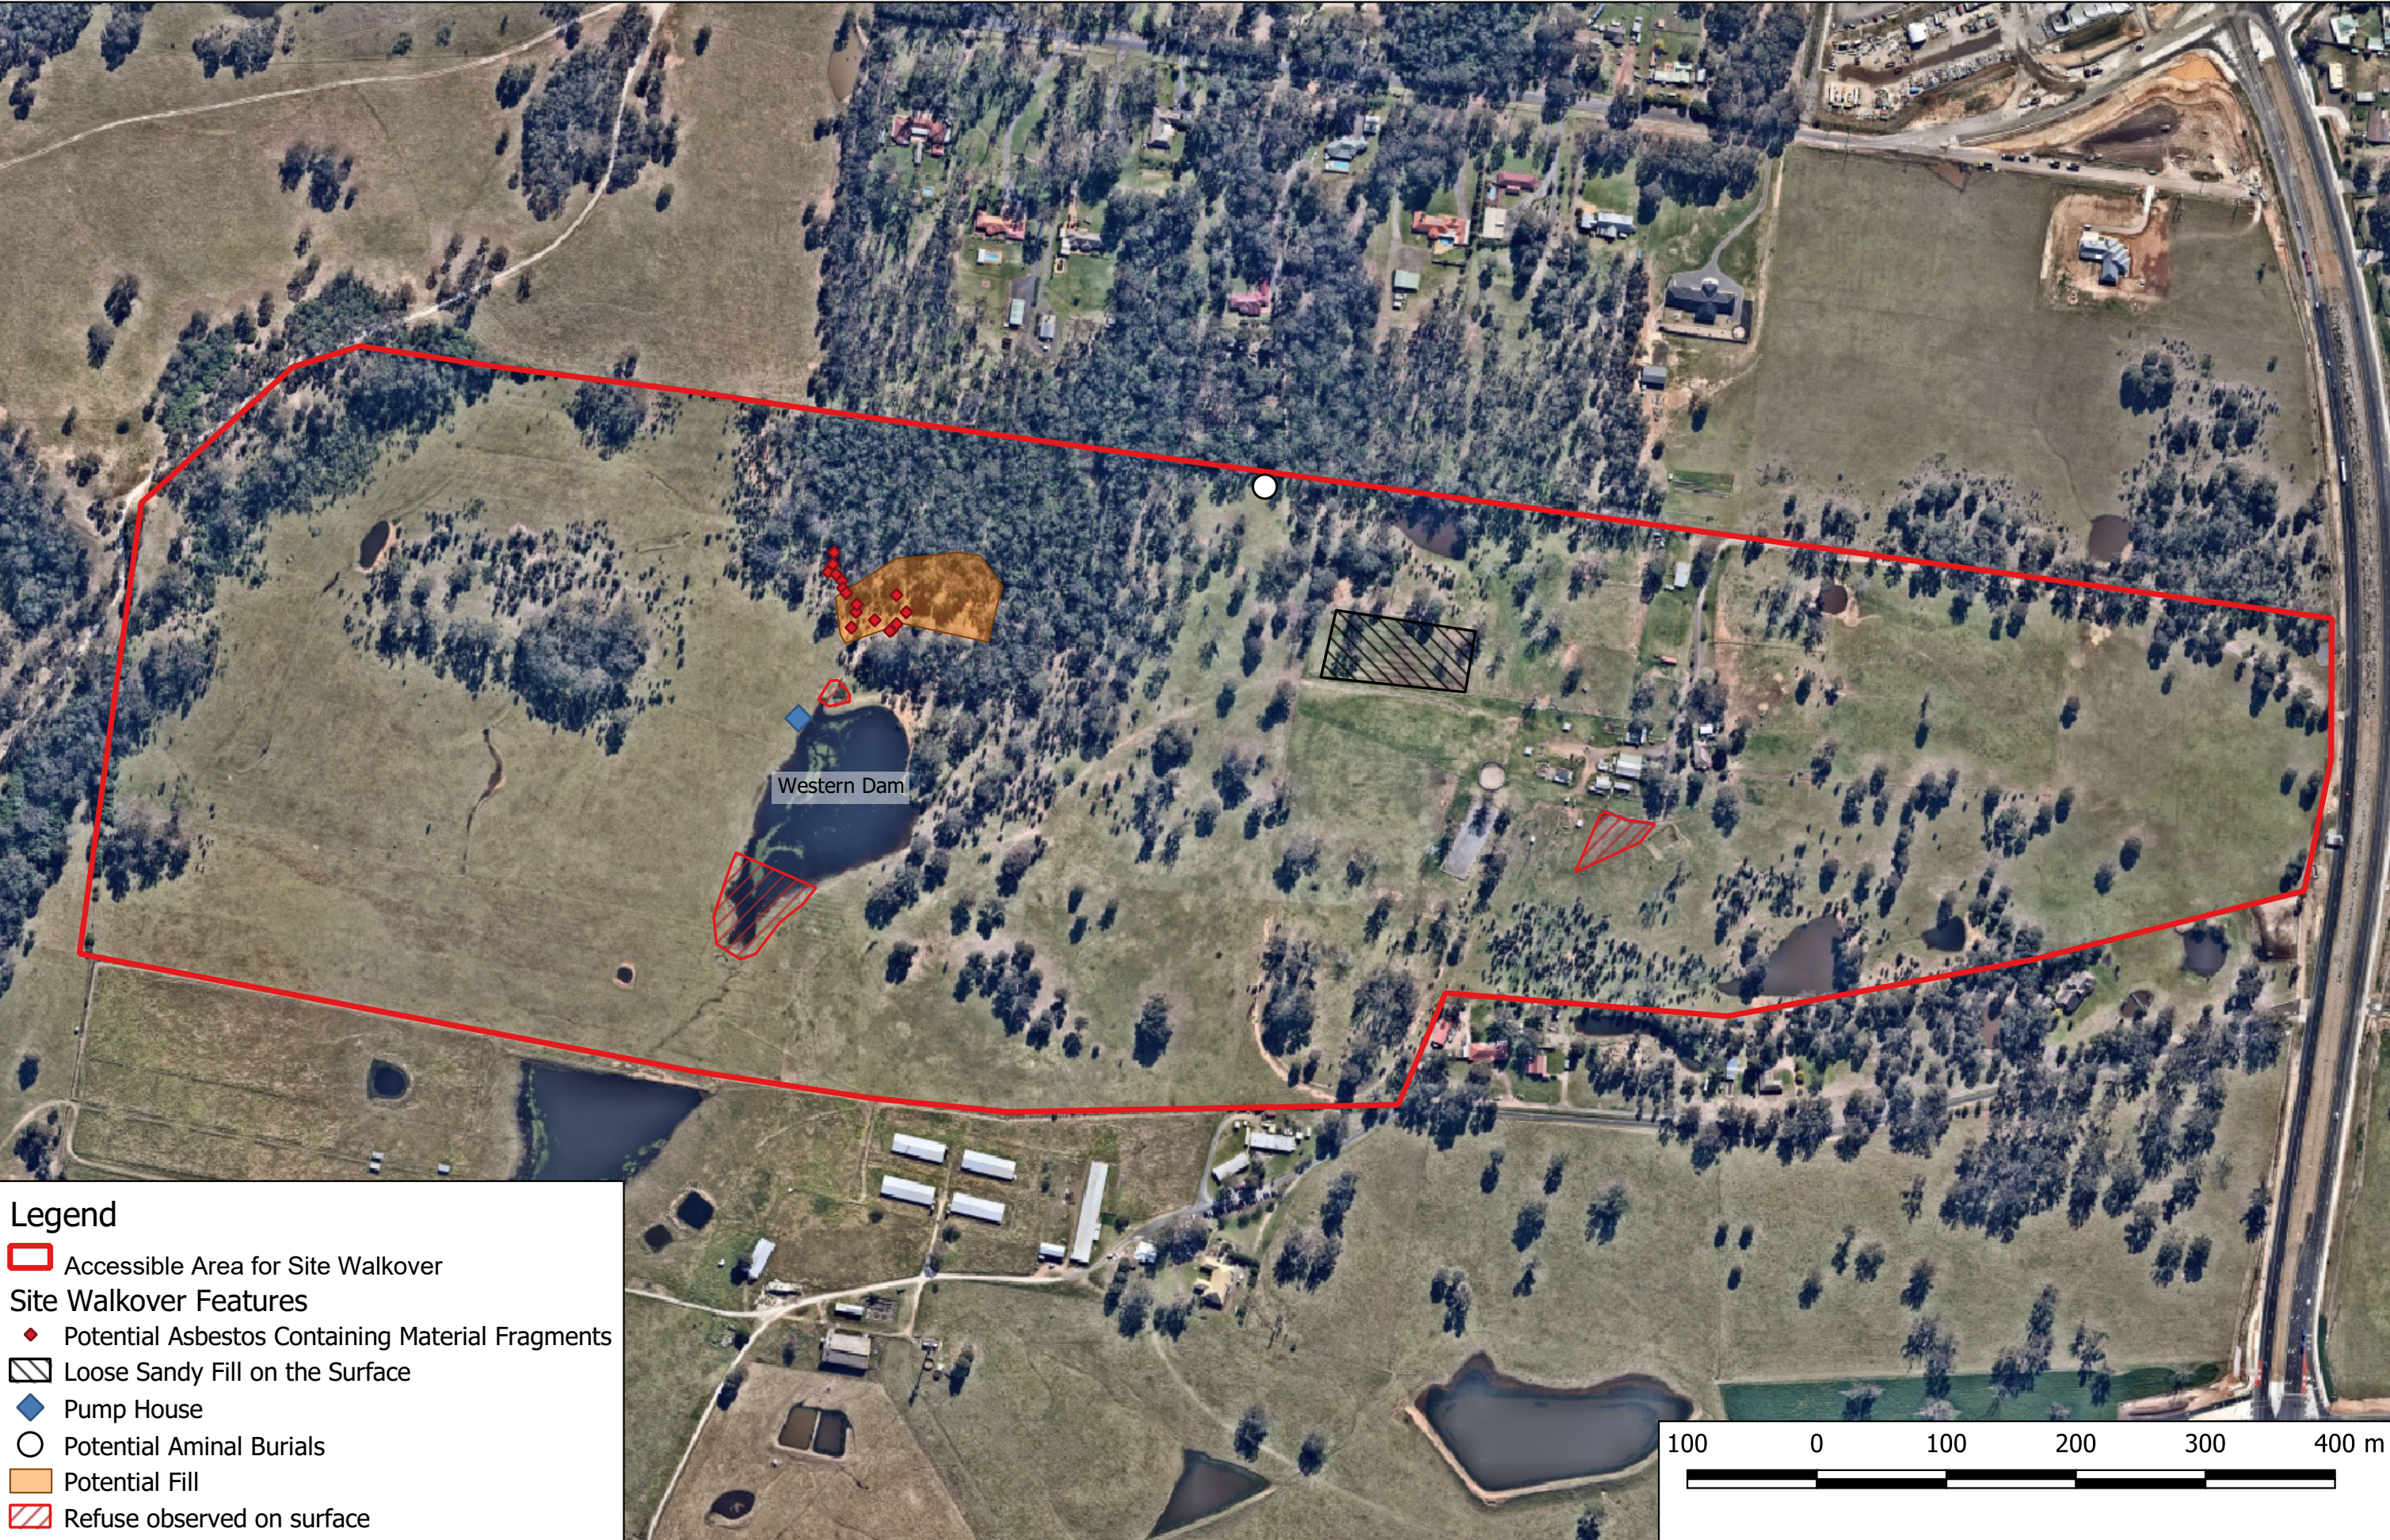
A site walkover was undertaken only at Lot 6 of Deposited Plan 1216926, as at the time of field work was the only accessible part of the site. The site walkover was conducted by an environmental engineer on 14, 28 and 30 January 2020. The general site topography was consistent with that described in Section 4. The site layout appears to have remained unchanged from the latest aerial photograph. The following key site features pertinent to the PSI were observed (refer to photographs in Appendix E and Drawing 3 in Appendix A).

- Accessible Area for Site Walkover
- Site Walkover Features
 - Potential Asbestos Containing Material Fragments
 - Loose Sandy Fill on the Surface
 - Pump House
 - Potential Aimal Burials
 - Potential Fill
 - Refuse observed on surface

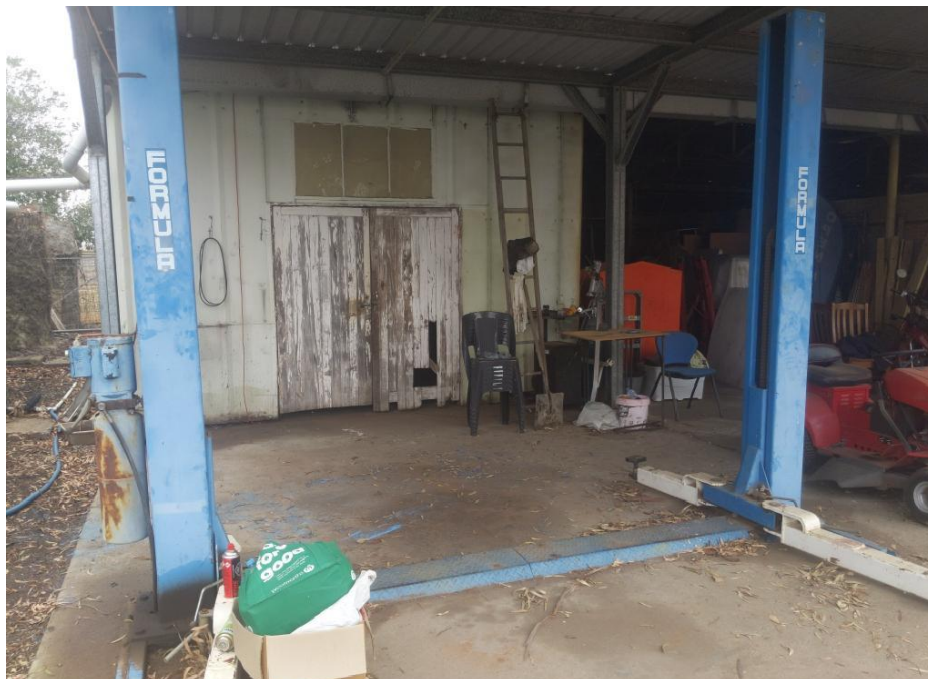
- A garage appears to be used for motor vehicle repair with a hydraulic vehicle inspection lift and some chemical storage (Photograph 4 and 5);
- Timber power poles were used in the supply of electricity to the buildings (Photograph 6);

Photo 4 : Hydraulic car jack in front of building clad with fibro cement sheeting

A hazardous building survey is also recommended to identify any hazardous building materials prior to any maintenance, demolition, or site redevelopment. Demolition of structures containing hazardous materials should be carried out by a licenced asbestos removal contractor.

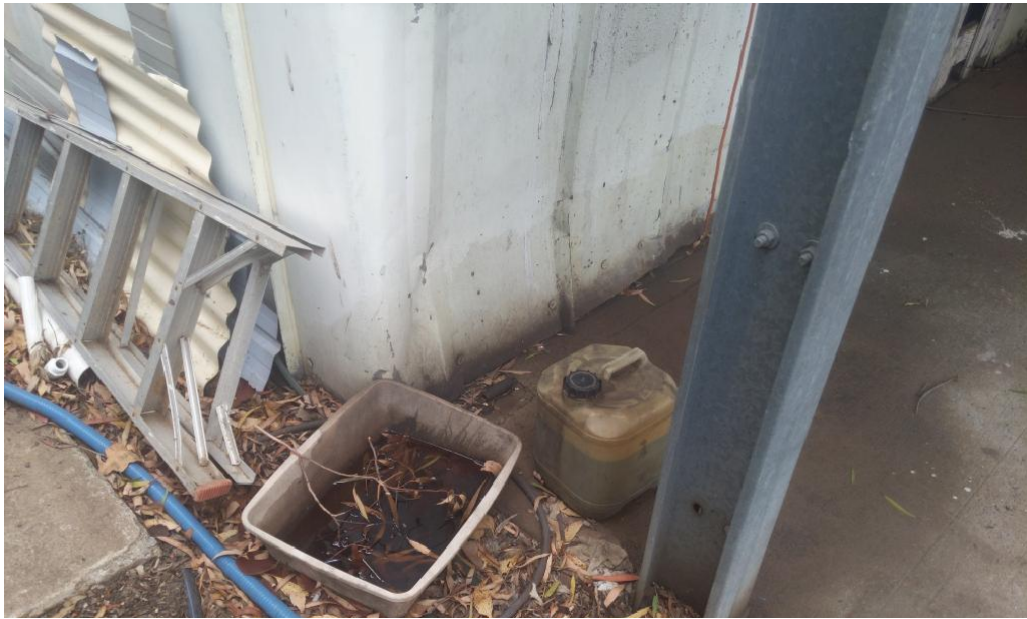
Photo 5 : Chemicals stored near hydraulic car jack

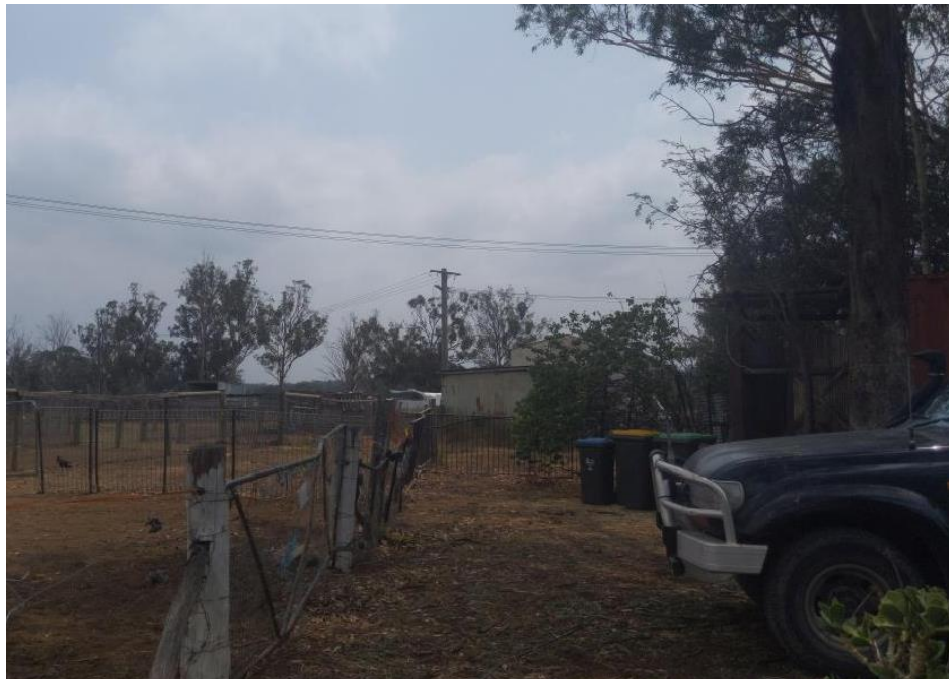
Photo 6 : Timber power poles

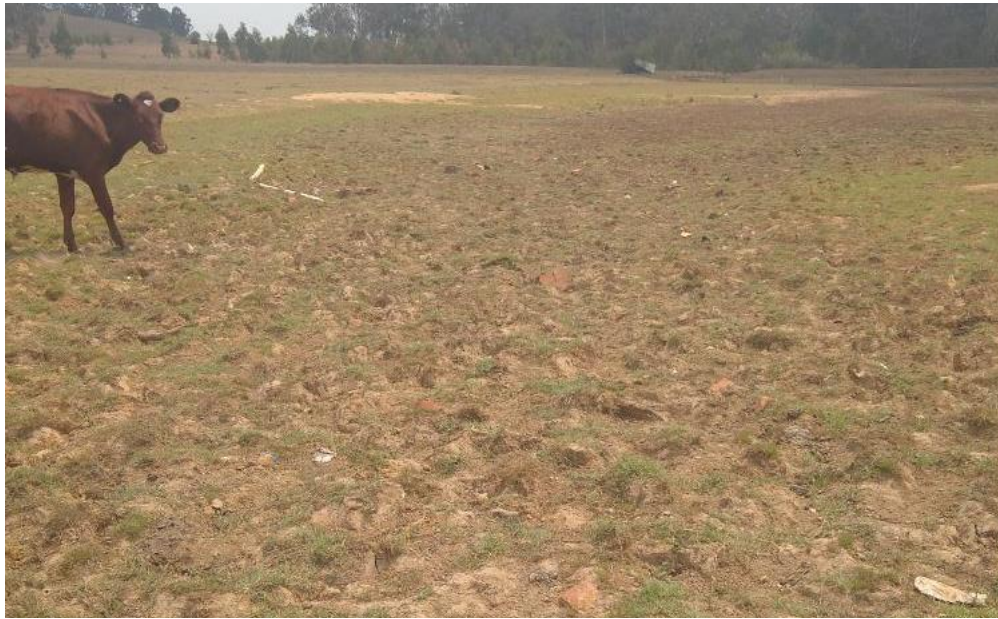
- General rubble including bricks, terracotta, wood and concrete was observed on the exposed earth surface to the south of the properties in the central portion of the site (Photograph 7) and surrounding the western dam (Photograph 8). See Drawing 3, Appendix A;

Photo 7 : Rubble observed on the surface

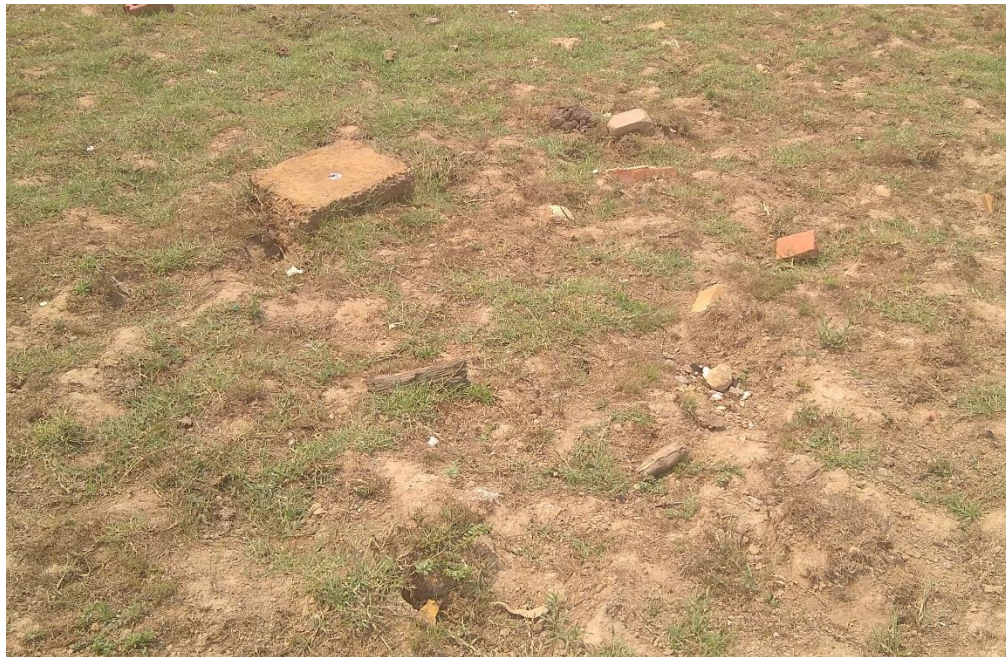
Photo 8 : Rubble observed on surface near the western dam

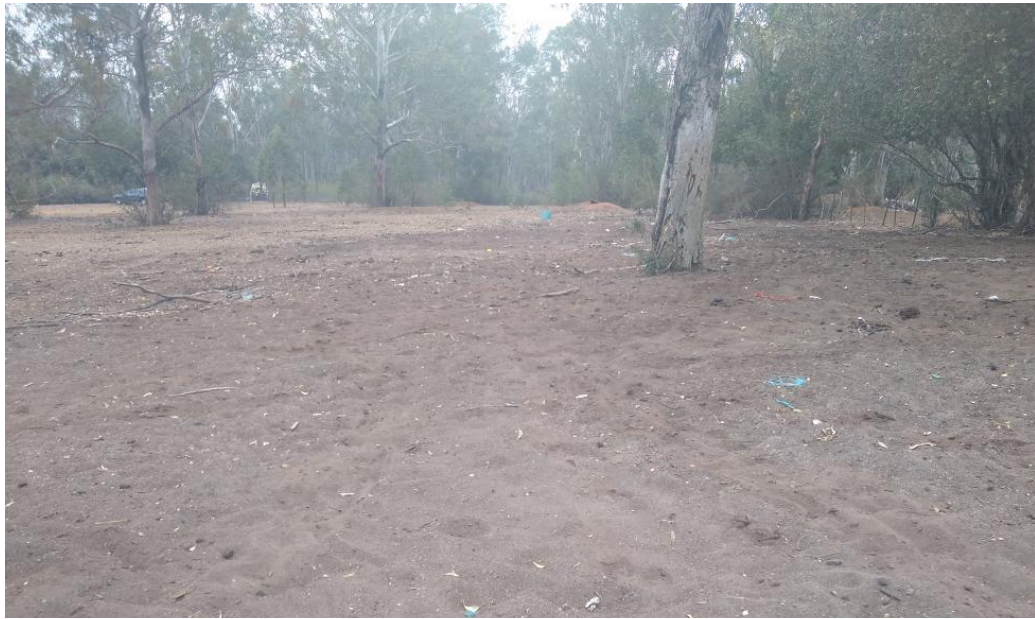
- A paddock was observed to contain loose sandy dark soil on the surface (Photograph 9 and Drawing 3);
- A pump house was observed adjacent to the western dam (Photograph 10 and Drawing 3);

Photo 9 : Loose sandy dark soil

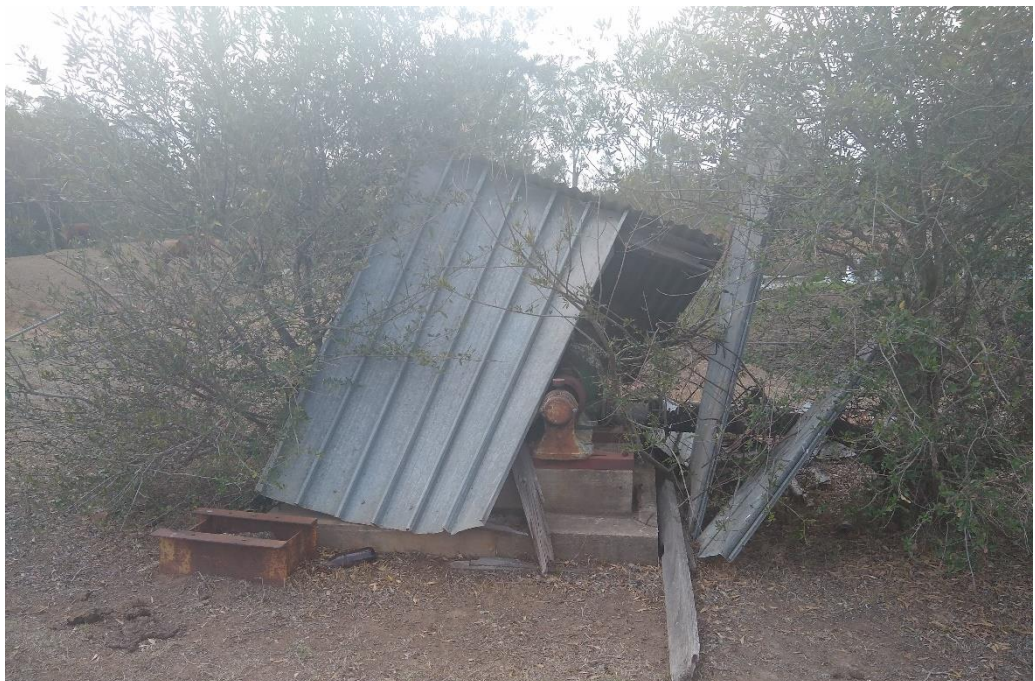
Photo 10 : Diesel pump house

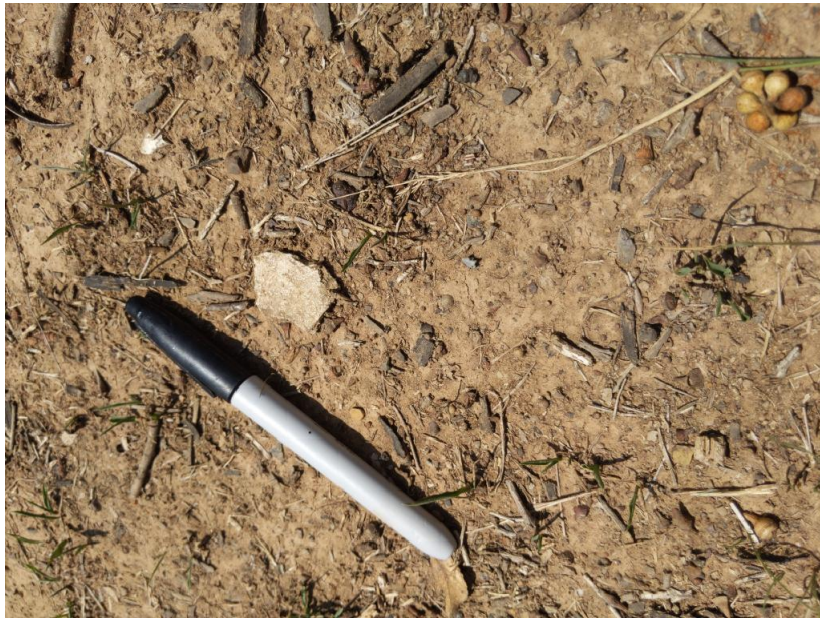
- Numerous potential Asbestos Containing Material (ACM) Fragments were observed north of the large dam on the western portion of the site (Photographs 11 and 12 and Drawing 3);

4	Site Walkover	Asbestos impacted fill	In Lot 6 of Deposited Plan 1216926, an area north of the western dam was observed to contain numerous fragments of potential ACM on the surface, with the surrounding soil suspected to be fill.
5	Site Walkover	Timber Power Poles	Timber power poles were observed providing electricity to several properties on the site.
6	Site Walkover	Animal burial	Potential horse or cattle burial was noted in Lot 6 of Deposited Plan 1216926 on the southern boundary during a site walkover, as indicated by a series of clustered mounds.
7	Aerial imagery	Substation site	The Endeavour Energy Bringelly Substation (Lot 10/1125892 and 1/733115) site appeared between 1986 and 1998. It has expanded progressively and now appears to sit entirely on hardstand.
8	Aerial imagery	Site Compound and carpark	The site compound and carpark first appeared in the aerial imagery in April 2018 and appears to started to be decommissioned, but not complete, between March 2023 and August 2023.

Photo 11 : Potential ACM

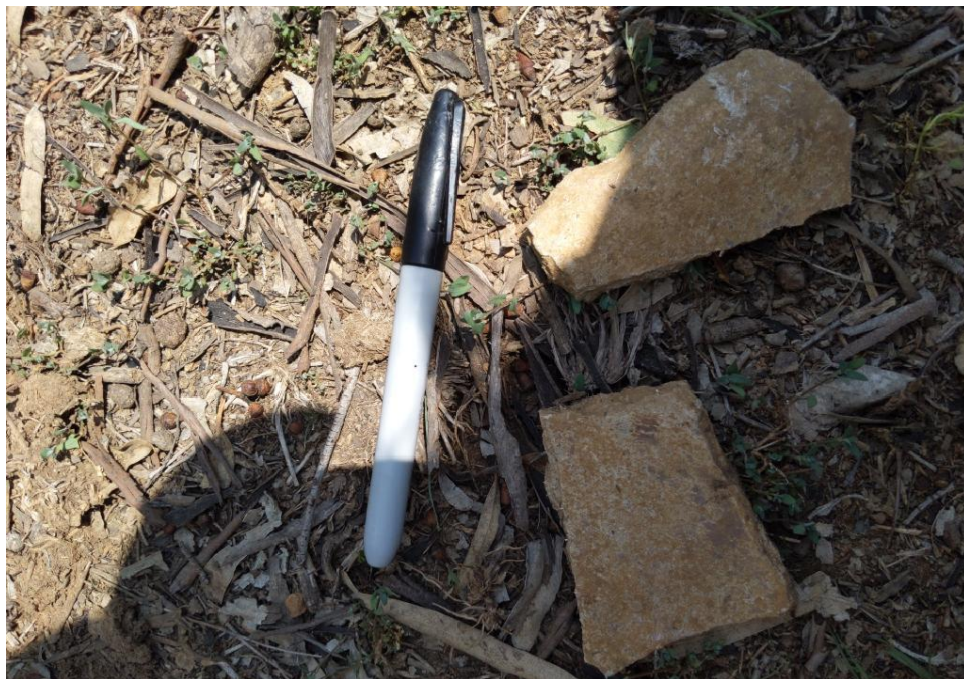
Photo 12 : Potential PACM

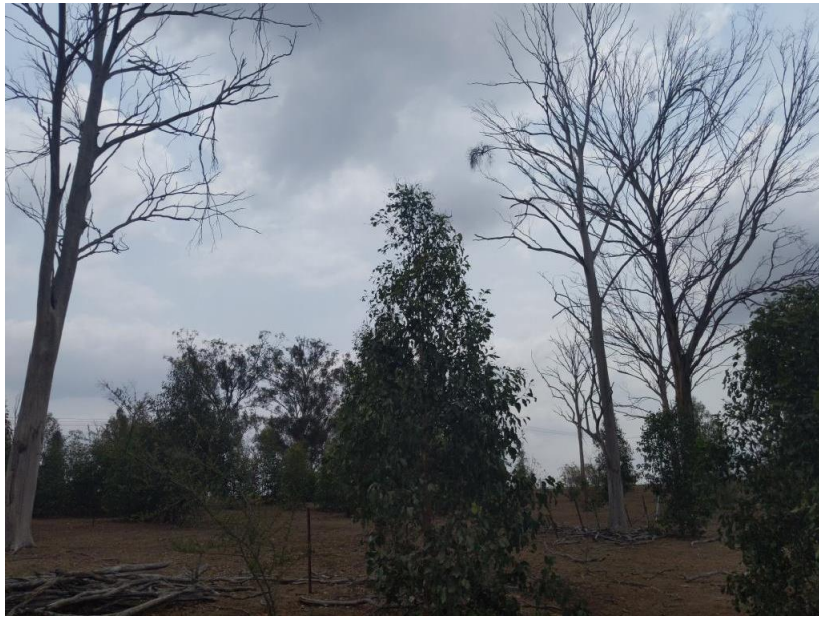
- The areas surrounding the potential ACM were observed to be potentially fill;
- A number of dead mature trees were observed on the southern boundary (Photograph 13);

Photo 13 : Dead mature tree

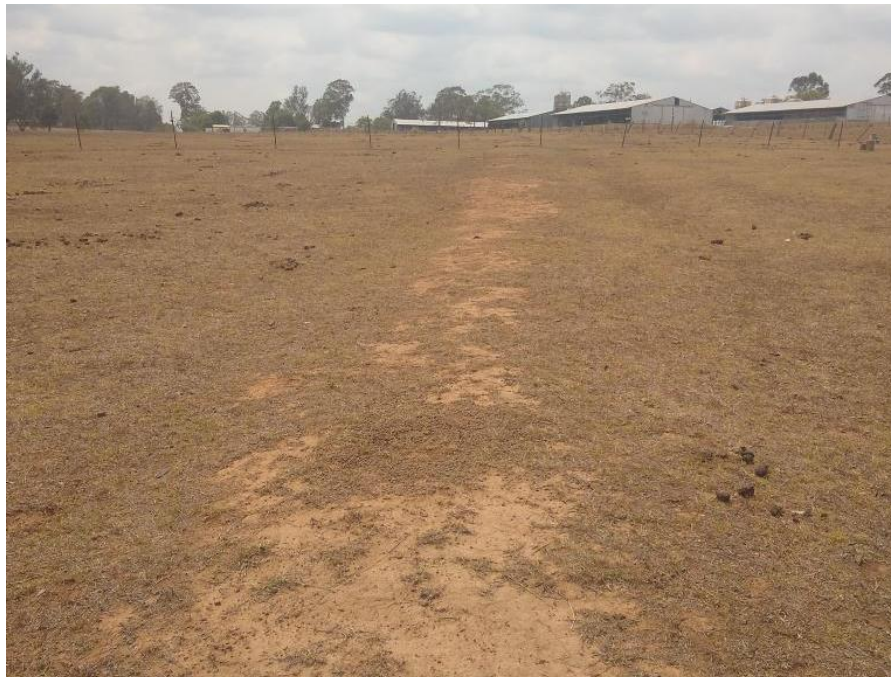
- A potential buried service was noted on the southern boundary (Photograph 14); and
- Potential horse/cattle burial pits were observed on the northern boundary (Photograph 15 and Drawing 3).

Photo 14 : Potential buried service

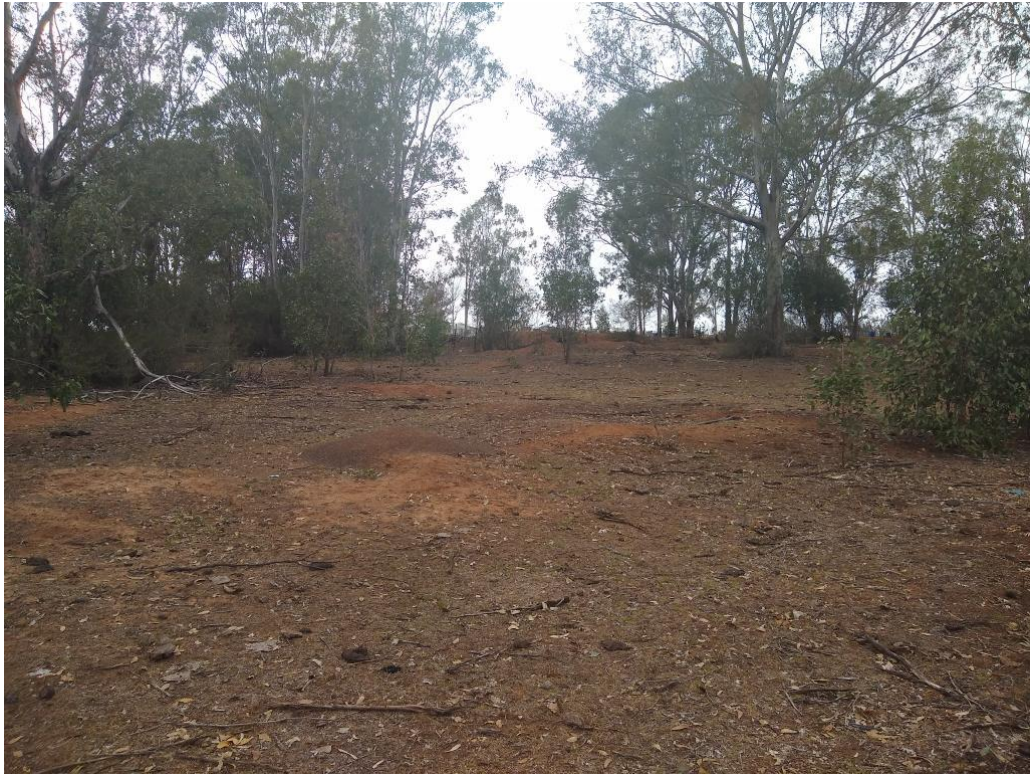
Photo 15 : Potential animal burials
