**Goulburn Mulwaree Council**  
**184-194 Bourke Street**  
**Goulburn NSW 2580**

**Project 94319.02**  
**1 October 2020**  
**R.001.Rev0**  
**PJS**

**Additional Excavated Natural Material Assessment**  
**Proposed Site Development**  
**20-24 Lockyer Street, (Lot 2, DP1238241), Goulburn**

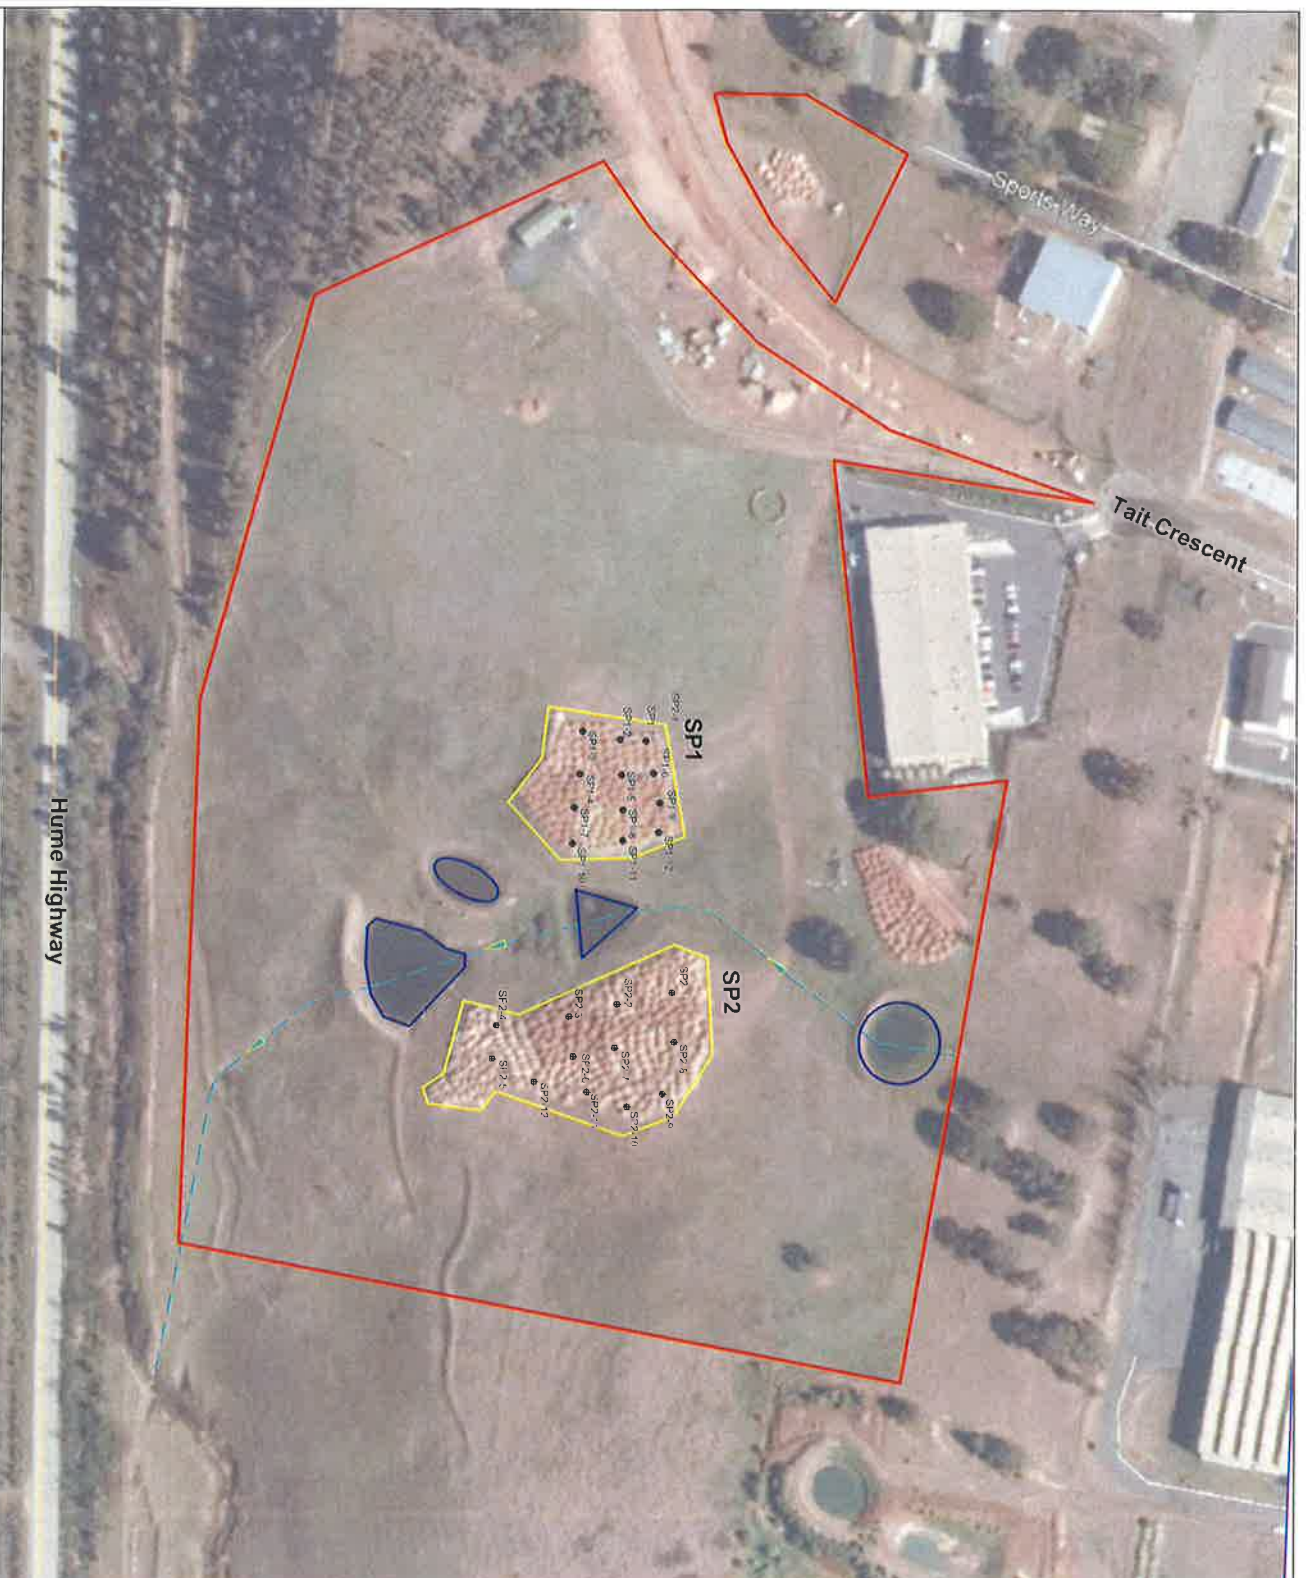
Stockpile SP2 is the subject of this assessment. The stockpile is located in the central portion of the site, to the east of a series of dams.

The stockpile is large and graded so that there are no steep sides. The stockpile is irregularly shaped with maximum dimensions of 120 m long and 60 m wide and a maximum height of approximately 1.5 m. Towards the south of the stockpile, the height is approximately 1.5 m. The area where unsuitable material was identified was in the vicinity of test pit SP2-4, located in the south-western part of the stockpile.

The site location, stockpile location and site layout are presented in Drawing 1, Appendix B.

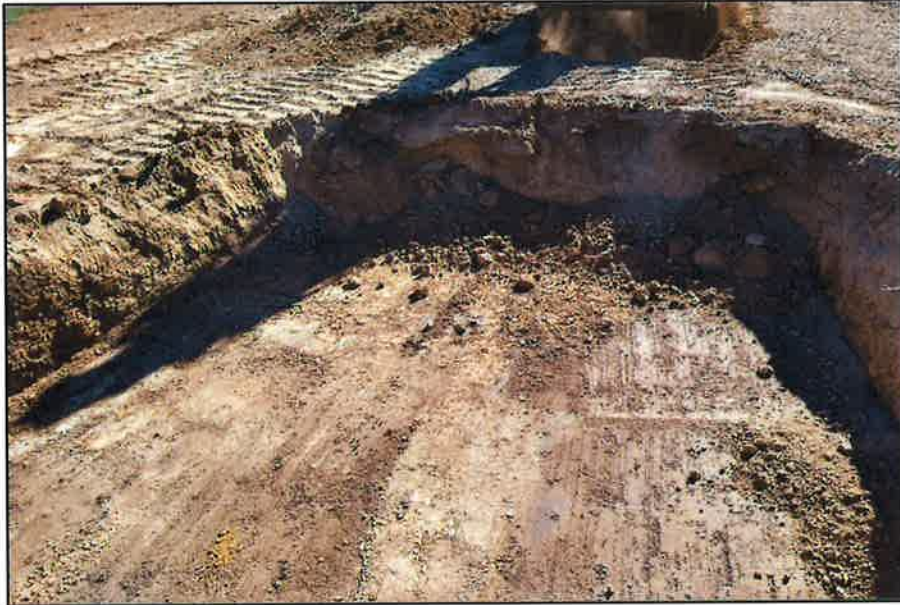
**Photo 1: View of excavation extent**

Observations made during the excavation indicated that little to no foreign material was observed in the sides and base of the resulting excavation.
