**310 MOAMA STREET
HAY NSW 2711**

**PRELIMINARY SITE
INVESTIGATION**

**FOR THE REZONING OF LAND
FOR A PROPOSED UNMANNED
REFUELLING FACILITY**

REPORT NO: 9404

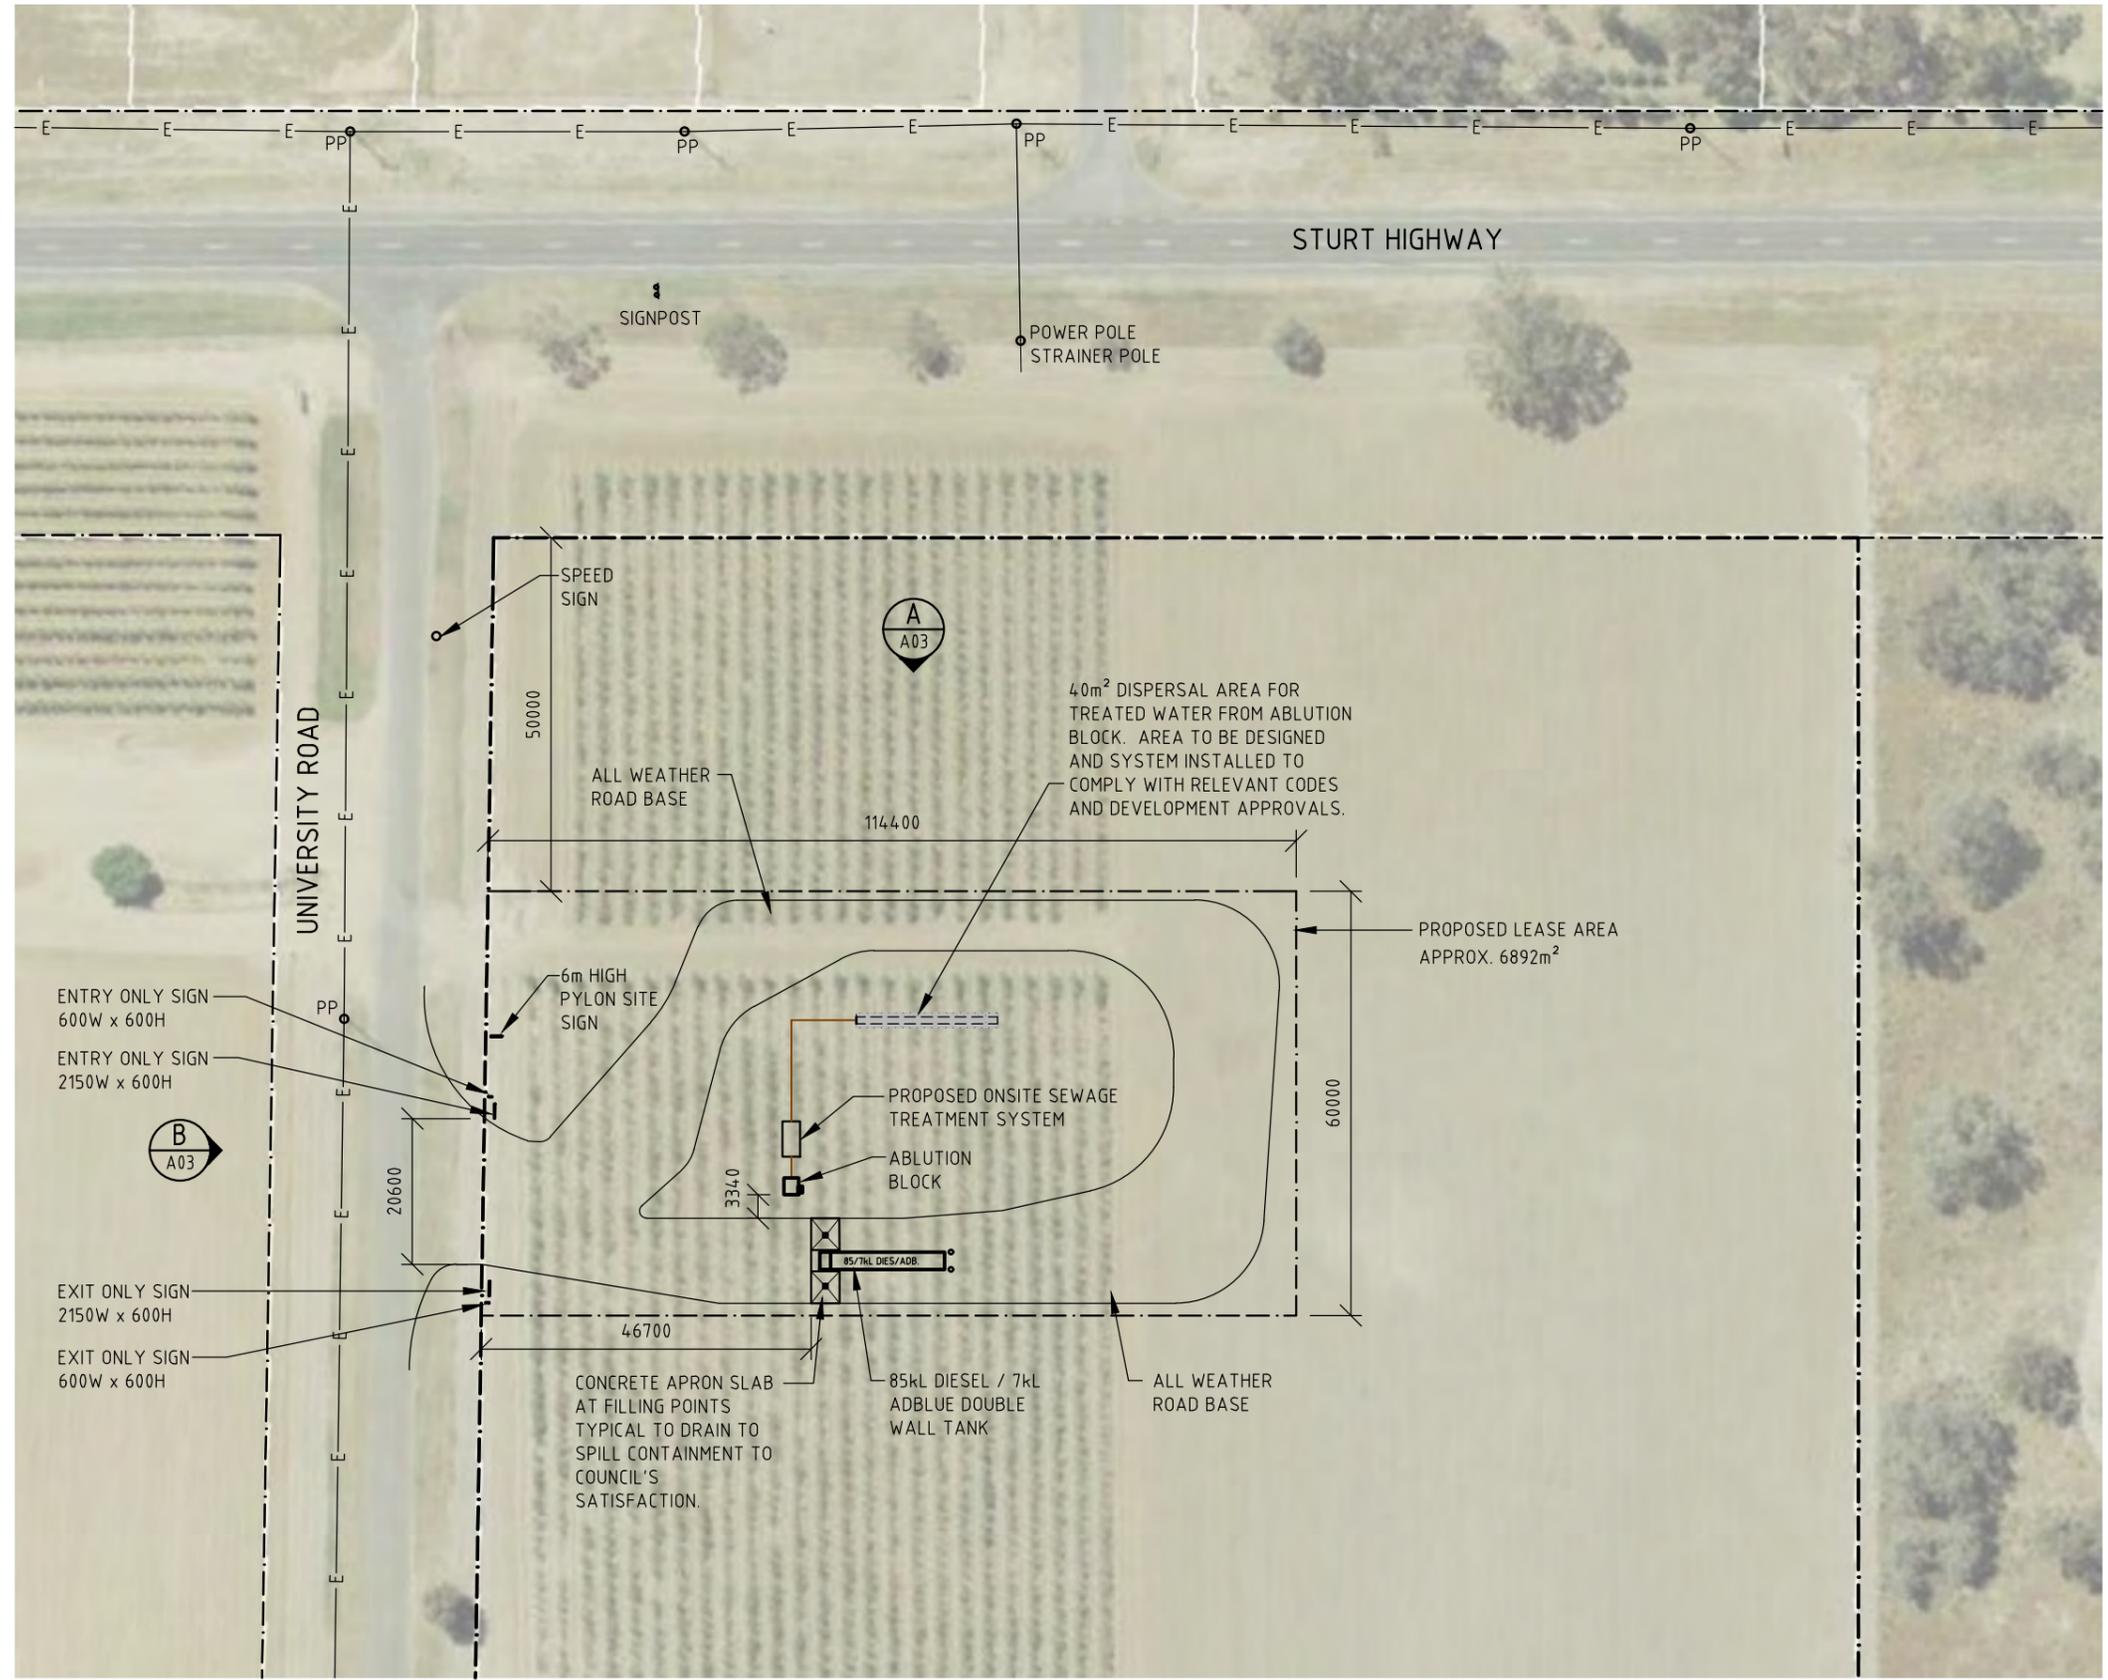
title				
PROPOSED SITE LAYOUT				
drawn DGC	approved 	date created 21.11.19	A1 scale	A3 scale 1:1000
status PRELIMINARY		drawing no. 19297-HAY-D01	rev 1

R.P.D.
 LOT 2
 DP1212081
 AREA APPROX 42,055m²

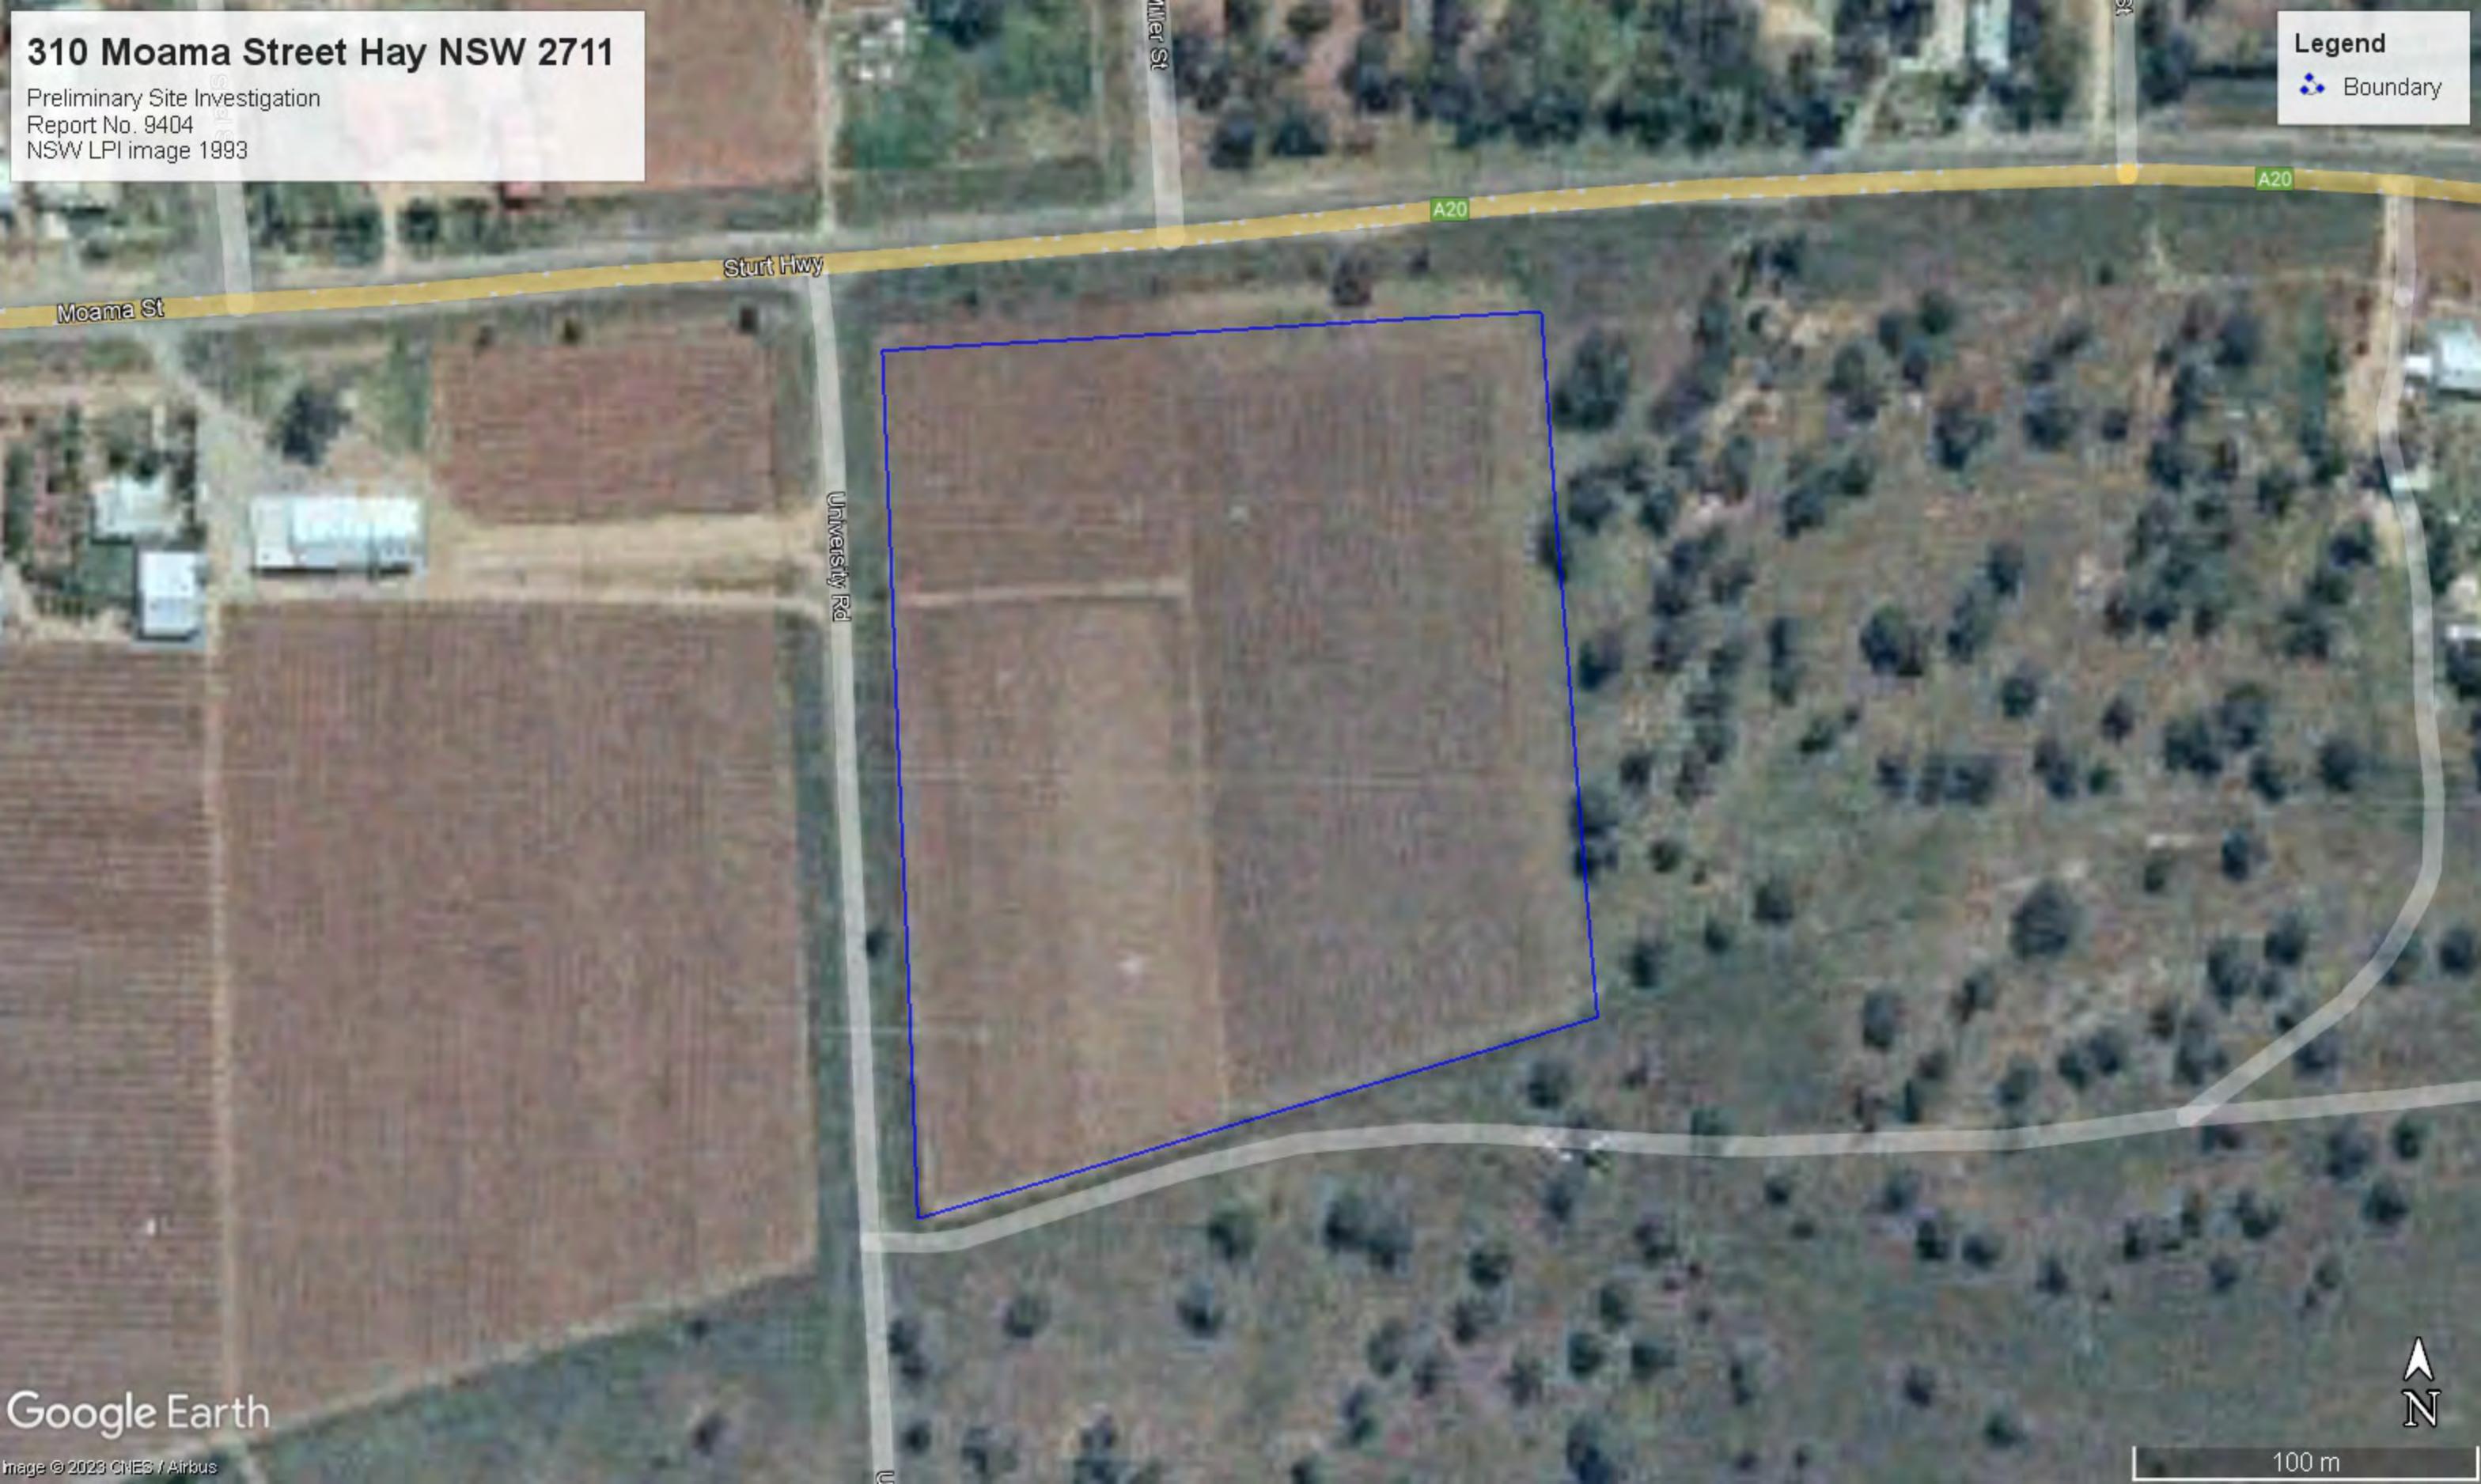
Preliminary Site Investigation
Report No. 9404
NSW LPI image 1993

1993 – The site has been divided into three paddocks with access via University Road to the west.

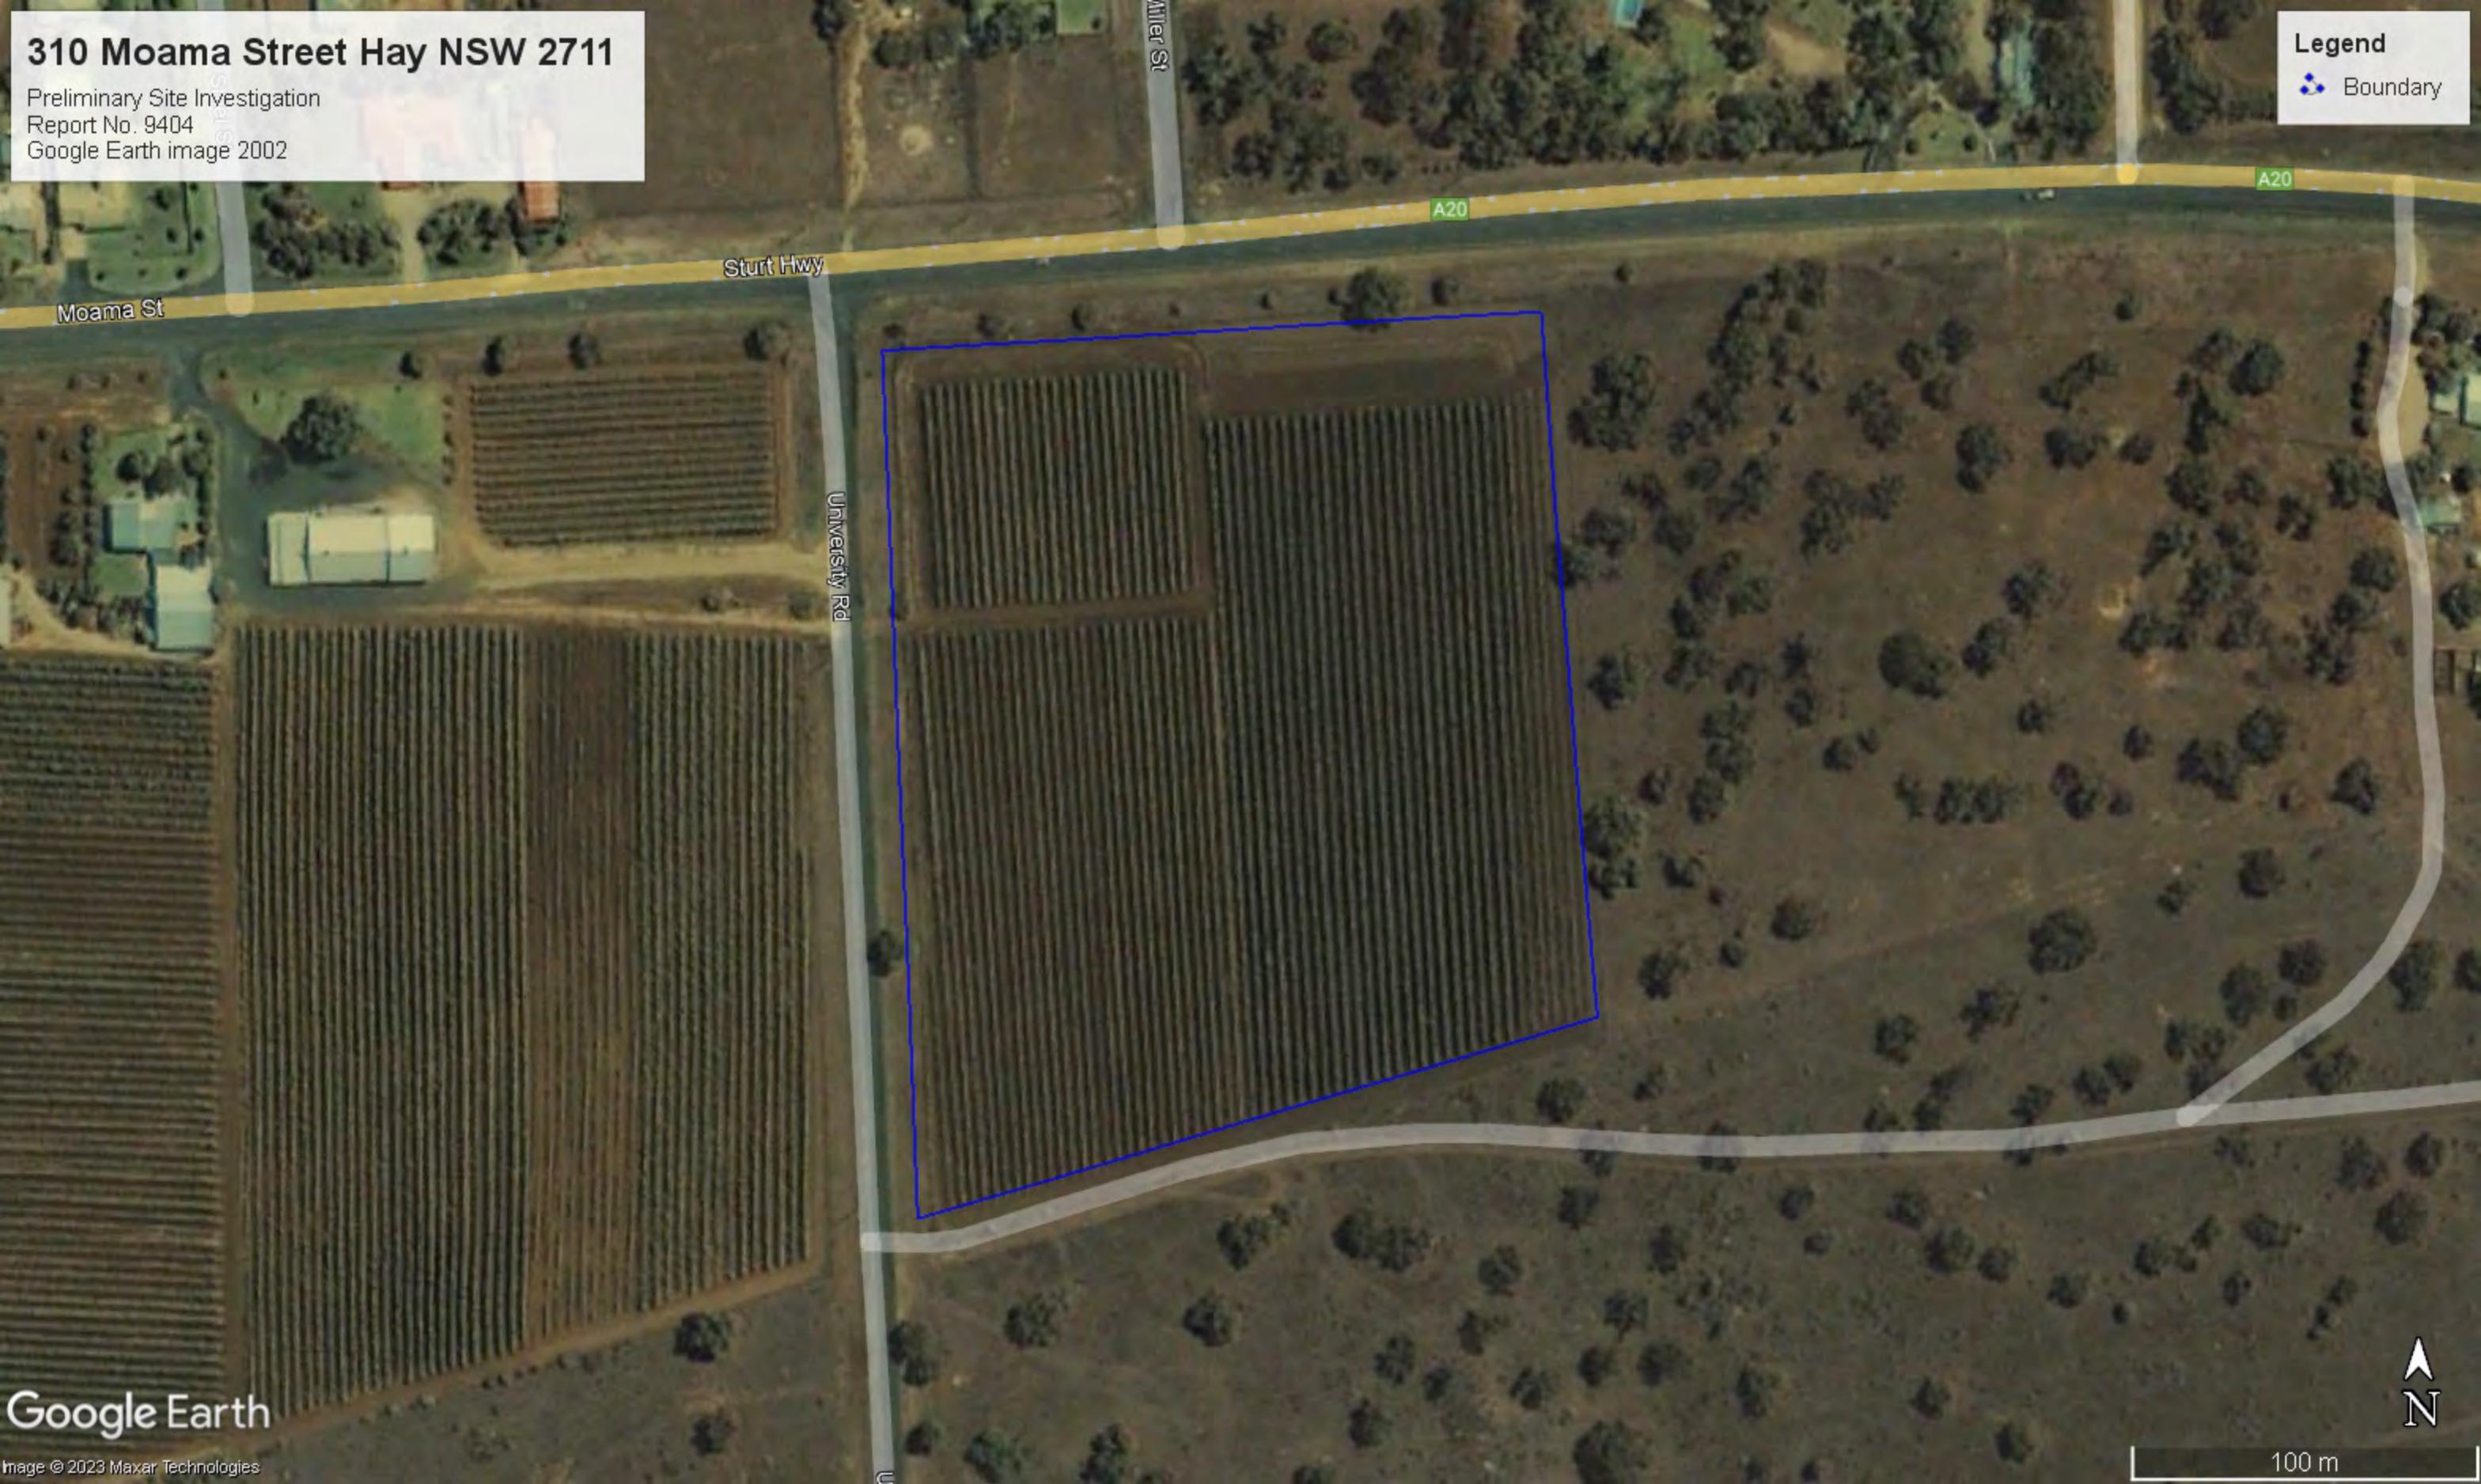
Preliminary Site Investigation
Report No. 9404
Google Earth image 2002

2002 – The whole site has been established as a vineyard.

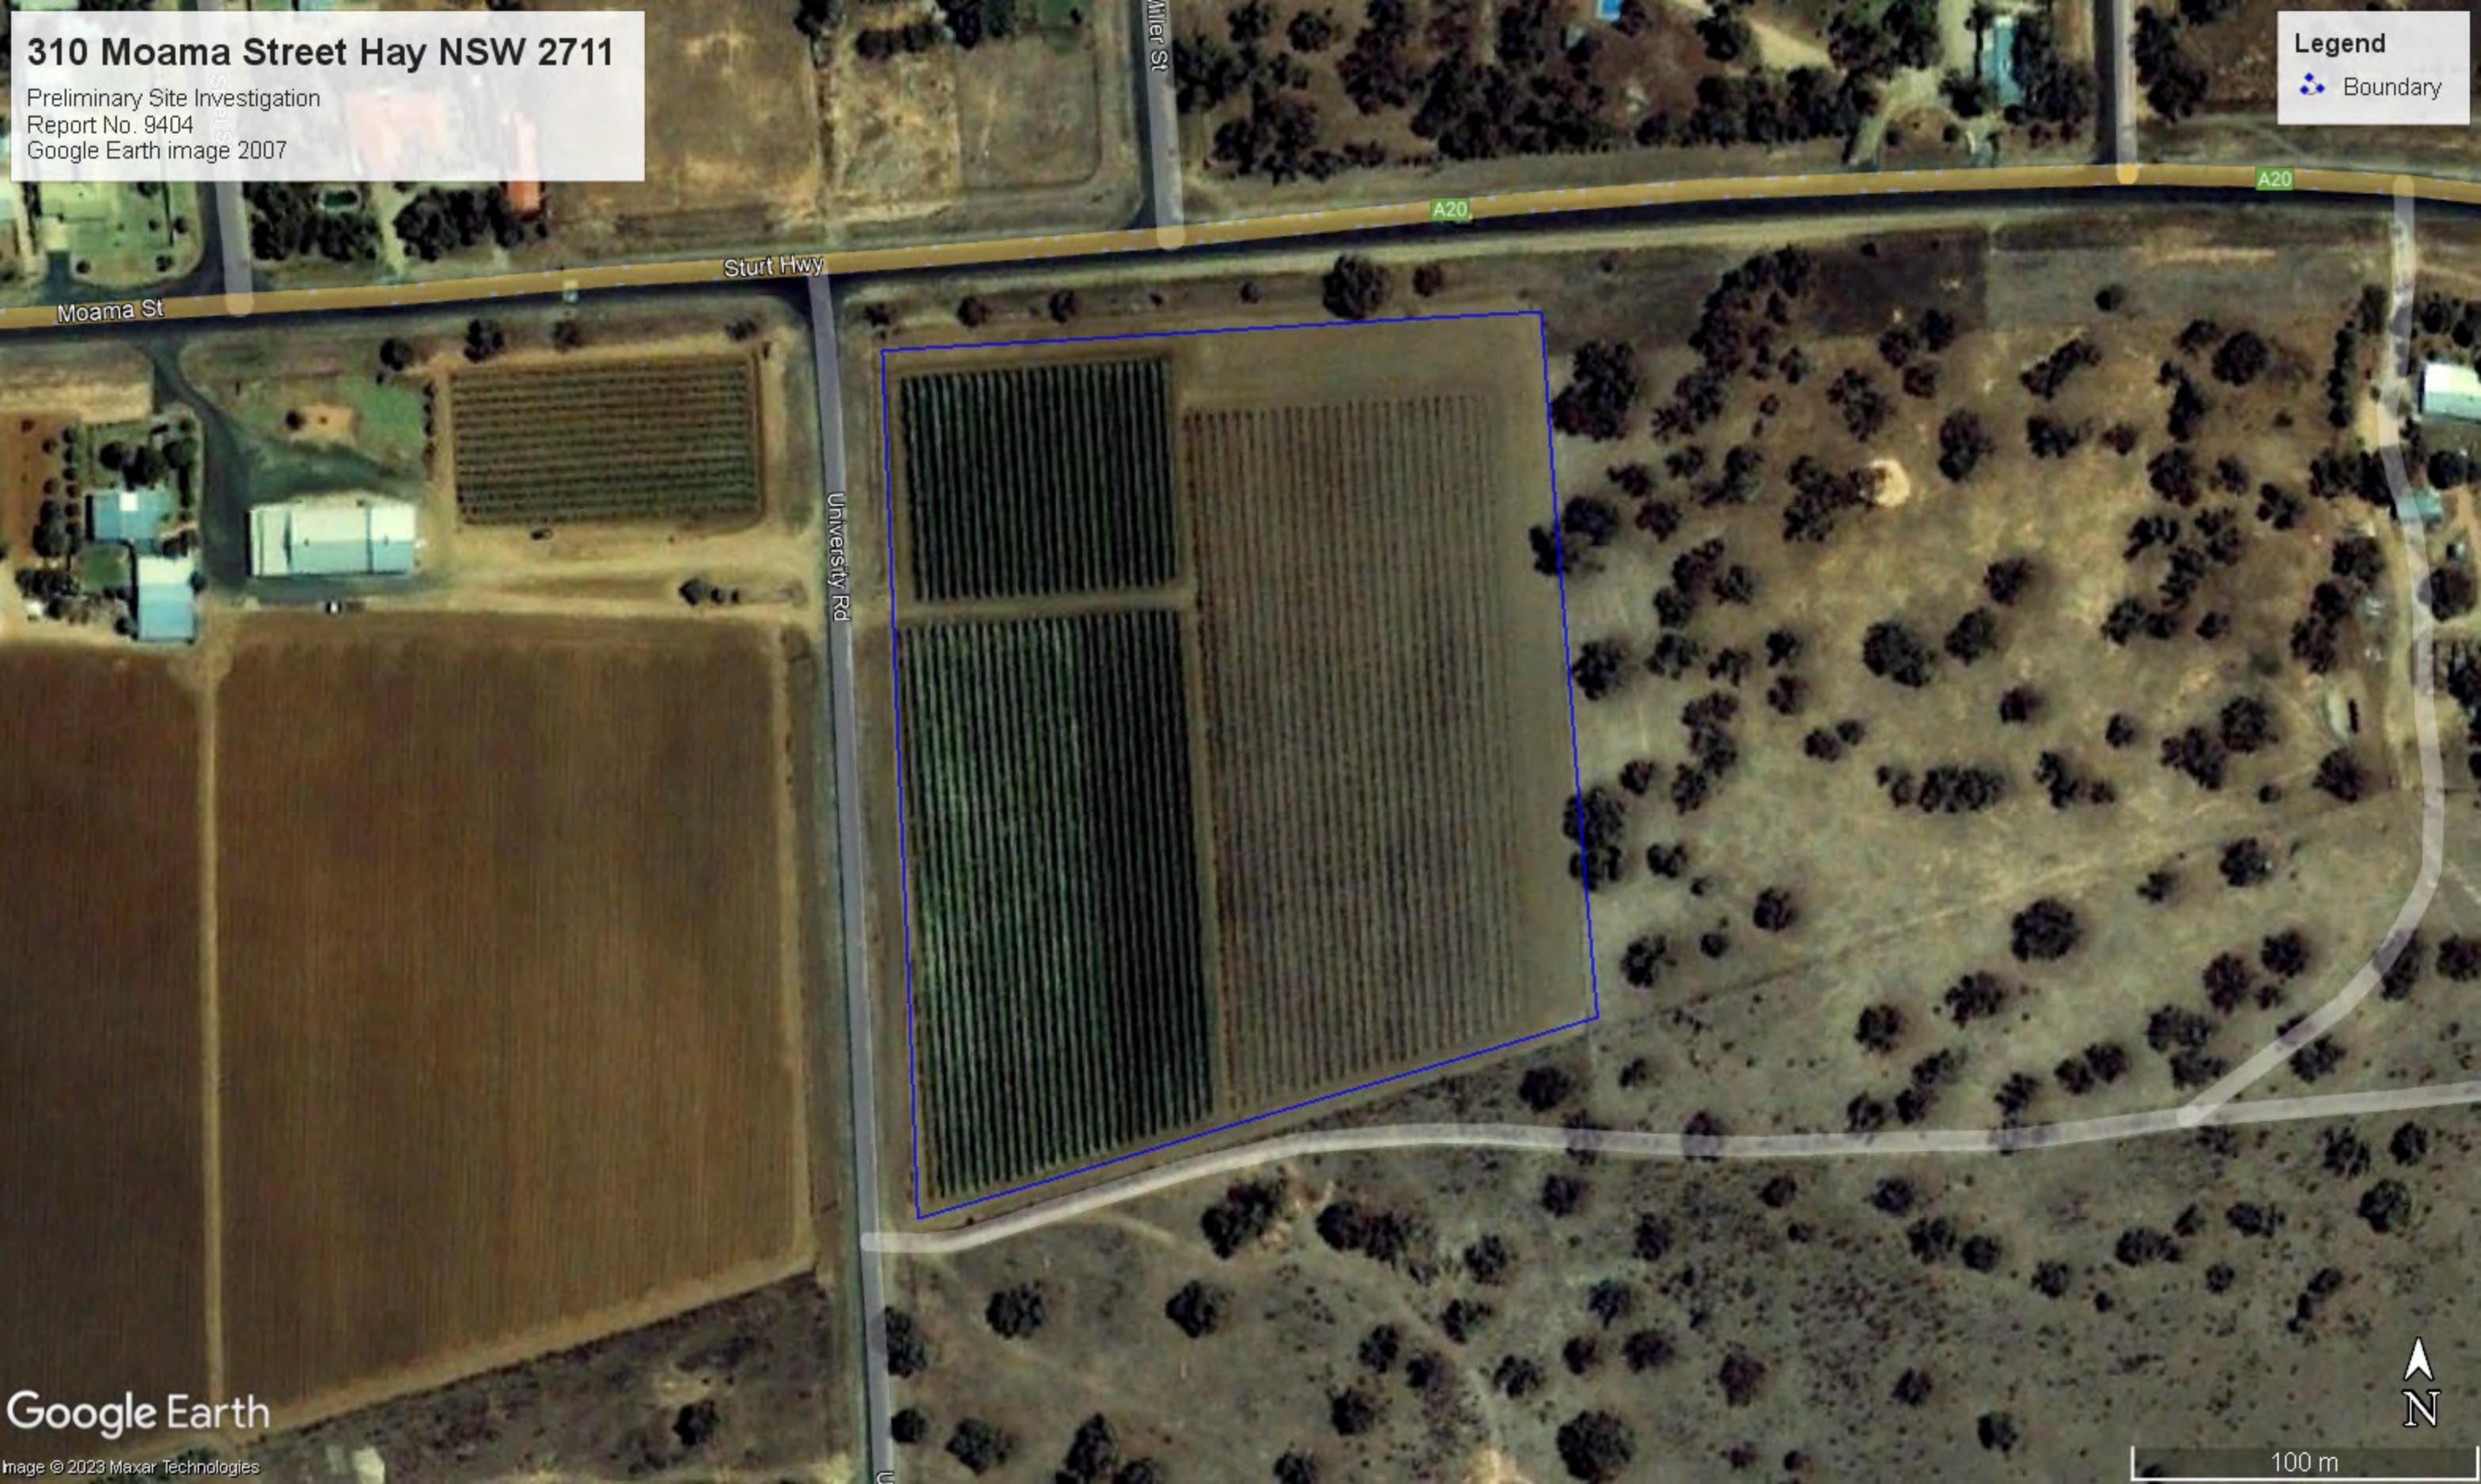
Preliminary Site Investigation
Report No. 9404
Google Earth image 2010

2010 – The vineyard has been removed from the eastern half of the site. A bonfire is visible in the approximate centre of the site.

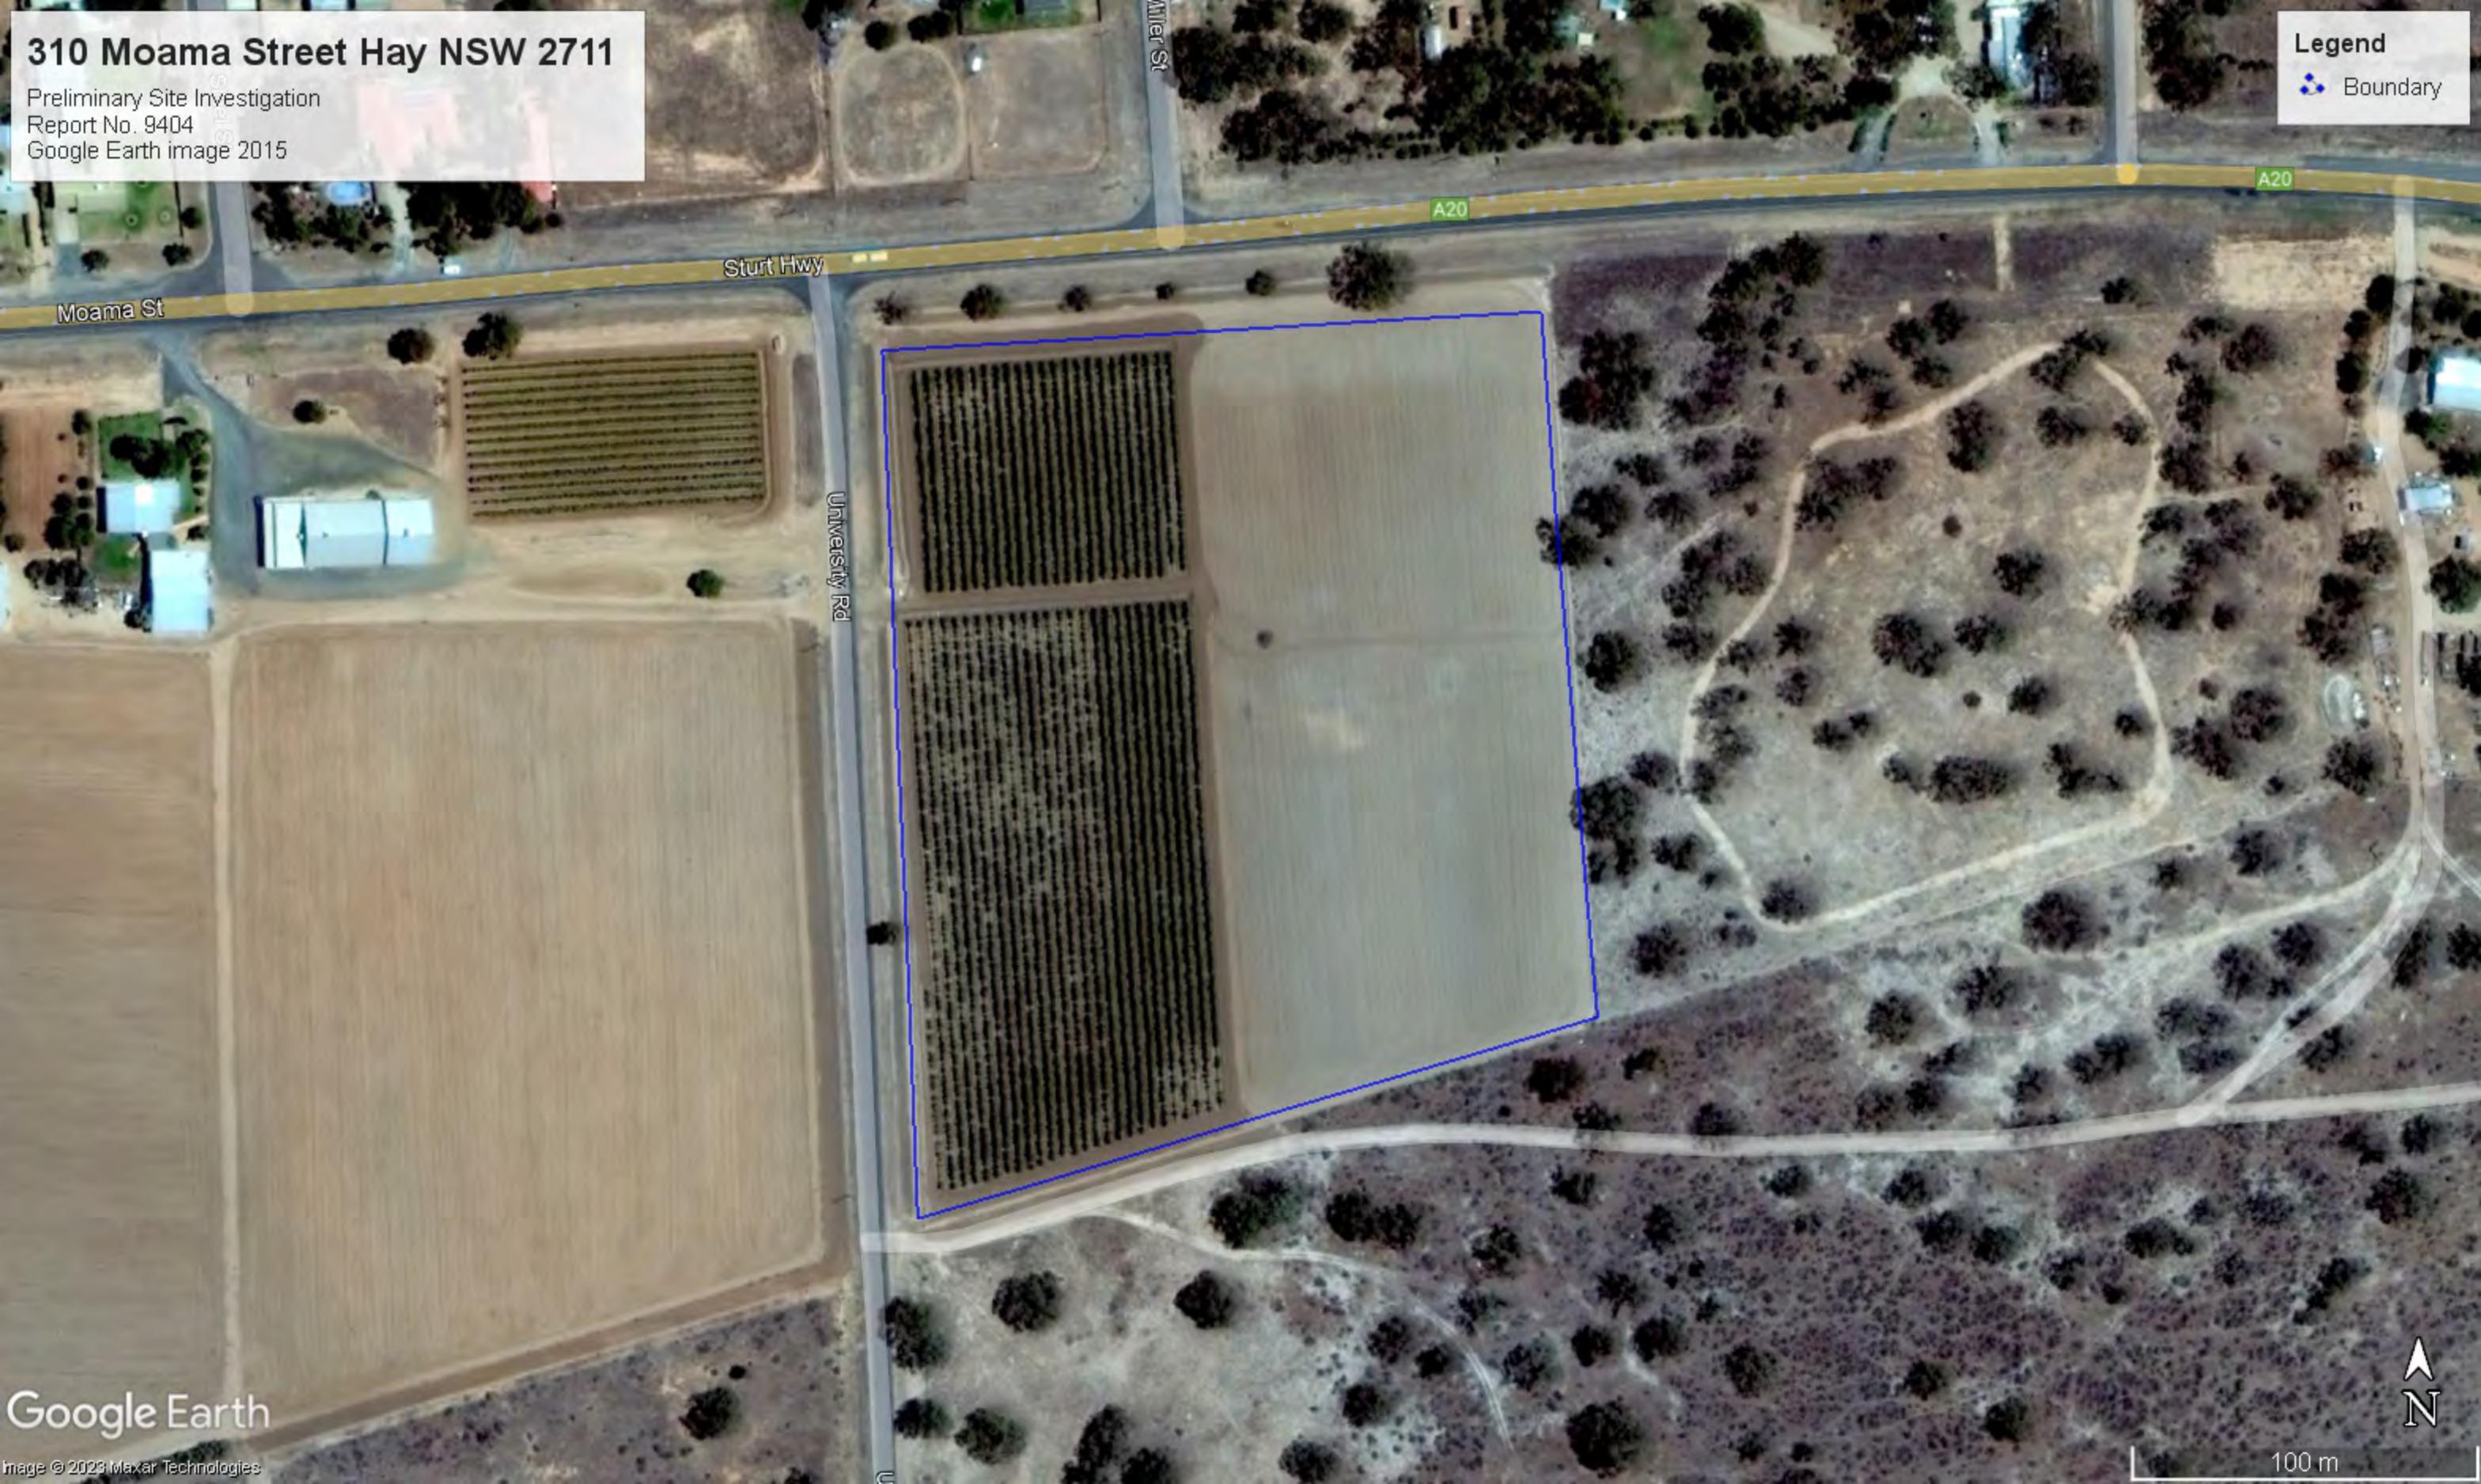
Preliminary Site Investigation
Report No. 9404
Google Earth image 2015

2015 – Remnants of a small bonfire is visible in the approximate centre of the site.

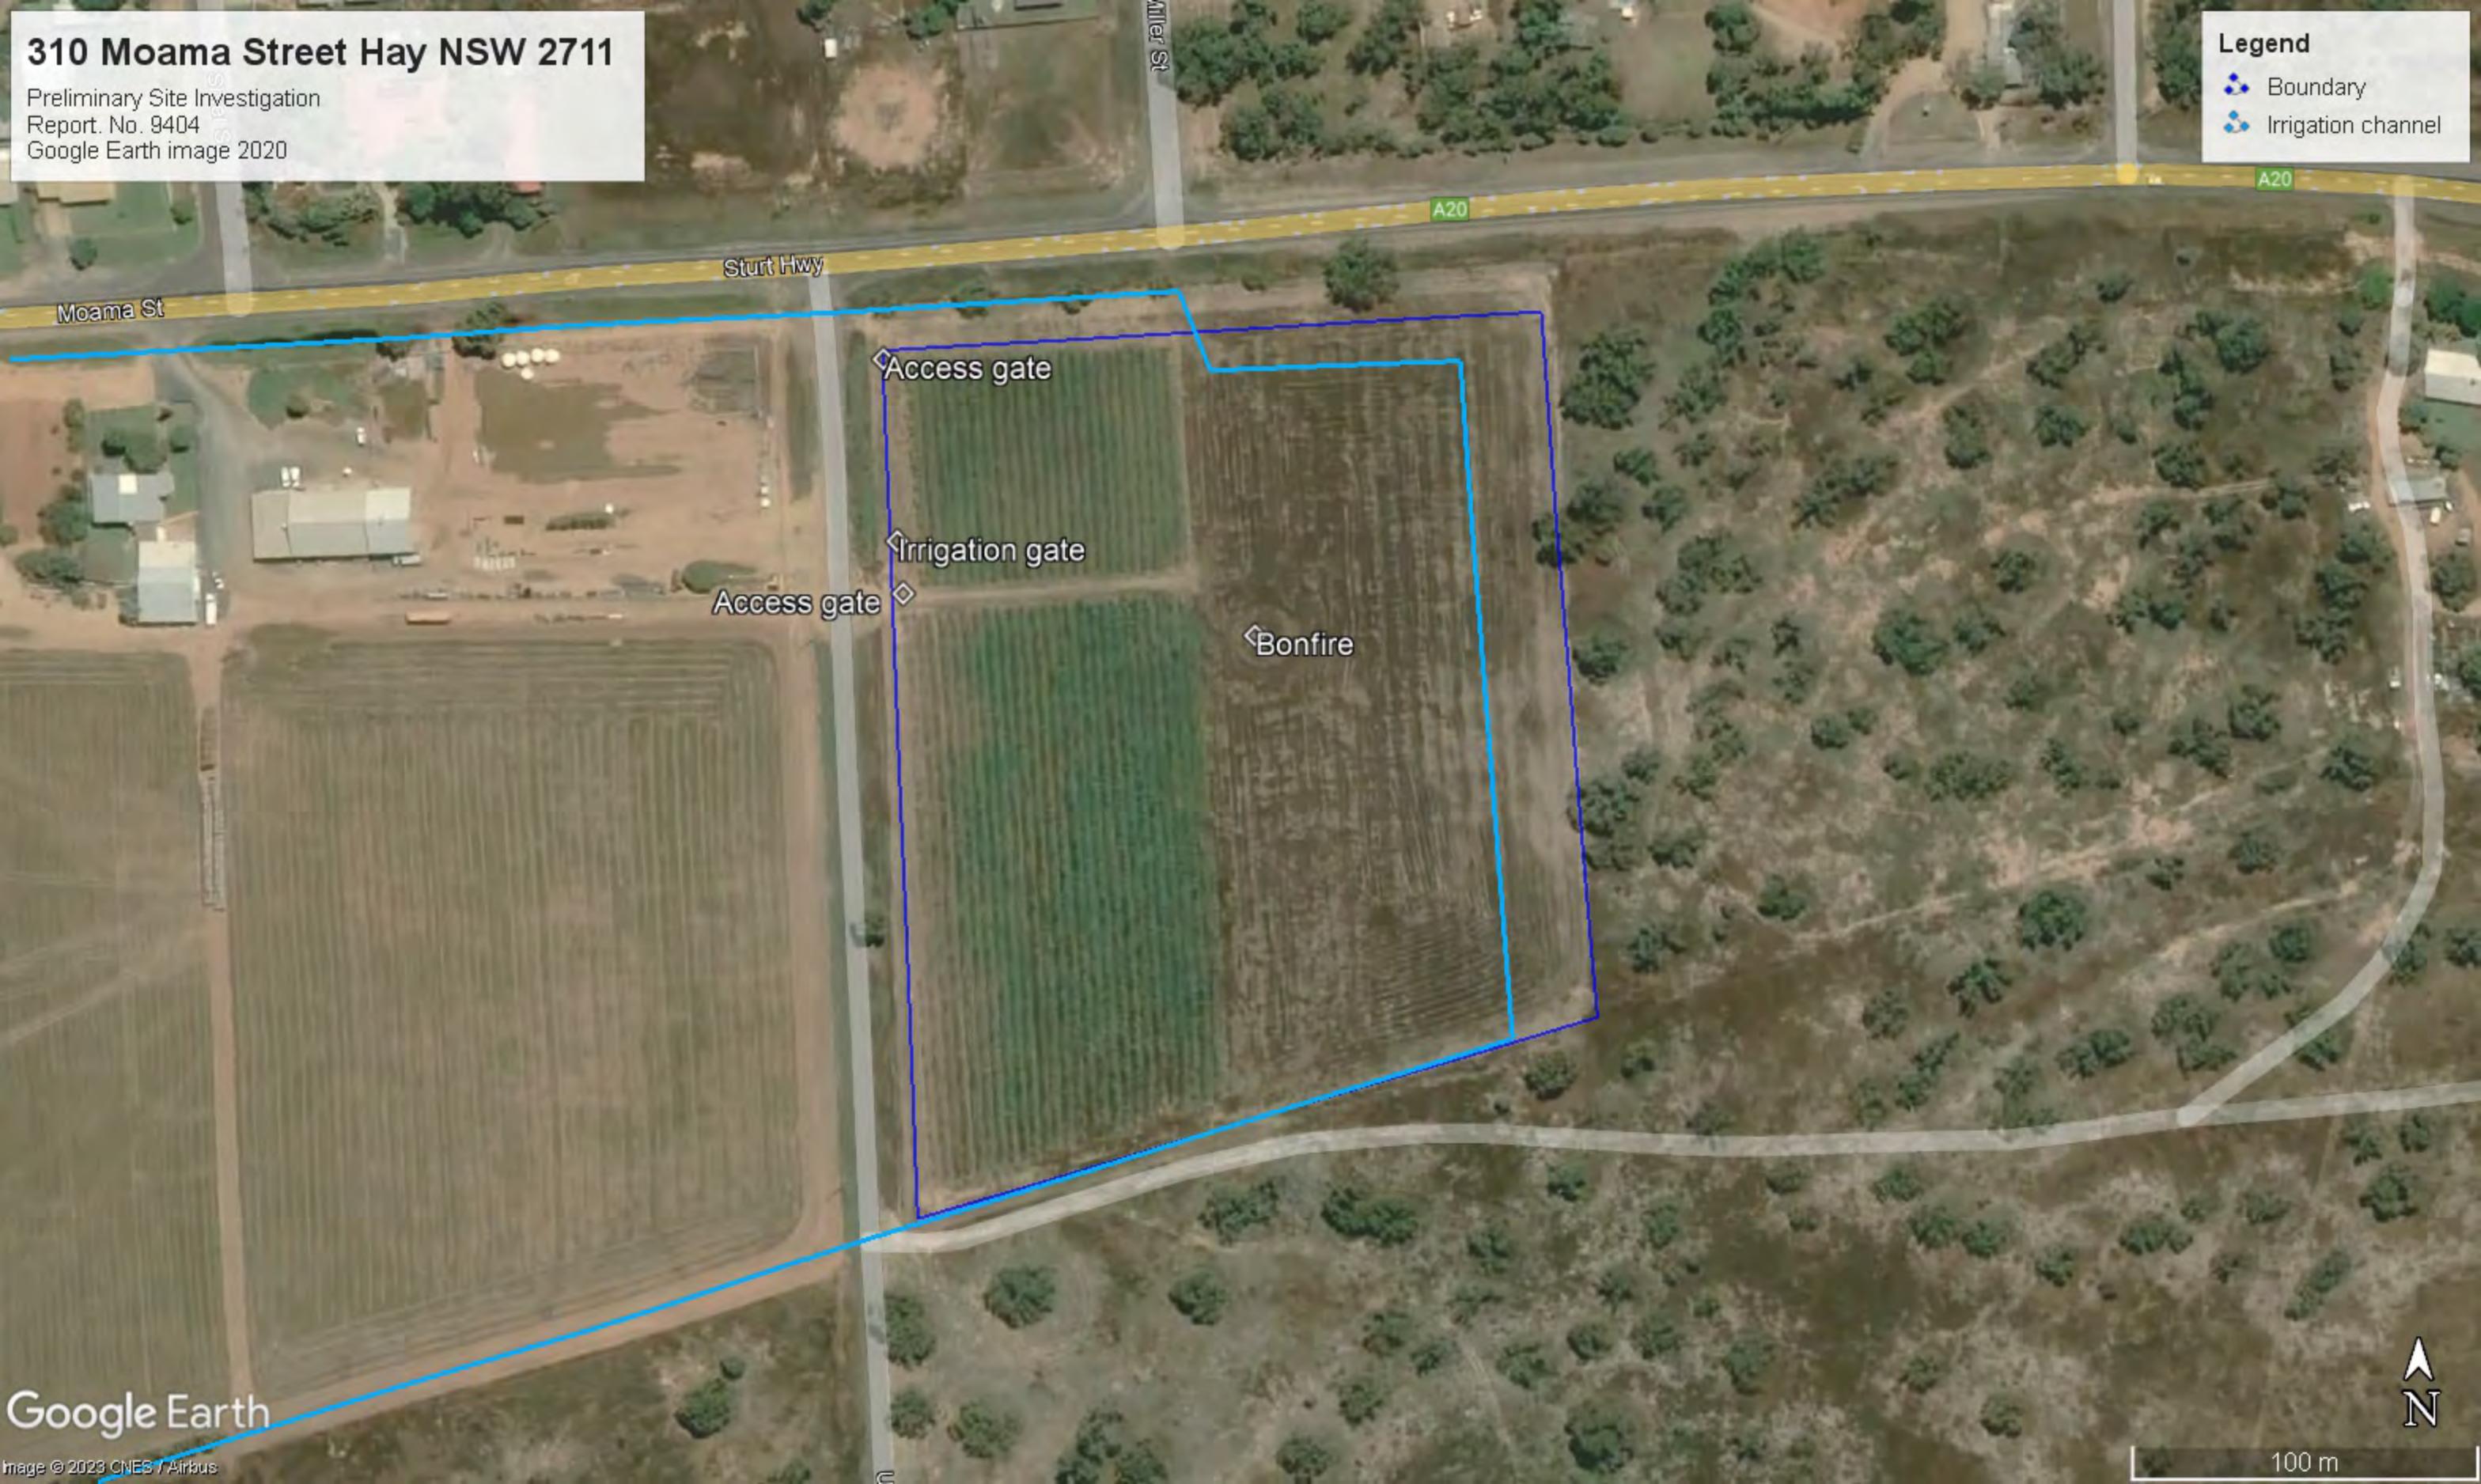
Attachment C : *Site features*

Irrigation channel

Access gate

Irrigation gate

- The site is located on a broad alluvial plain with cracking reddish brown high plastic clay soil.
- Access to the site is via University Road, with an irrigation channel and gate along this road.

- Remnants of a bonfire was observed in the centre of the site and appeared to consist of burnt fencing.
- A shallow channel enters the site along the northern boundary, travels south along the eastern boundary and then west along the southern boundary.
