**310 MOAMA STREET
HAY NSW 2711**

**PRELIMINARY SITE
INVESTIGATION**

**FOR THE REZONING OF LAND
FOR A PROPOSED UNMANNED
REFUELLING FACILITY**

REPORT NO: 9404

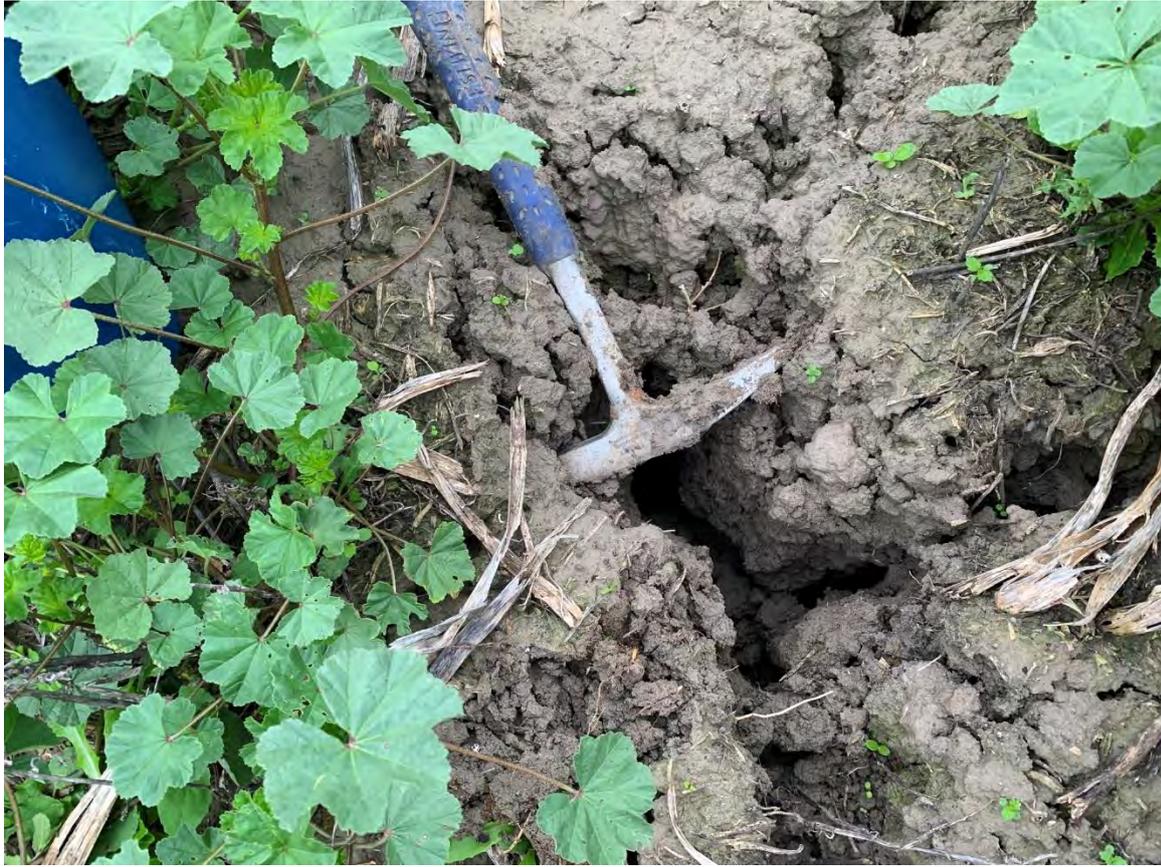
Soils are cracking brown highly plastic clay topsoils overlying cracking reddish brown highly plastic clay subsoil.

Photograph 1: The cracking clay.

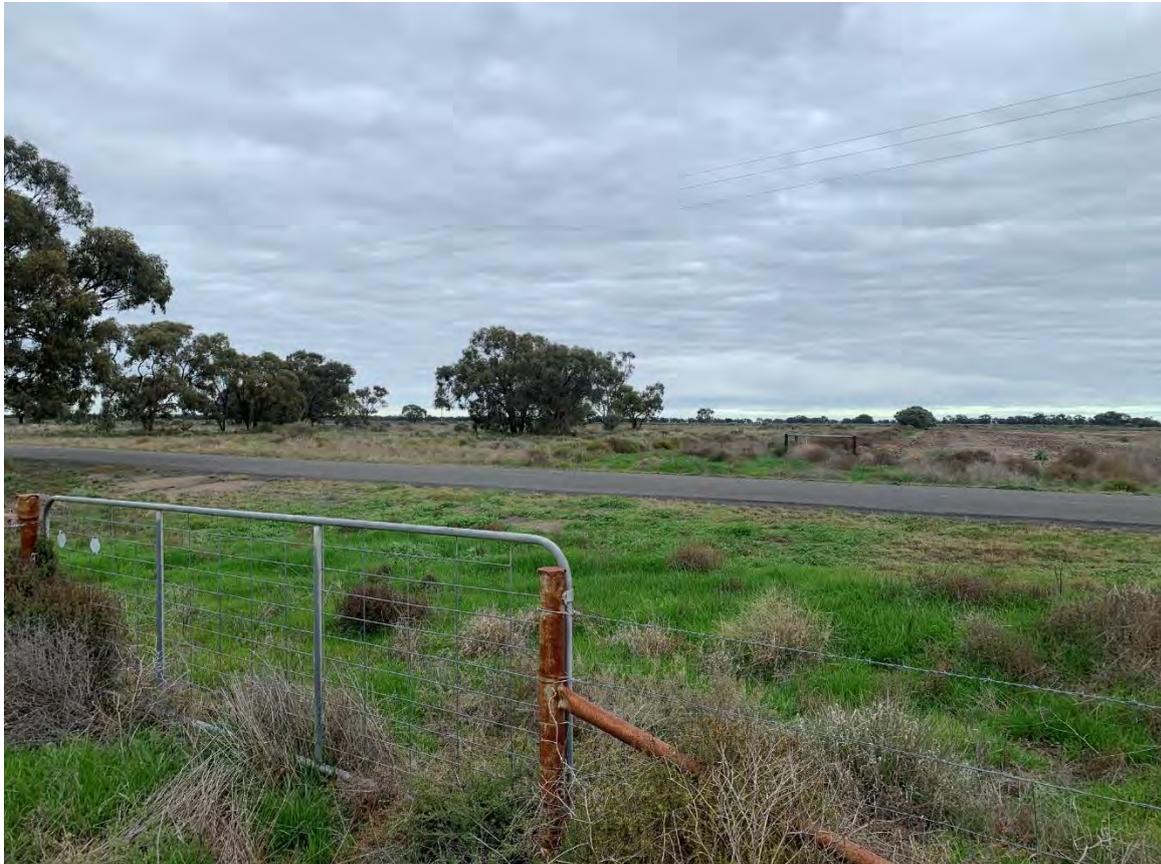
Photograph 2: Access gate to University Road.

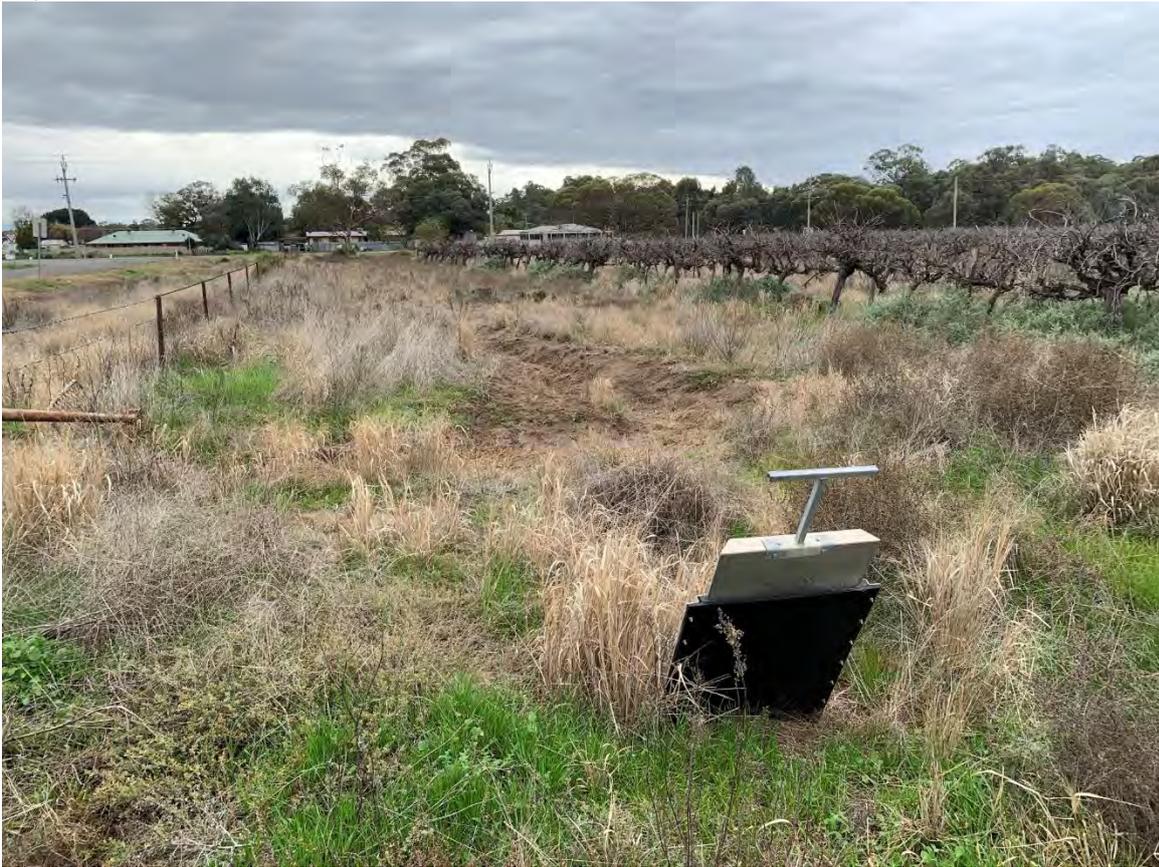
Photograph 3: Irrigation channel and gate along University Road.

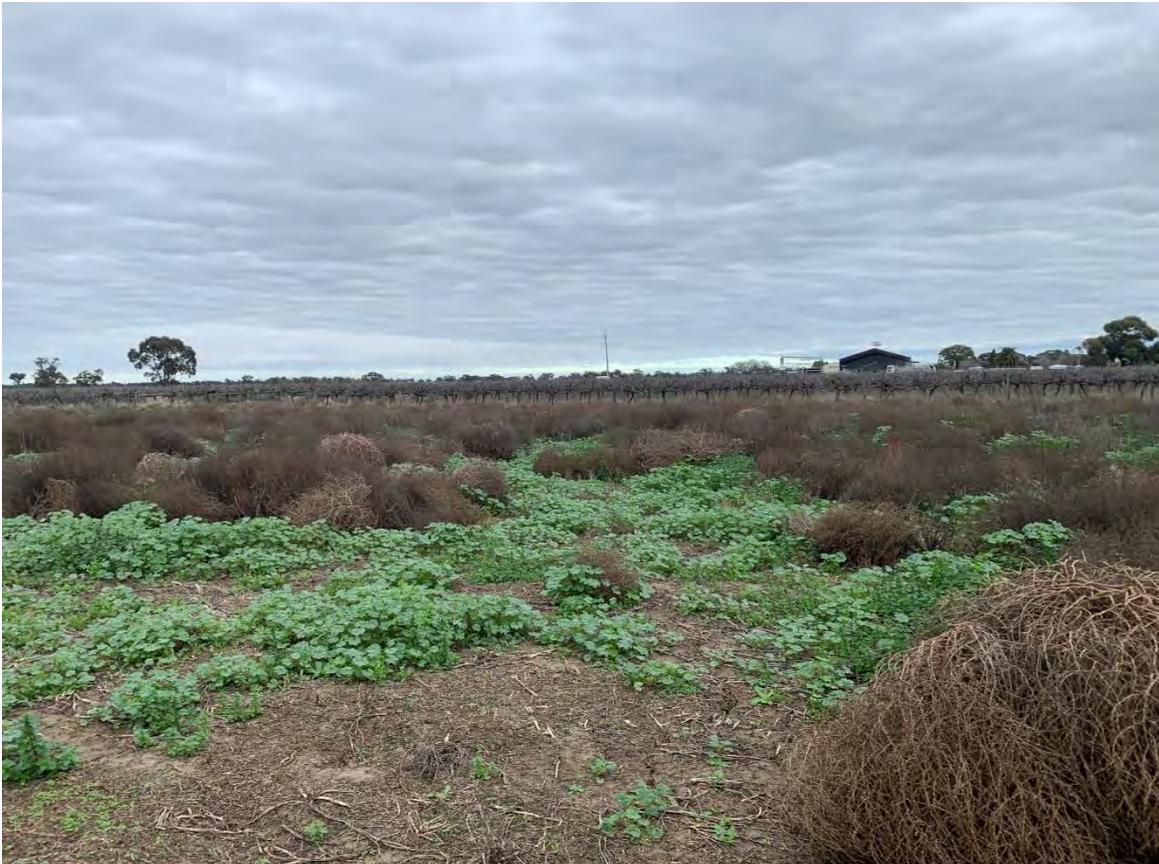
Photograph 4: Unimproved pasture with the vineyard in the background (facing east).

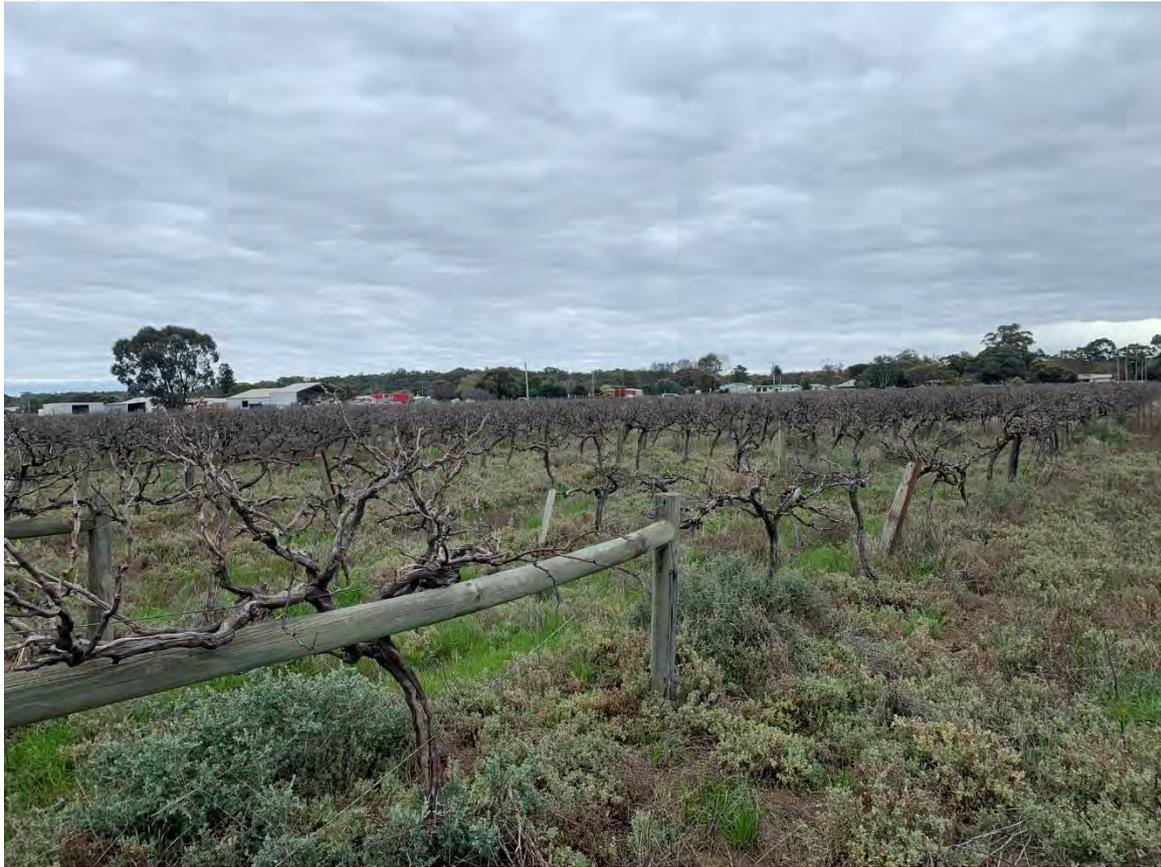
Photograph 5: Vineyard (facing north west). Tapper Agri Services can be seen in the background.

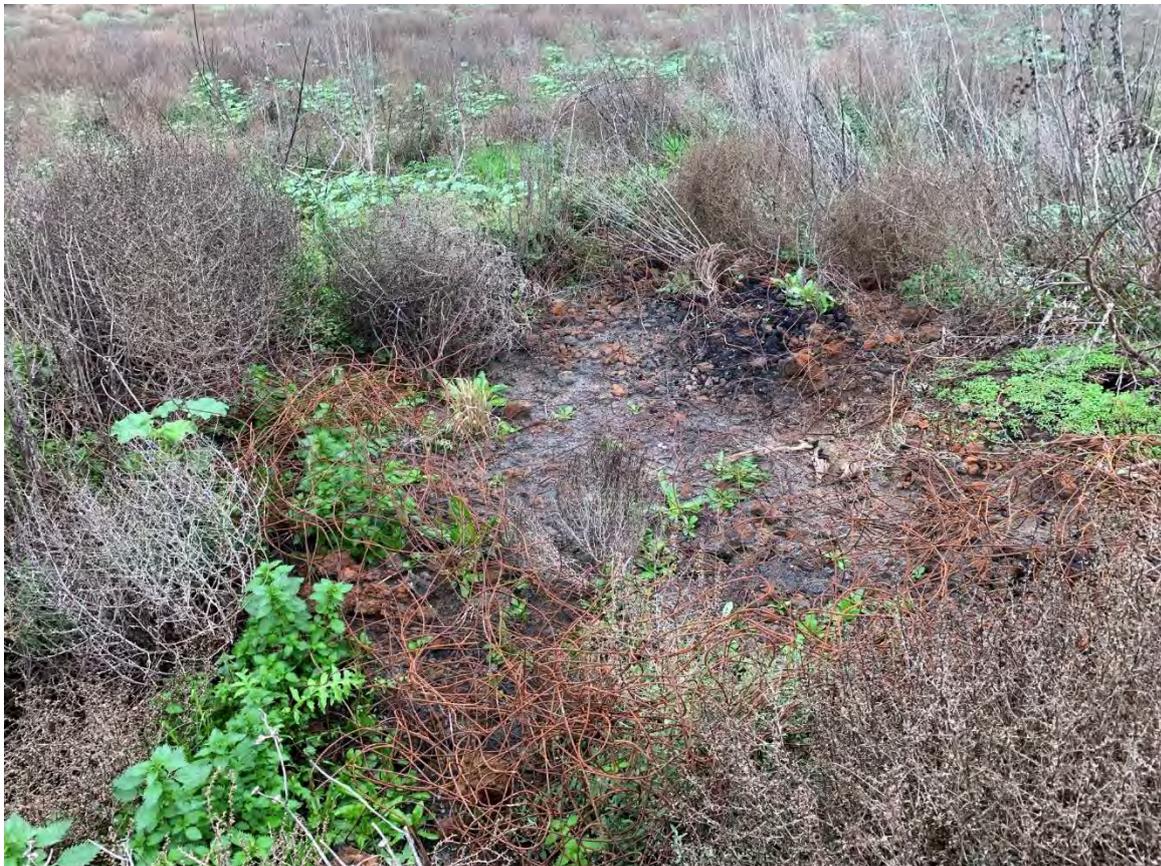
- Remnants of a bonfire was observed in the centre of the site and appeared to consist of burnt fencing.
- A shallow channel enters the site along the northern boundary, travels south along the eastern boundary and then west along the southern boundary.

Photograph 6: Remnants of the bonfire in the centre of the site.

The remnants of the bonfire are recommended to be classified in line with the NSW EPA (2014) Waste Classification Guidelines and disposed of at an appropriately licence landfill.
