# Preliminary Site Impact Statement

## Dubbo North West Urban Release Area, Dubbo

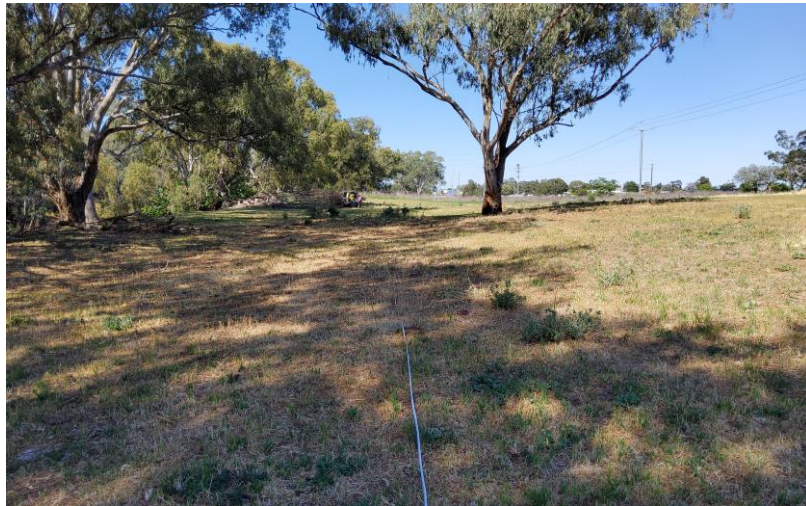
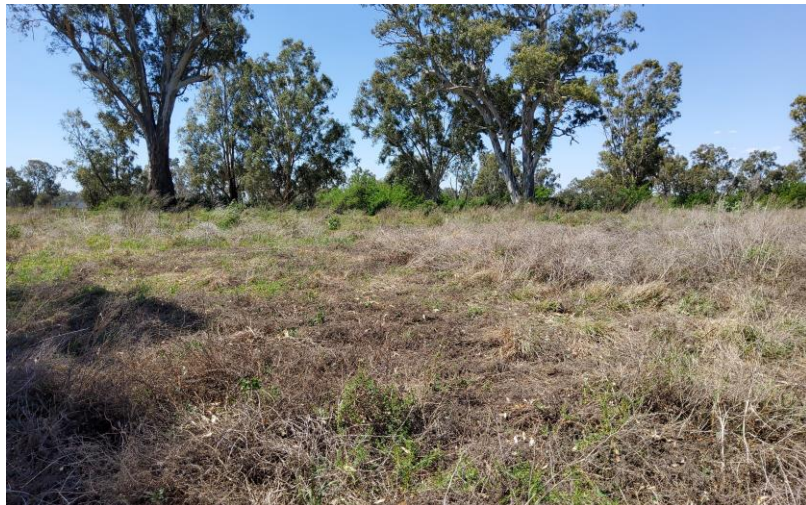
The most common trees at the site were river red gum (*Eucalyptus camaldulensis*) (**Figure 3**), yellow box (*E. melliodora*), inland grey box (*E. microcarpa*) and kurrajong (*Brachychiton populneus*). The eucalypts are naturally occurring in this locality whereas the kurrajong trees have typically been planted. Nesting sites were evident, particularly in the advanced, large diameter *E. melliodora* and *E. camaldulensis* trees, which should be protected wherever possible (**Figure 4**). Thick, mostly non-native, grass and herbaceous ground cover was evident across the majority of the site.

*Figure 3: River red gums near the Macquarie River.*

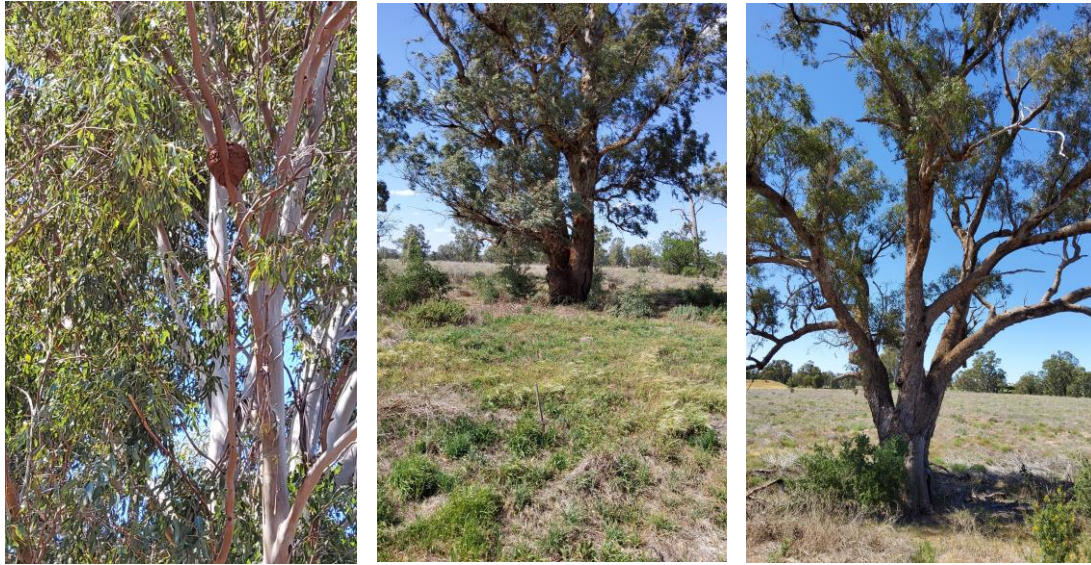
*Figure 4: Many trees had hollows and nests.*

- There were many significant habitat trees which should be retained wherever possible.
- Significant cultural heritage trees must be protected. It is an offence to harm indigenous heritage items under the National Parks and Wildlife Act 1974.
- Removal or trimming of trees or branches should only be performed by a professional arborist for safety and to minimise damage to the tree.
- Many areas of stockpiles and fill material of unknown origin exist across the site.
- Possible threatened species (TS) and endangered ecological communities (EEC).

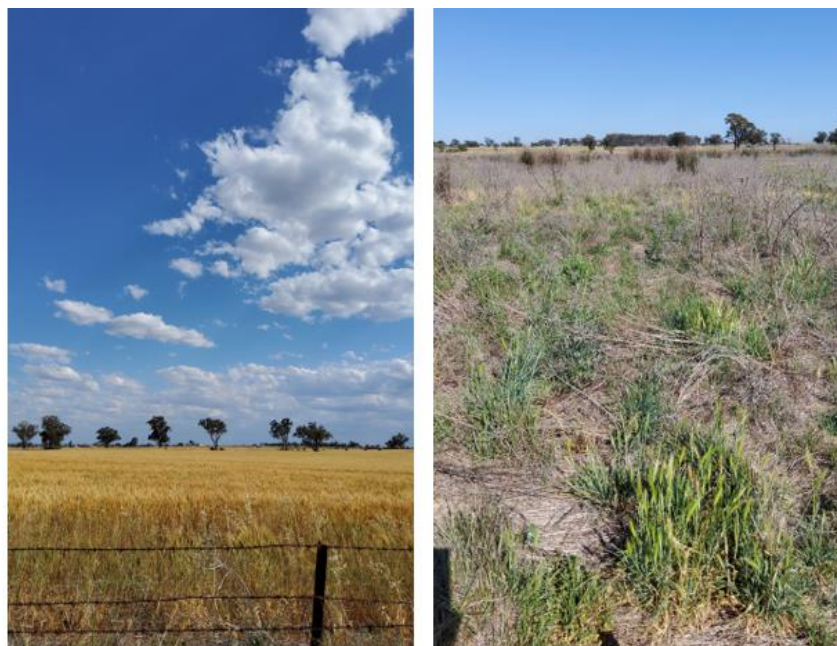
Figure 6: Cropped paddocks and low conservation value grasslands.

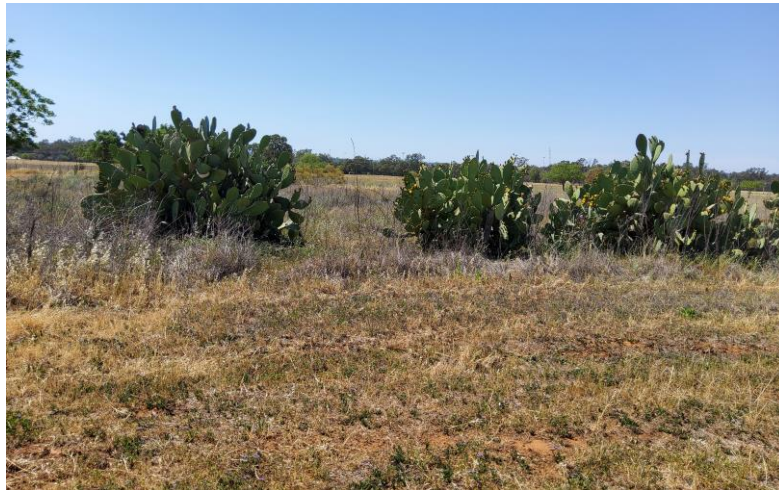
Removal of dead standing trees and timber debris from the ground is a key threatening process (KTP) as it removes or destroys natural assets potentially used by fauna. The use of the site for agriculture has resulted in minimal existing woody debris. To reduce impacts from proposed works, the removal of dead standing trees or debris from the ground should be limited to that which is necessary for the safe use of the area. Clearing of native vegetation is also a KTP and the design of the proposed residential housing area should consider preservation of existing mature habitat trees wherever possible. There was very limited occurrence of invasive weeds like prickly pear (*Opuntia sp.*) and pepper tree (*Schinus molle*) (**Figure 7**). Erosion was not evident at the site.

*Figure 7: Prickly pear for removal and control.*

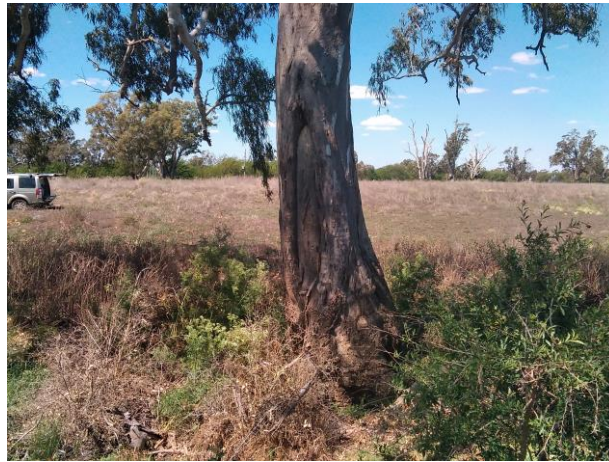
There were seven trees noted as potentially showing cultural scars. Indigenous scarred trees have pieces of bark removed that would have been used for traditional purposes and are one of the more identifiable and visible facets of cultural heritage. These trees (at WPs 77, 81-85 and 89) should be

*Figure 8: Culturally modified tree.*

protected from all disturbance with at least a 10 m buffer. Further study of Indigenous cultural heritage aspects will be specifically assessed by a separate site Aboriginal Cultural Heritage Assessment (ACHA).

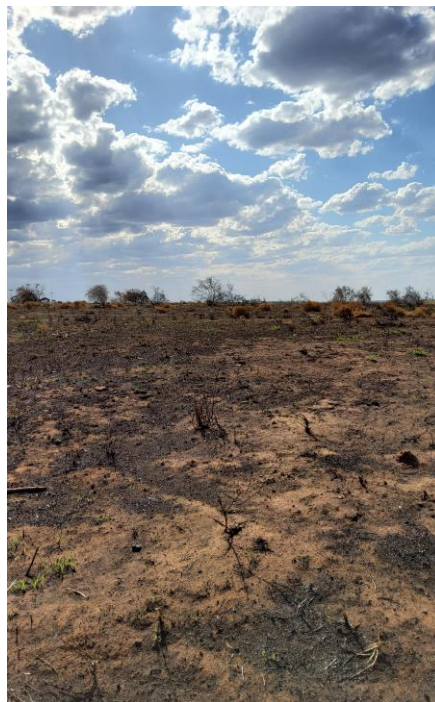
Three lots ( Lot 8, 53 and 133 in DP 753233) in the western portion of the site are owned by the Dubbo Local Aboriginal Land Council (LALC) and were recently burned, preventing field assessment.

*Figure 9: Recent fire prevented any observation of plant matter.*

Some areas of the site were not inspected due to access issues, time limitations and the condition of the Dubbo LALC land being recently burned. These areas should be inspected before the biodiversity assessment is finalised. Any remaining scattered paddock trees that have not been inspected, will be assessed before the biodiversity assessment is finalised.

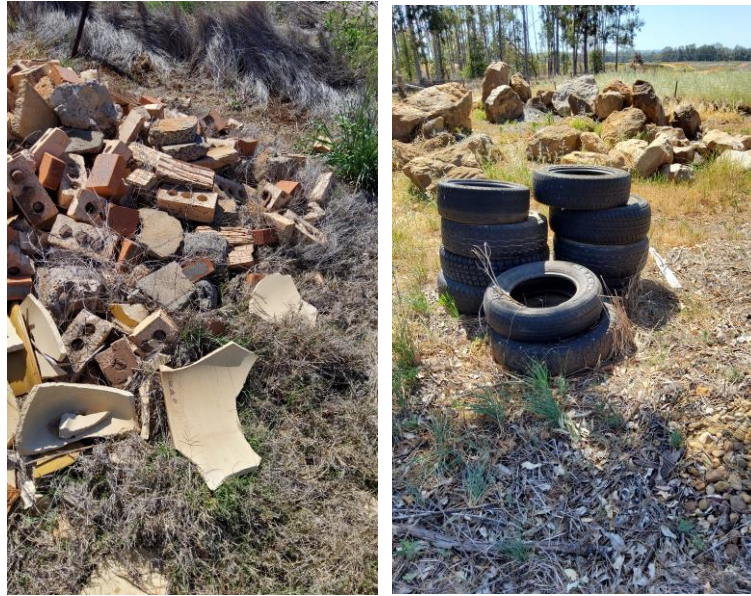
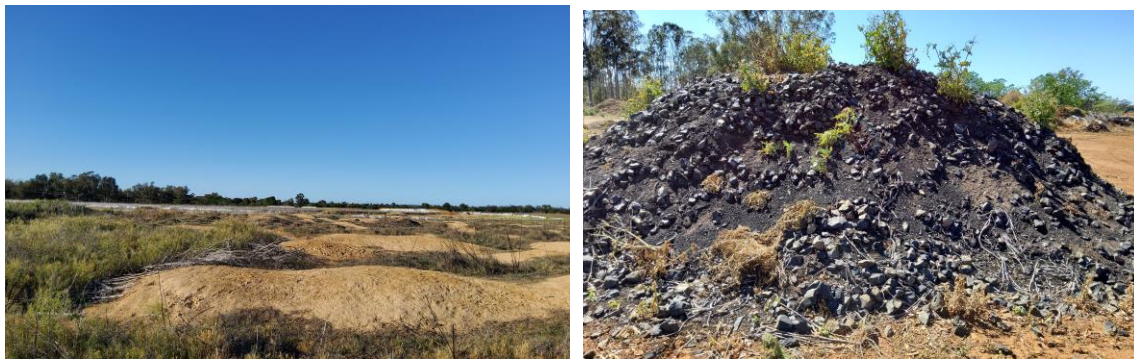
Residual materials from the decommissioned Sewage Treatment Plant exist (Lots 1 and 2 DP 958250 and Lot 1 DP 217195) and further investigation of this area is required.

*Figure 10: Building debris, waste and stockpiles of material of unknown composition.*

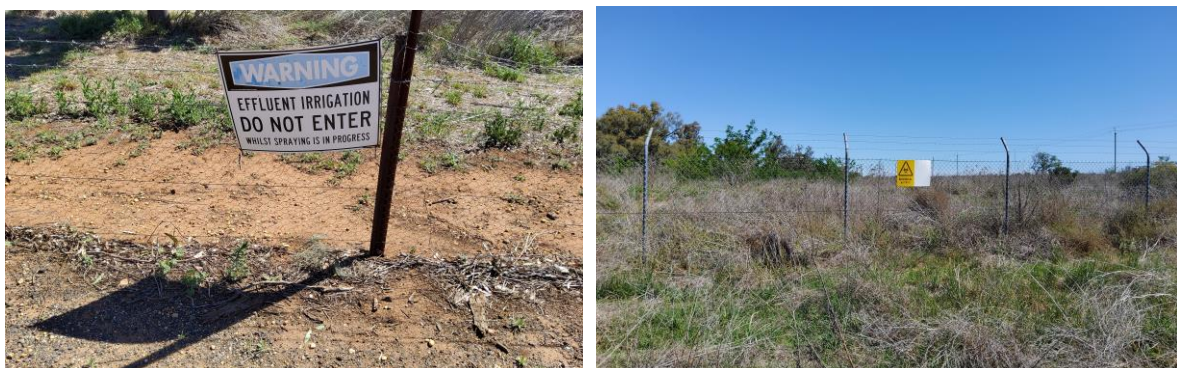
*Figure 11: Existing hazard signage.*
