# Meadowvale

Conservation Management Plan

Report No. R.02

Date: September 2025

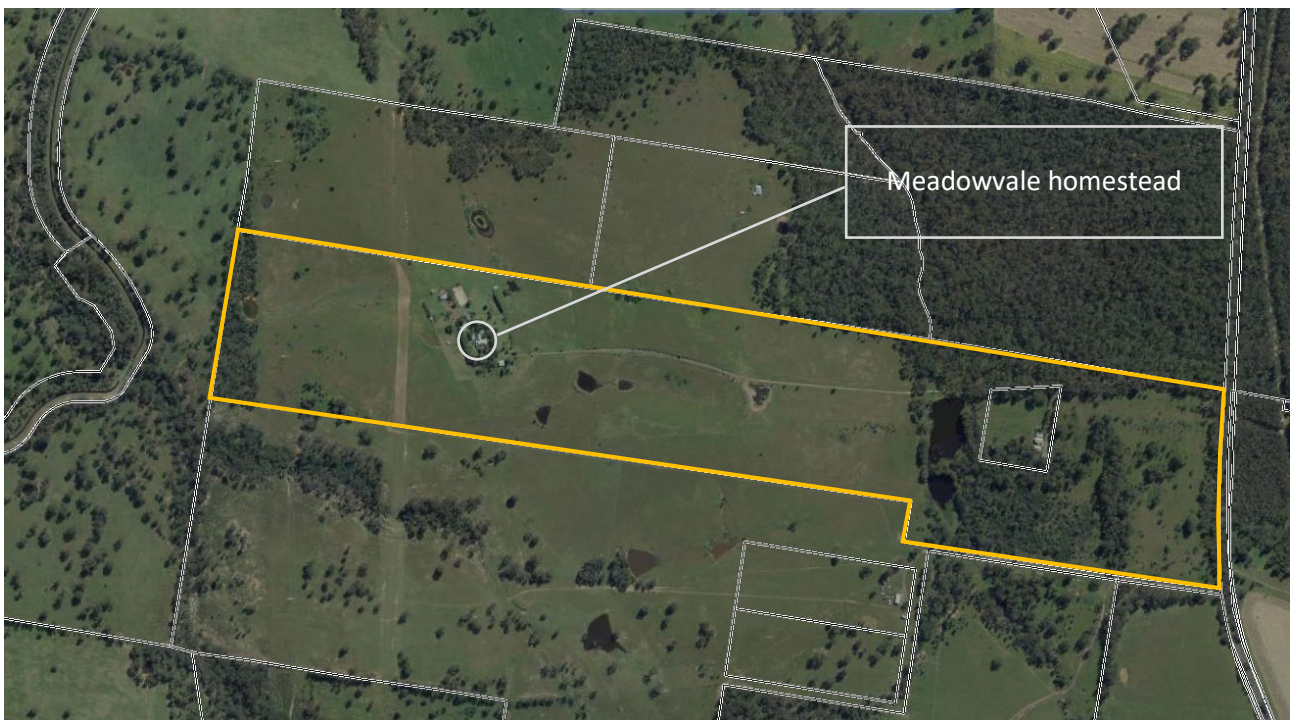
**Figure 1-2 Aerial photograph showing the allotment at 715 and 717 Appin Road that contains the Meadowvale homestead, which is circled.**

The site within which Meadowvale homestead sits is on the western side of Appin Road at No. 717 Appin Road, Gilead. The property at 715-717 Appin Road, Gilead has a land size of 69.6 ha.

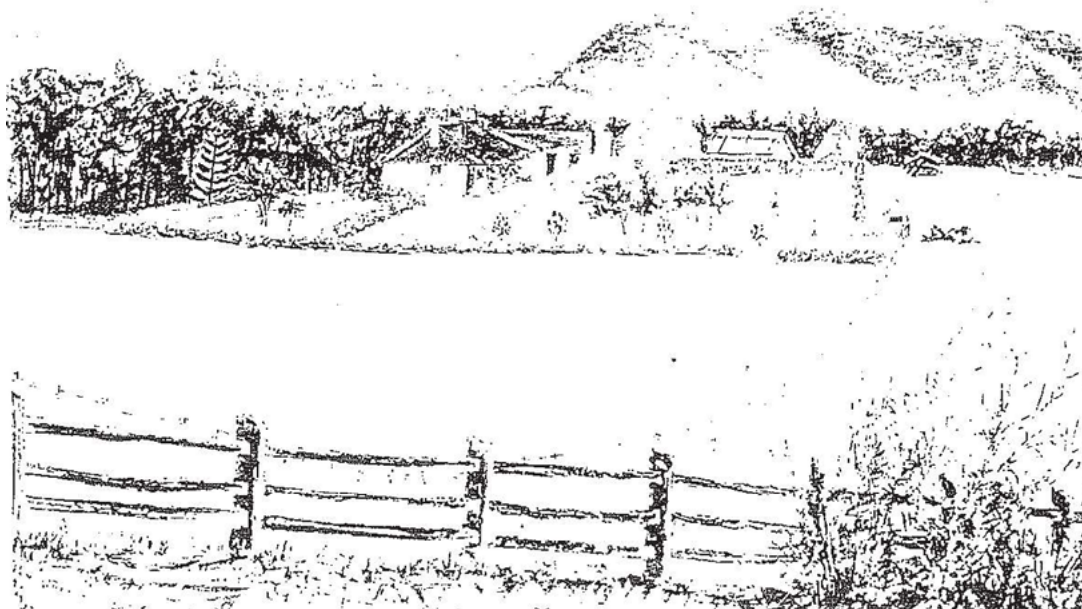
**Figure 2-2 Pencil sketch of Meadowvale dated 1861, looking south-west from near the boundary with Beulah**

Note the north-facing rear dormers in Figure 2-2. There is also a Norfolk Island pine growing in the front garden, left of the homestead, which grew for over a century, dying around 1970.

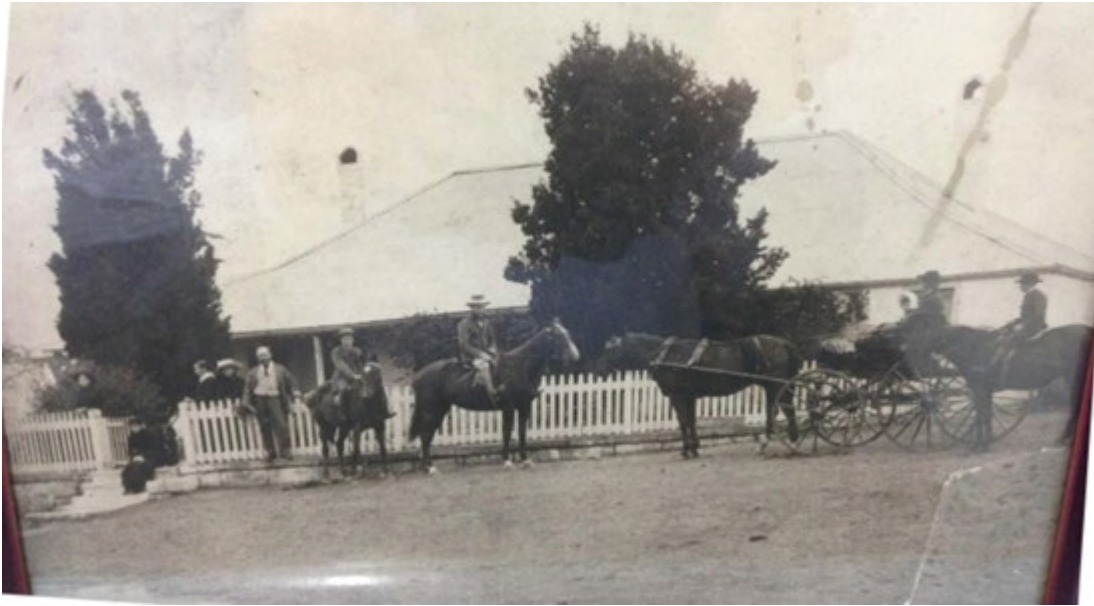
**Figure 2-3** Undated photograph c1890 showing the south entry front of Meadowvale homestead

This is the original form of the homestead. Source: personal collection as recorded by NBRSPartners

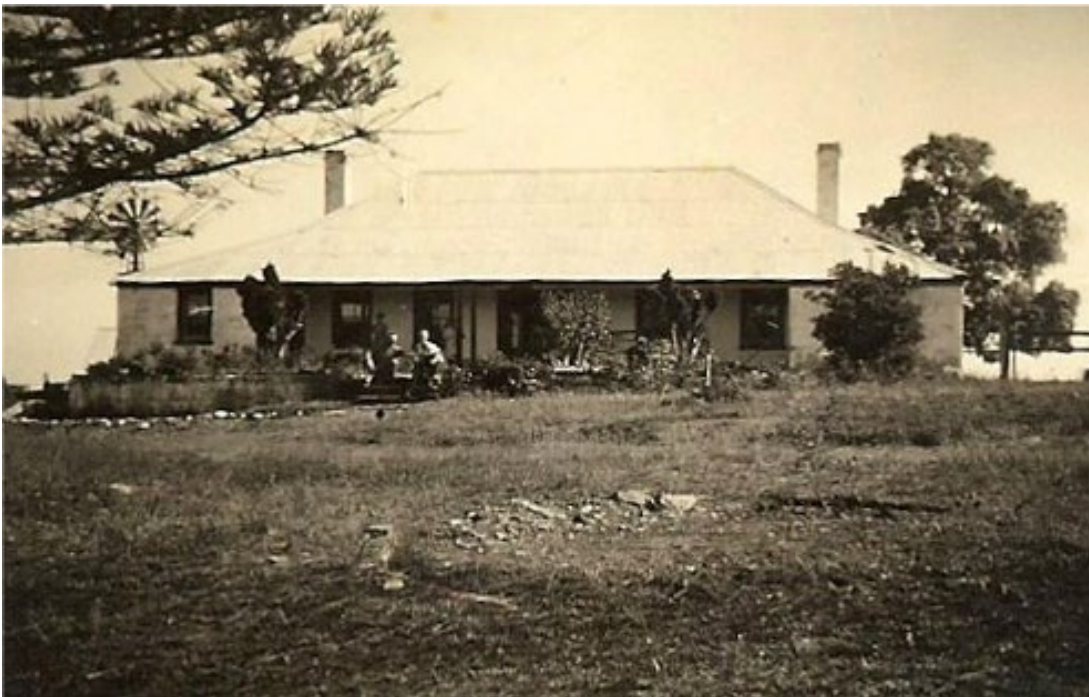
**Figure 2-4** Undated c1930 view of the south front of the homestead, showing the front conifers and picket fence gone. The 'Parramatta' arched hoods over the chimneys are gone too

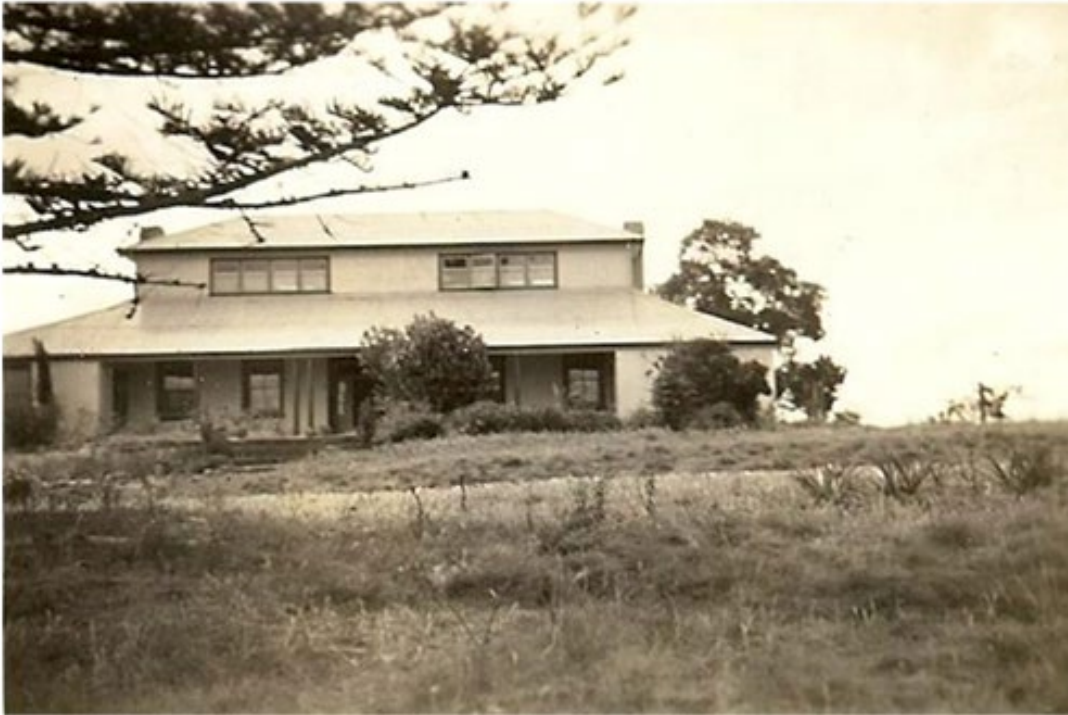
**Figure 2-5** Circa 1950 view of the entry front of Meadowvale the homestead. The attic has been extended as a pop-up.

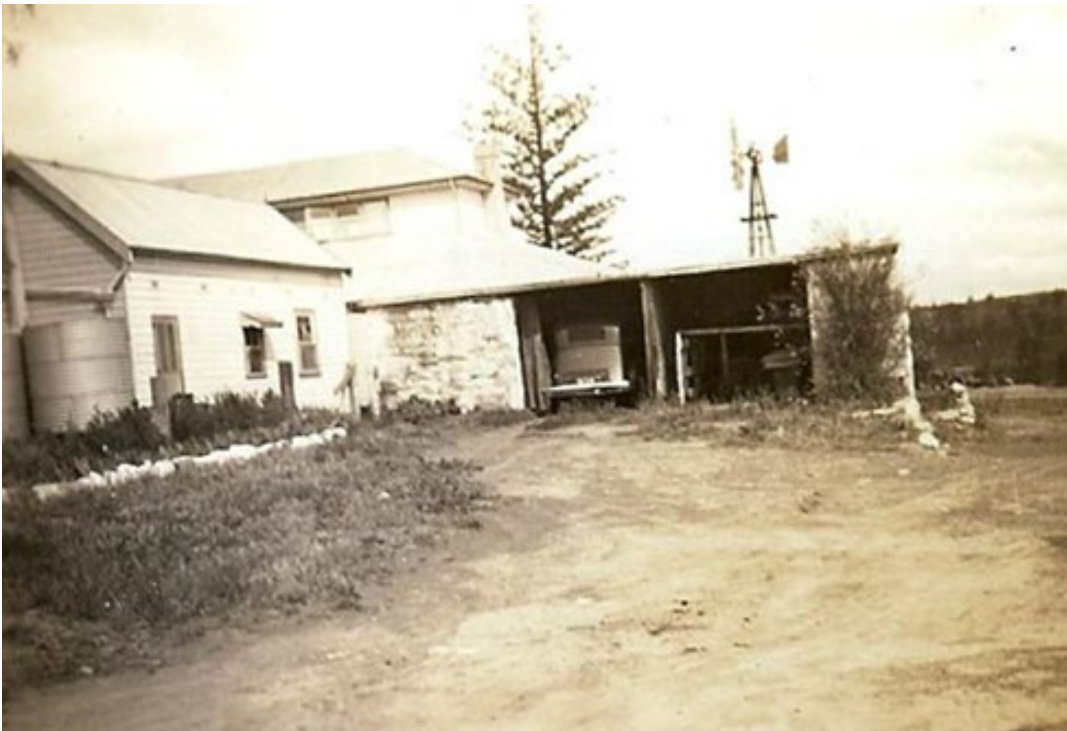
**Figure 2-6** Southwards view towards the rear of the house c1960. It shows an early twentieth-century extension on the west side of the homestead as a garage. The original form of the kitchen is apparent on the left.

There was a windmill located a short distance west of the homestead, seen in **Figure 2-6**. While it no longer stands, there are some cast iron remains lying nearby that appear consistent with the inter-war period. This windmill raised water for household use. It is noted in the clearing sale of July 1941 following the death of Mr AM Sutton.

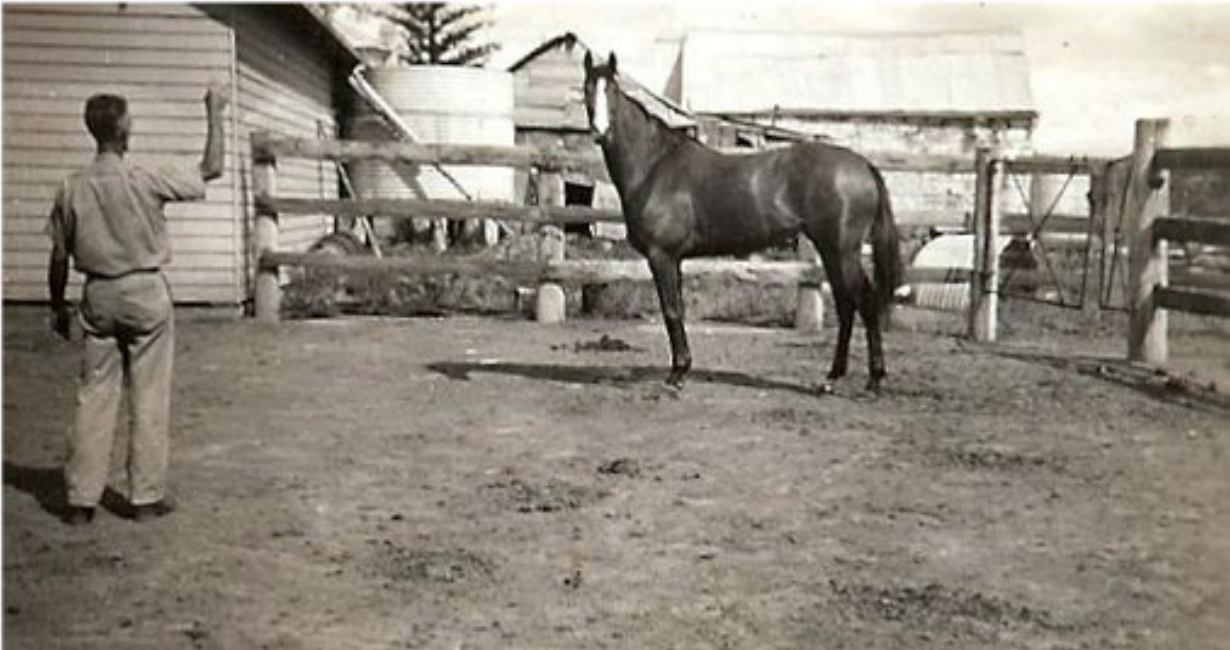
**Figure 2-7** Southwards view c1960 showing a glimpse of the homestead pop-up to the left of the Norfolk pine, and a rubble barn or convict barracks, since demolished. The northern wall of a rubble stone building might be seen behind the horse's front.

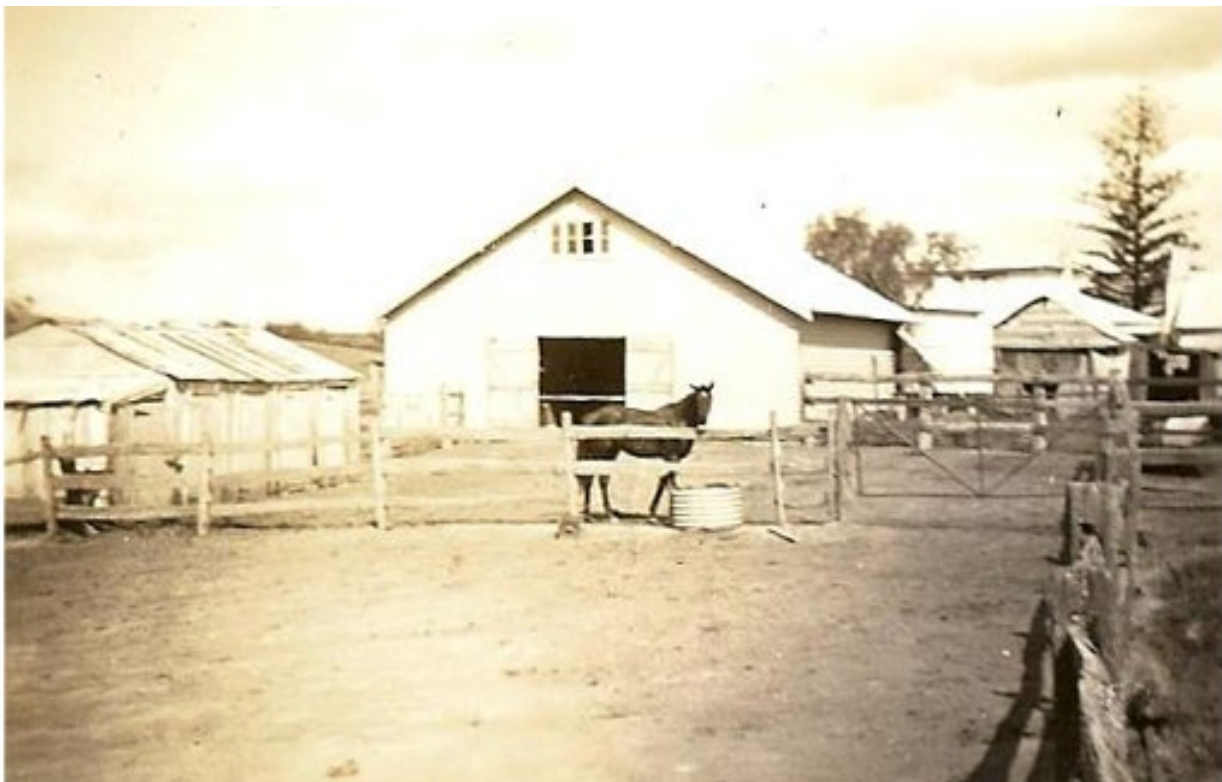
**Figure 2-8** Southwards view c1960 showing the post-war stable, and the homestead with pop-up extension behind. The slab hut with corrugated steel roof on the left is long gone.

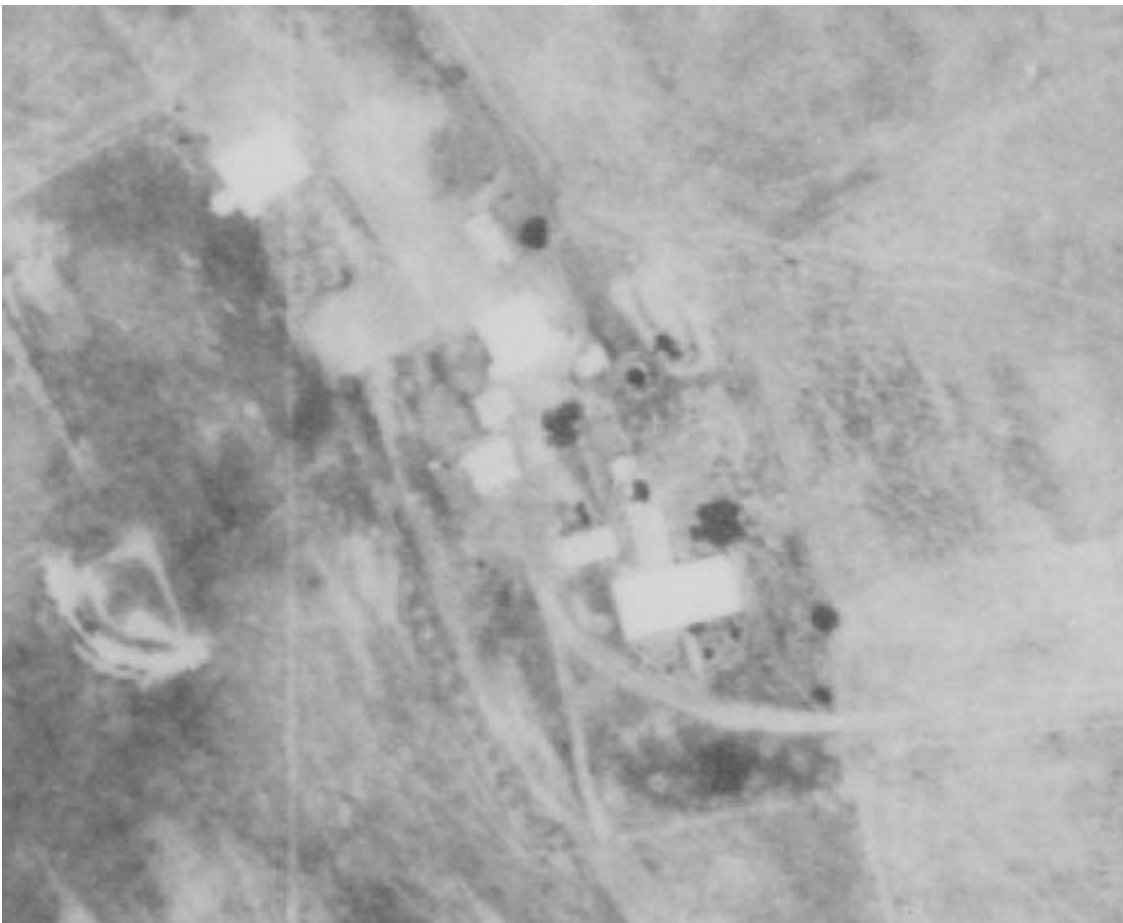
**Figure 2-9 1946 aerial image of the Meadowvale homestead and grounds**

**Figure 2-9**, the 1946 aerial image of the Meadowvale homestead and grounds to **Figure 2-12** provide an overview of the modifications and alterations having taken place at Meadowvale.

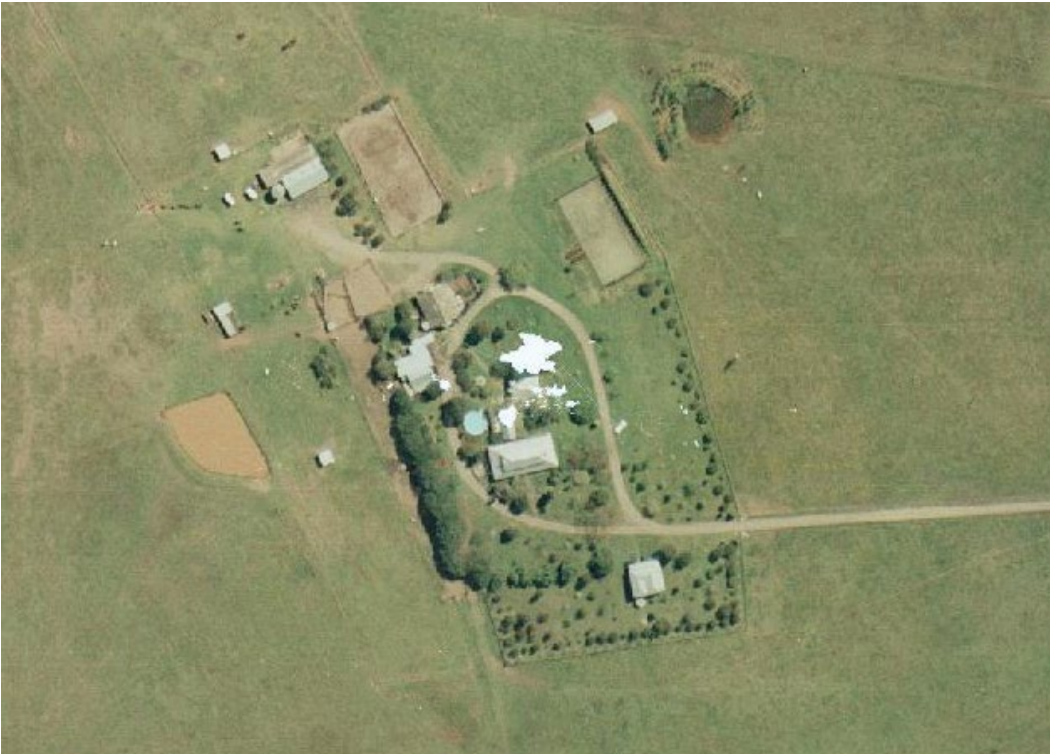
**Figure 2-12 1989 aerial image of the Meadowvale homestead and grounds**

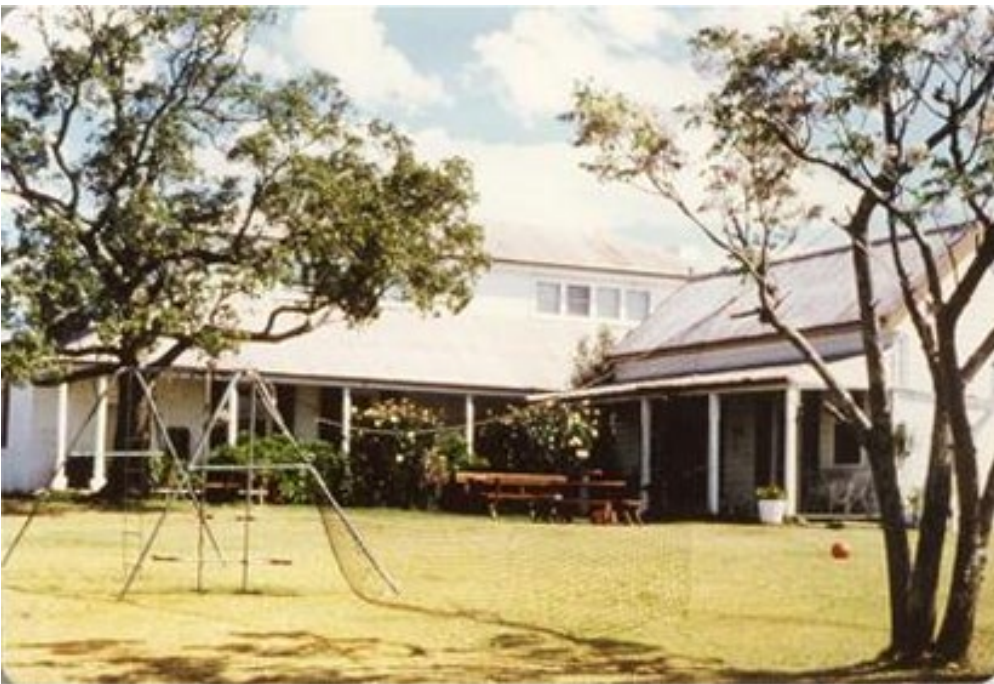
**Figure 2-13 1979 southwards view of the rear of Meadowvale showing the kitchen on the right.**

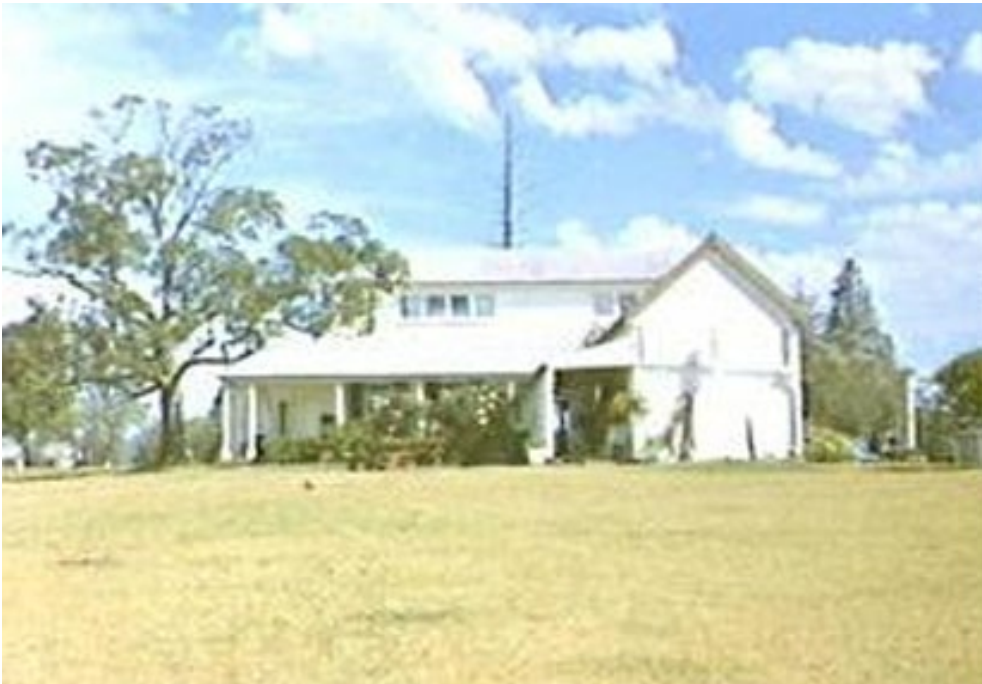
**Figure 2-14** 1979 view towards the rear of the homestead and northern wall of the kitchen on the right.

Source: private collection accessed by NBRSPartners. Note the Norfolk Island pine seen in earlier photos has died.

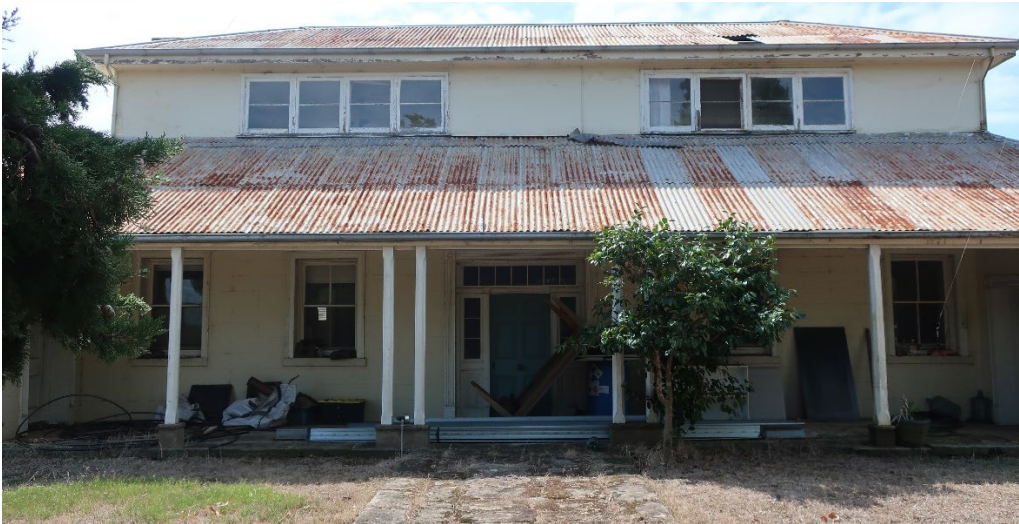
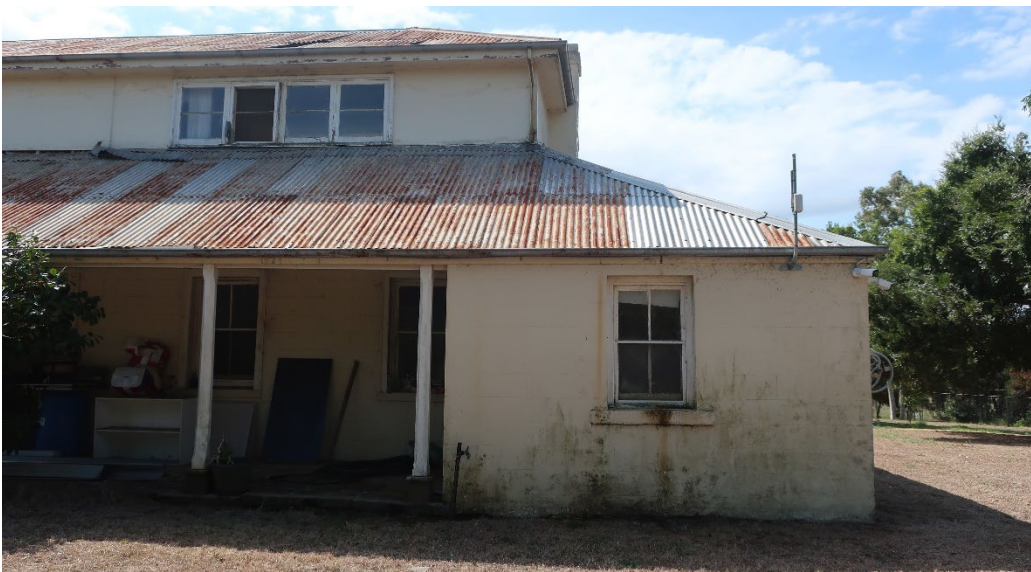
The homestead is constructed of massive sandstone perimeter walls, full brick internal walls, timber floor and roof structure, with good quality joinery remaining. The perimeter walls are made of sandstone blocks laid with lime mortar in irregular ashlar. The walls are 610 mm thick, which is unusually massive. This allows for deep reveals for the fenestration. The walls are plastered inside and rendered with ashlar lining on the exterior. The internal walls on the ground floor are 230 mm double brick. A section of damage reveals that the bricks are 75 mm high, which is surprising that the standard German brick size was used, when a house of around 1830 would normally be expected to have the traditional English brick height of 65 mm.

**Photo 3-3** The entry south elevation, shown in sections due to the planting nearby

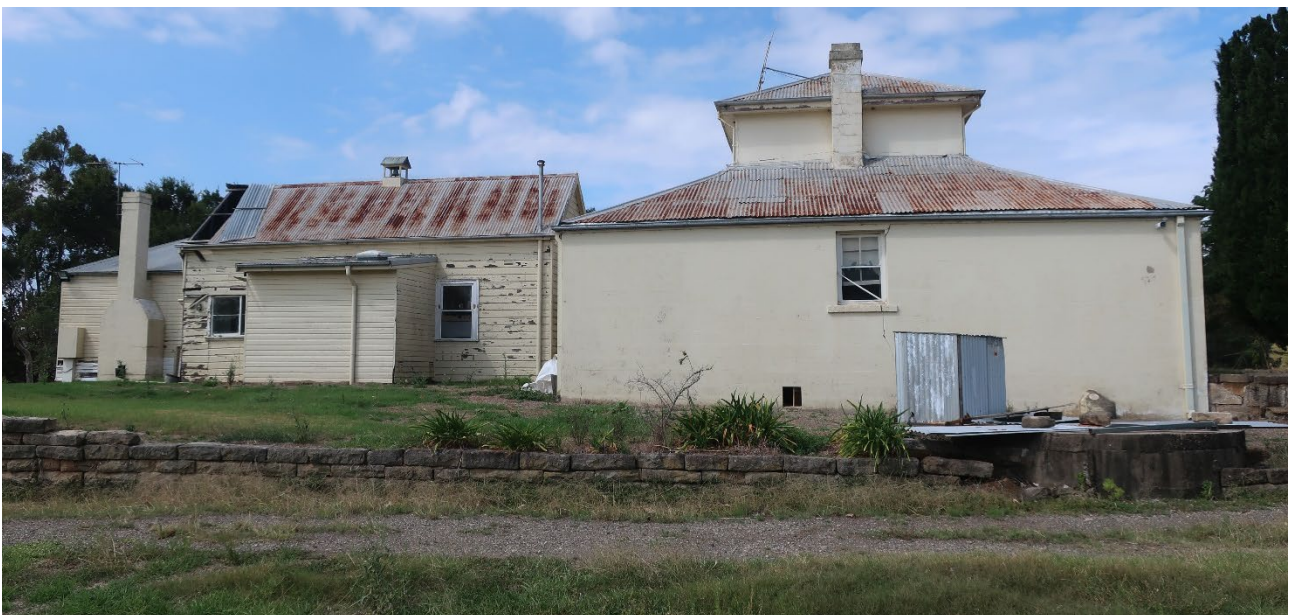
**Photo 3-4** The west elevation of the homestead (right), the kitchen wing (centre-left) and a c1990s neo-Victorian building on the far left

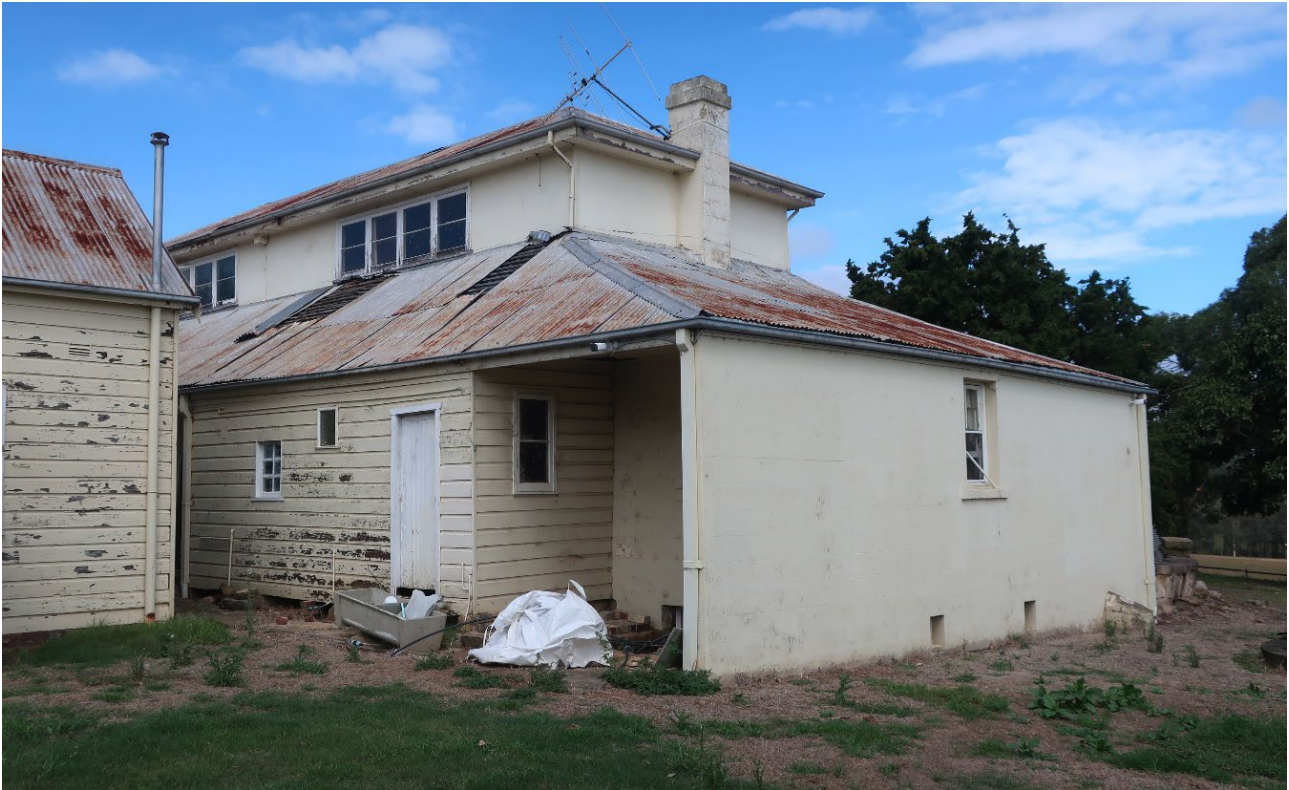
**Photo 3-5** The north-west corner of the homestead has a semi-enclosed section leading to a subterranean cool room

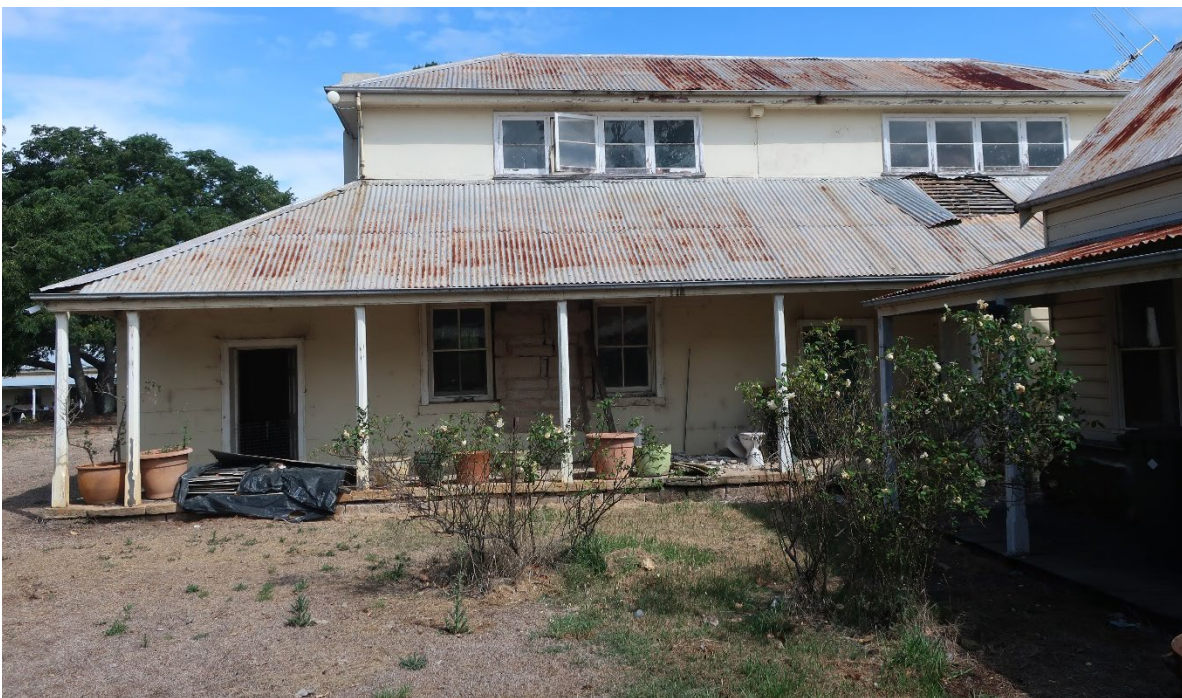
**Photo 3-6** The north elevation of the homestead

The floor is supported on the masonry perimeter walls with likely masonry piers within the under-floor space. Hardwood joists 70 x 140 mm support butt-jointed floorboards that are 20 mm thick and 140 mm wide. The first floor is likely to have deeper bearers supporting the same 140 x 20 butt jointed floorboards.

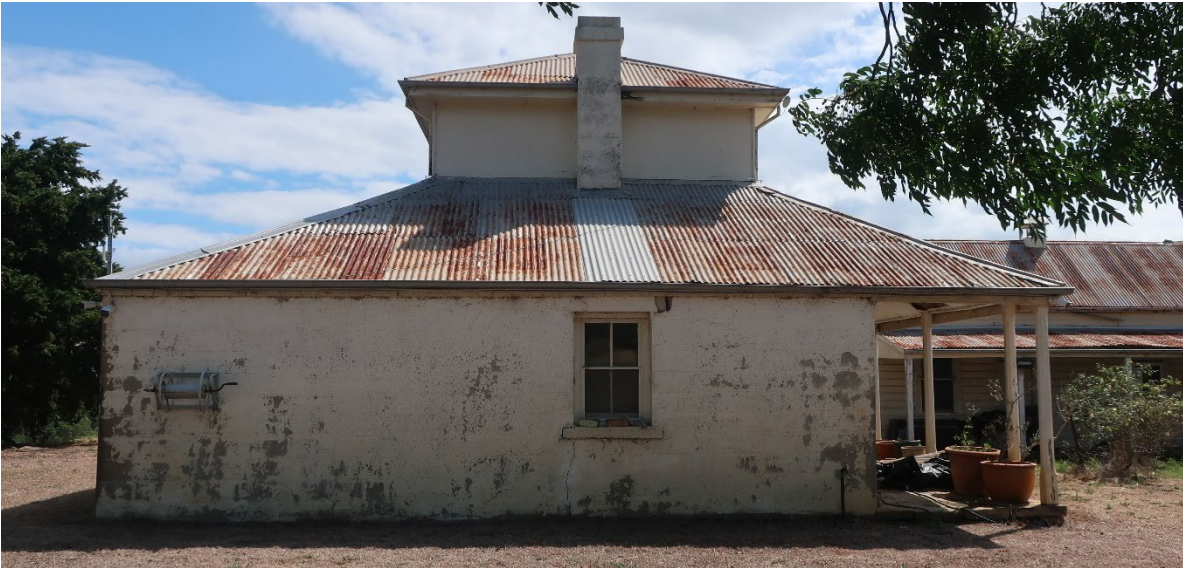
**Photo 3-7 The east elevation of the homestead**

The joinery is of a high standard. If it is original, it is an indicator of the established image sought by Andrew Hume. Helen Proudfoot stated in her 1973 report that, "Doors and windows have been replaced." The ground floor joinery has a Georgian style. The front door and doors between habitable rooms are framed with six panels with fine Georgian style mouldings holding each slim panel into the frame. Much of the original hardware remains, including locks. One timber mantelpiece remains in the east room. It is a slim item, with many decorative grooves and a turned box in each top corner. The skirtings remain in the building; they have Georgian profiles, with some slight differences between rooms. There are profiled architraves around internal doors and the windows that sit in deep recesses lined with plain timber.

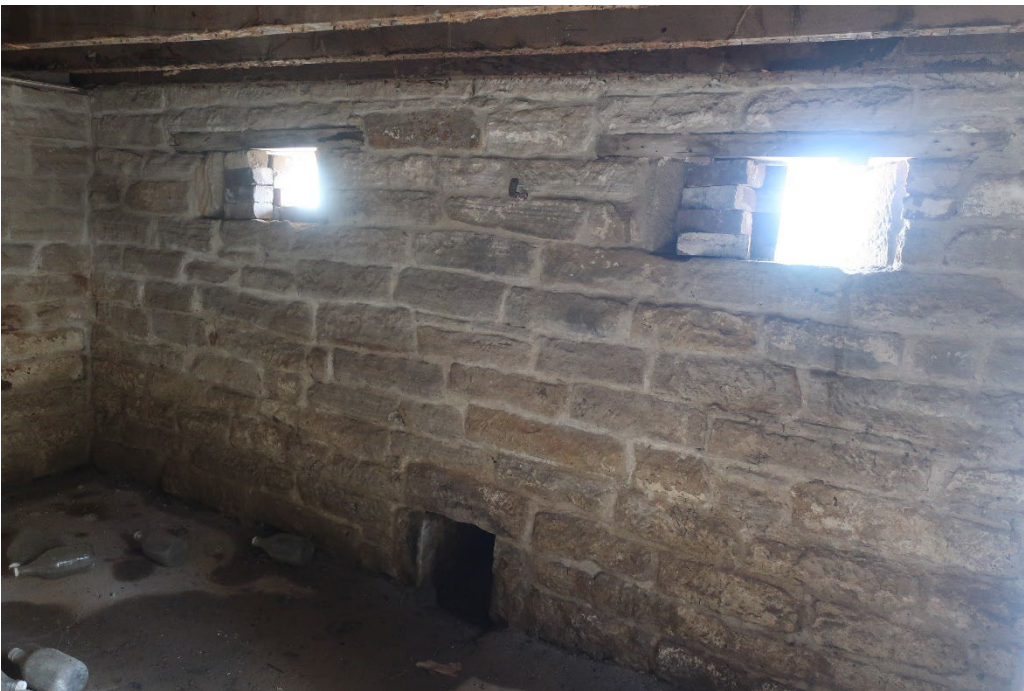
**Photo 3-8 The basement cool room under the west end of the homestead**

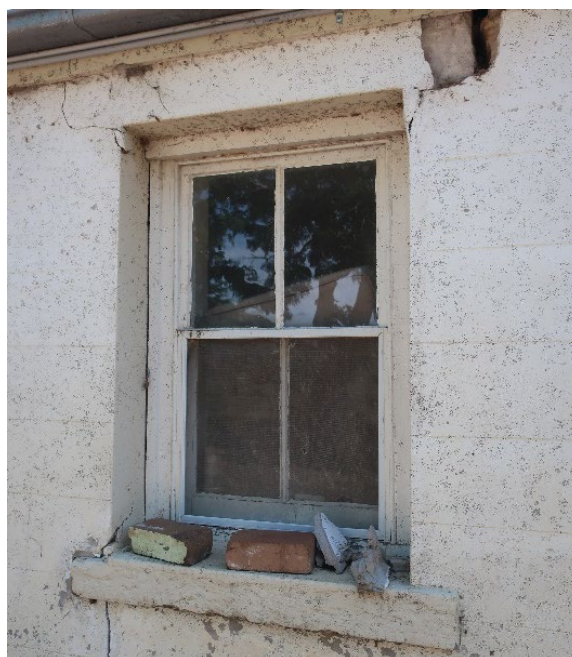
**Photo 3-10** A typical original sash window in the east facade

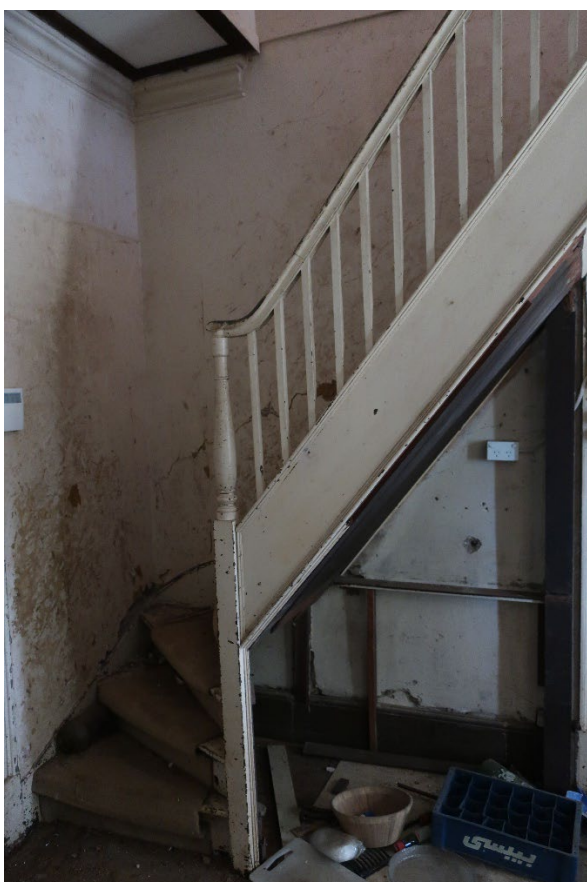
**Photo 3-11** The stair is clearly original

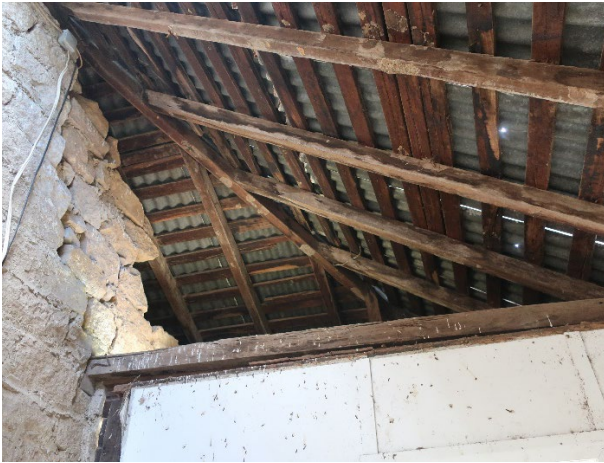
**Photo 3-13** Original roof framing above the former laundry on the northern side of the homestead

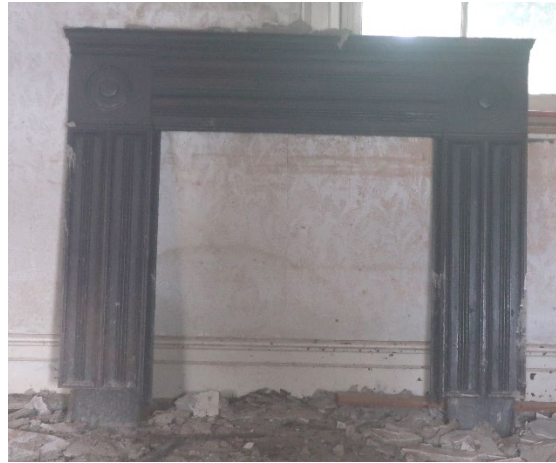
**Photo 3-14** The Georgian mantelpiece salvaged in its original east room

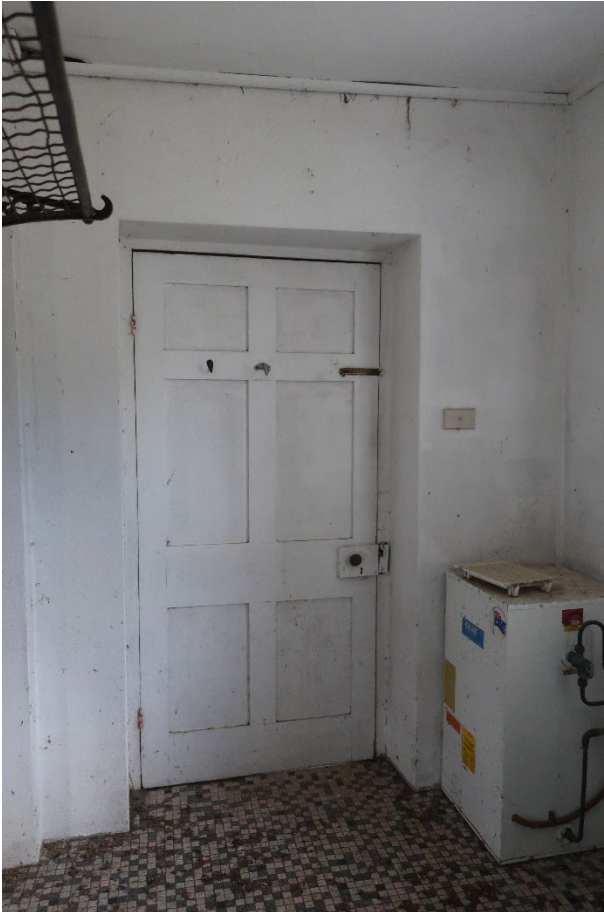
**Photo 3-15** A likely original door by the 1960s bathroom fit-out

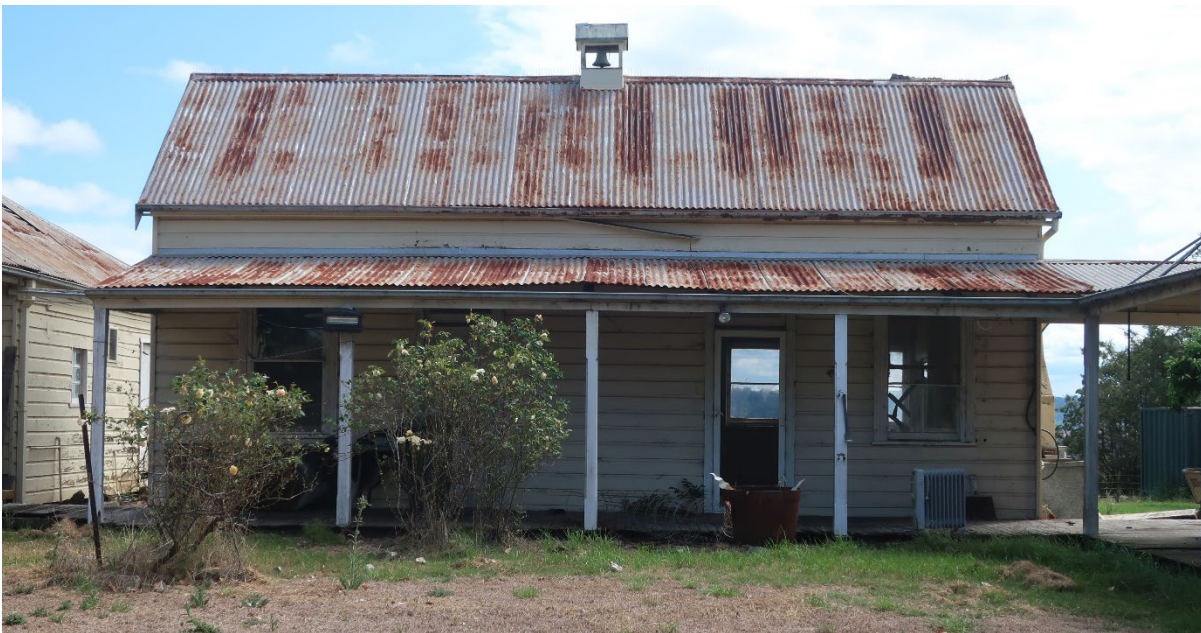
The fenestration is finely detailed for a service building in early Federation style with richly profiled architraves, four-panel doors with a low lock rail, windows are sliding sash with one or two panes to each sash.

**Photo 3-17 The front east elevation of the kitchen building**

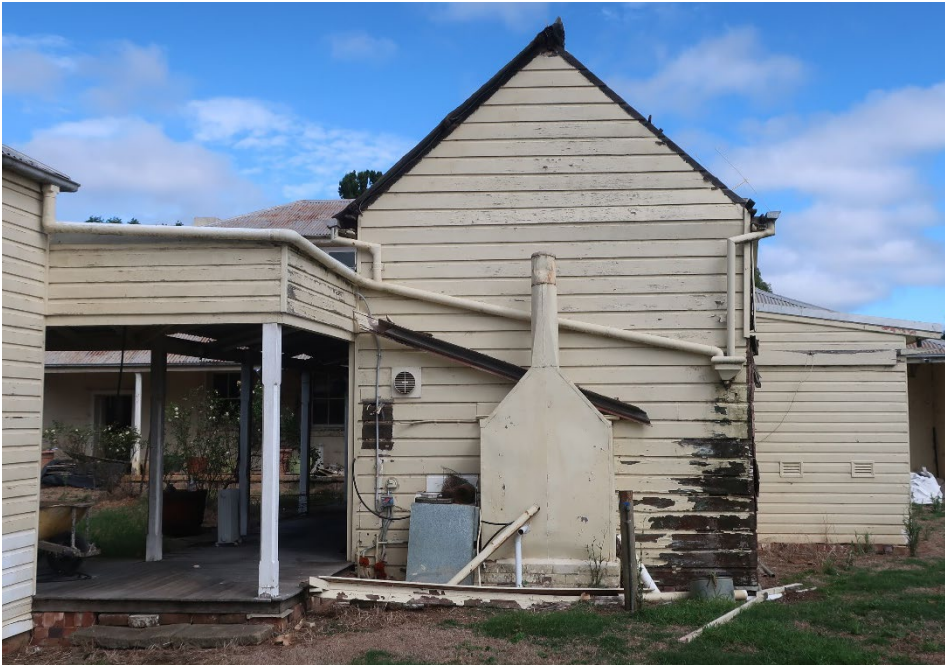
**Photo 3-18 The northern elevation of the kitchen building**

The interior of kitchen is lined with timber, consisting of a low skirting, vertical boards as a dado, topped with a chair rail, then v-jointed horizontal boards up to the ceiling. The ceiling in the south room is pressed metal with a cornice in Federation Art Nouveau patterns, while the northern kitchen room has a v-jointed timber board ceiling and a timber coved cornice.

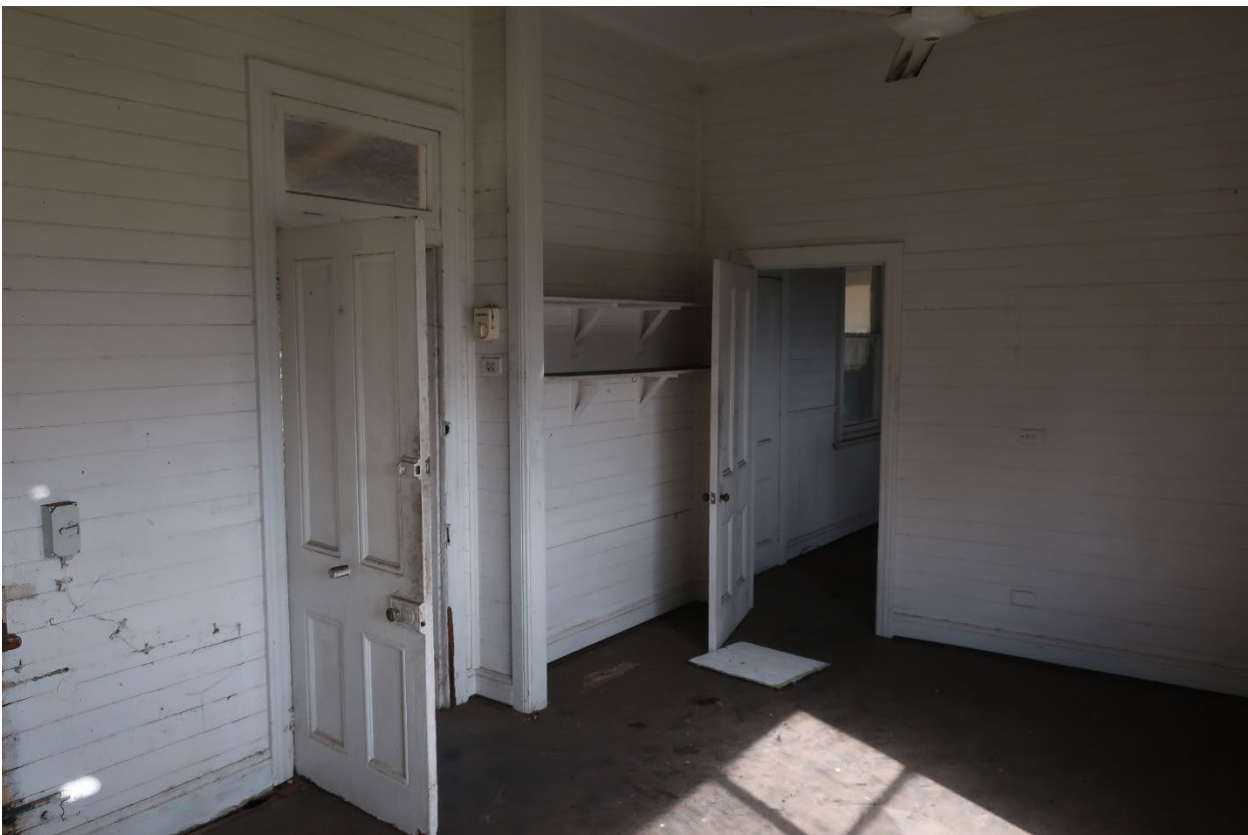
**Photo 3-19 Original early Federation doors, pressed metal ceiling and wall cladding in the kitchen**

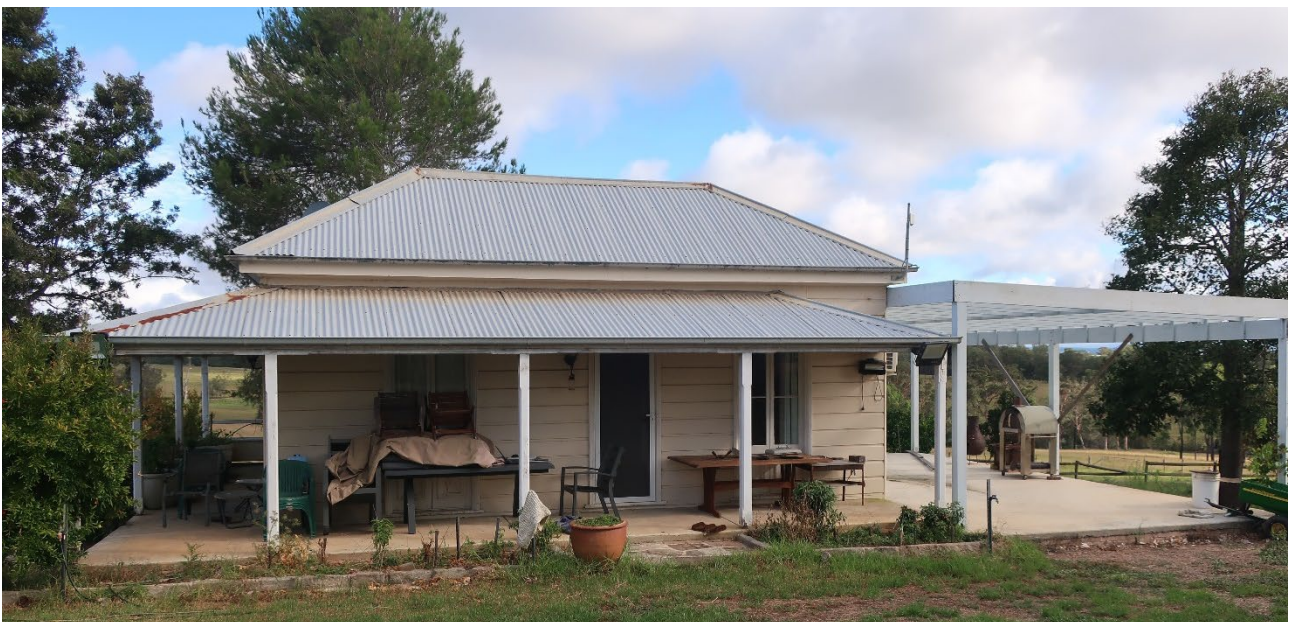
The architraves and fenestration are all convincing to be from around the 1890s. The evidence from aerial photographs shows that this cottage was moved here from 'Glenlorne' around 1976 to provide additional accommodation for the riding school operating at Meadowvale.<sup>5</sup> The brick footings and concrete slabs of the verandah date from c1976. The concrete slab on the western side was laid after 2010.

**Photo 3-20 The northern front of the southern cottage**

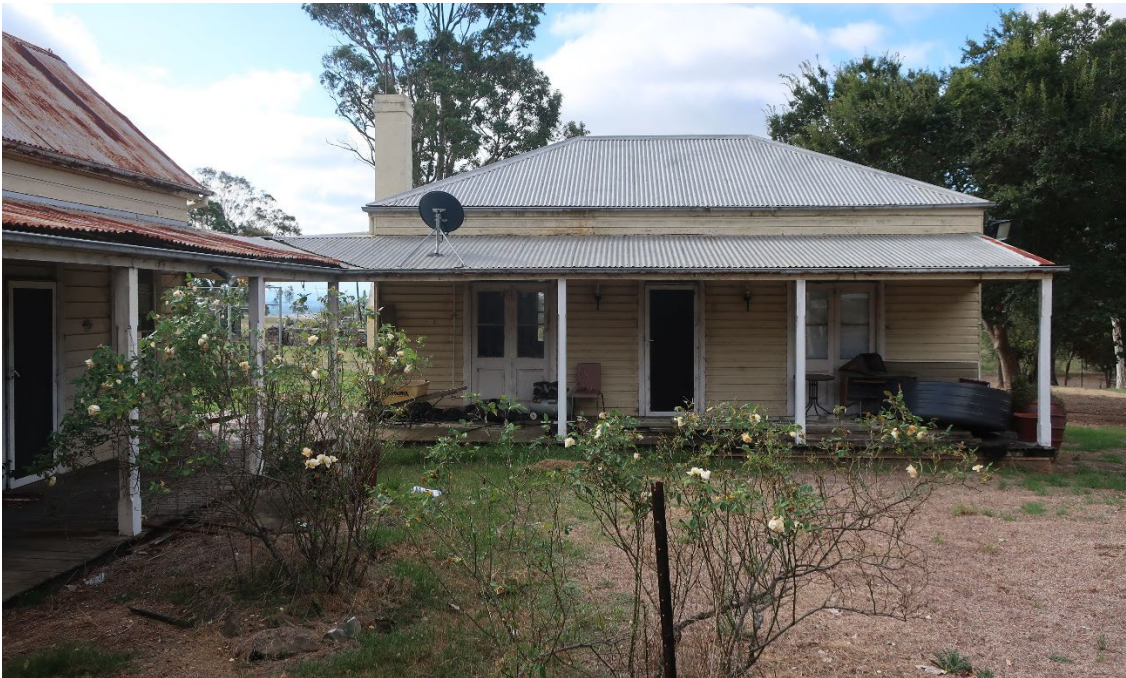
The windows are vertical sliding sash type, with a shorter lower sash in each, which is unusual. The front façade faces south and is sheltered by a verandah so the French doors are protected from rain. This façade has a central front door and a set of French doors on each side. The doors appear to be 1980s work. The interior is lined with particle board floor sheets. The walls and ceiling are lined with plasterboard with modern plaster coved cornices. There is a bagged brick fireplace, and a timber firewood box nearby. The building fabric agrees with the documentary evidence that it was between 1979 and 1984.

**Photo 3-21** The southern entry front of the northern cottage
