# Meadowvale

Conservation Management Plan

Report No. R.02

Date: September 2025

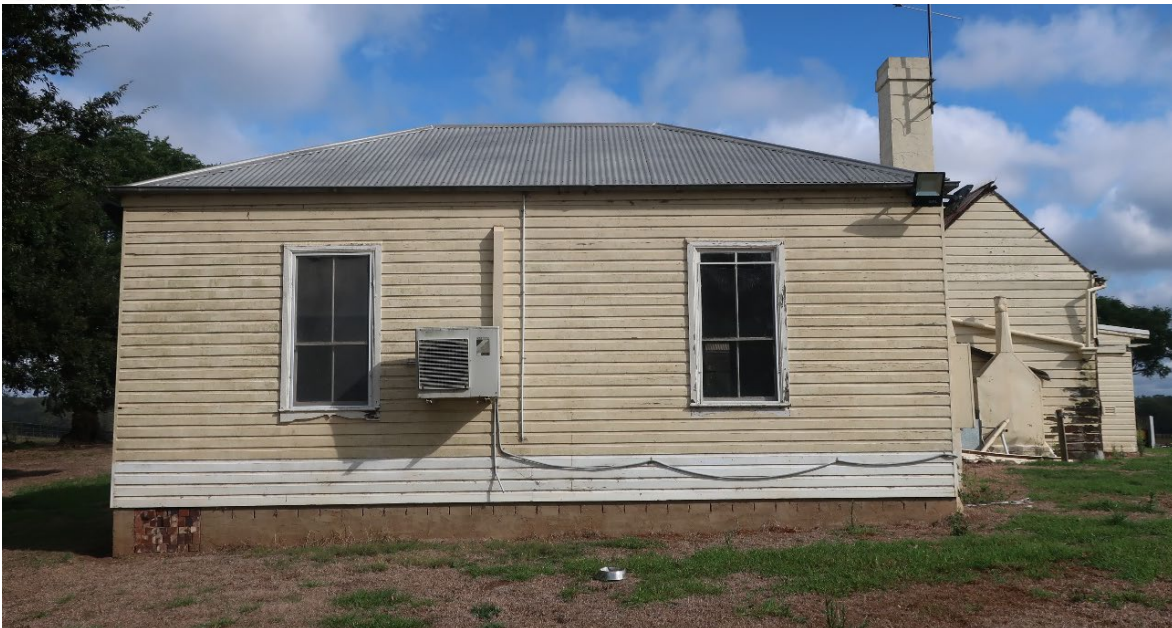
**Photo 3-22** The northern façade of the northern cottage, the kitchen is seen behind on the right

The northern cottage is located to the north of the homestead and attached to the kitchen with a timber-framed walkway, forming a semi-enclosed courtyard open to the east. The cottage is a single room space detailed to resemble a late Victorian timber cottage. It has a modern brick plinth, piers, and at the western end there is a chimney with an external fire breast, that is bagged and painted in an early Victorian style that was common in regional dwellings. The walls and roof are framed in conventional timber. The walls are clad in weatherboards cut with a rusticated pattern at a smaller scale than those of the adjacent kitchen. The hip roof is clad with corrugated steel and is shaped with minimum overhang for the quad guttering.

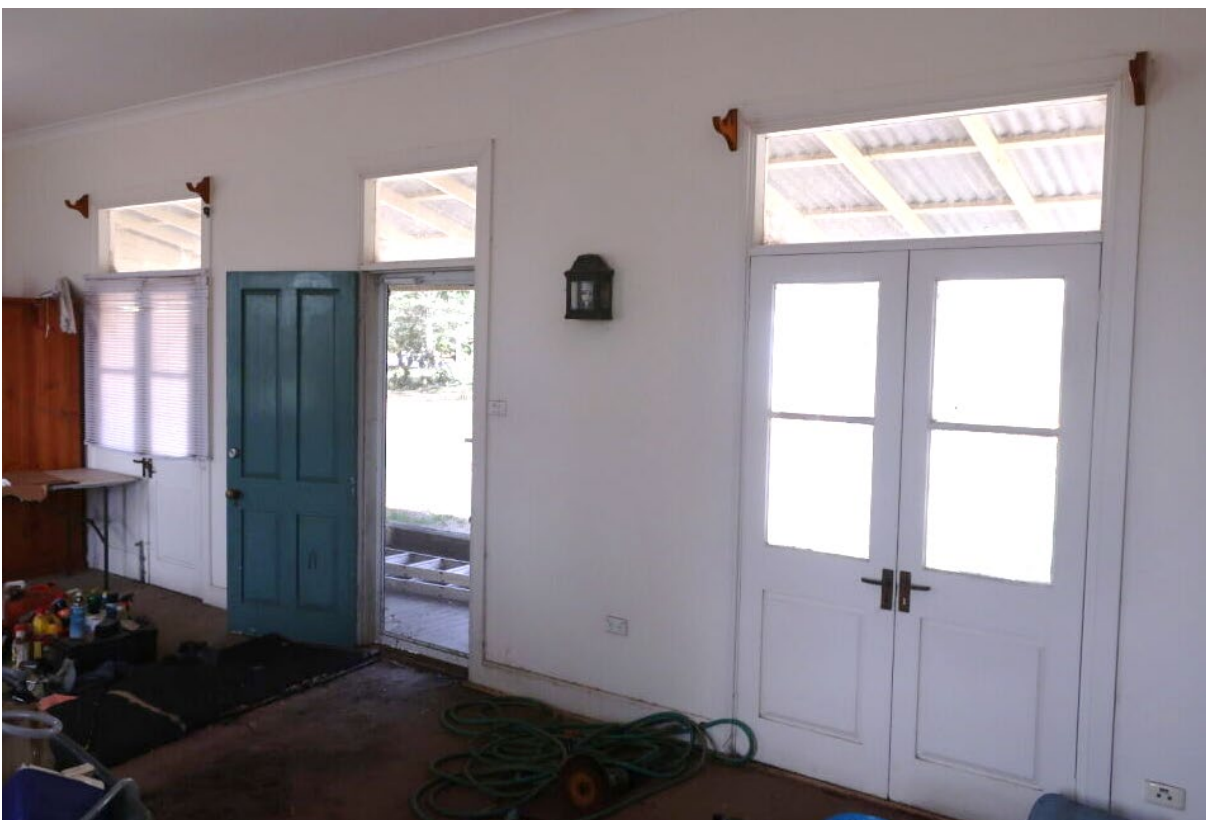
**Photo 3-23** Interior of the northern cottage

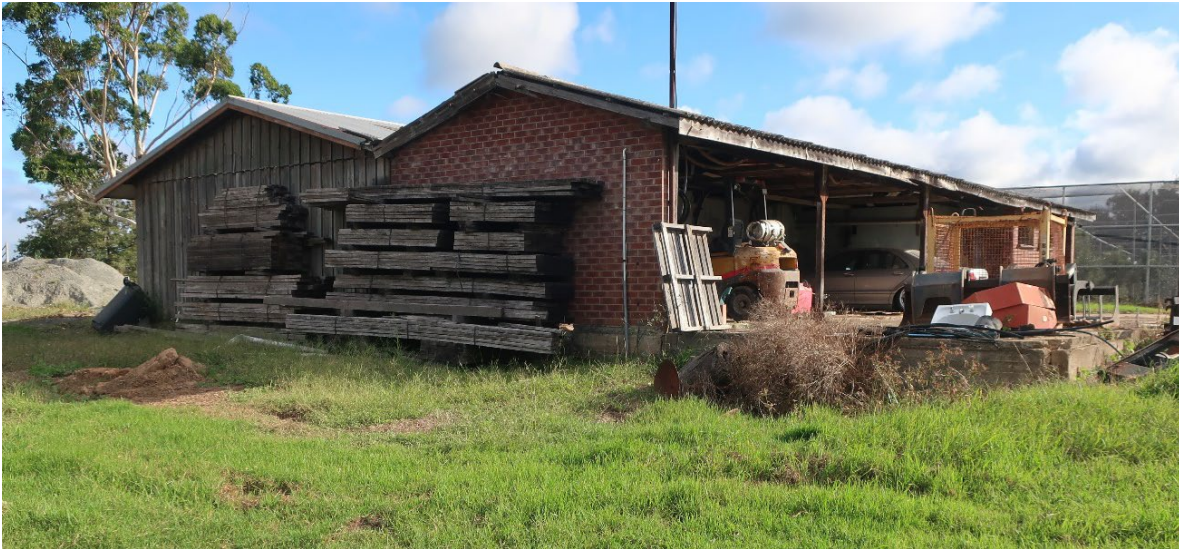
There is a post-war shed located 100 m north-east of the homestead. The northern brick section was likely built to protect farming vehicles. There are smaller enclosed spaces at the western end for storage of smaller items and a bathroom. It is built with red brick walls on a concrete footing and has corrugated asbestos sheet roofing of a type developed in the 1950s. The internal doors are ledged timber. The

attached southern shed has vertical timber cladding and a corrugated steel roof, typical of the late twentieth century.

**Photo 3-24 The farm shed, looking south-west**

In the mid twentieth century, there was a steel sheet silo in the south-western corner of these two sheds. This silo was likely installed when the adjacent shed were built in the early post-war period. The silo was removed in the 2010-15 period

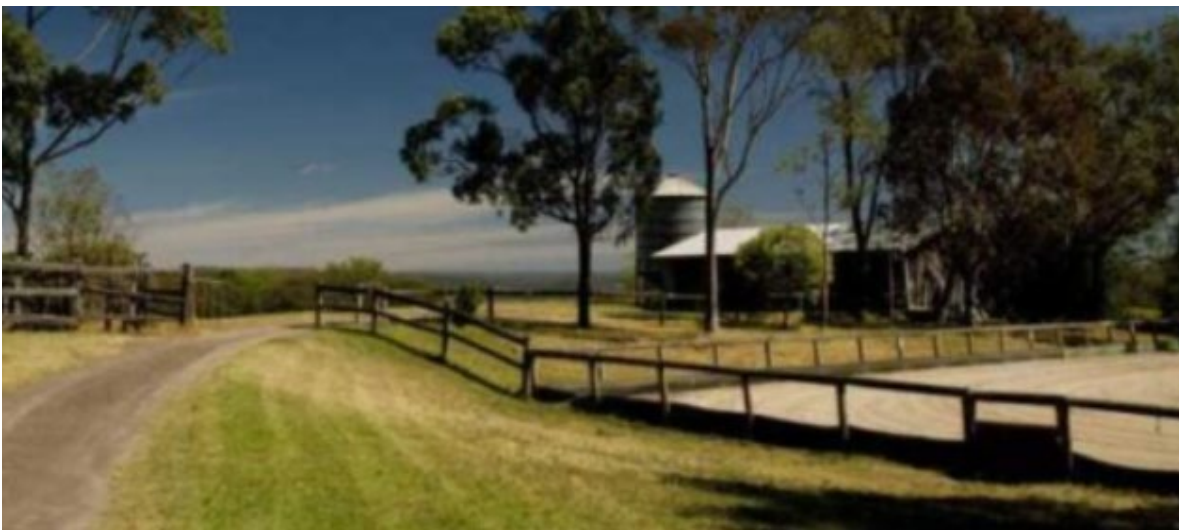
**Photo 3-25 The steel silo (now removed) adjacent to the agricultural sheds**

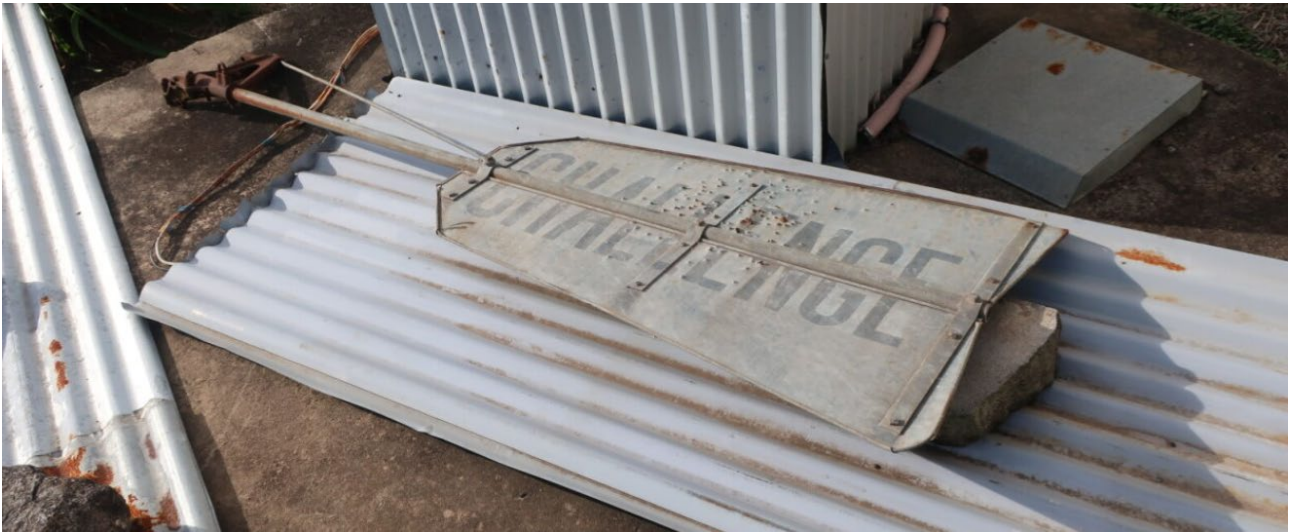
There was a windmill located a short distance west of the homestead, seen in **Figure 2-6**. While it no longer stands, there are some cast iron remains lying nearby that appear consistent with the inter-war period. This windmill raised water for household use. It is noted in the clearing sale of July 1941 following the death of Mr AM Sutton.

**Photo 3-26** Remains of the windmill on the concrete septic tank, west of the homestead

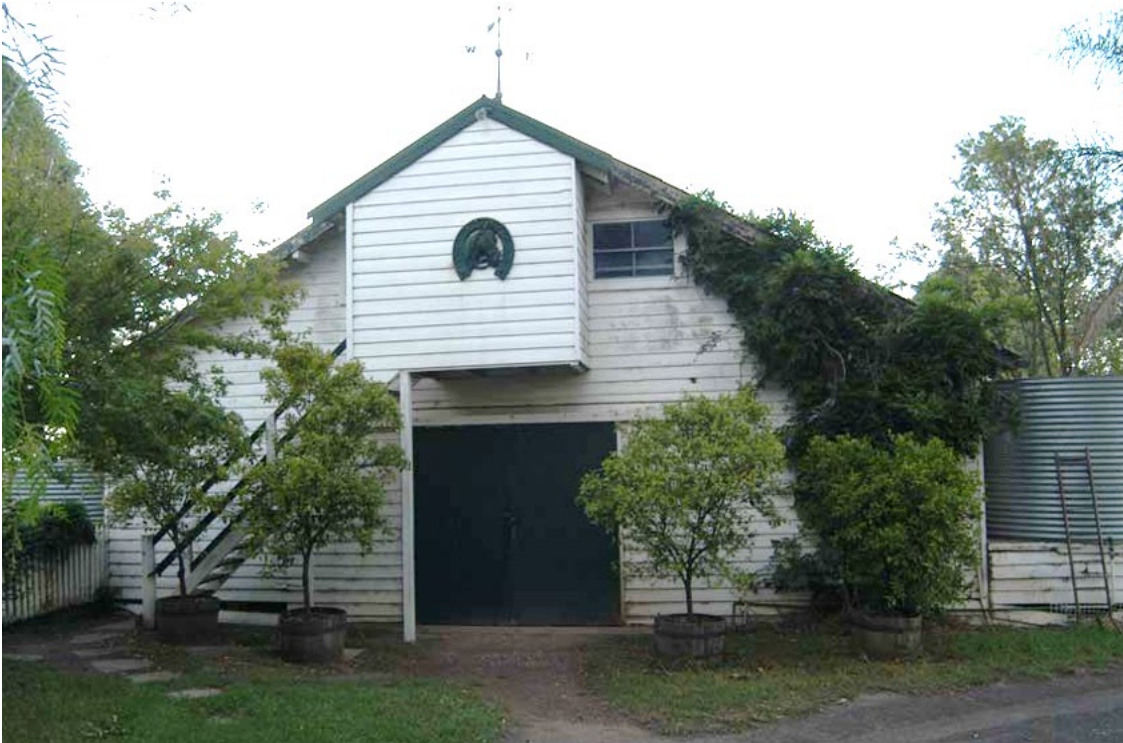
A timber stable with loft towards the northern end of the Meadowvale group was located shortly to the north of the elliptical drive. It appears to have been built in the early post-war period. This stable had a simple gable with the ridge running north-south. It was clad in weatherboard. The windows seen in the 1950s in **Figure 2-8**, and they have a late inter-war character. The stables were removed with the approval of Council after 2010. The cast iron horse and horseshoe plaque on the building seen below, remains on site.

**Figure 3-2 The stables, southern front**

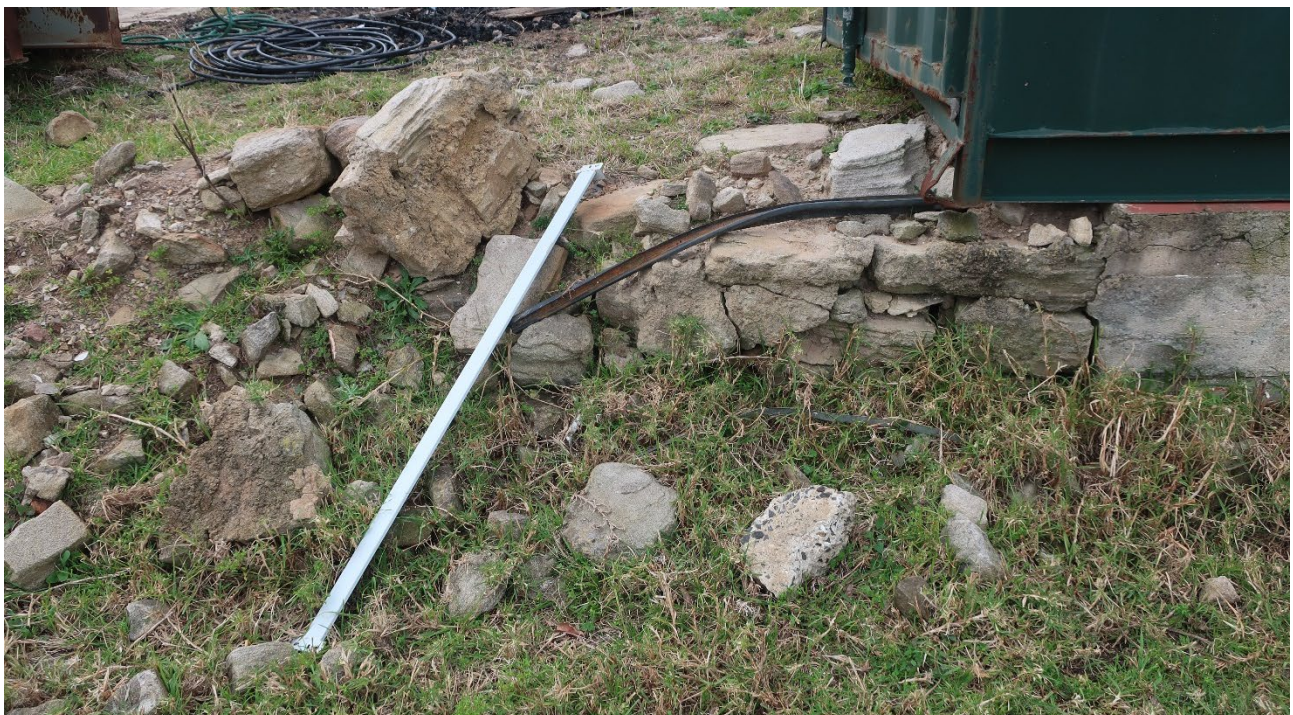
South-west of the stables, there was a rough stone building of a single storey, whose stone elements may have been built in the early nineteenth century. Many of the stones were unshaped rocks, crudely bonded together in thick walls with a soft mortar. The plan below shows a single space with small openings and a hearth at the east end for cooking. This cottage was later extended towards the north with fibre-cement cladding and bricolage over the twentieth century. The dwelling burnt down after 2010, leaving some plinth

**Figure 3-4** Remains of the rough stone cottage following a fire

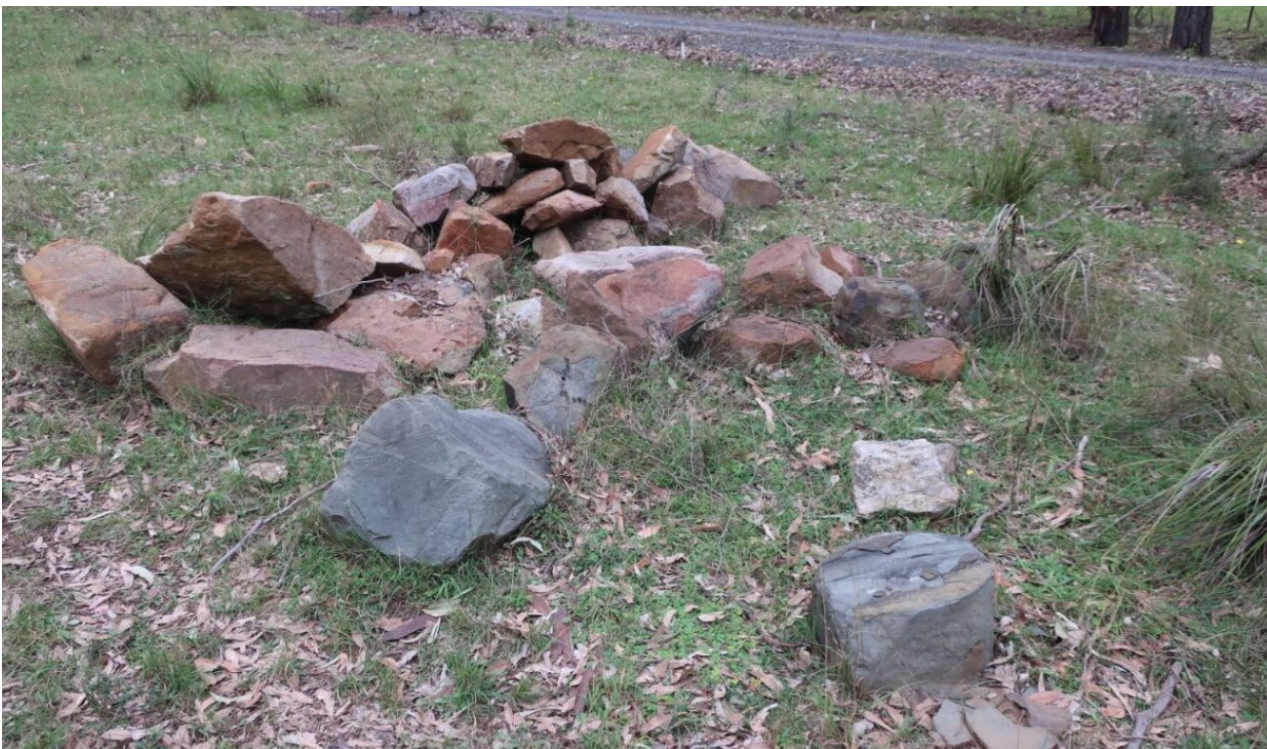
**Photo 3-31** unshaped sandstone and mudstone located 200 m west of the property entry

There are two piles of unshaped stones near the driveway, within 200 m of the entry to the property. These stones are a mixture of sandstone and mudstone. The stones are different to the pale cause sandstone used in the homestead and remains of other early buildings at Meadowvale. One of the piles of stones is gathered over a steel star picket. Star pickets have been in use for about a century, so these piles of stones are not remarkably old. However, the stones have been in place for many decades because there are many layers of exfoliation in place. It is possible that these stones were dumped on the site with the intention of using them in drainage works near the driveway and creek. These stones do not appear to have heritage significance.

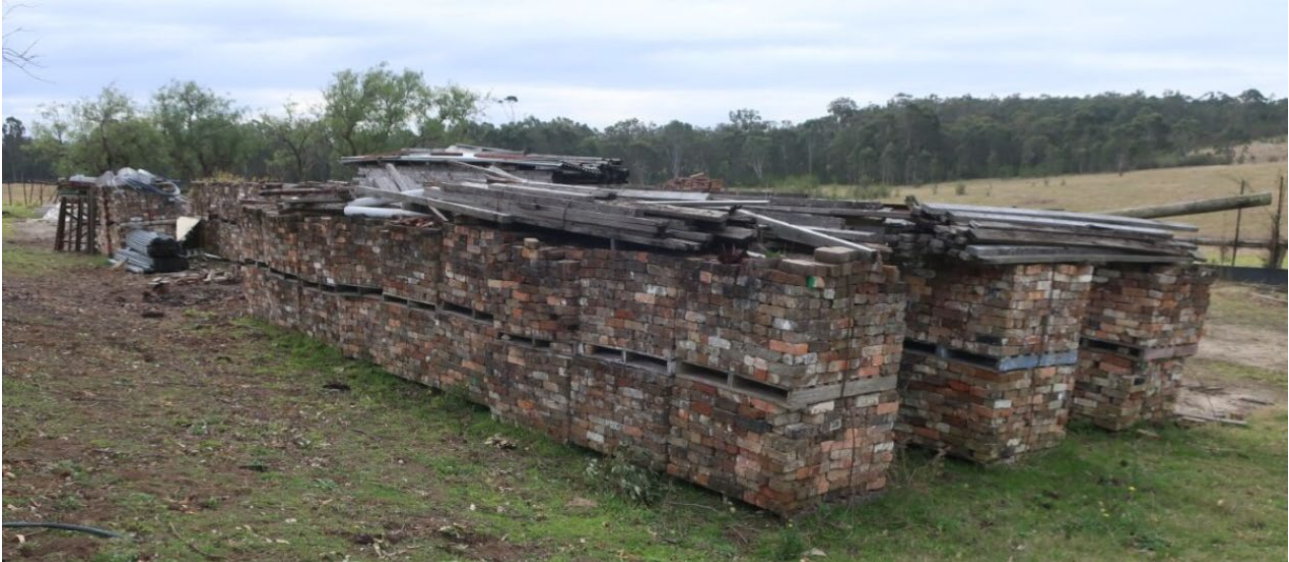
**Photo 3-32 Second-hand building materials on the former dressage area**

There are many palettes of second-hand bricks placed on the sandy dressage rectangle set up for the post-war phase of horse training on the site. These bricks are the traditional English size that was used in Australia before German brick making machines were imported in the late nineteenth century. These bricks, hardwood timbers and other second-hand building materials were brought to the site after 2015 and have no historical connection to the Meadowvale property. See Photo 3-30.

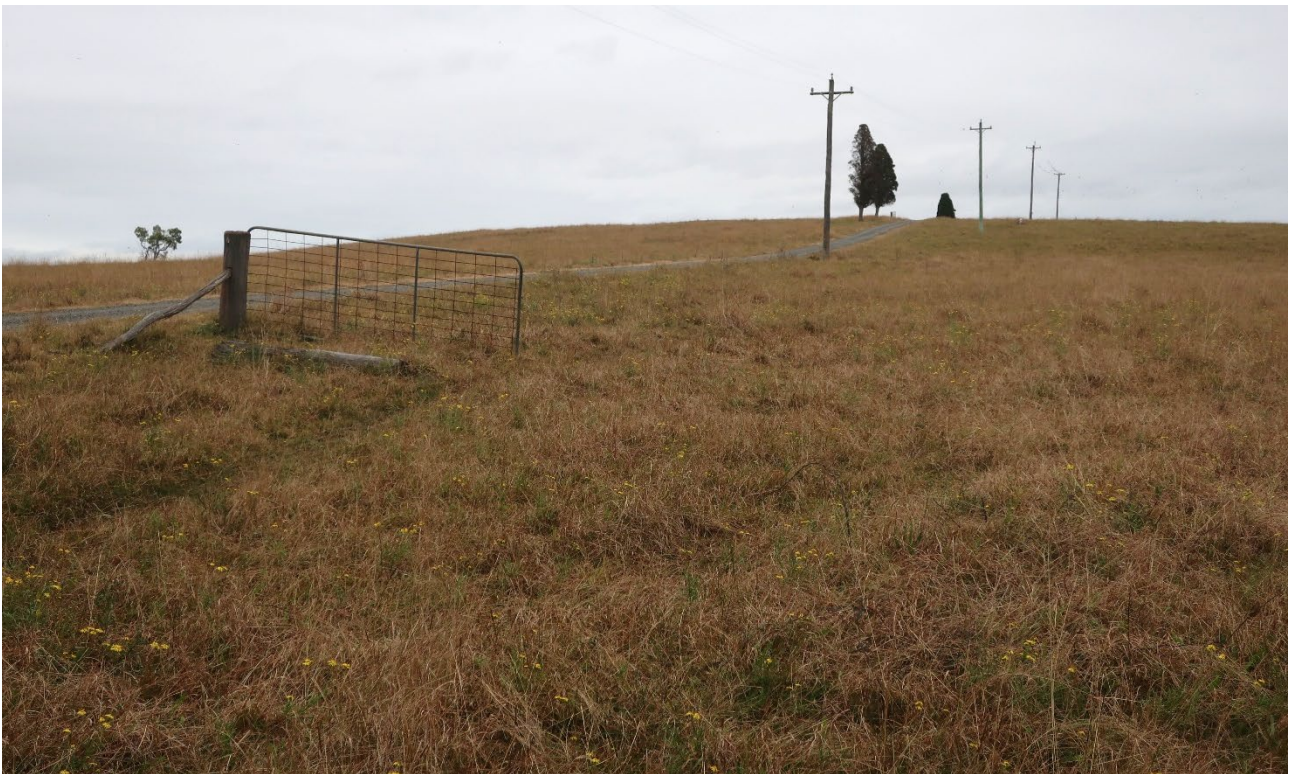
**Photo 3-36** View showing the gravel driveway rising over the hill towards the west

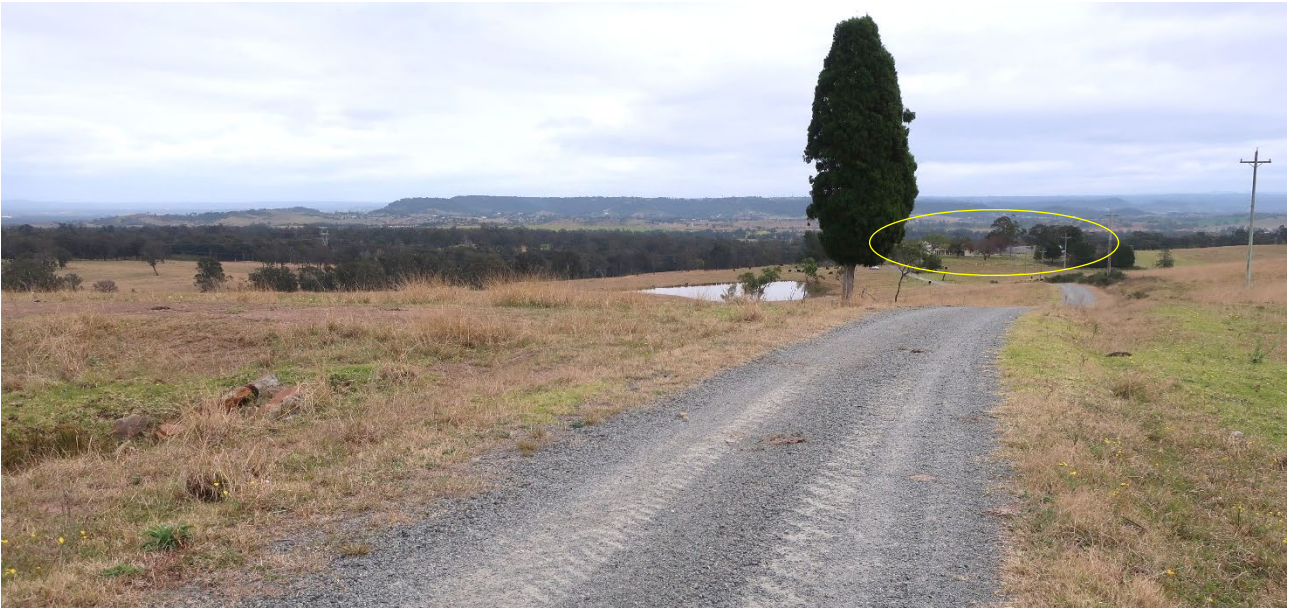
**Photo 3-37** Westward view from the drive over the Meadowvale hilltop. The homestead is circled

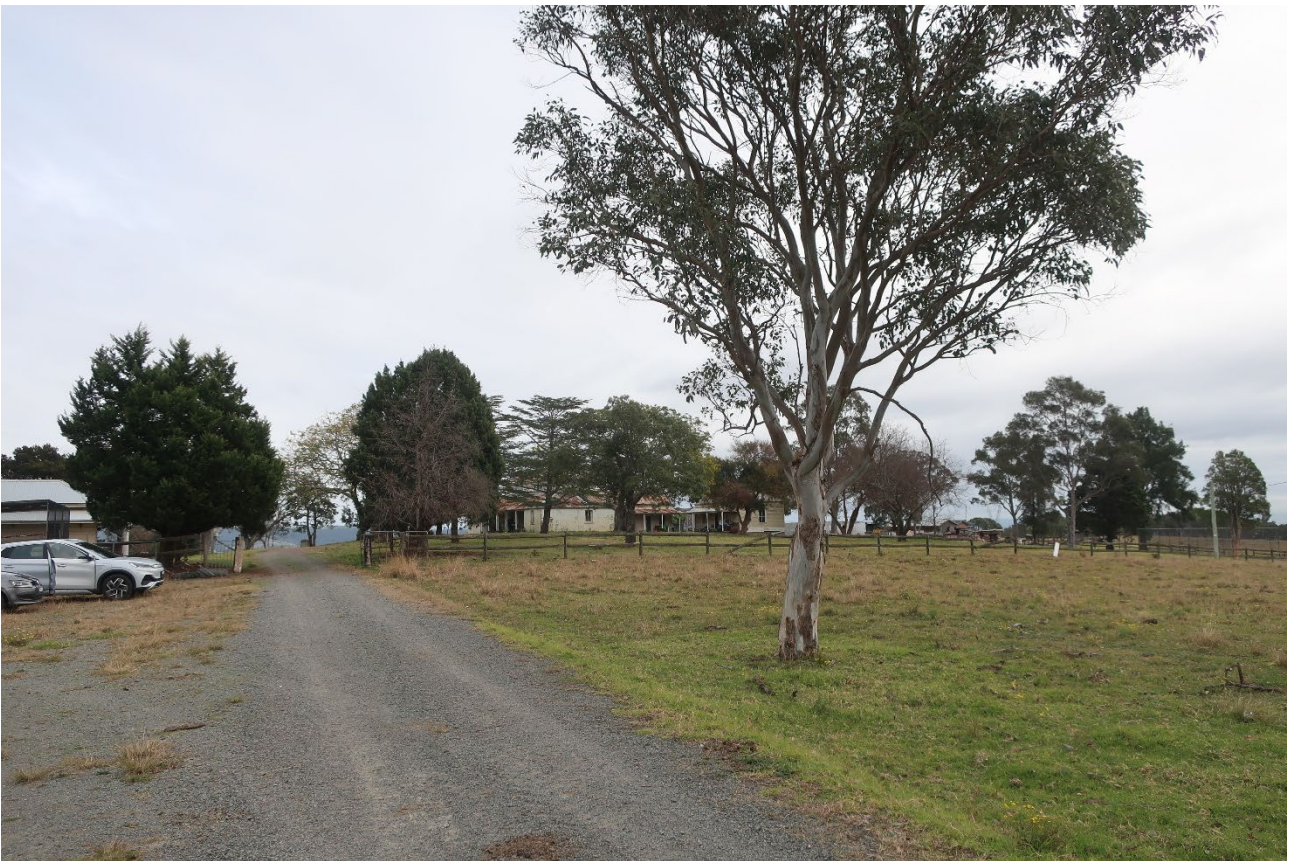
**Photo 3-38** The driveway approach to the fenced home garden, looking west

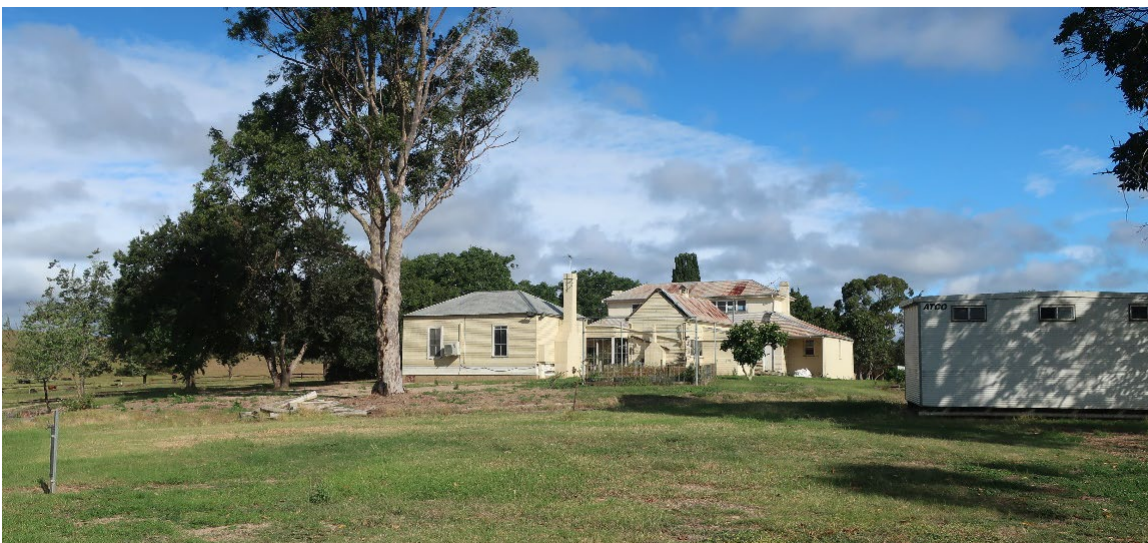
**Photo 3-40** Southwards view towards the rear of the two-storey homestead, looking over a traditional working farm landscape

The long rear elevation of homestead and its traditional first floor windows look northwards over the working agricultural landscape behind the homestead. The fenced tennis court located north-east of the homestead was built in 1980 and has a tall screen of trees on the northern and eastern sides.

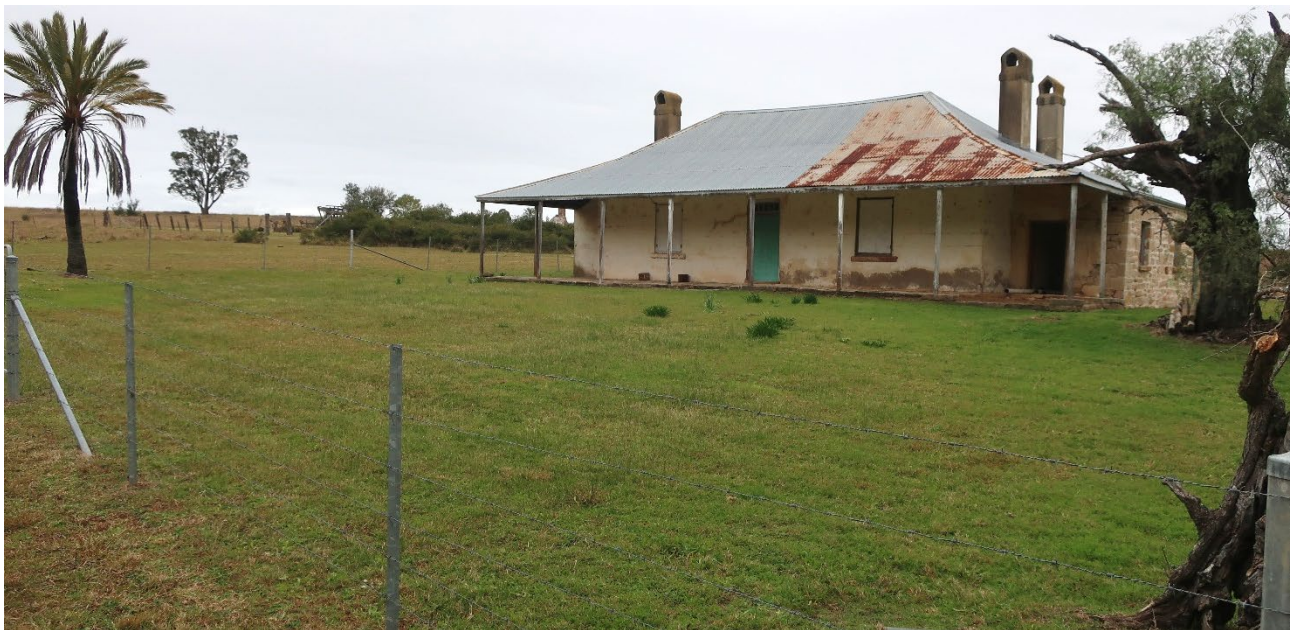
**Photo 4-1** Beulah Homestead, seen looking south-west

The Beulah homestead is located over a ridge to the north of Meadowvale such that the two homesteads have no views to each other. However, it is possible to stand on the ridge near the property boundary between the two, and look south-west to Meadowvale homestead, and to look north to Beulah homestead. The ridge is close to the eucalyptus tree seen on the horizon in Photo 4-1.

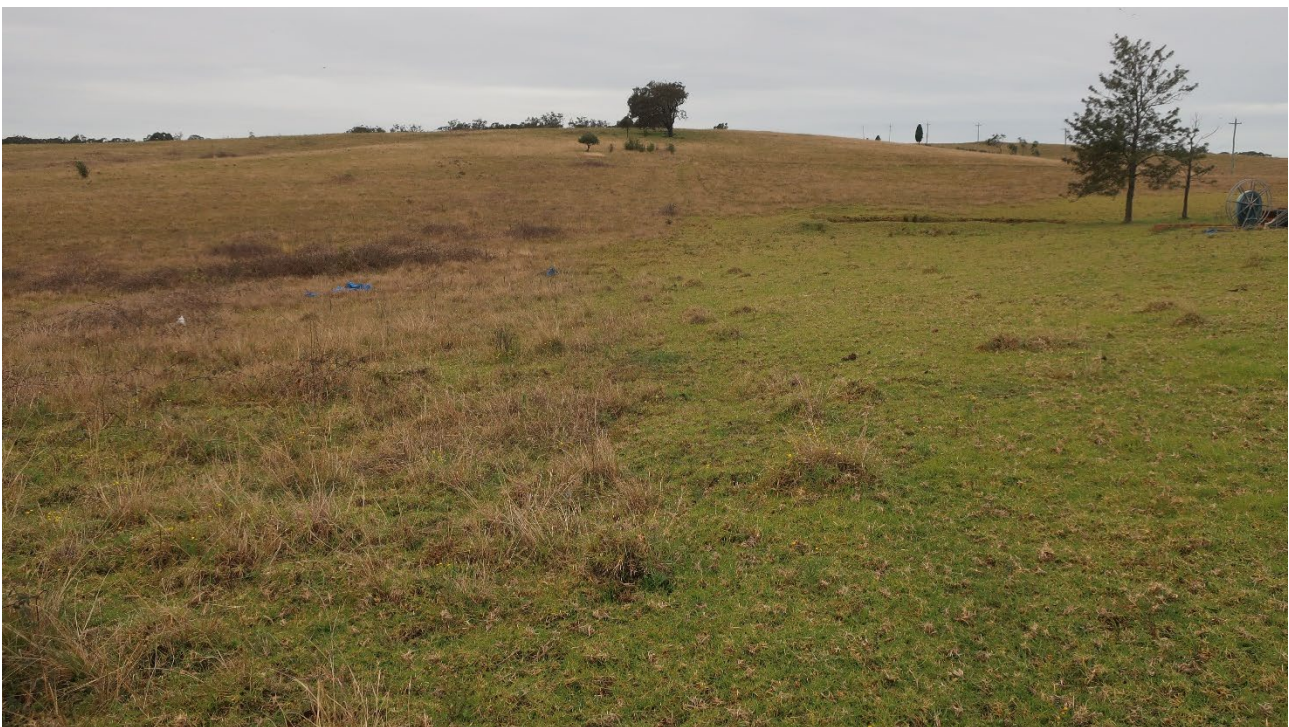
**Photo 4-5** Easterly view from near the Meadowvale home garden looking towards Beulah

Photo 4-5 demonstrates the lack of a view between the homesteads of Meadowvale and Beulah due to the large hill in between.

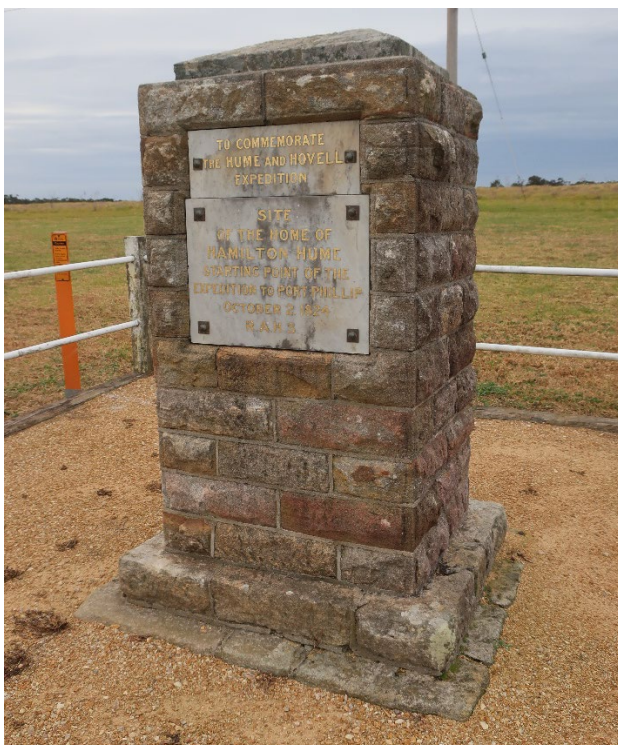
**Photo 4-8 The Hume Monument, Appin Road, Gilead**

The Hume monument is 650 m south-east of the nearest point of the property Meadowvale.

The lower plaque reads, "SITE OF THE HOME OF HAMILTON HUME STARTING POINT OF THE EXPEDITION TO PORT PHILLIP OCTOBER 2. 1824 R.A.H.S." A fence of timber posts and steel rails surrounds the monument. Meadowvale is a former property of Andrew Hume, father of Hamilton Hume, so there is a close historical association between it and the Hume Monument.

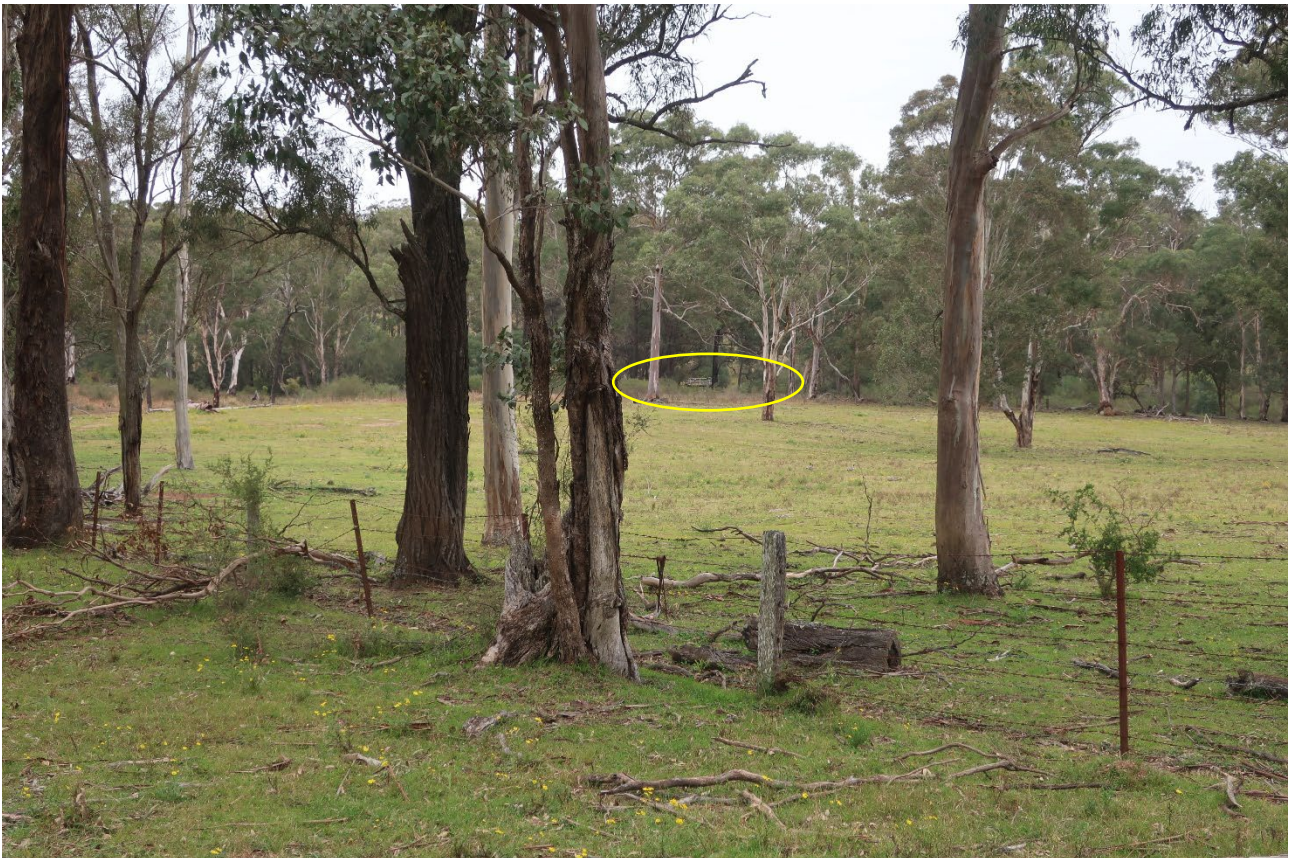
**Photo 4-10 View from Meadowvale property towards the Upper Canal System**

The canal is constructed of several different structural systems over its length, including lining of sandstone, shale, concrete and cast iron. The canal is not accessible from Meadowvale, and it is difficult to see from Meadowvale. The listing notes that the water of the canal moved through wrought iron aqueducts as it flowed over creeks and other deep depressions. The canal passes over Nepean Creek 160 m west of the south-west corner of the property Meadowvale. The only section of the canal that can be glimpsed from the property Meadowvale is a stop board riser made of concrete with a pipe rail safety railing.

There is only a distant glimpse from within the property Meadowvale to the Upper Canal System, as shown in Photo 4-10. There is no other view from the property Meadowvale to any part of the Upper Canal System.

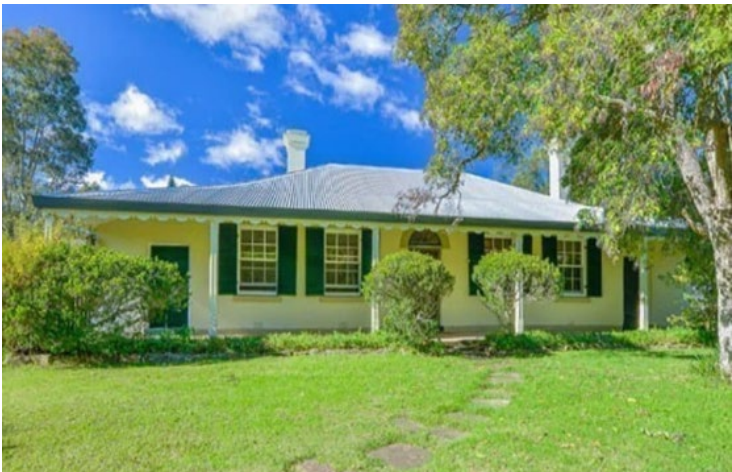
| Location | Details | Image |
|---|---|---|
| <b>Denfield</b><br>Appin Road,<br>St Helens<br>Park | Farmhouse of similar design built in 1837 by John Farley. It also has rendered walls with ashlar lining, a detached kitchen connected by sandstone flagging.<br><br>Photo Source:<br>Jonathan Chancellor,<br>Urban.com | |

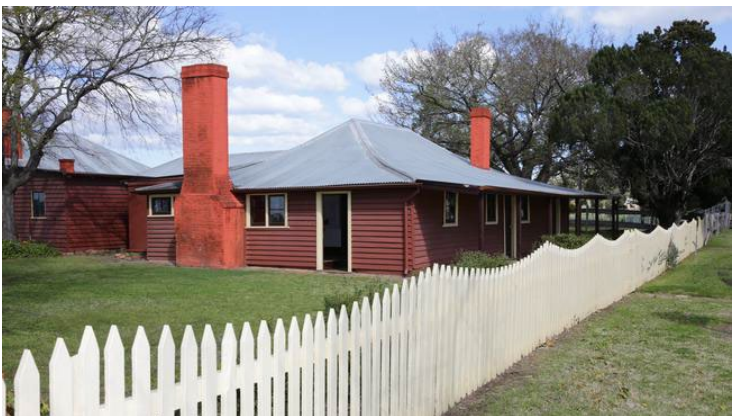
| Location | Details | Image |
|---|---|---|
| <b>Old Belgenny Homestead,</b><br>Macarthur Estate,<br>Camden | Timber weatherboard homestead of similar size and shape, designed by Henry Kitchen, built in 1821. John Macarthur died here in 1834. | |

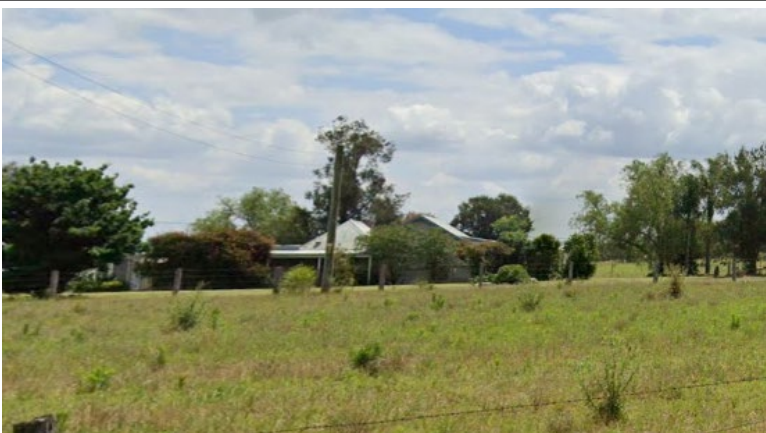
| Location | Details | Image |
|---|---|---|
| <b>Mayfield House,</b><br>Cawdor Road,<br>Cawdor | Single storey brick farmhouse built 1850s with a separate kitchen building. | |

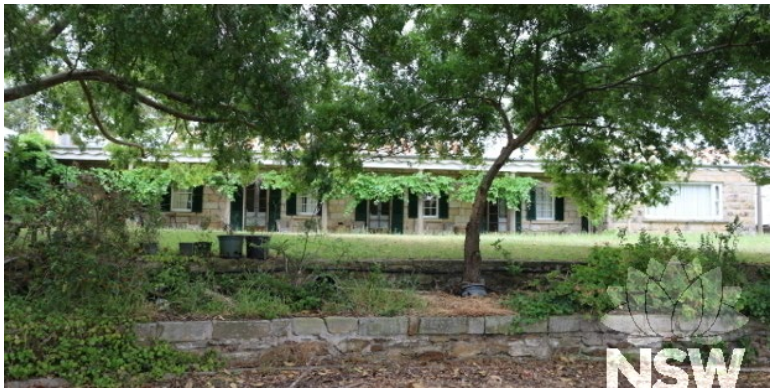
| Location | Details | Image |
|---|---|---|
| <b>Mount Gilead Estate, 901 Appin Road, Gilead</b> | <p>Mount Gilead is a larger and grander homestead than Meadowvale, but in a similar style with a similar plan. Its agricultural service structures are more significant.</p> | |

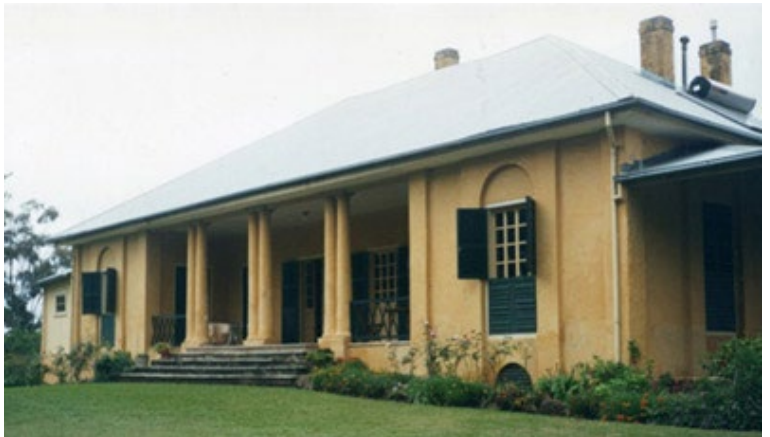
| Location | Details | Image |
|---|---|---|
| <b>Horsley, Fairfield</b> | <p>The Horsley Complex was built 1804-32. It has a similar plan as Meadowvale, but it is built on a grander scale.</p> | |

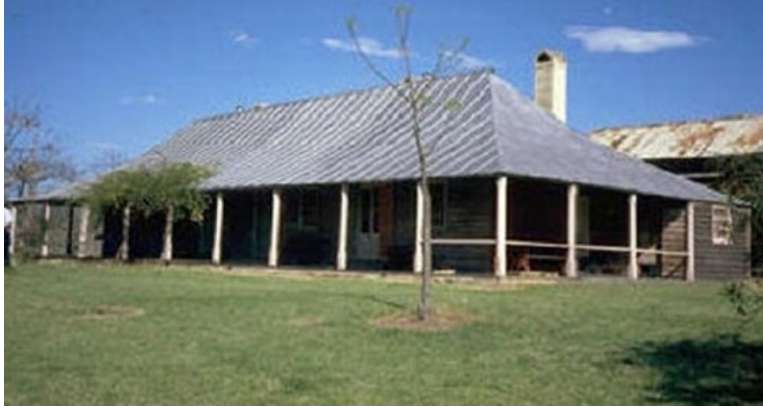
| Location | Details | Image |
|---|---|---|
| <b>The Cottage, 2 St Thomas Road, Mulgoa</b> | Farmhouse from c1810 with similar shape and scale, possibly the oldest weatherboard dwelling in Australia. Similar shape and size to subject building, but this is older and of light-weight materials. | |

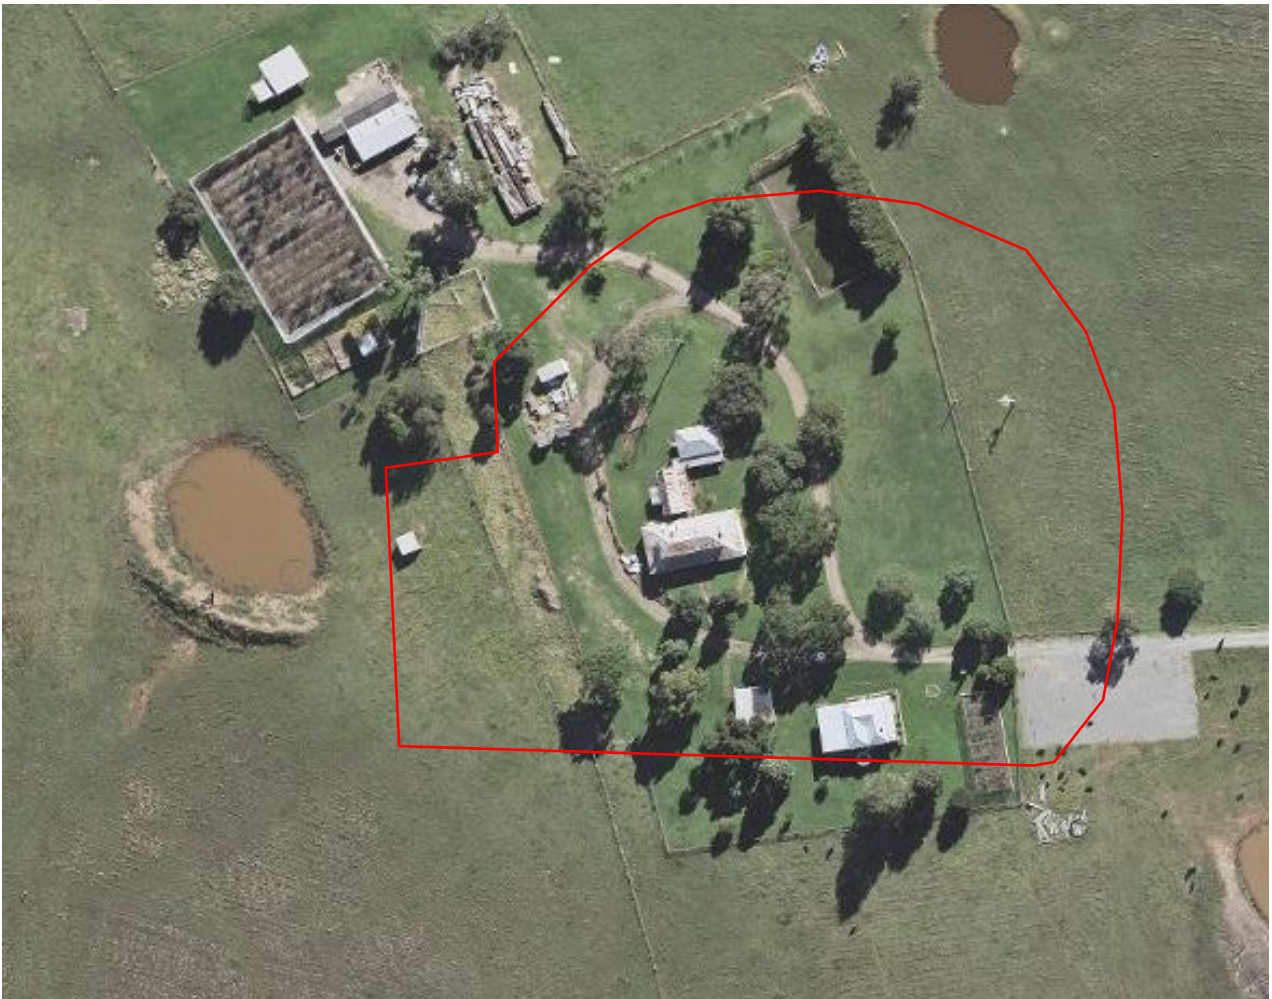
**Figure 5-1 The recommended heritage curtilage of Meadowvale**

The curtilage needs to be large enough that the homestead becomes a local landmark and has a viable use. The recommended curtilage above has an area close to 2 ha. With the hilltop included within the curtilage, there is potential for Meadowvale to become a local landmark in a subdivision.
