Staff Road Workers Houses

Heritage Assessment

Prepared for Boral Recycling Pty Ltd
12 April 2023 – Final Report

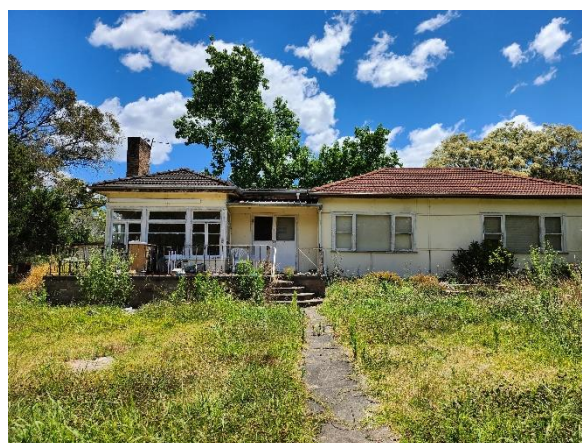
Figure 4. Front façade of 3 Staff Road. The north-eastern extension is clearly visible to the right.

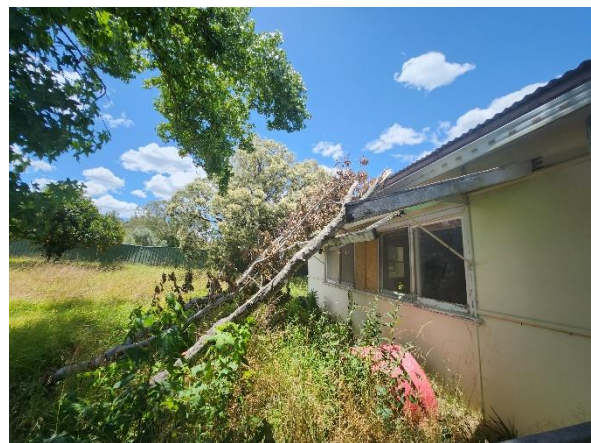
Branches have fallen off the mature plane tree at the rear of the house. This has damaged the eaves and awning at the rear of the house (see Figure 10). One window is missing at the rear of the cottage and has been boarded up.

Figure 10. View to rear of dwelling.

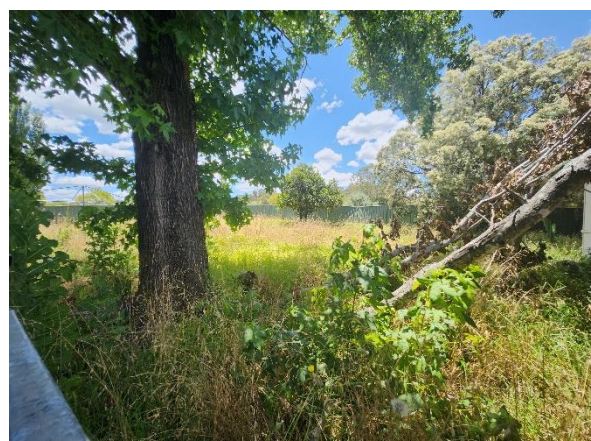
Figure 12. Overview of rear yard, showing overgrown nature of landscape.

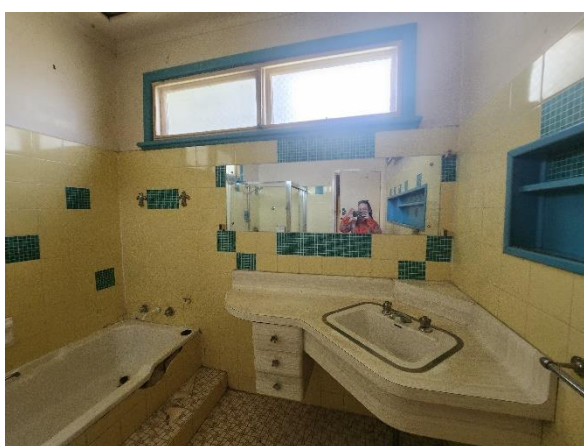
Internally, the house shows signs of general wear and tear including ripped carpet and linoleum, broken tiles in the bathroom and mould growth. Extensive mould growth was visible in the bathroom.

Figure 21. Overview of bathroom.

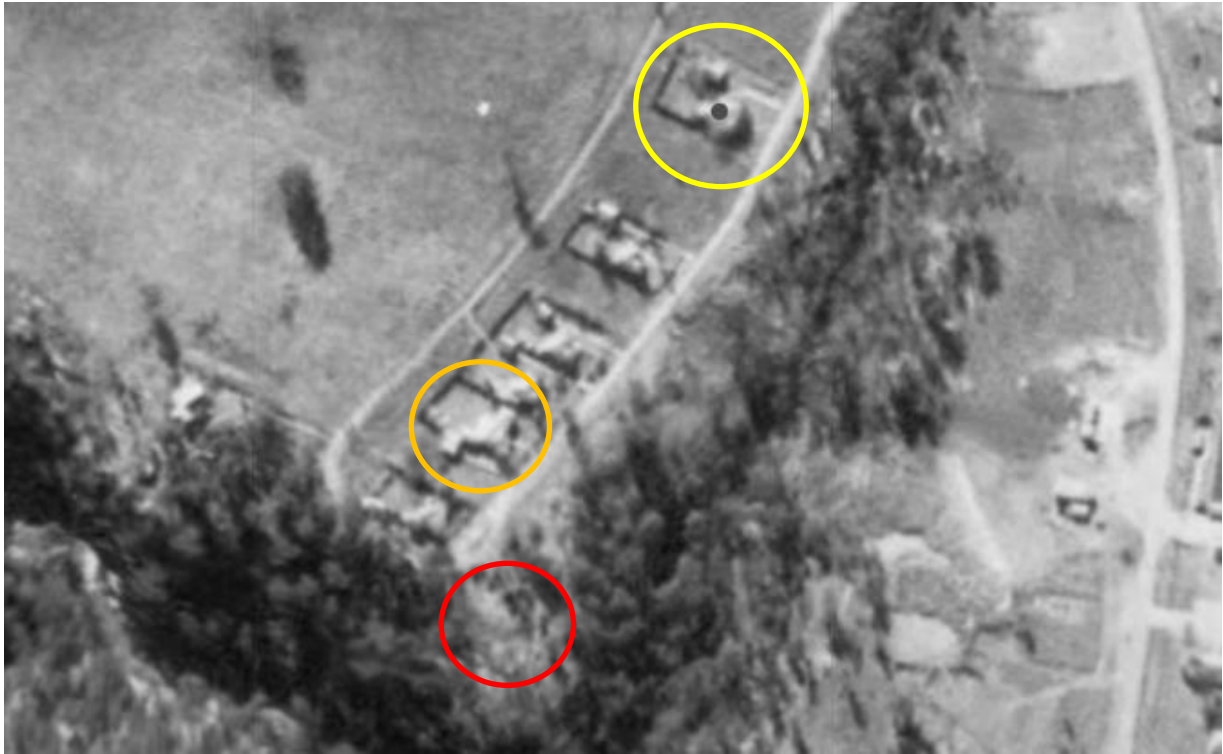
Historical aerial photographs show that the former managers cottage was constructed between 1969 and 1972 (Figure 43 and Figure 44). The former managers cottage was demolished by 2018 (Figure 42).

Figure 43. Historical aerial photograph showing Staff Road, 1969. Indicative location of former managers cottage outlined in red. No. 10 Staff Road outlined in yellow and No. 3 is outlined in orange. *Source:* Historical Lands Viewer.

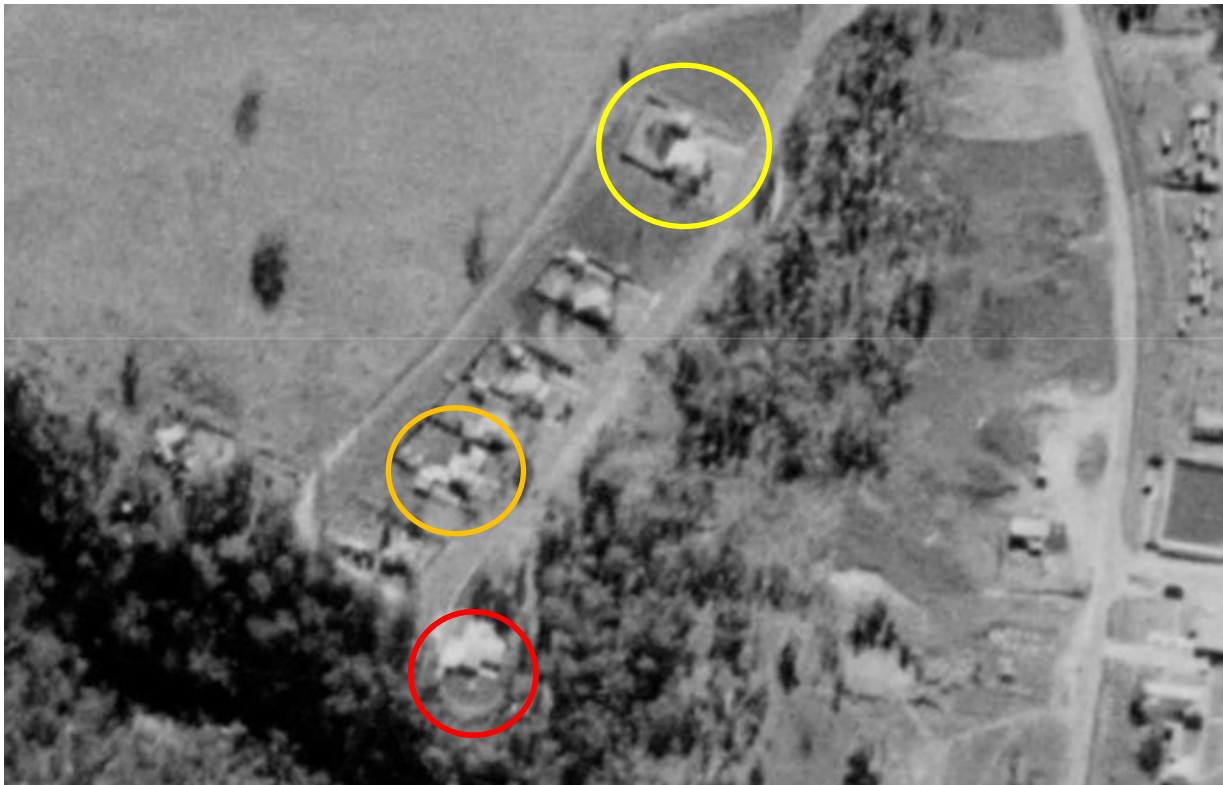
Figure 44. Historical aerial photograph showing Staff Road, 1972. Location of former managers cottage outlined in red. No. 10 Staff Road outlined in yellow and No. 3 is outlined in orange. *Source:* Historical Lands Viewer.

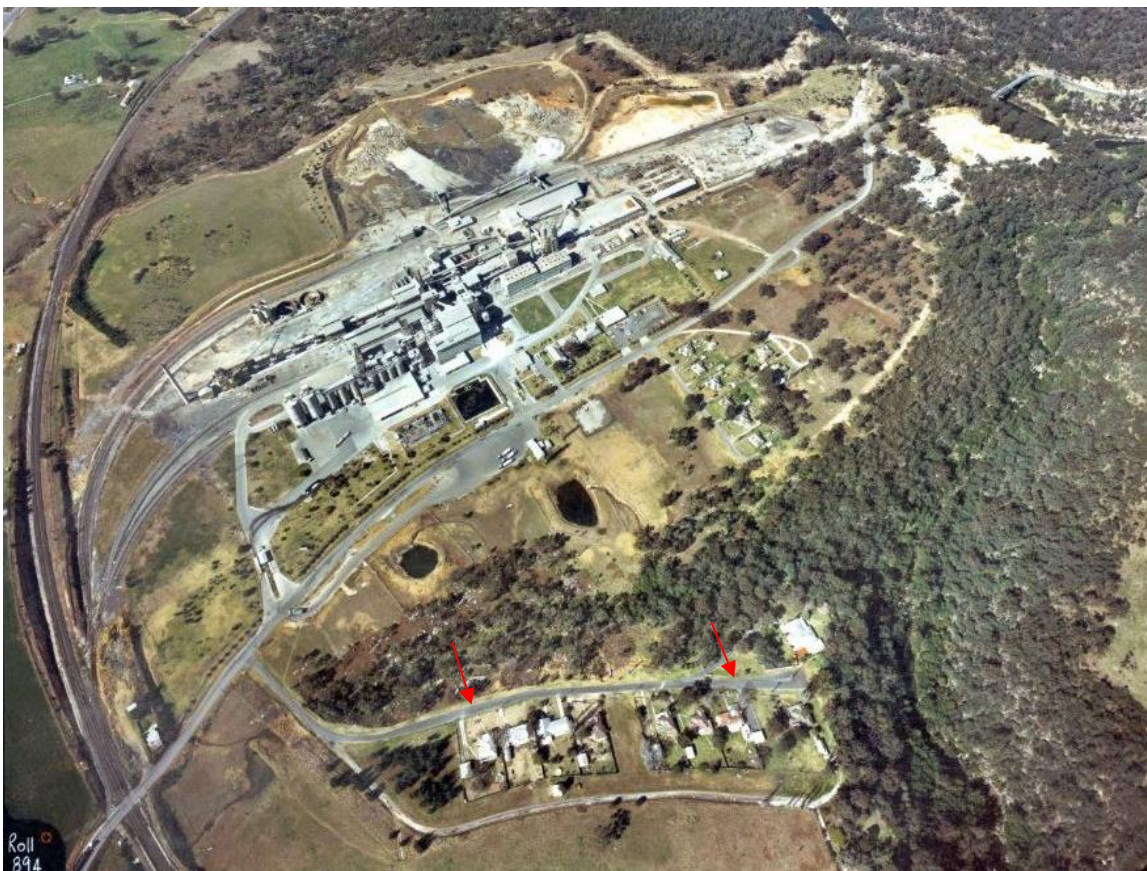
Figure 47. Oblique aerial, 1985. Staff Road is in the foreground. 3 and 10 staff Road are indicated with a red arrow. The managers cottage is located at the far right, on the north side of Staff Road. *Source:* Boral Cement Ltd.

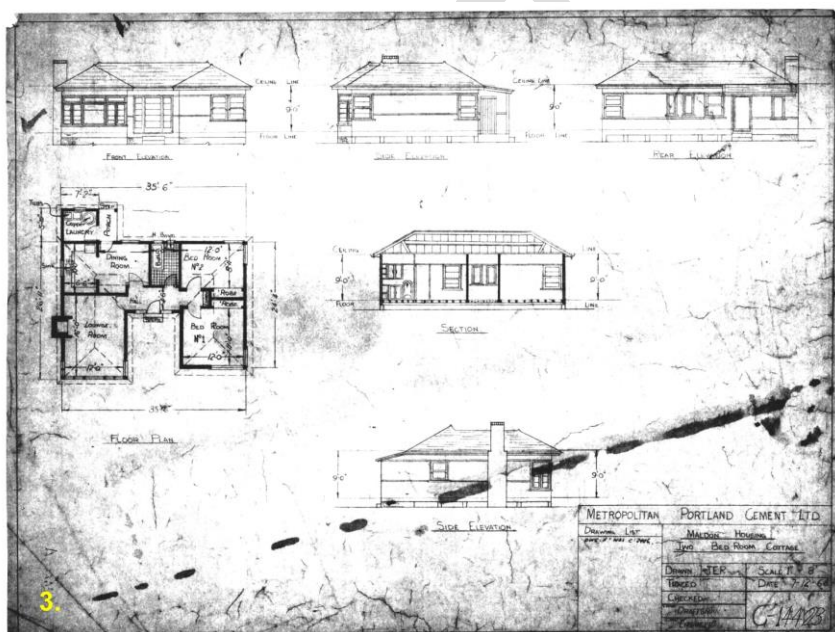
Image caption	Image 18. Architectural drawing for 'Metropolitan Portland Cement Ltd, Maldon Housing, Two Bedroom Cottage', dated 7 December 1966 (James Whitfield). Potentially for alterations to 3 Staff Road.				
Image year	1966	Image by	Picton & District Historical and Family History Society Inc Facebook page, posted 28 November 2021	Image copyright holder
